Shepherds Farm, Tunstall, Suffolk

Archaeological Record

**Shepherds Farm,
Woodbridge Road,
Tunstall, Suffolk**

An Archaeological Record

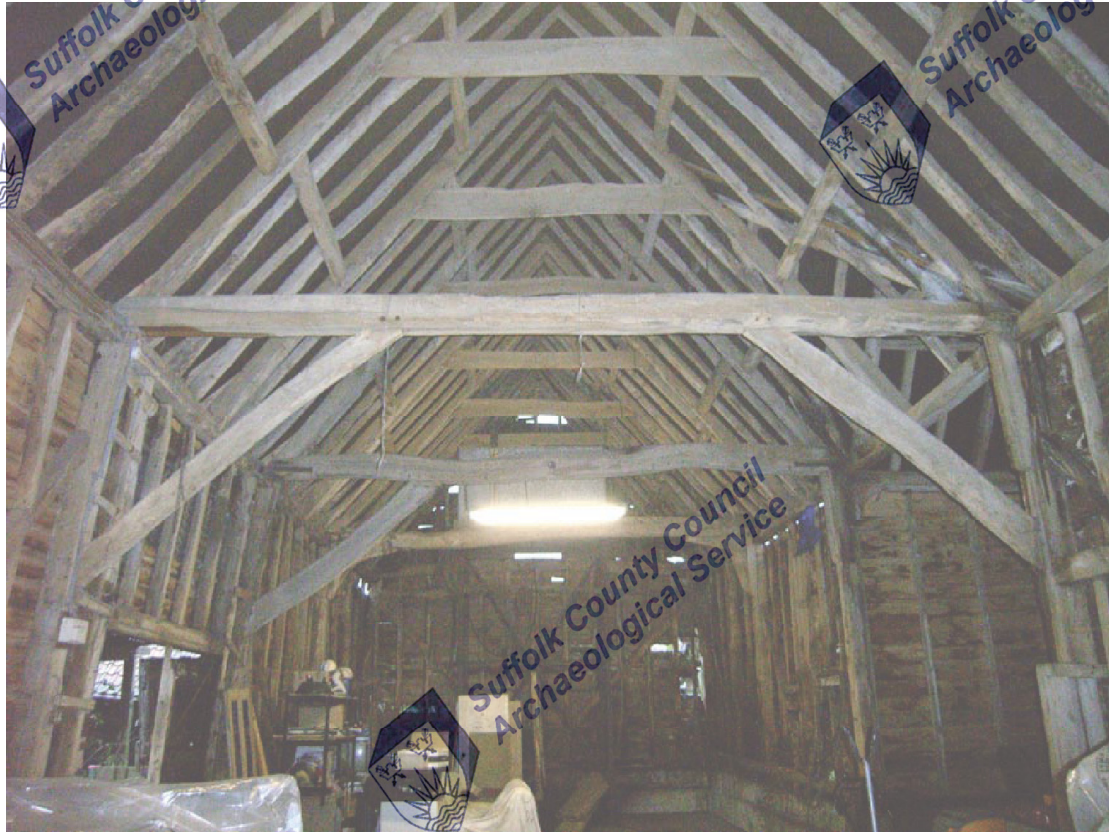
A2.3 Barn (1) Roof structure from south showing original arch-braces flanking central bay

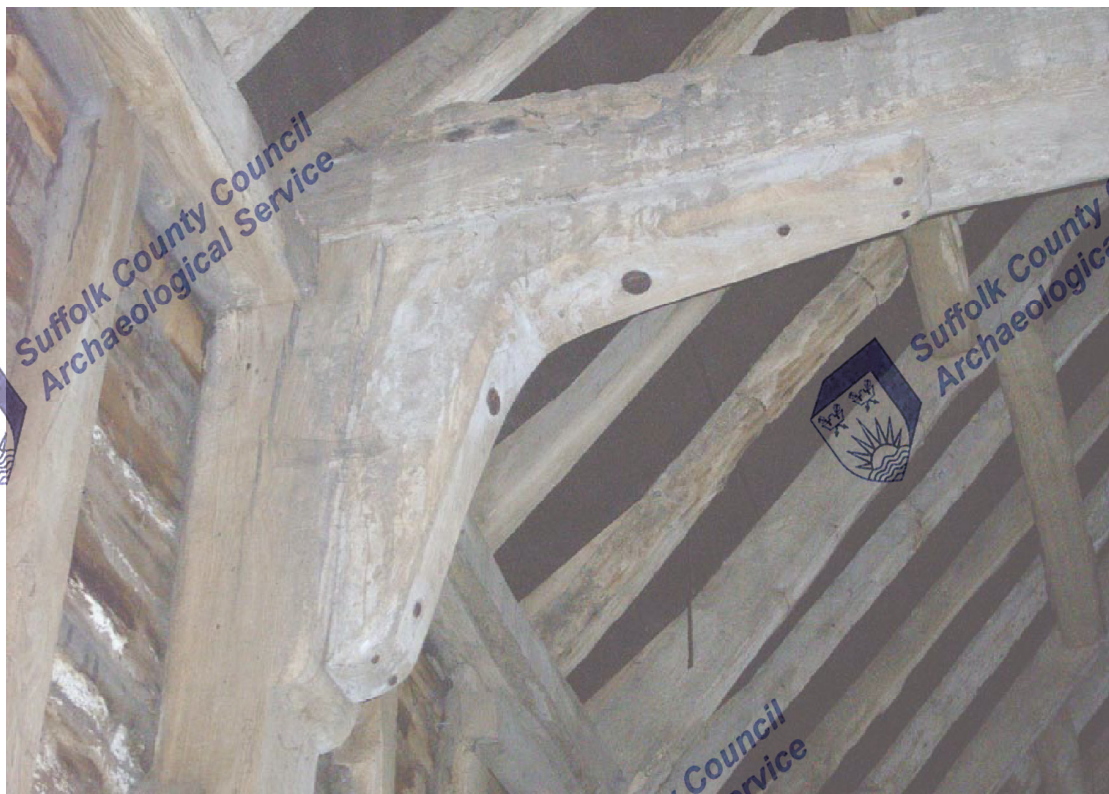
A2.4 Barn (1). Detail of the original jowl and bolted knee-brace in the open truss dividing the two northern bays, seen from the north

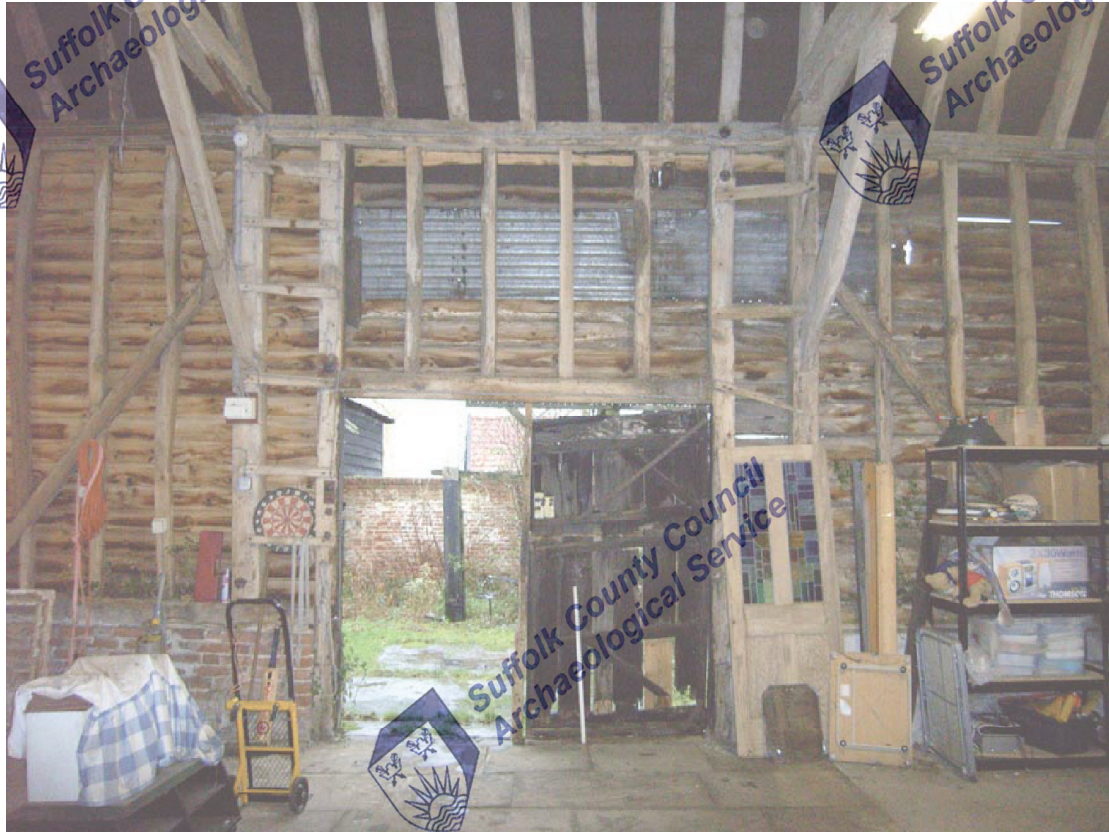
A2.5 Barn (1). Interior of central bay showing original wide, low door to west

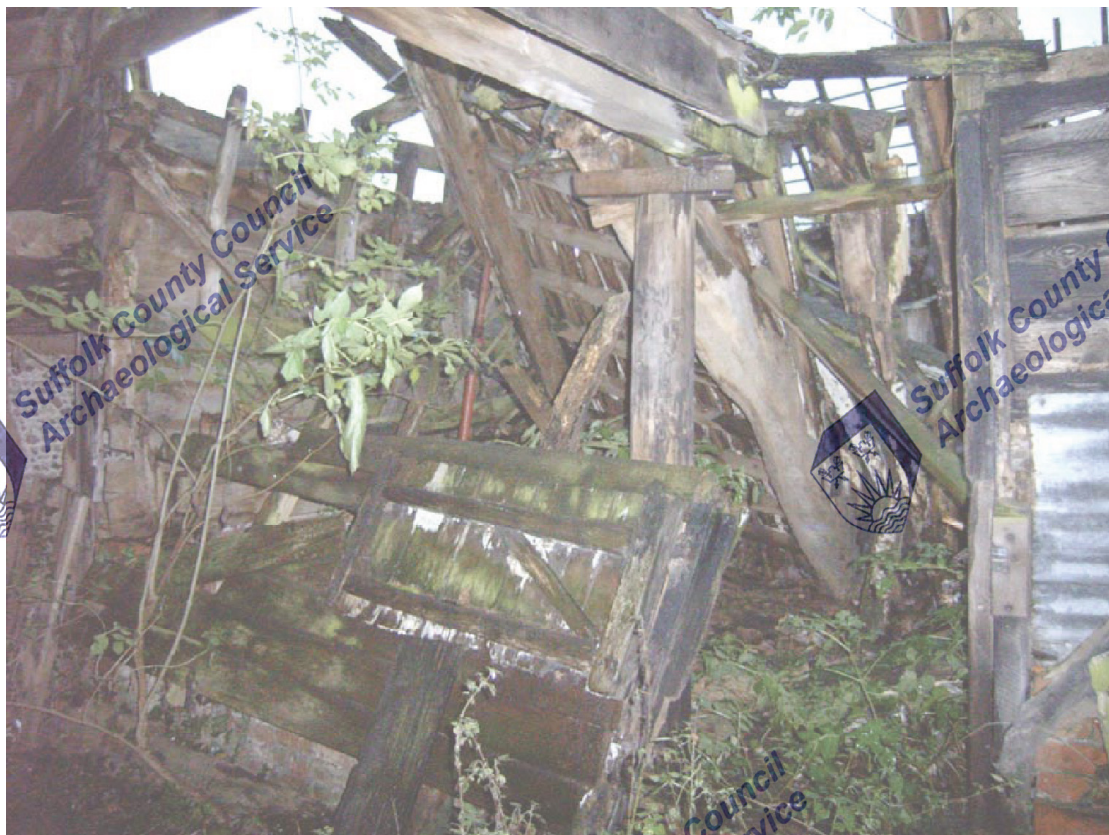
A timber-framed and weatherboarded axial stable and hay loft (2) extends by 5.5 m (18 ft) from the barn's northern gable. Although built as a separate structure of lower height (approximately 3 m (10 ft) at the eaves) it appears broadly contemporary with the barn, but had collapsed prior to inspection leaving only fragments of its walls *in situ*. A narrow shed which probably operated as a tack room projects by approximately 2.5 m (8 ft) from its eastern elevation, extending beyond the plane of the barn, but close inspection was hampered by the unstable condition of the structure. The remains of a hay rack and boarded manger lie against the interior of the northern gable as indicated by a broken line in figure 5, and the stable was entered from the western yard by a doorway some 1.5 m from the corner of the barn.

A2.6 Exterior of collapsed stable (2) from west showing position of entrance door to right

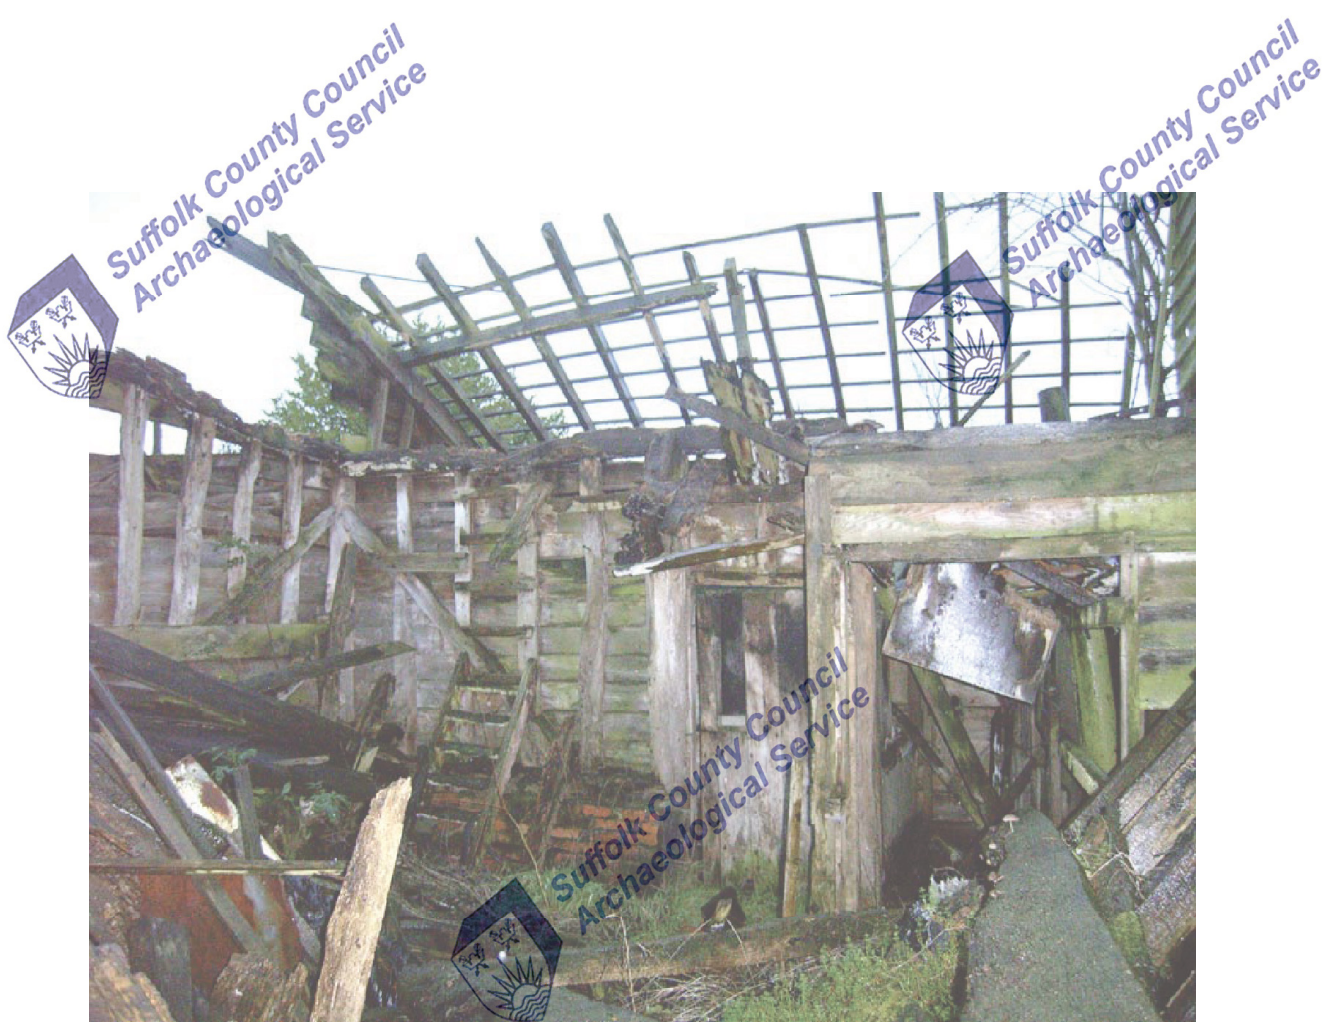
2. Early-19th century timber-framed and weatherboarded stable with hay loft (collapsed). Hay rack and manger to interior of northern gable. A probable tack room projects from the eastern elevation (2a) but this had collapsed beyond recognition prior to inspection along with a probable shelter shed in the same direction.

A2.7 Interior of stable (2) showing eastern elevation with door to collapsed shed (2a) to right

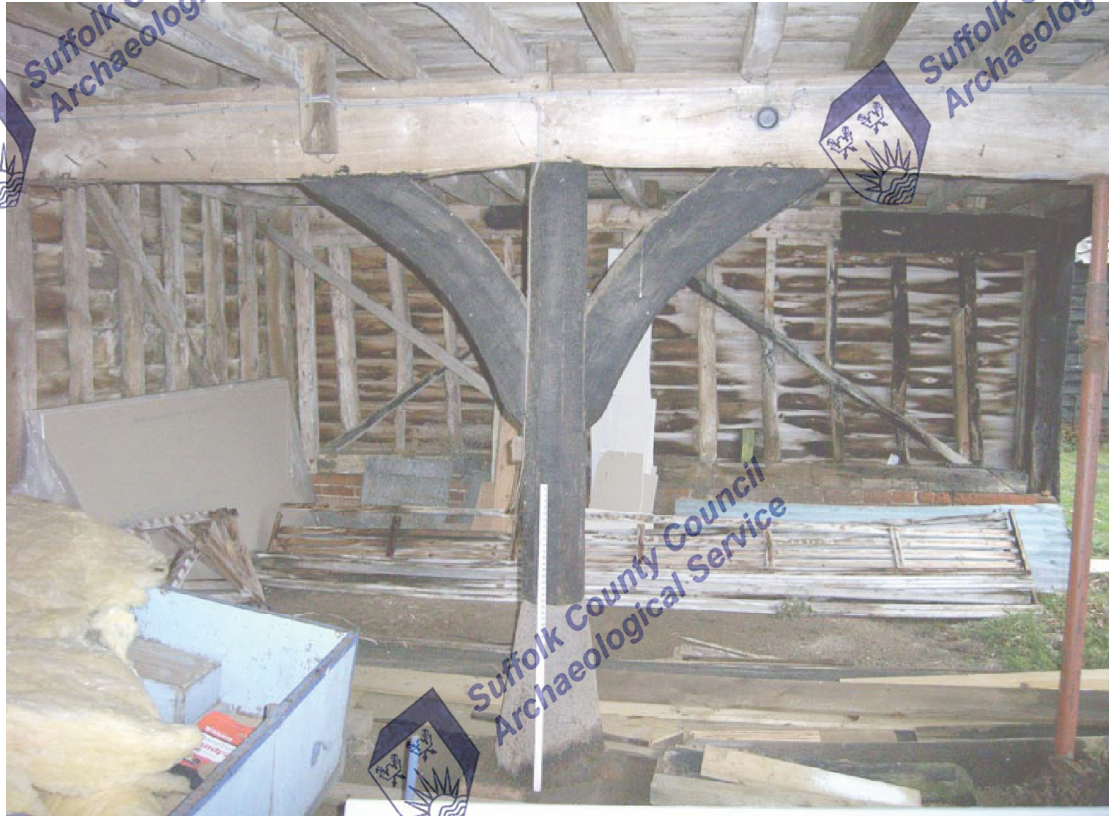
The arcade posts of the southern elevation are linked to the mid-rails by curved knee-braces, but large arch-braces radiate from the two axial Sampson posts which support the binding joists. Unusually, these posts are octagonal in section, and rest on equally unusual conical bases of hollow iron that probably represent secondary insertions; their resemblance to medieval crown-posts is striking, but the timbers have not been re-used and the braces are bolted rather than tenoned to the structure. The western bay contains a 20th century ceiling and is shown as a separate compartment in figure 1. The walls contain primary braces and are of similar style to those of the barn, with a tall plinth of red brick. An external stair against the eastern gable leads to the undivided granary above, which lacks any evidence of grain bins. Its use as a granary is confirmed by the survival of original lath-and-plaster between the studs of the rear, northern elevation, and by the heavy bracing of the floor (with inverted bolted knee-braces). The studs of the front, southern elevation are softwood replacements of the 20th century. The clasped-purlin roof structure is an original feature, and the building survives largely intact from the early-19th century.

A2.9 Cartlodge (4). Interior from west showing the one of the two unusual octagonal Sampson posts with arch-braces to the binding joists and conical iron bases

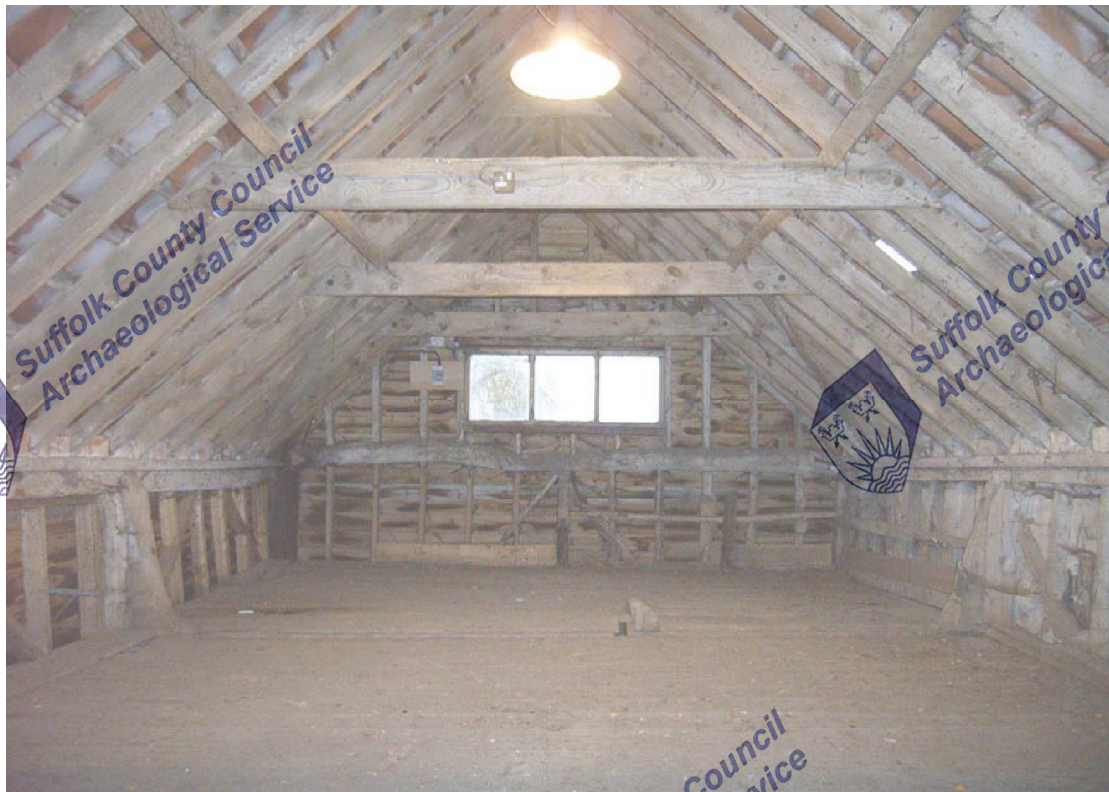
A2.10 Cartlodge (4). Interior of the first-floor granary from its entrance door in the eastern gable, showing inverted knee-braces to the floor joists and original plaster to the right
