**The Barn,  
Homestead Farm,  
Low Common Road,  
Ashill, Norfolk  
NHER 51882**

**Historic Building Record**

**The Barn,  
Homestead Farm, Low Common Road,  
Ashill, Norfolk**

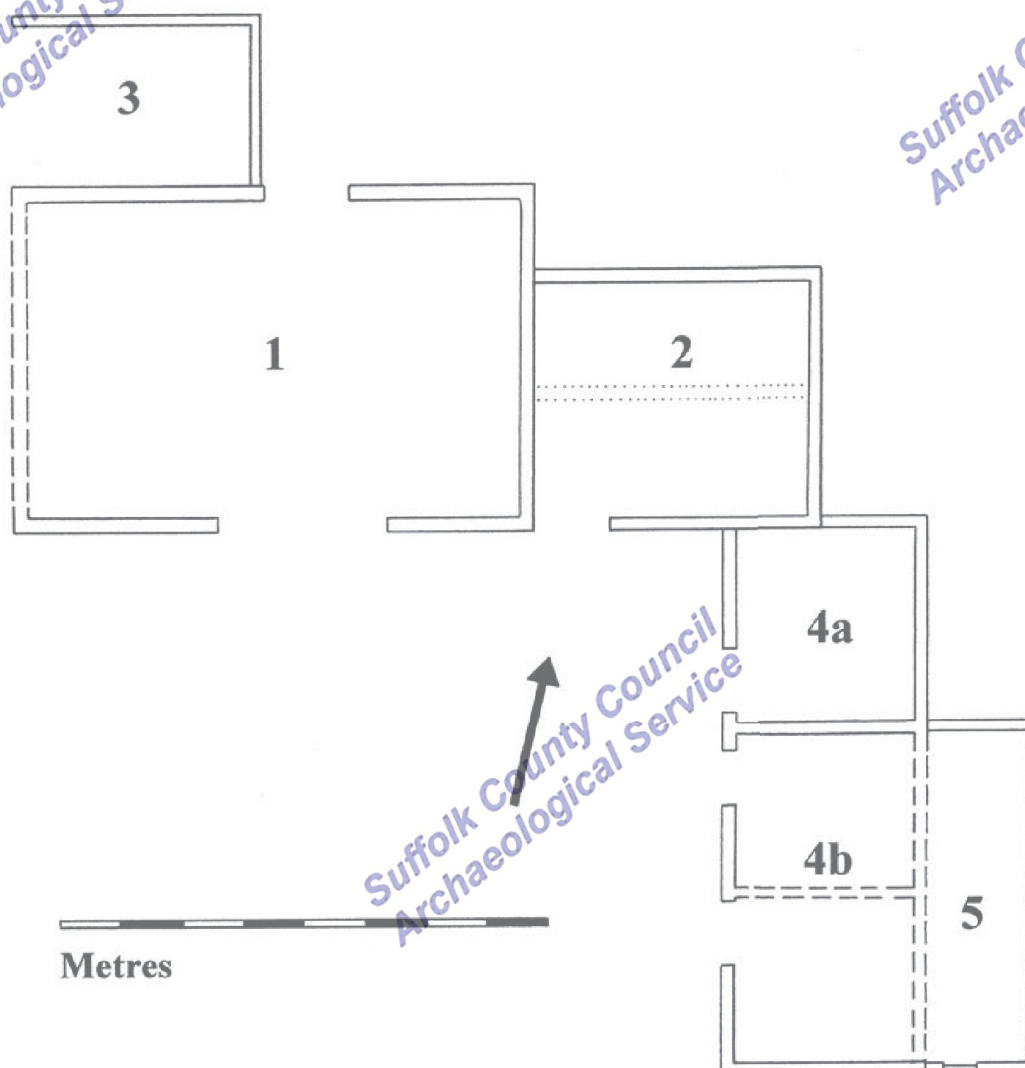
**Figure 3**

Schematic block plan of historic buildings, showing their original layout and numbering each for ease of reference in the text and photographic record. Broken lines indicate walls that have been removed or rebuilt

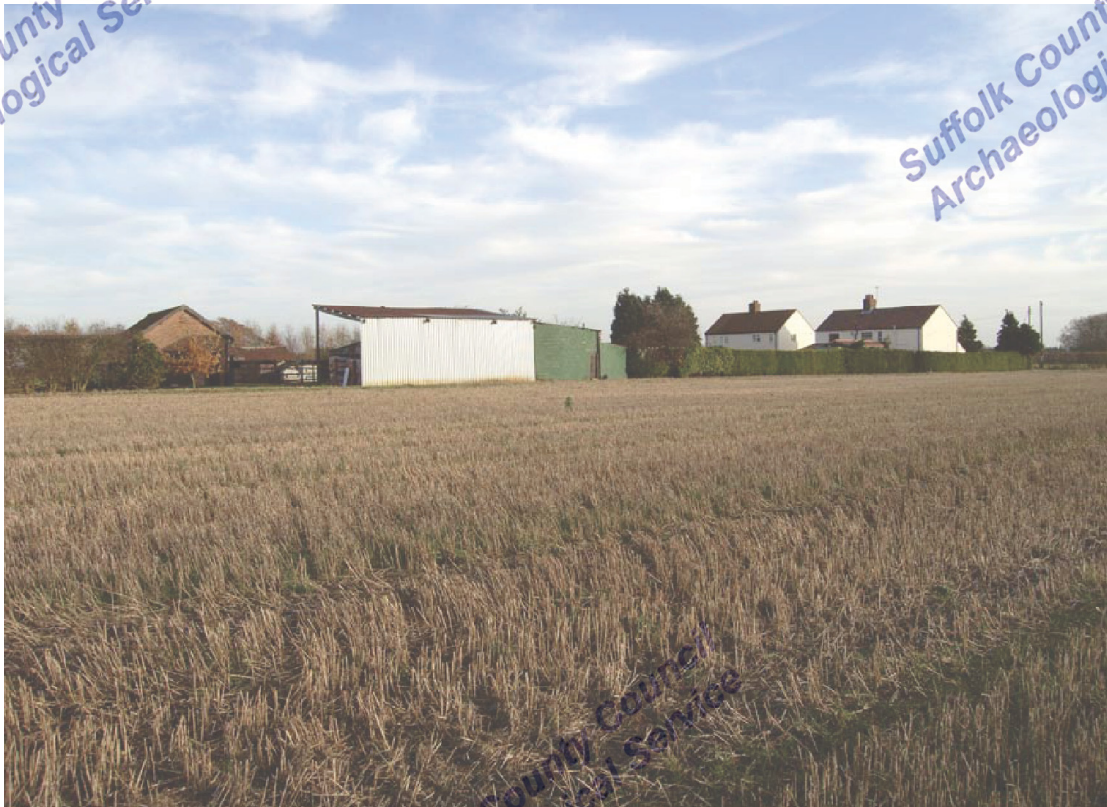
A2.1 General view of site from north-west showing barn (1) left with 20<sup>th</sup> century vehicle shelter in centre and Homestead Farmhouse to right

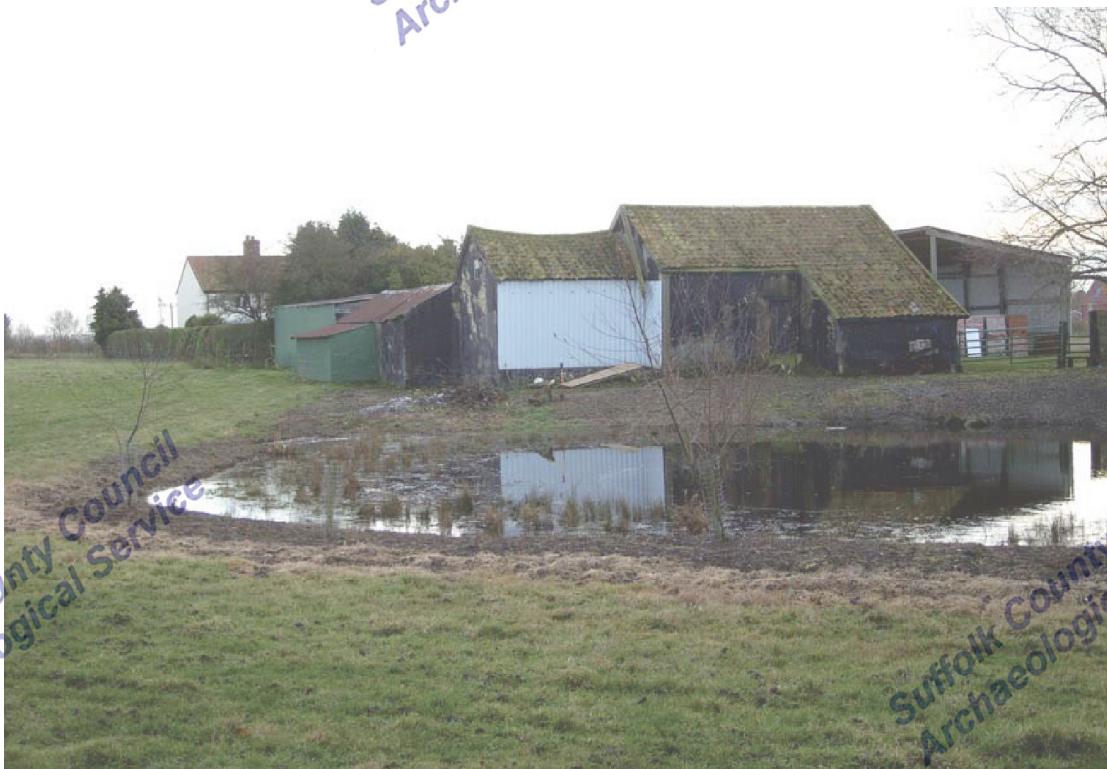
A2.2 General view from north showing the proximity of the pond to the farm buildings (the neathouse (2) is shown in the centre, the barn (1) to the right and the loose boxes (4) left

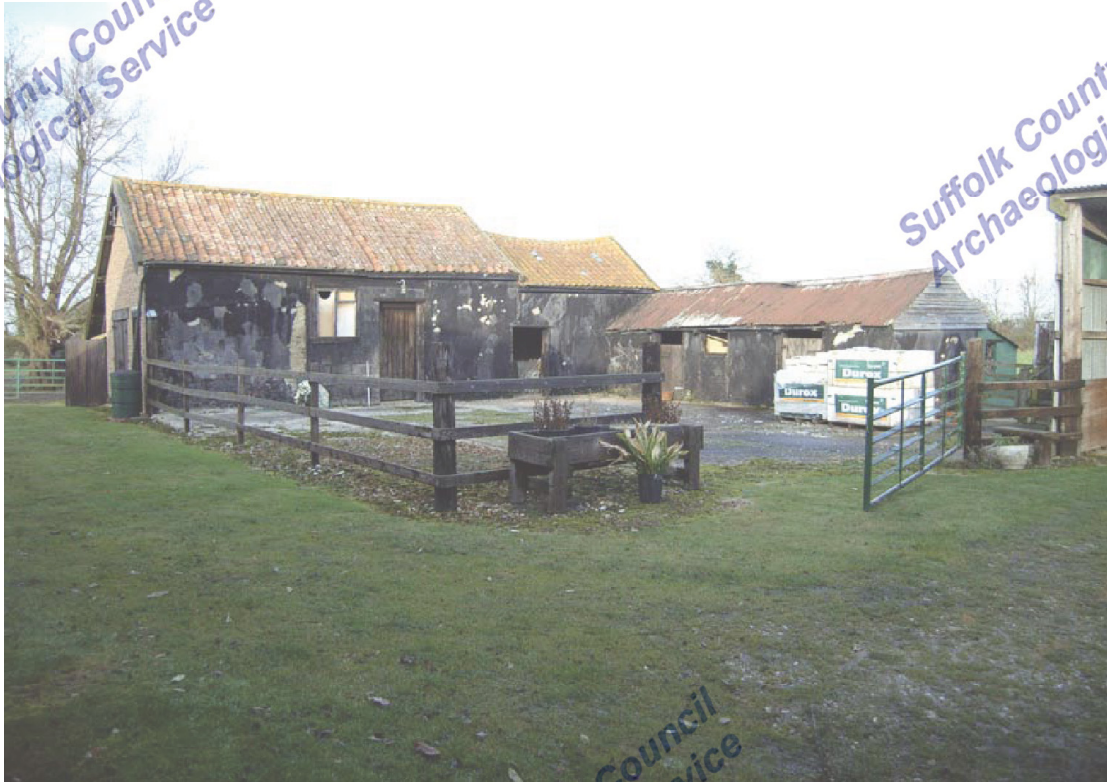
A2.3 General view of the yard complex from the south-west showing the barn (1), neathouse (2) and loose boxes (4) from left to right respectively

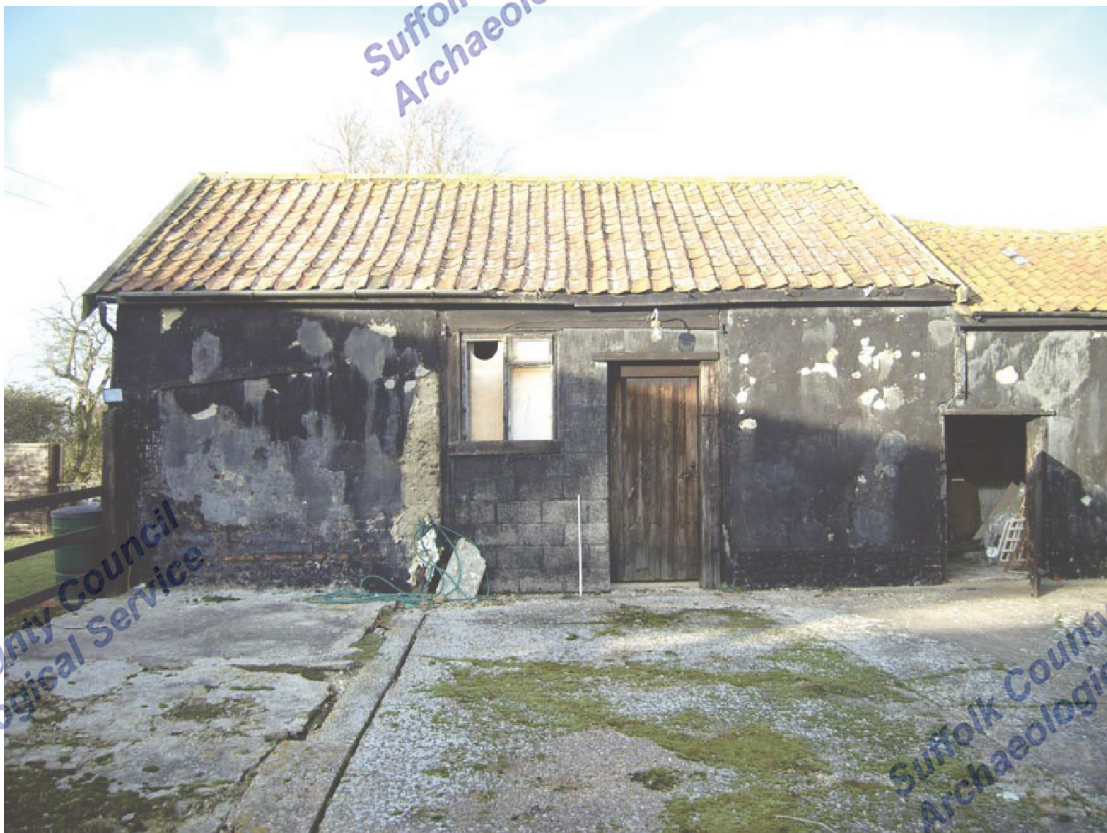
A2.4 Southern external elevation of the barn (1) showing its partly blocked central entrance with scar of demolished shelter shed to left and door of neathouse (2) to right

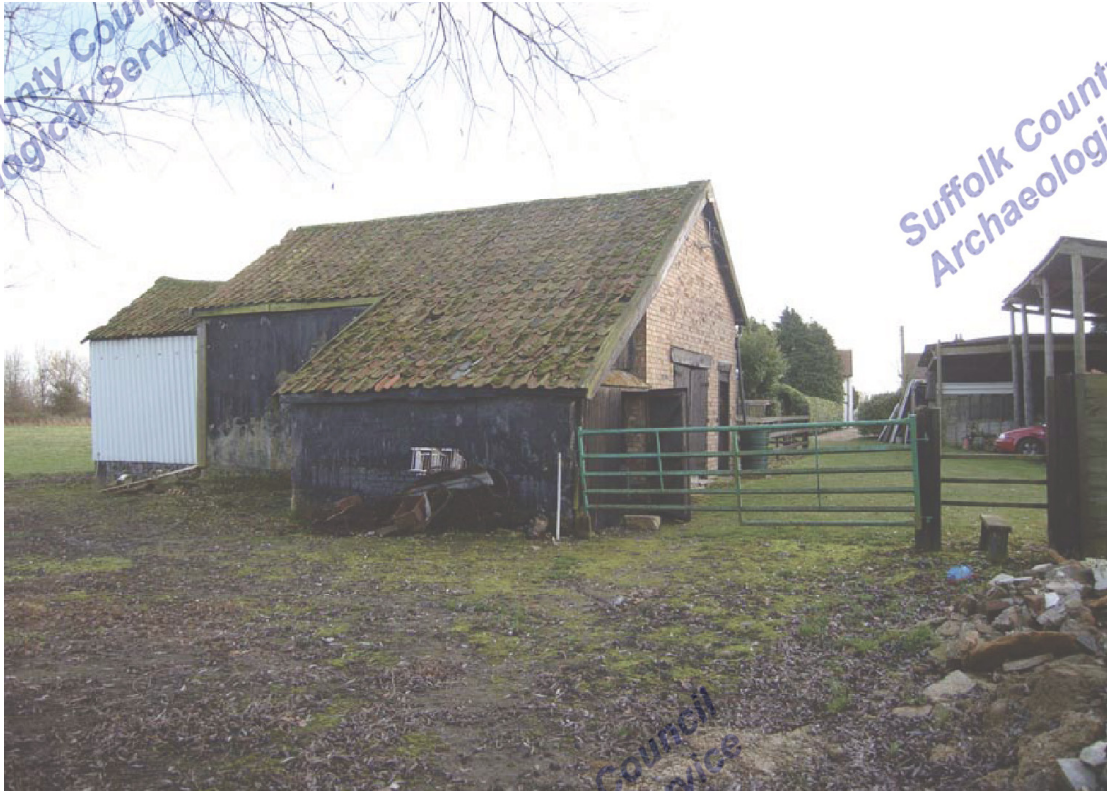
A2.5 General view of complex from north-east showing the barn (1) to left, with neathouse (2) beyond, and the entrance to the site from Low Common Road to right

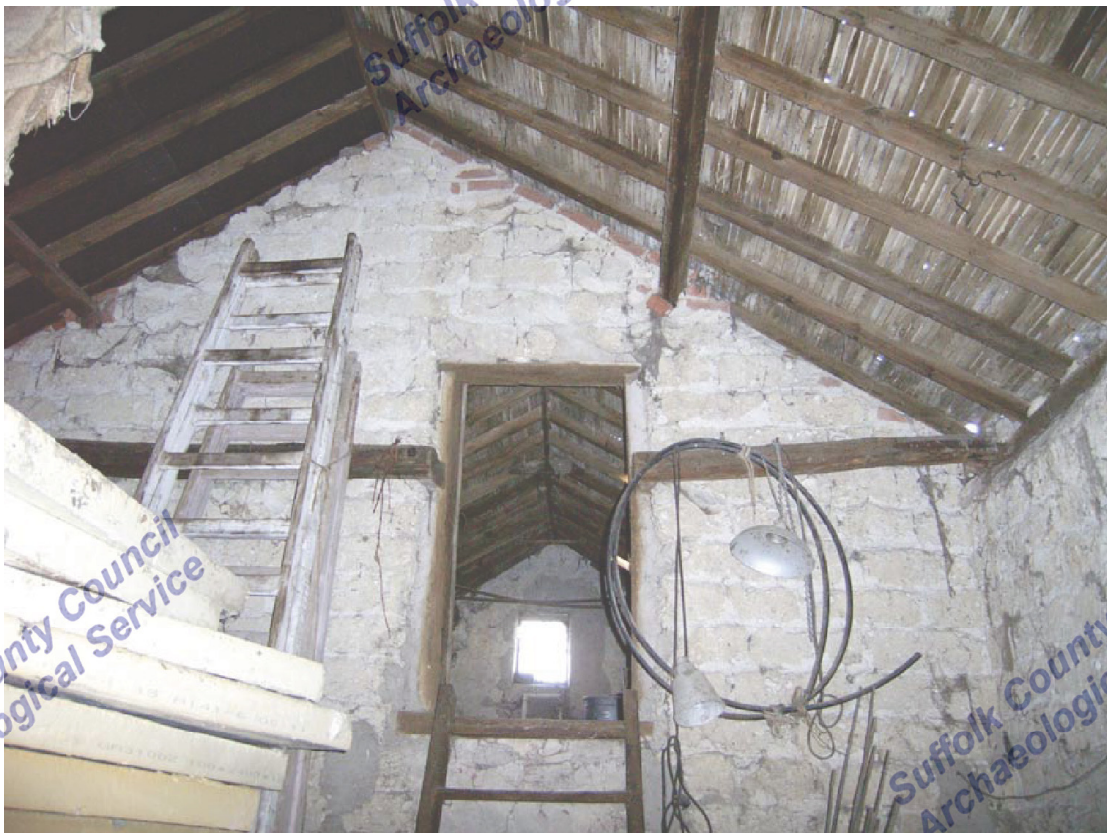
A2.6 Detail of the inserted access in the eastern gable of the barn (1) to the granary over the neathouse (2) interrupting the tie-beam and clay-lump fabric

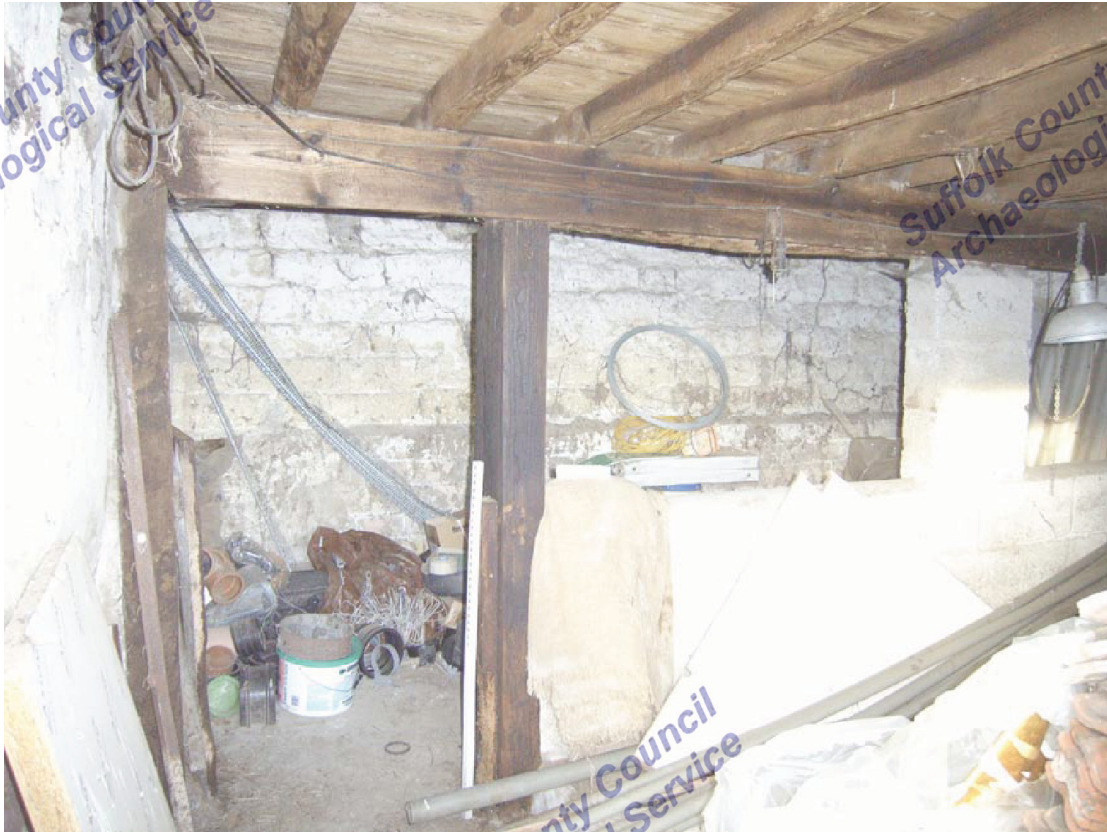
A2.7 Interior of the neathouse (2) from its southern entrance showing its low ceiling height and 20<sup>th</sup> century axial partition to the right

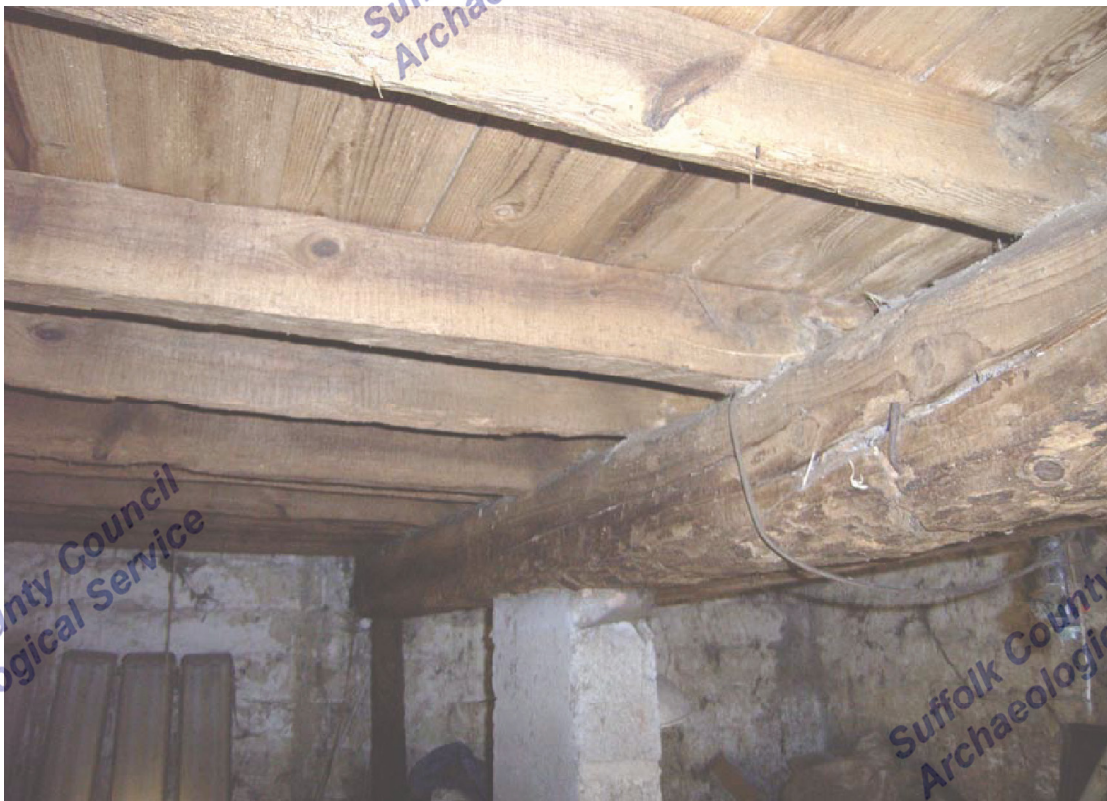
A2.8 Detail of the pine axial ceiling joist and lodged common joists in the neathouse (2) seen from the west

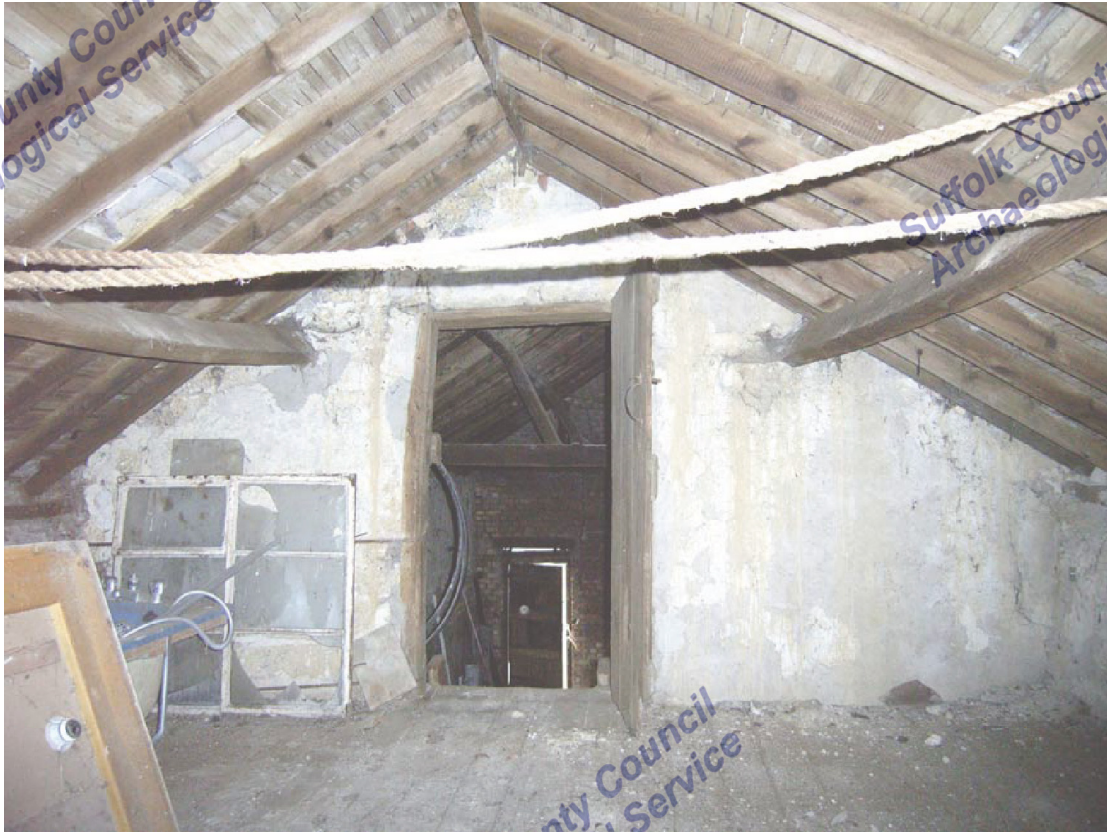
A2.9 Interior of the granary above the neathouse (2) from east showing the entrance door in the eastern external gable of the barn (1)

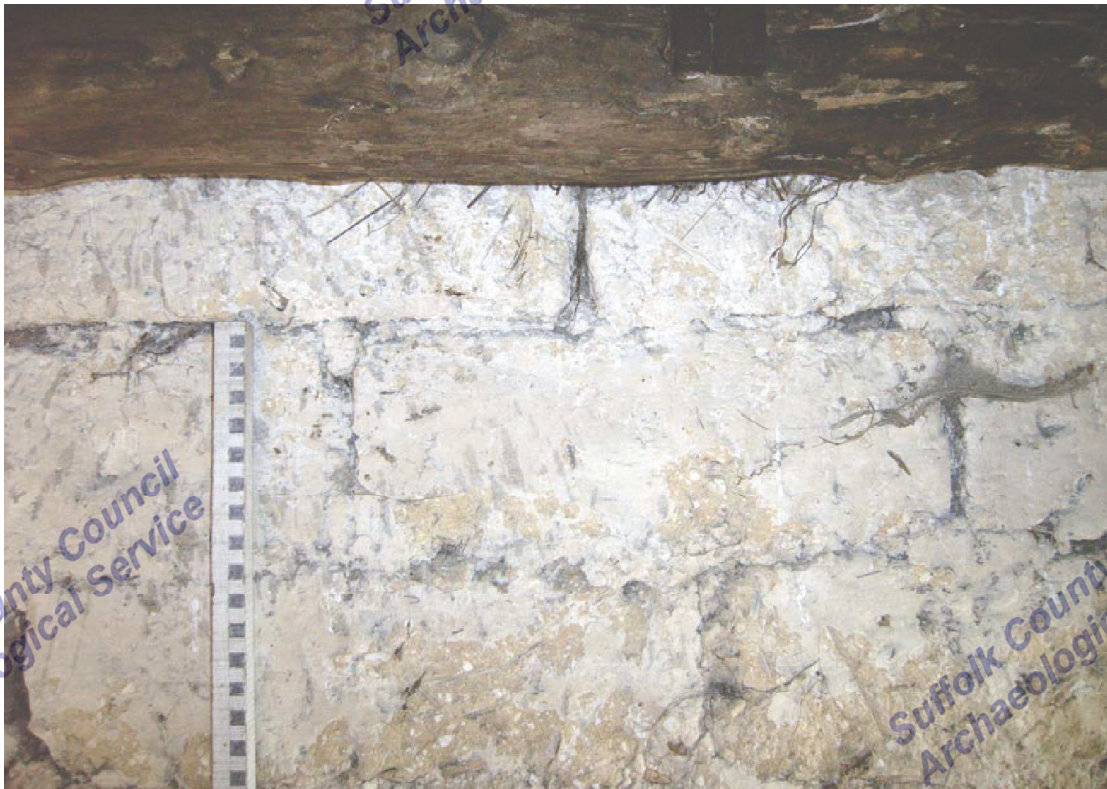
A2.10 Detail of the clay lump fabric in the southern gable of the loose box (4a) showing its pine tie-beam above
