**White Wheat Farm,
Baylham,
Suffolk**

Archaeological Record

**White Wheat Farm,
Upper Street,
Baylham, Suffolk**

An Archaeological Record

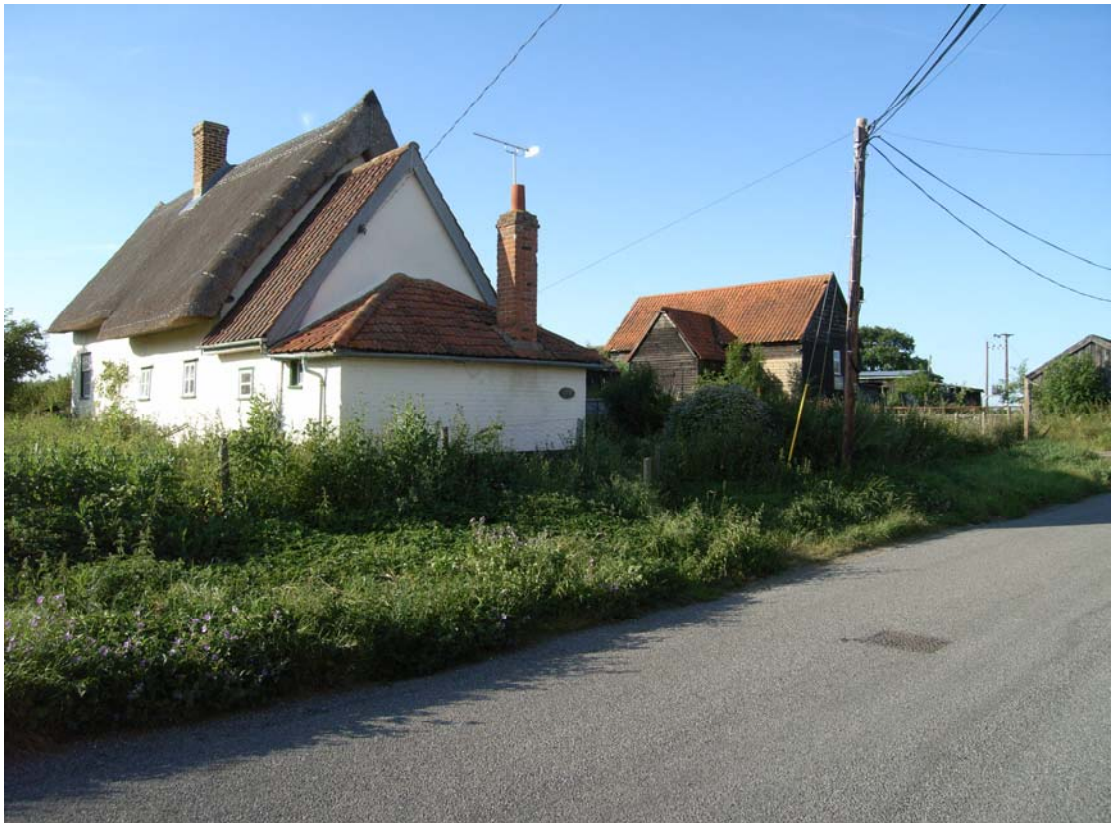
A2.1 General view from Upper Street to west showing listed farmhouse (10) left and barn (1) right

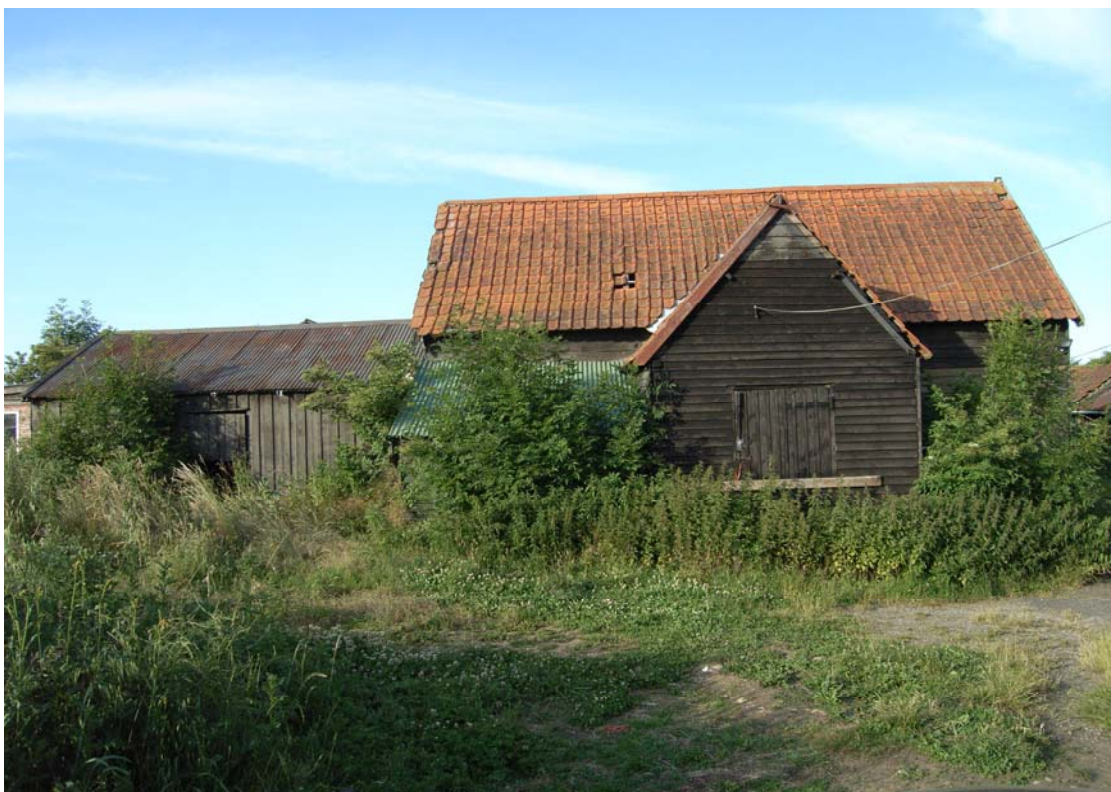
A2.2 Exterior of barn (1) from south-west showing shed (2) to left

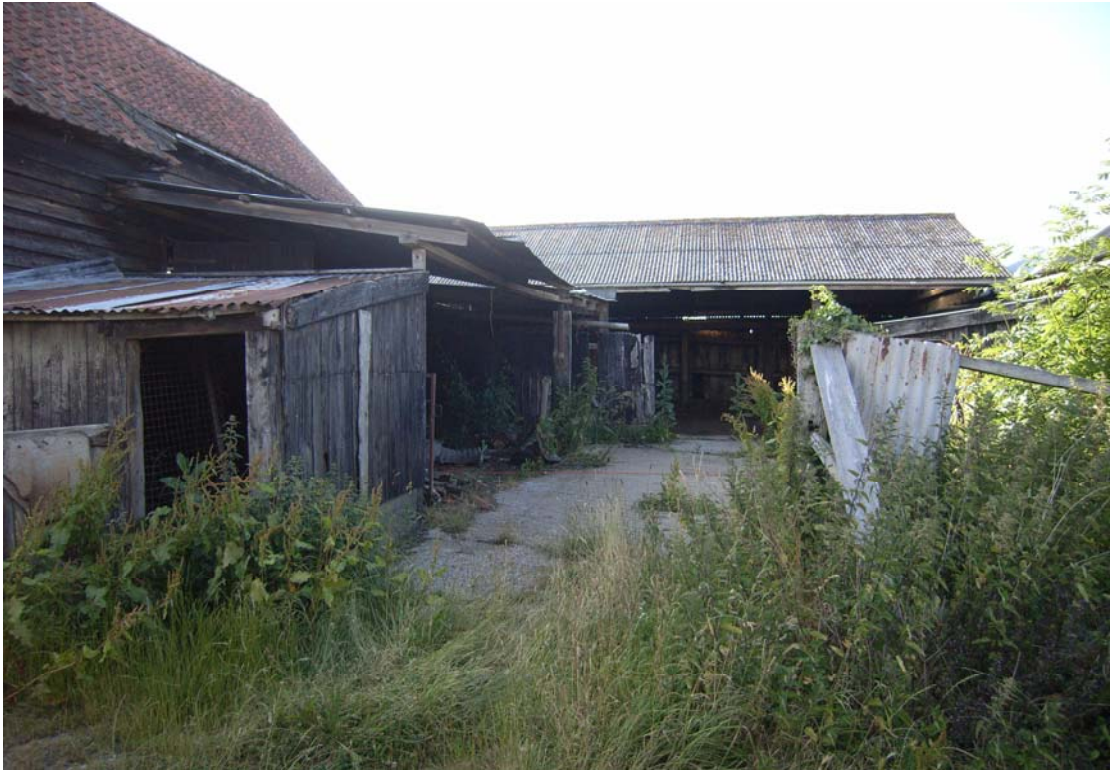
A2.3 Open yard to east of barn seen from south, showing barn (1) left with covered yard (3) in rear.

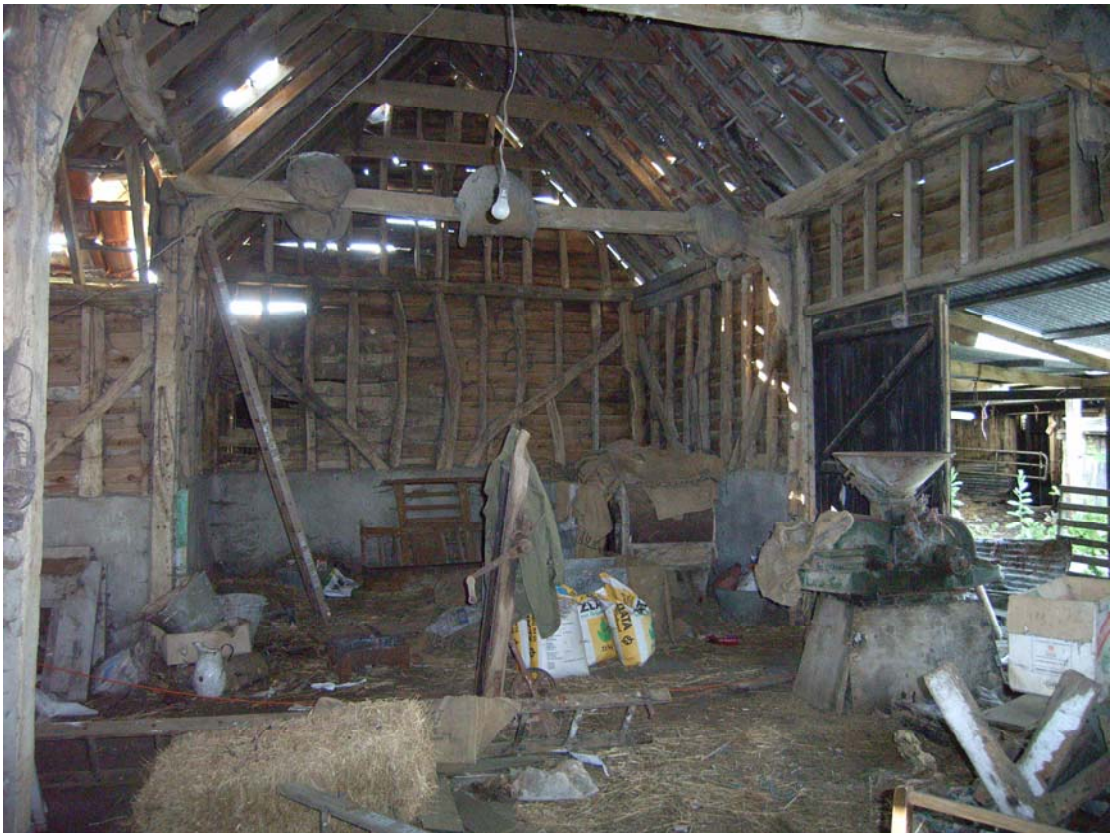
A2.4 Barn (1). General view of interior from southern gable showing entrance from eastern yard to right and porch to left

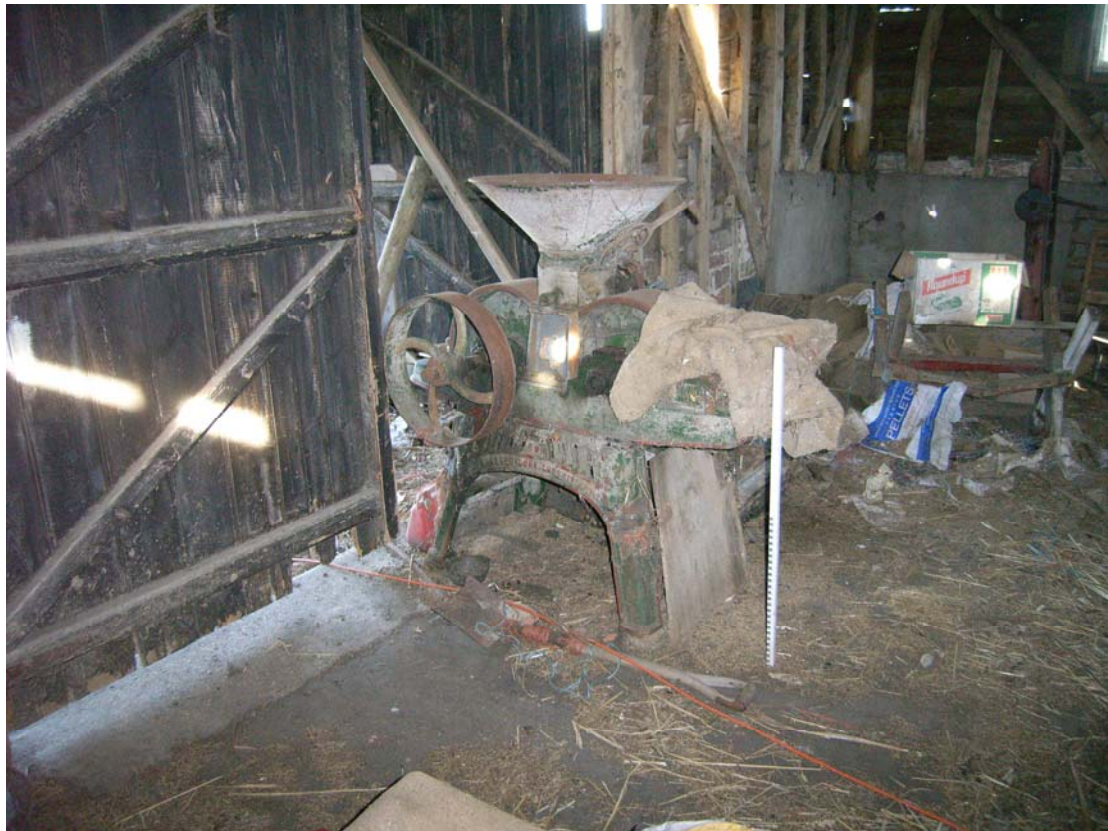
A2.5 Barn (1). R. Hunt corn crushing machine inside entrance viewed from north

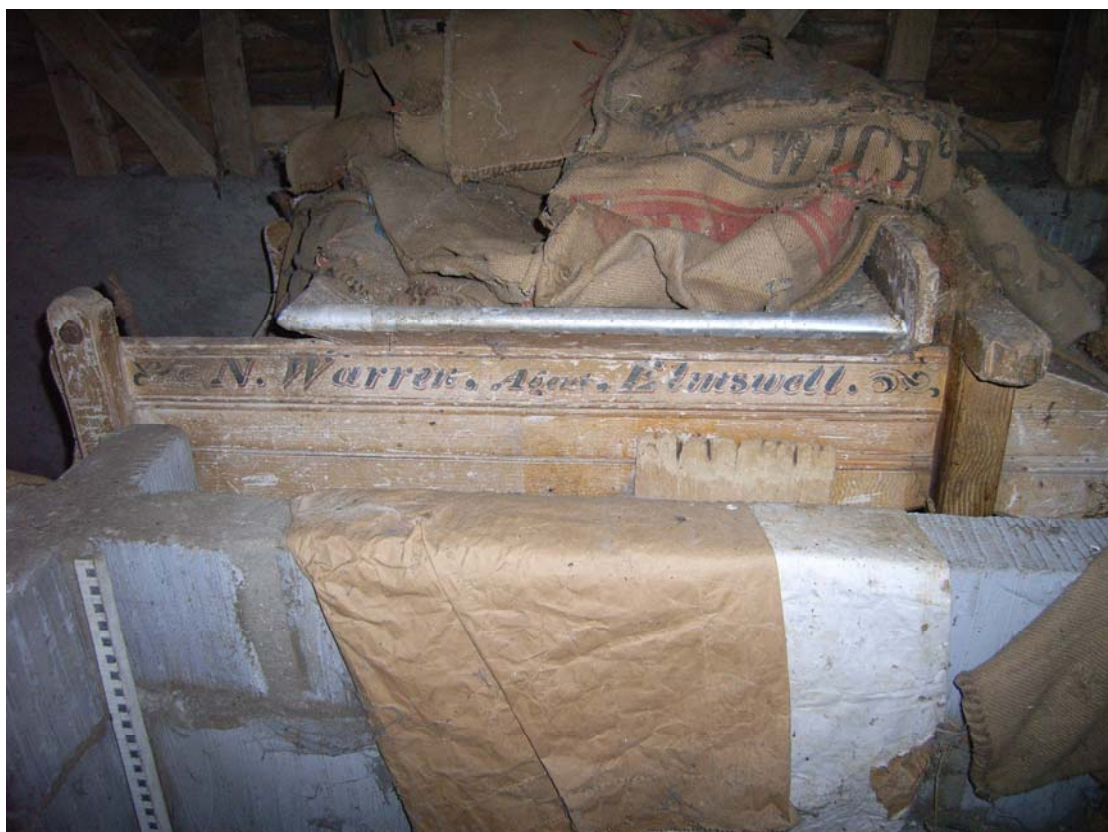
A2.6 Barn (1). Detail of painted name to side of 19th century mill to north of entrance: N. Warren Agent Elmswell

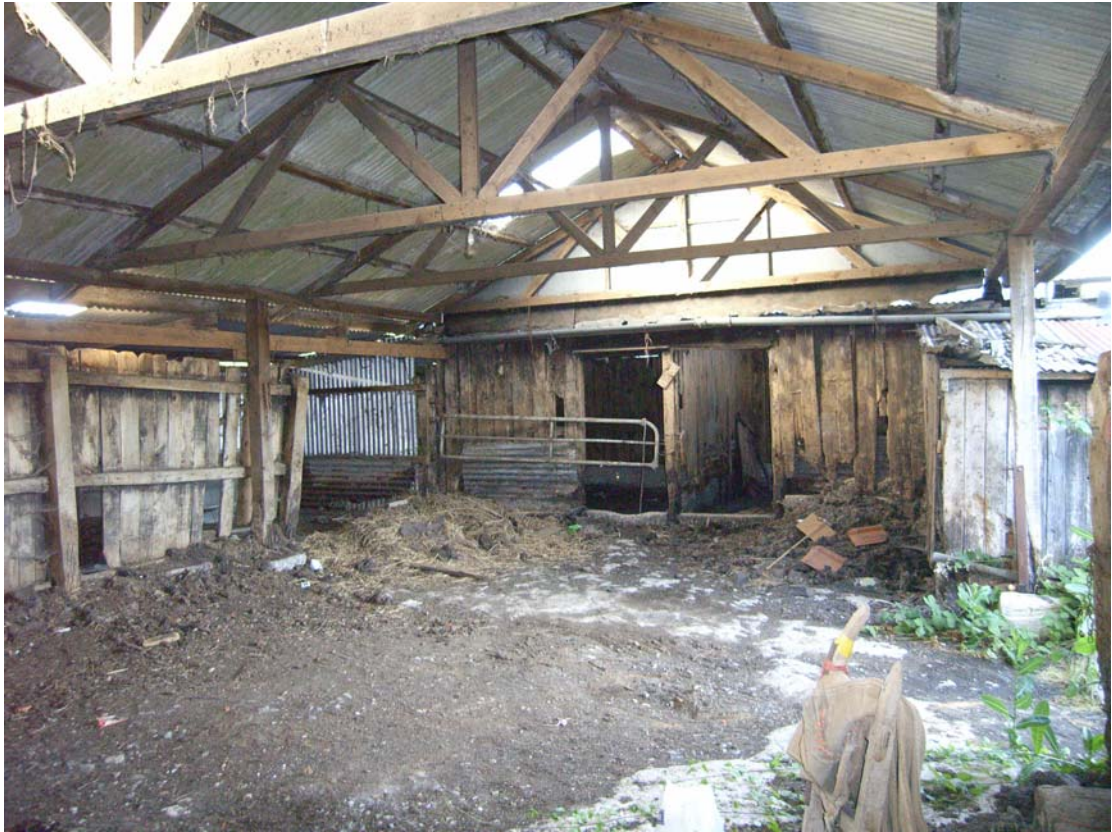
A2.7 Interior of covered yard (3) from west showing range of loose boxes (4)

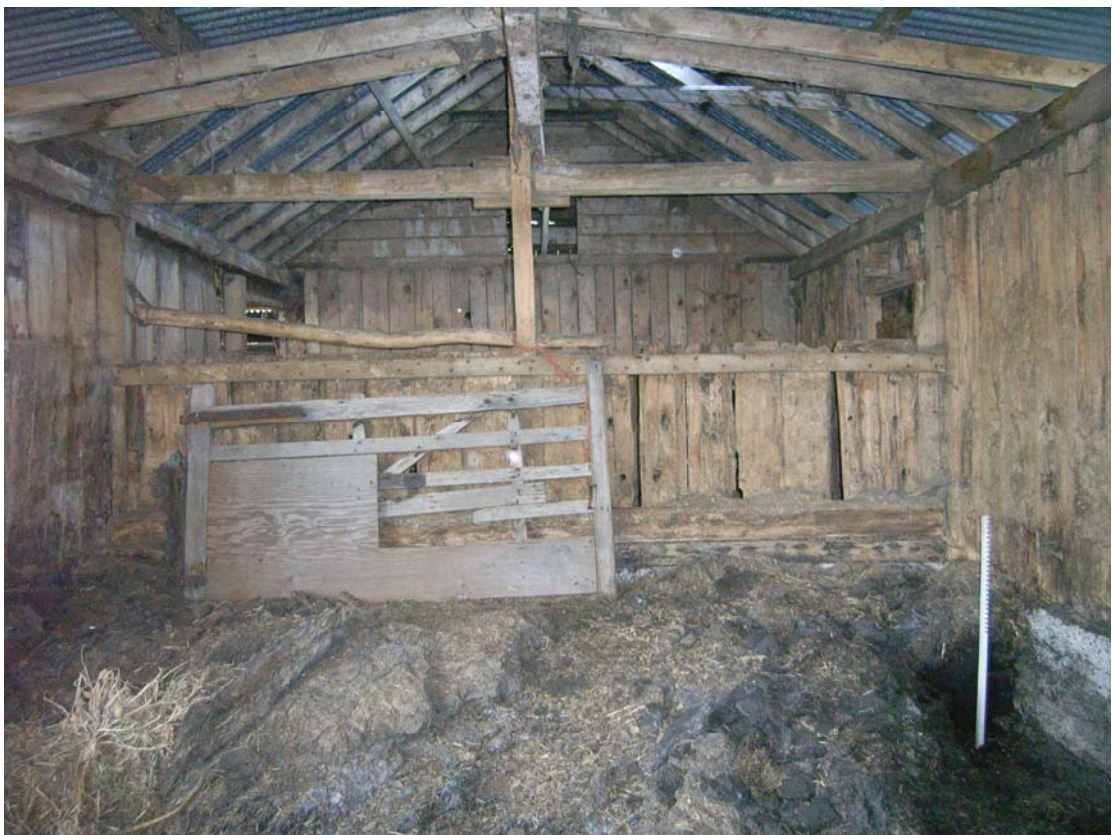
The long cattle shed which forms the eastern side of the former cattle yard alongside the barn also consists of boarded rails and is an addition of c.1900 which is shown on the Ordnance Survey of 1905 (but not that of 1884). It consists of a series of loose boxes or cattle stalls and retains a depth of manure belonging to the small herd of Murray Grey cattle kept here until recent years (information from an acquaintance of the present farmer, who was not available in person at the time of inspection). The shed of boarded rails which adjoins the barn’s northern gable is not shown on the Ordnance Survey of 1926 but was probably erected soon afterwards; it contains narrow central entrance doors in both eastern and western elevations and probably served as a storage shed or possibly a milking parlour, but lacks any relevant fixtures and fittings. The shed presently houses a series of chicken coops. A lean-to equipment shelter was added to the eastern elevation of the cattle shed in the mid-20th century, and various other improvised shelters and stalls were added to the yard. The northern end of the yard was provided with a roof at the same period, and various metal sheds were added to the east and north of the site during the second half of the century. The chief interest of the yard buildings lies in their relatively inexpensive boarded construction, which illustrates a type of structure found only smaller holdings that rarely survives the passage of time.

A2.8 Interior of southern loose boxes (4) from south, showing depth of cattle manure
