**Gissings Farm,  
South Green, Hoxne,  
Suffolk**

HXN 045

**Archaeological Record**

OASIS ID: suffolkc1-54017

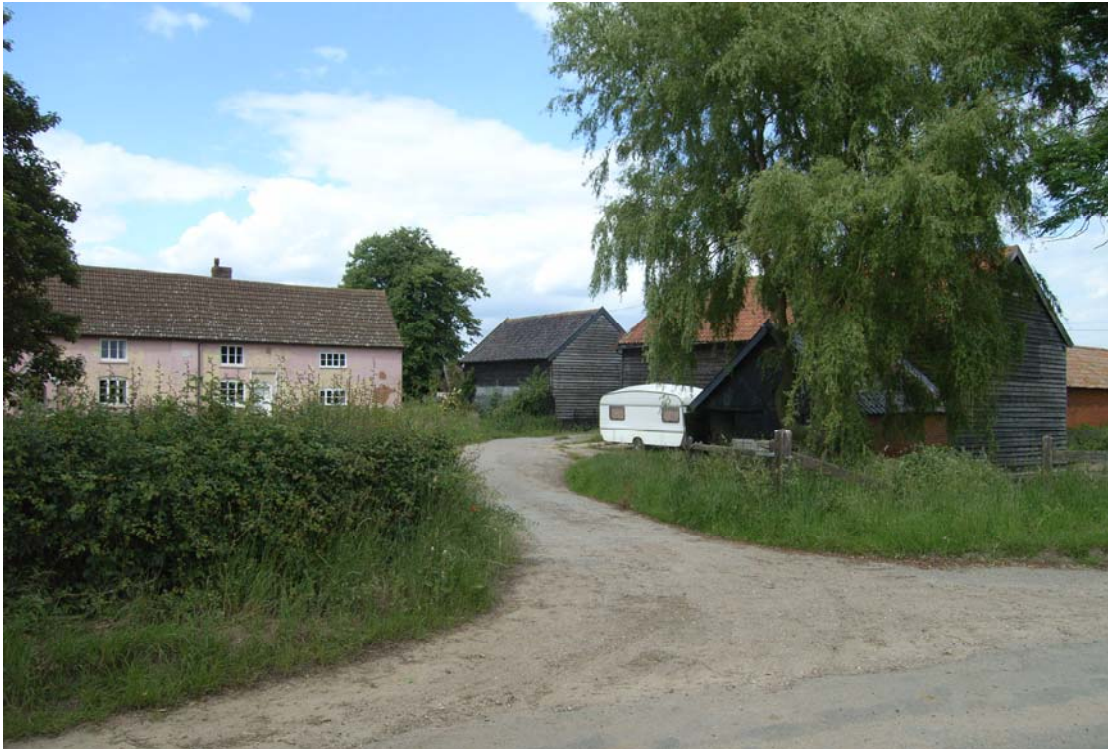
A2.1 General view of entrance to site from south-west showing house (10) to left and barn (1) to right with granary (4) in centre

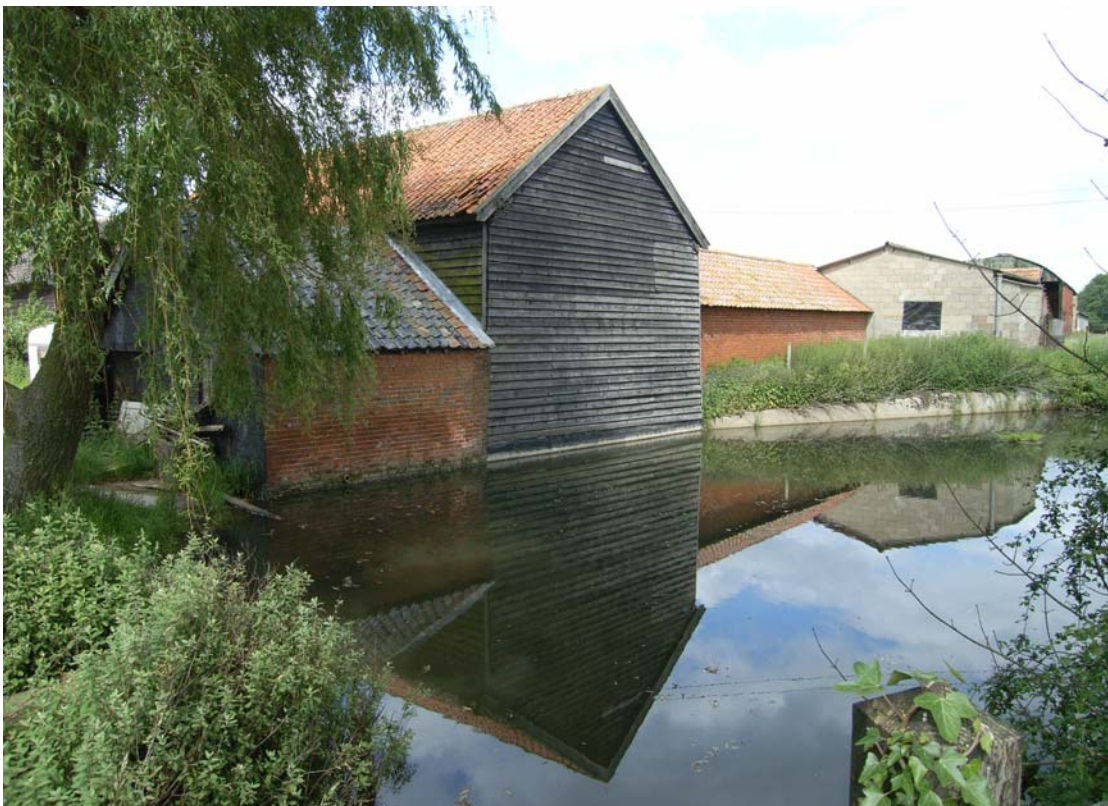
A2.2 General view of barn complex across pond from south-west, showing from left to right shed (2), barn (1), stable (3), block-work shed (9) and shelter shed (5)

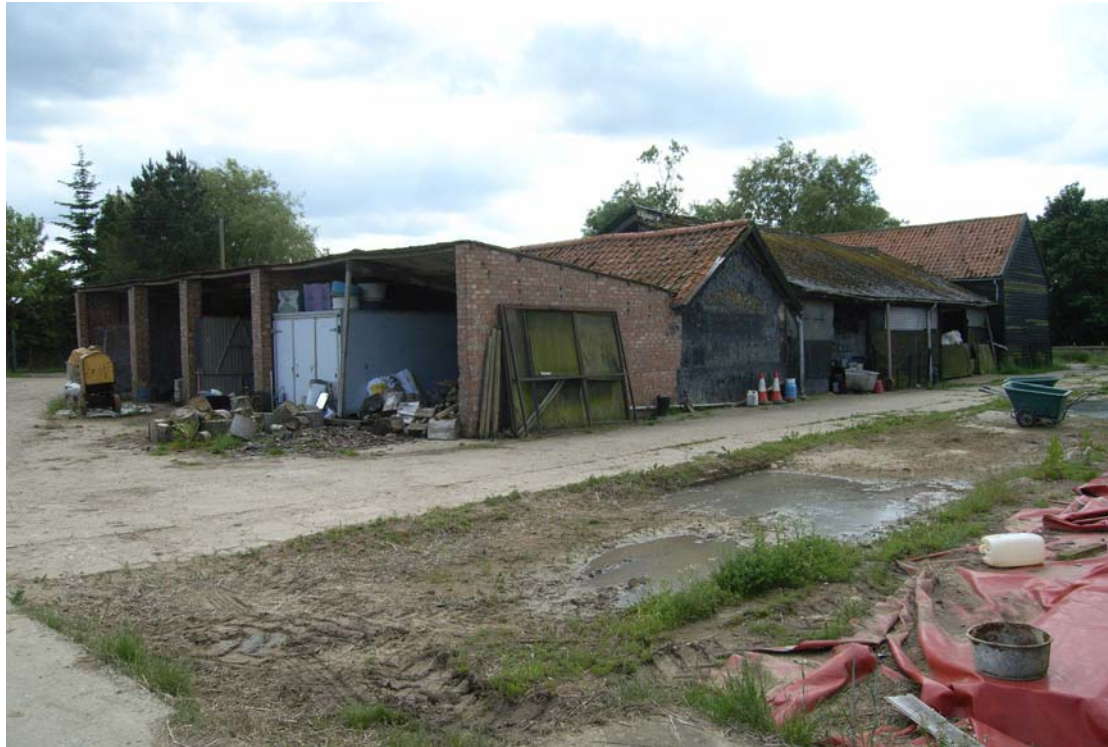
A2.3 General view of barn complex from north-east showing barn (1) to right and 20<sup>th</sup> century brick shelter (6) to left.

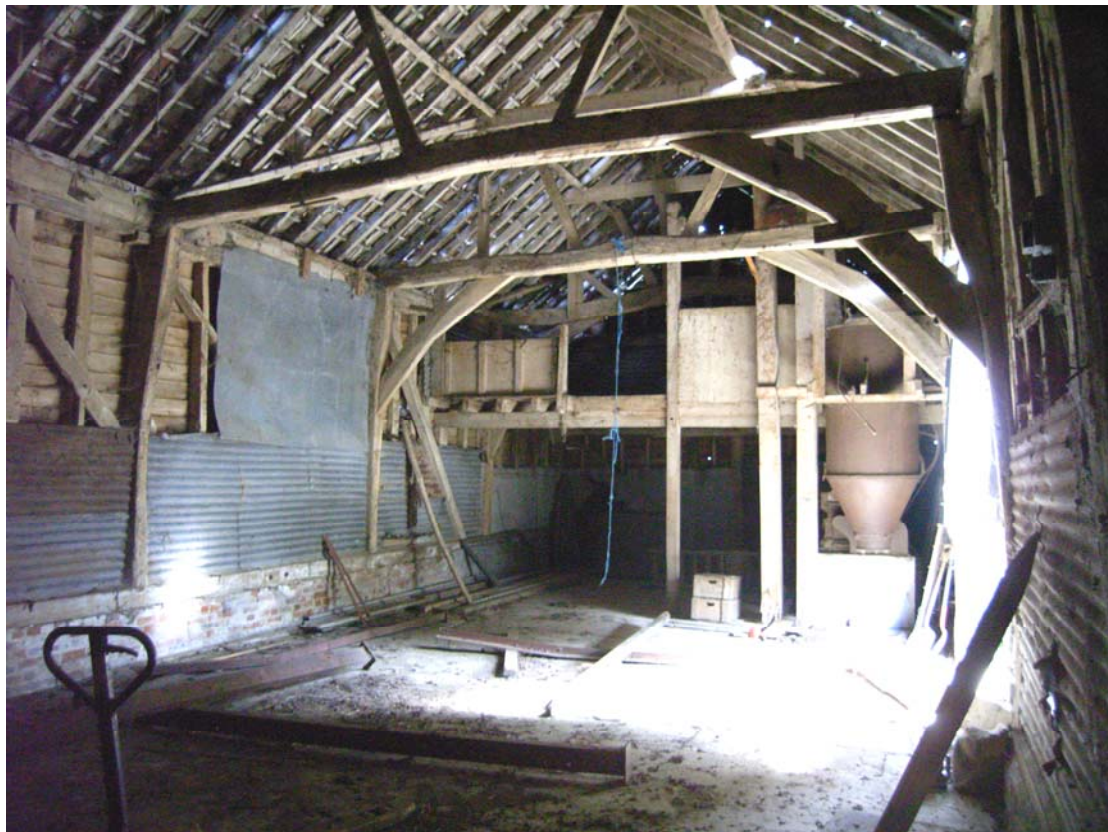
A2.4 Barn (1). General view of interior from north showing largely intact 5-bay late-16<sup>th</sup> century timber frame beneath 19<sup>th</sup> century roof, with blocked original eastern entrance to left and 20<sup>th</sup> century granary and milling floor to south

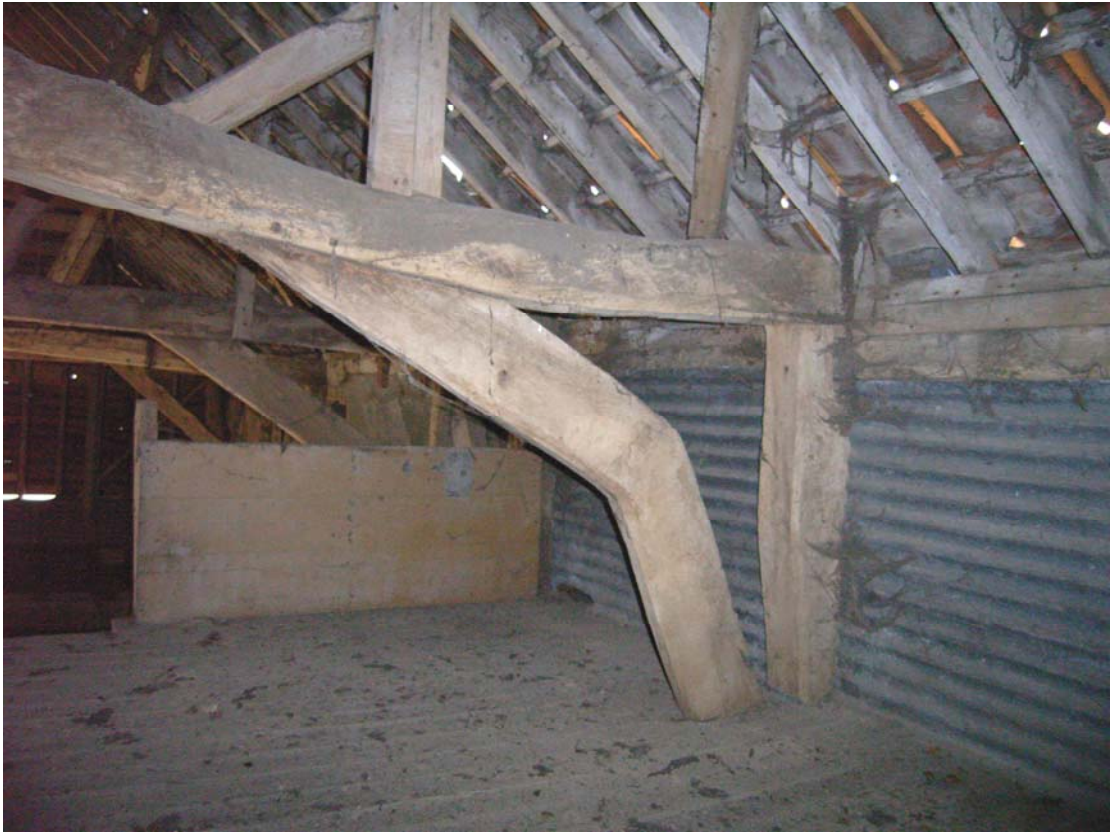
A2.5 Barn (1). Eastern elevation from south showing original cranked arch-brace and tie-beam above granary floor

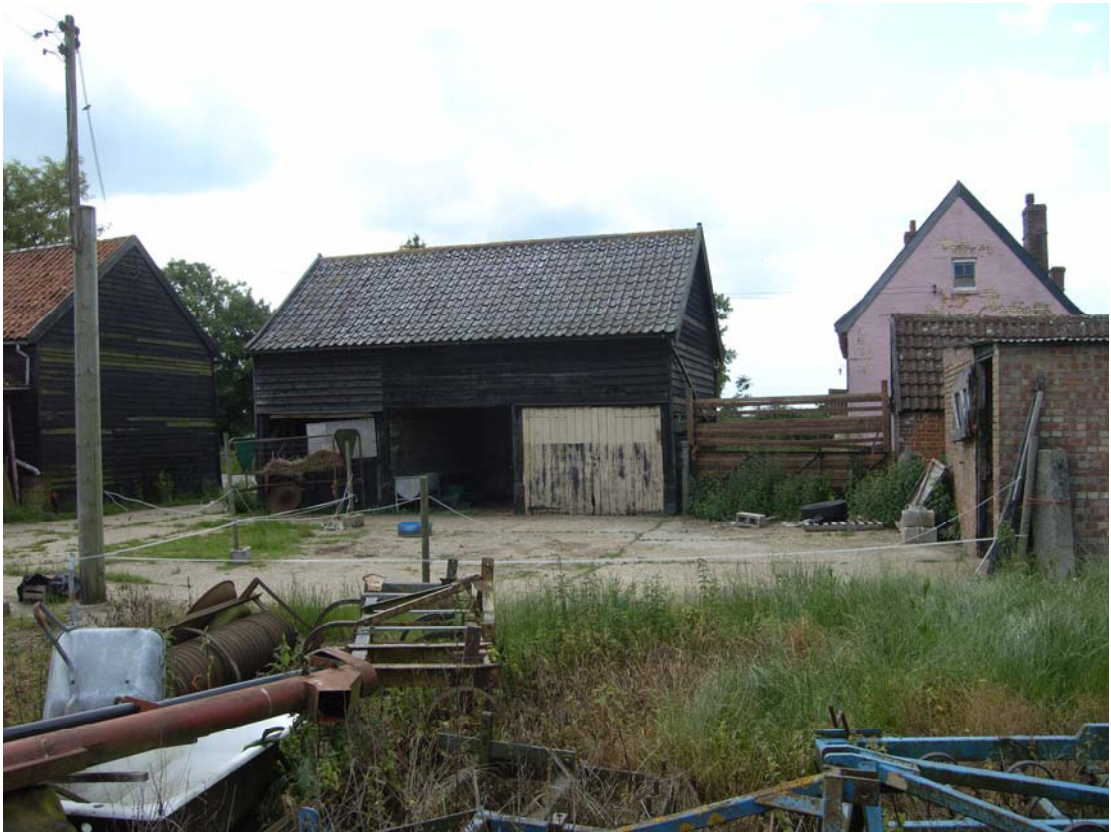
A2.6 Granary (4). Exterior from east showing barn (1) to left and house (10) to right

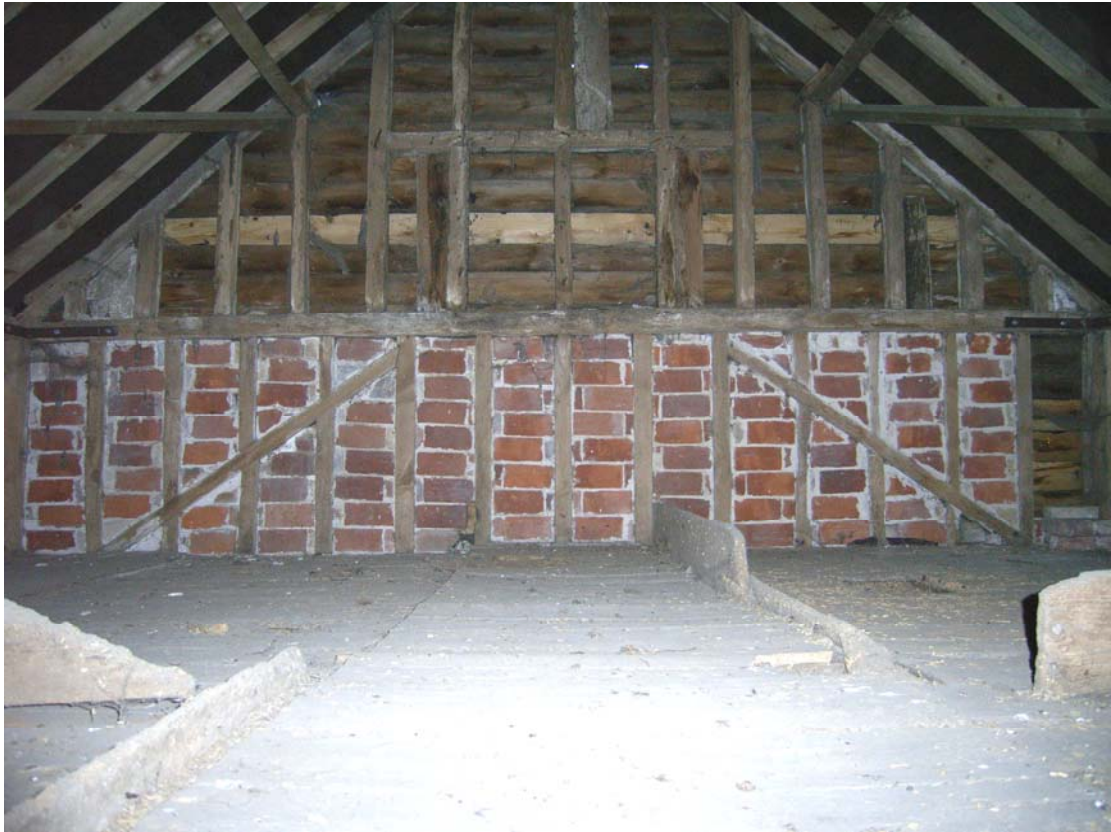
A2.7 Granary (4). Interior of granary floor showing blocked window in northern gable and remains of boarded grain bins with central passage from external entrance in southern gable

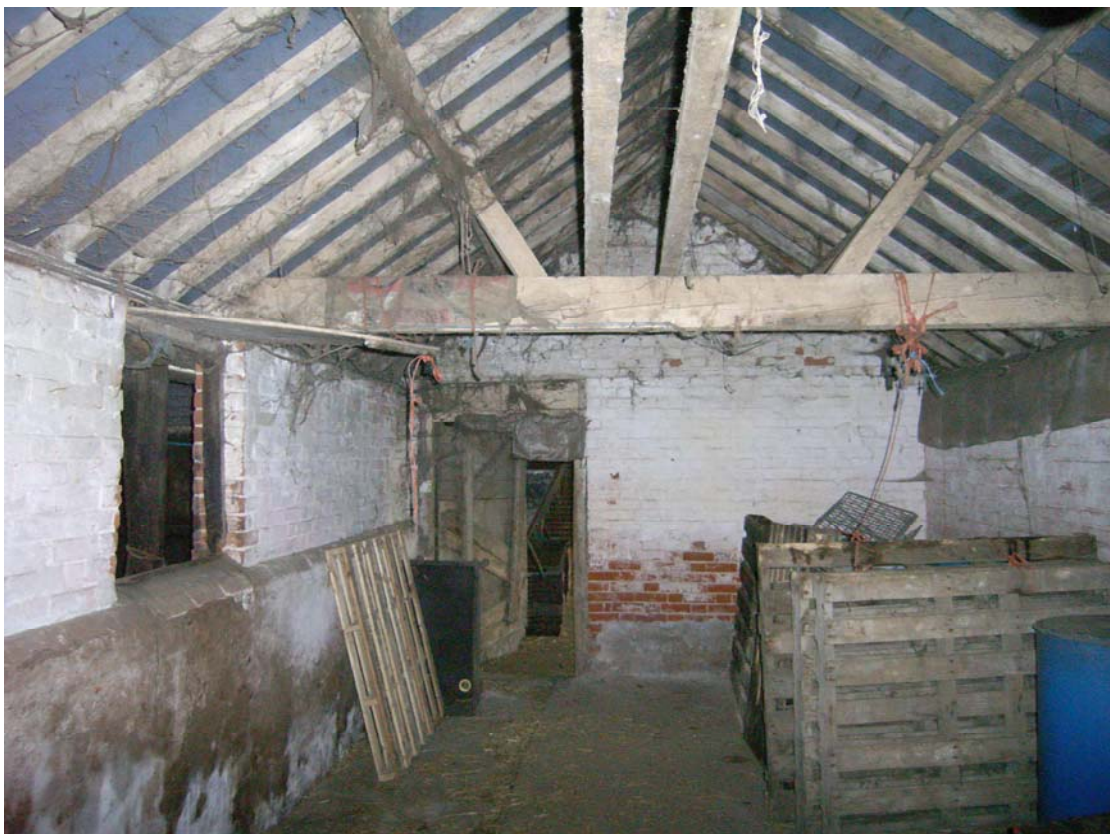
A2.8 Stable (3). Interior from west showing gable door and window to yard (8) left
