**The Maltings,
Worlingworth,
Suffolk**
WGW 025

Archaeological Record

**The Maltings,
The Red House,
Shop Street,
Worlingworth, Suffolk**
(TM 2206 6856)

An Archaeological Record

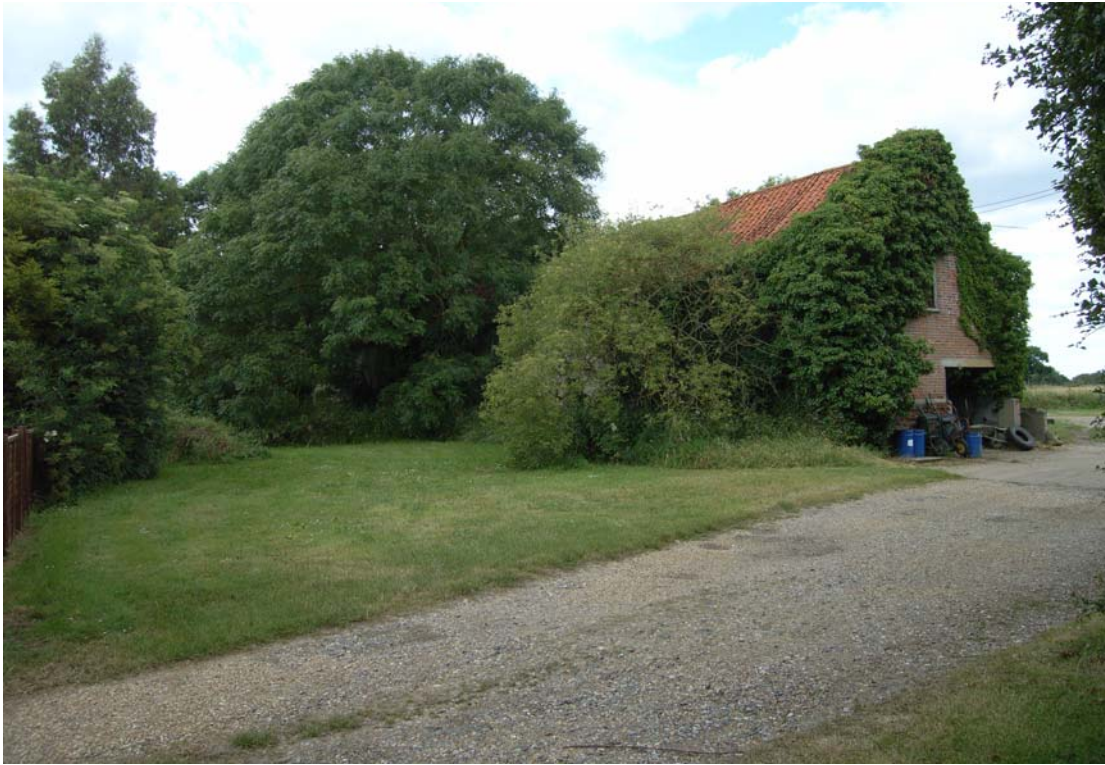
A2.1 General view of maltings from site entrance to south-east showing overgrown condition of main southern façade (rebuilt eastern gable visible to right)

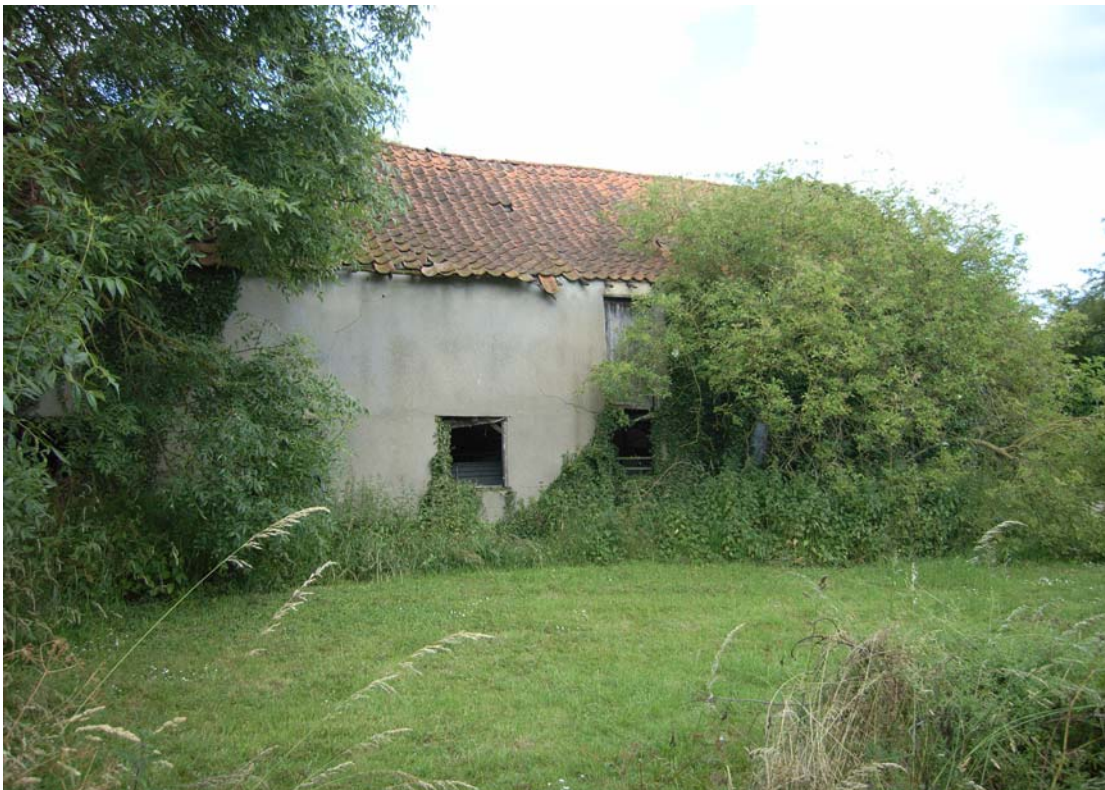
A2.2 Exterior of southern elevation showing easternmost bays with first-floor loading door in bay 10

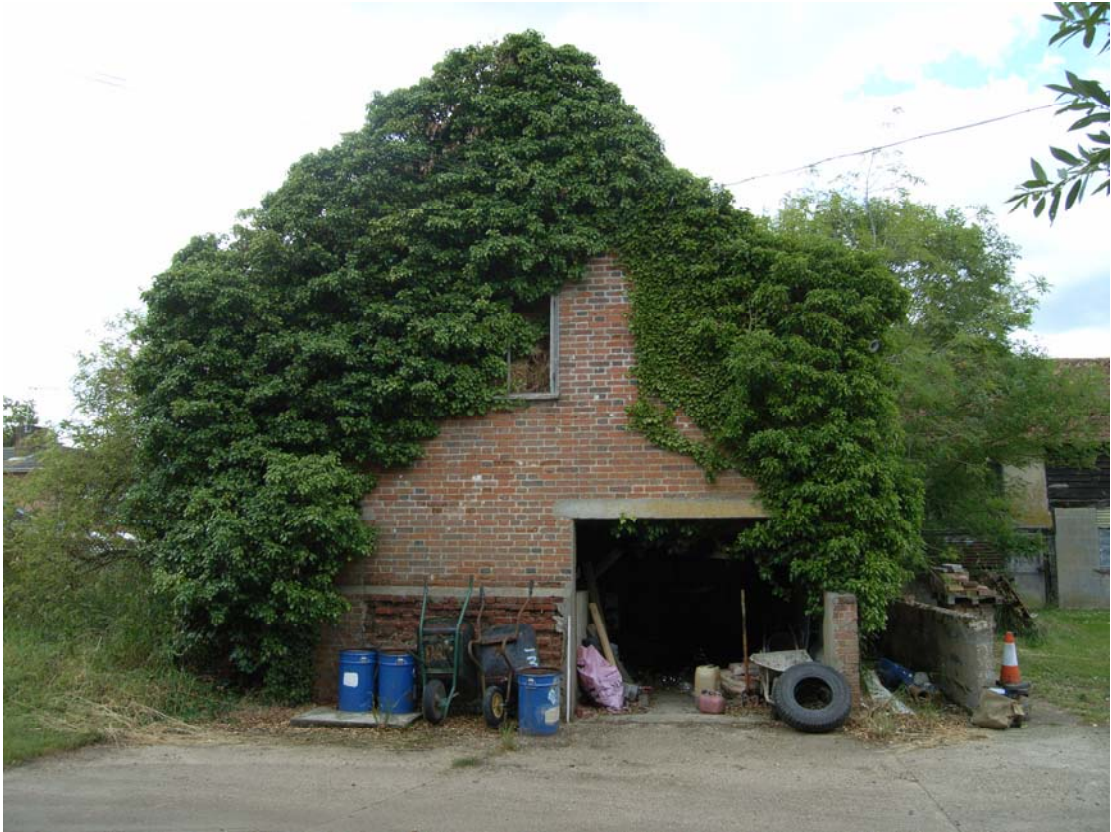
A2.3 Exterior of eastern gable showing secondary brickwork and entrance. Earlier brickwork at base shows signs of heat abrasion.

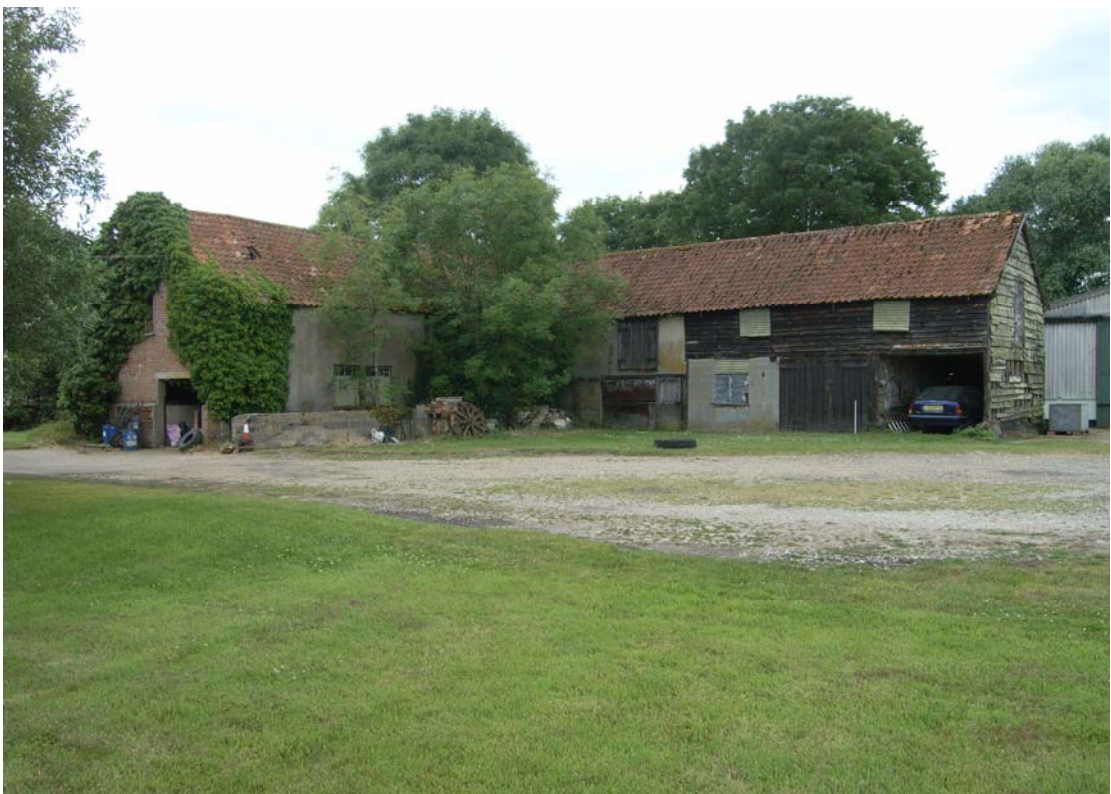
A2.4 Exterior from north-east showing later rear wing to right and eastern gable of original southern range to left

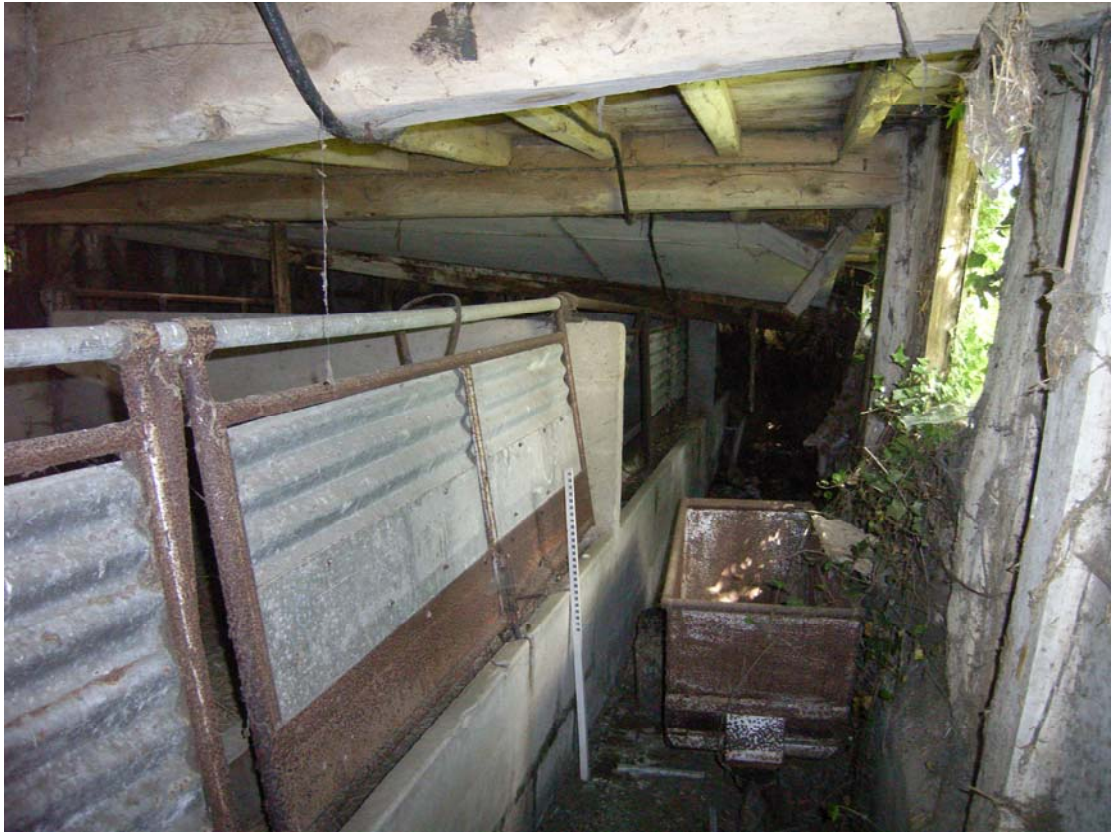
A2.5 Interior of southern range looking east on ground floor from western bay 1 with southern elevation to right and 20th century pig sties to left. Note intact original ceiling

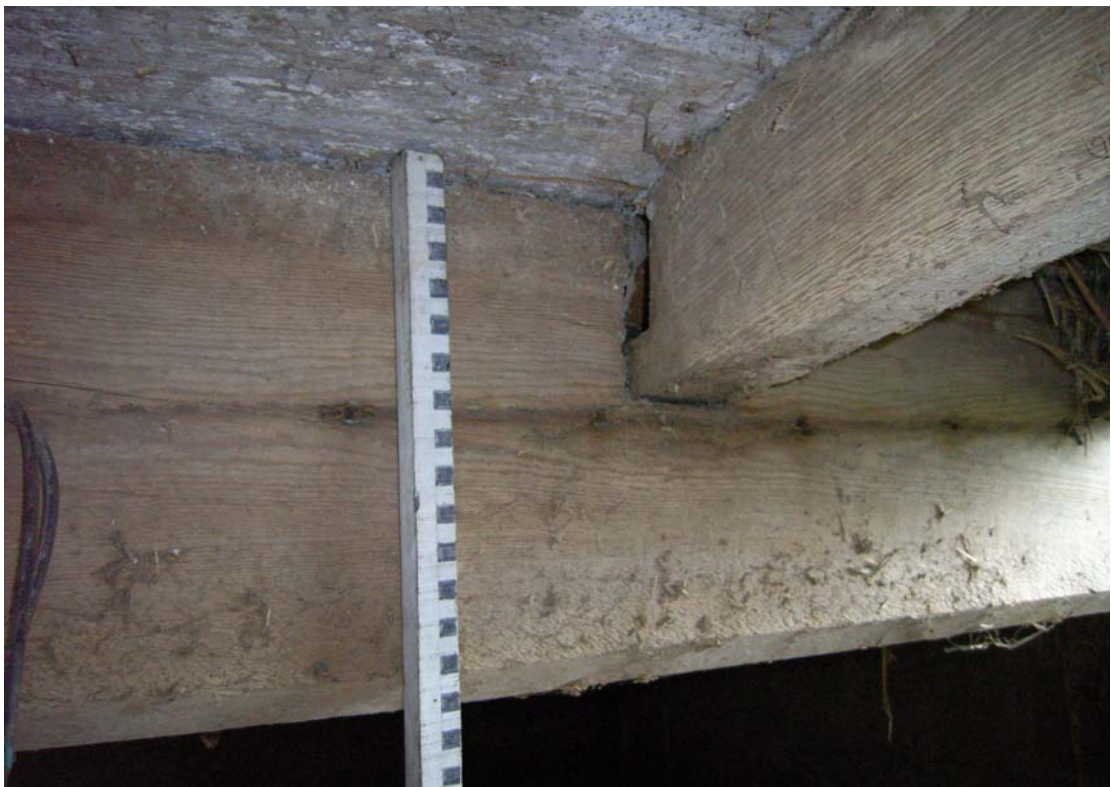
A2.6 Detail of original deal binding joist with oak common joists secured by soffit-tenon joints with diminished haunches. The common joists bear incised carpenters' numerals

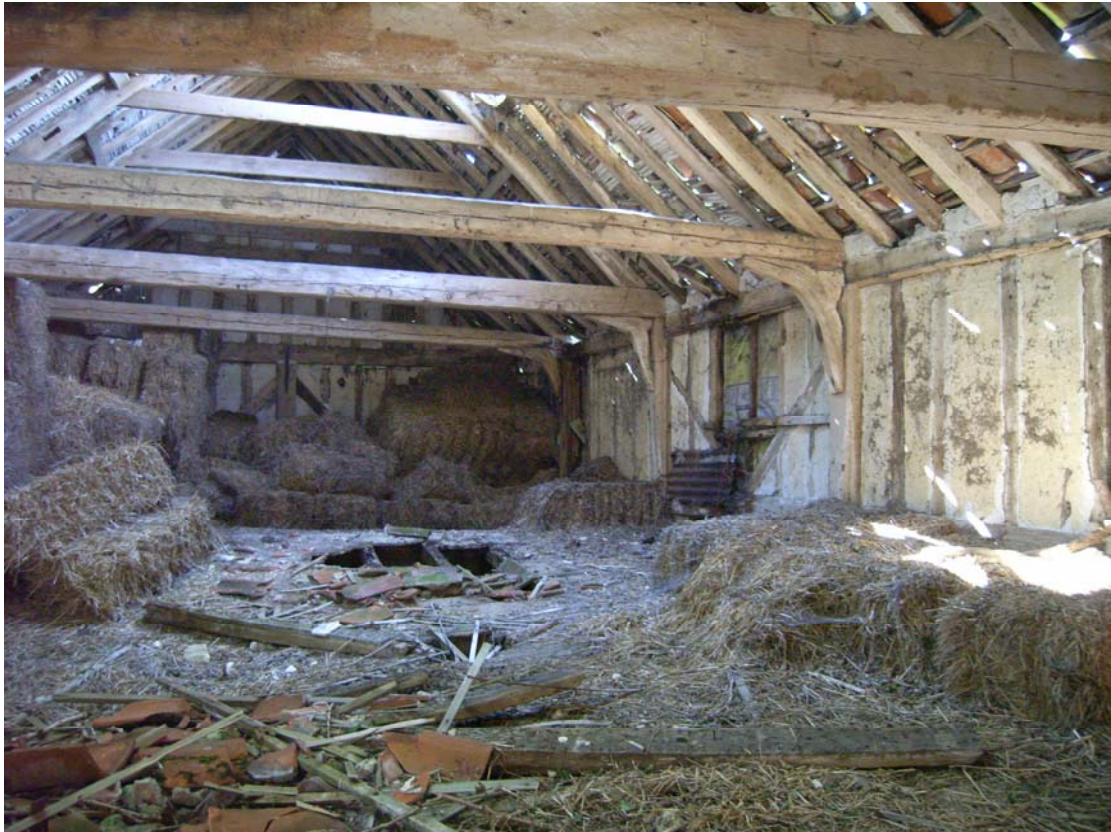
A2.7 First floor of southern range looking towards western gable with rear walls of bays 1-4 to right

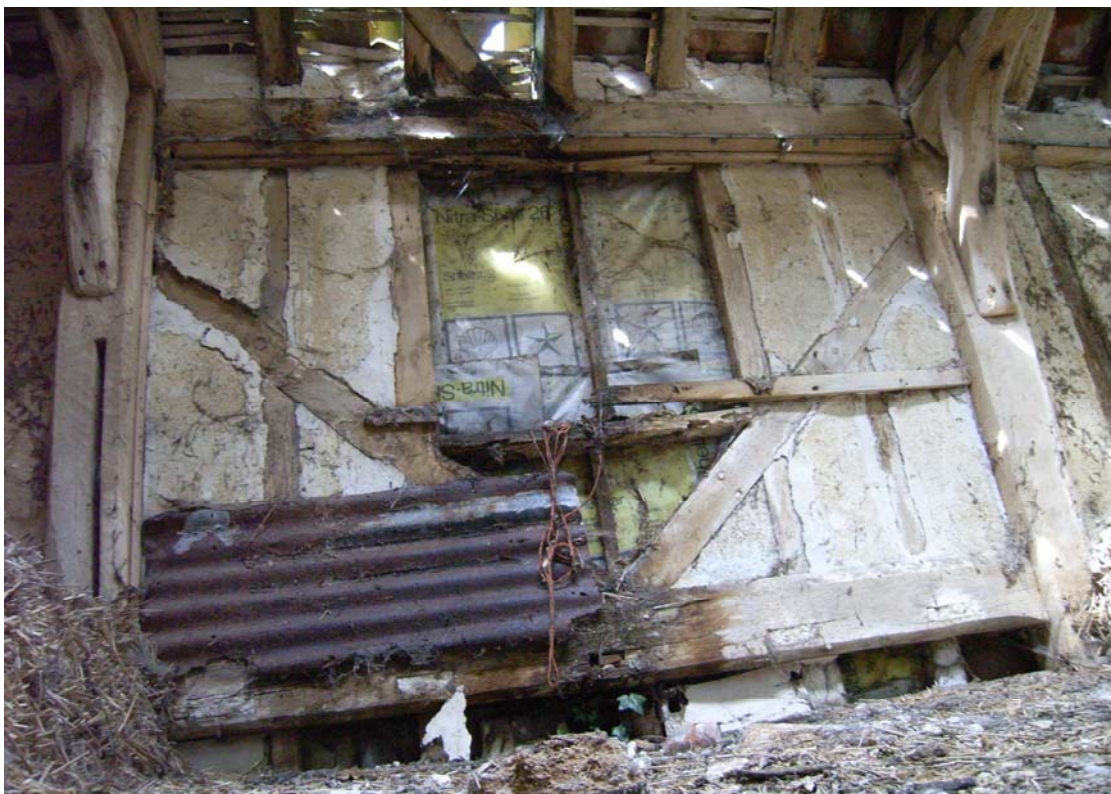
A2.8 First floor internal northern elevation of bay 3 showing high mid-rail 15 cm above floor and a blocked window aperture with original sliding shutter rails. Some timbers re-used.

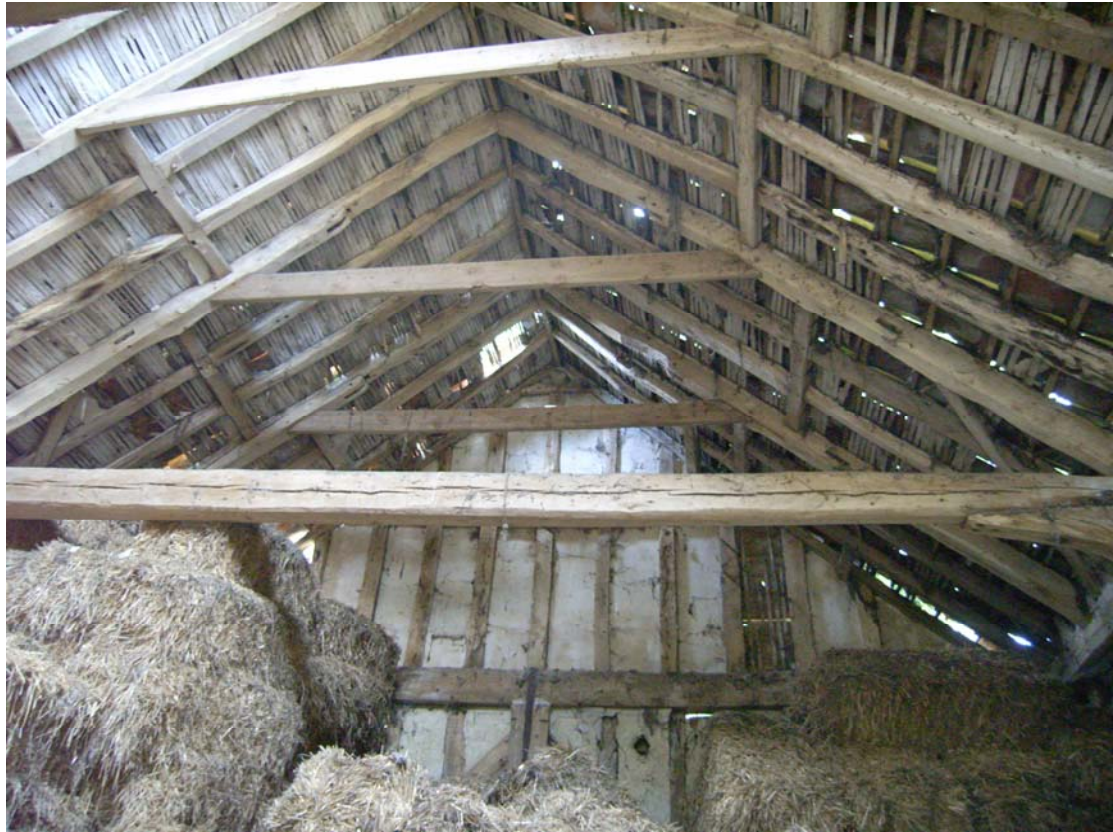
A2.9 Internal elevation of western gable showing re-used timbers in original staggered butt-purlin roof structure

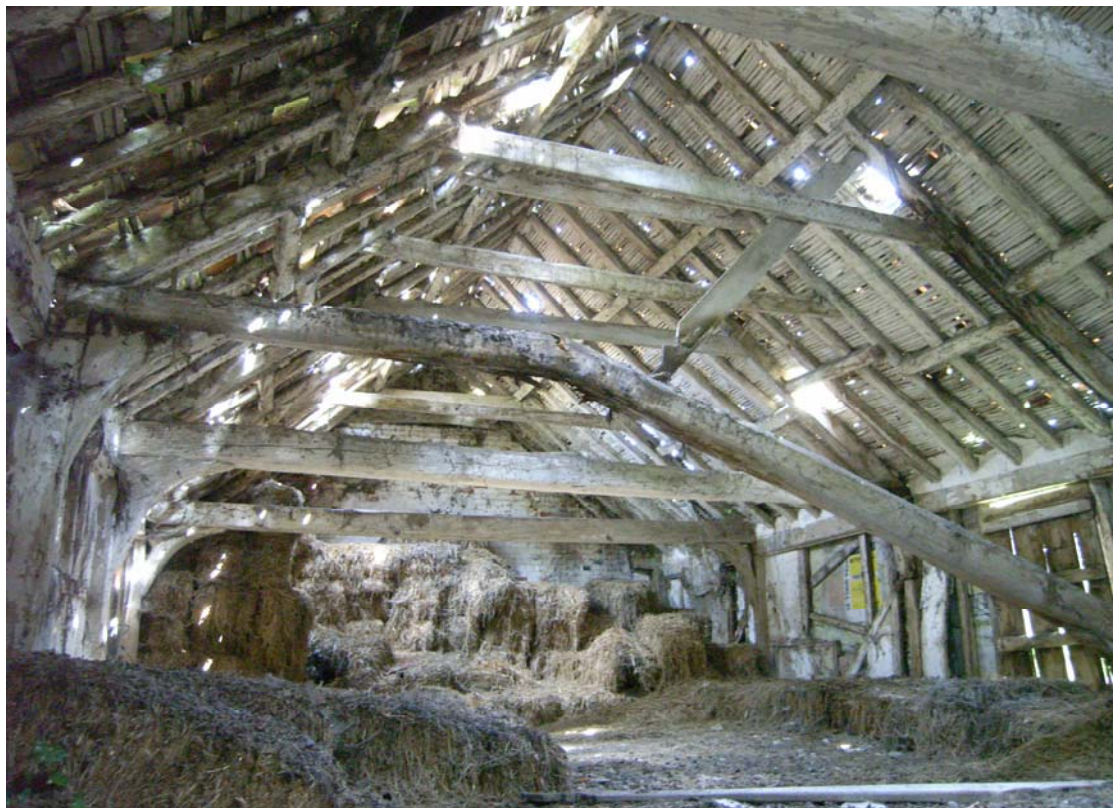
A2.10 Roof structure of clasped-purlins with nailed butt-purlins in eastern half of southern range (looking towards eastern gable). Note first-floor loading door in bay 10 to right

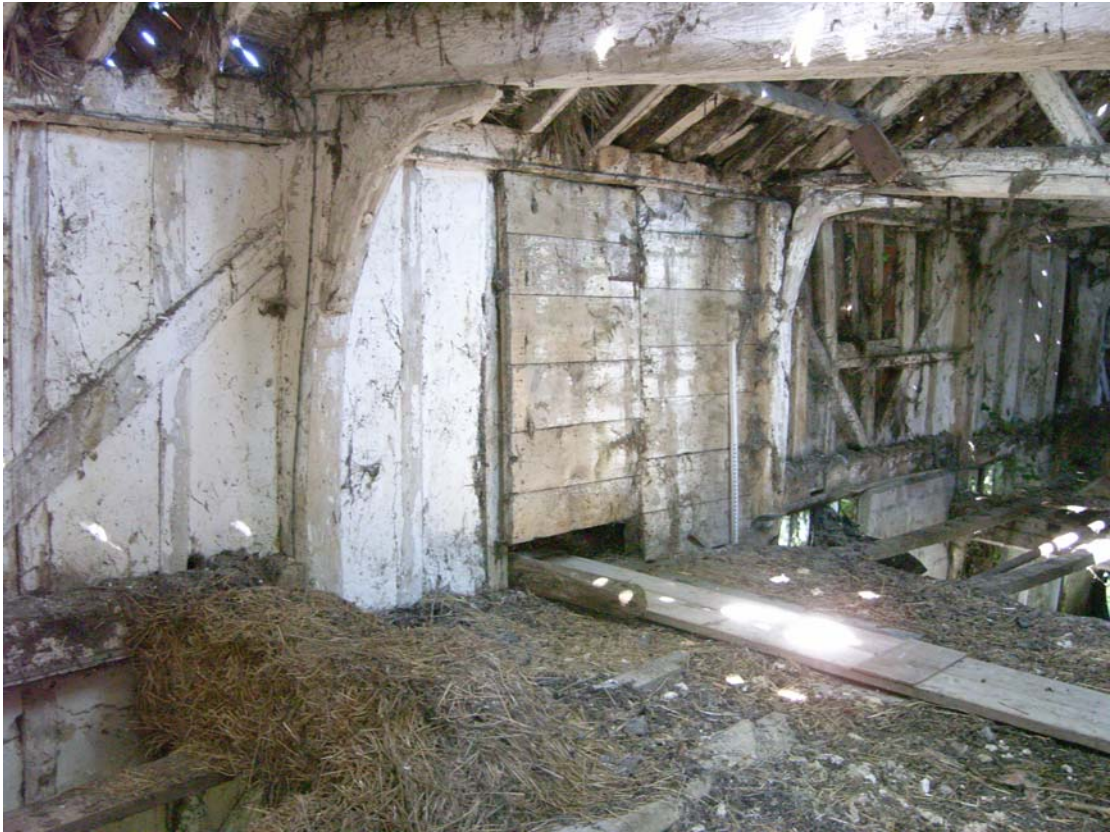
A2.11 Internal northern first floor elevation of bay 7 (centre) showing boarded door to rear wing and lower mid-rail than adjacent bays

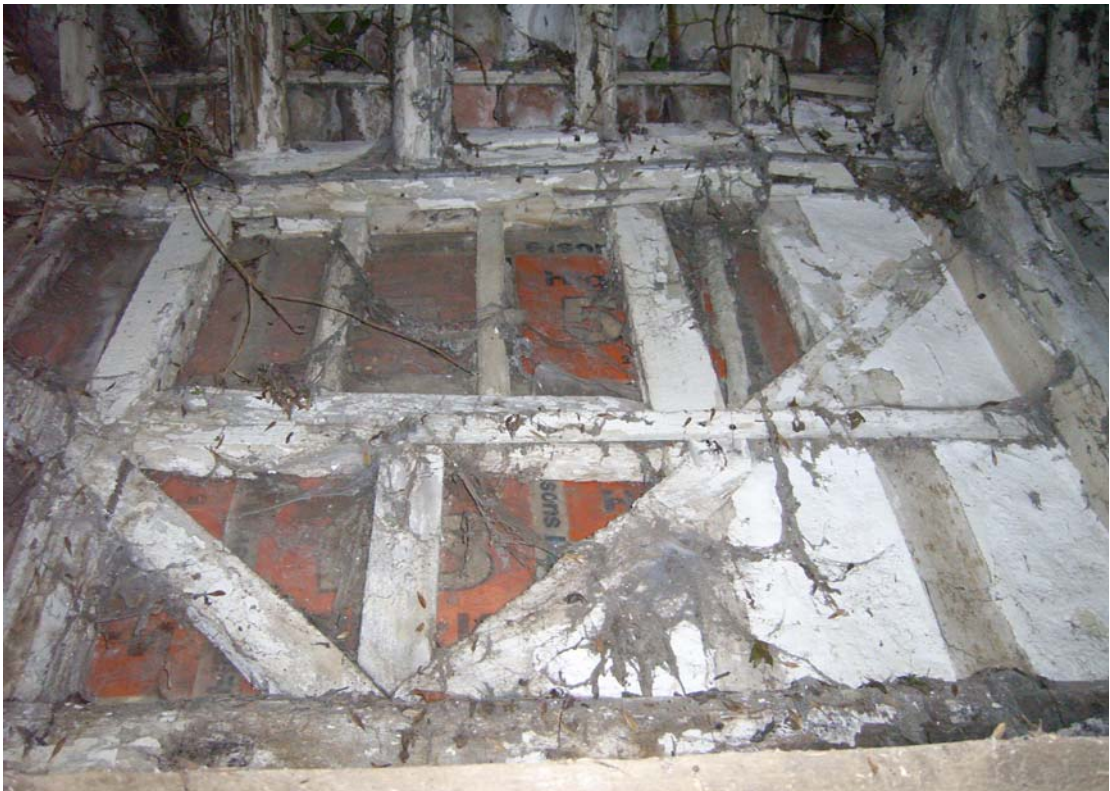
A2.12 Detail of original first-floor window mullions & shutter rails in northern elevation of bay 8.

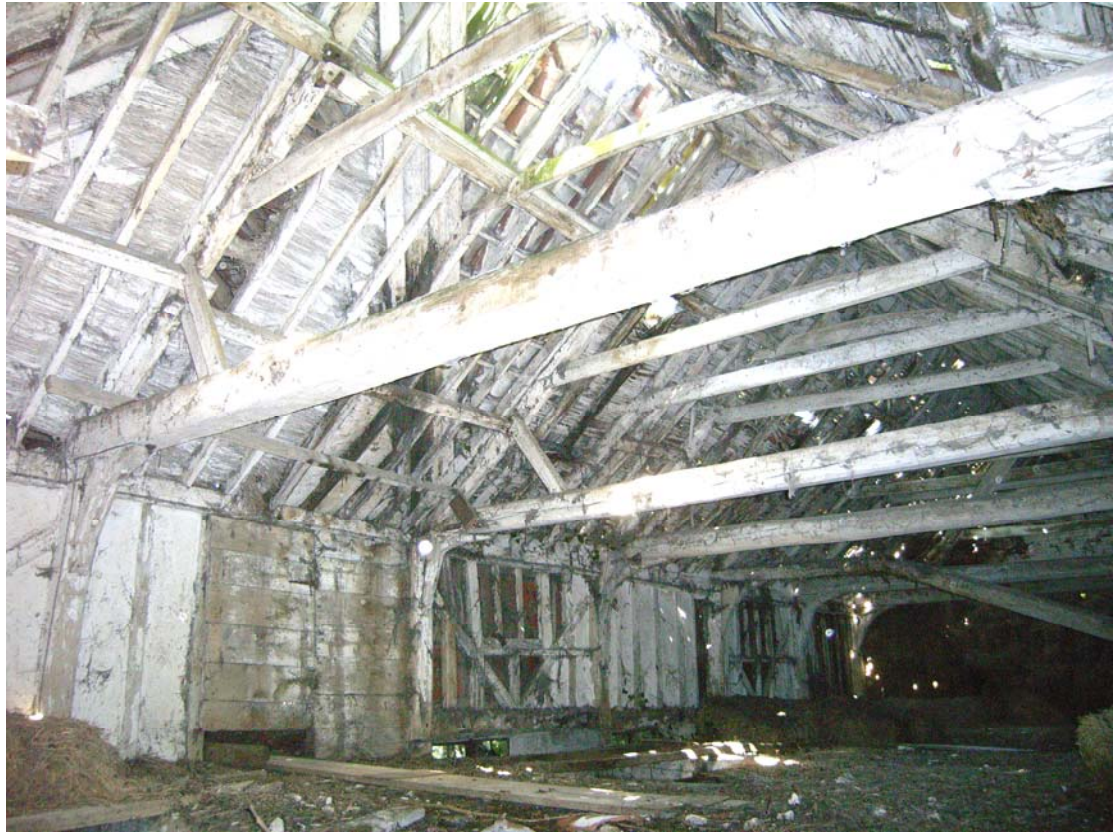
A2.13 Northern internal elevation of first floor showing bays 6-12 (left to right)

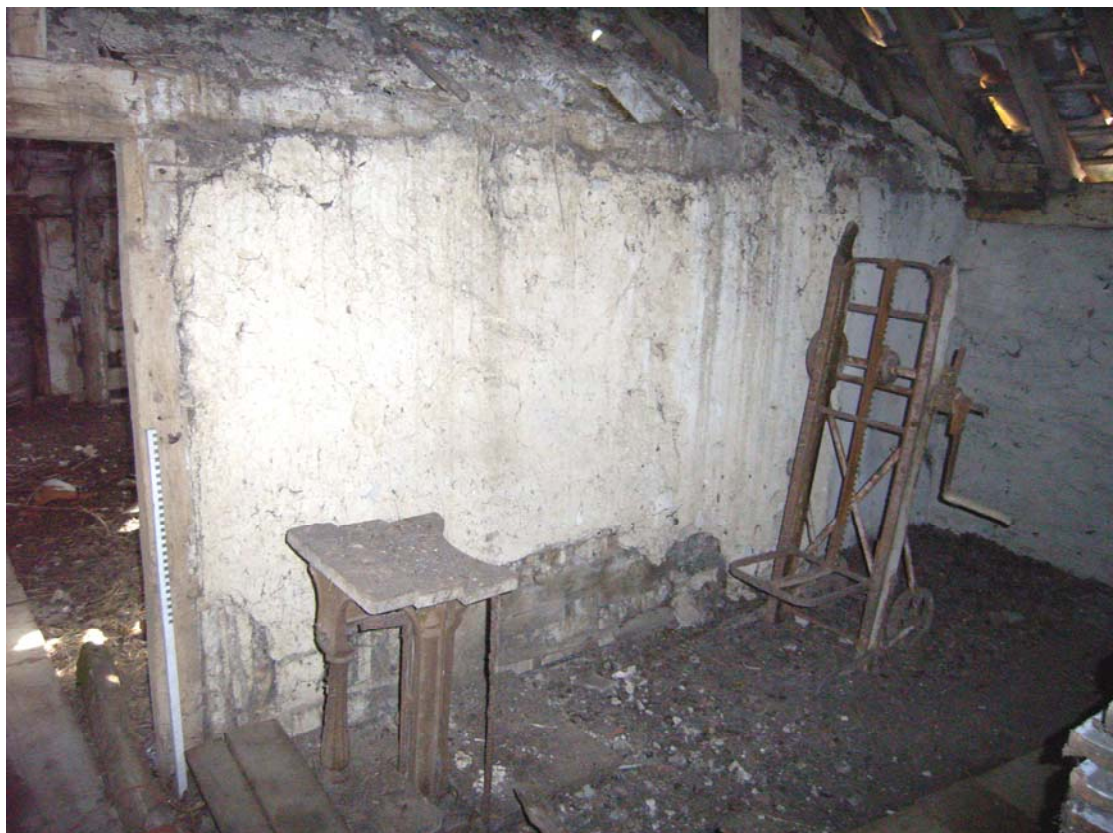
A2.14 Rendered external elevation of bays 6 & 7 from bay 13 showing first-floor door in bay 7 to left with weighing machine and sack trolley to right

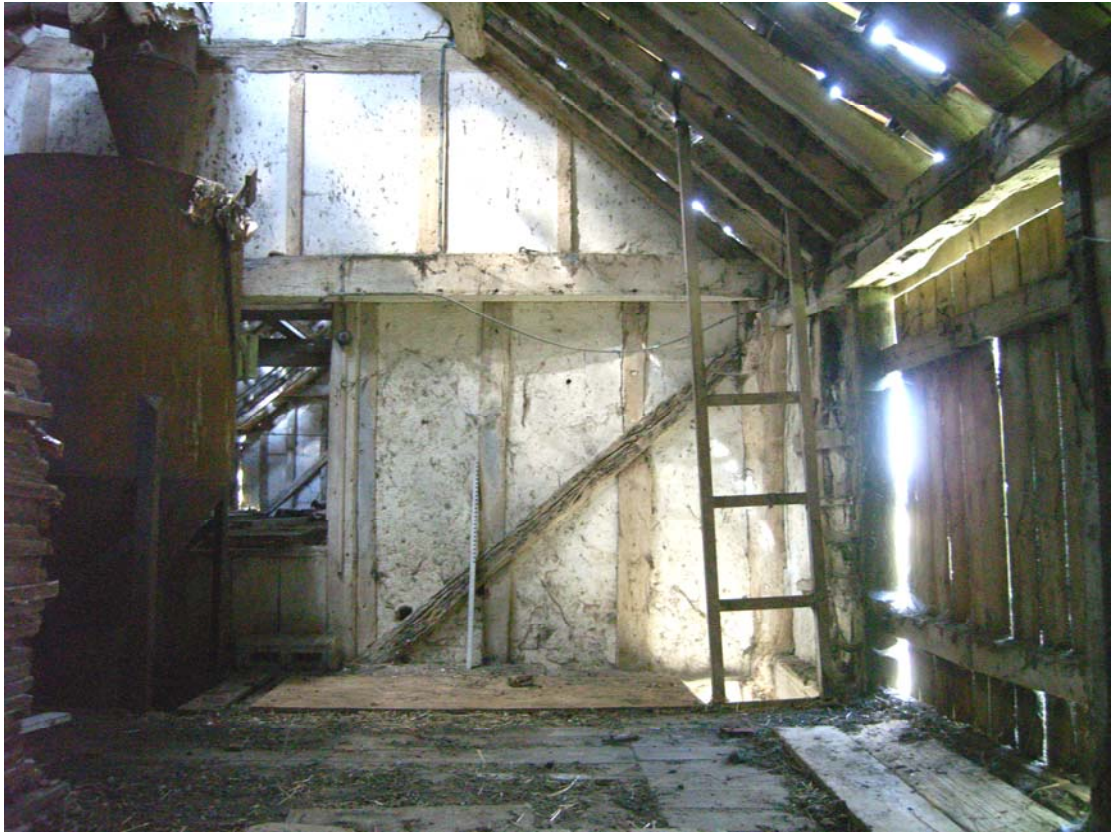
A2.15 First floor of rear wing looking north to original gable & ladder in north-east corner of bay 14 showing large hopper to left

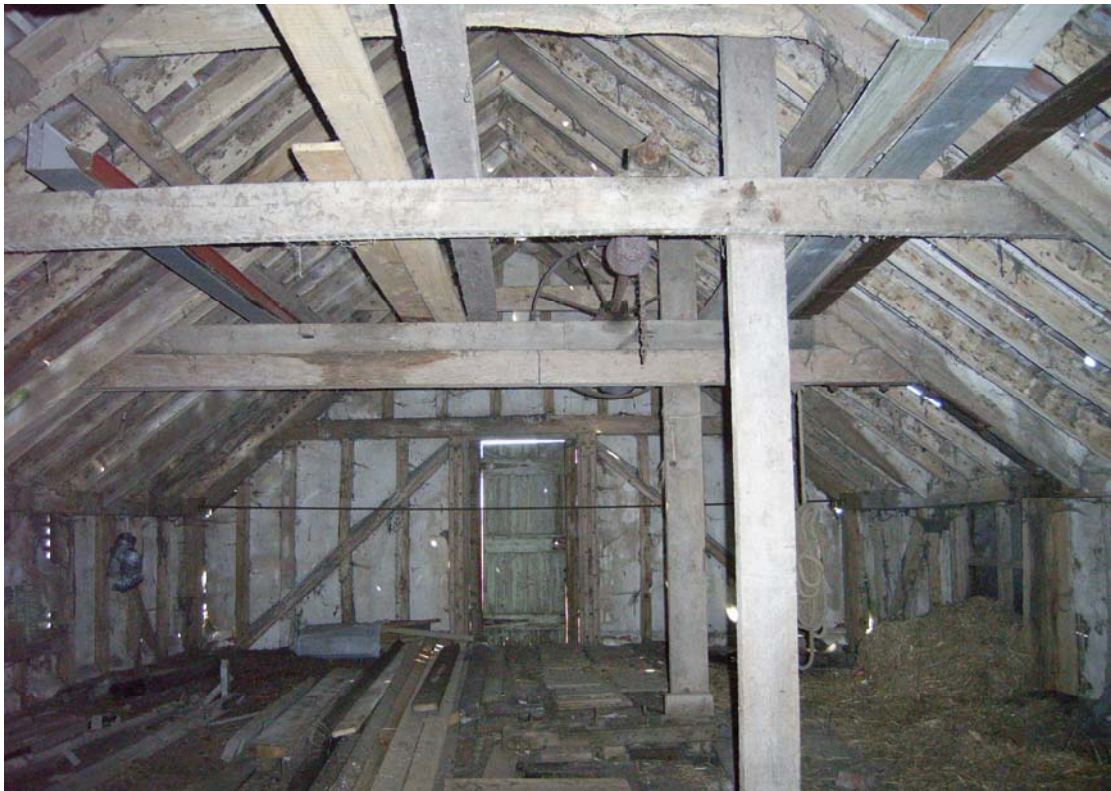
A2.16 First floor of bays 15-17 looking towards northern gable and showing sack hoist chain and wheel in roof
