**Beech Farm,
The Green,
Bardwell, Suffolk**

Historic Building Record

The Farm Buildings, Beech Farm, The Green, Bardwell, Suffolk

An Archaeological Record

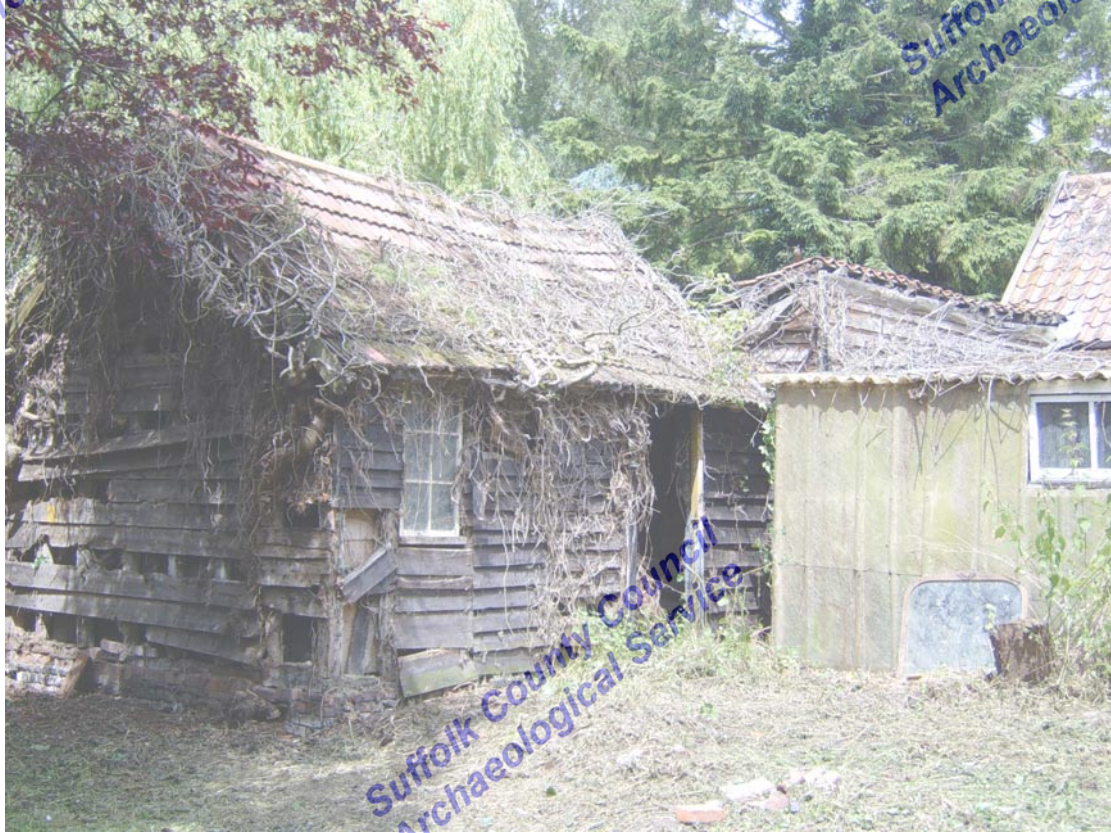
A2.1 Before Inspection. Exterior of shed (1) from south-east showing barn (3) to right

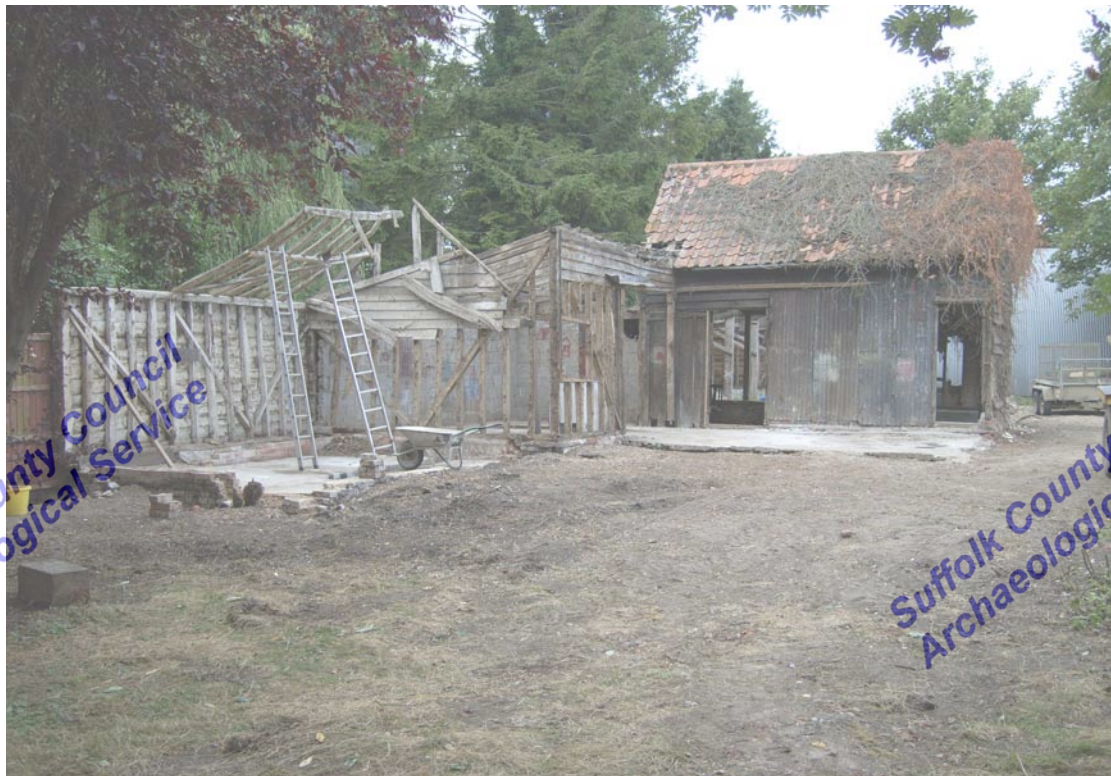
A2.2 General view from south showing remains of shed (1) to left, stable (2) in centre & barn (3) to right

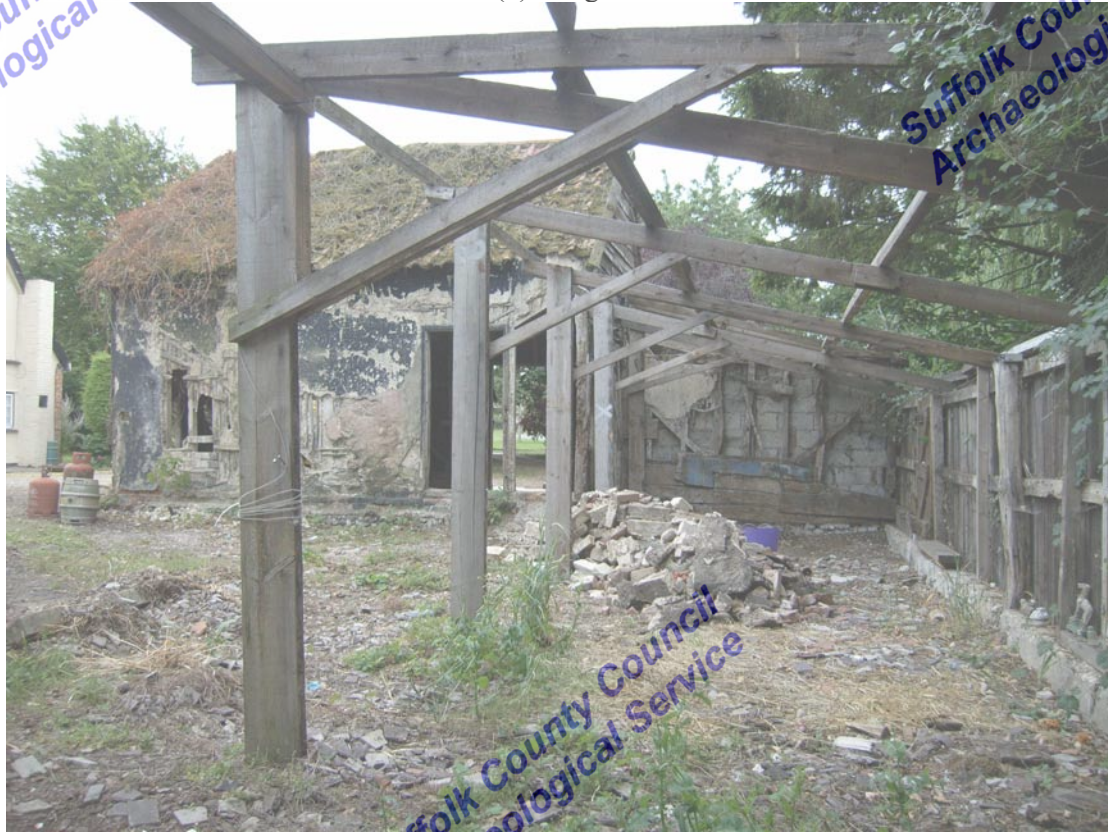
A2.3 Open-sided shelter (4). Interior from north showing barn (3) to left.

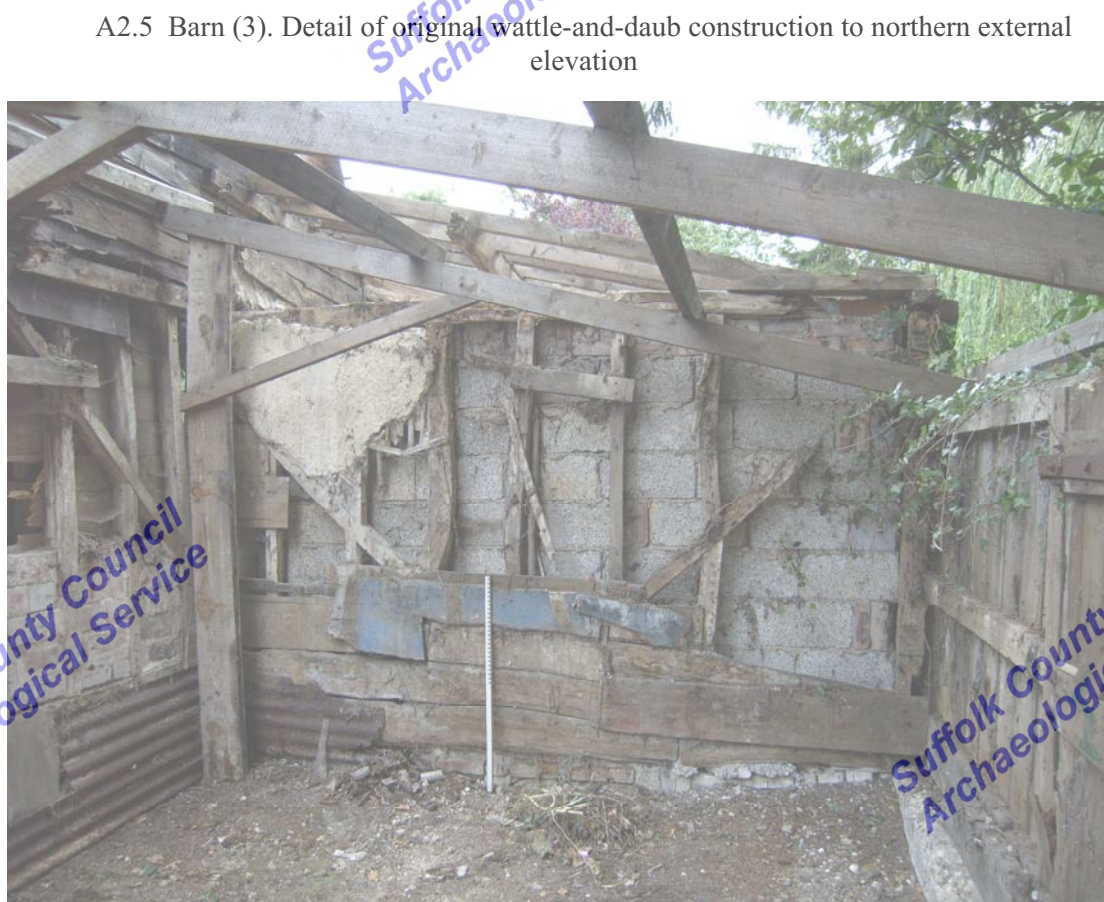
A2.6 Stable (2). External northern gable originally belonging to shed (1), showing remains of original external clay daub and barn (3) to left

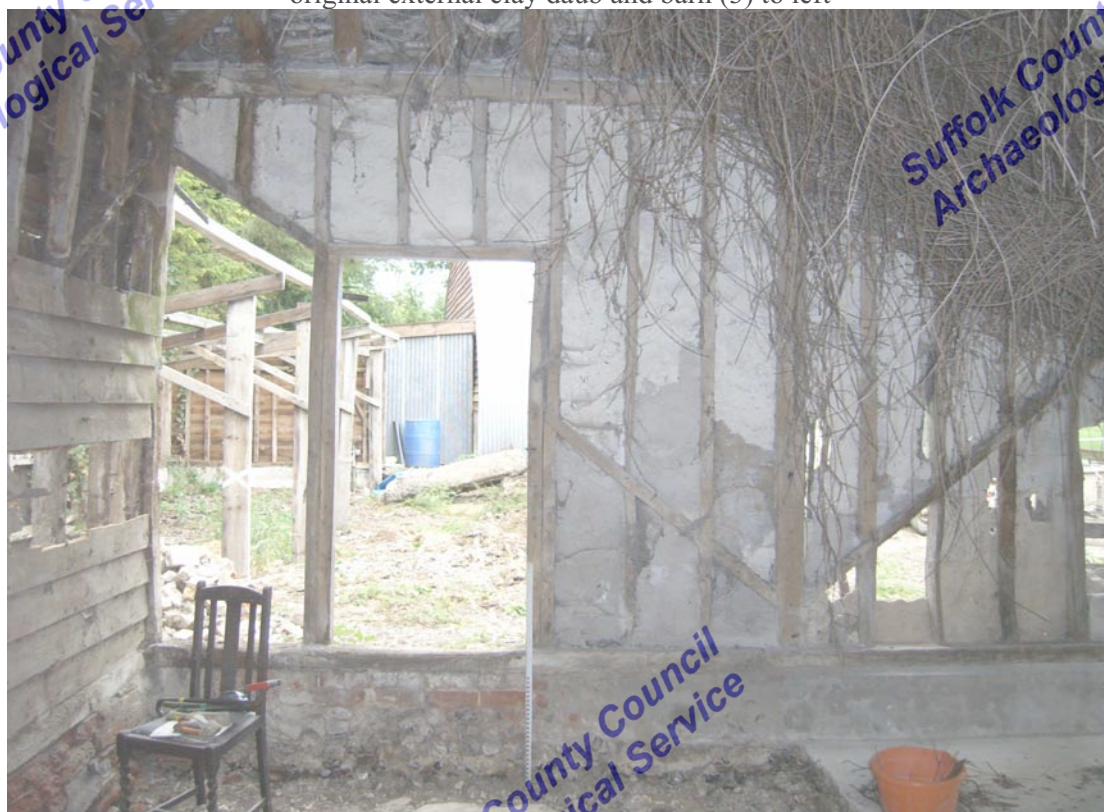
The original layout is not typical, with only a single external door of 2.3 m in width (7.5 ft) at the western end of the southern elevation and a second door of normal width at the southern end of the western gable. The latter opened into the corner of the adjacent shed. The existing additional doors in the southern and northern elevation are later insertions which interrupt the

original frame. Given the absence of any thoroughfare or through-draught for threshing purposes, and its relatively late mid-19th century origin (it is not shown on the 1839 tithe map) the barn was probably purpose-built as an animal feed store. A loading door in the eastern gable suggests the former presence of a milling platform, but extensive vegetation obscured any further evidence of such a feature – whether original or secondary.

A2.7 Barn (3). Interior of northern elevation showing later door interrupting primary wall brace

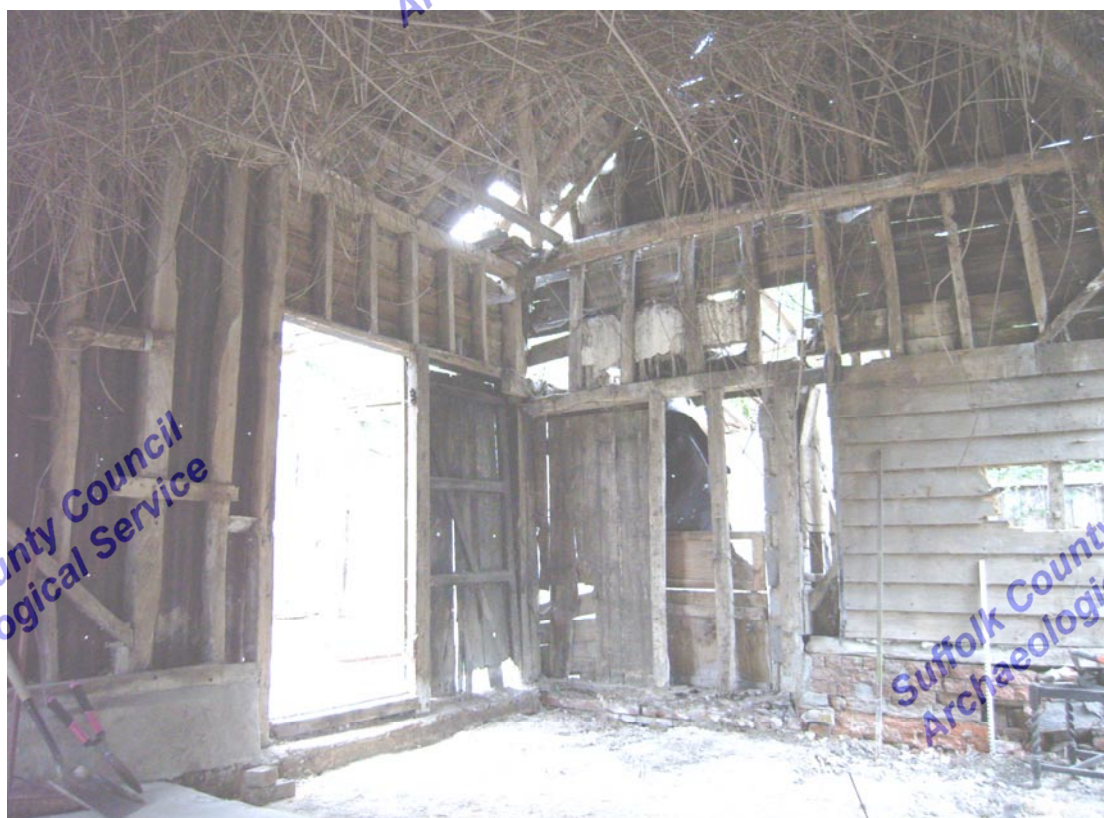
A2.8 Barn (3). Interior of south-western corner showing original wide door in southern elevation to left
