Poplar Farm Barn, Poplar Farm, Linstead Parva, Suffolk

Historic Building Record

OASIS Ref: suffolkc1-54084

An Archaeological Record

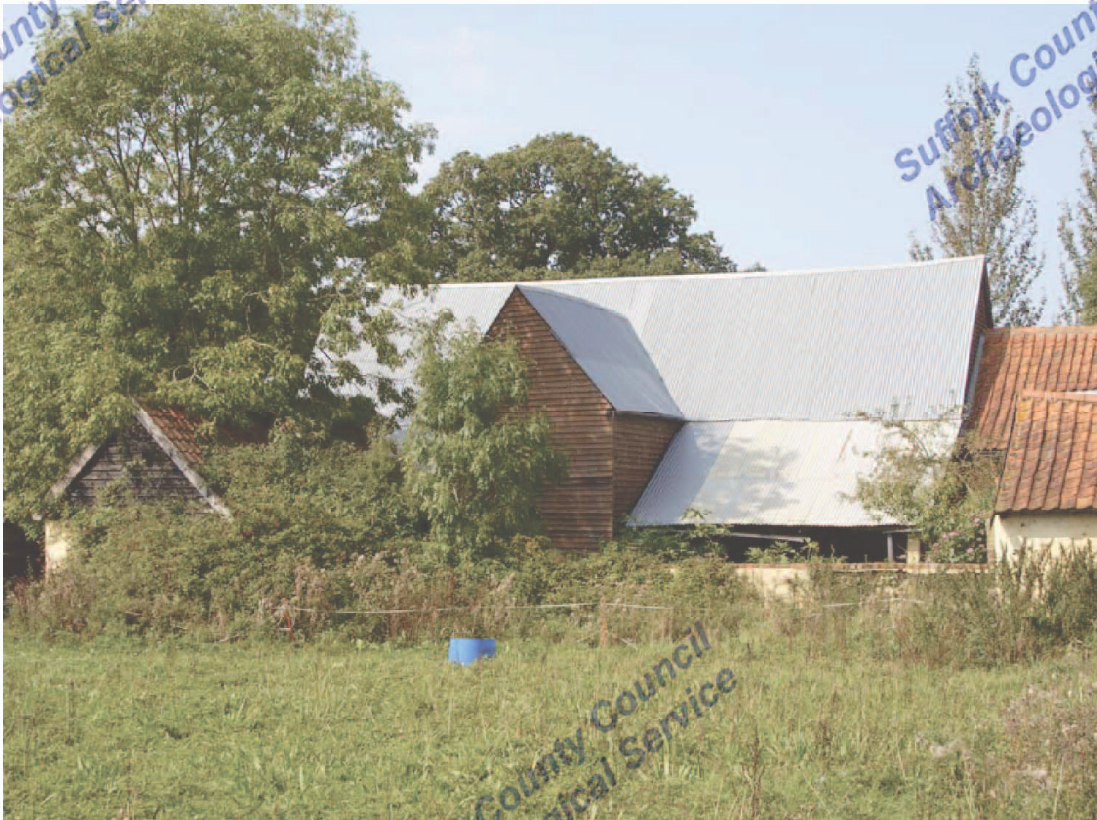
A2.1 Exterior of barn from east showing narrow porch with detached clay-lump shed (5) to left, and converted animal shed (7) and shelter shed (6) to right

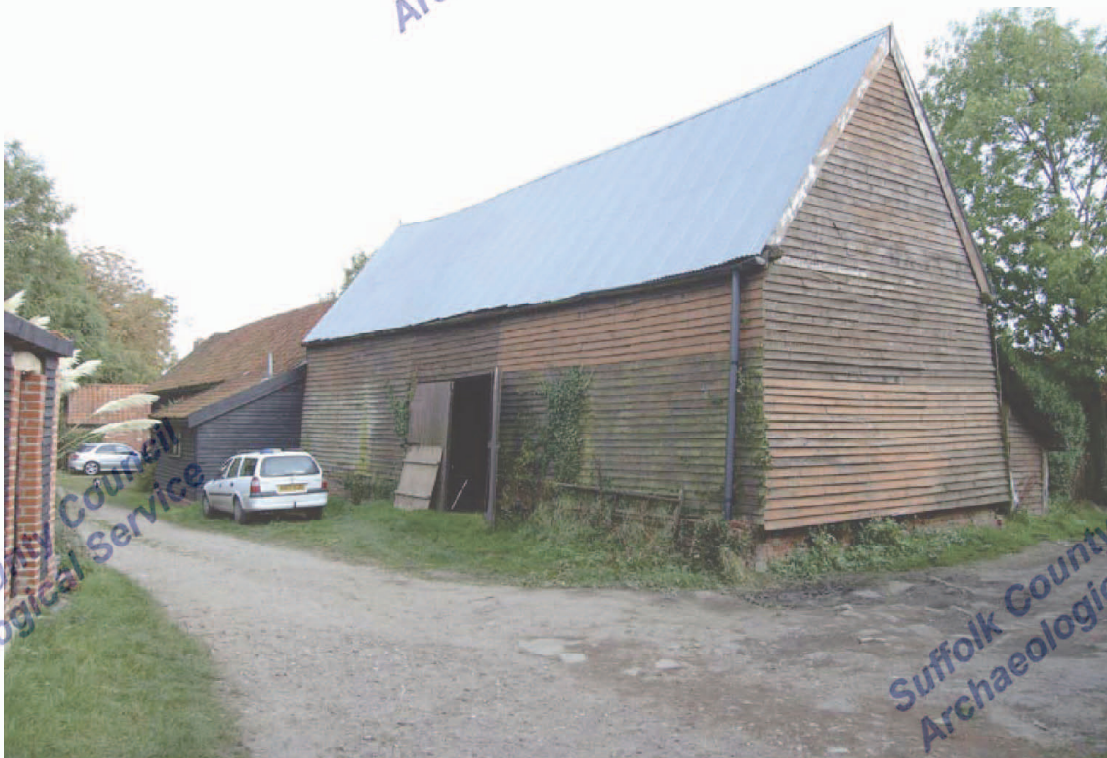
A2.2 Exterior of barn from west showing lean-to shed (3) to right and converted animal shed (7) to left

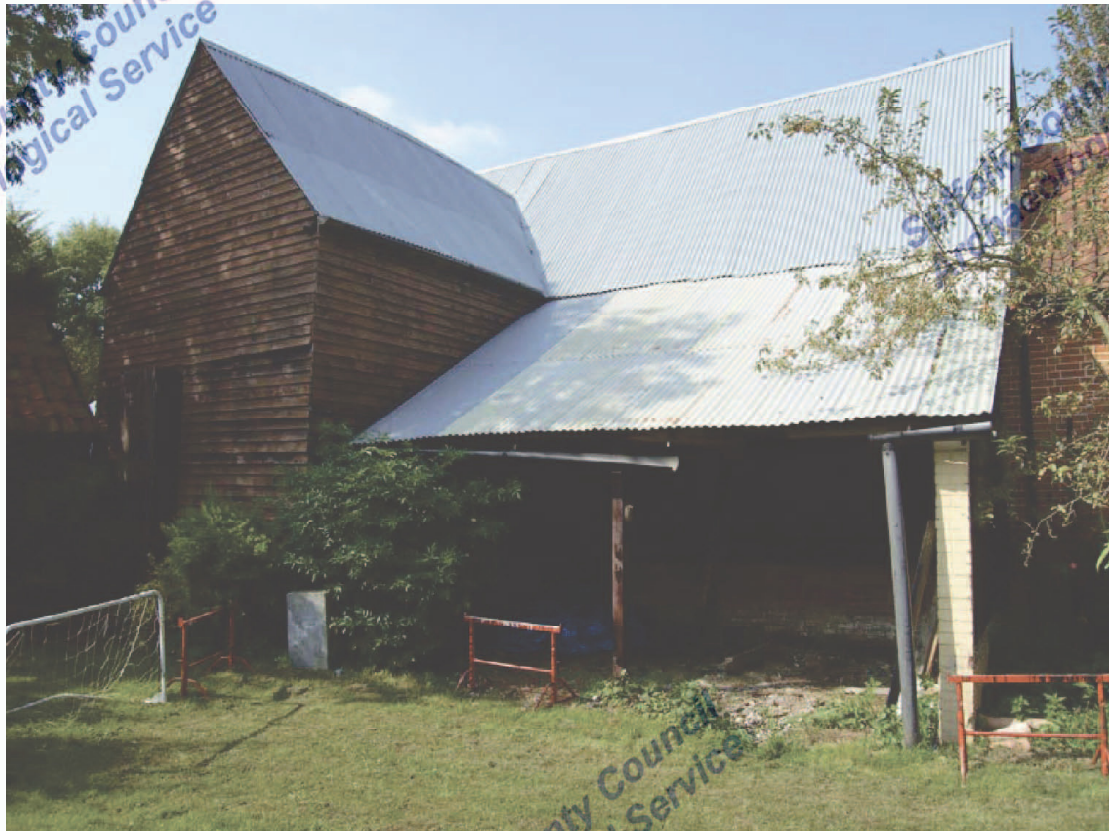
A2.3 Exterior of barn from east showing porch to left and lean-to shelter shed (4) right

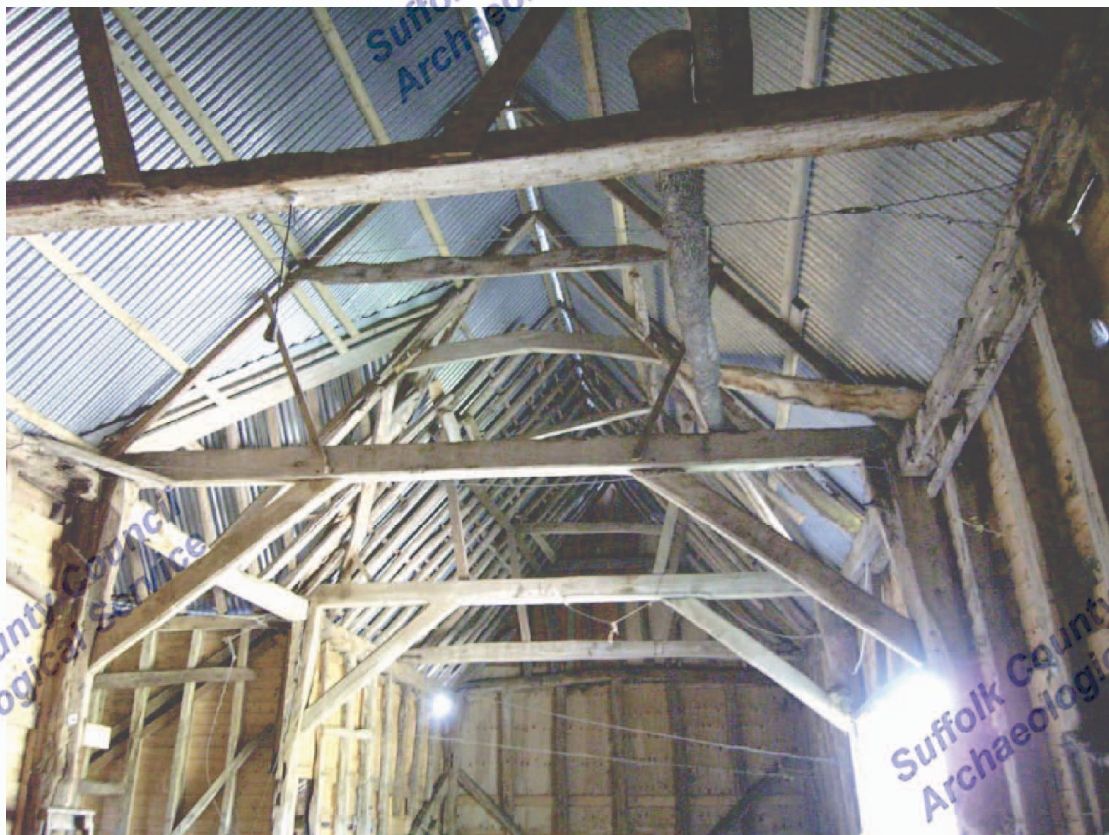
A2.4 Barn Interior. Roof structure from north-east showing original tie-beams, arch-braces and clasped-purlins

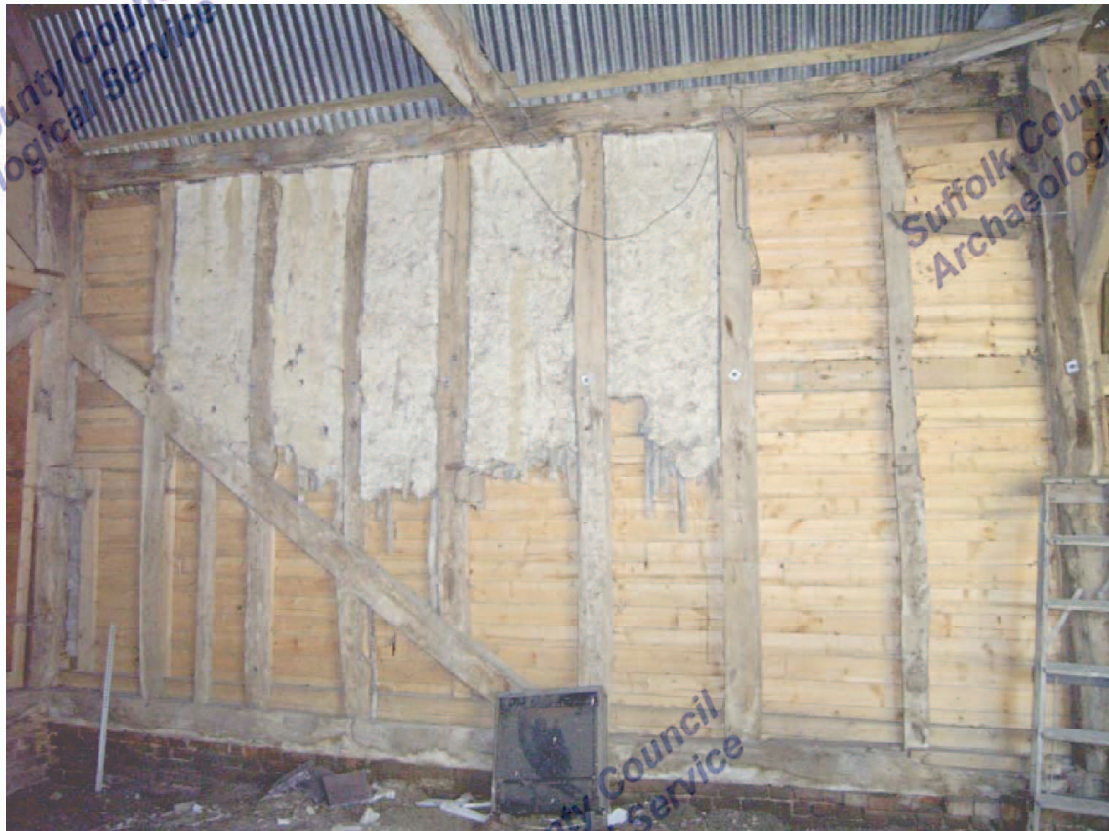
The barn is currently clad in weatherboarding, most of which was renewed in the 1990s, but a substantial area of original wattle-and-daub infill survives in the rear wall to the north-east of

the porch. The barn was initially rendered externally, as the exterior faces of the timbers are waney and unfinished. Such render was typically roughcast and whitewashed, but was often replaced by weatherboarding in the 19th century.

A2.5 Barn. Interior of rear (south-eastern) wall showing surviving panels of original wattle-and-daub infill with porch to right and north-eastern gable to left

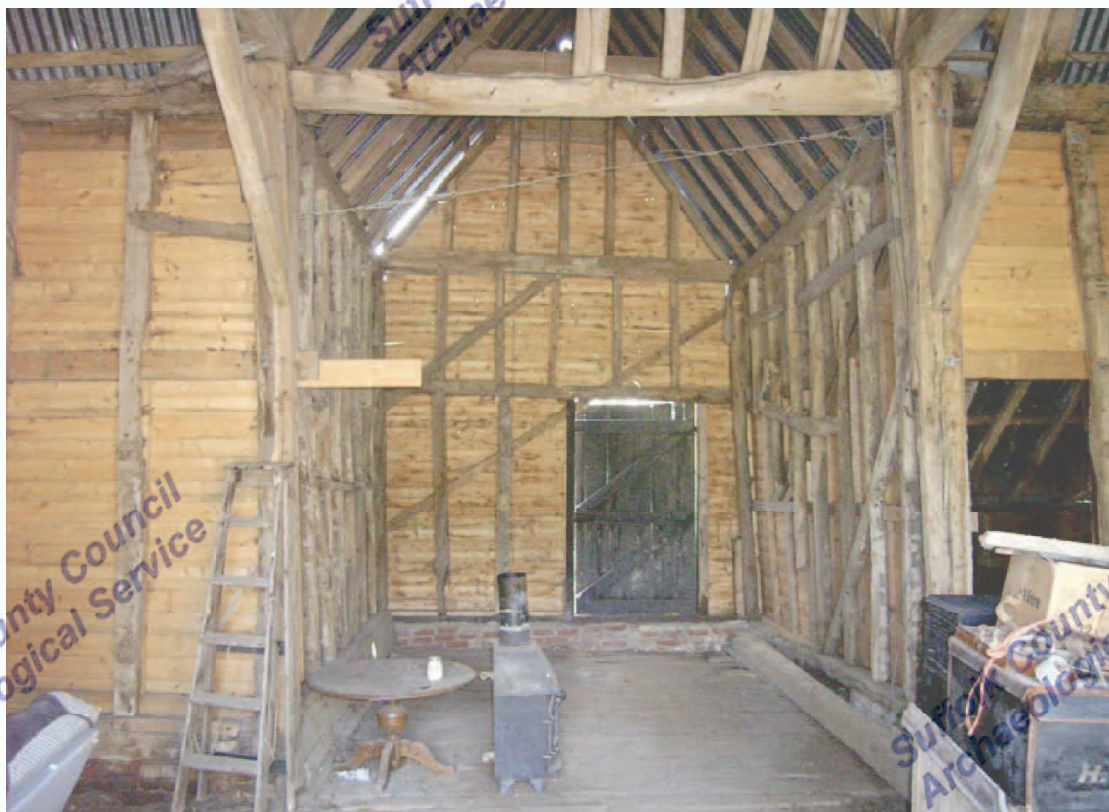
The roof-plate of the central bay in the north-western elevation contains no stud mortises and this bay has always operated as the principal entrance of the barn – as it does today. The roof-plate in the opposite, south-eastern elevation, in contrast, contains five empty mortises for studs which were probably removed when the porch was built later in the 18th century. Prior to the 19th century local barns rarely contained cart thoroughfares but reflected the likely original arrangement here, with full-height doors opposite a low, narrow rear door that was just sufficient to create a through-draught for threshing and winnowing.

A2.6 Barn. Central bay with empty mortises of removed studs in roof-plate showing narrow later porch (2) with modern door in position of original wide door beneath original mid-rail

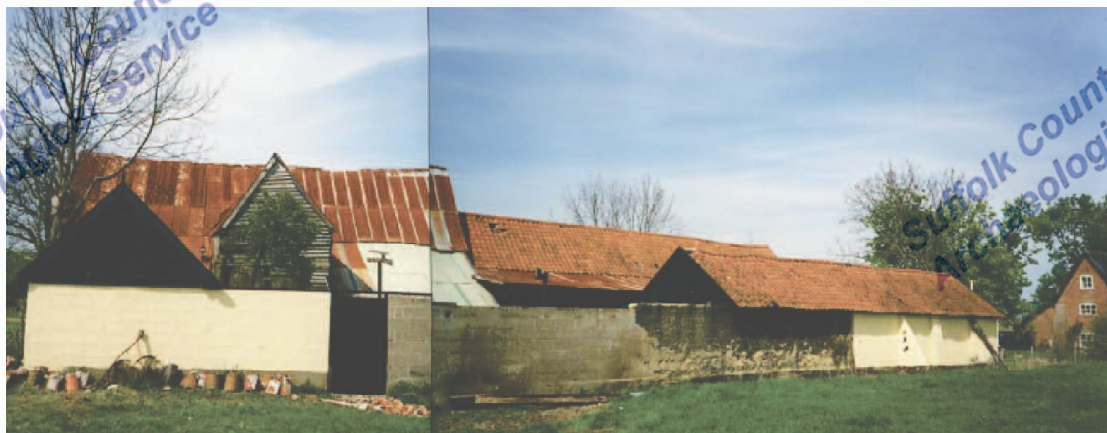
A2.7 Circa 1990. Farm complex from south showing barn to left (uniting two photographs)

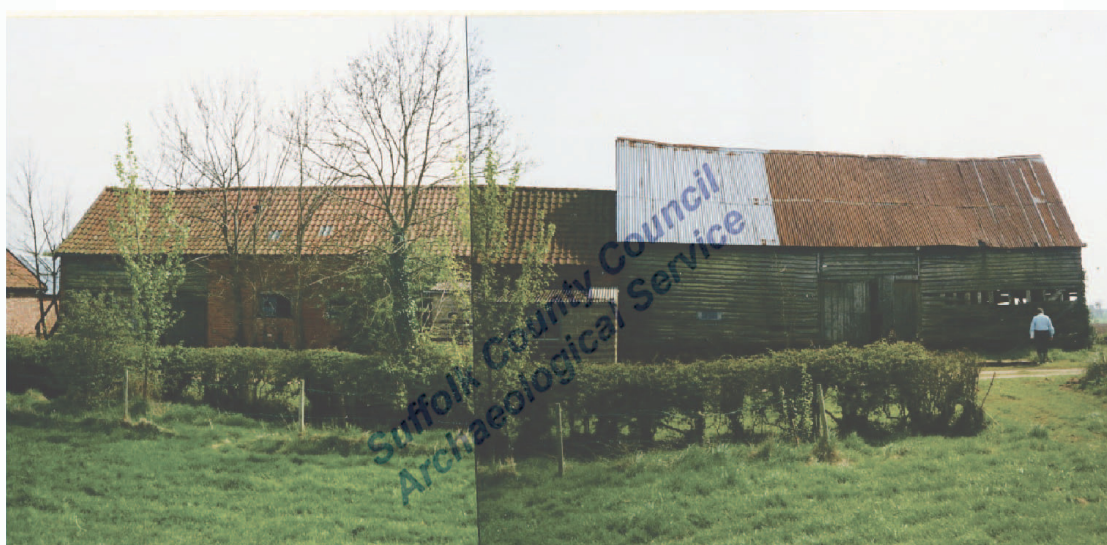
A2.8 Circa 1990. Farm complex from north-west showing barn to right (uniting two photographs)

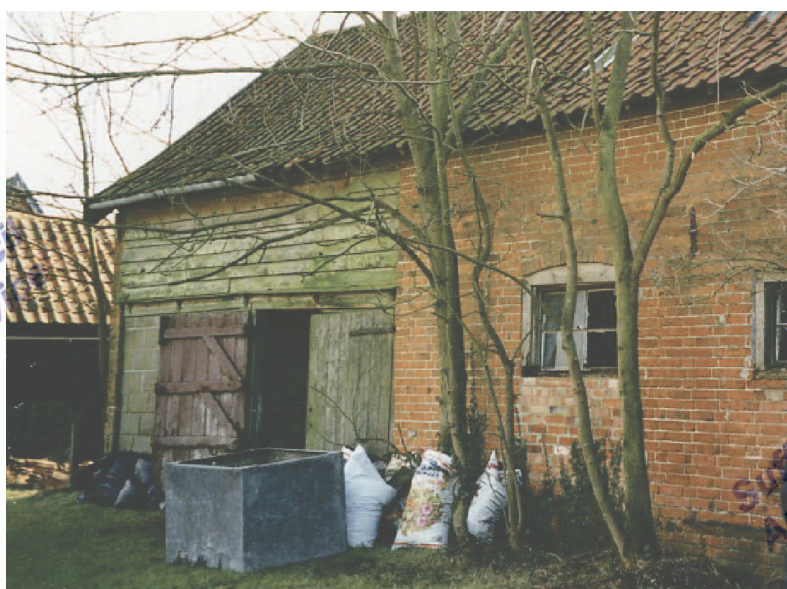
A2.9 Circa 1990. Exterior of shed (7) before conversion showing former cart shed to left
