Ringshall Free Church, Ringshall, Suffolk

Historic Building Record

Ringshall Free Church Lower Farm Road Ringshall, Suffolk

An Archaeological Record

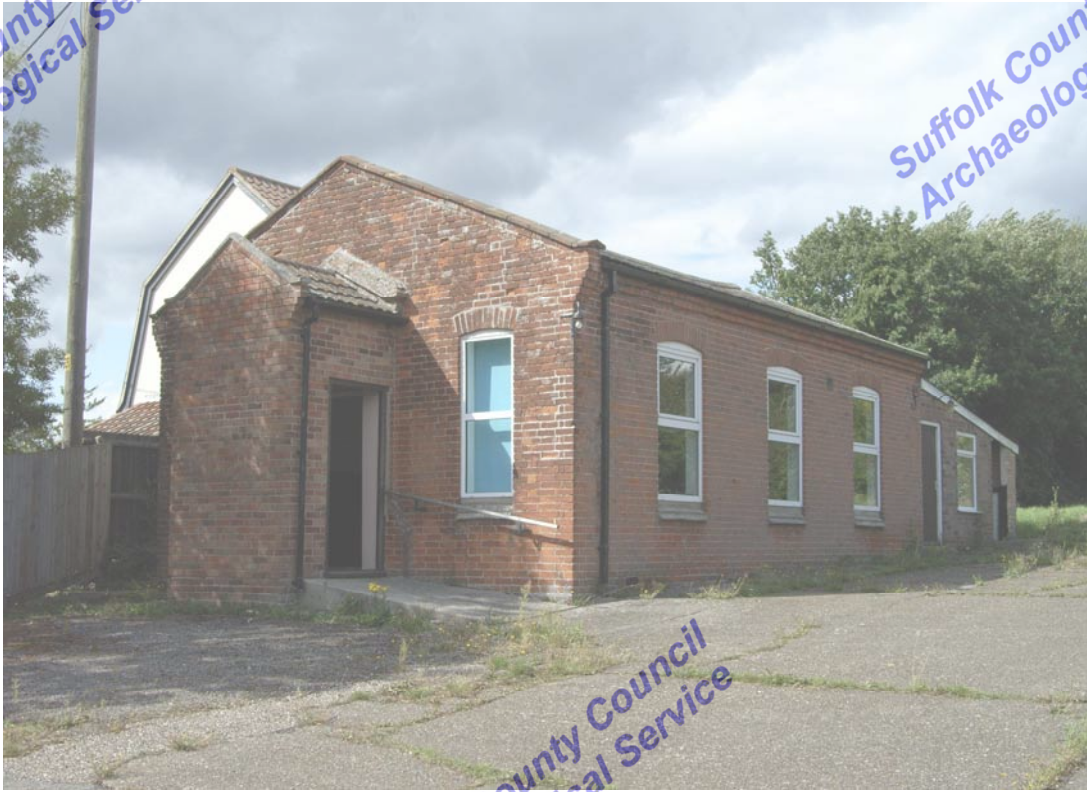
in the mid-20th century obscured the original door case, but its pediment and splayed feet can still be seen.

A2.1 Exterior from south-east showing pedimented arch of original entrance in southern gable just visible above 20th century porch (4)

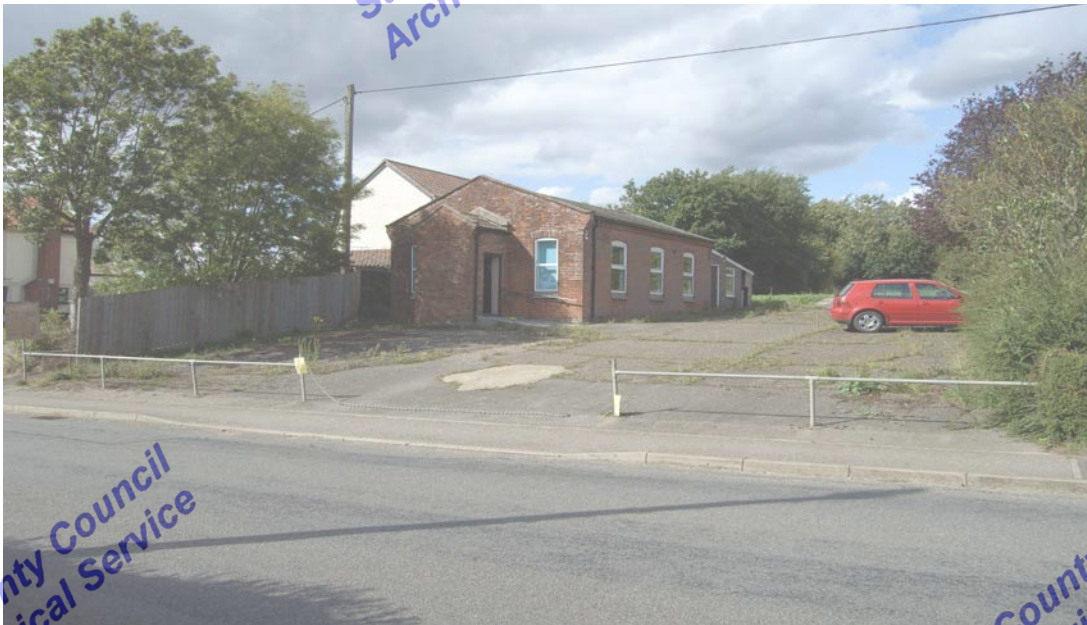
A2.2 General view from south-east showing entrance to site from Lower Road

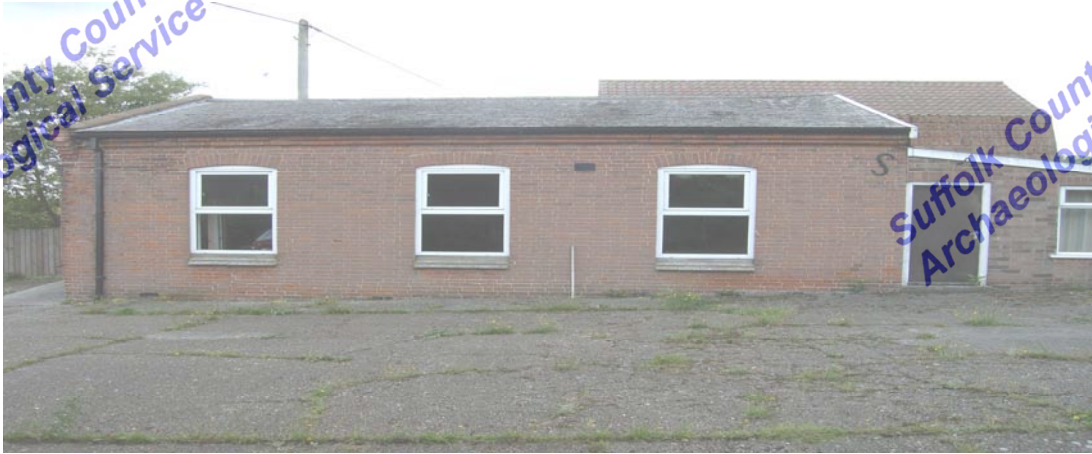
The original structure, shown as area 1 in figure 3, consists of uniform red brickwork in Flemish bond and extends to 6.4 m in overall width by 9.5 m in length (21 ft by 31). Aligned approximately north-south it formed a single hall rising to 3.4 metres (11 ft) at its eaves beneath a low-pitched slate roof. The building was arranged symmetrically, containing three tall windows in each side elevation and two narrower windows flanking an original entrance in the centre of its southern gable. This entrance was approached from the road through a small yard of approximately 10 metres by 10, but the grounds have since been enlarged considerably to the east and north as shown in figures 1 and 2. The window apertures lie beneath segmental arches and almost certainly contained vertical sashes, but now possess modern PVC replacements.

A2.3 Eastern external elevation showing recently replaced windows with 20th century extension (3) to right.

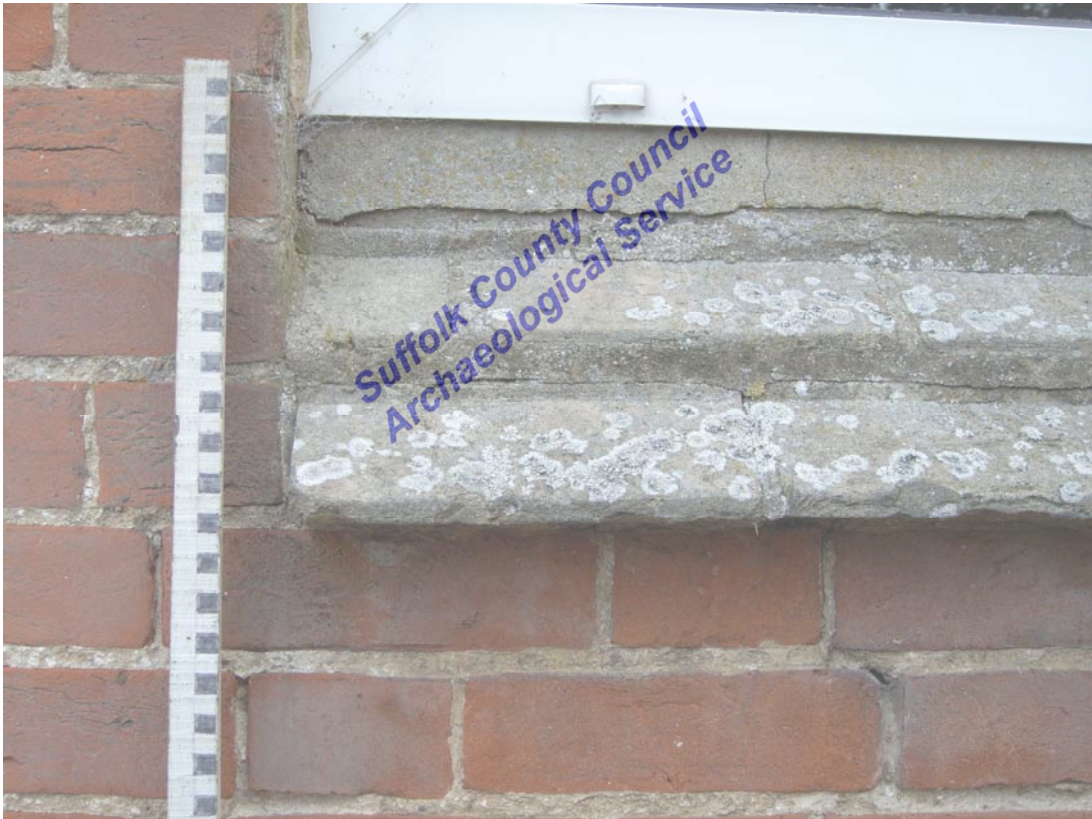
A2.4 Detail of original moulded gault brick window sill in eastern elevation

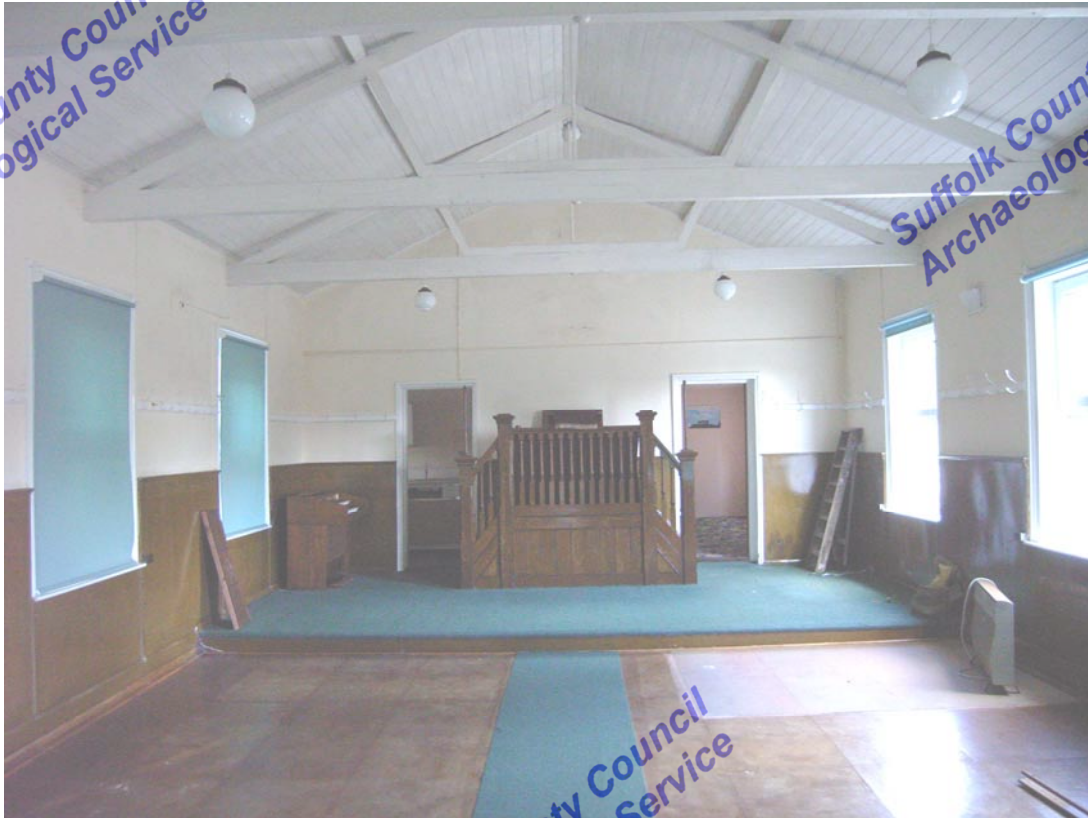
A2.5 Interior of Hall (1) from southern entrance showing dais and pulpit to north

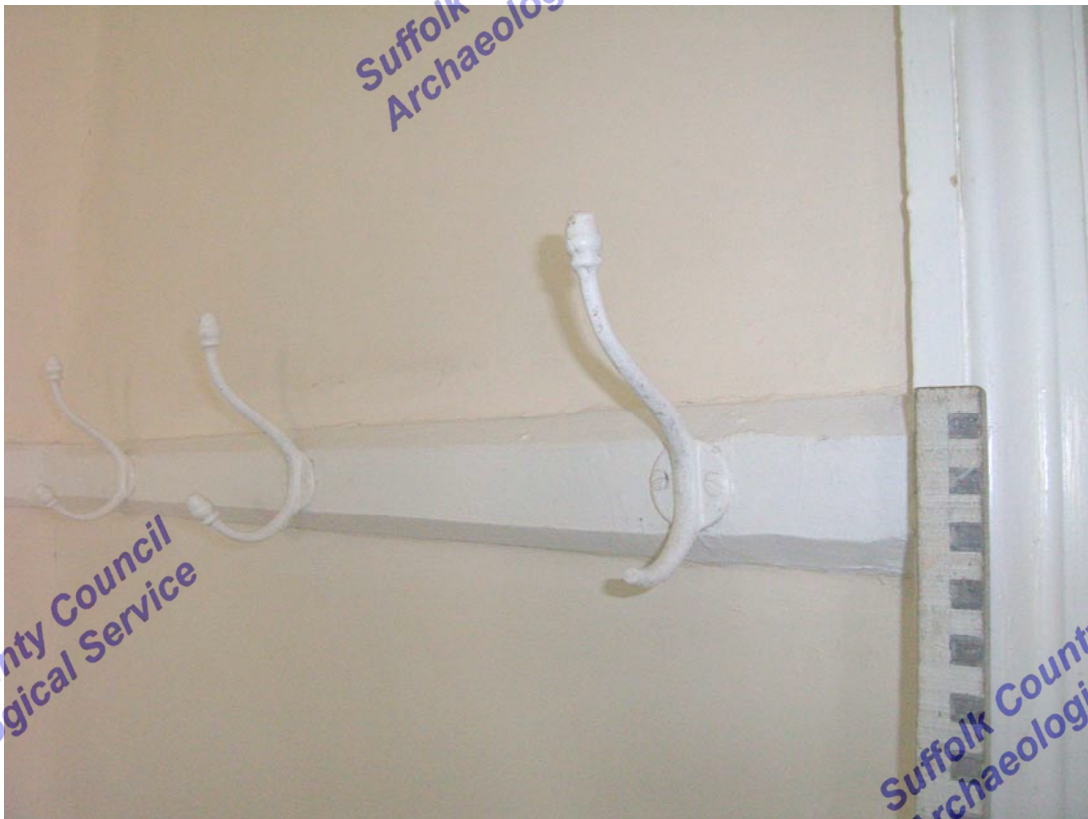
A2.6 Detail of hook rail extending around interior of Hall (1)
