**The Barn,
Hall House,
Summer Road,
Walsham le Willows,
Suffolk**

Historic Building Record

**Barn at Hall House,
Summer Road,
Walsham le Willows, Suffolk
(TL 999 715)**

An Archaeological Record

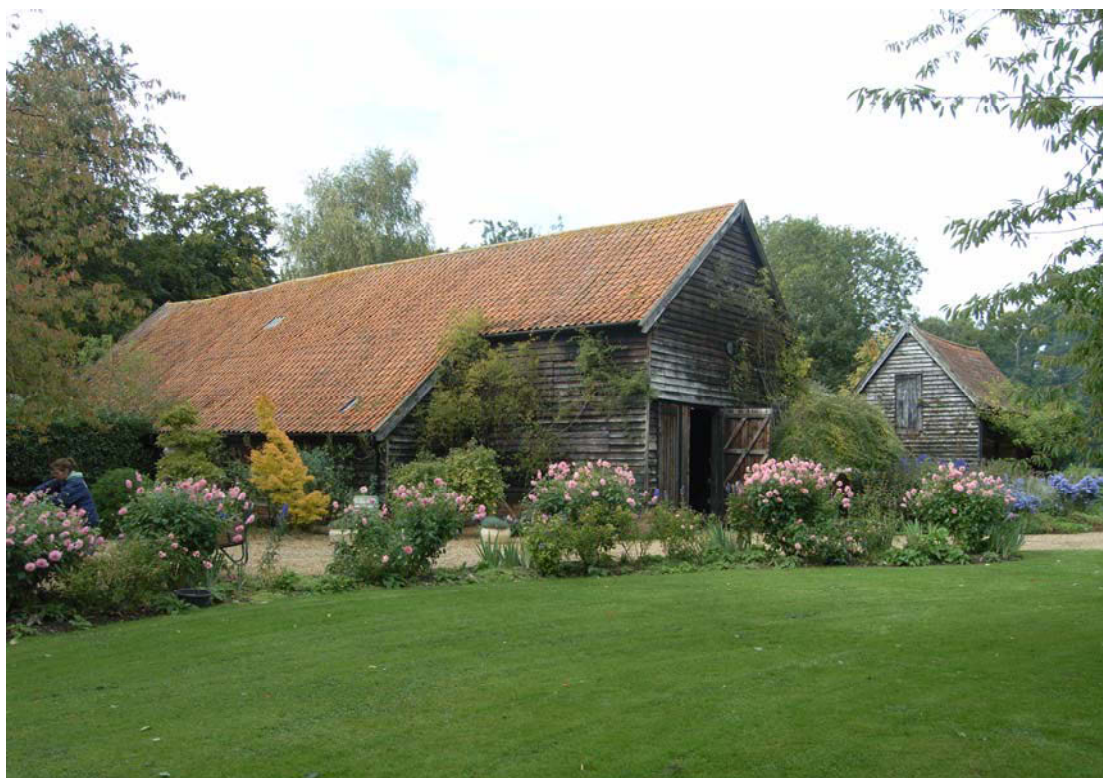
A2.1 View of site from south-east showing barn with later lean-to & western extension (1) to left and cartlodge (2) right

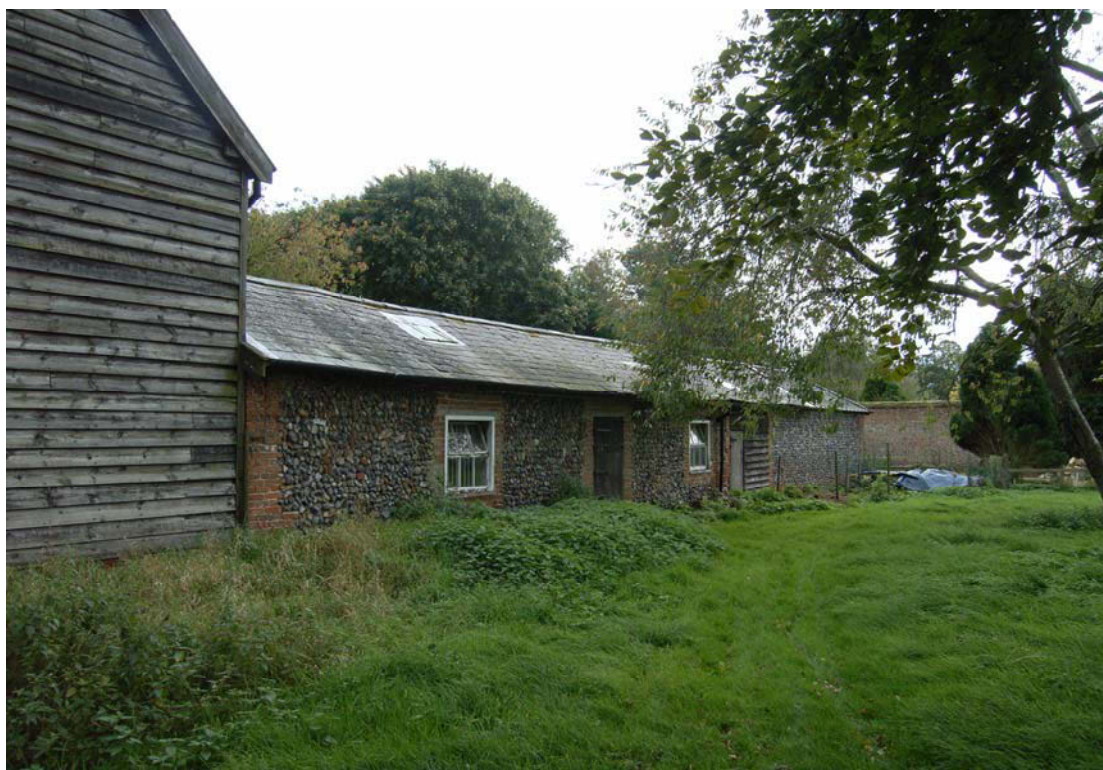
A2.2 Exterior of stable range from approximate site of medieval road to Sandpit Farm to north-west, leading to Cowwell lane to south

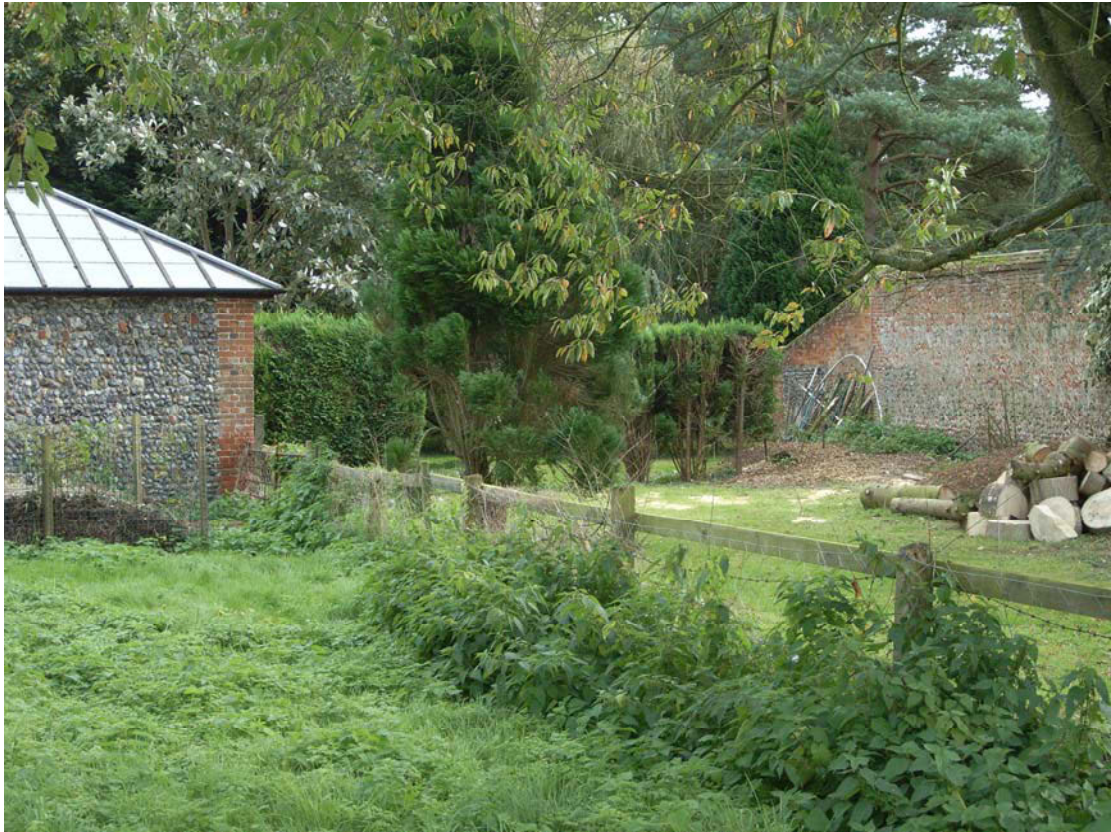
A2.3 Site of medieval road known as Cowwell Lane from north-west showing stable to left & The Willows right

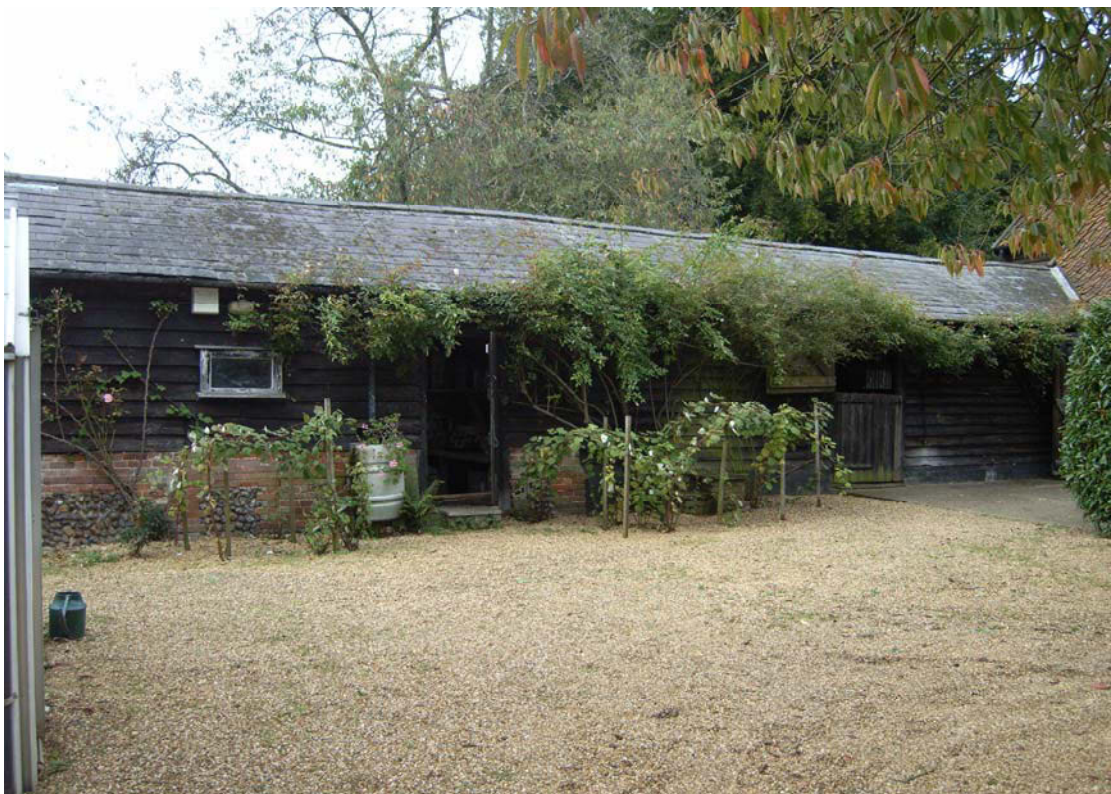
A2.4 Exterior of stable range from east showing barn and entrance to shed J to right with entrance to shed K left

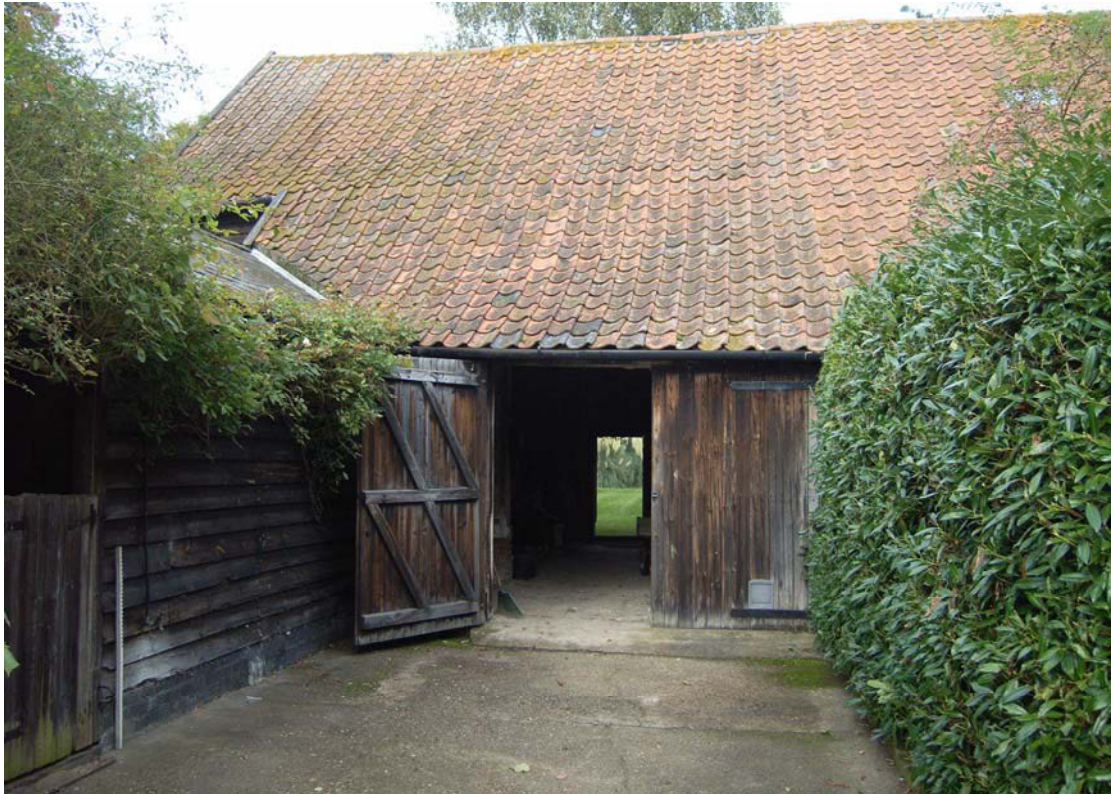
A2.5 Exterior of barn from south showing entrance to lean-to shed G with formerly open-sided shelter of stable range to left

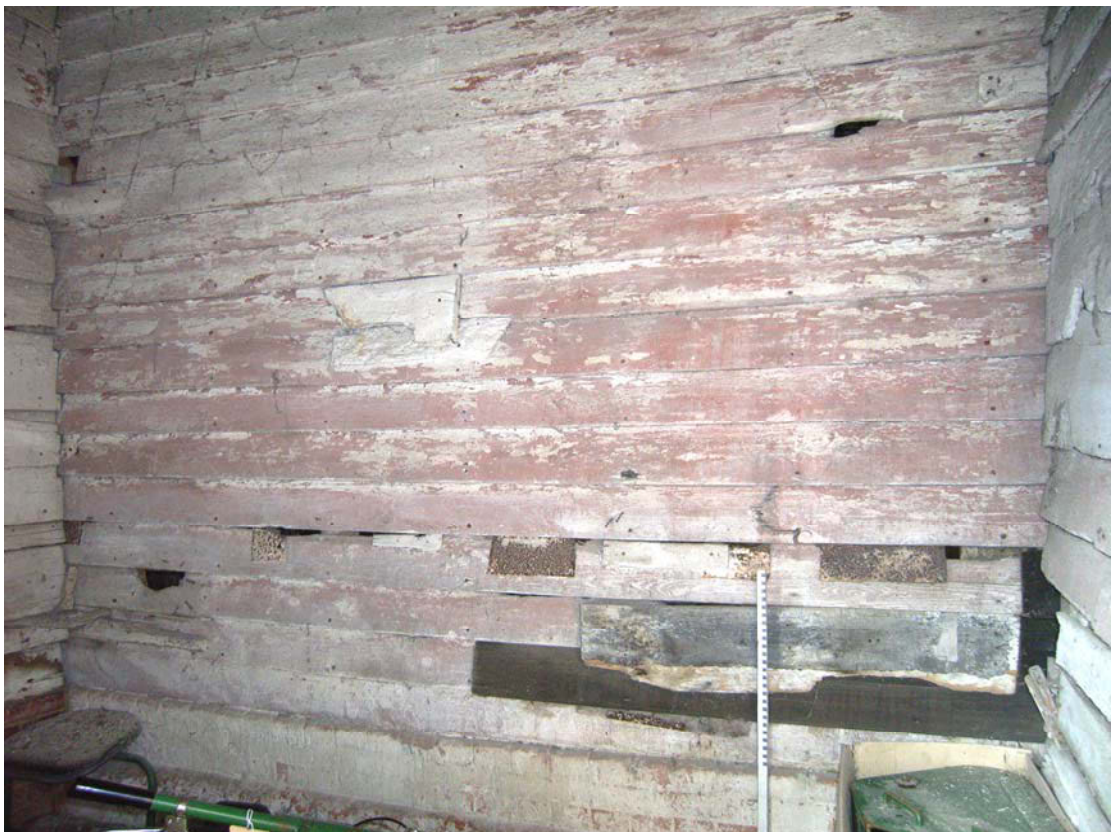
A2.6 Interior of shed H from south showing rare original reddled external boarding to barn beneath later whitewash

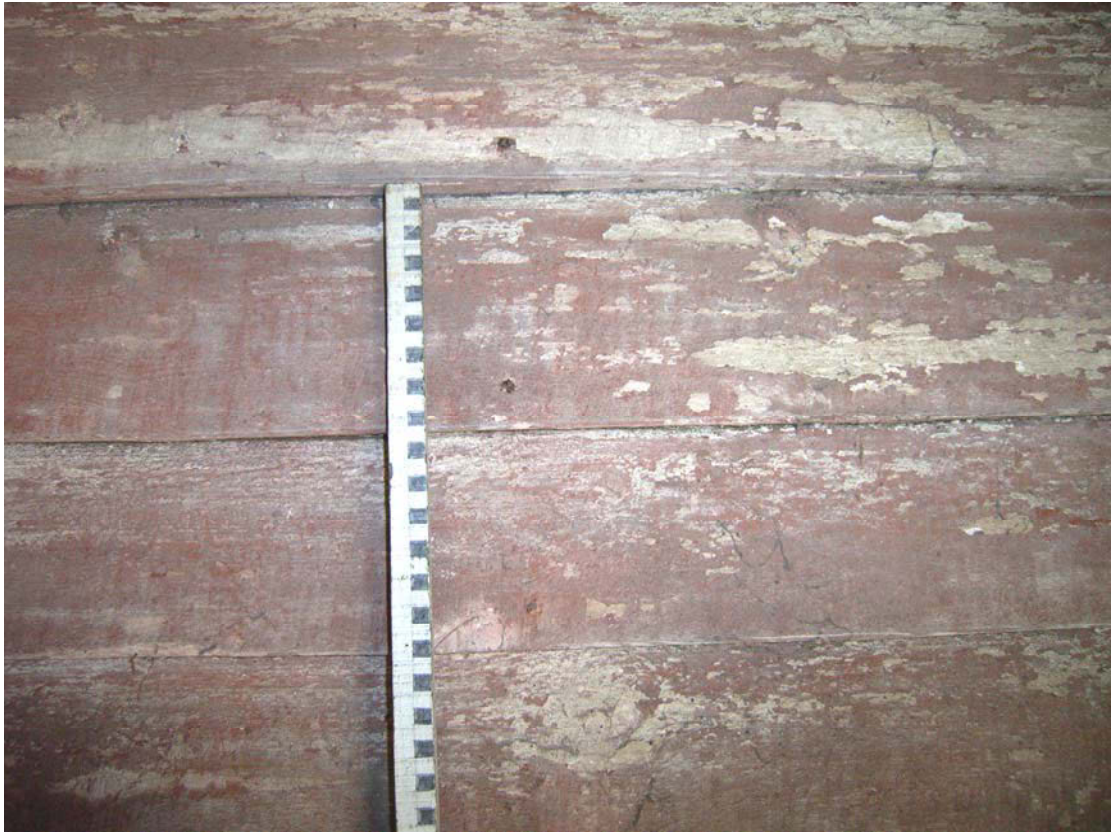
The external weatherboarding of the southern elevation is largely original, and consists of narrow, overlapping pine boards of 17 cm (7 ins) in width, painted with red ochre. The boarding which remained external in the second half of the 19th century was repainted with tar in the usual manner, and much of it was later replaced, but the southern elevation was protected by the construction of a lean-to before 1842 and survives in remarkably good condition. Red ochre was used to protect and decorate many Suffolk barns in the 18th and early-19th centuries, and the Red Barn in which Maria Marten was murdered in 1827 was by no means unique, but most was destroyed when tar became readily available as a cheap by-product of the town gas industry. Fragmentary survivals are not uncommon, but the almost intact southern elevation of the barn at Hall House is the best and most extensive example of my acquaintance and is of considerable historic significance. Some boards retain evidence of a grey/blue pigment which was also common, but these represent repairs and have been re-used from elsewhere (Blue Barns are almost as frequent in the documentary record as Red Barns).

A2.7 Detail of original reddled external boarding to barn preserved within later shed H

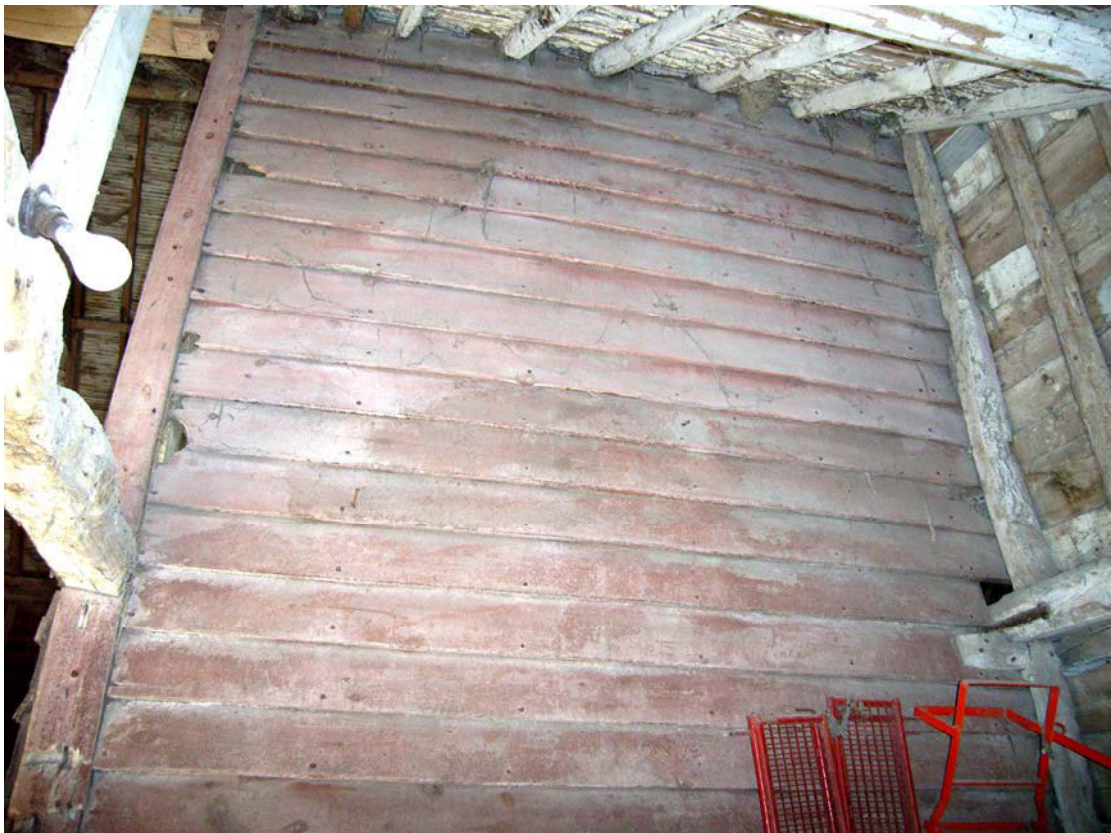
A2.8 Rare reddled external boarding to bay C of barn from later lean-to shed G

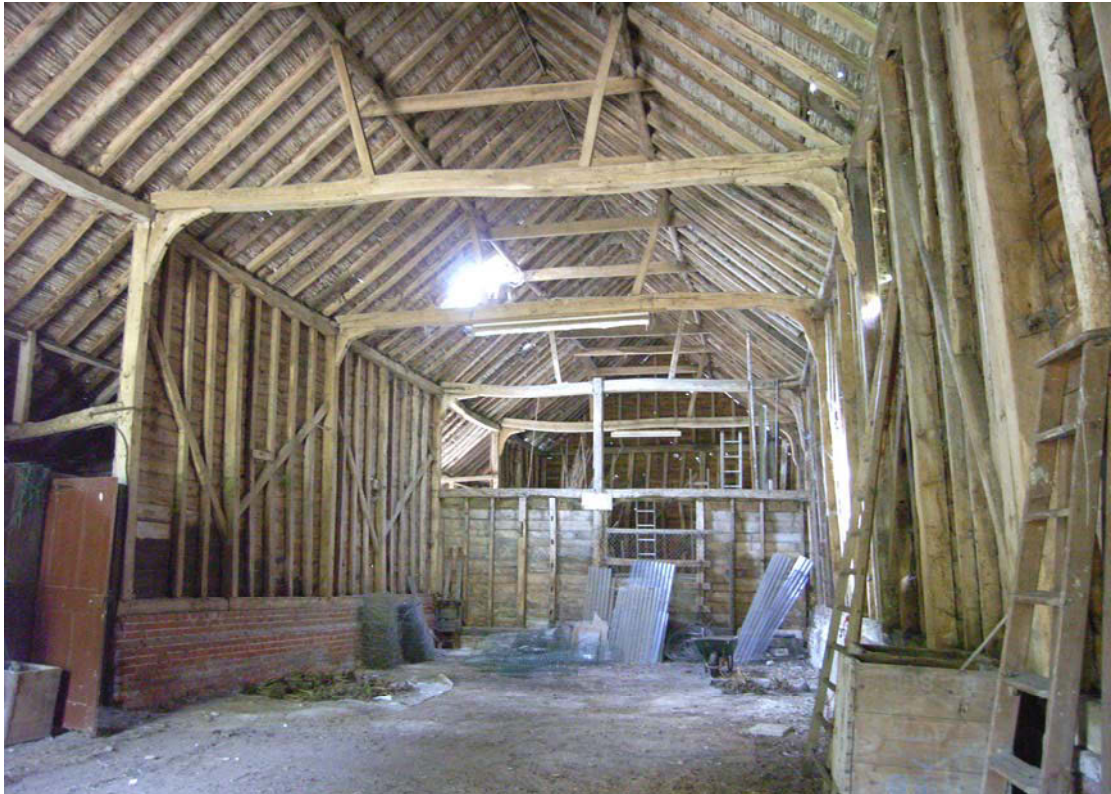
A2.9 Interior of barn. General view looking west from eastern gable. The original structure ended at the partition between bays C & B shown here in the rear and was later extended westwards by two bays.

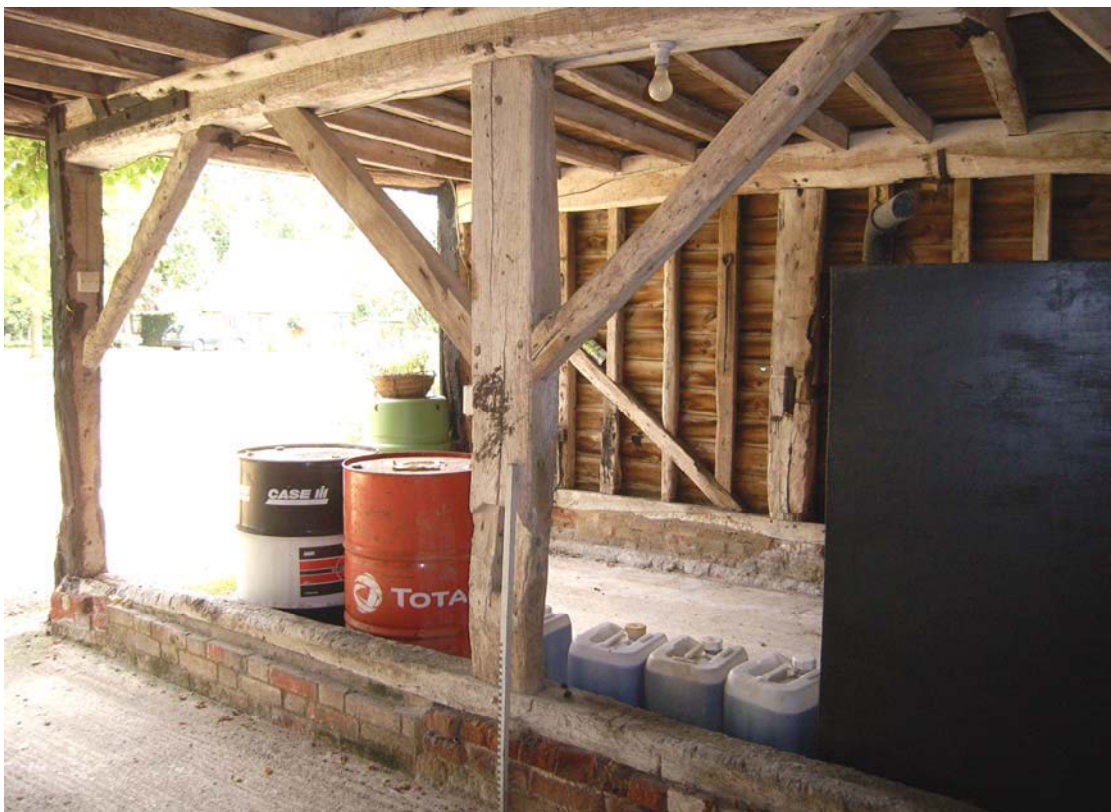
A2.10 Interior of cartlodge (2) from north-west showing open bays & re-used timber
