ARCHAEOLOGICAL WATCHING BRIEF REPORT

Nettlestead Chace, Nettlestead

NTT 015

A REPORT ON THE WATCHING BRIEF, 2007

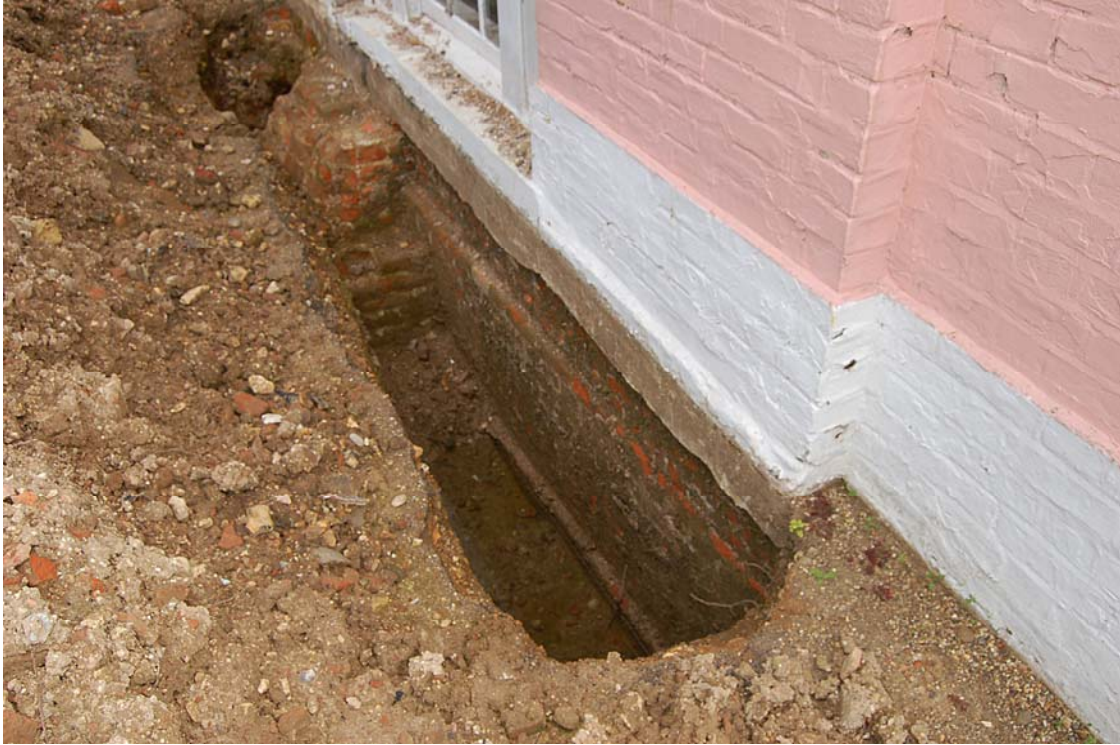
The foundation is constructed of red bricks bonded with light grey mortar. At depths of c. 0.50m and 1.10m below ground level it steps out 80mm. It extends to >1.20m below ground level (Fig. 7).

The buttress is located below the window of the drawing room and overlaps stepped foundation 0039 (Fig. 7). It is constructed mostly of red bricks, with a few yellow bricks, bonded with a yellowish mortar. The brickwork seems to be of 19th-century date. The upper part is five courses deep (0.45m) and 0.90m wide, stepping out to 1.40m wide and extending to a depth of >1.20m below ground level. The extent of the buttress to the northwest is unknown, although it is likely to have been roughly square in plan.

Figure 7. View of foundation 0039 and buttress 0019, looking east

According to Aitkens the front wall of the house consists largely of 16th-century brickwork with a thin brick skin applied in the 1830s or 1840s when the existing porch was built. Foundation 0039 is assumed therefore to be of 16th-century date also. Given its great depth 0039 must also have been a cellar wall; this suggests that there is a Tudor cellar to the northeast of the present building and this is borne out by the nature of the deposit that was excavated from the inspection trench. It suggests also that there might be a backfilled cellar beneath the drawing room.

Buttress 0019 is of 19th-century date and its purpose must have been to reinforce foundation 0039 when alterations were made to this façade.

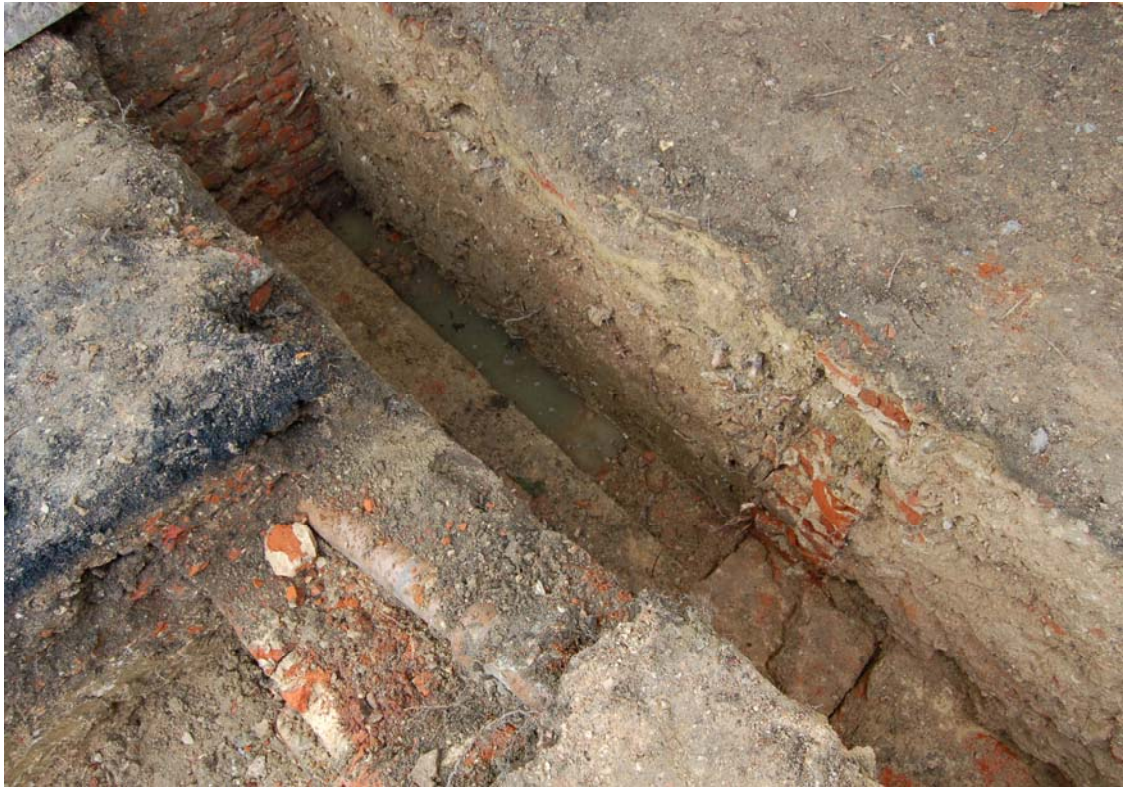
0011 is an L-shaped foundation seen at the base of the construction trench for the rebuilding of the northeast wall of the ‘study’ wing, 1.50m below modern ground level (Figs. 9 and 10). At its southeast end it is tied into foundation/cellar wall 0022, which supports the end wall of the ‘study’ wing. There is a slight suggestion that it makes a return to the northeast at this point, on the same alignment as the garden wall shown on the cover illustration.

At its northwest end 0011 supports cellar wall 0010/0013 (see Figure 10); this is clearly bonded to the foundation and of contemporary build. 0011 is built against, but is not bonded to, foundation/cellar wall 0015.

Figure 9. View of the construction trench for the rebuilding of the northeast wall of the 'study' wing, showing L-shaped foundation 0011 (in plan), overlying cellar wall 0010/0013 (in section) and cellar wall 0022 (in elevation, top left)

Foundation 0011 and wall 0010/0013 represent the northeast corner of a small cellar. It is clearly contemporary with the 'study' wing of the existing house, which Aitkens dates to the 16th century.

The stratigraphic evidence suggests that foundation 0011 and cellar wall 0010/0013 were built after the partial demolition of foundation/cellar wall 0015; the same deposit of cellar infill – 0008 – seals foundation 0015 and abuts cellar wall 0010/0013. This provides further evidence for the remodelling of this part of the Tudor mansion and demonstrates that the 'study' wing was not part of the original design of Nettlestead Hall.

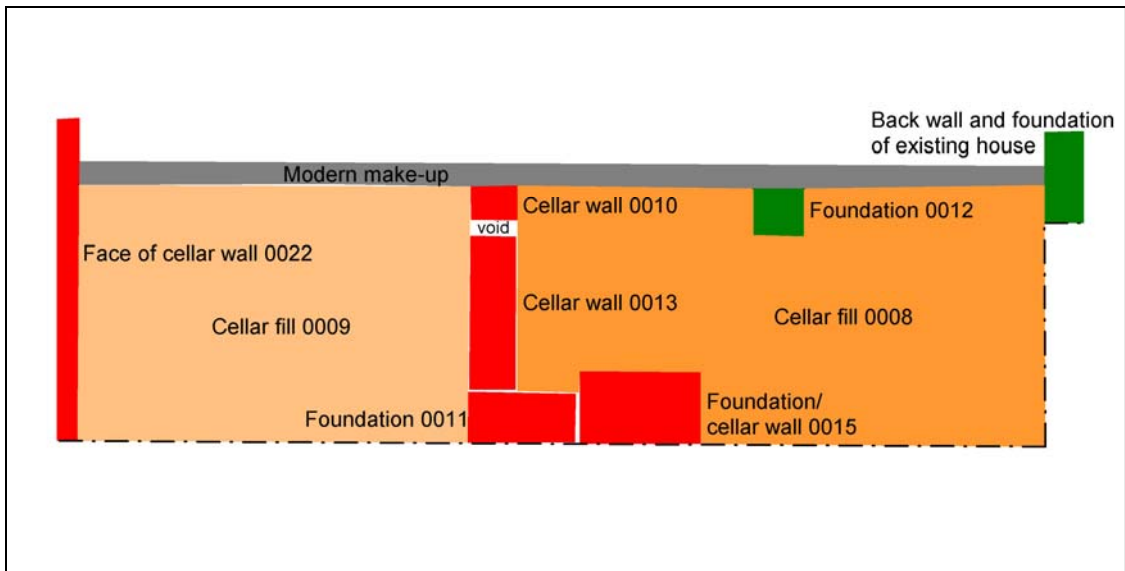
0015 is a substantial brick foundation/cellar wall (oriented northeast–southwest) recorded in plan and section at the base of the construction trench for the rebuilding of the northeast wall of the ‘study’ wing (Fig. 10). It is 0.64m wide, >1.00m long and at least 0.40m deep, extending to >1.50m below modern ground level. It is built of soft, red bricks bonded with white mortar.

The foundation has been truncated to 1.10m below ground level and is sealed by a thick deposit of brick/mortar rubble (cellar infill 0008).

It is likely that 0015 and 0029 were contemporary, forming the southeast corner of a cellar of unknown depth and extent. Both walls are truncated and sealed by demolition rubble, suggesting that this part of the Tudor mansion was remodelled. Note that foundation 0001 is on the same alignment and of the same width as 0015 (though relatively shallow), suggesting that it belonged to the same phase of construction.

Figure 10. Schematic northeast-facing section in the construction trench for the rebuilding of the northeast wall of the 'study' wing

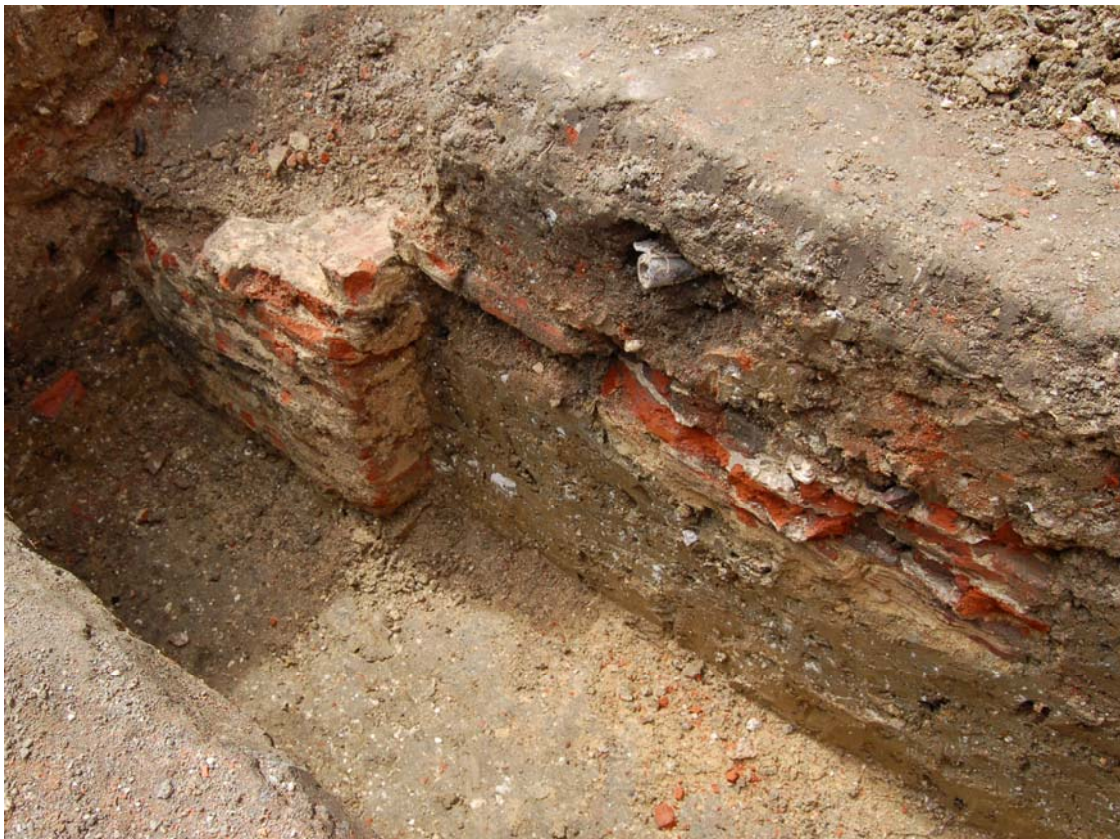
0001 is a shallow brick foundation (oriented northeast–southwest) recorded in section only, it having been cut through by the construction trench for the new playroom (Fig. 11). It is >1.25m long x 0.62m wide x up to 0.28m deep (four surviving courses), extending to 0.45m below ground level. The bricks are red and of a soft fabric, measuring 220 x 110 x 52mm. They are bonded with a hard, buff-coloured mortar with frequent lime flecks.

0005 is the northeast corner of a brick structure, possibly a foundation (Fig. 11). The observed masonry is L-shaped, measuring >0.70m northwest–southeast and only 0.22m northeast–southwest, having been truncated by the construction cut for septic tank 0014 (see below). The structure is 0.60m high (ten surviving courses) and extends to 1.06m below modern ground level. The brickwork is of an irregular bond and the bricks and mortar are similar to those used in nearby foundation 0001.

Figure 11. Brick structure 0005 (left) and foundation 0001 (right)

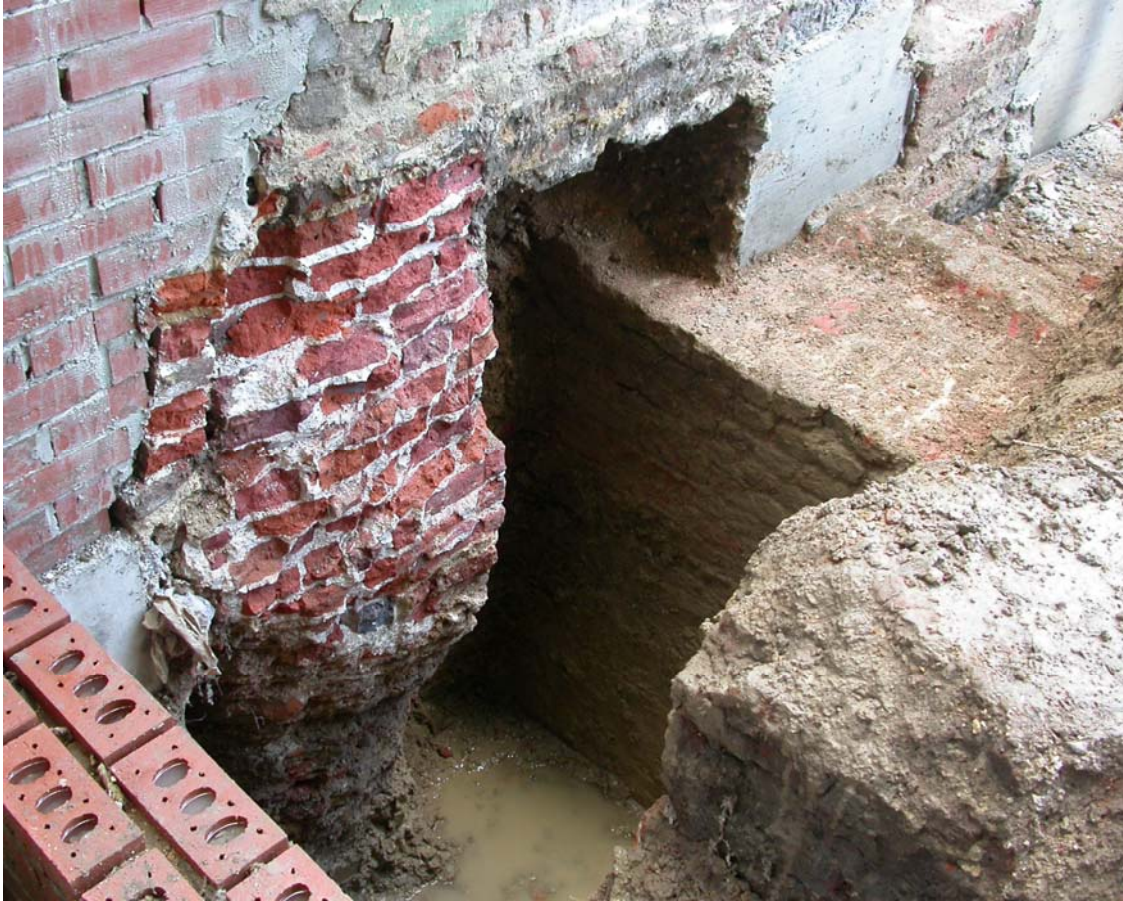
0029 is a substantial brick foundation/cellar wall recorded in plan in an underpinning trench against the rear of the house. It is built of soft, red bricks laid in a random pattern and bonded with white mortar (Fig. 12).

The foundation is oriented northwest–southeast and runs under the rear wall of the existing house. It is 0.78m wide, >1.30m long and at least 1.40m deep, extending to >2.20m below ground level. It has a slight batter on its southwest side, suggesting that it is wider at its base. The extent of 0029 to the southeast is unknown, although it does not appear in section in the construction cut for the southeast foundation of the new playroom. It is truncated to 0.60m below ground level and sealed by brick/mortar rubble, presumably demolition material.

Brick/mortar rubble deposits (cellar infill) abut the southwest side of the wall, with natural clay/silt 0004 surviving to the northeast of the wall.

0031 is a block of brickwork beneath the shallow foundation for the rear wall of the house (Fig. 12). It is 0.70m wide and projects at least 0.15m southeast of the wall. Its face has been cut back in the course of current building work, so its original extent to the southeast is unknown. However, it certainly did not appear in section in the opposite side of the underpinning trench, 0.70m from the back wall of the house.

0031 is built mostly of red bricks, with a few reddish purple examples, bonded with a hard, off-white mortar. It is approximately 18 courses high, with a depth of 0.90m (1.20m below ground level). It is assumed to be underpinning the rear wall of the house and it is noted that it also extends below the southwest side of a large 16th-century fireplace in the dining room.

Figure 12. Underpinning 0031 (left) and foundation/cellar wall 0029 (right)

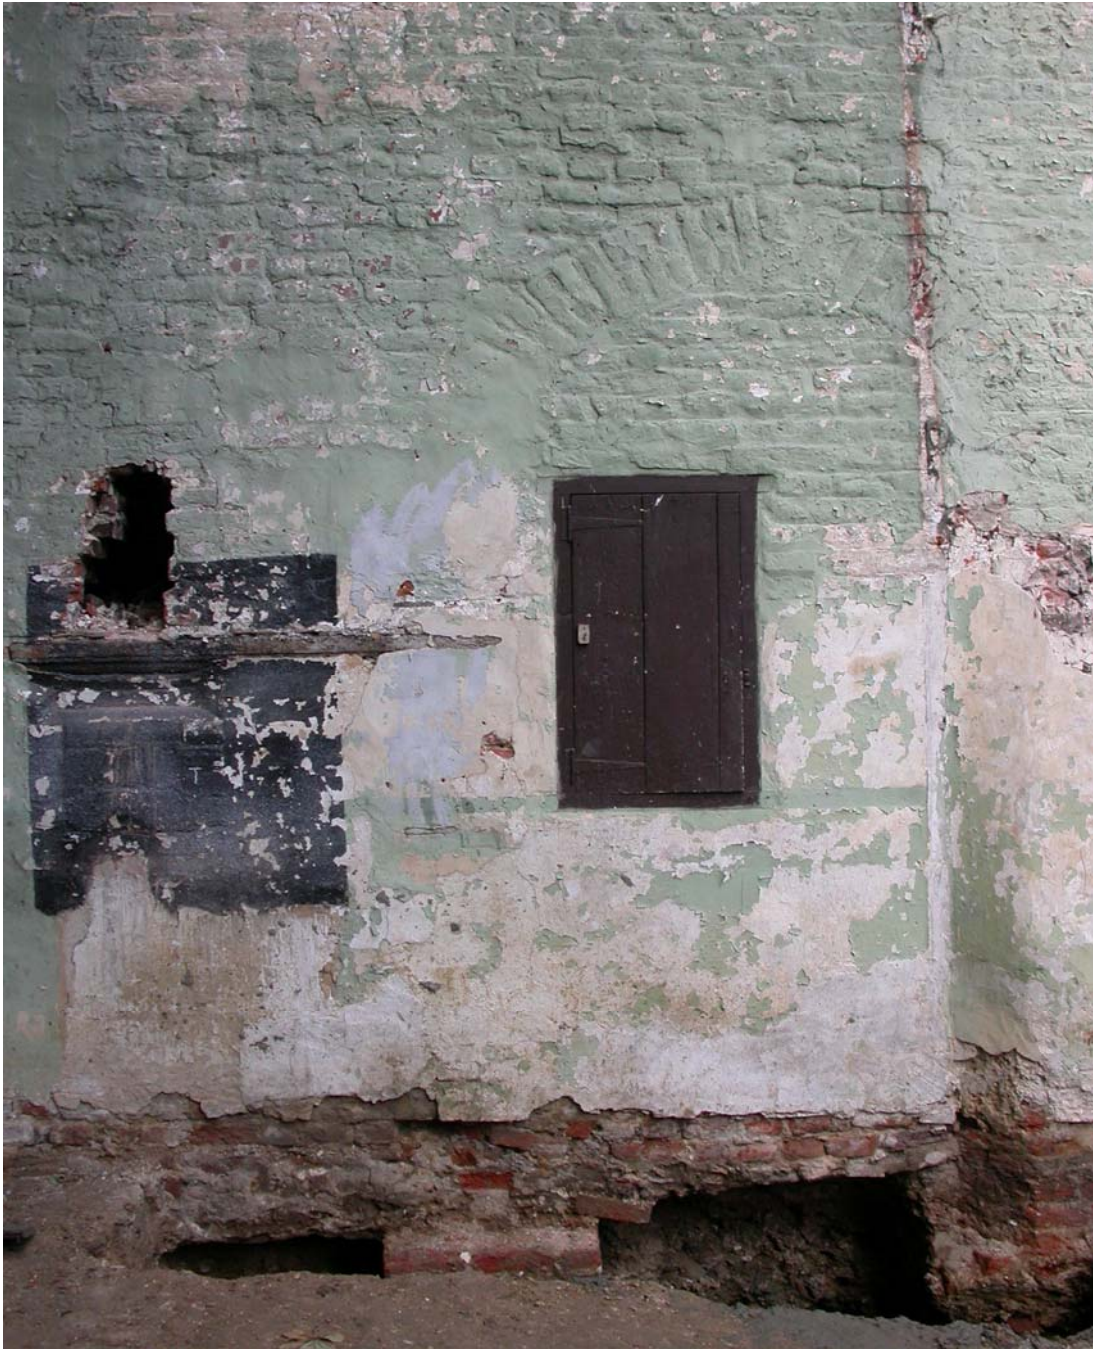
0028 is a stepped brick plinth beneath the rear wall of the house. Its upper part is 0.65m wide and 0.35m high (five courses), but its length is unknown. This sits on a slightly wider (0.90m) mortared brick rubble base, of unknown depth. The bricks appear to be relatively modern and it is assumed to have been constructed in the 19th century. It is probably associated with the blocking of an overlying arch in the rear wall of the house (Fig. 13). This arch formed part of a corridor connecting the dining room with a demolished room to the south; the latter is possibly represented by foundations 0001 and 0029.

Figure 13. The top of brick plinth 0028 (lower centre) beneath a blocked arch

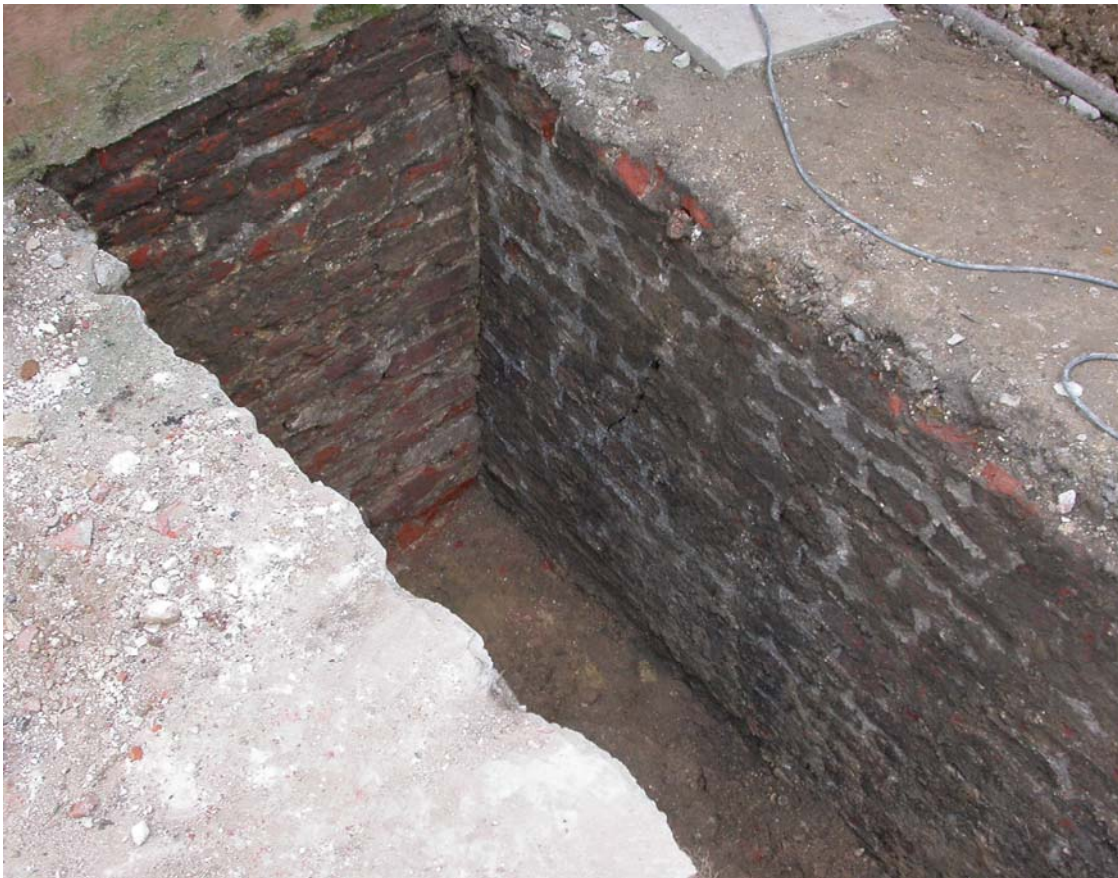
Figure 15. 19th-century foundation 0023 (left) abutting earlier cellar wall 0025

This is the brick foundation for the northeast wall of the existing house. It consists of 15 courses of red brick with an irregular bond, over two courses of mortared brick rubble. The mortar is grey or buff coloured, consistent with that used on the rear wall of the house and other 19th-century brickwork. To the northwest 0023 abuts earlier cellar wall 0025 and it was constructed on top of cellar floor 0024 (Fig. 15).

The cellar represented by walls 0025 and 0027 and floor 0024 extends beneath the existing house, but must have gone out of use when the house was rebuilt in the early 19th century. At that time foundation 0023 was built free-standing within the cellar and the cellar backfilled with demolition rubble 0026. The extent of the cellar to the southeast is unknown. Note that the ground to the northeast of wall 0025 was not cellared.

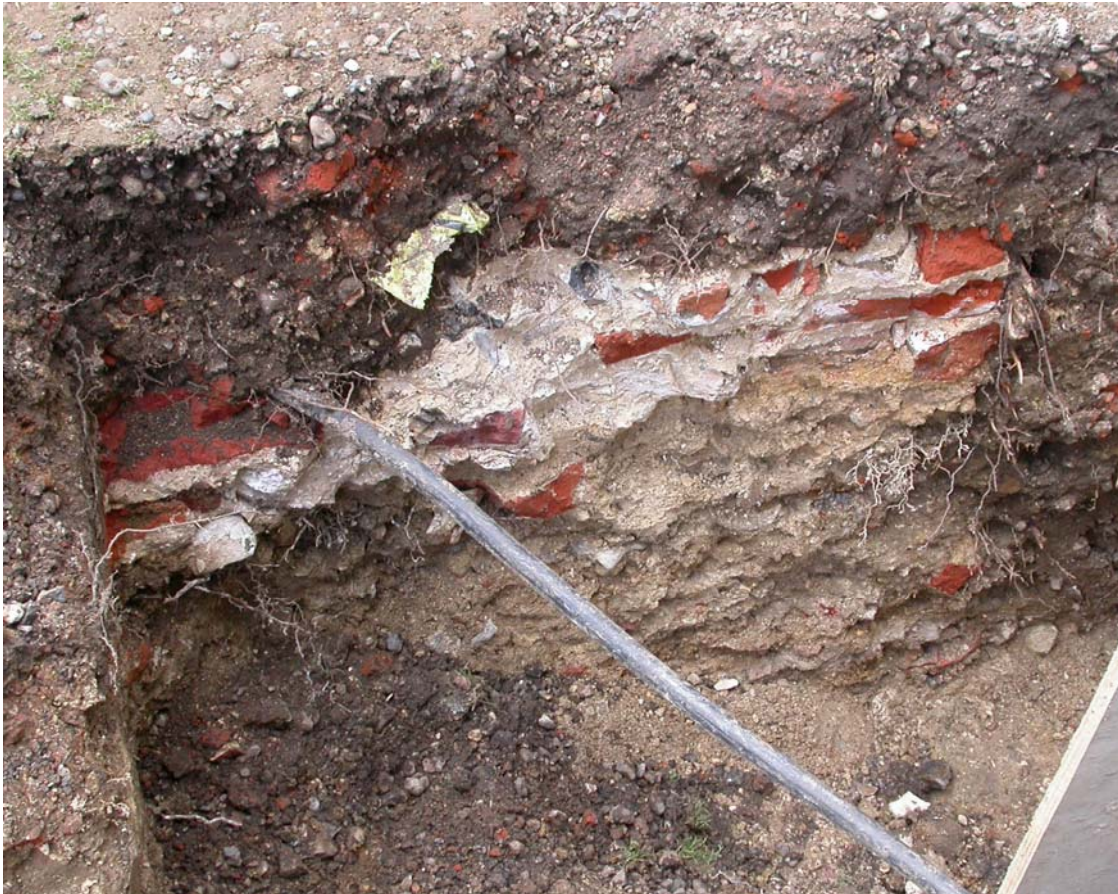
0016 is a shallow foundation of red brick with occasional flint nodules bonded with off-white mortar (Fig. 16). The foundation survives to three courses deep (0.23m) and is 1.0m wide. Its extent to southwest and northeast is unknown, although it probably connected with foundation 0030.

0016 overlies a deposit of crushed mortar and brick/tile/flint rubble 0017, more than 0.50m thick. The function of this deposit is unknown, although it might be filling a robber trench on the same orientation as wall 0016.

Figure 16. Northeast-facing section showing brick-and-flint foundation 0016 overlying demolition deposit 0017
