**23 Trimley Road,  
Kirton,  
Suffolk**

**Historic Building Record**

**23 Trimley Road,  
Kirton, Suffolk  
(formerly Malting Farm and Malthouse)  
(TM 277 394)**

## **An Archaeological Record**

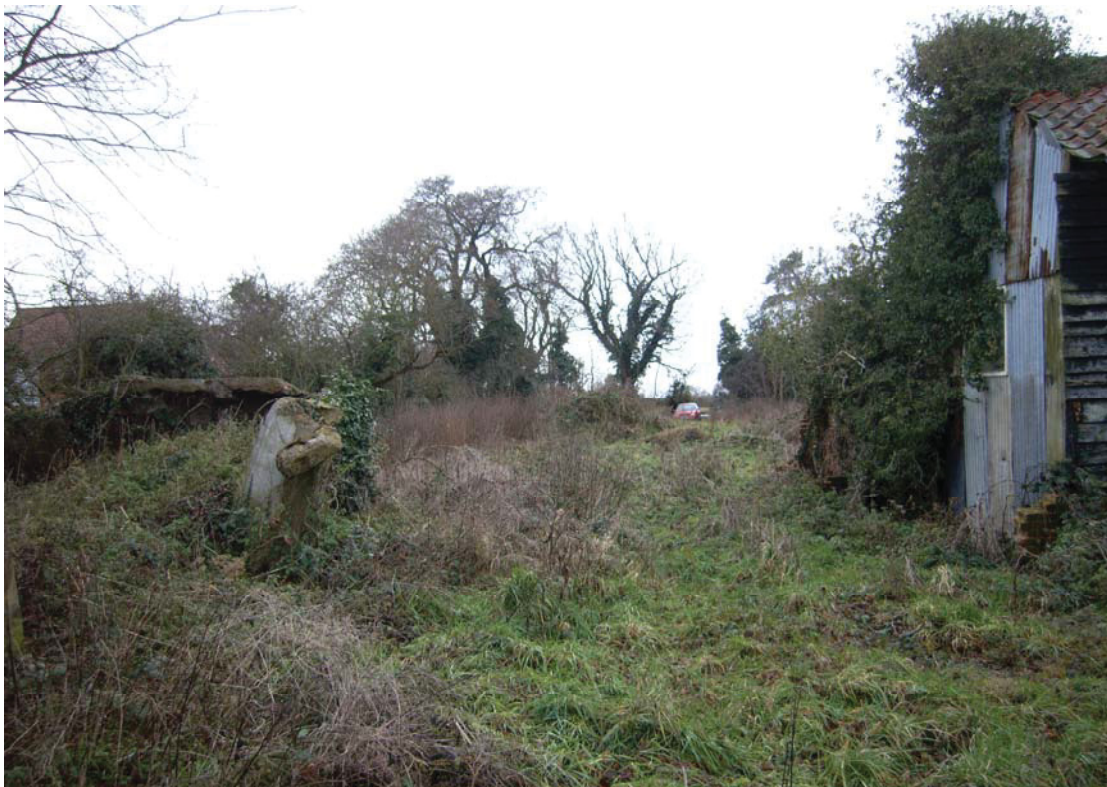
A2.2 General view of site from east showing site of demolished maltings in centre with southern gable of barn to right and remains of WWII gun emplacement to left

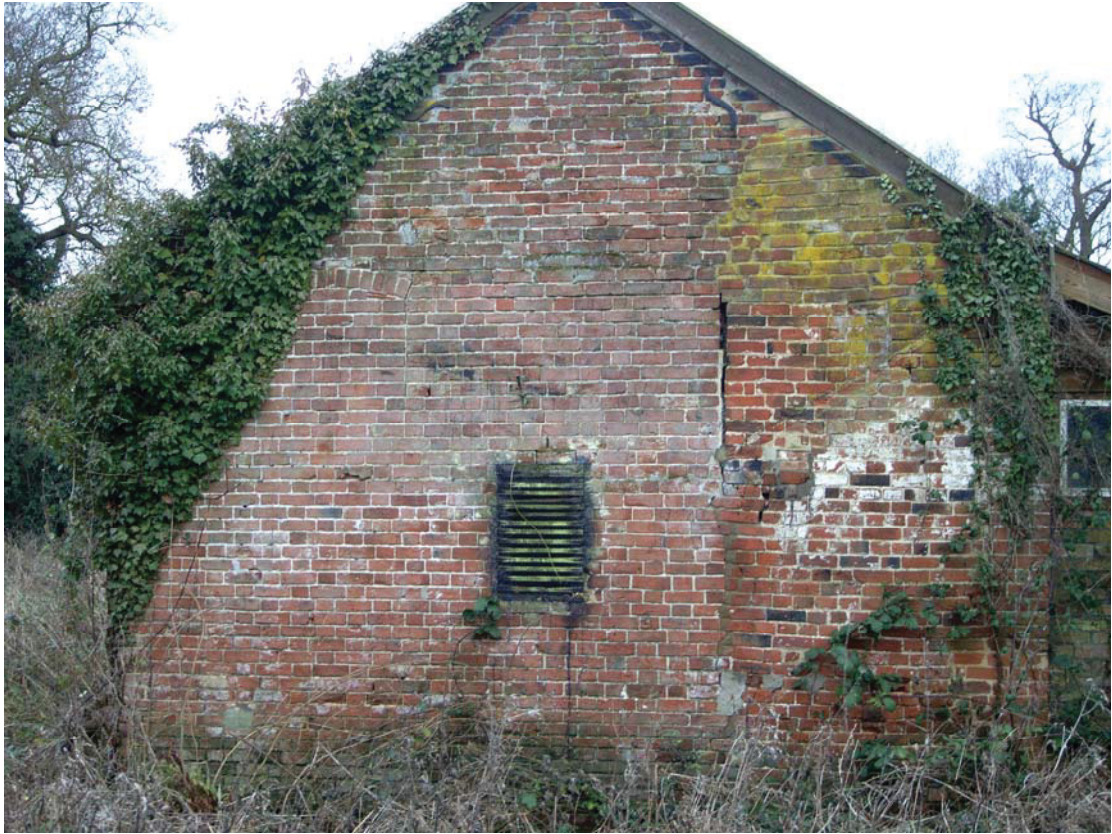
A2.5 Stable. Eastern external gable showing blocked window of original building to left with blocked door and scar of demolished eastern range to right

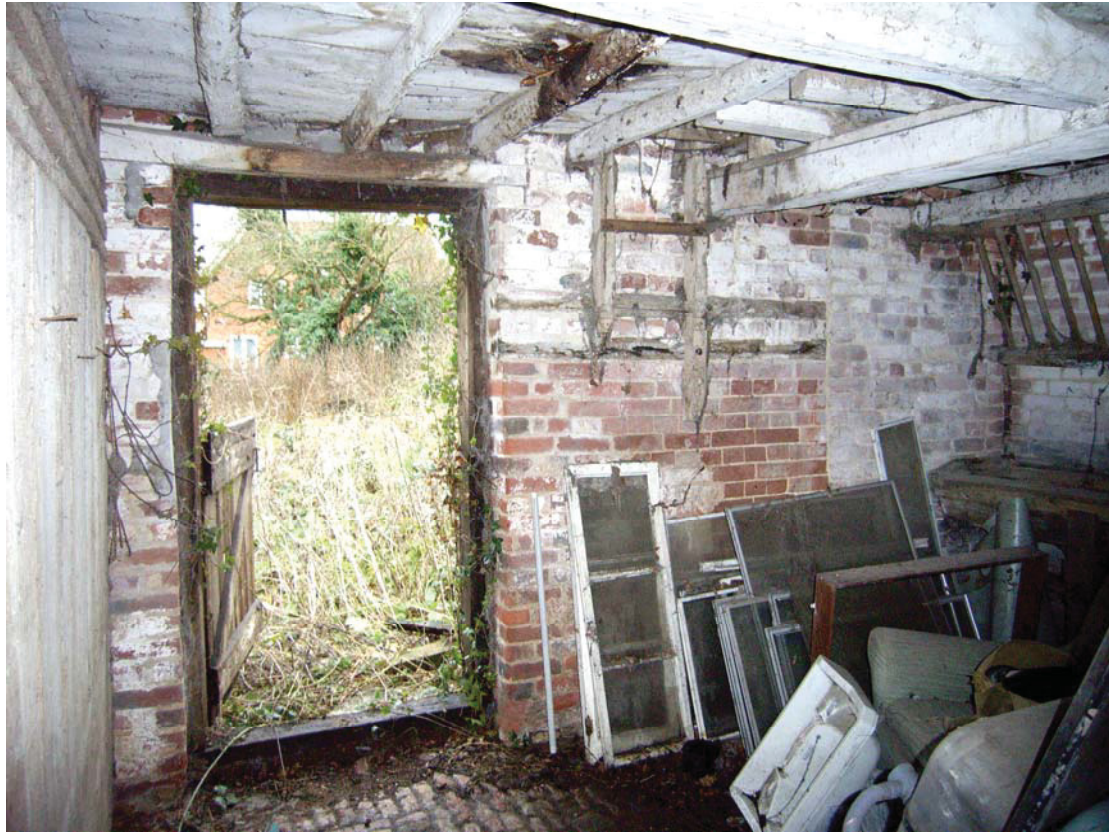
The brickwork contains numerous anomalies which do not relate to the stable's late-19<sup>th</sup> century layout, and the building evidently incorporates parts of an earlier 19<sup>th</sup> century structure of uncertain purpose. This structure is shown as a simple rectangle on the tithe map of 1839, and may have operated as a storage or vehicle shed. The arch of a blocked window is visible to the south of the eastern gable, now interrupted by the loft ceiling, and a probable blocked door lies to the north. Both the southern and northern elevations contain straight joints where brickwork of different dimensions and date abut each other. The height of the blocked window suggests the early-19<sup>th</sup> century building did not contain a hay loft and did not therefore operate as a stable.

A2.7 Stable. Internal southern elevation of southern stall (A1) showing loft ladder to right of entrance, with vertical junction in brickwork & hay rack to right and boarded partition to tack room (A3) to left.

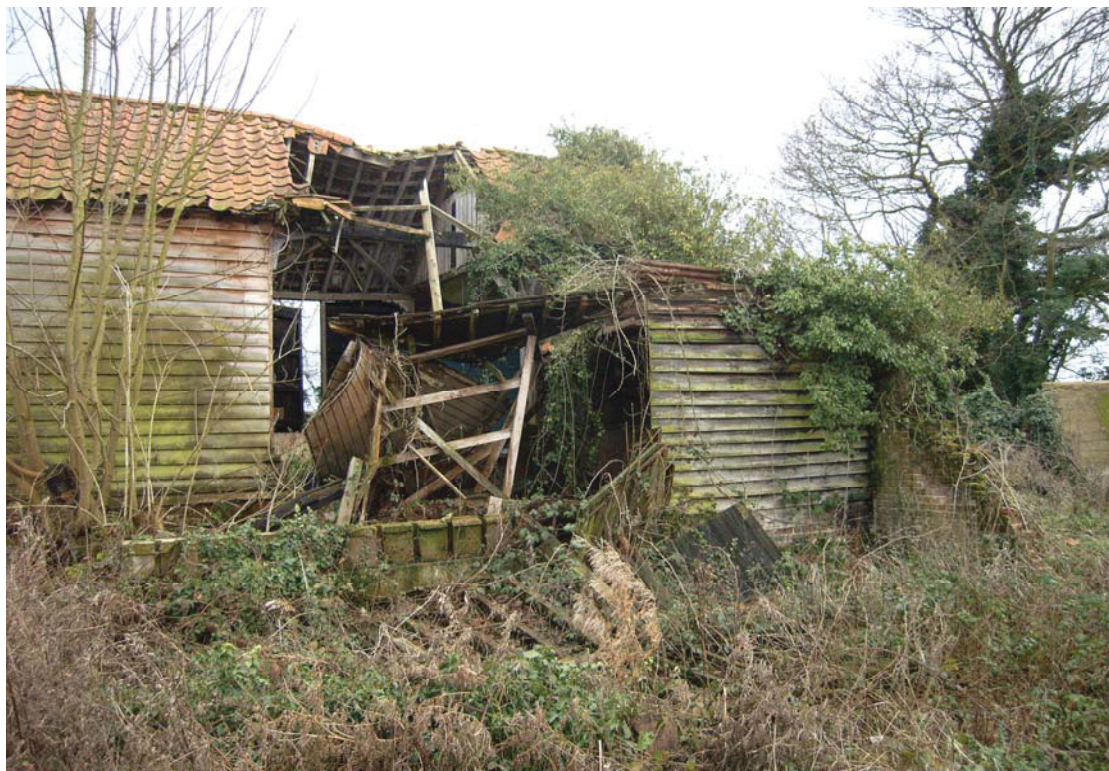
The timber-framed and weatherboarded barn to the east of the stable contains four bays with full-height double-hung doors in the penultimate southern bay of its eastern elevation. The same bay opened onto a porch or lean-to shed to the west, but this had collapsed prior to inspection. The building is shown on the Ordnance Survey of 1879/80 but not the tithe map of 1839, and its fabric is consistent with an origin during the 1860s or 1870s.

A2.8 Barn. Exterior from north-west showing collapsed porch with possible brick corner of demolished maltings to right

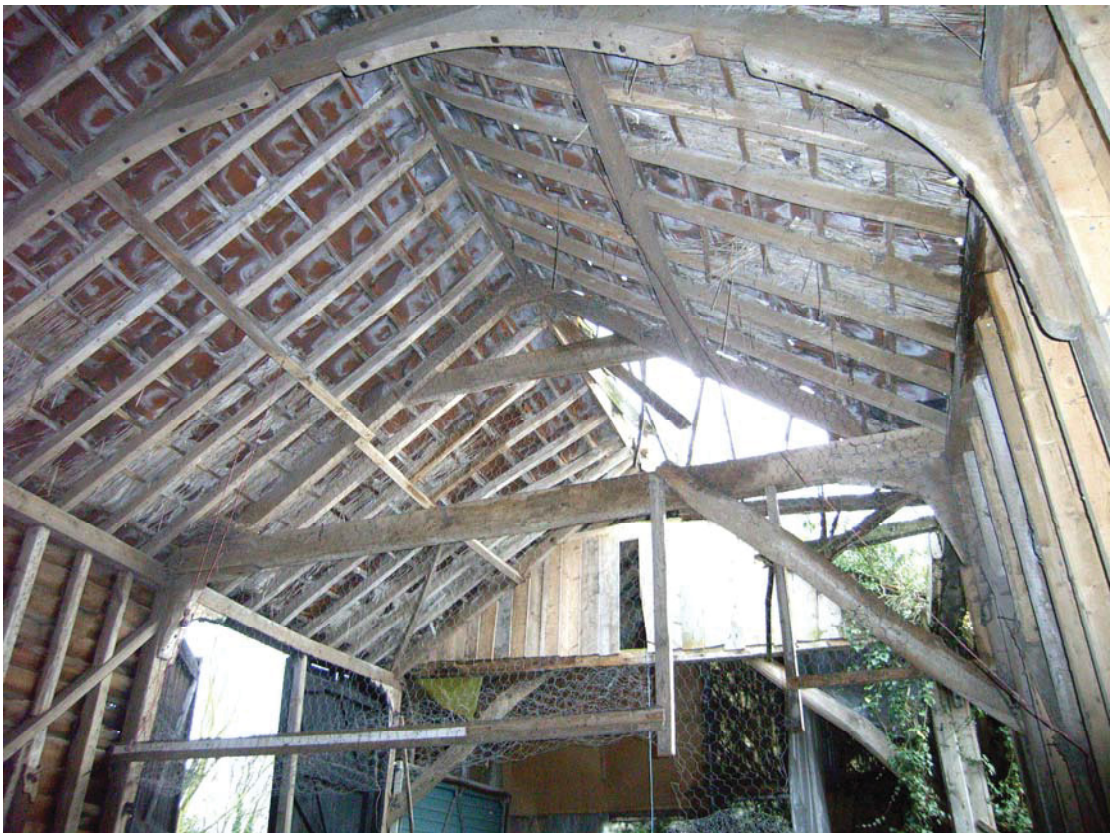
A2.10 Barn. Original butt-purlin roof structure viewed from north, showing secondary tie-beam braces
