# Brick Kiln Farm, Sibton, Suffolk

## Historic Building Record

**Farm Buildings at  
Brick Kiln Farm,  
Rendham Road,  
Sibton, Suffolk**

**An Archaeological Record**

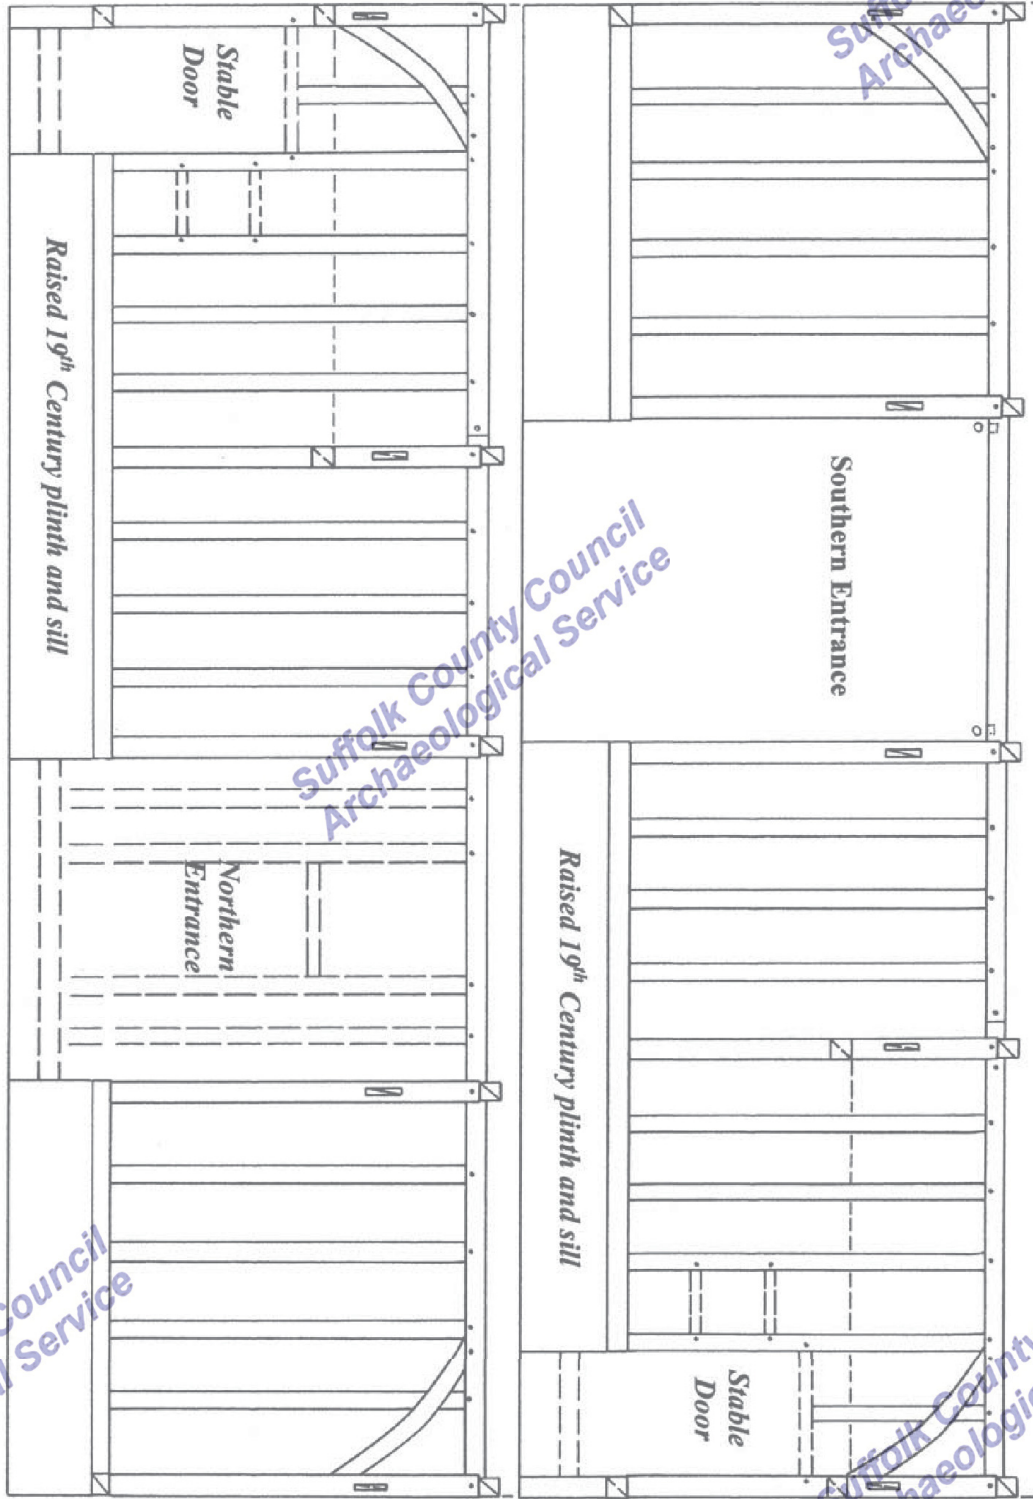
Figure 8. Internal Southern (top) and Northern Elevations of Barn

The stable bay extends to 3.5 m (11.5 ft) in length, and was entered by opposing doors against its western gable. Each door was a little over 1 m in width (41 ins) with a small window attached to its eastern jamb as shown in figure 8. The sills and lintels of these features have been removed, but their pegged joints are fully exposed in the frame (which in other respects remains intact). The windows were each 53 cm in height and 58 cm in height (21 ins by 23) and probably contained diamond mullions, but no evidence of these now remains. The horses would have entered by the through-passage against the western gable and faced a hay rack and manger against the missing eastern partition.

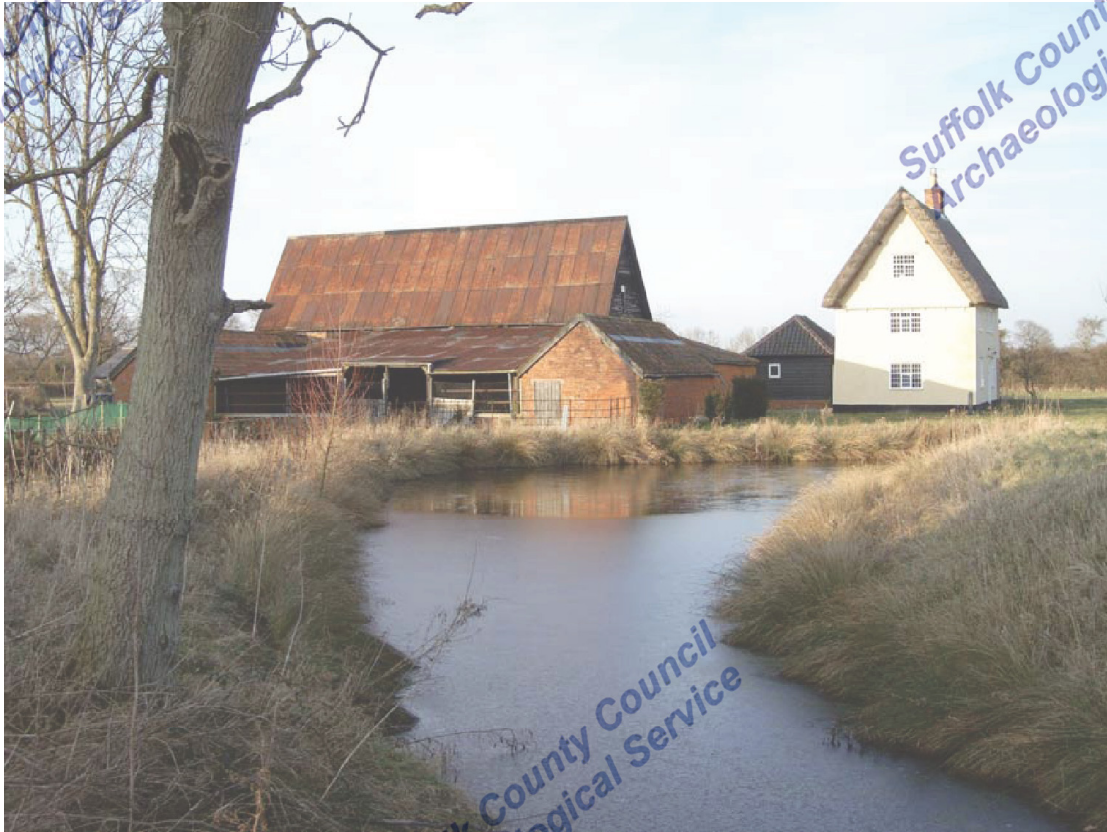
A2.1 General view from south-east showing pond in former brick kiln yard in foreground, early-17<sup>th</sup> century farmhouse to right and contemporary barn to left

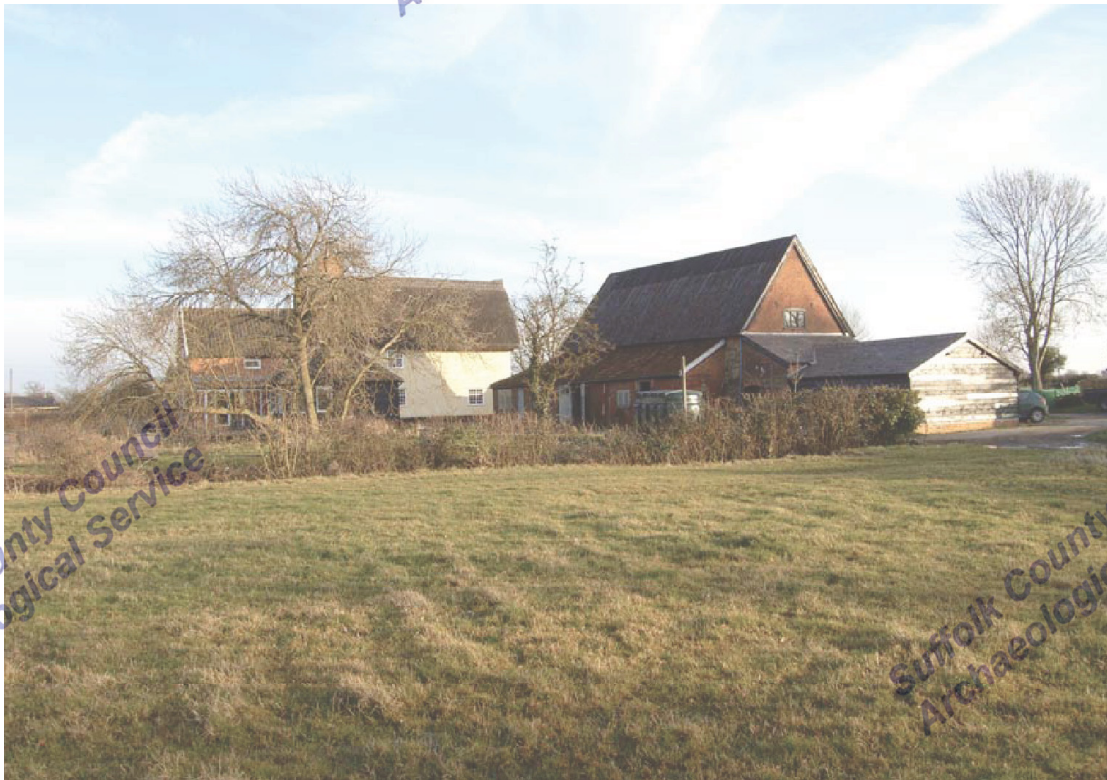
A2.2 General view of site from Horse Meadow to west showing house to left and barn right

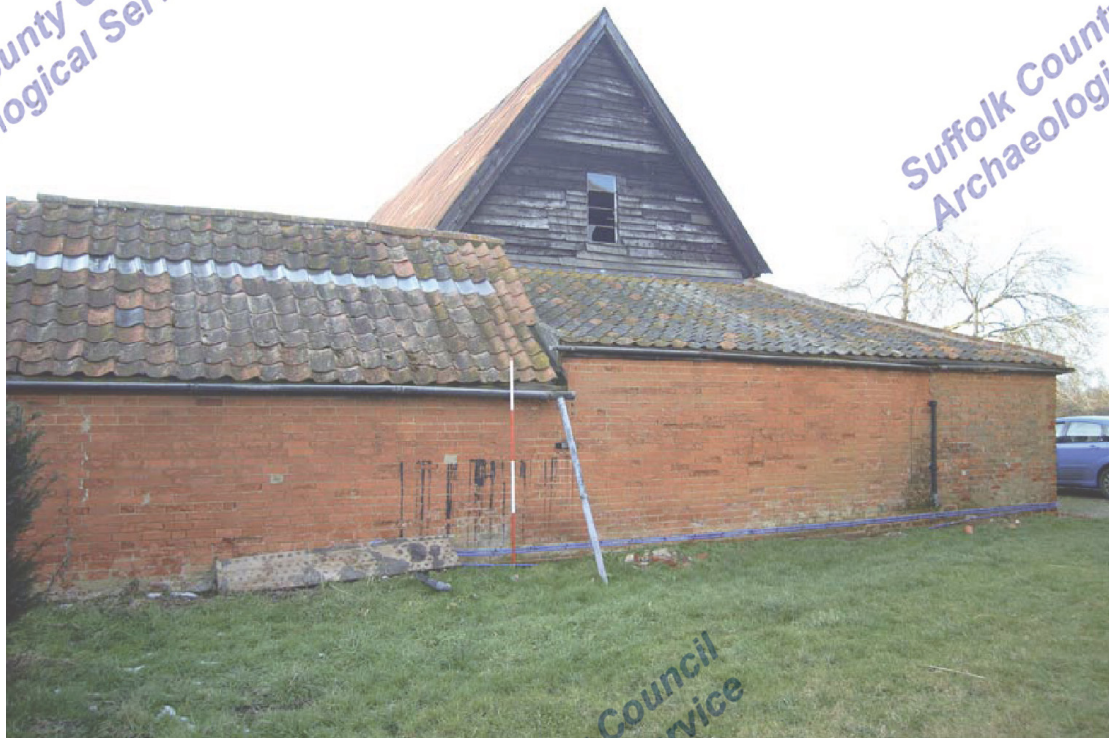
A2.3 External eastern elevation of barn showing 19<sup>th</sup> century brick shed (7) in foreground

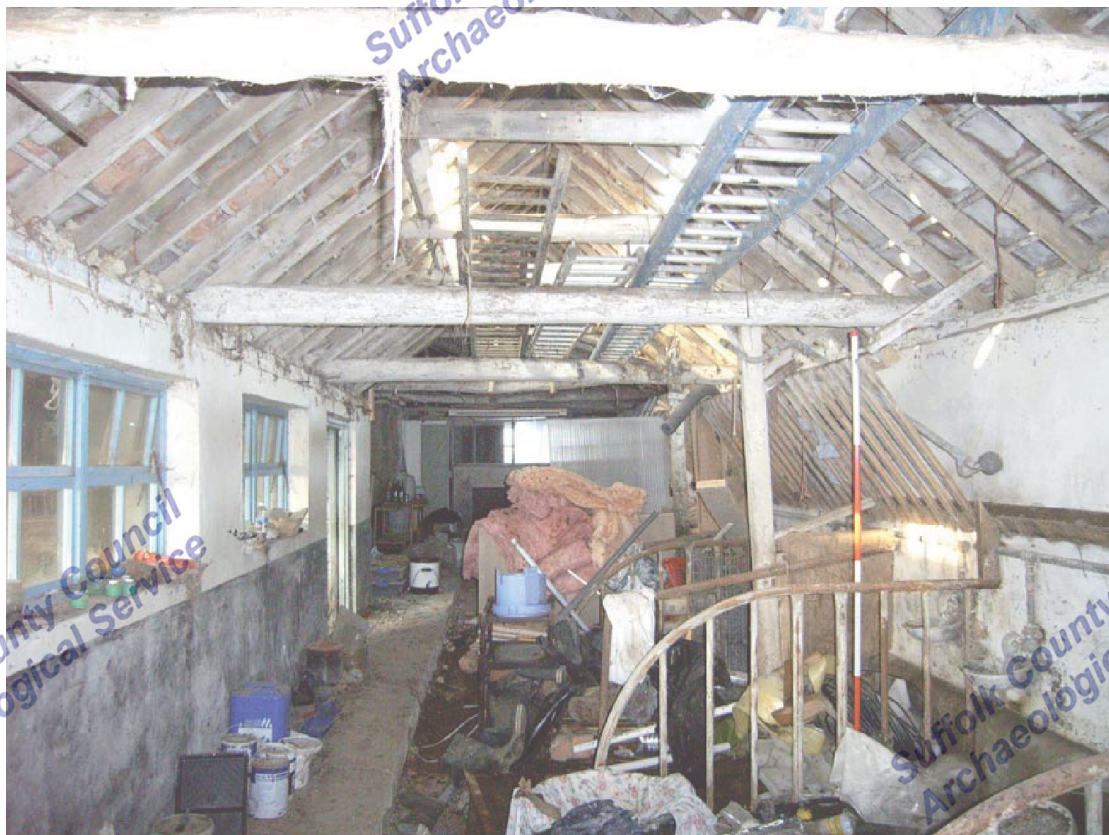
A2.4 Interior of brick shed to east of yard (7) south showing former open arcade to left and 20th century cattle stalls, hay rack and trough to right

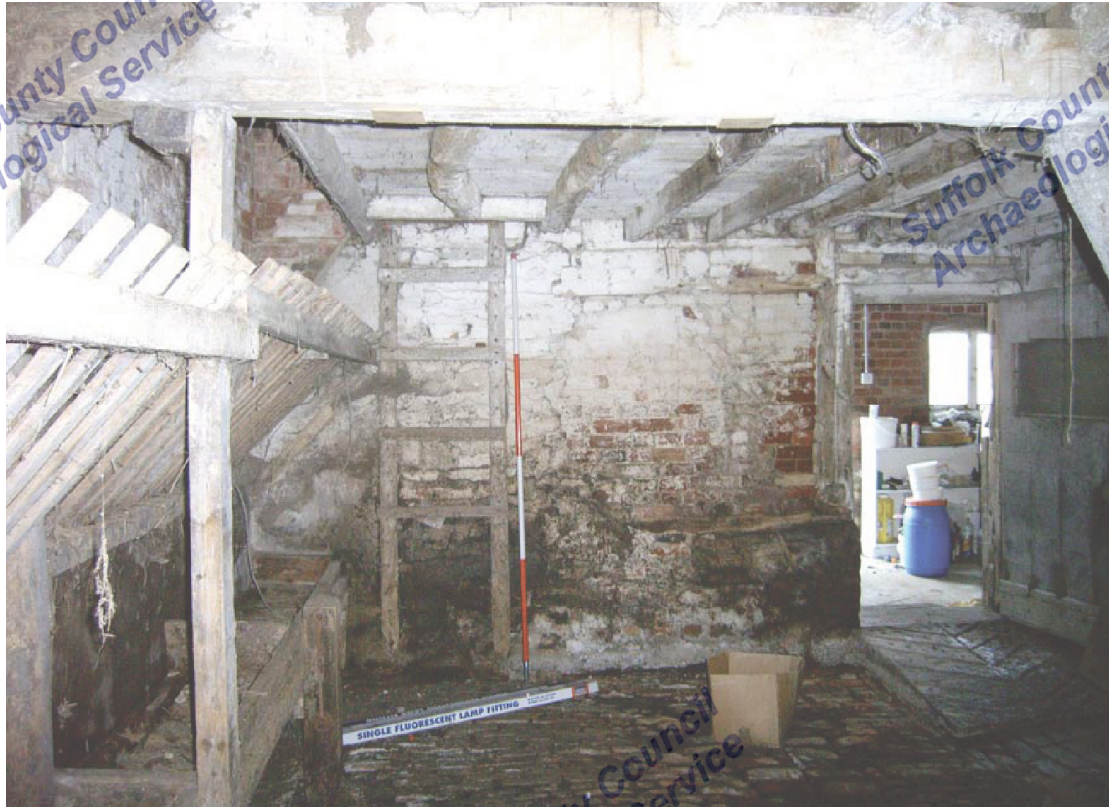
A2.5 Internal northern elevation of 19<sup>th</sup> century stable (2) showing hay rack and manger against western gable to left (lowered for cattle), loft ladder and entrance to right. The entrance is in the same position as that of the 17<sup>th</sup> century stable

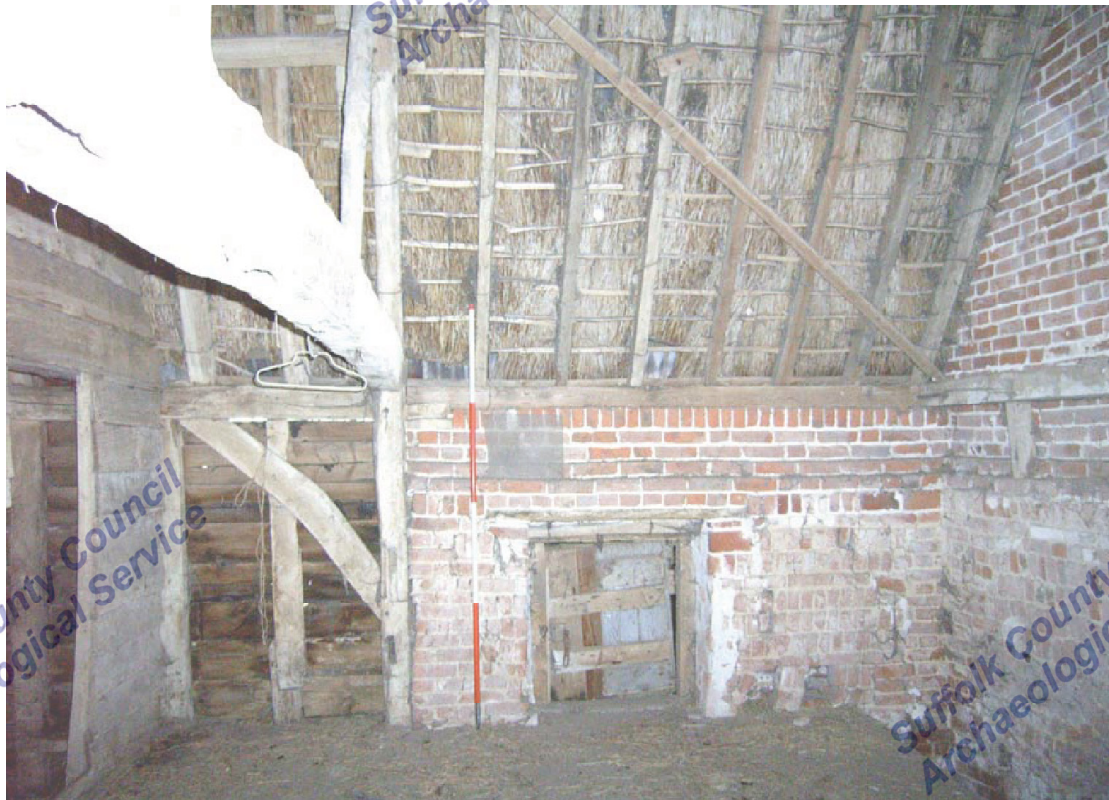
A2.6 Southern internal elevation of hay loft above 19<sup>th</sup> century stable (2) showing loading door & corner of 17<sup>th</sup> century barn & stable to left

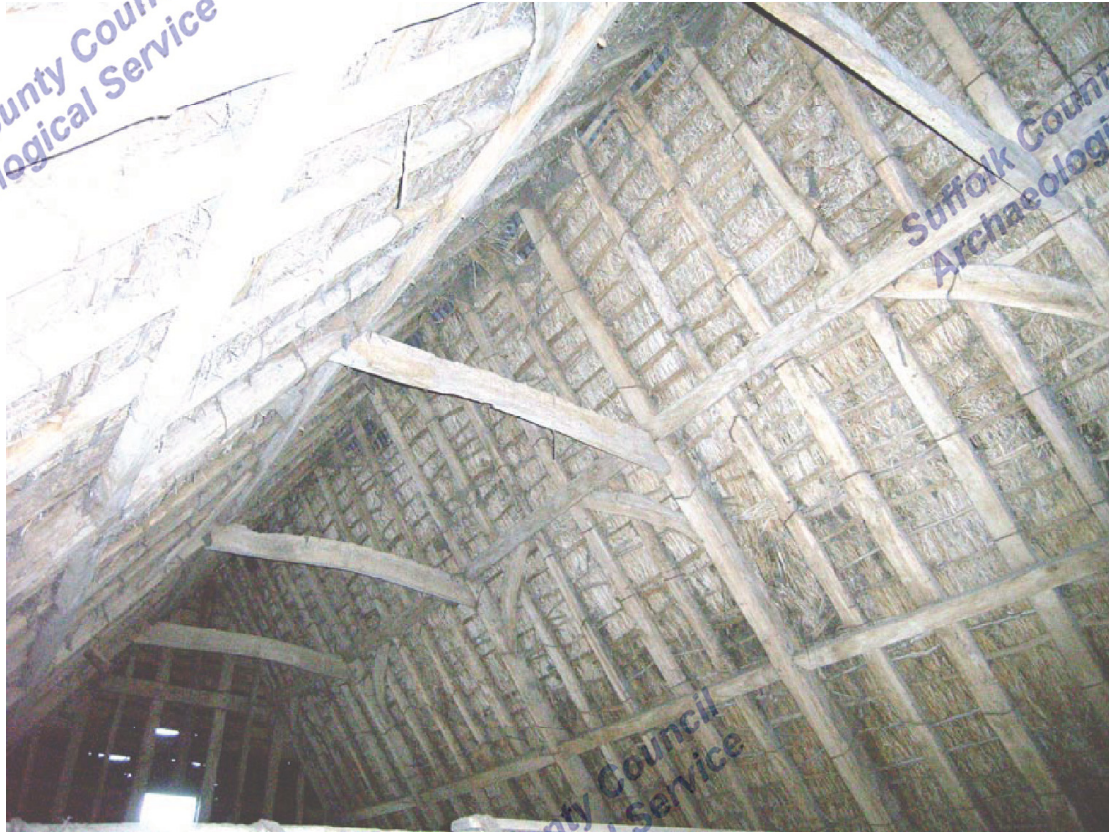
A2.7 Original roof structure of barn from west showing intact wind braces with upper tier of clapsed-purlins and lower tier of butt-purlins

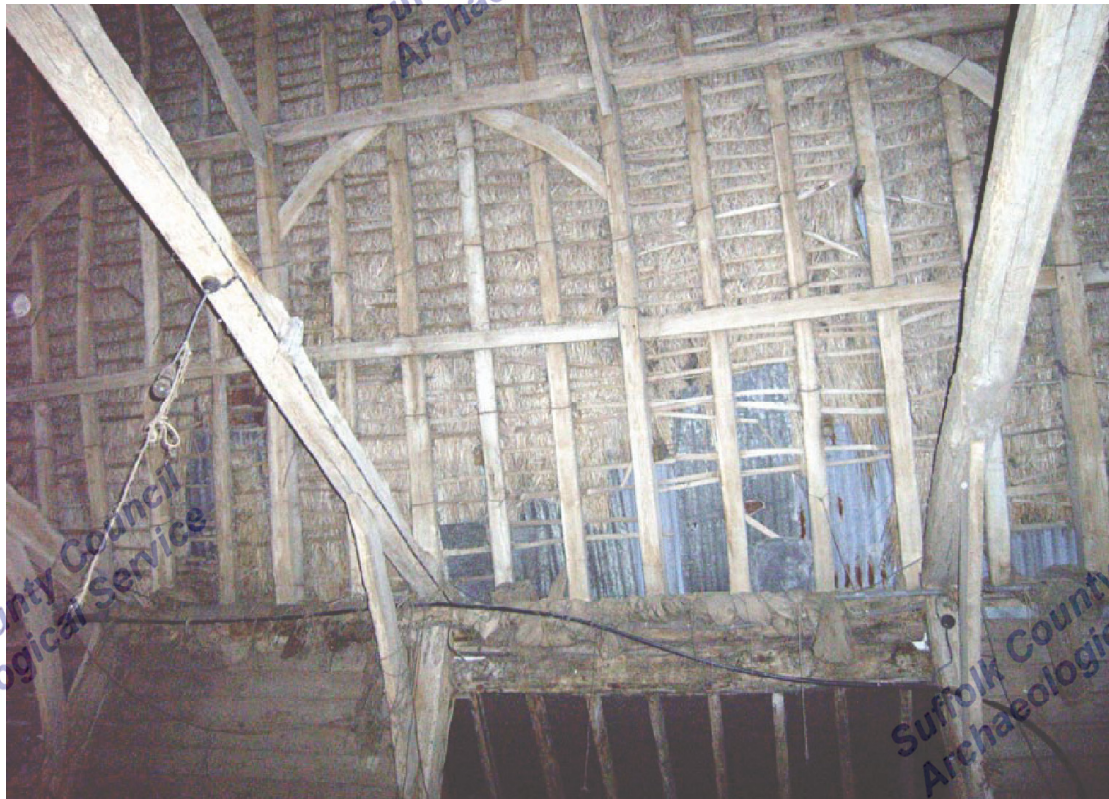
A2.8 Intact roof structure and arch-braced open trusses tie-beams flanking central northern bay of barn

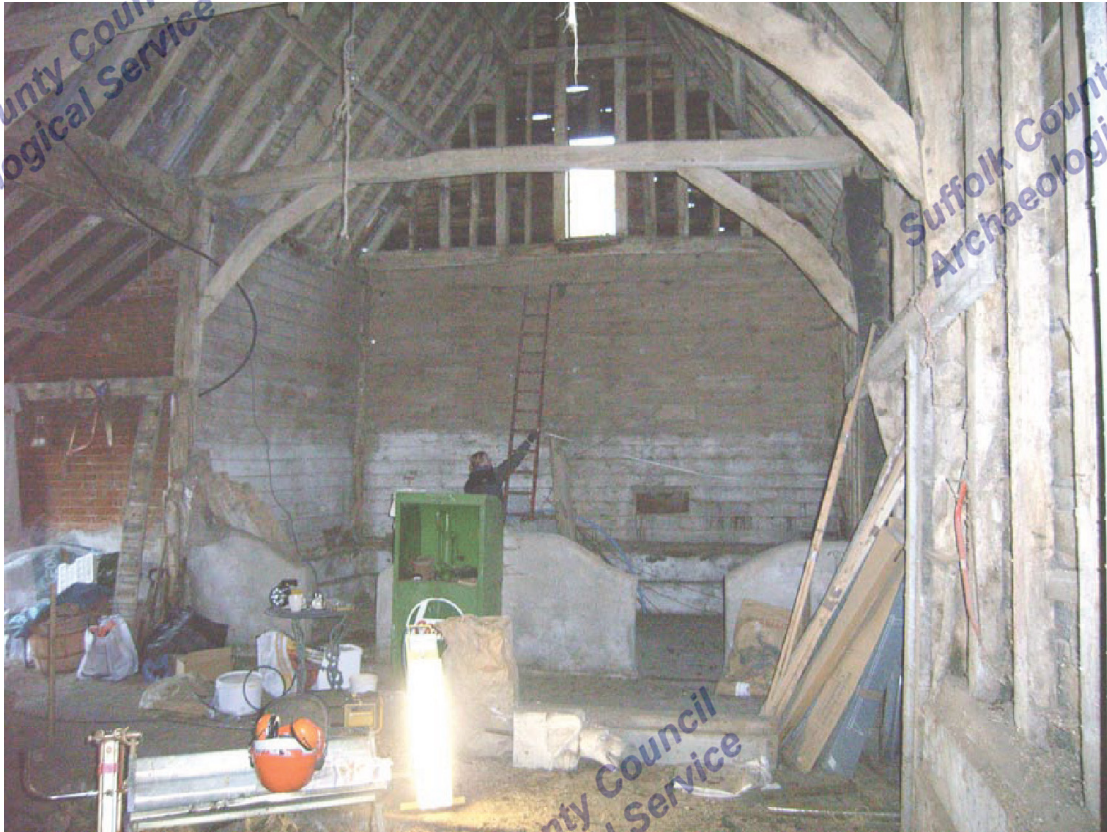
A2.9 General view of barn interior from west showing original arch-braces to tie-beams with internally boarded eastern gable in rear

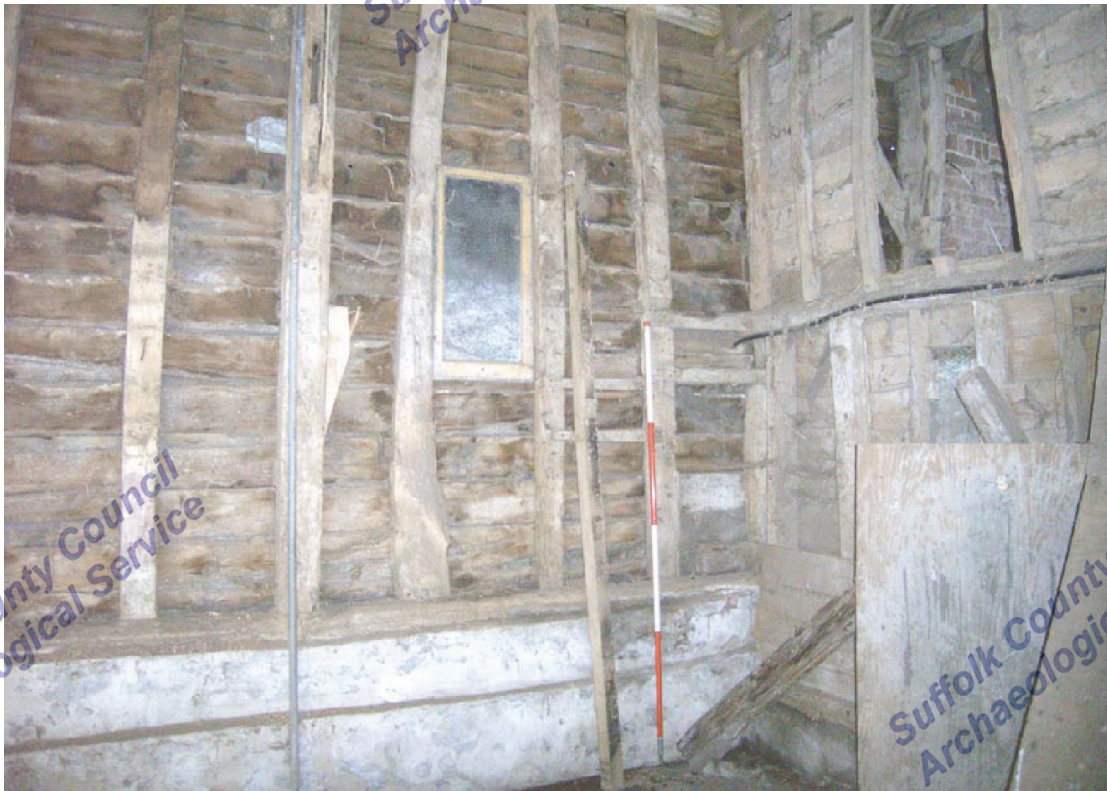
A2.10 Southern elevation of original stable bay, now within barn, showing mortise of removed partition rail in storey post to left with arch-brace mortise above
