**Barn at Wenham Hill,
Great Wenham,
Suffolk
WMM 008**

Archaeological Record

**Barn at Wenham Hill
(Formerly Wenhamhill Farm),
Wenham Lane,
Great Wenham, Suffolk**

An Archaeological Record

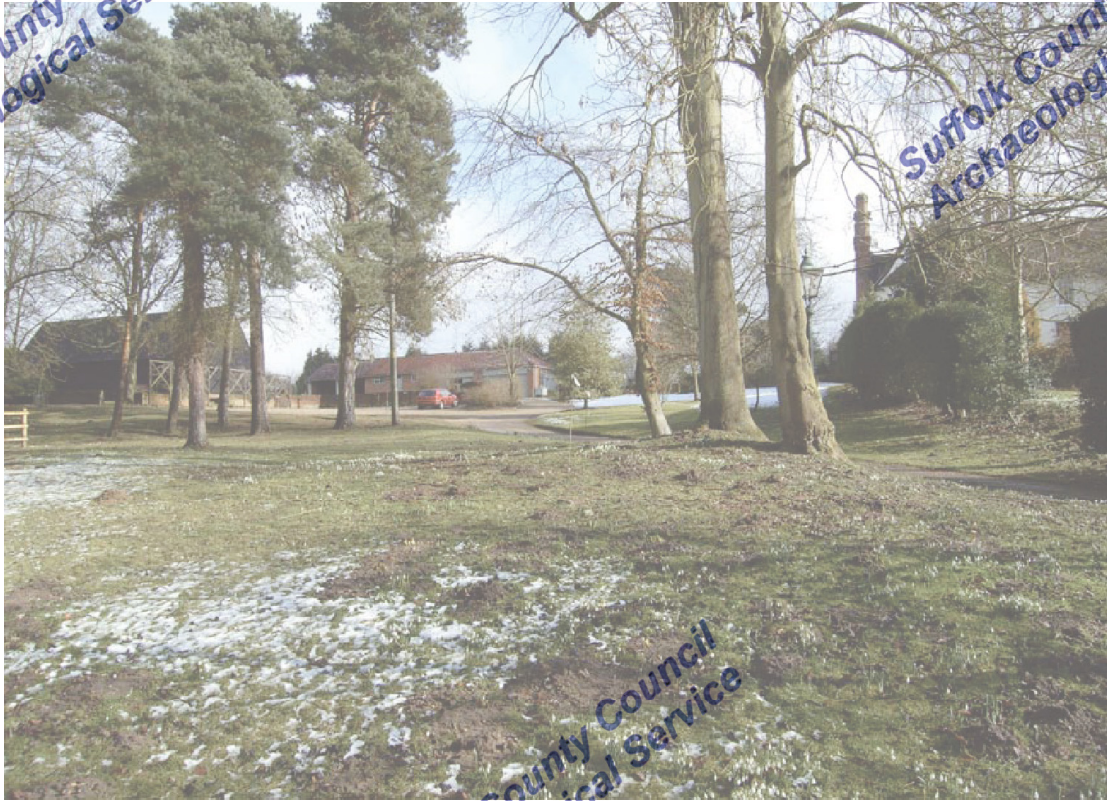
A2.1 General view of site from west showing barn (1) to left, brick shed (2) in centre and house (3) to right

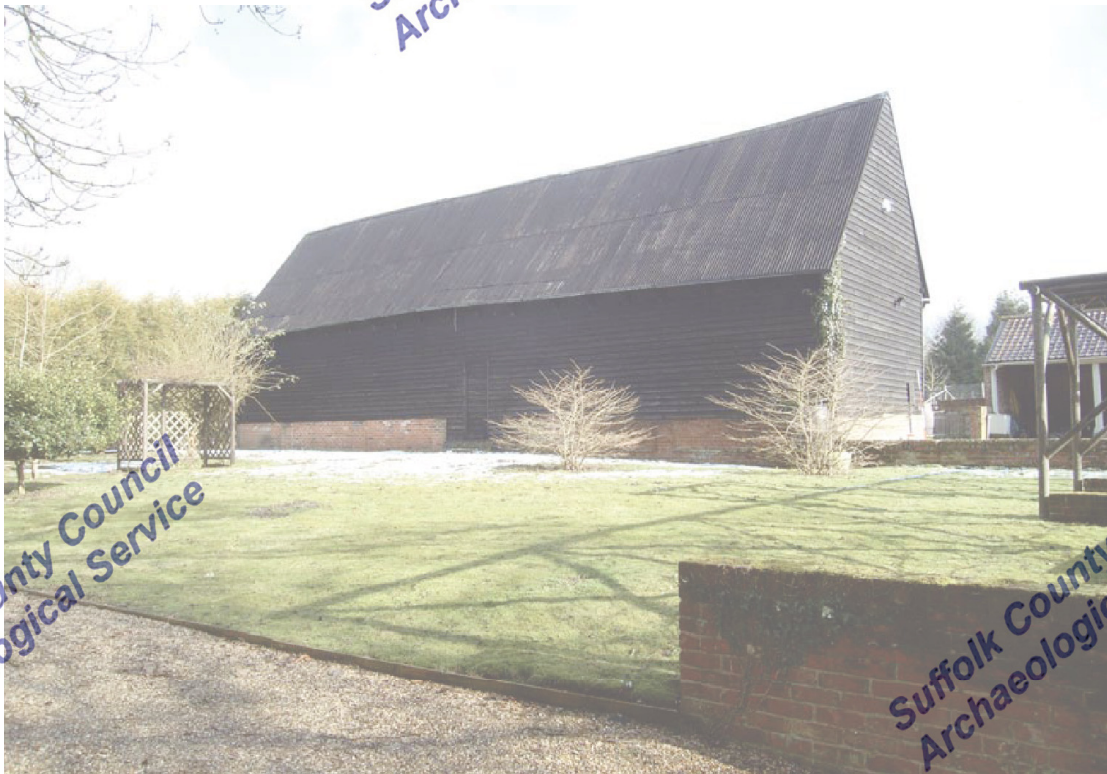
A2.2 Western external elevation from south-west showing blocked entrance in central bay (C) and brick shed to right

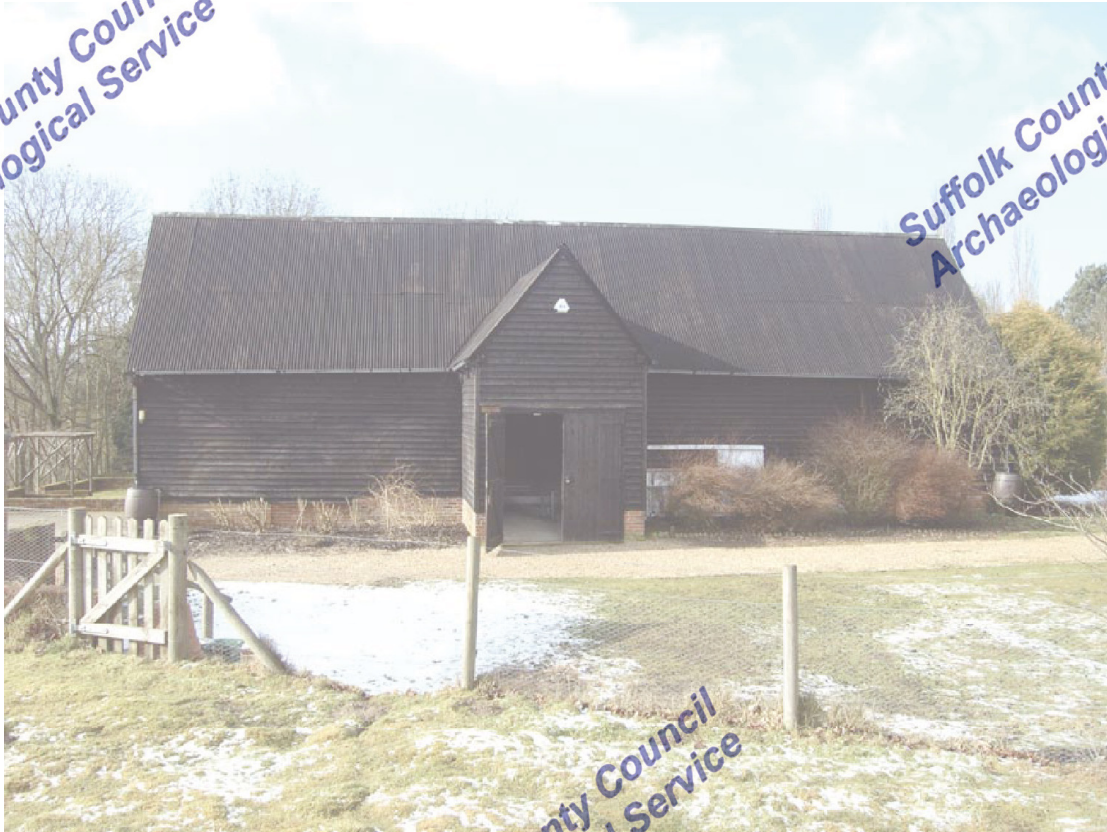
A2.3 Eastern external elevation showing porch in central bay (C)

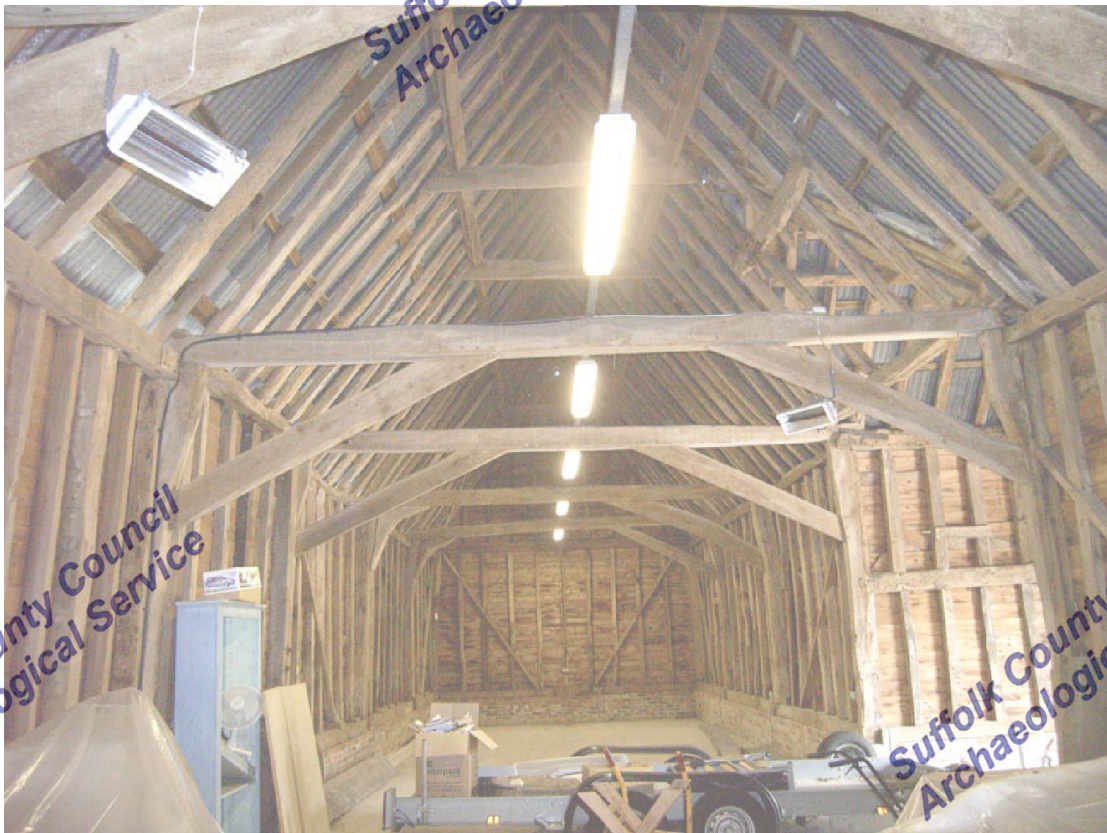
A2.4 General view of interior from south showing secondary clapsed-purlin roof with intact arch-braces to tie-beams and porch in bay C to right

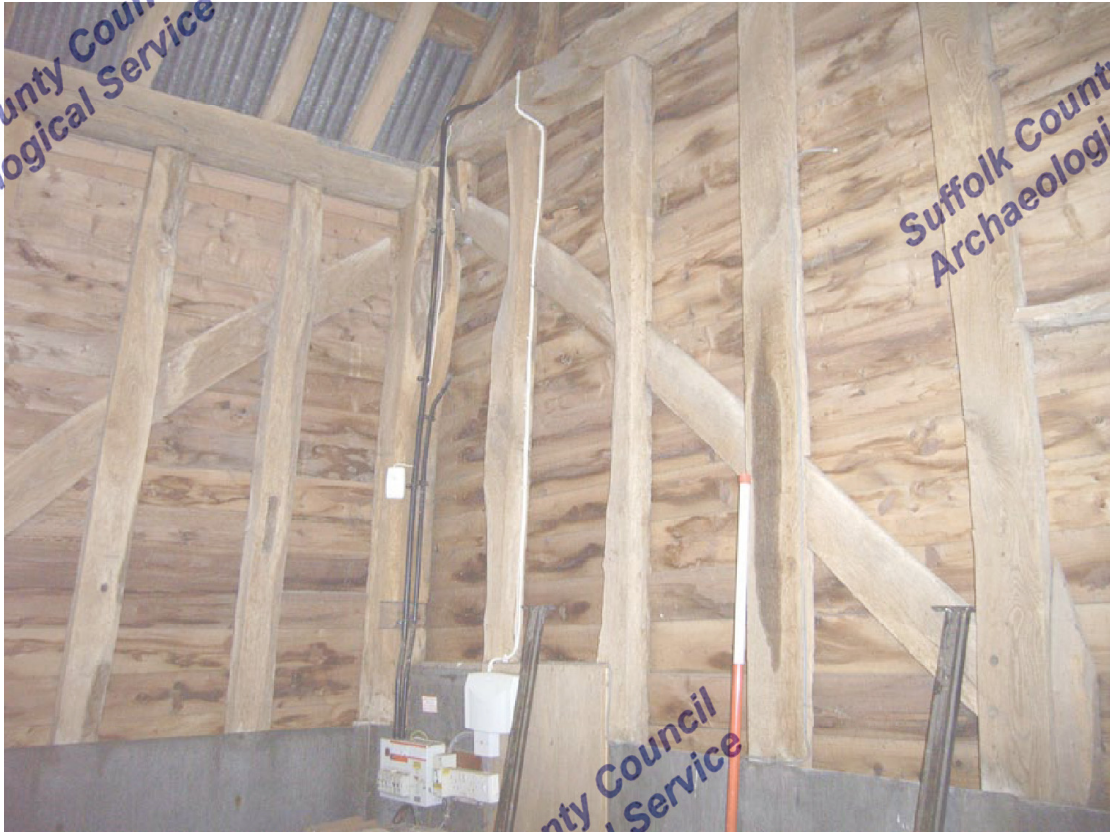
A2.5 South-eastern internal corner showing southern gable to right with original externally tenoned wall braces

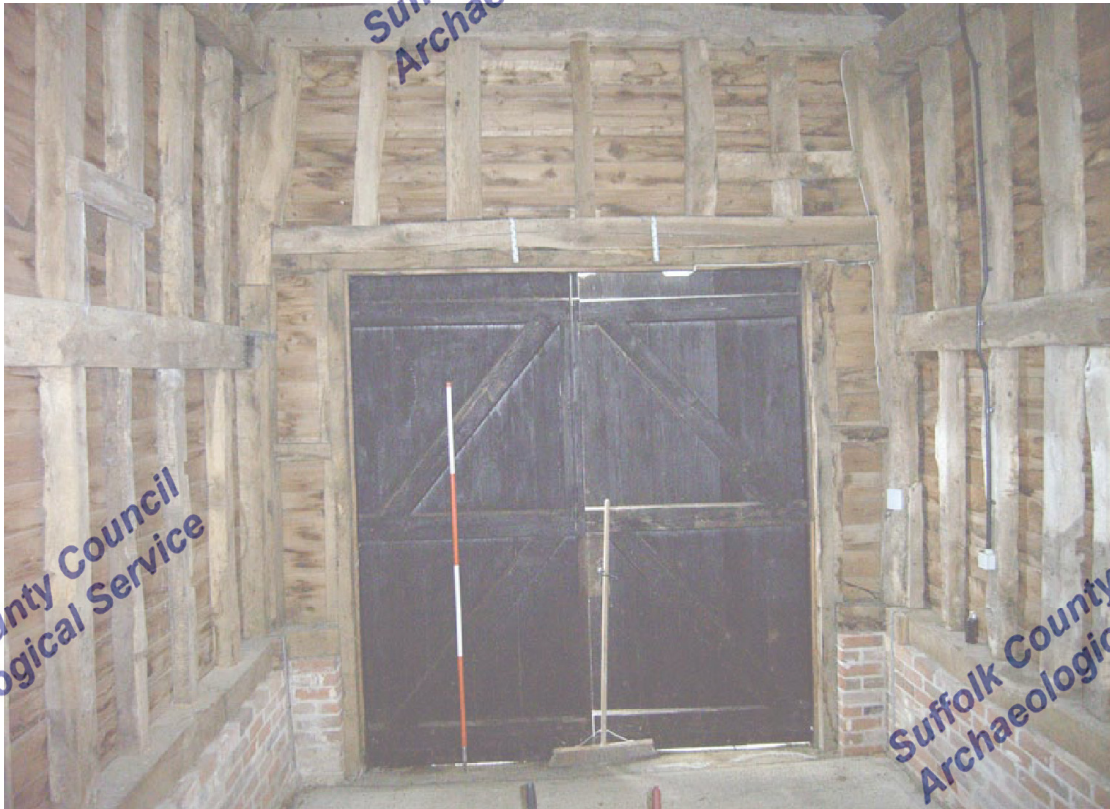
A2.6 Internal eastern elevation of porch (G) showing mid-rails in side elevations and mortises of original door jambs in tie-beam

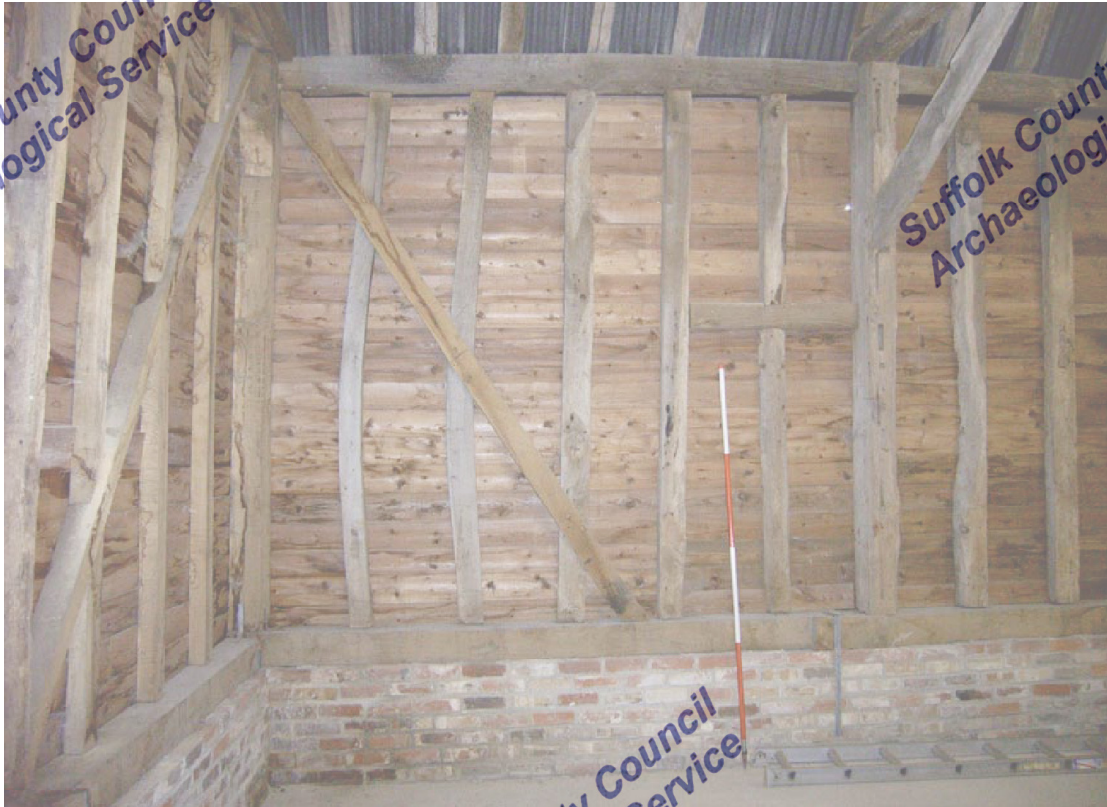
A2.7 Eastern internal elevation of northern bay (F) showing apparently secondary door lintel and secondary arch-brace replacing closed partition to right. External bracing removed. Rebuilt northern gable to left

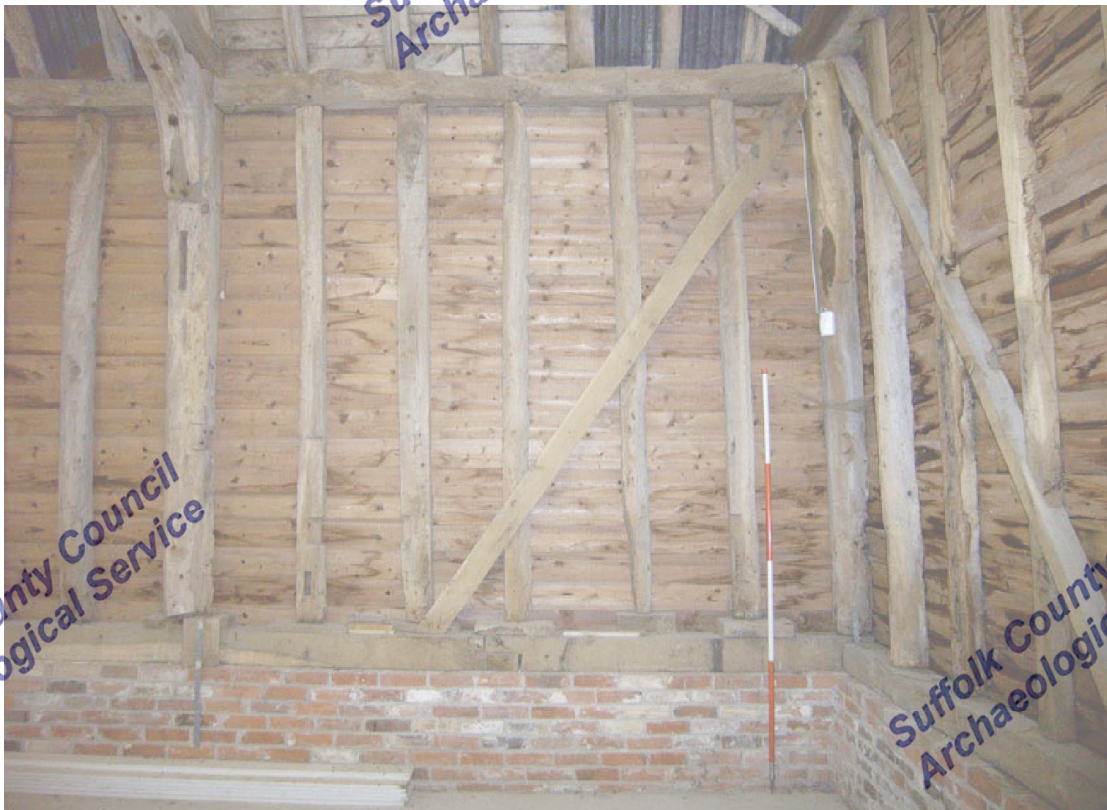
A2.8 Internal western elevation of northern bay (F) showing original studs (external wall braces removed) and plinth rebuilt
