**Proctor's Barn,
Walsham le Willows,
Suffolk
WLW 098**

Archaeological Record

**Proctor's Barn,
Crownland Road,
Walsham le Willows, Suffolk**

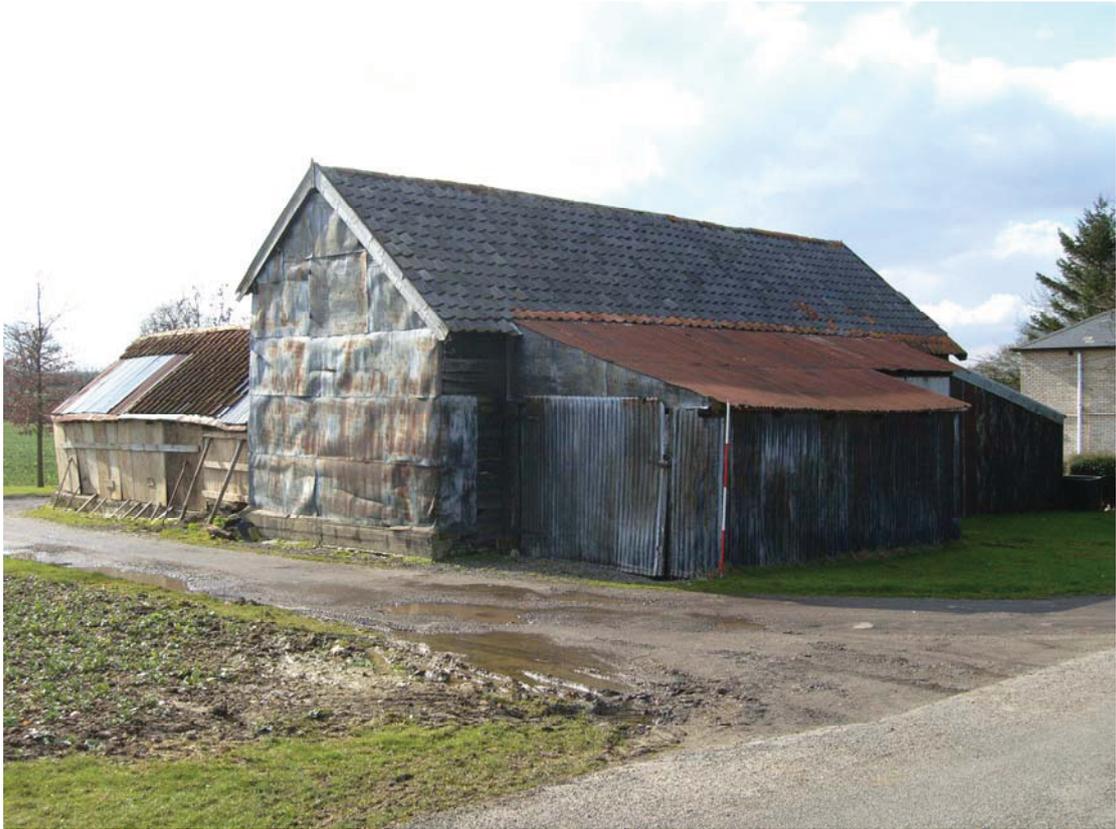
A2.3 Exterior of barn from north-east showing farmhouse in rear to right, showing 20th century lean-to porch and sheds to right and 19th century clay-lump shelter shed (C) to left

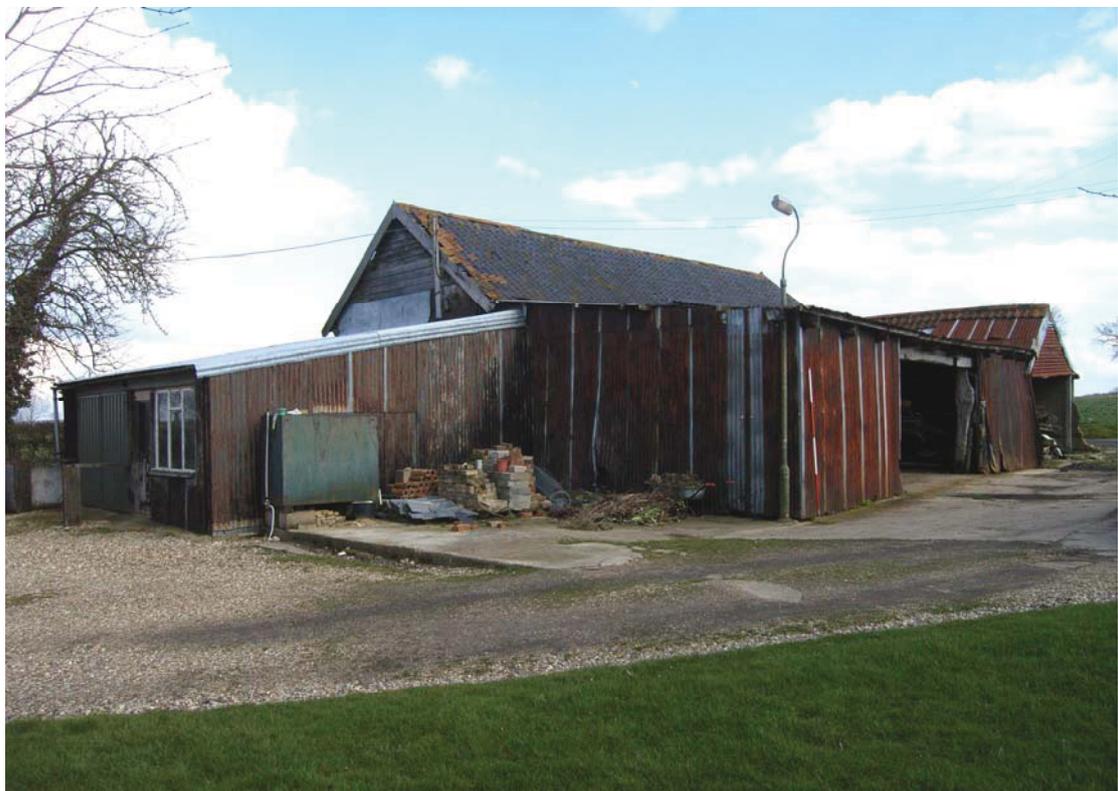
A2.4 Exterior from south-west showing 20th century shed (F) to left & covered yard (G) to right

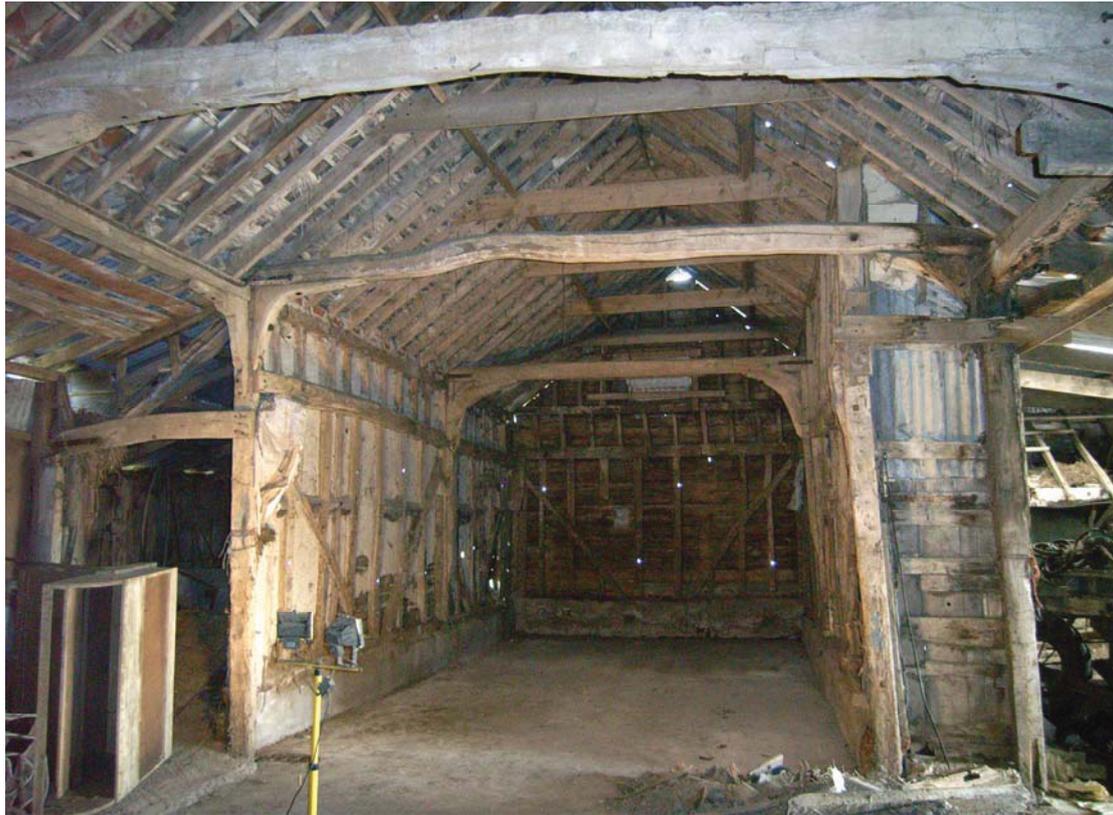
A2.5 General view of barn interior from west showing narrow 17th century structure (A) with raised walls in rear and wider 18th century structure (B) in foreground

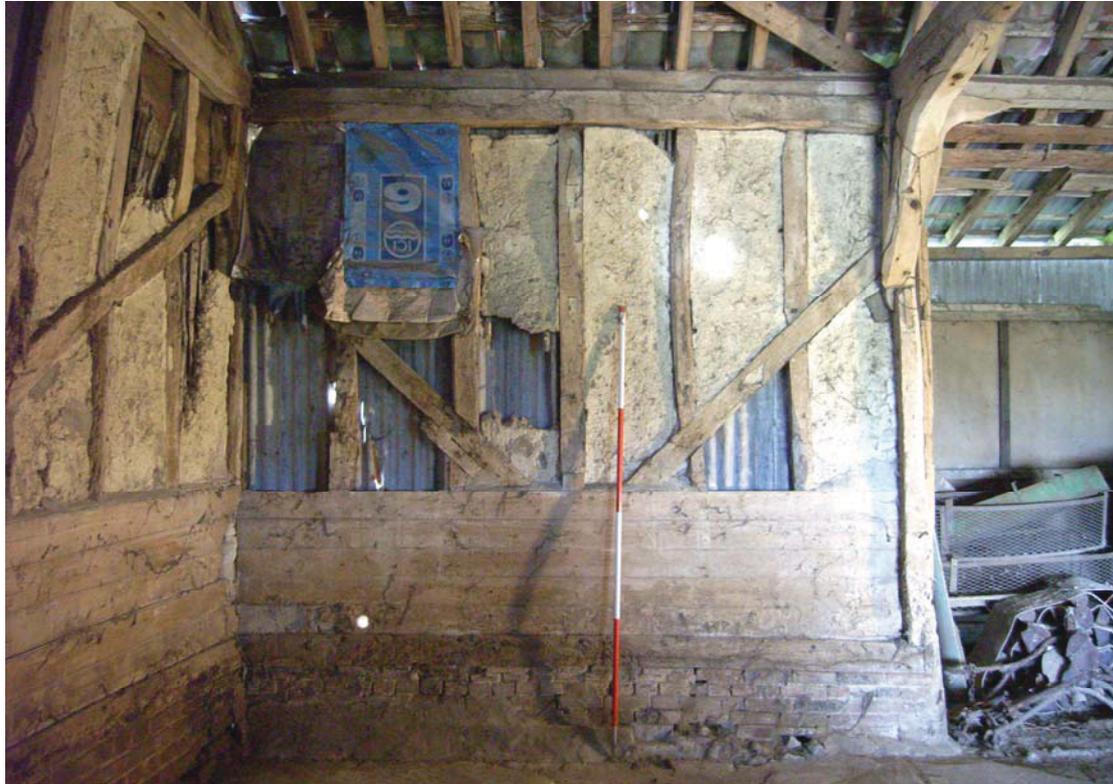
A2.6 Internal northern elevation of western bay (B1) showing original wattle-and-daub infill with entrance bay to right (B2) and re-used ovolo-moulded window mullion in western gable to left

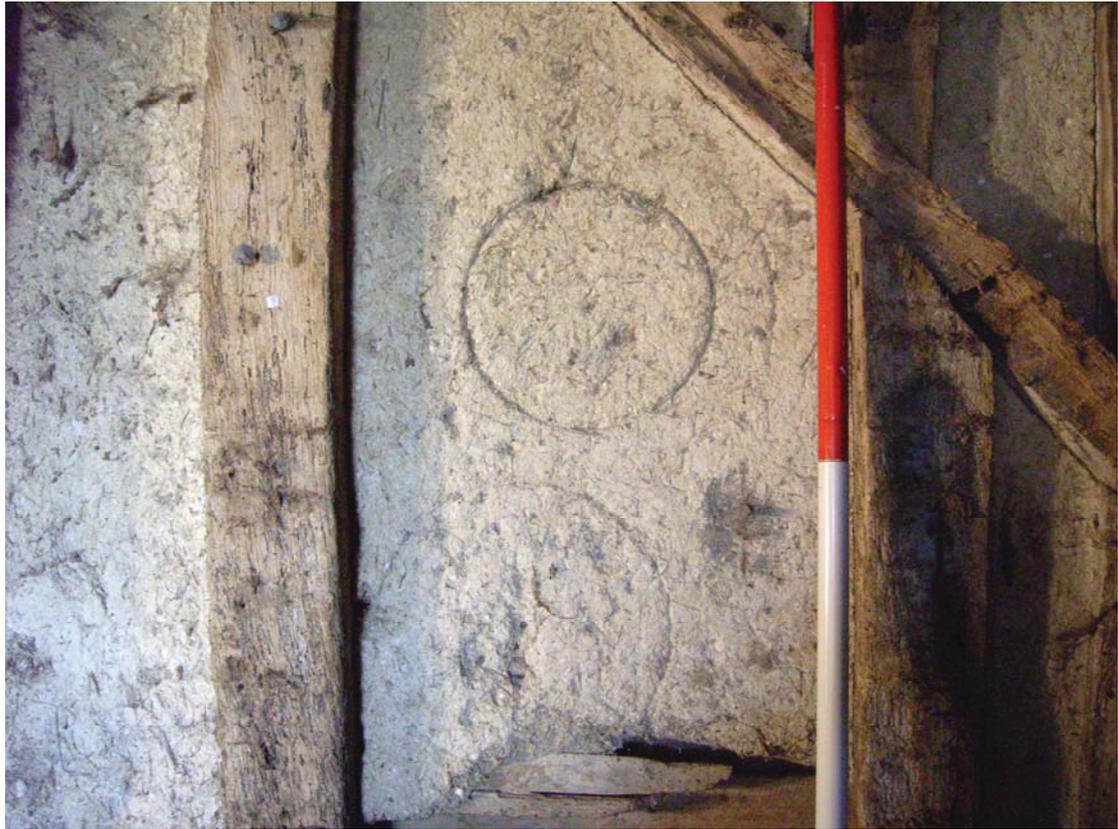
A2.7 Detail of apotropaic (protective) circles in daub of northern internal elevation of bay A1

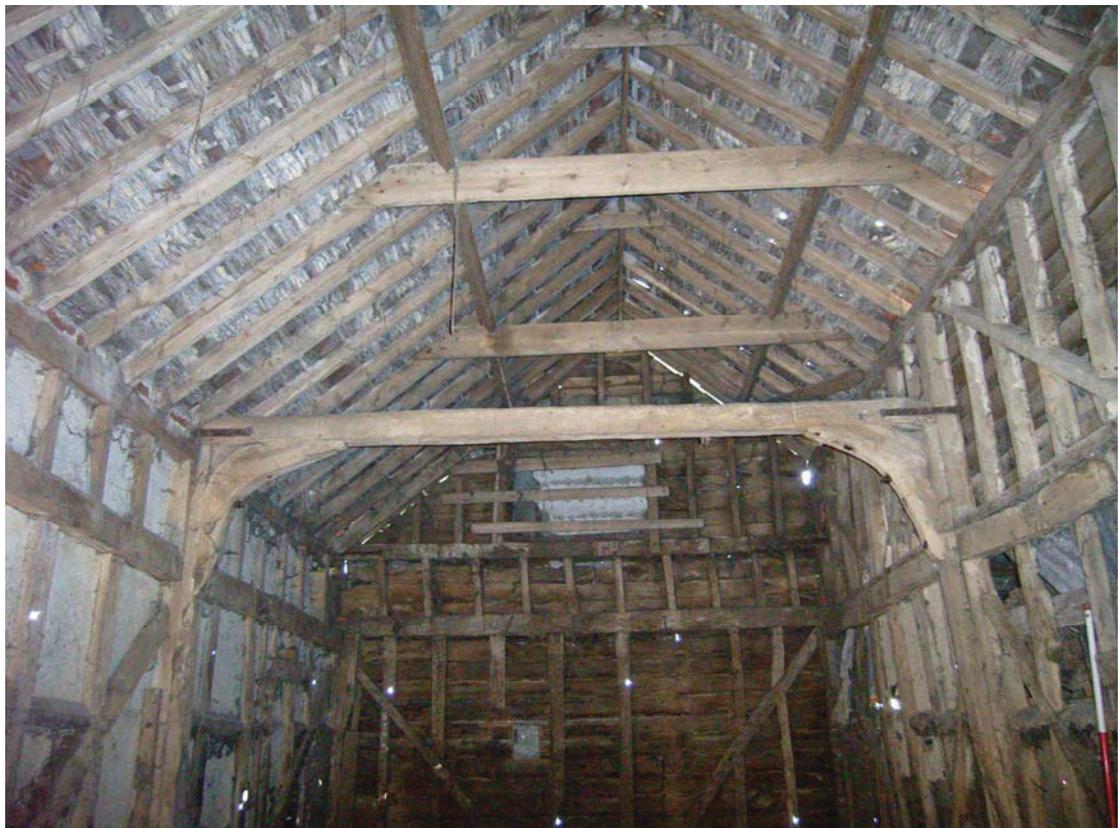
A2.8 19th century roof structure from west showing greater height of roof raise in structure A to south (right). The raised tie-beam contains pegged mortises for a missing partition.
