**Potash Farm,
Dallinghoo,
Suffolk
DLL 014**

Archaeological Record

**Potash Farm,
Potash Farm Road,
Dallinghoo, Suffolk**

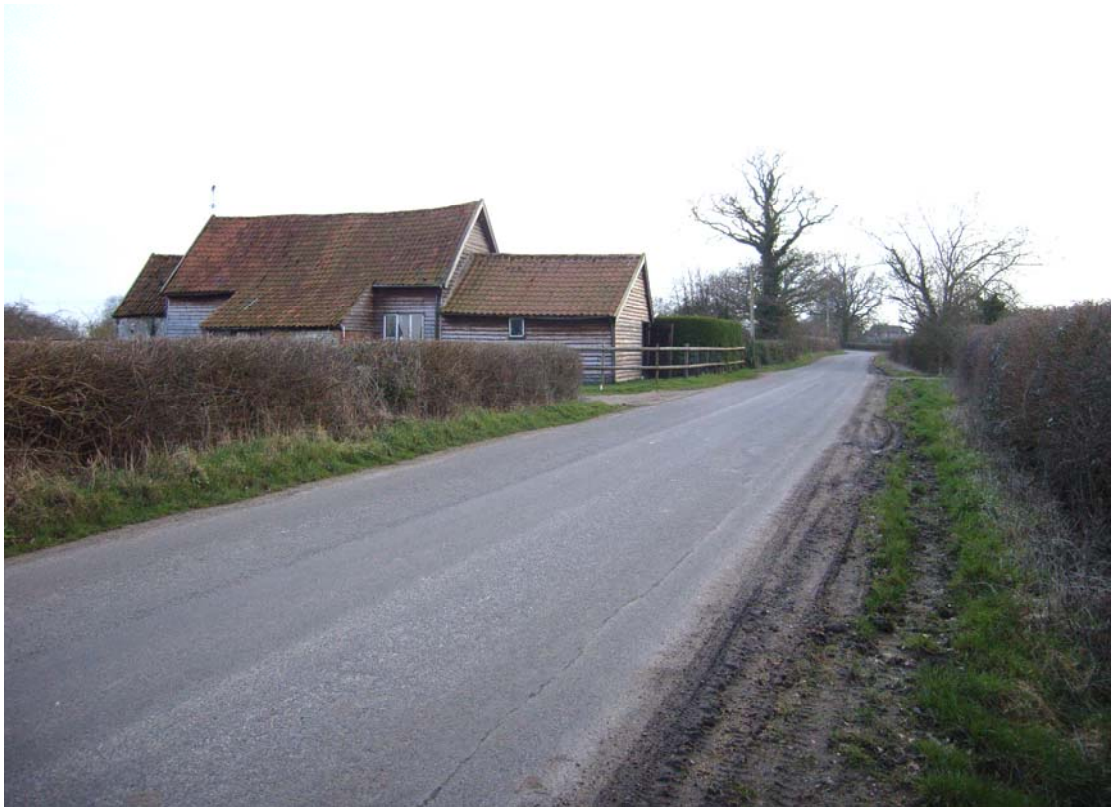
A2.1 General view of site from Potash Farm Road to north, showing barn (A/B) in centre with brick stable (C) to left and recently rebuilt shed (E) to right.

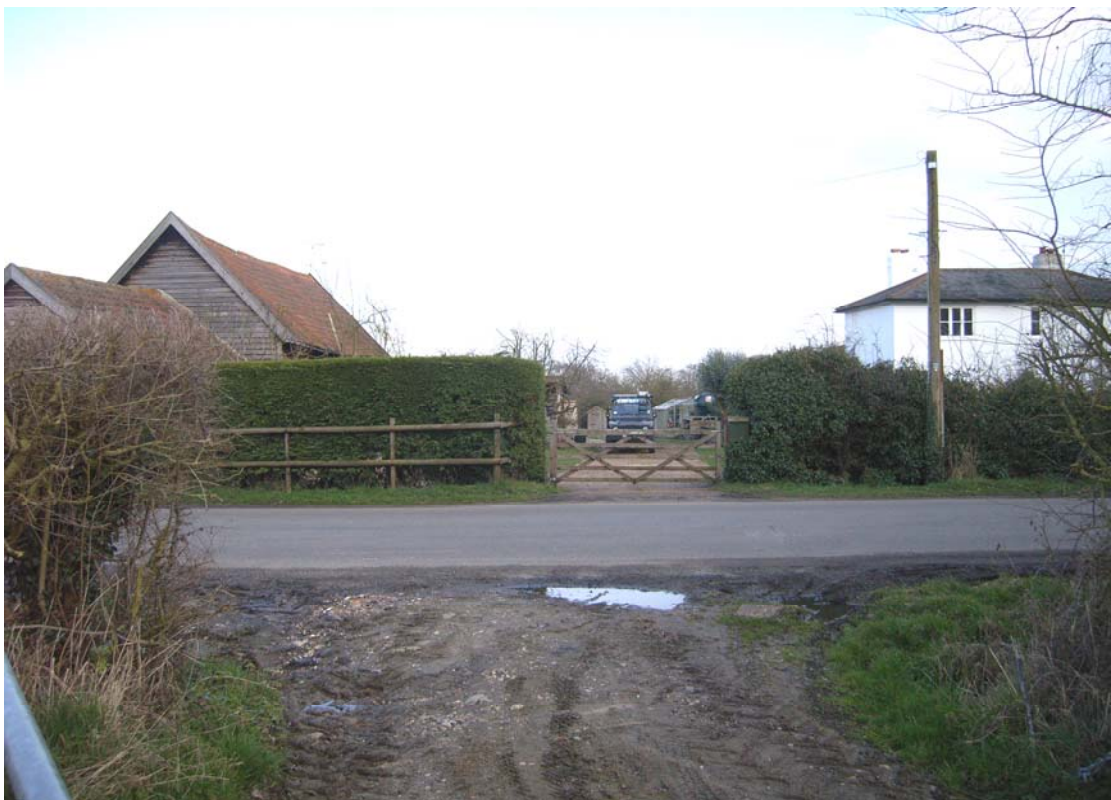
A2.2 General view of site from west showing proximity of farmhouse to right

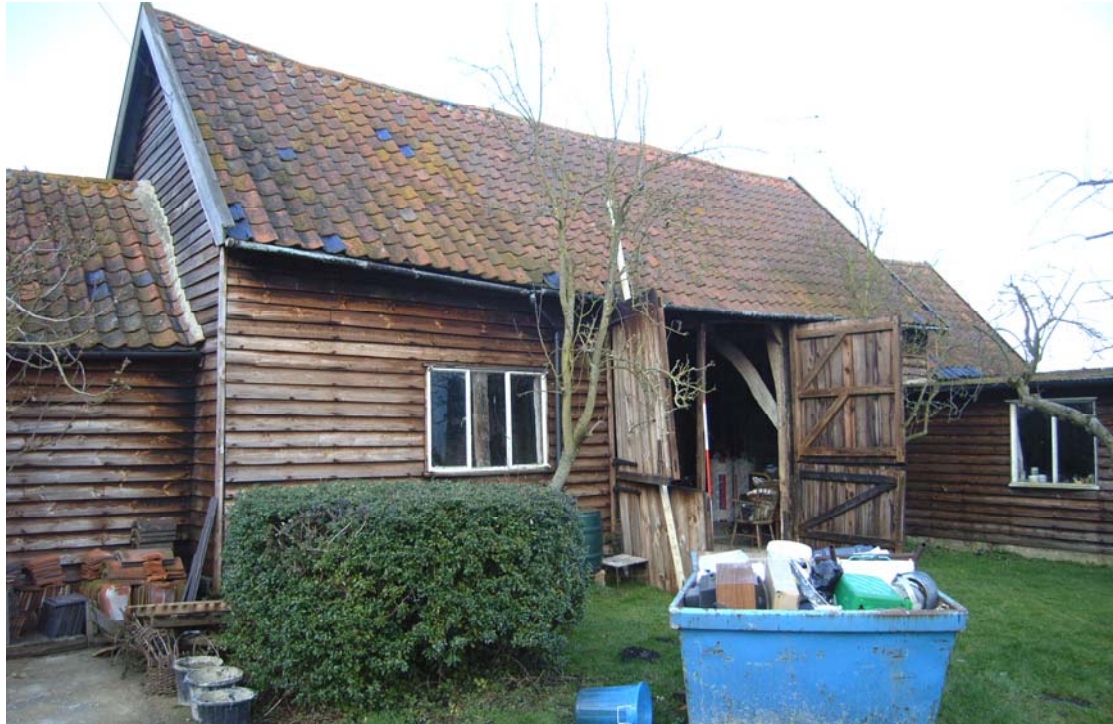
A2.3 Southern external elevation of barn from south-west showing double-hung doors original 17th century entrance bay (A2) to right & 18th century extension bay (b) to right. The sheds to right and left are modern.

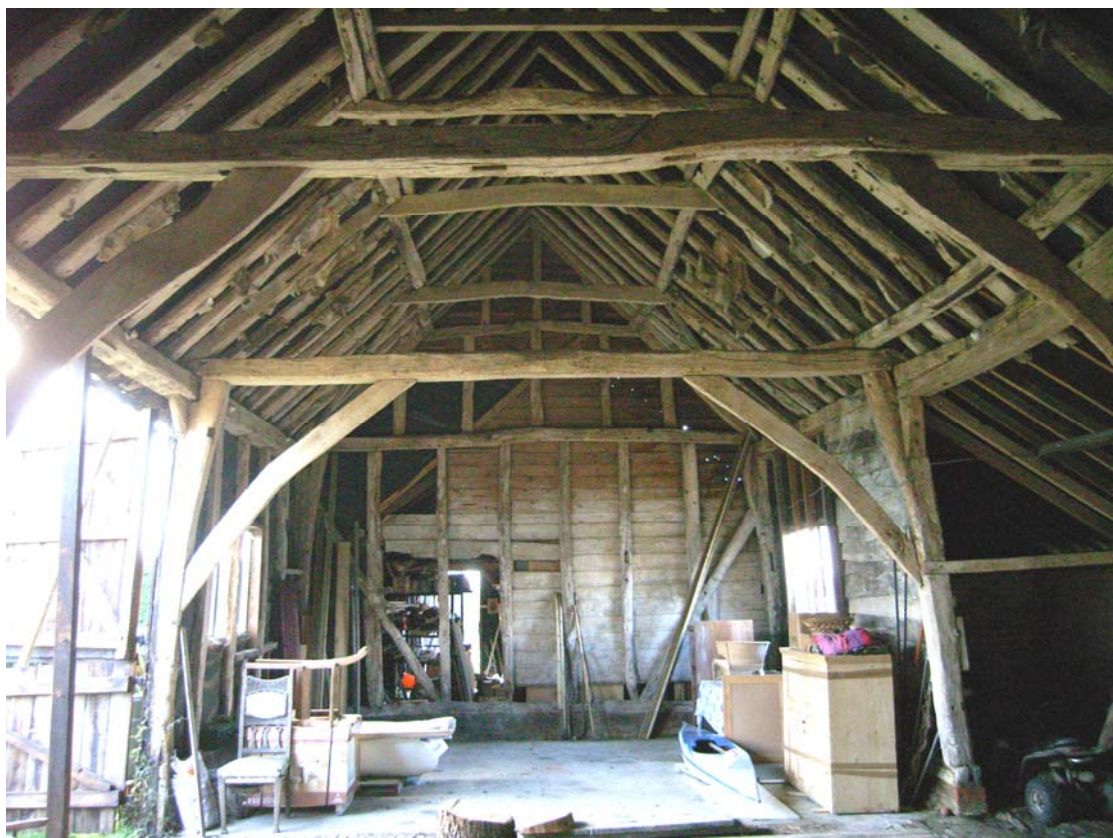
A2.4 General view of barn interior from structure B to east, showing 18th century arch-braces and stud mortises of original eastern gable in tie-beam, & 17th century arch-braces of structure A in rear

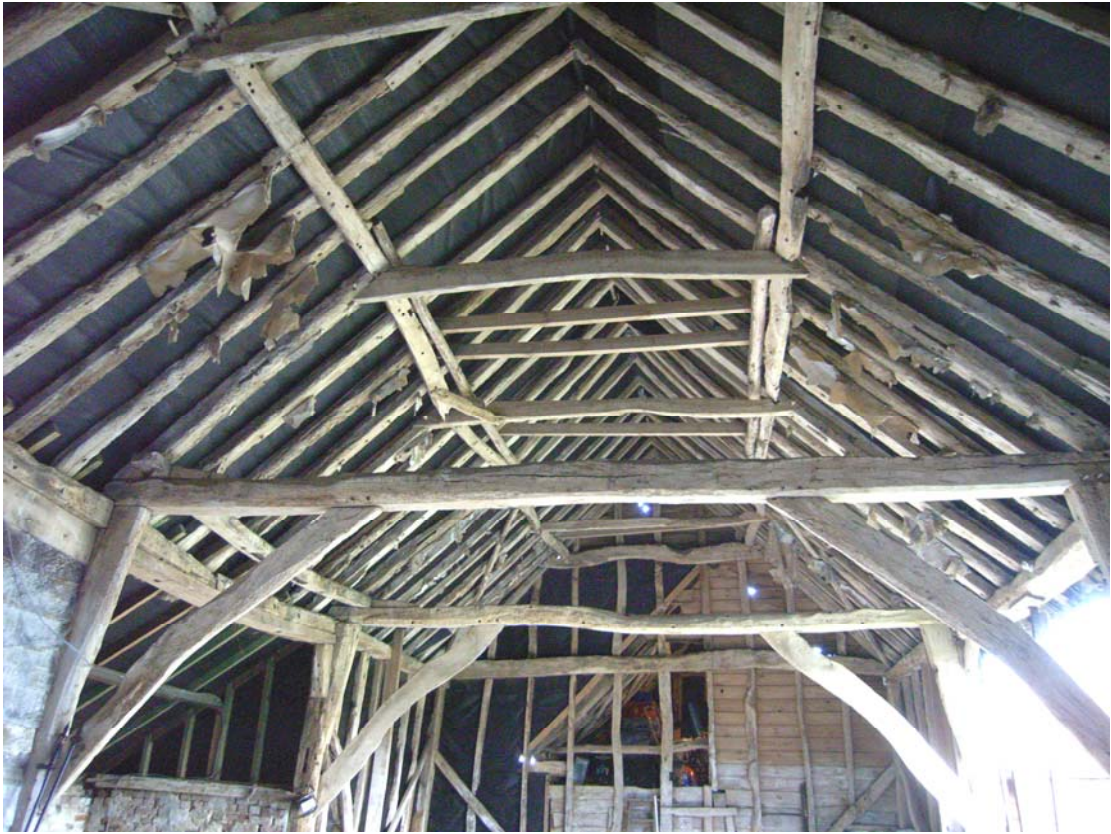
A2.5 Barn roof structure from west showing clapsed purlins with wind brace mortises in principal rafters, and profile of stable roof in rear

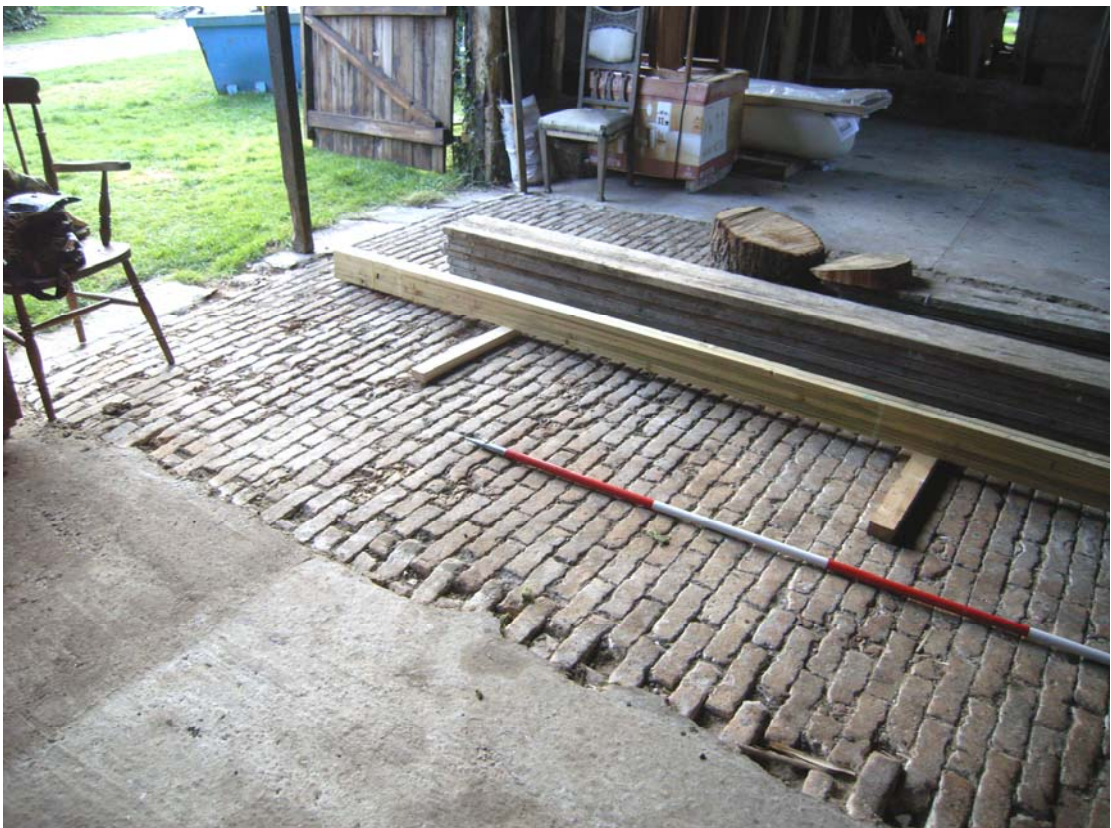
A2.6 Brick threshing floor in bay A2 seen from north-east, showing southern entrance to left

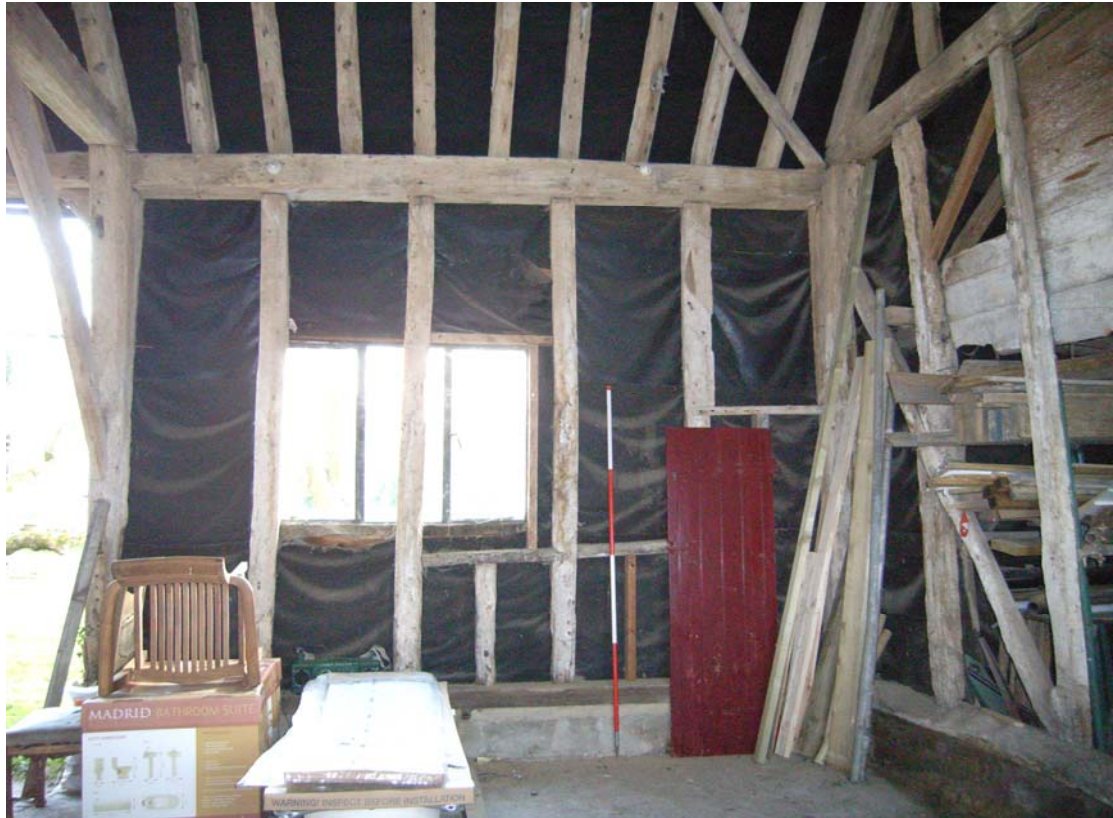
A2.7 Southern internal elevation of western bay (A1) showing original wall studs with mortises and trench for missing internal brace to right.

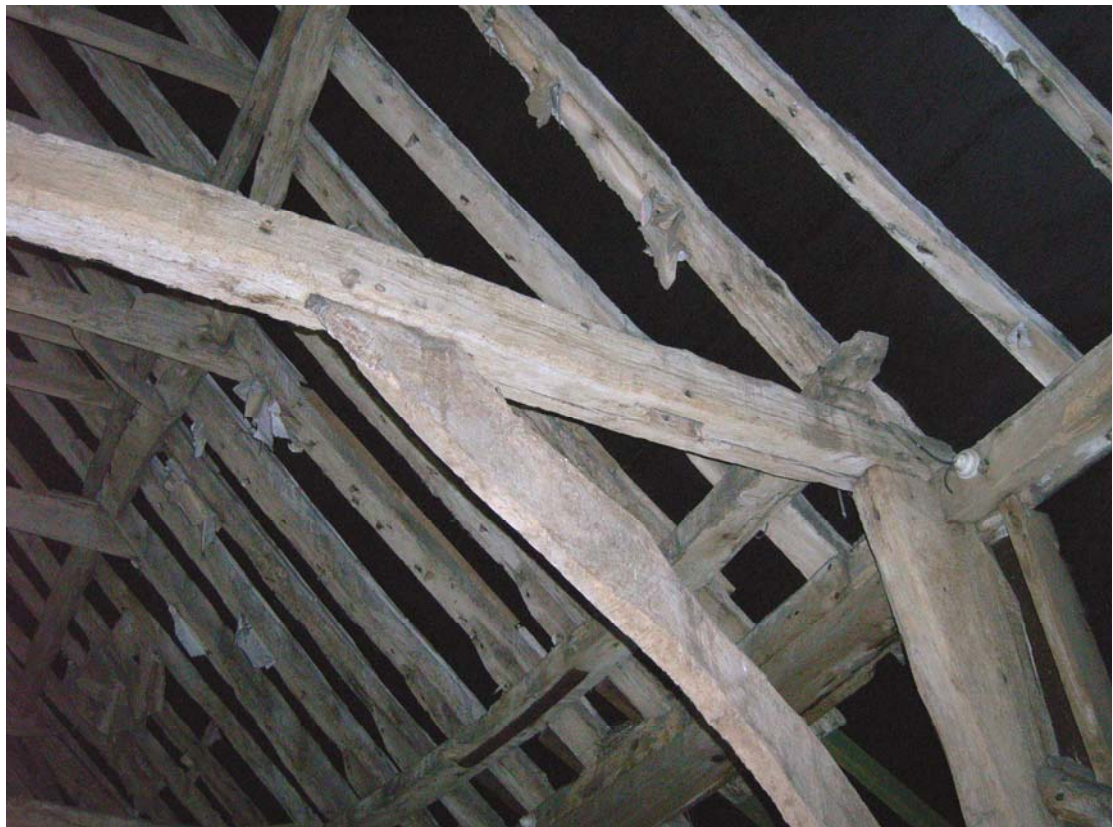
A2.8 Detail of weathering to eastern elevations of tie-beam & north-eastern corner post of original barn (A).
