DUNWICH GREYFRIARS: DUN 092 & 094 **Archaeological Recording Works Associated with the** **Rebuilding of a Section of the Precinct Wall and** **Repairs to the Gateways and Refectory**

SCCAS Report No. 2008/52; Oasis No. suffolkc1-57321

Stuart Boulter & Linzi Everett
Field Team
Suffolk C.C. Archaeological Service

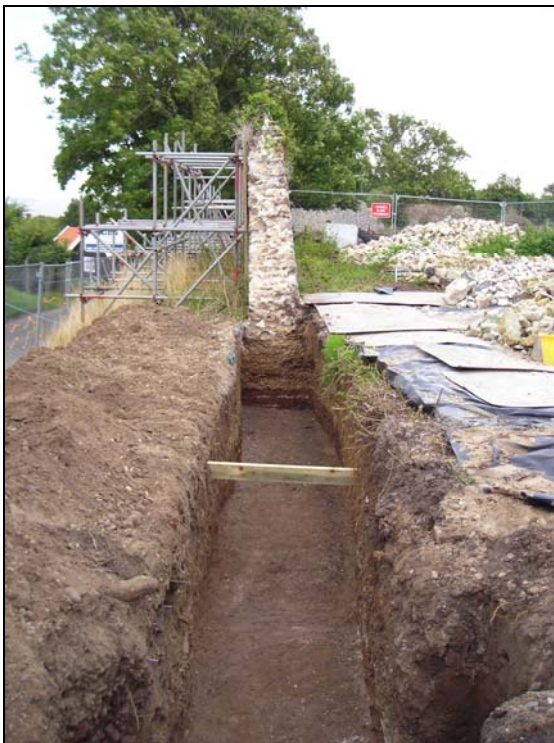
Plate 15 New footing trench, northern end

The trench was cut entirely within the existing footing, measuring 0.9 metres wide and no more than 1.1 metres deep, exposing the full depth of the upper footing and a maximum of 0.2 metres – 0.3 metres of the lower footing (Plates

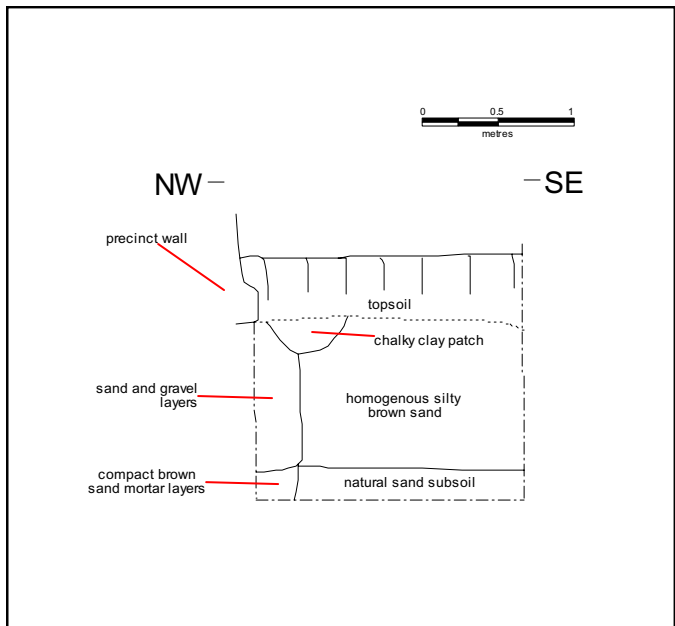
Fig. 8 Trench 1, constructed section, scale 1:50

supervision of an archaeologist. The depth of the trenches, coupled with the loose nature of the deposits, meant that access to the trenches was considered too dangerous and recording was limited to photographs and measurements taken from the side of the trench. A section was constructed of Trench 1 (Fig. 8) which provides a representative profile through the footing seen in Trenches 1-4.

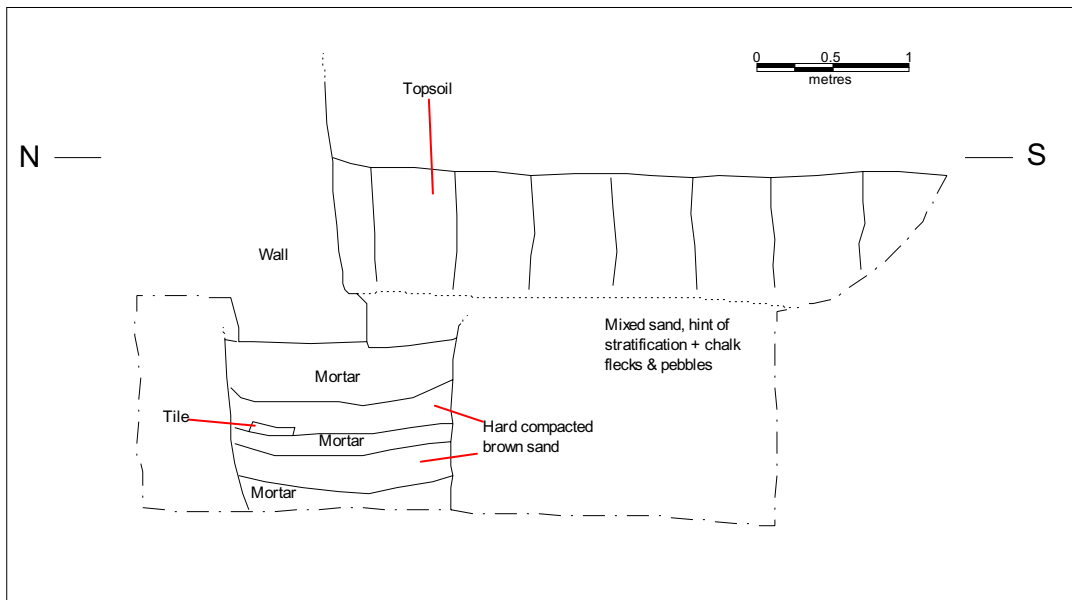
Fig. 9 Underpinning Trench 7, NNE-SSW section, scale 1:50

In all four trenches, the bottom of the precinct wall stepped out at a point c.0.25 metres from its base, the similar toed profile that was seen in the fallen section. The wall was 0.7-0.8 metres thick at its base. The underlying footing was vertical sided in Trenches 5-7, but stepped internally in Trench 8 (Figs. 9

& 10). In Trench 7, the bottom of the footing was not encountered at a depth of 1.10 metres below the base of the wall, but in Trench 8 it was shallower, with its bottom recorded only 0.9 metres below the base of the wall. The internal edge of the footing was between 0.5 and 0.6 metres from the wall, while that externally was between 0.1 and 0.2 metres out from the wall, although this measurement must be considered to be only a rough estimate due to the confined nature of the holes. In Trenches 5-7 the footing was remarkably consistent with a thick layer of sand, gravel and lime mortar overlying alternate layers of compacted brown sand and lime mortar. In Trench 8, the thick upper layer of sand/gravel/mortar was absent, but alternate layers of lime mortar and compacted brown sand were present.

The thick layer of mixed sand, gravel and mortar seen immediately below the wall in Trenches 5 – 7, and the stepped nature of the footing in Trench 8 were interpreted as a two phase foundation similar to those seen to the west, but with an upper component exhibiting a somewhat different composition.

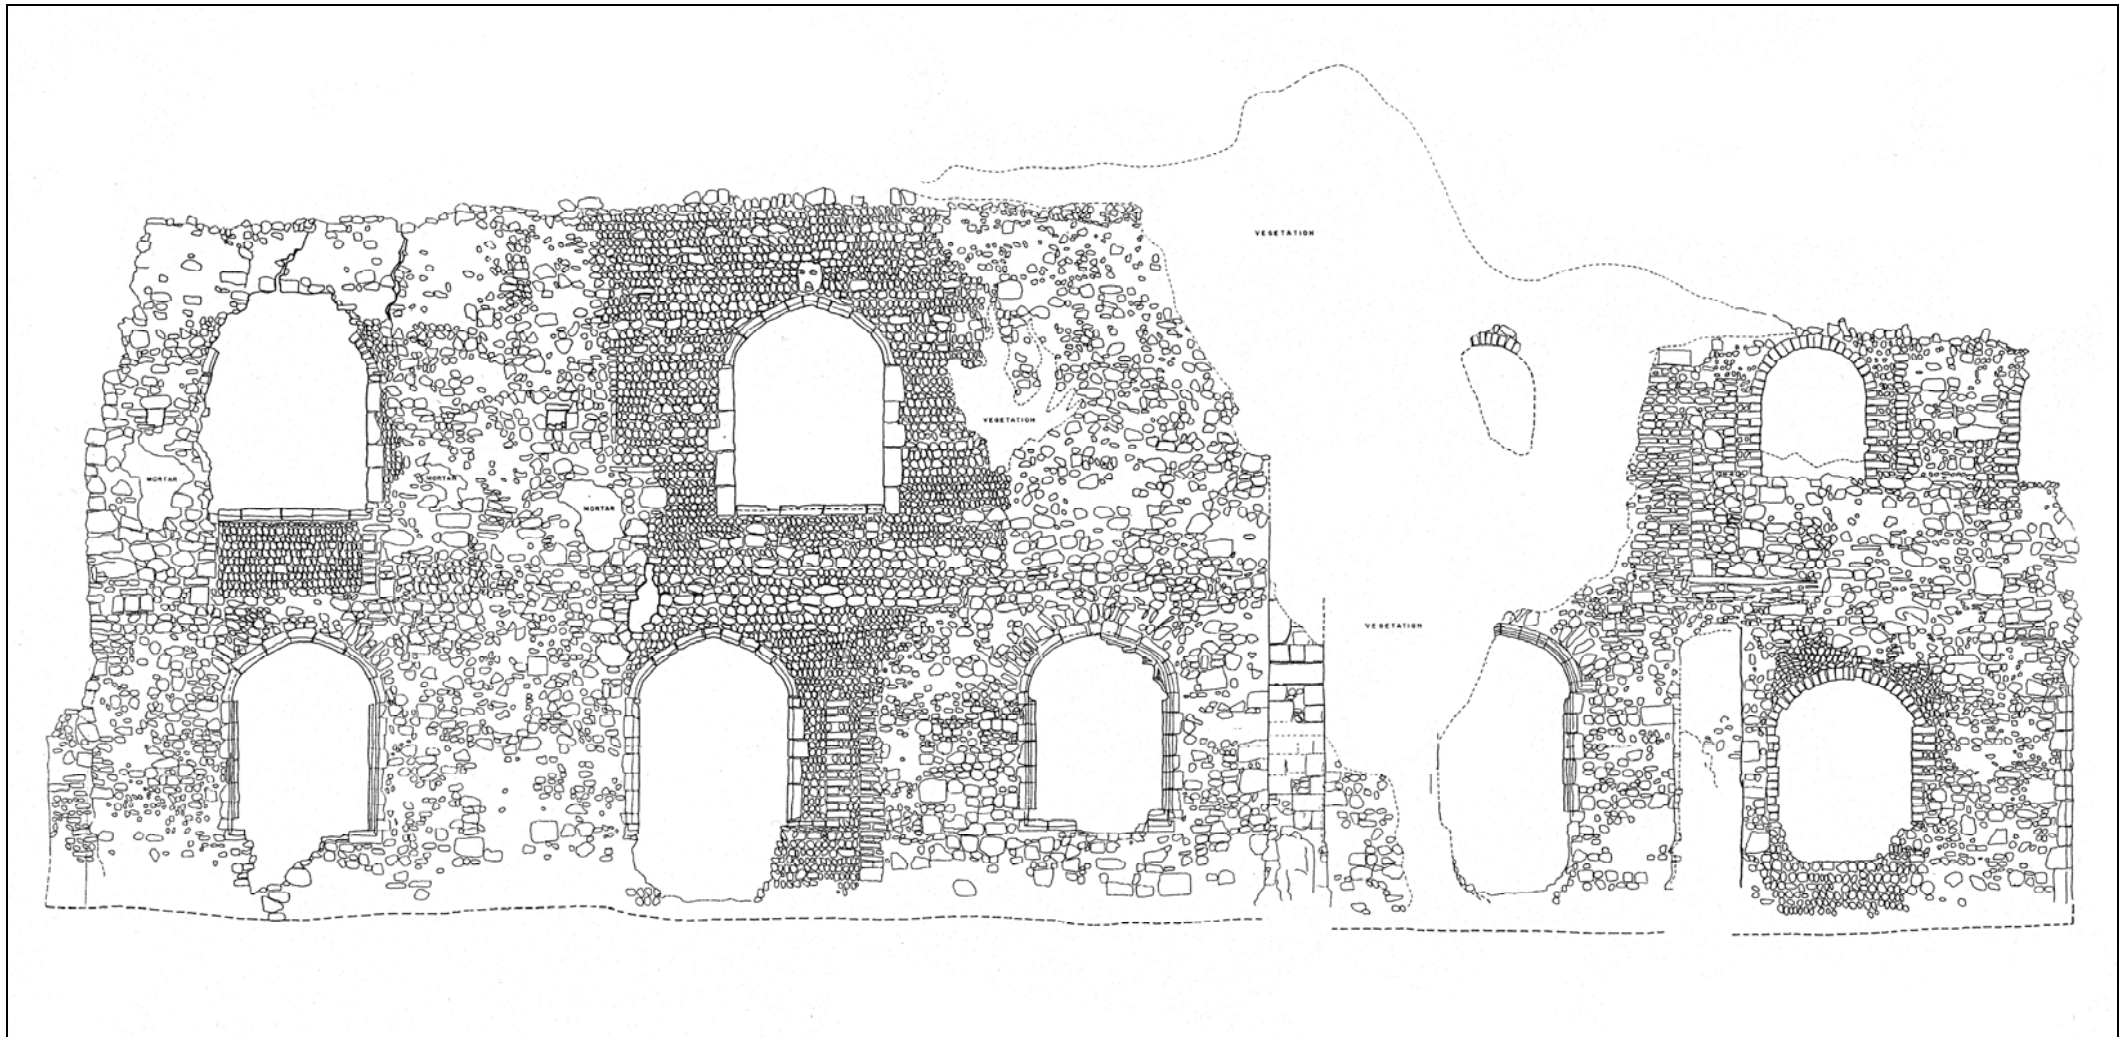
Fig. 13 c.1:70 scale elevation of the north wall (0050) of the refectory (Terrestrial Surveys 1990)

Phase I: Wall 0050 included significant areas of medieval fabric (0001) and associated architectural features, the latter mainly dressed with Caen limestone mouldings (Figs. 12, 13 & 14 & Plate 45).

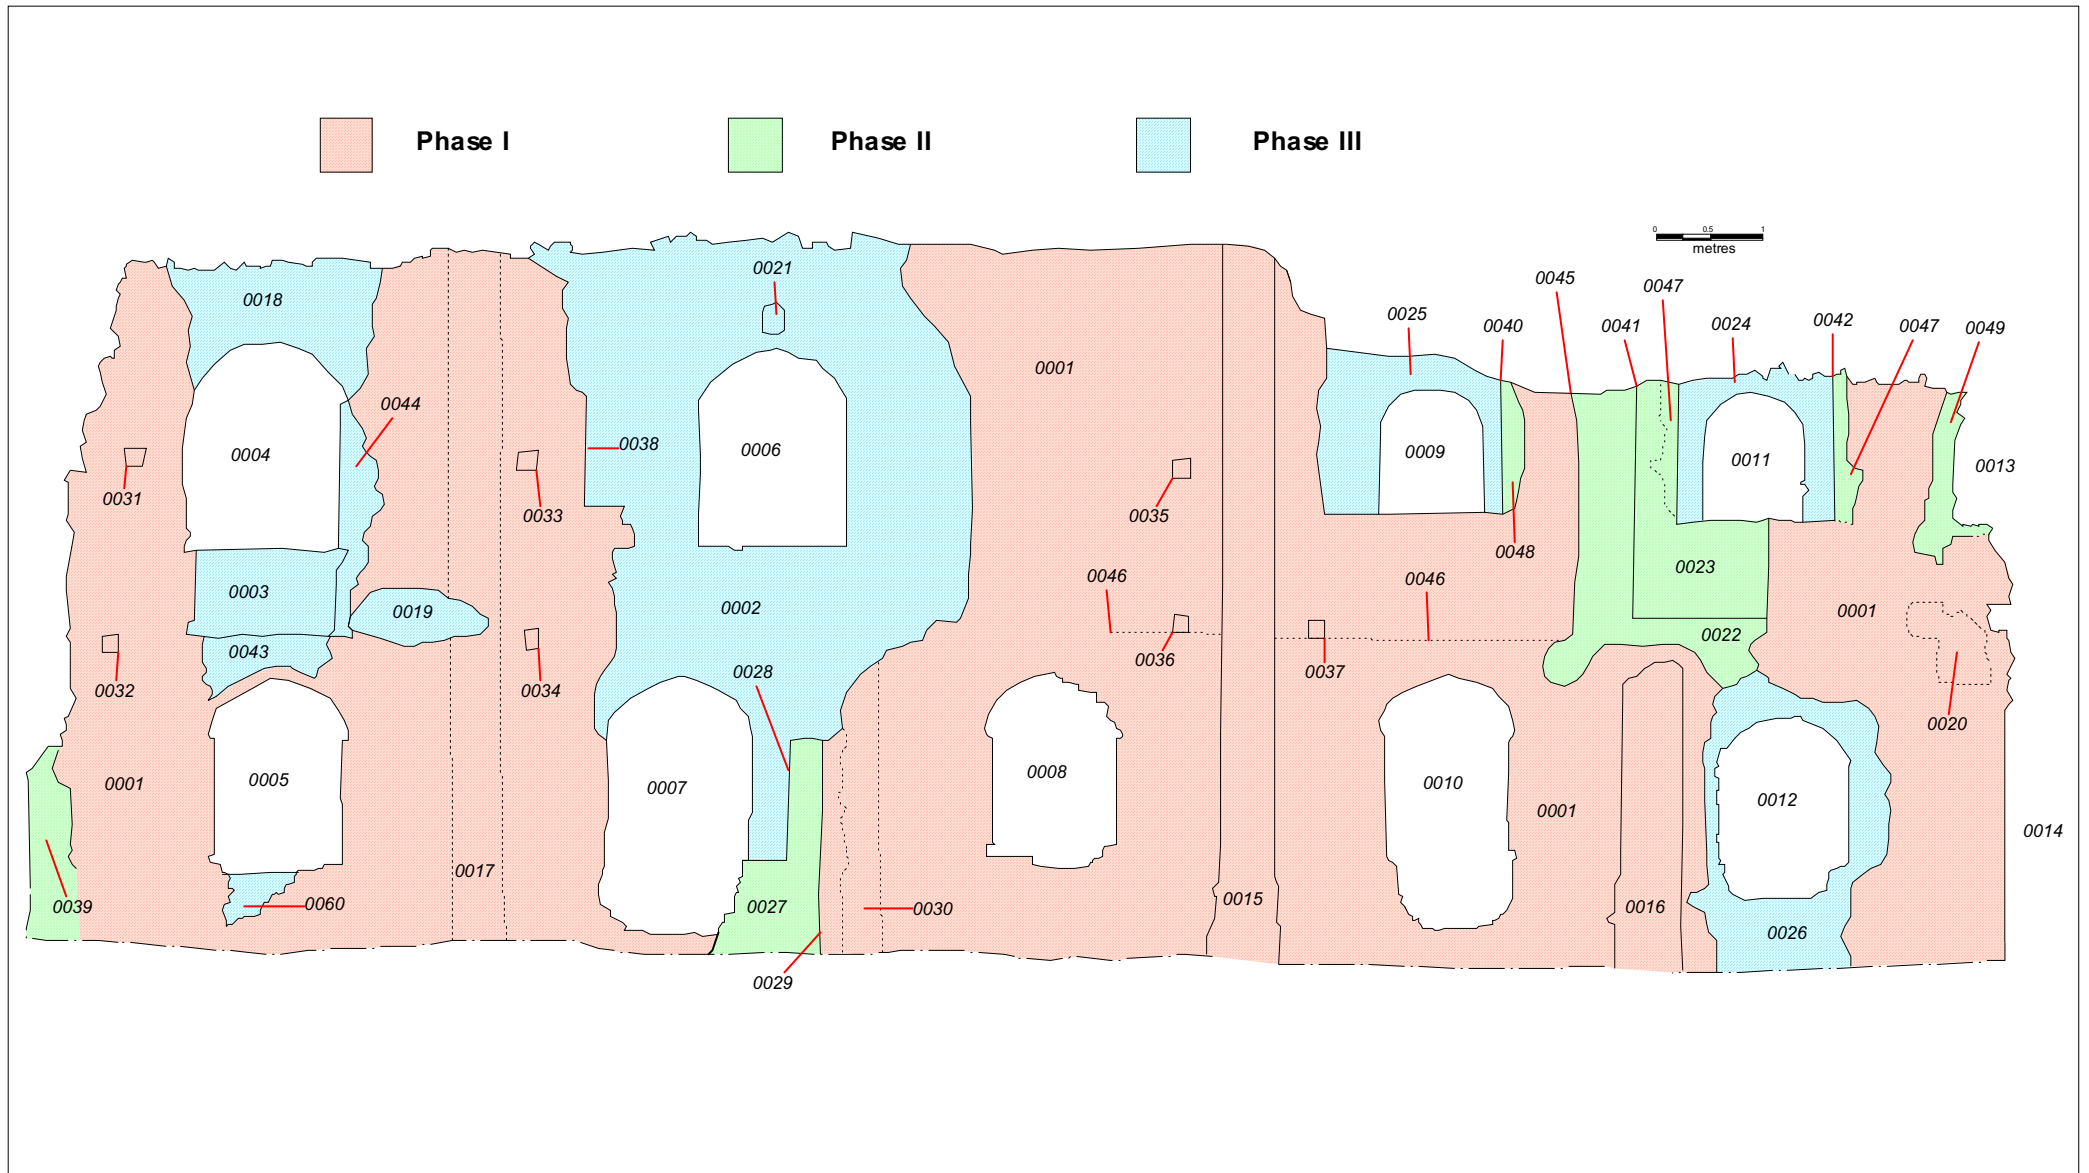
Fig. 14 c.1:70 elevation of the refectory north wall 0050

Phase II.b features forming part of wall 0050 relate entirely to a series of three first floor window openings (0013, 0040 & 0042) at the western end (Fig. 14). Two of these (0040 & 0042) were subsequently blocked during Phase III.a. Window opening 0040 was marked by its western jamb (0048), in brick, its eastern side was missing and was only represented by the junction of Phase I fabric with the later Phase III.a blocking fabric 0025. In contrast, window

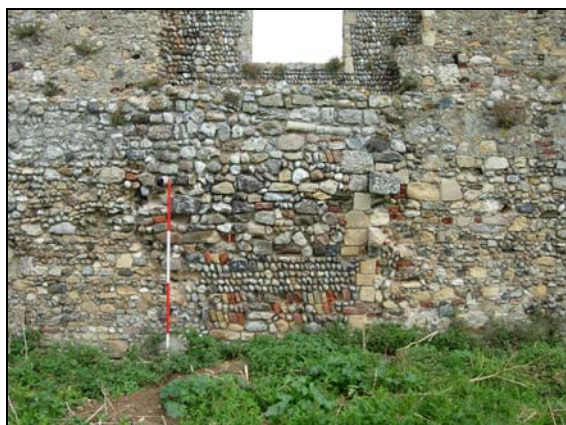
Plate 54 Wall 0052, south face, patched fabric
