**Bridge Farm,
Hacheston,
Suffolk
HCH 031**

Historic Building Record

Bridge Farm, Lower Hacheston, Hacheston, Suffolk

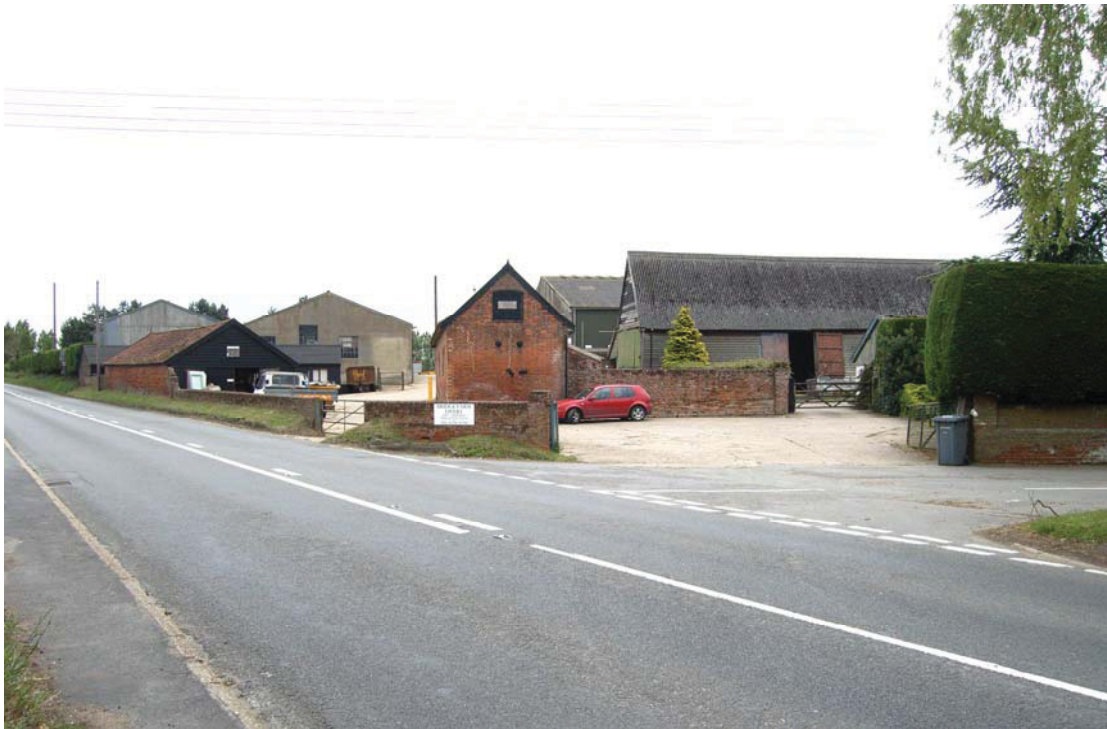
A2.1 General view of entrance to site from main road (B1078) to north-west, showing barn to right with converted brick shed and 20th century buildings to left

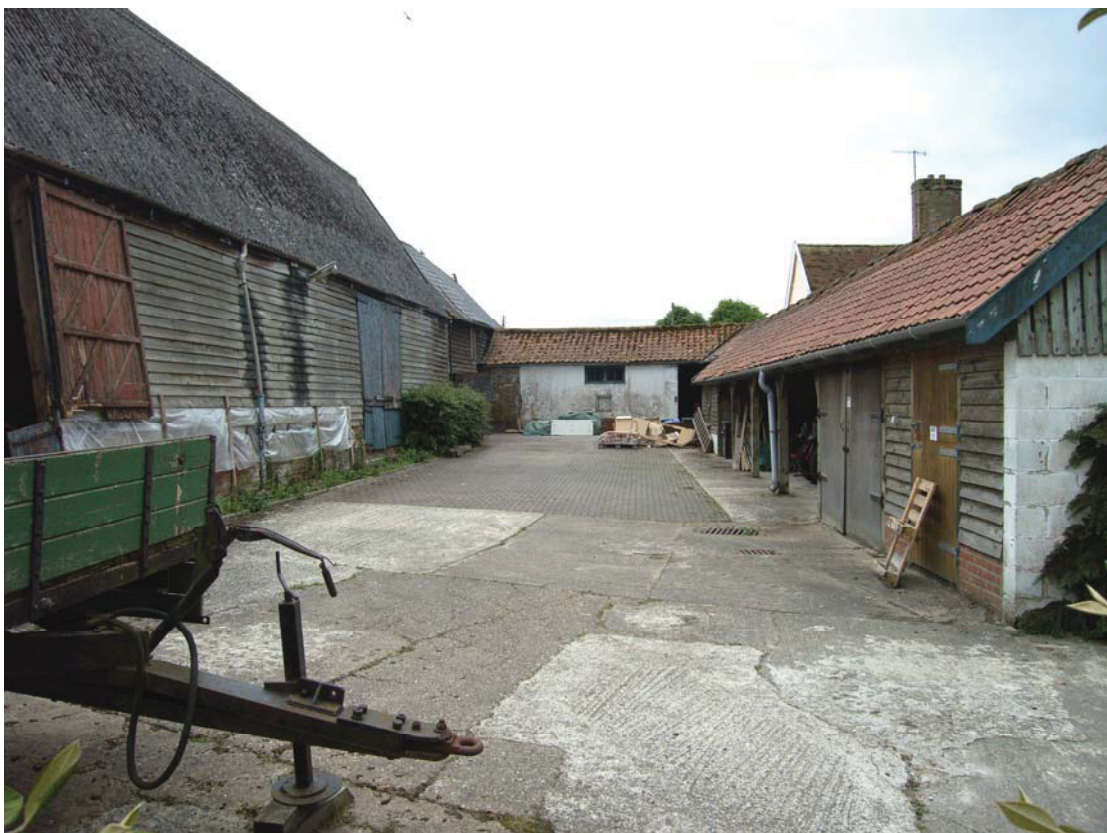
A2.2 General view of yard from north showing barn (A) to left and much rebuilt shelter shed (D) to right.

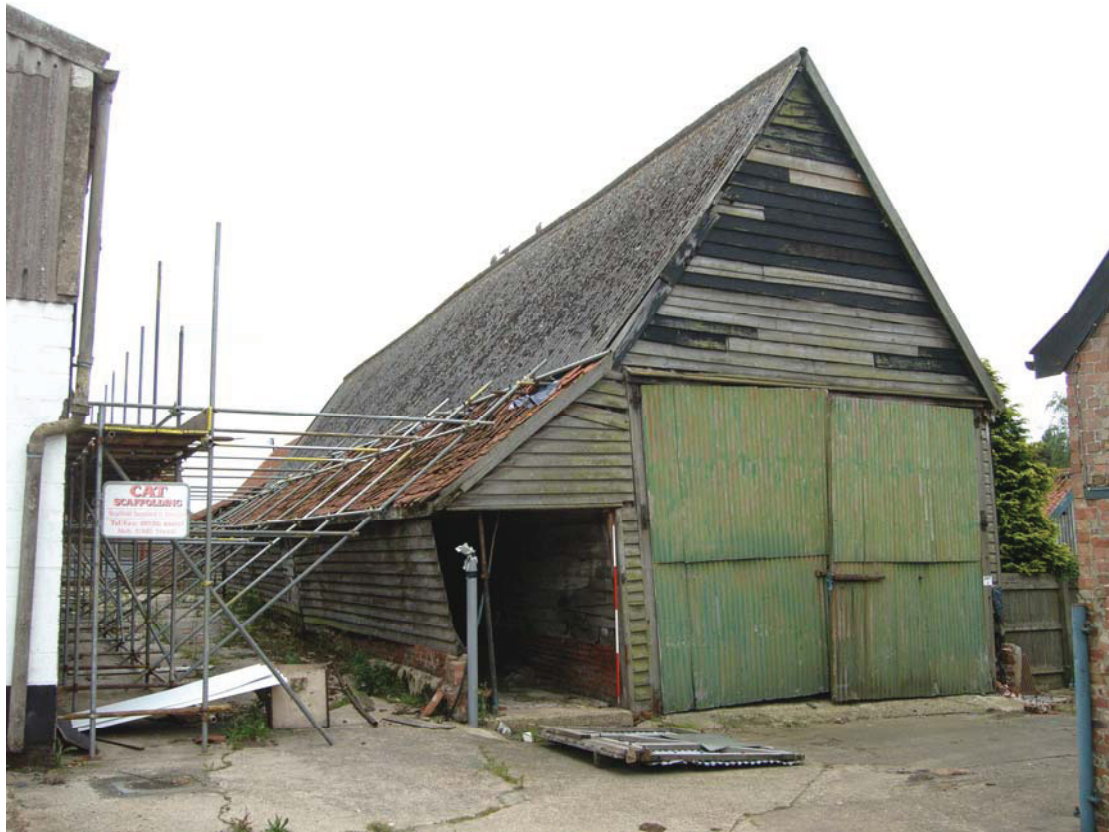
A2.3 Exterior of barn from north-west showing northern gable with steeply pitched roof (formerly thatched) and rear lean-to (A4) to left

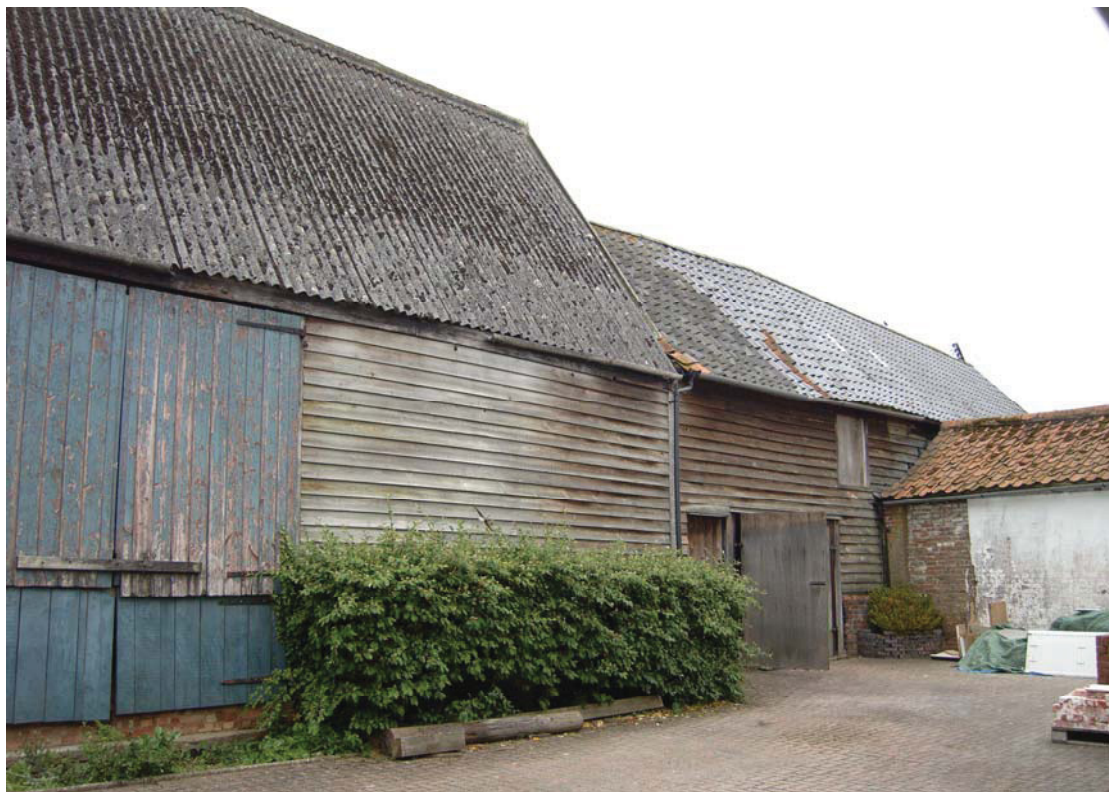
A2.4 Junction of barn (left) and granary (B) from yard to north-west, with modern brick shed to right

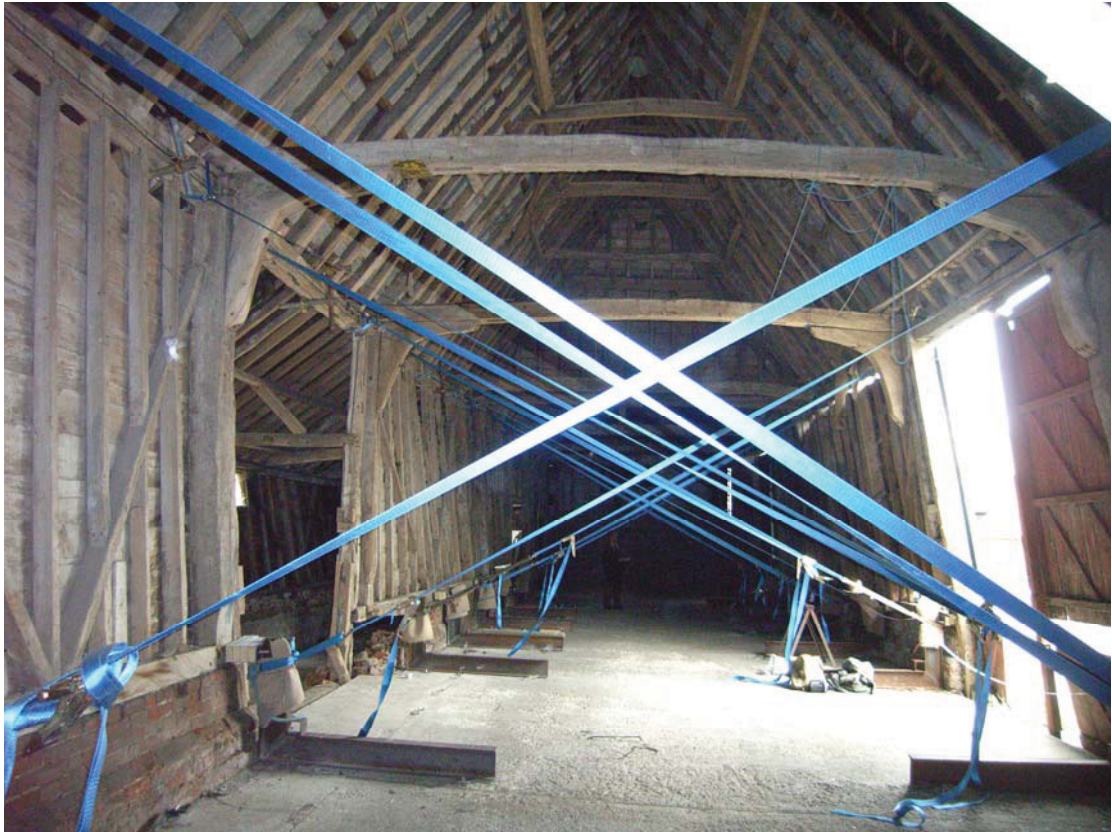
A2.5 General internal view of barn from north showing modern bracing straps.

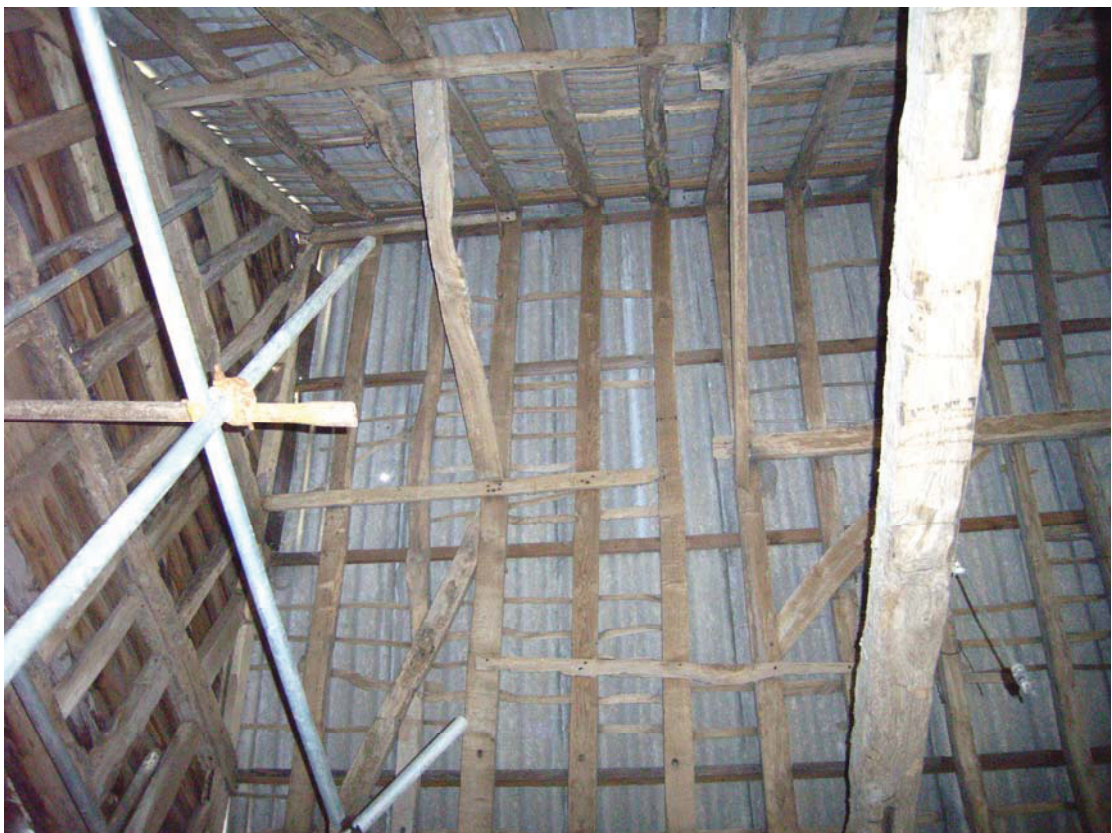
A2.6 Northern end of roof from west showing wind braces of original 17th century open-framed gable right (A1) & former hipped gable of mid-17th century extension bay (A2) left

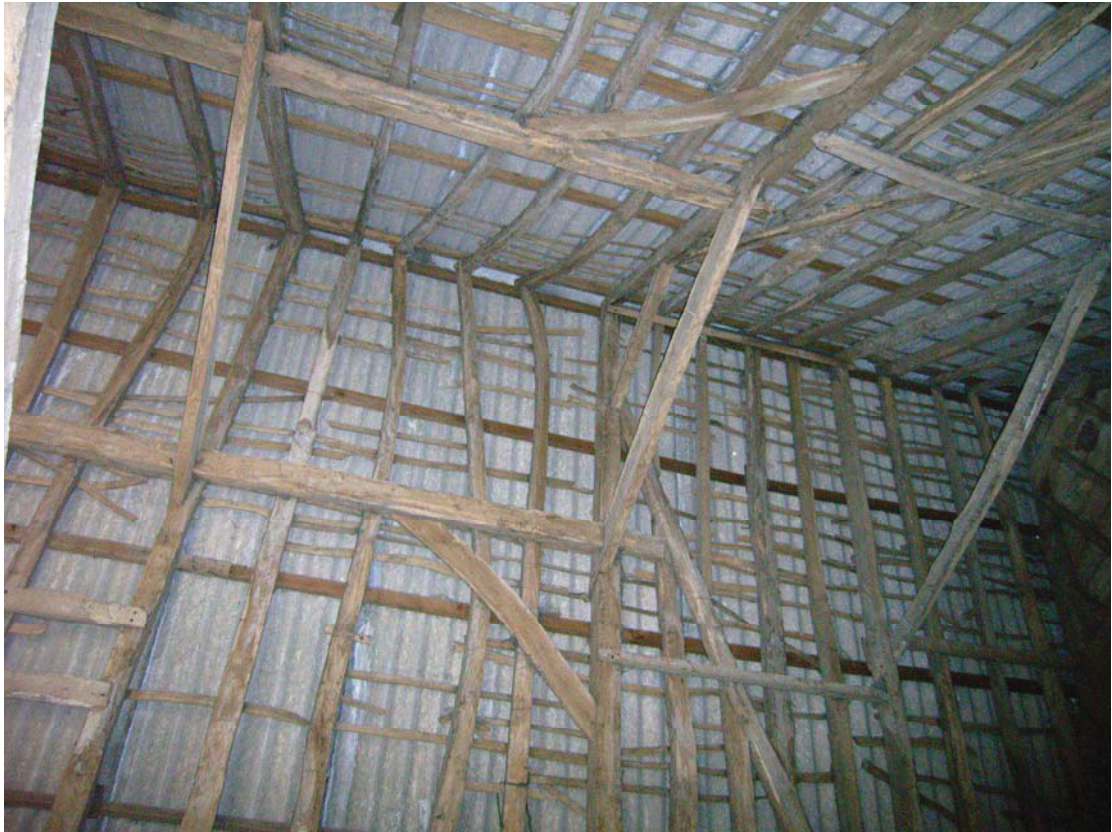
A2.7 Southern end of original 17th century roof (A1) seen from west, showing wind braces and original hip collar in centre

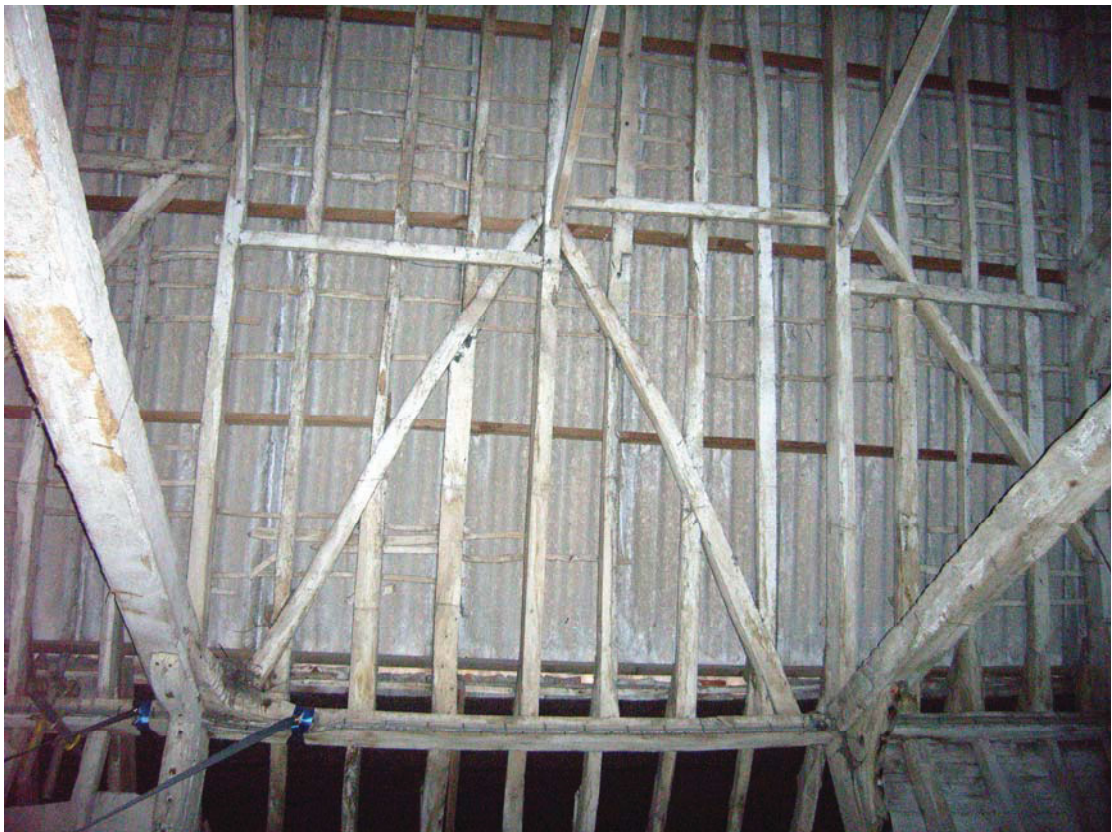
A2.8 Detail of staggered butt-purlin roof of early-19th century structure (A3) from west

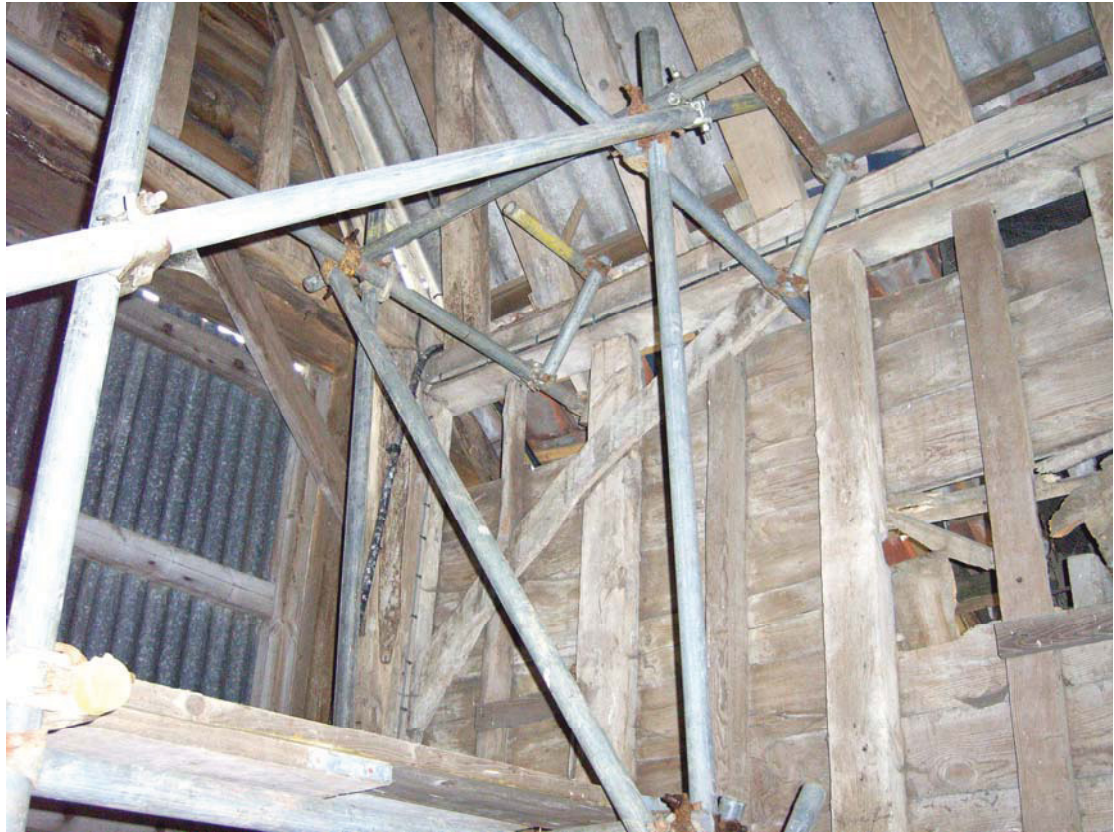
Although the roof structures, roof-plates, tie-beams and storey posts of the 17th century phases remain intact, the only wall-framing to survive lies in the eastern elevation of the extension (A2). The remaining studs were replaced with narrow studwork interrupted by diagonal 'primary' braces during the mid-19th century refurbishment of the site, which probably

A2.9 Detail of original internal corner brace and studs in eastern elevation of mid-17th century northern extension bay (A2). The northern gable to the left has been rebuilt

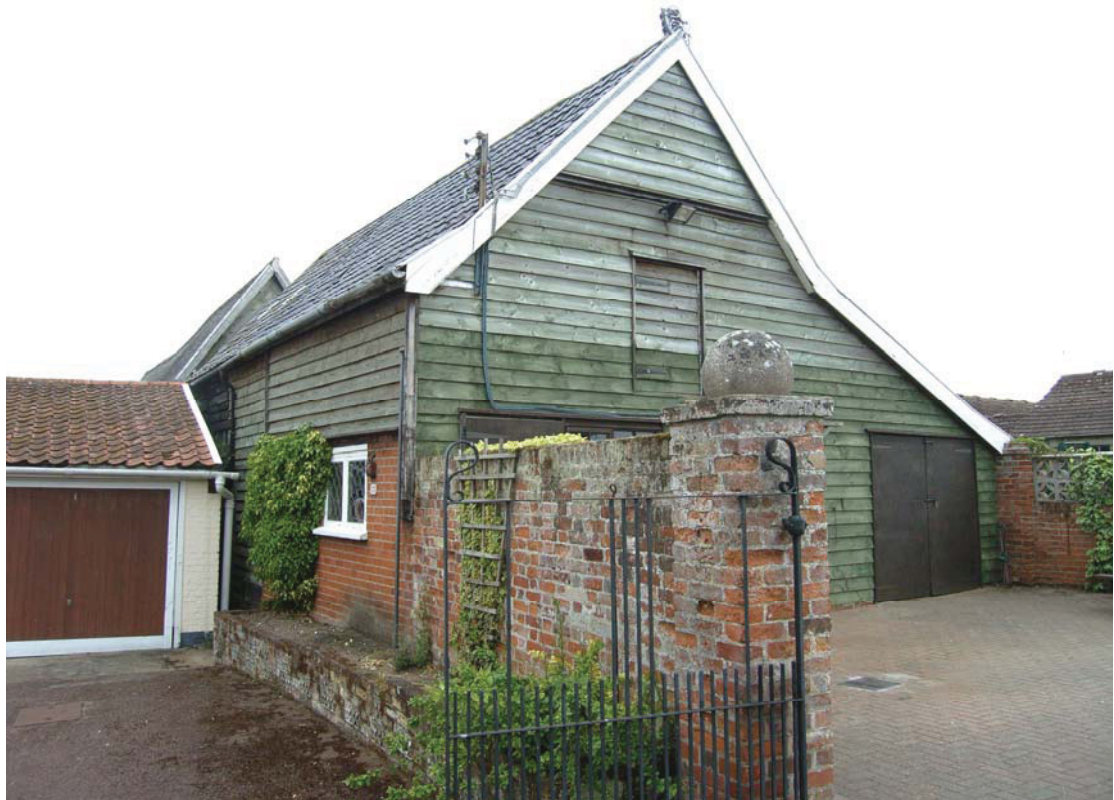
A2.10 Exterior of granary (B) from south-east showing the rebuilt western elevation to the left with blocked loading door in the gable

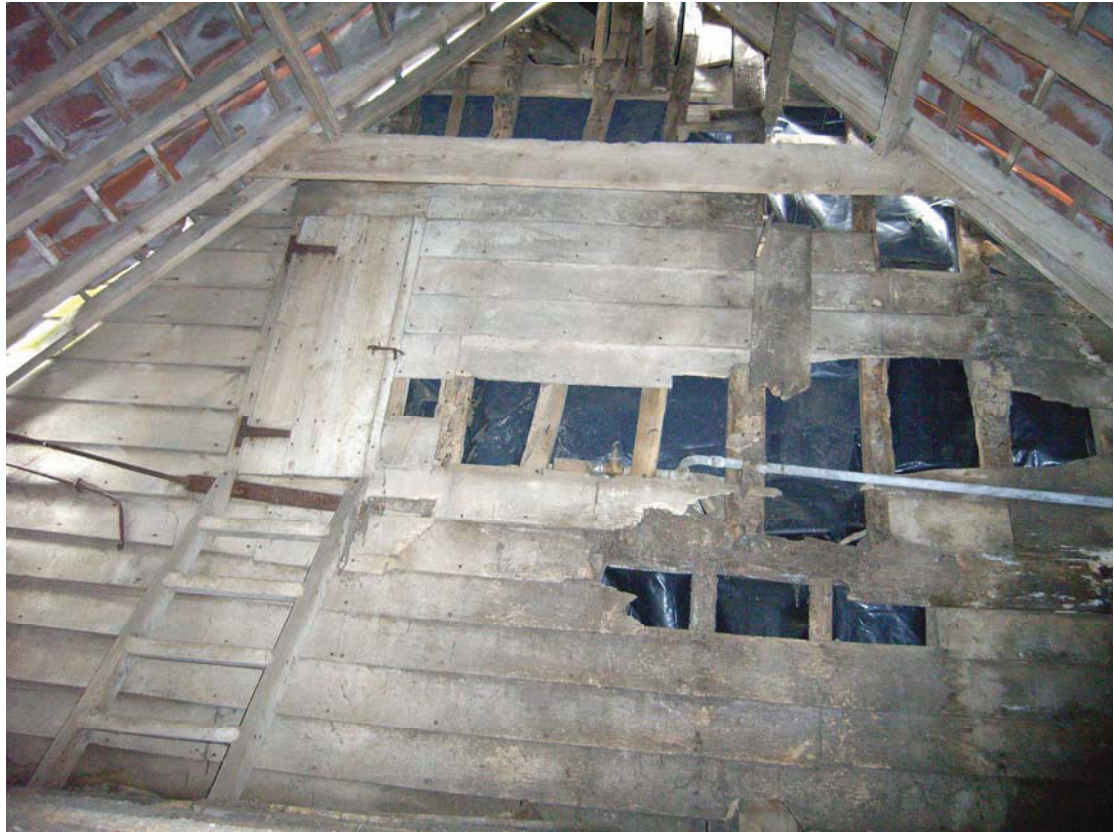
A2.11 External southern gable of barn from loft of infill shed (B2), showing ladder and door to former loft in barn

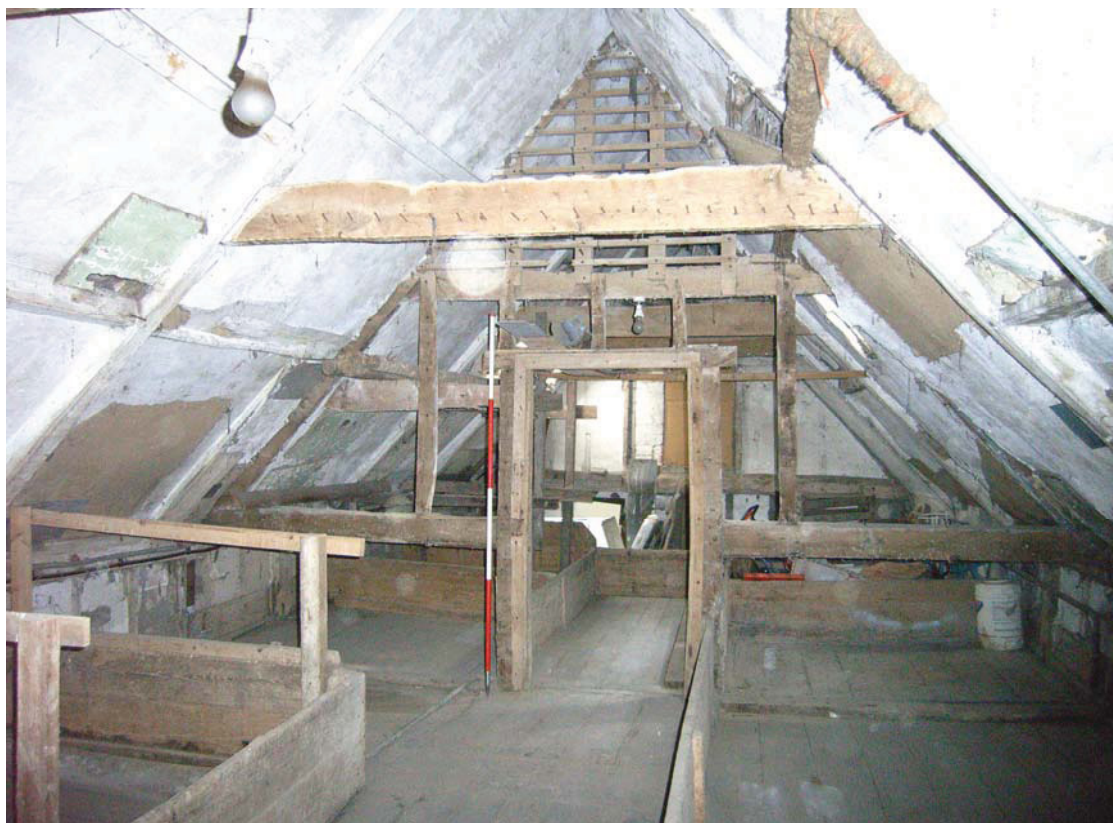
A2.12 Interior of first-floor granary (B1) from south, showing 19th century grain bins with central passage and butt-purlin roof structure
