WATCHING BRIEF REPORT

Alterations to:
**Hadleigh Baptist Church,
George Street,
Hadleigh**

SMR ref. HAD 073

Application Number B/01/01449/FUL

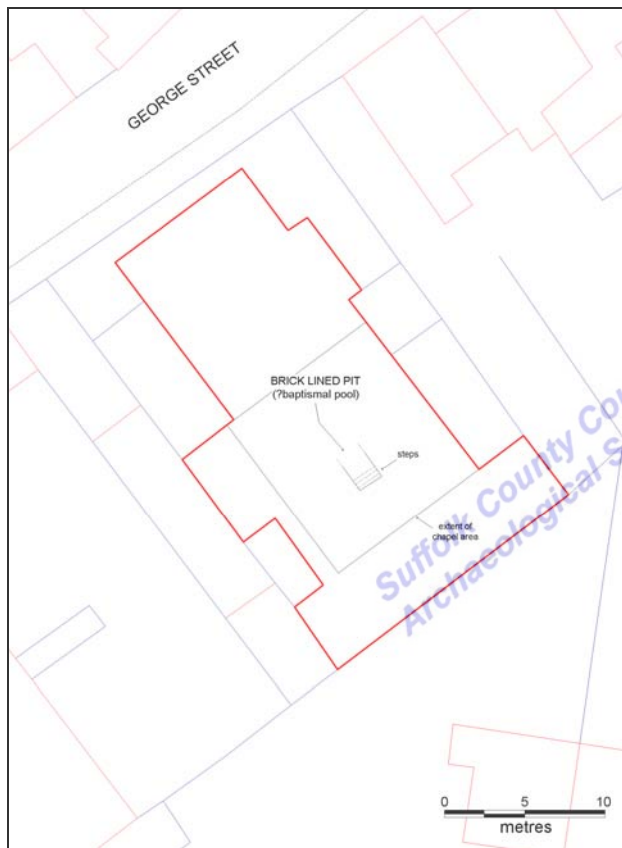
figure 2: location of pool within church

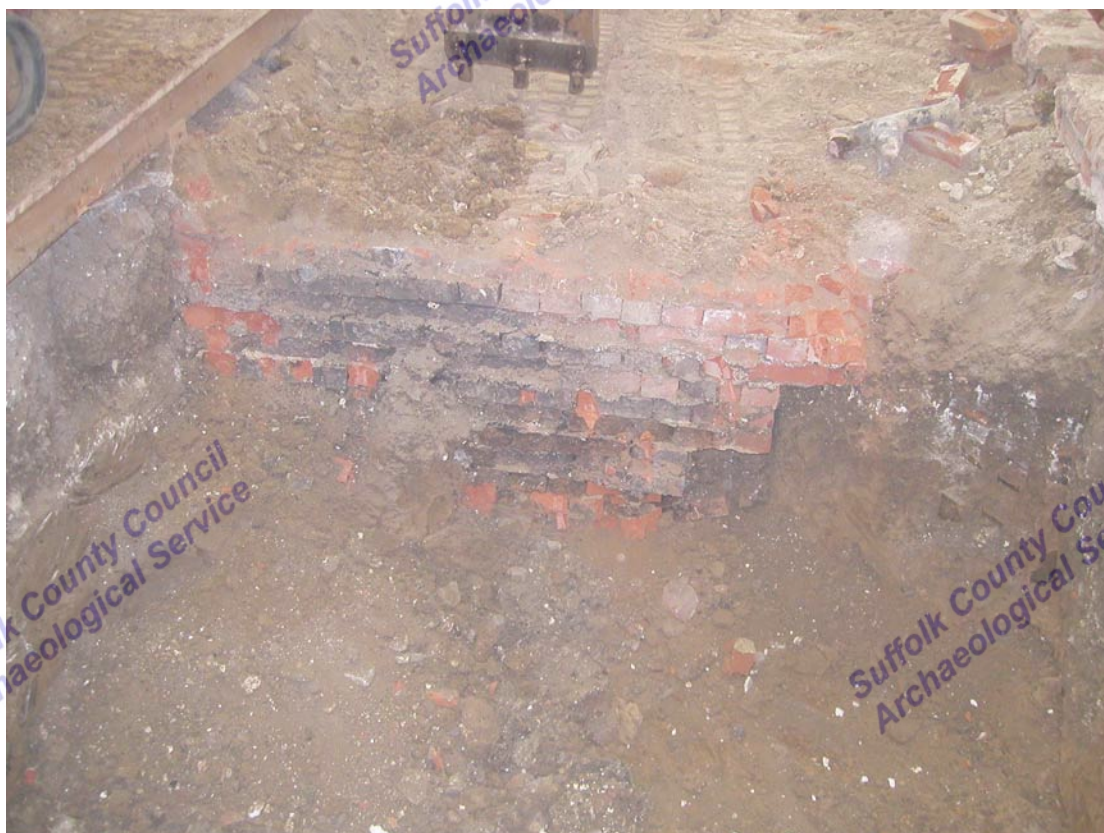
Plate I

The site was visited on the 12th May 2004 in order to inspect the excavation of a large hole within the existing building for the purpose of constructing a baptismal pool. The visit was in response to a call from the on-site contractors who reported having uncovered some brick walls under the floor of the church. At the time of the visit part of the wooden floor within the chapel area of the church had been lifted to reveal a loose earth surface beneath within which the very top of a series of brick walls could be seen. It was initially thought these were dwarf walls constructed to support the main joists of the wooden floor but upon closer examination it was found that they formed the lining of what appeared to be a rectangular shaped pit situated along the central northwest-southeast axis of the church, but slightly towards its southeast end (see figure 2). At the time of the visit the contractors had excavated adjacent the southwest outer edge of the pit to a depth of c.1.65m. The revealed soil profile

The brick lined pit is undoubtedly the remains of an earlier baptismal pool for use in ceremonies at the church and possibly dates from the original construction of the church in 1830 (as indicated by a stone set in former front wall). The hard cement rendering on the internal faces are presumably to make it water tight. The relining of the pool through the addition of extra brickwork at its base could have been in response to a leak, or to strengthen the base as a precaution against leaks as the weight of the water could have led to localised subsidence and deformation of the base. Alternatively, its purpose may have been simply to reduce the depth of the pool.

The outer face of the southwest wall of the pool revealed on the 12th May 2004

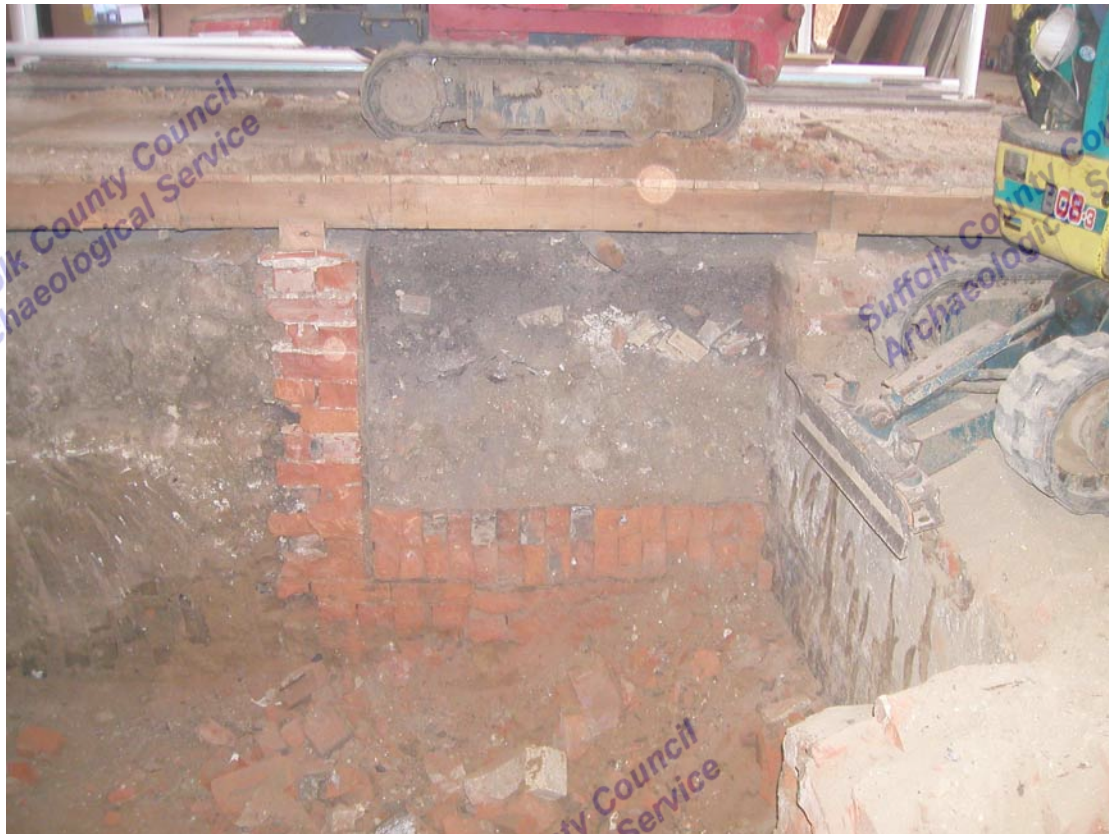
Plate II

A second visit was made on the 13th May 2004 to observe further excavations within the church. The hole seen the previous day had been enlarged, cutting away much of the previously seen brickwork to reveal a cross section across the width of the pit and exposing the inner face of its northeast wall. The brick lined pit had an internal width of 1.6m and initially a depth of 1.34m. The internal faces of the brickwork were lined with a very hard cement render. At a later stage the floor of this feature had been raised through the addition of two courses of bricks laid end to end on their narrow sides, these too were then sealed under a hard cement render. This reduced the depth of the pit to 1.05m.

Cross-section across the width of the pool

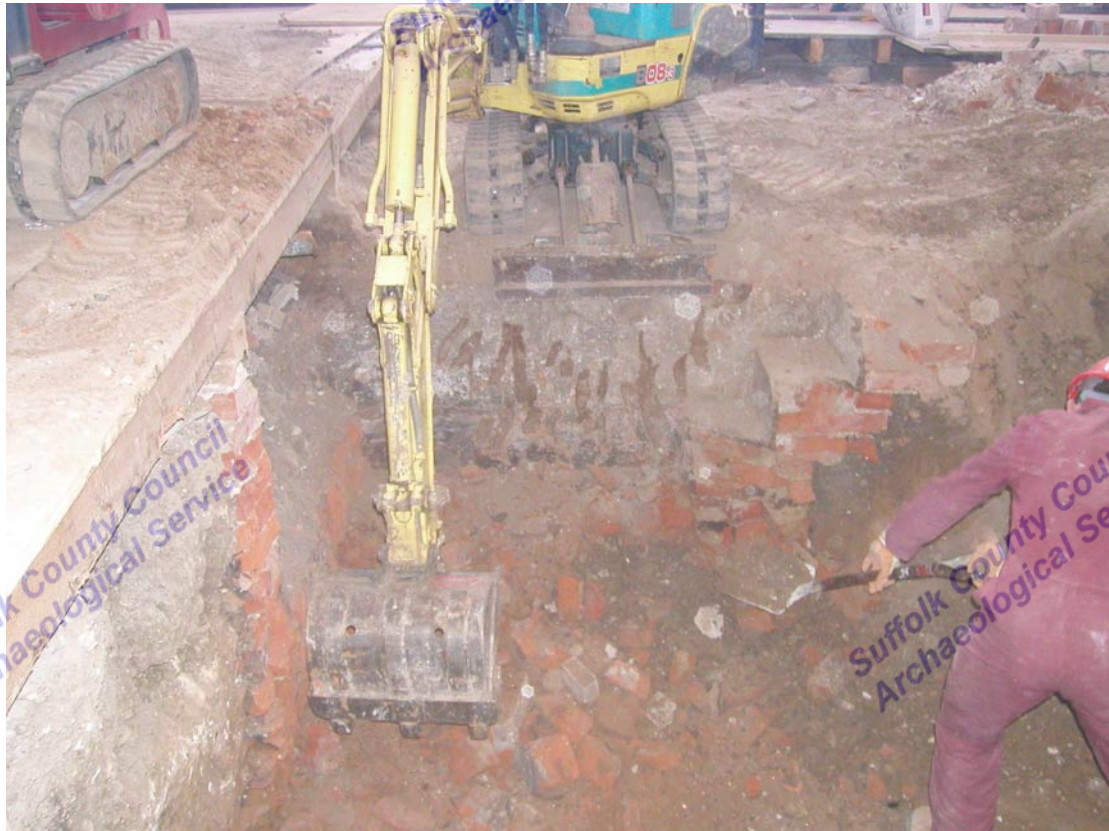
Plate III

At the southeast end of the pit three steps were formed in brickwork although this was later reduced to two steps by the raising of the floor. The pit was completely filled so that it was flush with the surrounding ground surface with two distinct fills. The lower fill

View illustrating the internal face of the northeast wall and the three steps
