The Barn, Chippenhall Hall, Fressingfield, Suffolk FSF 063

Historic Building Record

July 2009

This report provides a written and photographic record at English Heritage (2006) Level 2 of a redundant barn. It has been prepared to a brief written by Suffolk County Council Archaeological Service (Edward Martin, dated 11 June 2009, Ref. SpecHBR(EM)_ChippenhallHall_Frassingfield_09) and is intended to fulfil a condition of planning permission for conversion (Mid Suffolk District Council application 1160/09).

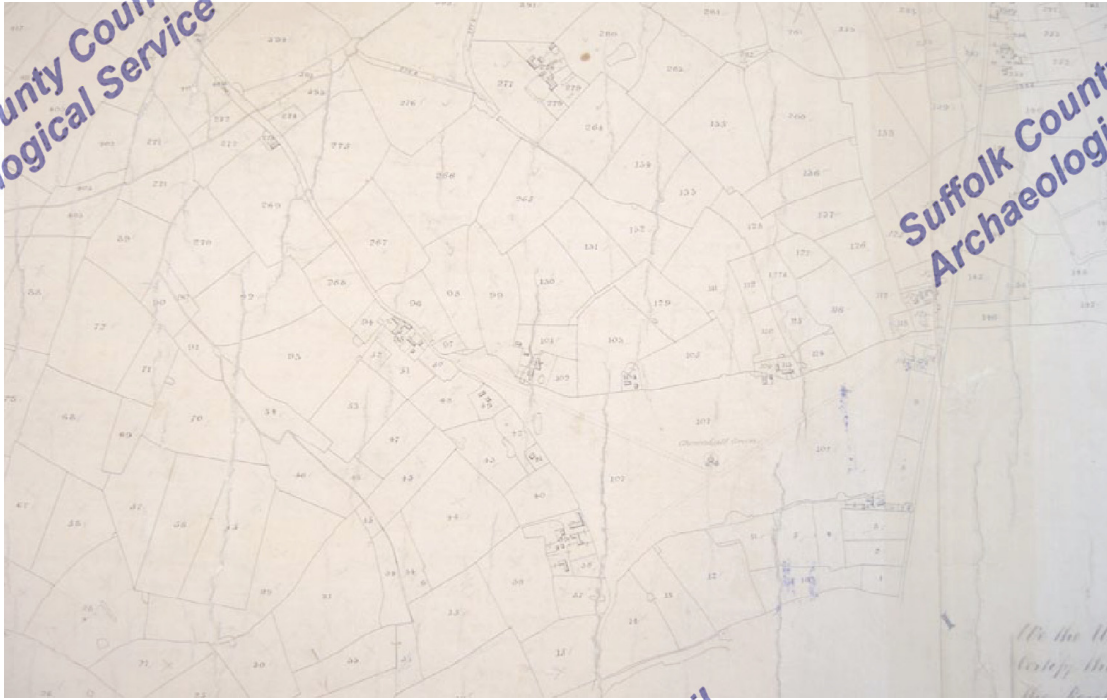
Figure 2.

Fressingfield Tithe Map of 1838 (SRQ Ipswich branch)
Chippenhall Hall is shown at top centre, with Chippenhall Green and the boundaries with Cratfield and Laxfield bottom right. North is oriented towards the top-right.

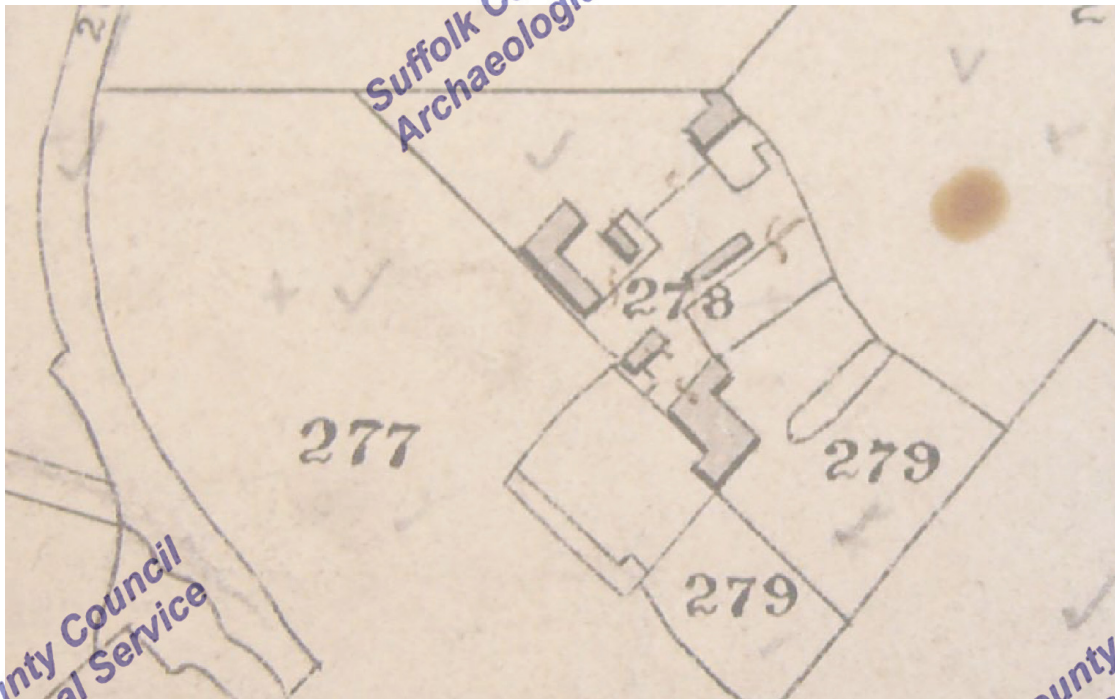
Figure 2a

Detail of 1838 tithe map

The area marked '278' is described as 'homestead' on the tithe apportionment, '279' as an orchard, '277' as Little Hill (pasture) and the fields to the north and west as 'Backhouse Meadow' and 'Bower Hill' respectively. The house is shown to the bottom right and the L-shaped barn & attached shed at top left. Although the barn occupies the same site as today, it lacks an eastern porch and is the existing structure's predecessor

The 1838 tithe map shows an L-shaped building on the site of the present barn and the recently demolished shelter shed outlined in figure 1. The eastern porch is not shown however, and as this appears to be contemporary with the barn it seems likely that the map depicts an earlier barn on the same site. The present arrangement is clearly shown on the first edition Ordnance Survey of 1884 however (figure 3), along with a sophisticated complex of new farm buildings immediately to the north. Many local farmyards were similarly refurbished in the 1850s and 1860s as intensive cereal production was replaced by mixed animal husbandry after the price of grain fell sharply (thanks to the Repeal of the Corn Laws in 1846). These buildings had been converted and heavily altered by the time of inspection, but photographs in the owner's possession suggest they were typical single-storied red brick structures of the period with pantiled roofs. A stable with a hay loft and unusual arched gable vents lay to the north-east of the yard complex and is said to have retained historic fixtures and fittings such as a manger and hay rack before conversion. It is also understood from the present owner that the barn yard was used in the 1970s to film a television drama based on the murder of Maria Martin in the Red Barn at Polstead.

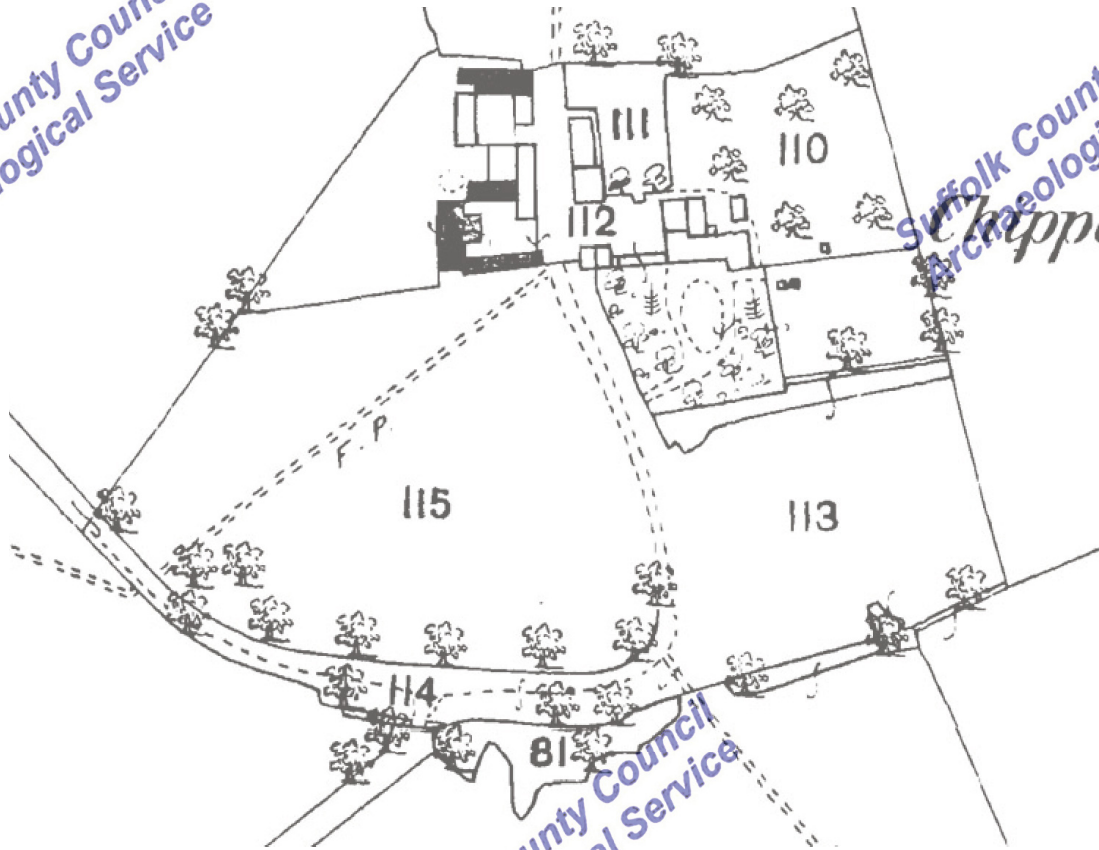
Figure 3

First edition 25 inch Ordnance Survey of 1884, showing a sophisticated new complex of mid-19th century farm buildings to the north of the barn. These have been recently converted and are no longer recognisable. The barn is clearly the present structure, with a central lean-to porch projecting from its eastern elevation into an enclosed cattle yard. The recently demolished shelter shed is shown to the south of the yard

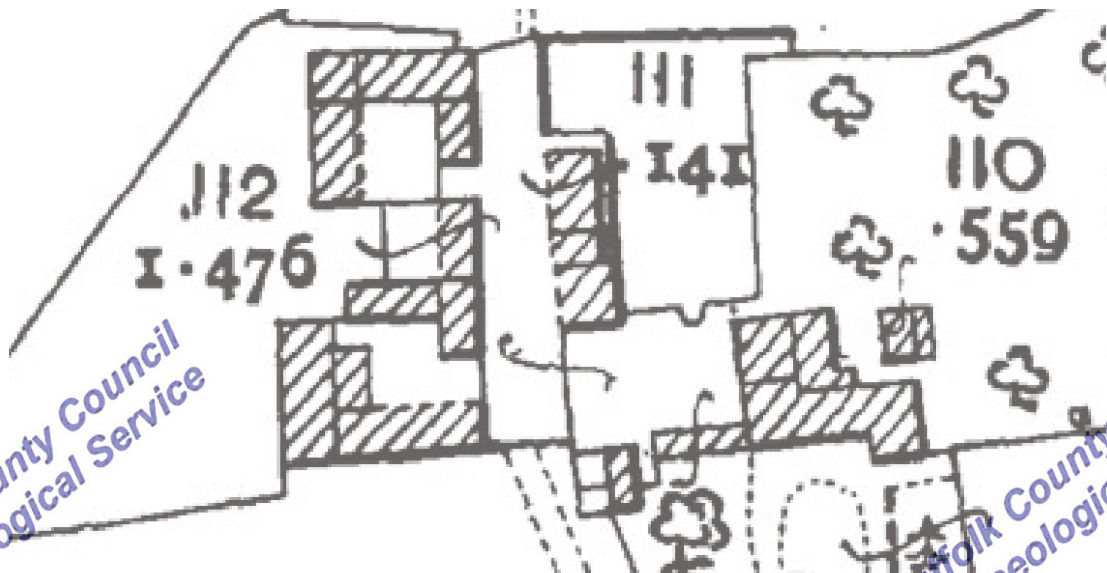
Figure 4

Second edition 25 inch Ordnance Survey of 1904, which uses broken lines to indicate open-sided structures. The demolished shed to the south of the yard was an open-sided cattle shelter shed, while the converted granary to the right of the central drift evidently contained a cartlodge on its lower storey.

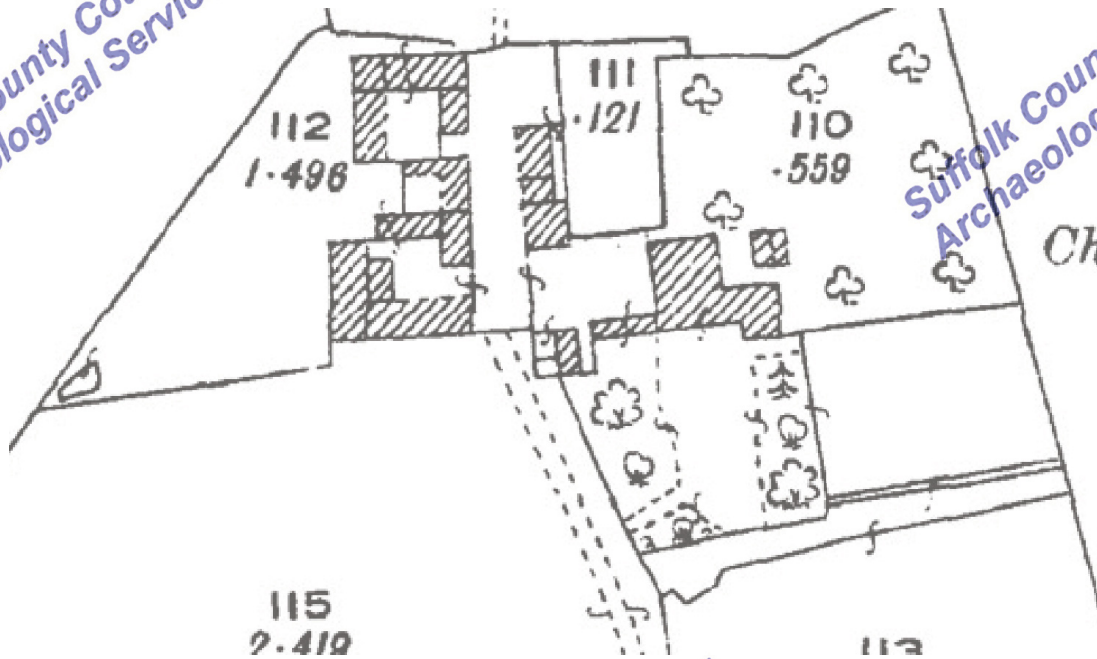
Figure 5

Third edition 25 inch Ordnance Survey of 1927, showing little change since 1904. Photographic and anecdotal evidence suggests the mid-19th century farm complex survived largely intact until its conversion in recent years

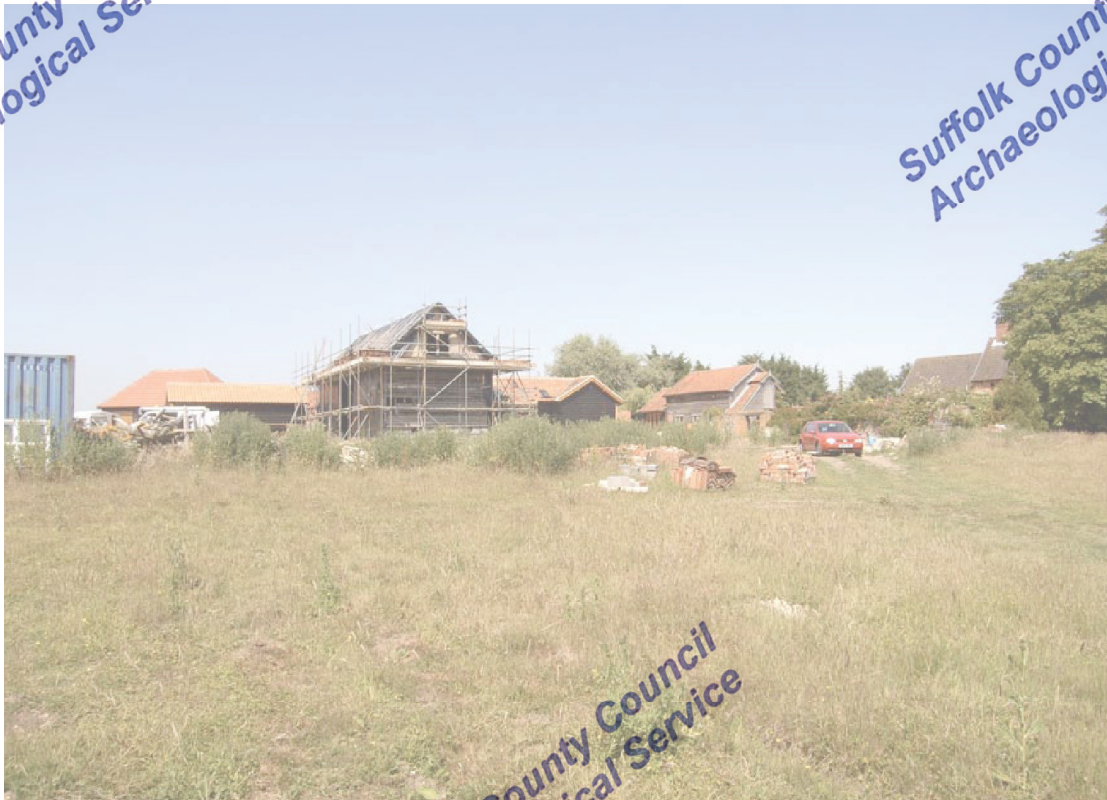
A2.1 General view from south-west, showing house to right with barn in centre & new development in rear

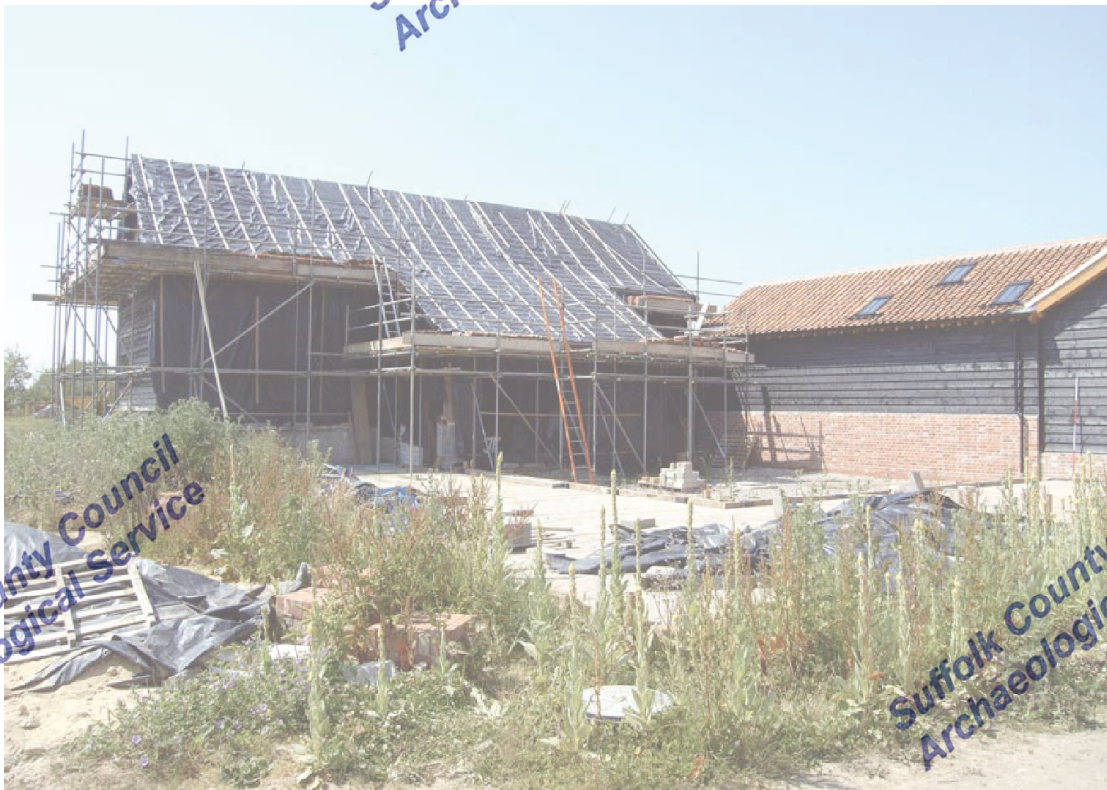
A2.2 Eastern yard from south-east, showing site of demolished southern shed to left

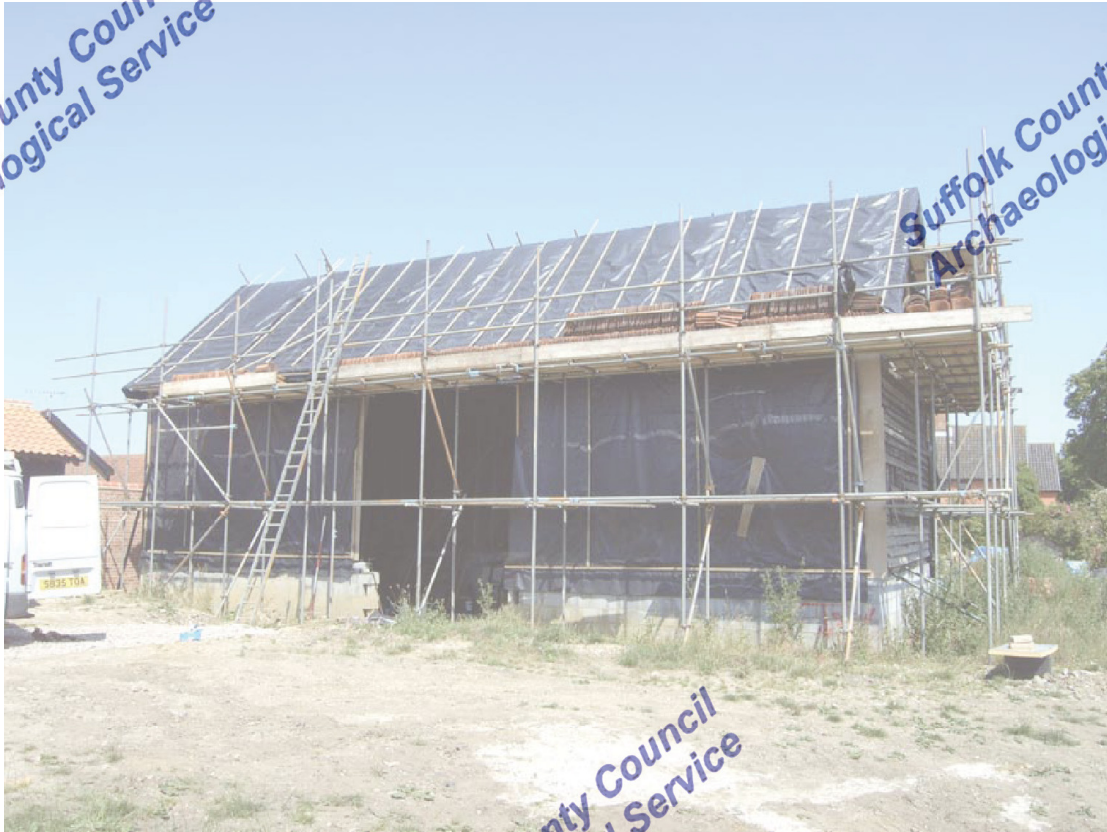
A2.3 External western elevation showing original central entrance

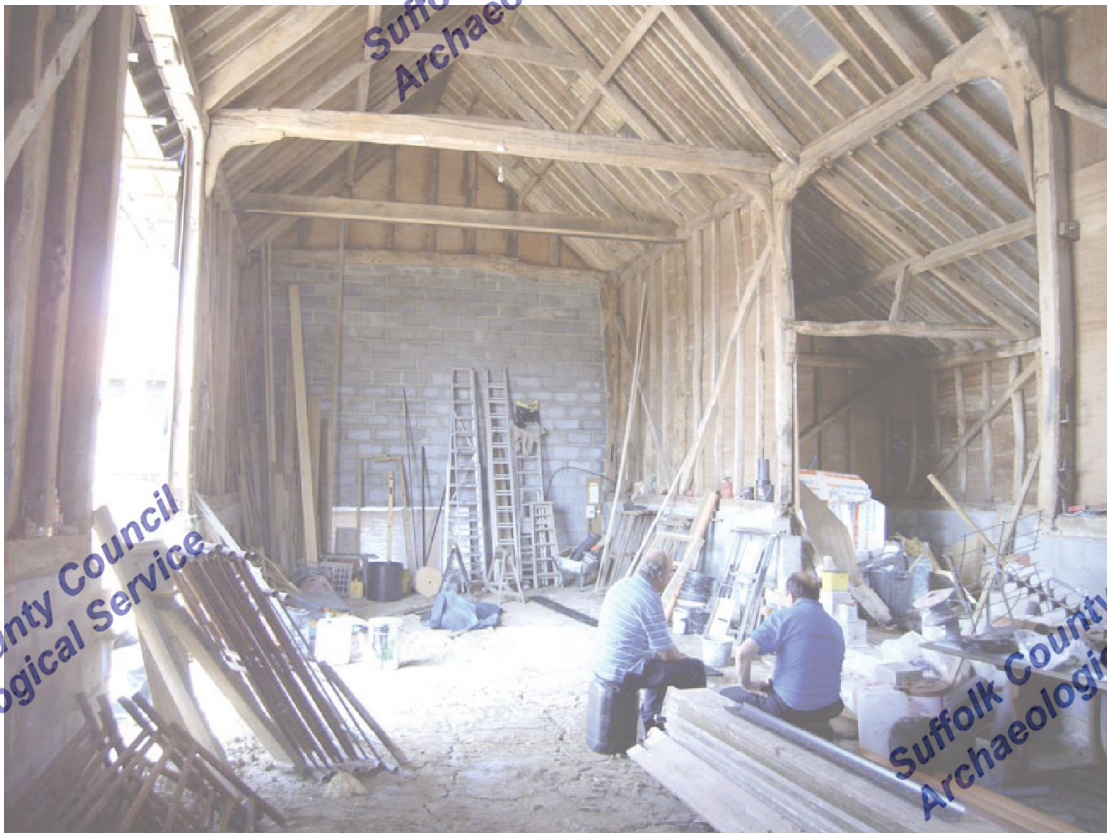
A2.4 General view of barn interior from south showing central entrance to left with recently rebuilt northern gable in rear

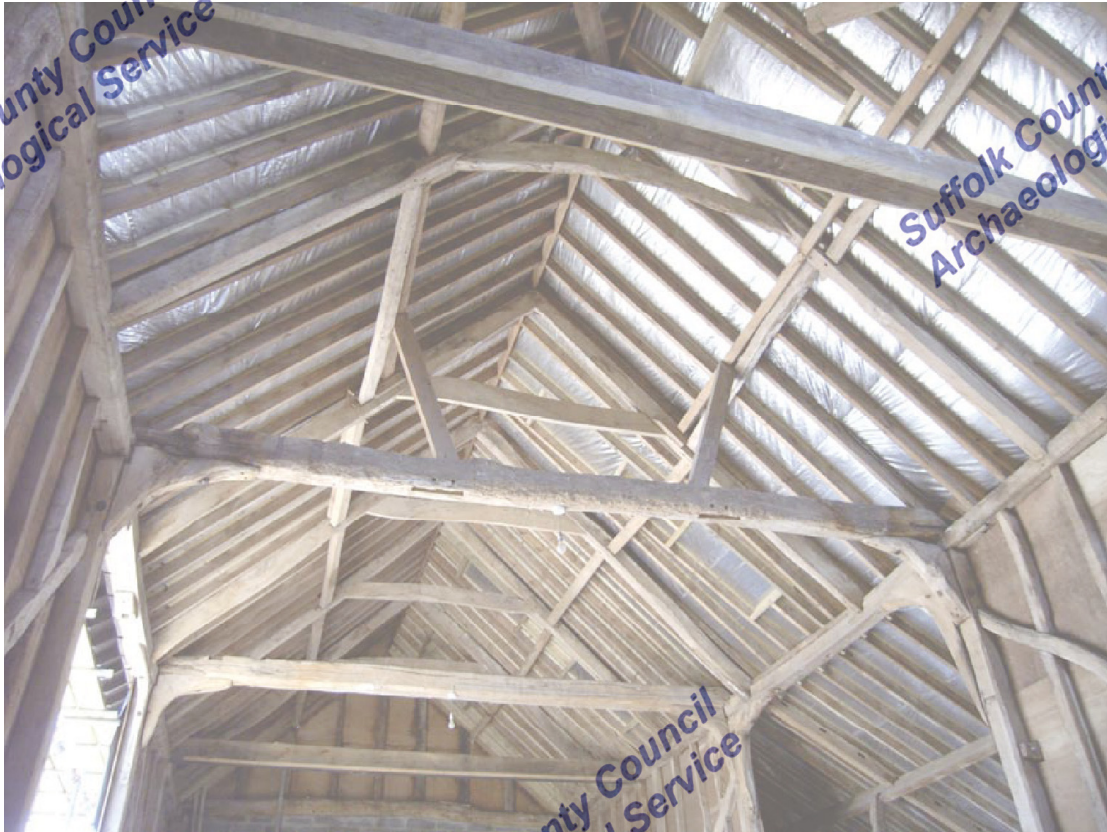
A2.5 Butt-purlin roof structure from south showing re-used tie-beam with arch-brace mortises.

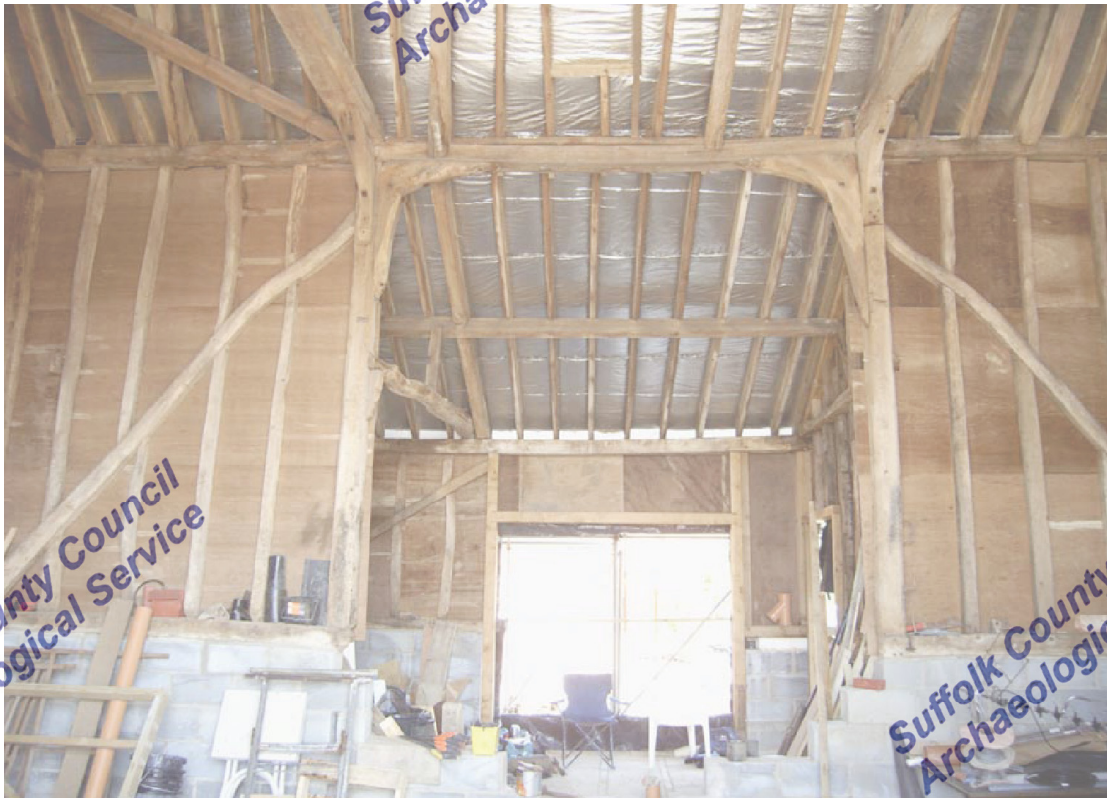
A2.6 Internal eastern elevation of central bay showing access to lean-to porch and position of original external door (jambs and lintel renewed).

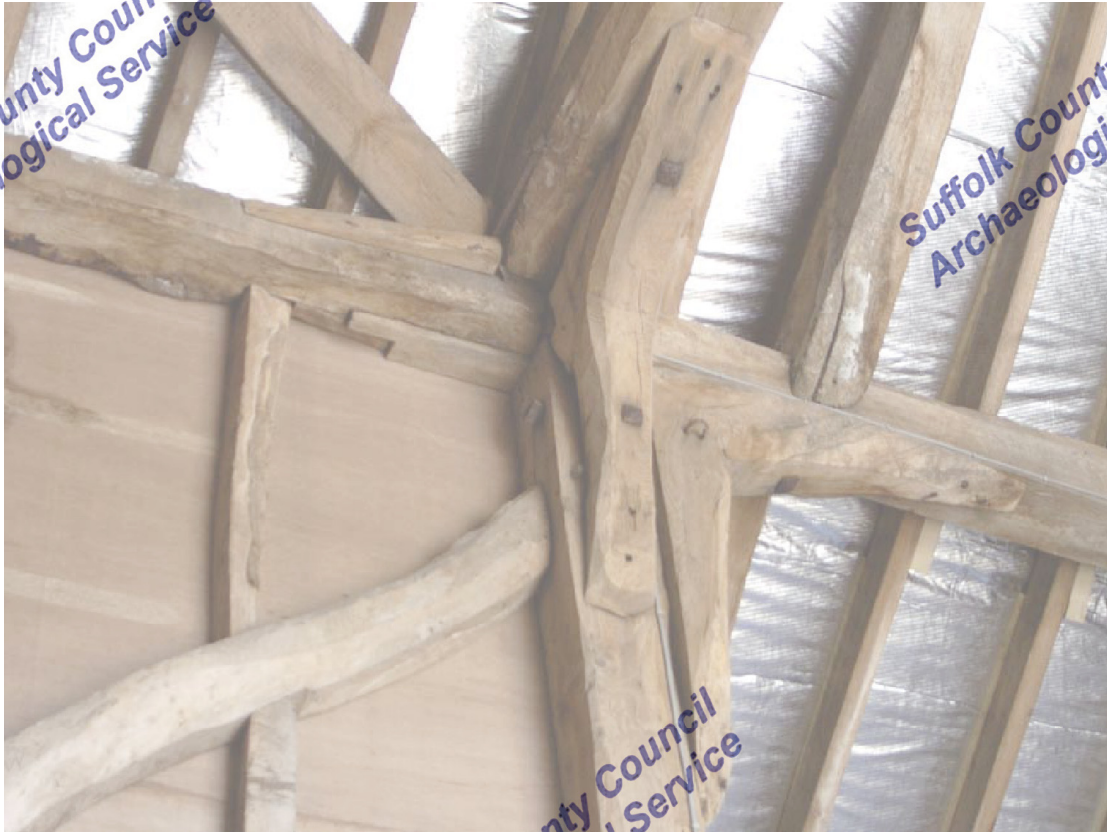
A2.7 Detail of original bolted knee-braces, pegged and tenoned primary brace and face-halved and bladed scarf joint to north of lean-to porch

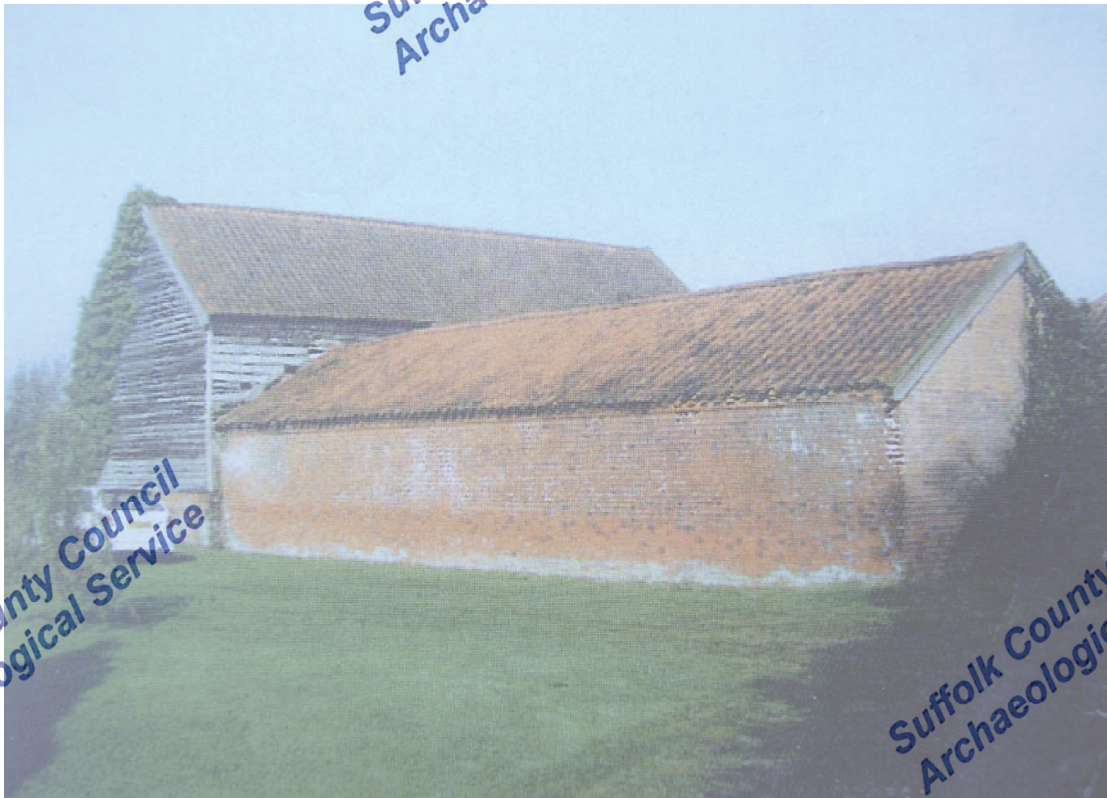
Conversion work on the barn was already well underway at the time of inspection, with substantial areas rebuilt in cement blocks. The shed which formed the southern side of a small cattle yard to the east of the barn had been demolished, but photographs taken prior to demolition (such as A2.8) along with 19th century maps and a number of roof trusses piled nearby suggest that it formed a mid-19th century cattle shelter shed with an open arcade to the north; it extended to approximately 16.75 m in length by 5.5 m in width (55 ft by 18) and consisted of red brick with a pantiled roof of prefabricated roof trusses incorporating iron king posts. The shed and barn appear to have formed a unified and sophisticated 'model farm' of the 1850s or 1860s, but the remaining buildings on the site had been converted or were in an advanced state of conversion at the time of inspection and were no longer recognisable.

A2.8 Exterior of barn and southern yard shed from south-east before demolition (photograph from estate agent brochure in possession of owner)
