Brook Barn, Wortham, Suffolk WTM 046

Historic Building Record

Brook Barn, Mellis Road, Wortham, Suffolk

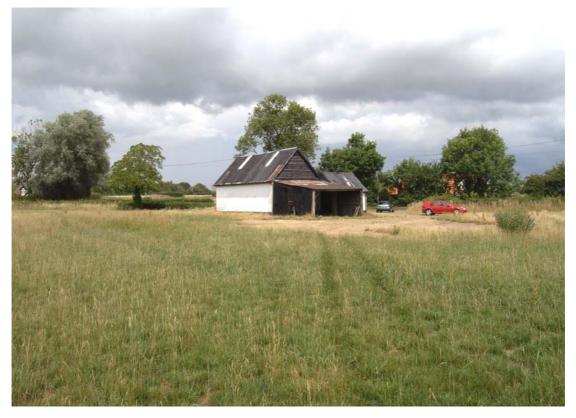
A2.1 General view of site from south-west showing isolated location of barn at field edge

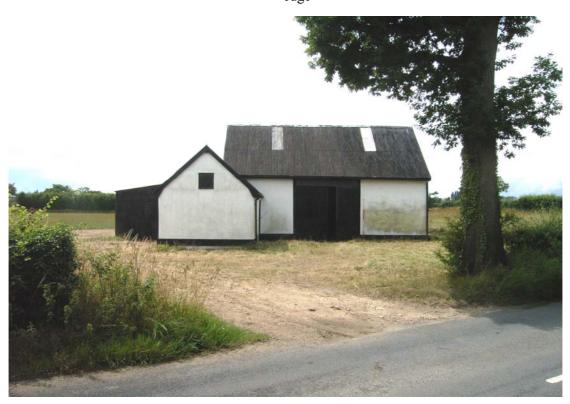
A2.2 General view of barn from Mellis Road to east, showing modern doors to the original barn entrance and the clay-lump shed to the left

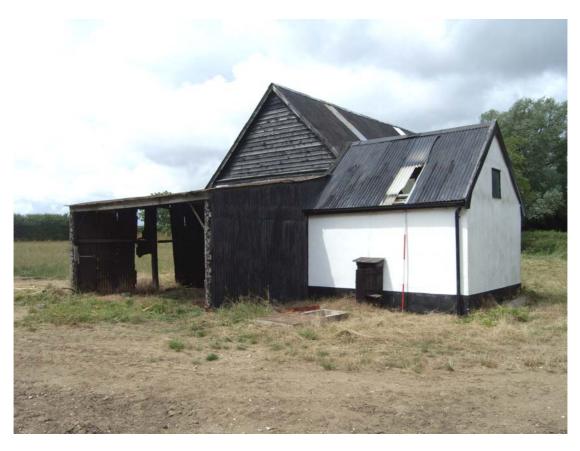
A2.3 Exterior from south-east showing clay-lump shed to right and lean-to shed to left with southern gable of barn in centre

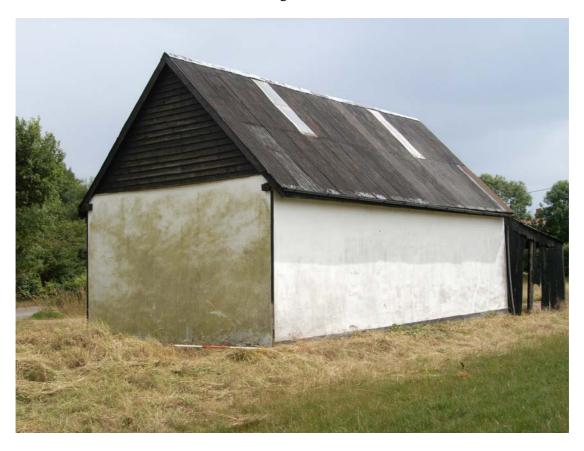
A2.4 Exterior from north-west showing modern render and corrugated iron roofing

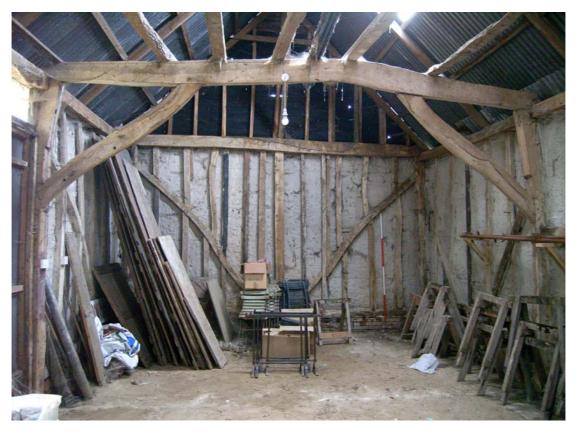
A2.5 General internal view of barn from north showing original arch braces to southern tiebeam, with original chalk floor and primary wall bracing.

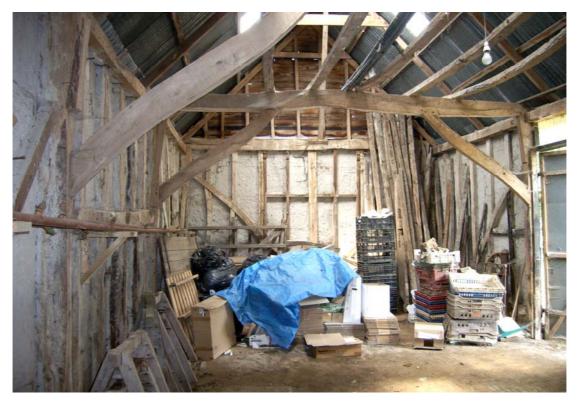
A2.6 General internal view of barn from south showing original arch-braces & central entrance to right. The roof structure is modern but a number of original rafters are lodged on the tie-beams and leaning against the northern gable.

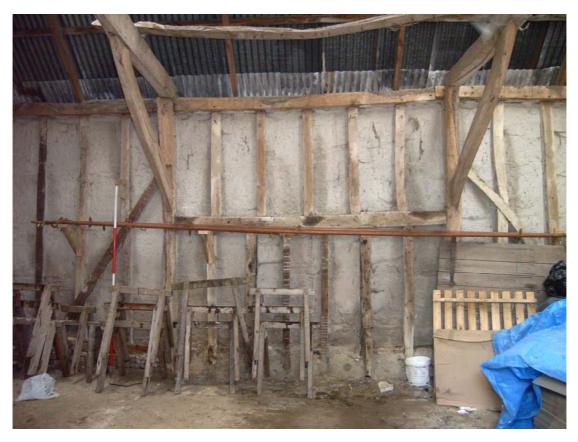
A2.7 Internal bay of western internal elevation showing the original lintel of the rear door (the door now blocked by the central pair of narrow studs, but the jambs intact)

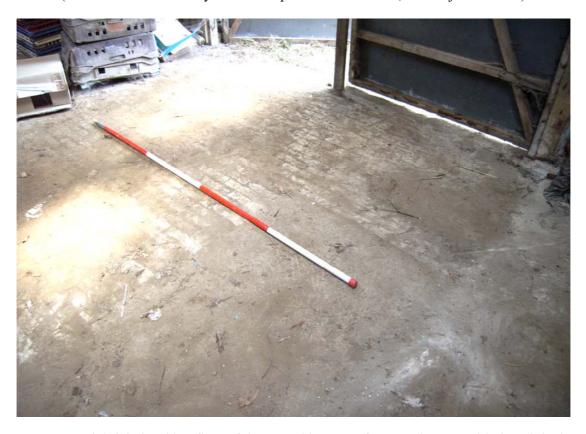
A2.8 Gault brick threshing floor of the central bay seen from south-west, with the original rammed chalk floor of the southern bay to the right
