**St. Andrews Church, Aldringham Cum Thorpe (ARG 015);
Building Recording & Monitoring Report**

SCCAS Report No. 2008/237; Oasis No. suffolkc1-63144

Stuart Boulter
Field Team
Suffolk C.C. Archaeological Service

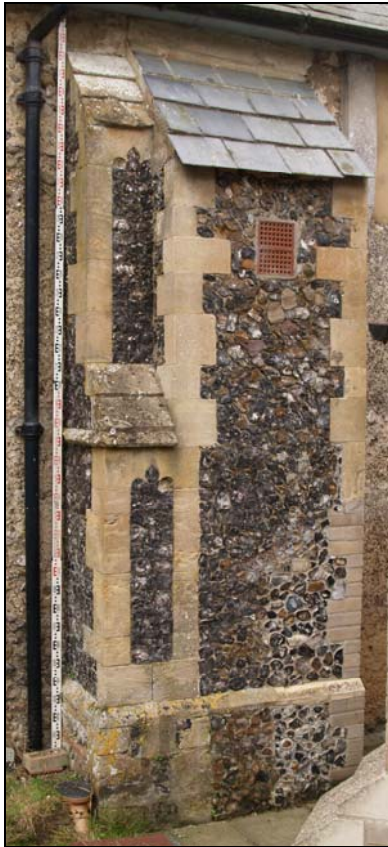
Plate 1 Buttress 0112

At the point which would have marked the junction between the nave and chancel a wide, but shallow, buttress (0112) is present, which is clearly more recent in date than the diagonal buttress (0115) to the east. Incorporating an iron vent, the facing of buttress 0112 had been constructed using closely spaced dark coloured flint forming decorative flushwork panels.

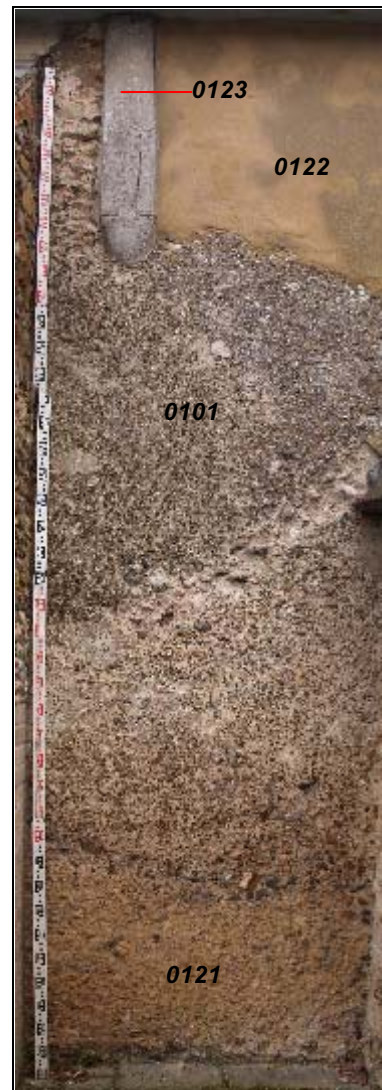
Plate 2 N. nave wall between buttress 0112 & vestry

rich render as the chancel (0101), with a c.1 metre strip (0121) at its base a later patching (Plate 1). A channel cut into this render on line with the roof of the old vestry to the west is evidence that prior to the construction of the new vestry, the old roof had extended down, possibly to form a shed-like storage area or a similar functional facility. While covered with a hard brown render (0122), where visible, the top of the nave wall is seen to be comparable with fabric 0102, to the east. At this juncture there is also another vertical element of the ironwork bracing (0123), again disguised with hard cementitious mortar.

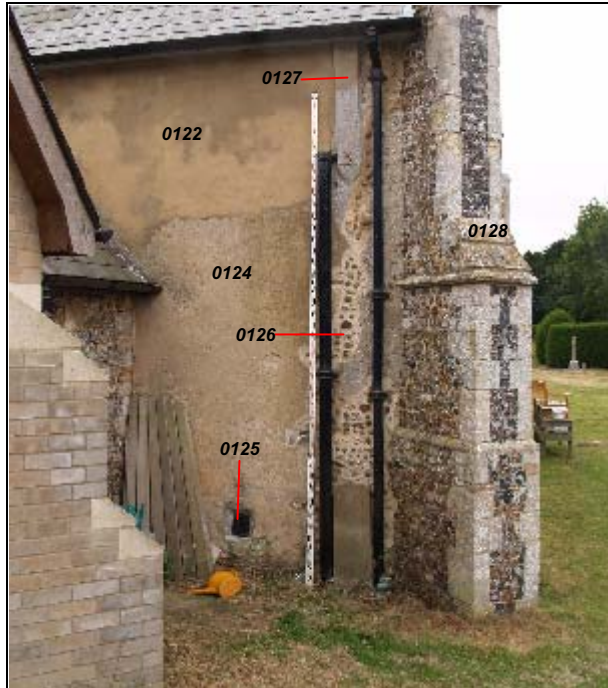
Plate 3 W. end of nave N. wall

To the west of the old vestry, the nave wall is almost entirely covered with render. At the top of the wall this is of the same hard brown type (0122) seen to the east of the vestry, while that lower down is lighter in colour with a higher aggregate content (0124). The lower render appears to post-date the insertion of an iron vent (0125) close to the base of wall. A vertical crack at the western end of the nave wall has been recently filled (0126). The crack itself almost certainly represents the junction between original nave wall fabric and that of the new nave wall and buttresses. The crack/junction in the fabric is mirrored in the west end of the nave south wall. At the western end of the wall there is another of the ironwork bracing (0127) elements covered with cementitious mortar.

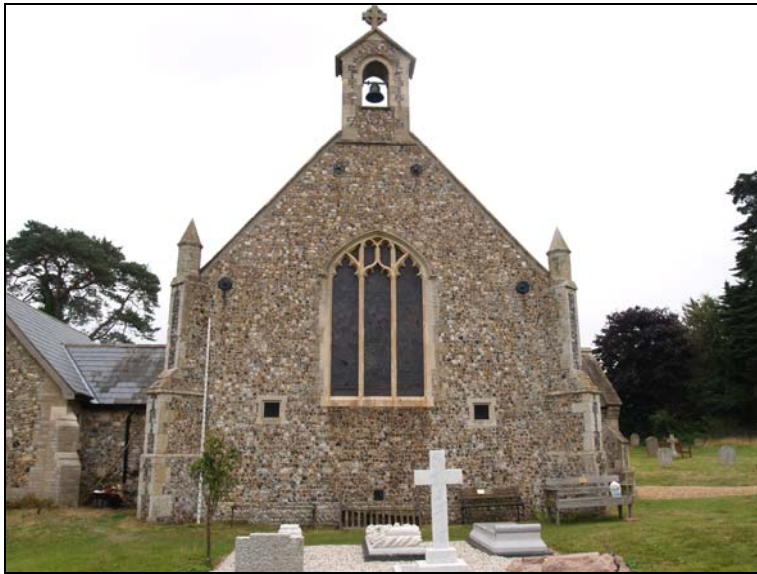
Plate 5 W. wall of nave

The west wall of the nave (Plate 5) is entirely the product of the Victorian rebuilding. The character of the facing (0177) which comprises uniformly sized, closely spaced, poorly coursed, knapped/split white, chocolate brown and dark grey flints is similar to that of the buttresses, further evidence for the latter being refurbished during the Victorian rebuilding. The buttresses at the west end of the nave (0128 & 0159) are topped with brick pinnacles. There is also a bell cote (0178) at the apex of the gable and two ventilation grids (0179 & 0180), similar to those on the north and south walls (0118, 0119 & 0136, 0137 respectively), one either side of the perpendicular style window (0182). A third, smaller iron ventilation grid (0181) is central to the wall towards its base and is similar to 0125 in the north wall and 0153 in the south. The perpendicular style window (0182) is constructed using a combination of limestone and brick dressings.

Four circular iron features (0183 – 0186) occupy a similar position in the wall to those (0173 – 0176) at the east end and are certainly attached to the same horizontal components of the bracing frame.

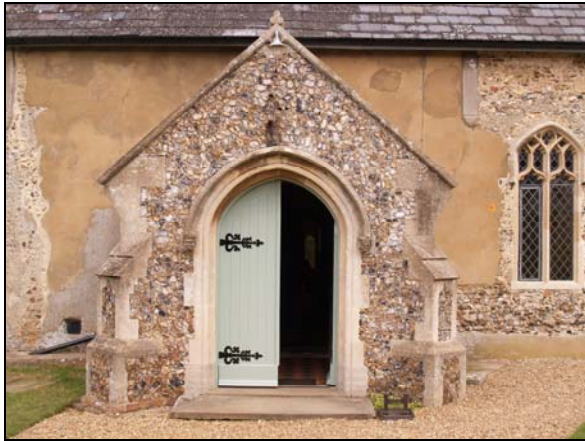
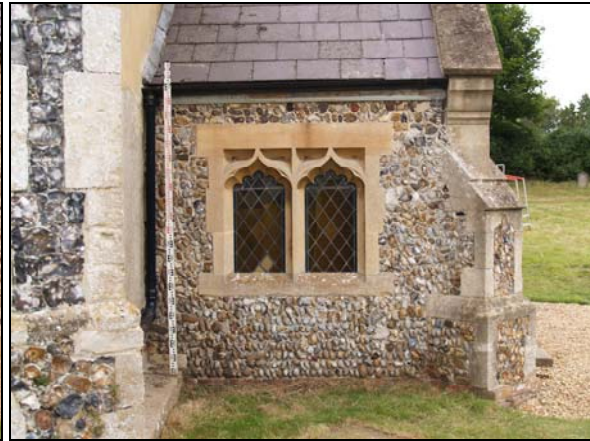
Plate 6 Porch S. wall

Plate 7 Porch W. wall

The porch (0187) (Plates 6 & 7) is faced with uniformly sized, uncoursed knapped flints, some of which are the same chocolate brown variety used in the buttresses and west nave wall. In addition, the limestone dressings on the diagonal porch buttresses are similar in both architectural style and limestone type to those used in the corner buttresses, a further indication that they all form part of the same phase of refurbishment. The hood mould around the exterior doorway has headstops, as does the actual south nave doorway inside the porch. The latter may also be Victorian in date as there is documentary evidence (see discussion) that the nave south doorway was one of the architectural features requiring major consolidation work. There are windows in both side walls of the porch which, given the size of the structure, are large and incorporate heavy limestone dressings. With essentially two-lights divided by perpendicular tracery element, the windows are stylistically broadly in keeping with the rebuilt west nave window.

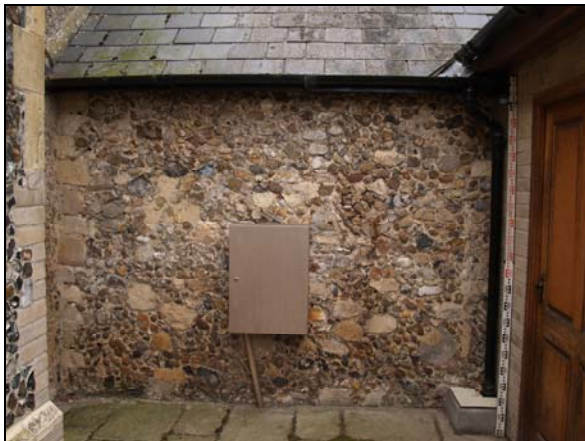
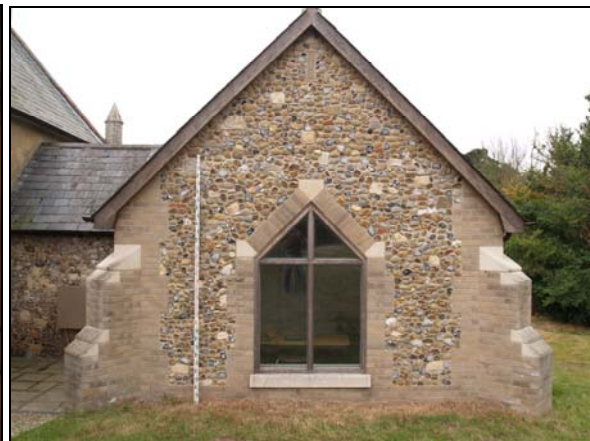
Plate 8 Victorian vestry, E. wall

Plate 9 Modern vestry, E. wall

The vestry complex on the north side of the church comprises the small Victorian vestry (0188) which now effectively forms a link through into the modern building (0189) to the north. Materials used to construct the Victorian vestry include a random mix of rounded flints, sandstone, re-used limestone masonry and over-fired bricks, the latter either wasters from a kiln, or possibly even salvaged from the fabric of an industrial structure (Plate 8). The modern vestry (Plate 9) is constructed using a facing fabric comprising mixed flints and stone broadly similar in character to that of the earlier vestry phase. Dressings are mainly in buff-coloured brick with tooled limestone forming the principle elements.

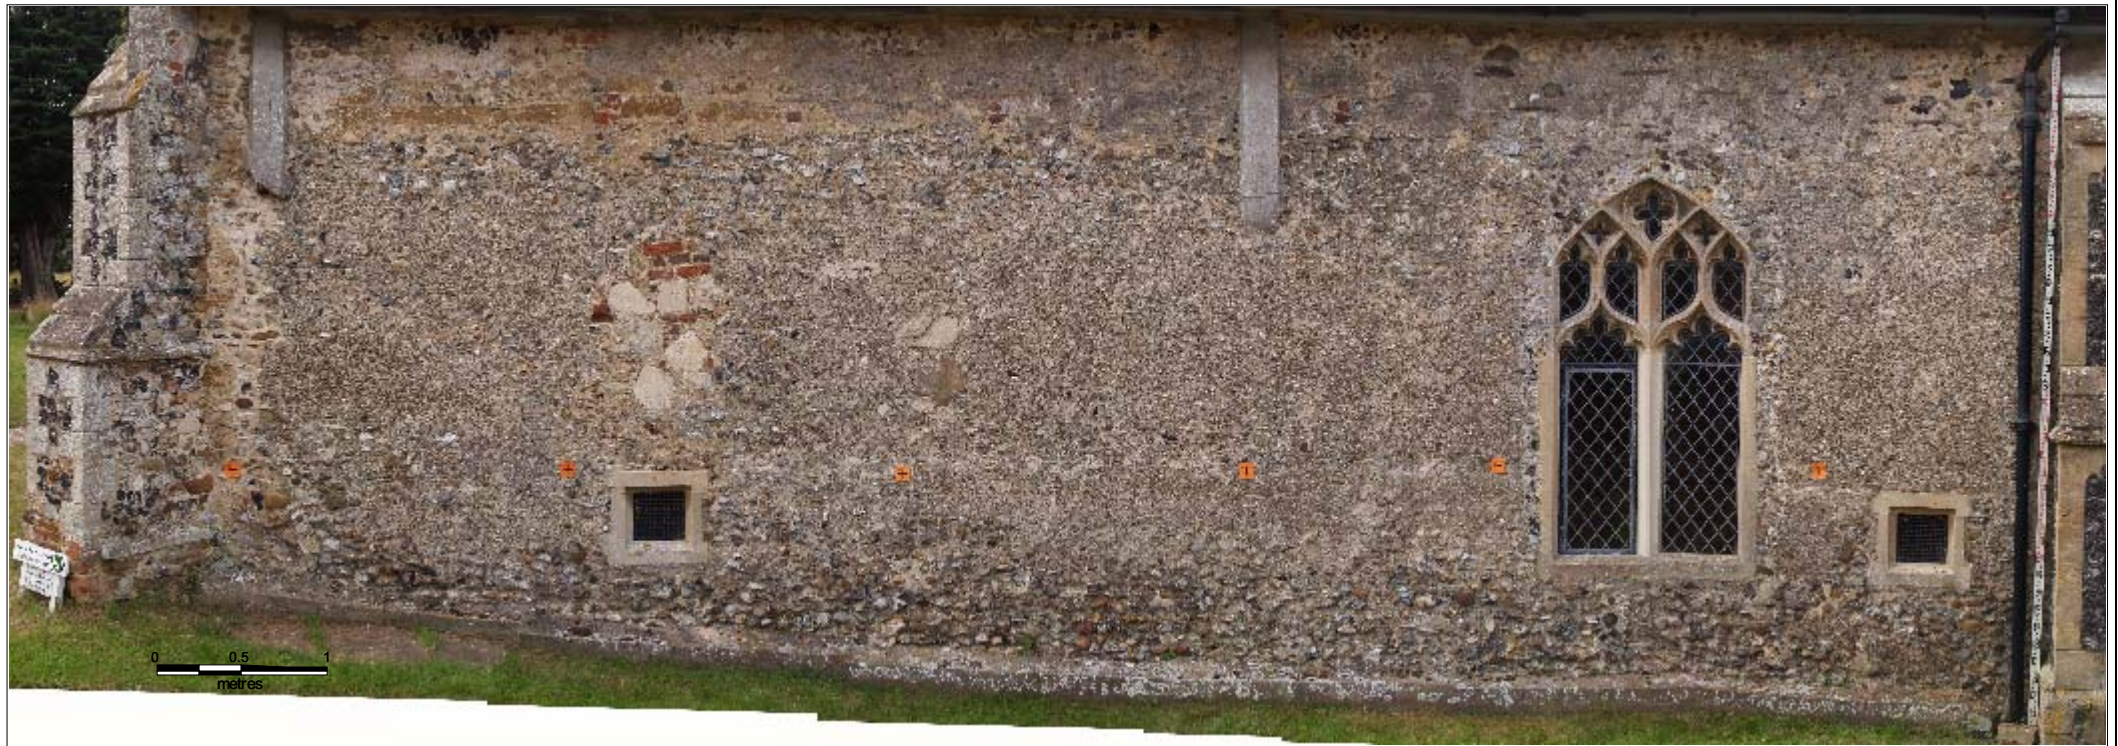
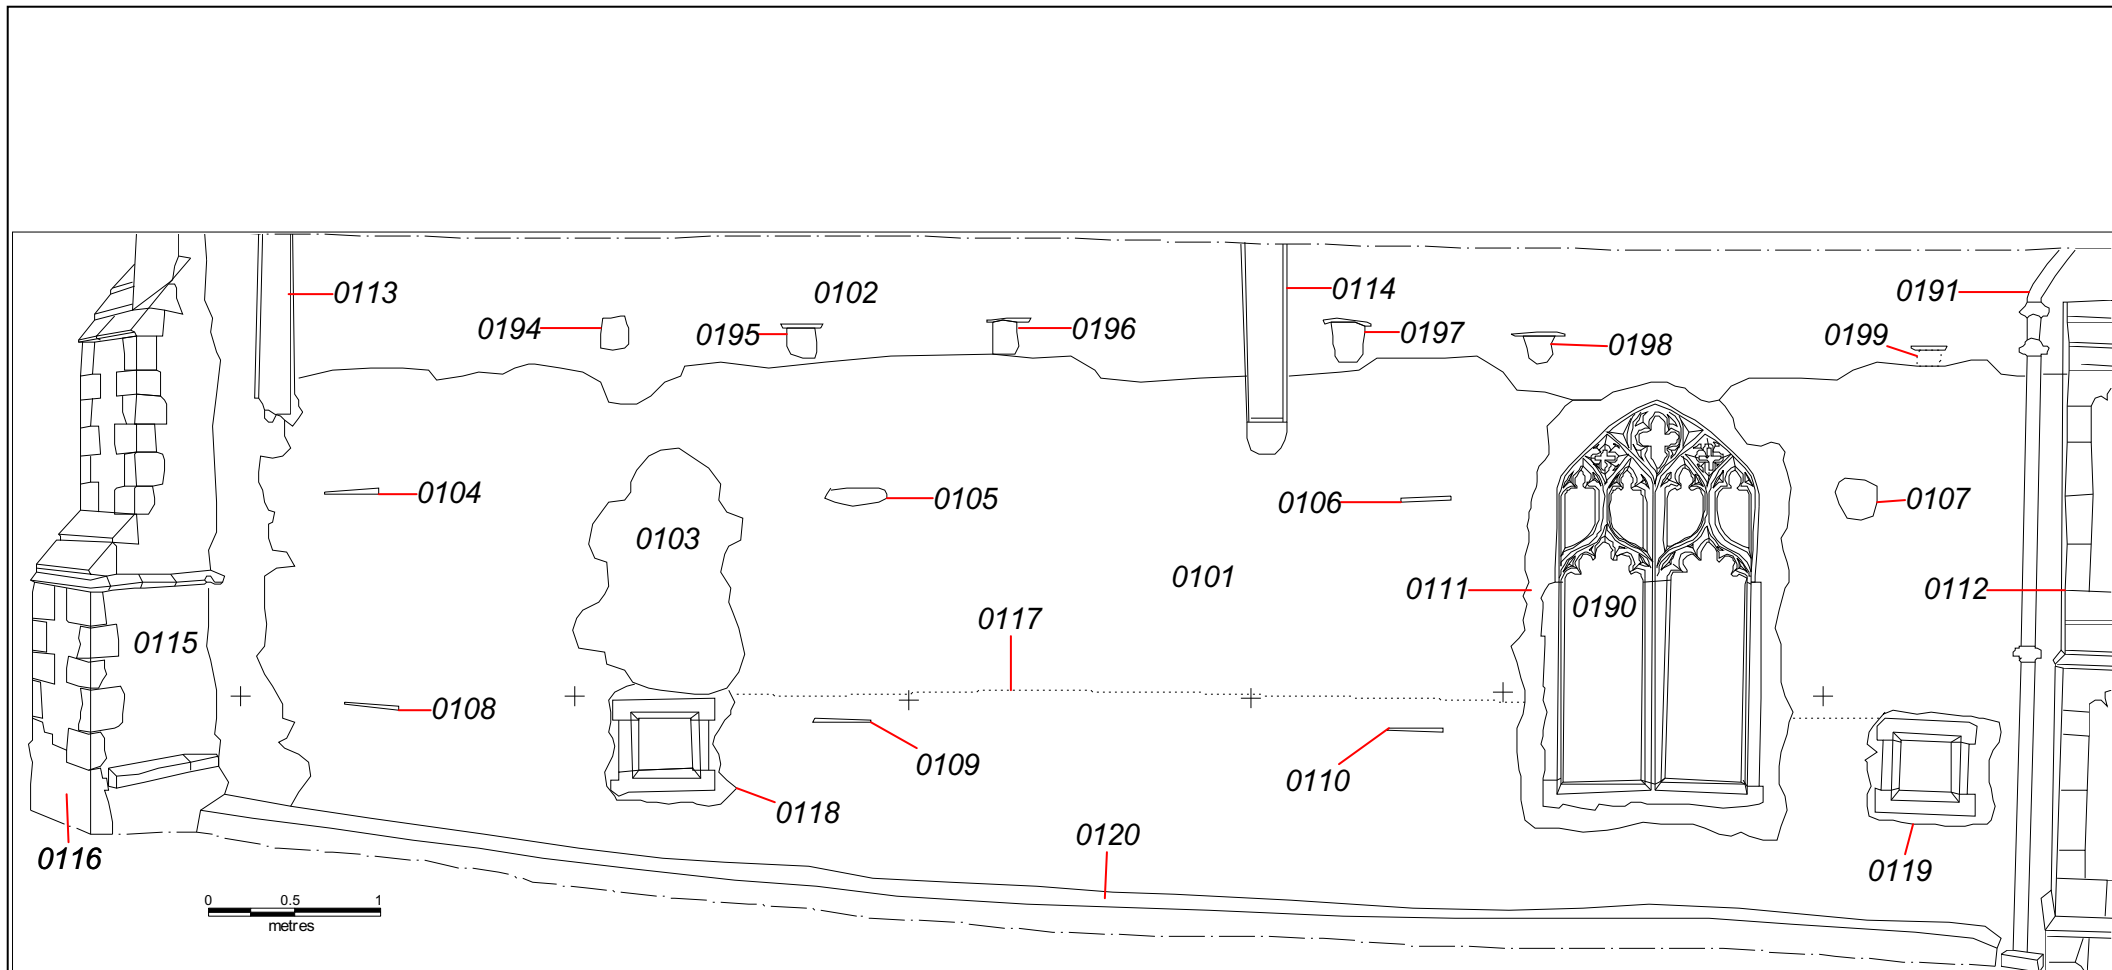
Fig. 2 North chancel wall, annotated elevation

Due to a marked slope of the ground surface down from east to west, the height of the chancel wall varies between c.3.55 metres, to the east, up to c.4.20 metres at the projecting buttress (0112) located at a point that once would have formed the division between nave and chancel. A projecting concrete, or at least concrete covered, plinth (0120) runs the entire length of the chancel from the diagonal buttress (0115) at the east end down to the buttress marking the nave/chancel division (0112). The wall fabric clearly exhibits two distinct phases separated by a relatively regular horizontal junction c.0.80 metres down from the top of the wall. The lower fabric (0101) is characterised by its surface treatment, an applied render with an extremely high aggregate content (predominantly gravel-sized flints). Prior to the weathering out of mortar matrix, the render would almost certainly of presented a more uniform surface. Approximately 80% of wall fabric 0101 has this layer surviving. A distinct horizontal junction in the render (0117) at approximately the height of the surveying crosses was interpreted as the break between two working lifts. The absence of render in a c.0.8 metre strip along the base of the wall may be the result of damp rising behind it or disruption during the construction of plinth (0120). This area provided the opportunity to record the character of the underlying wall face which, at that juncture, comprises very roughly coursed, closely spaced, relatively uniform-sized flint cobbles set in an aggregate rich lime mortar. Structural features contemporary with fabric 0101 are limited to seven putlock holes (0104 - 0110), five of which (0104, 0106 & 0108 - 0110) were recognised only due to the fact that the wooden planks forming their tops project through the render layer which covers the hole itself.

The second wall fabric (0102) forms a c.0.8 metre strip along the top of the wall, usually an indication that the wall has been raised in height. While partially obscured by a coating of buff/yellow (weathered grey locally) mortar, the facing fabric of (0102) is visible, particularly towards the eastern end of the wall. Fabric 0102 was entirely different to 0101 below, comprising a mixture of coralline crag slabs (a local building stone), rounded flint pebbles/cobbles and ferruginous sandstone. Generally the fabric was roughly coursed, but where slabs of coralline crag were used, these did provide more formal coursing on a localised basis. Six putlock holes (0194-0199), topped with roof-tile or flat pieces of ferruginous sandstone, were associated with this fabric.

While heavily remodelled, probably as part of the Victorian refurbishment, and exhibiting later brick patching (0116), buttress (0115) at the east end of the wall appears to be contemporary with wall fabric (0102) and has a clear junction between it and lower wall fabric 0101.

There is one perpendicular style window (0190) in the north chancel wall with a clear insertion line at its junction with wall fabrics 0101 and its associated render coating and upper fabric 0102. However, while elements of the window may be original, there has been some repair and the hood mould is missing. In addition, the fabric (0111) filling the gap between the window masonry and the insertion line has not weathered to the degree that could be expected if it was later medieval in date. This would suggest that at the very least, the window has been reset, probably during the 19th century refurbishment.

Two square vents (0118 & 0119) had been inserted through wall fabric 0101, probably as part of the 19th century alterations.

Immediately above vent 0118 there is an area of inserted fabric (0103) comprising reused limestone masonry and red brick. The shape of the blocked area was relatively irregular and quite small. It is unclear whether this represents patching or the actual blocking of an architectural feature such as a small lancet window.

Two vertical elements (0113 & 0114) of the extensive iron bracing structure around the top of the nave and chancel walls extend through to the external wall face and have been disguised with hard grey cement. That to the east (0113) has lost part of the lower cementitious covering exposing rusted ironwork at its base.

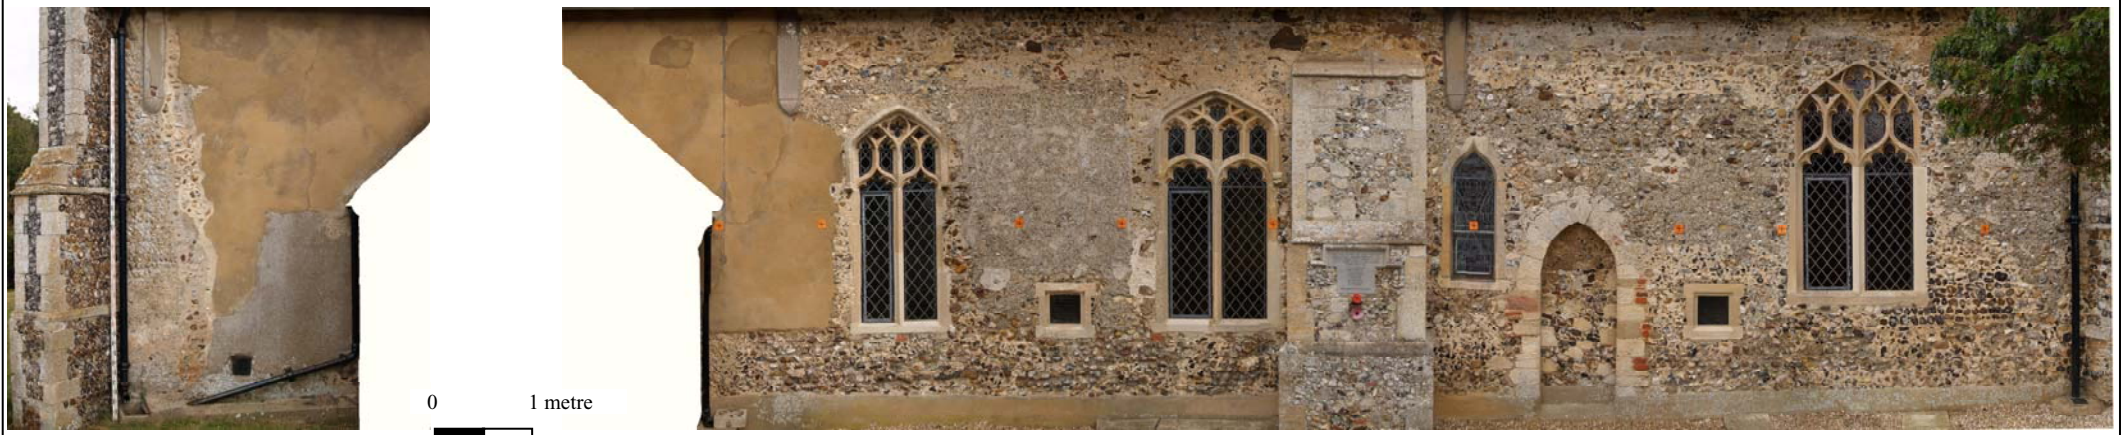
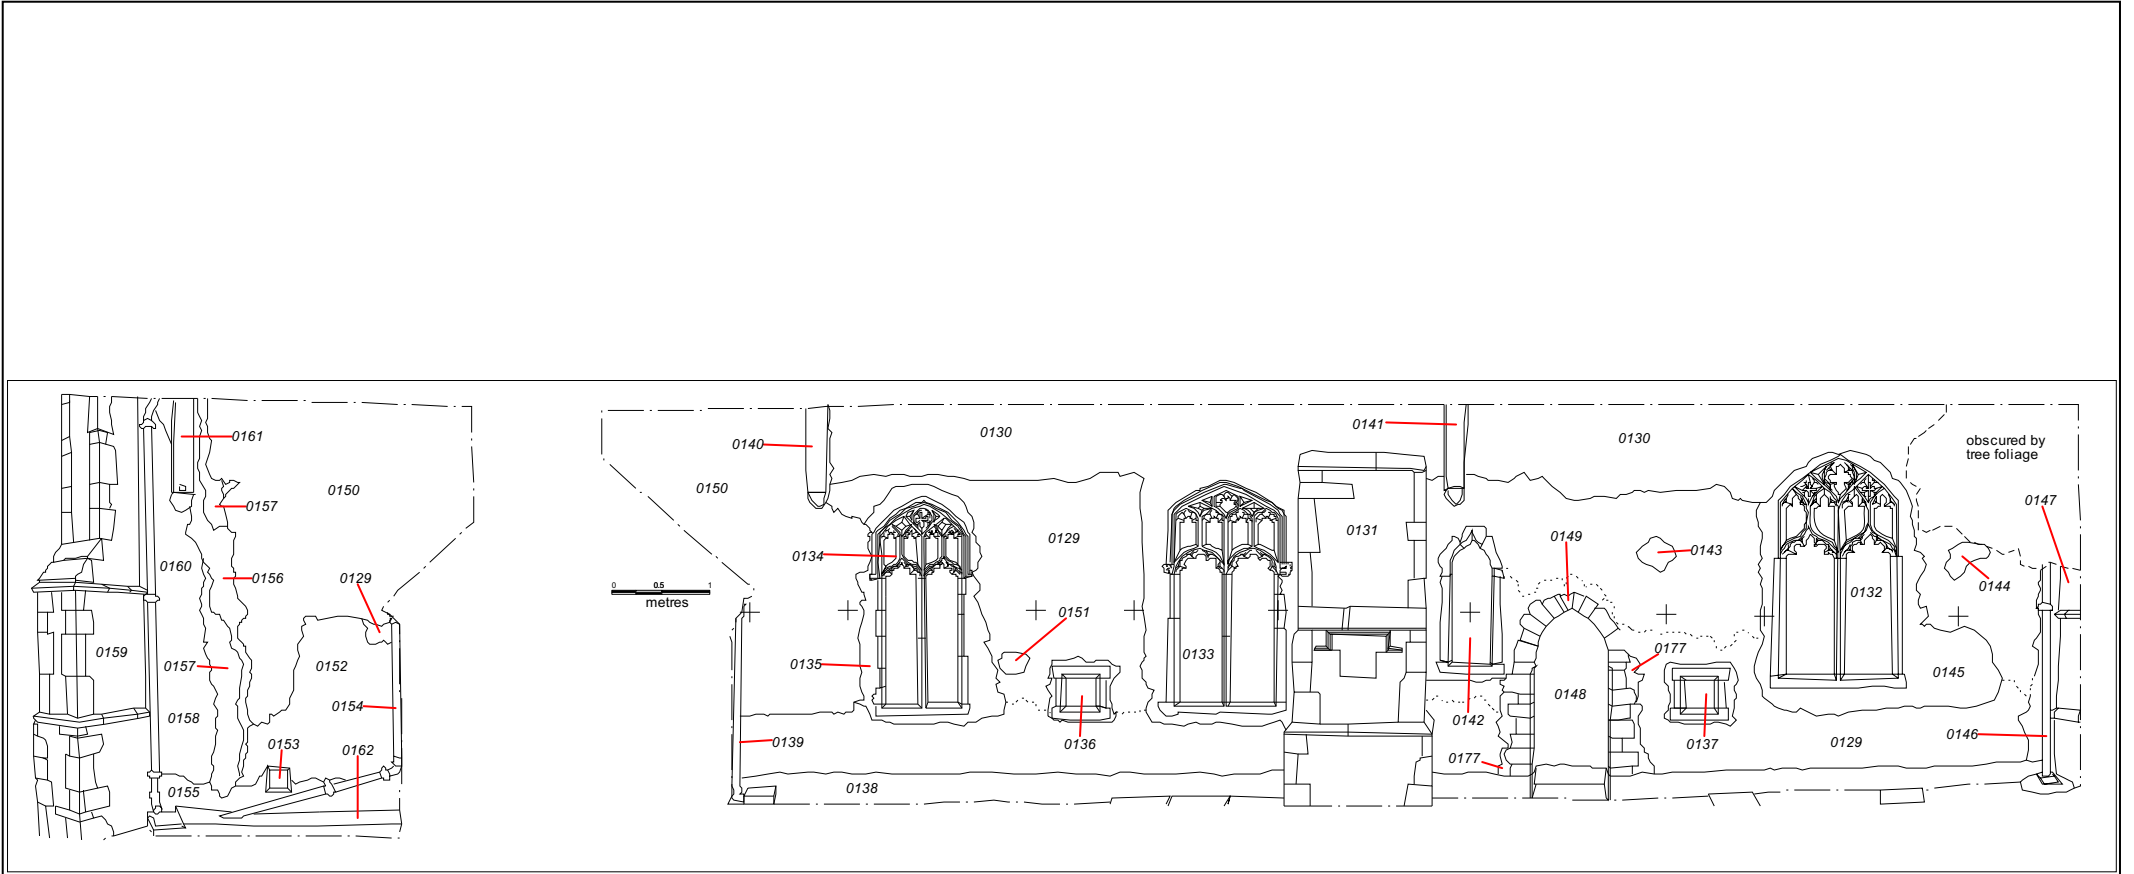
Fig. 3 South nave & chancel wall, annotated elevation

The principle two components of the wall fabric of the nave and chancel south wall are similar to those recorded in the chancel north wall. While there is no basal plinth on the south side, east of the porch, a strip of hard cementitious render (0138) had been applied to a height of c.0.30 metres, running from the east end of the chancel to the east wall of the porch. To the west of the porch there was a basal plinth (0162), similar to that on the north side of the chancel.

The main wall fabric (0129), equivalent to 0101 in the north chancel wall, comprises very roughly coursed flint cobbles set in a aggregate rich lime mortar. Clearly, this phase of wall had once been covered with the same aggregate rich render as the north wall, but it has not survived to the same extent. The lower part of the wall has no surviving render of this type and has locally been coated/repointed with a chalky mortar similar and possibly contemporary with that facing the c.0.80 strip of fabric (0130) above 0129, the result of the heightening of the nave/chancel walls.

Three blocked putlock holes are visible in wall fabric 0129, two in the chancel wall (0143 & 0144) and one in the nave (0151). Two other architectural features may be

contemporary with the lower wall fabric 0129, the priest's door (0149), now blocked with fabric 0148, and the adjacent ogee arched window (0142). However, if these are contemporary with fabric 0129, they have at least undergone some alteration and, in the case of the doorway, been partially reset, the latter evidenced by the insertion line and brick infilling (0177) around the jambs.

Upper wall fabric 0130 is similar in character to that (0102) on the north side of the building and comprises a mixture of coralline crag slabs, rounded flint pebbles/cobbles and ferruginous sandstone. Again, the fabric exhibits rough coursing, which is more pronounced in the areas where slabs of coralline crag have been used. Buttress 0147 at the eastern end of the wall is thought to be contemporary with upper wall fabric 0130, although undergoing refurbishment during the 19th century rebuilding, while 0159, to the west may be entirely Victorian in date.

Fabric 0130 continued down around perpendicular window 0133 with which it must be considered to be contemporary. The other two perpendicular windows, 0134 to the west and 0132 to the east, show clear insertion lines. In the case of 0134, the window has been inserted entirely into lower wall fabric 0129, and the associated infill (0135) around the window is consistent with it being broadly contemporary with adjacent window 0133, although the tracery is not identical. Window 0132 at the eastern end of the wall has an insertion line which runs through both the upper and lower wall fabrics 0129 and 0130. Similarly to window 0190 in the north chancel wall, the hood mould is missing, some of the tracery has been replaced and the infill around the window (0145) does not exhibit the weathering characteristics that could be expected if it had been subjected to centuries of exposure. It is on this basis,

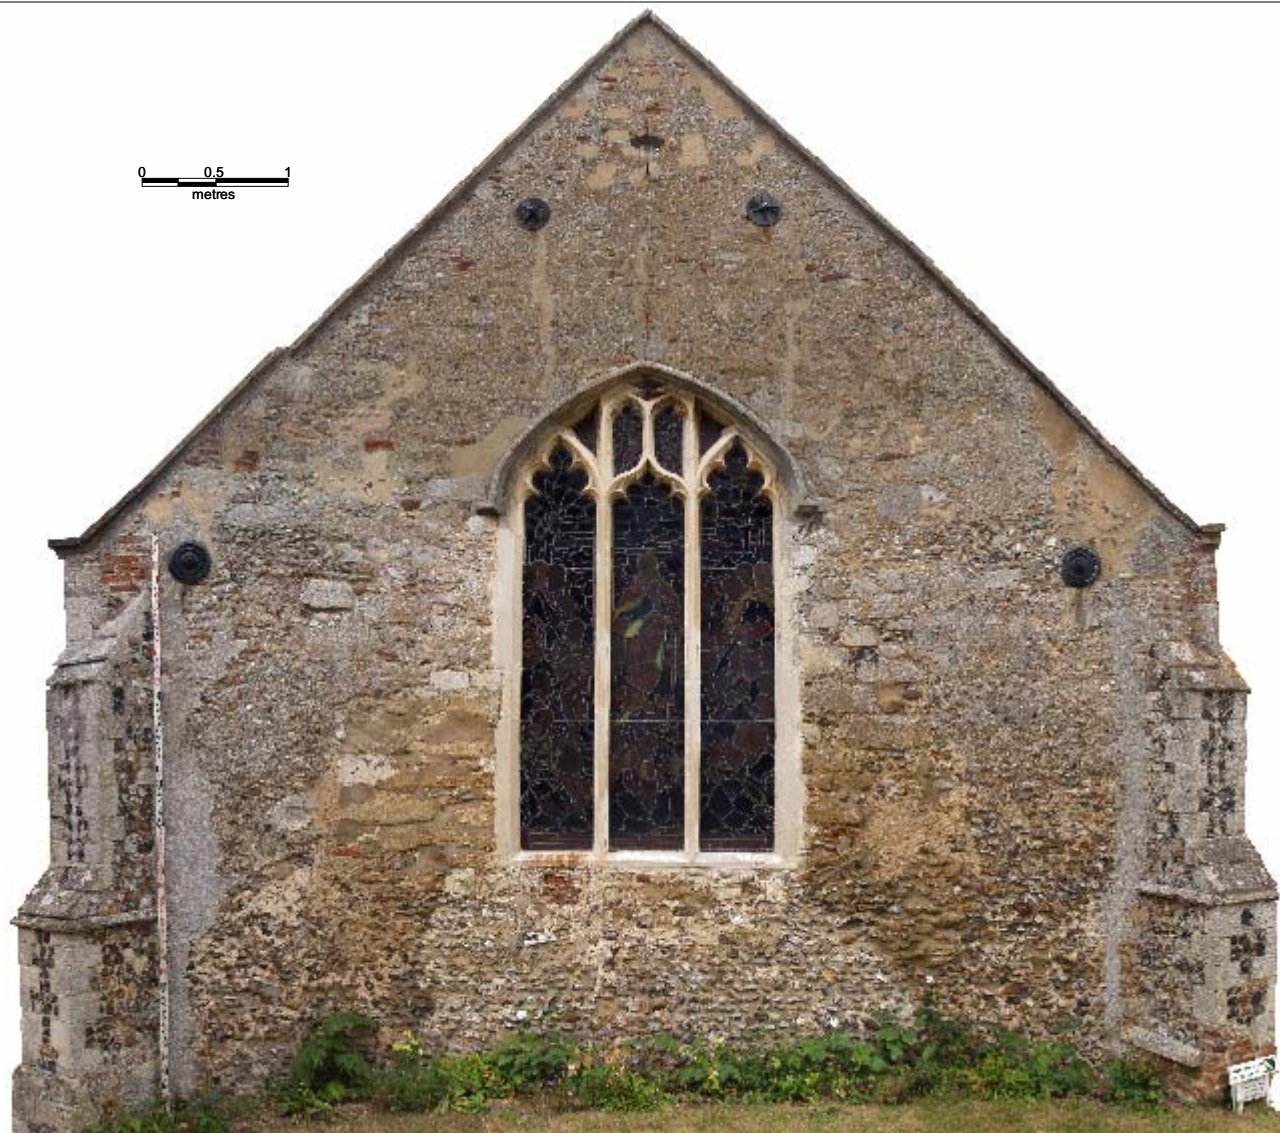
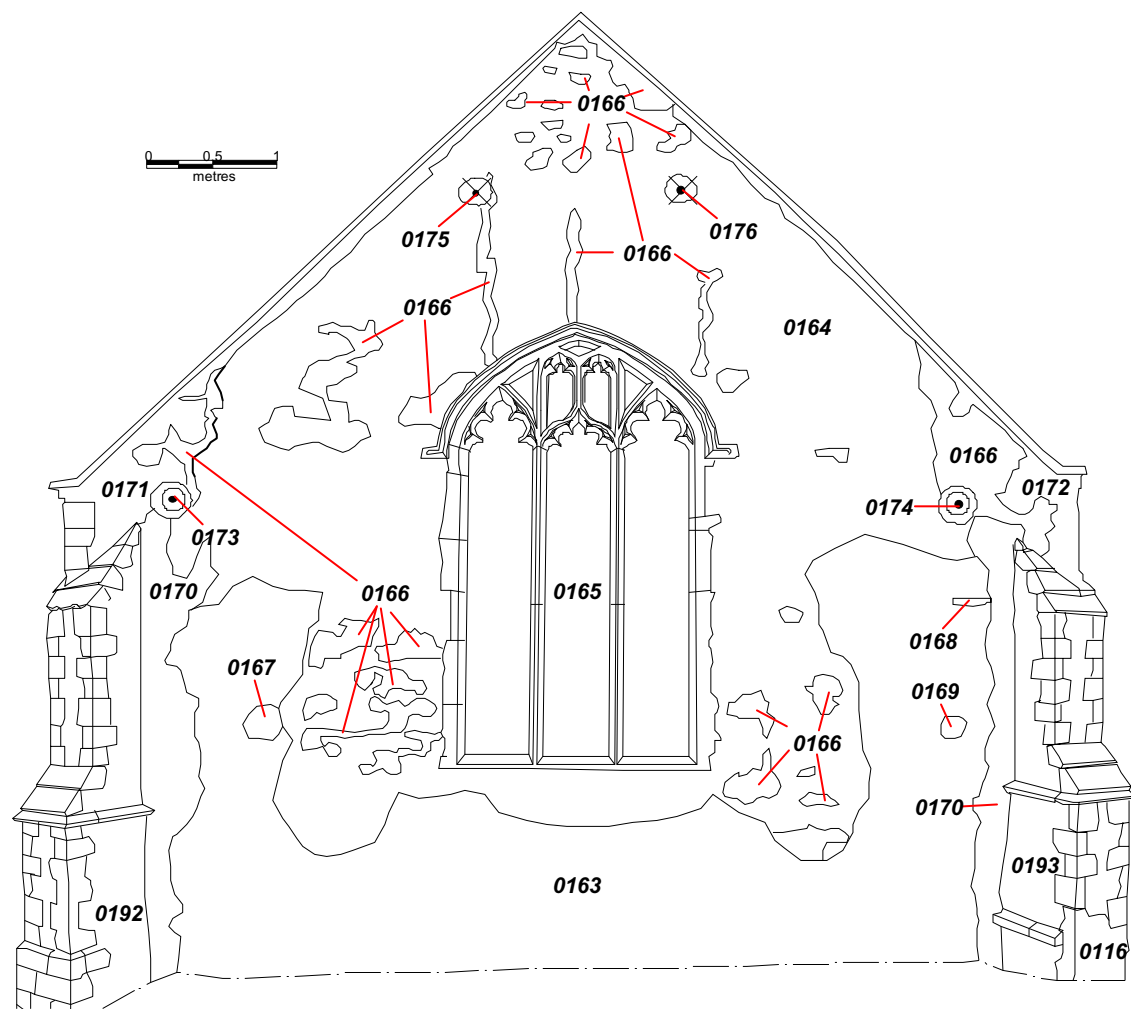
Fig. 4 East chancel wall, annotated elevation

Original wall fabric (0163), comparable to that forming the best part of the lower c.3.00 metres of the north and south walls (0101 & 0129), is present as a c.1.00 metres high strip along the base of the wall, rising up to c.3.00 metres either side of the window. Two rounded lobes of the upper fabric (0164) projected down into 0163, one each side of the window. The aggregate-rich render extensively on the north wall and to a lesser extent on the south wall is present over 0164, but only in small areas of the wall at a height of between 2.00 and 3.00 metres either side of the window. Below this, the facing of fabric 0163 projects through at least three phases of localised repointing and can be seen to comprise roughly coursed flint pebbles, with the coursing more distinct immediately below the window in the area of heaviest repointing, possibly indicating some additional patching. Three putlock holes (0167 - 0169) were recorded in fabric 0163. The lower two, 0167 & 0169, had been blocked with mortar, while the third (0168) at a higher level above 0169, was marked by a horizontally placed roof-tile in the facing fabric.

Secondary wall fabric 0164, comparable to 0102 in the north wall and 0130 in the south, formed the entire gable end and continued down in strips either side of the large perpendicular window (0165) with which it seemed to be contemporary. While somewhat patched locally with recent hard brown mortar (0166), and with large areas obscured with a layer of mortar that may be contemporary with the wall itself, it was still possible to see that slabs of coralline crag had been used extensively throughout, along with flint pebbles and occasional ferruginous sandstone fragments and exotic

clasts. The north-east and south-west diagonal buttresses (here numbered 0193 & 0192 respectively) have a clear junction with 0163 fabric which has been filled with hard grey cement mortar (0170). While the buttresses are thought to be contemporary with the second phase wall fabric 0164, they have almost certainly undergone refurbishment during the 19th century rebuilding and even later patching in brick (0116). All four of the corner diagonal buttresses described in the text are similar in character. Flushwork panels on the front use predominantly dark grey knapped flint, while knapped chocolate brown flint seems to have been deliberately selected for the side panels. Similar chocolate coloured flint has been used in the construction of the nave west wall and in patchings (e.g. 0145 in the south wall). It is this, along with near pristine state of the limestone dressings, exhibiting precise unweathered edges, which has been seen as evidence to suggest that they owe their present condition to the Victorian rebuilding. However, the localised presence of

Also attributed to the 19th century rebuilding are the four circular iron features (0173 – 0176) which form part of the structural bracing frame, elements of which project from all of the four main walls of the church.

The small areas of brick (0171 & 0172), above the buttresses, are contemporary with the insertion of the ironwork.

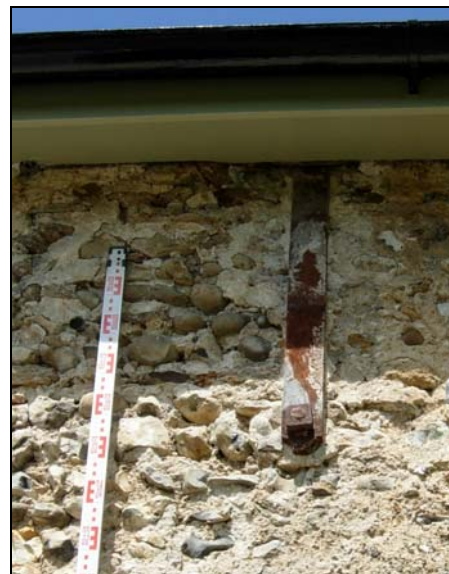
Plate 13 Detail of wall tie 0140

The removal of the cementitious covering over the iron wall ties revealed that roof-tiles nailed into the wall had been used to build out around the ironwork prior to the introduction of the formal cement render. On the north side of the church all of the iron ties extended for a similar distance down the wall, while on the southern side, the end ties were c.0.2 metres longer than the middle two. Plate 13 shows iron tie 0140 after the removal of its tile and render covering.

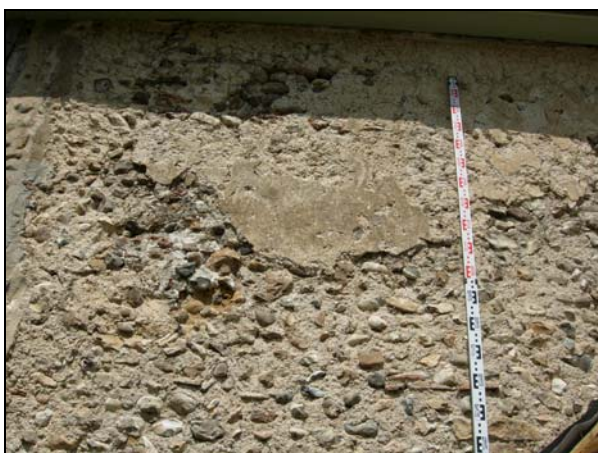
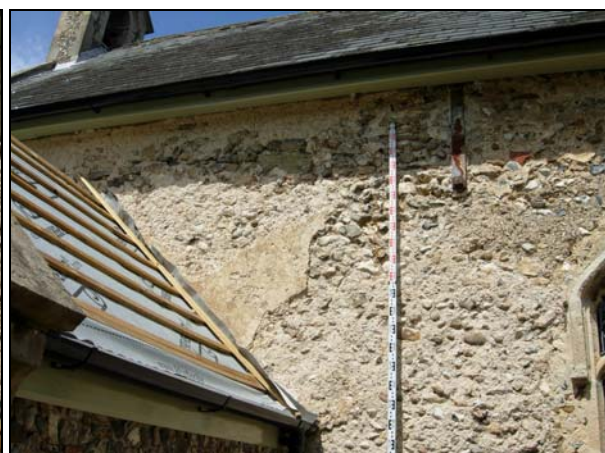
Removal of the hard brown render coat (0150) from around the porch exposed the continuation of surface treatment layer 0129 and the remnants of another phase of applied lime render (0200) which included areas where its formal face remained intact (Plates 14 & 15). Given that this layer clearly extends over medieval fabric and the post-1842 rebuilt fabric (0201) above the porch, the extent of which was both visible in the face of the wall and could be inferred from the sketch drawing of c.1842 (Plate 17), then it must be contemporary or later than the major Victorian rebuild.

Plate 14 Detail of south wall west of porch

Plate 15 Detail of south wall east of porch

Wall fabric 0201 was roughly coursed and included flints, sandstone and occasional tile fragments. The junction between fabric 0201 and the medieval wall fabric 0129 below essentially continues the line of that between the two medieval fabrics (0130 & 0129) to the west. If the identification of fabric 0201 as a component of the Victorian rebuild is correct, it would suggest that the 19th century demolition/collapse had stopped at this point, possibly due to it being a line of weakness. This interpretation is consistent with the evidence provided by the sketch drawing of 1842 (Plate 17), although the degree of accuracy presented in this drawing is unknown. Alternatively 0201 could be a continuation of medieval fabric 0130, but unfortunately this could not be ascertained with any degree of certainty during the on-site investigations.
