ARCHAEOLOGICAL BUILDING SURVEY REPORT

St Bartholomew's Chapel, Sudbury SUY 002

A REPORT ON THE BUILDING SURVEY, 2004

David Gill
Field Team
Suffolk C.C. Archaeological Service

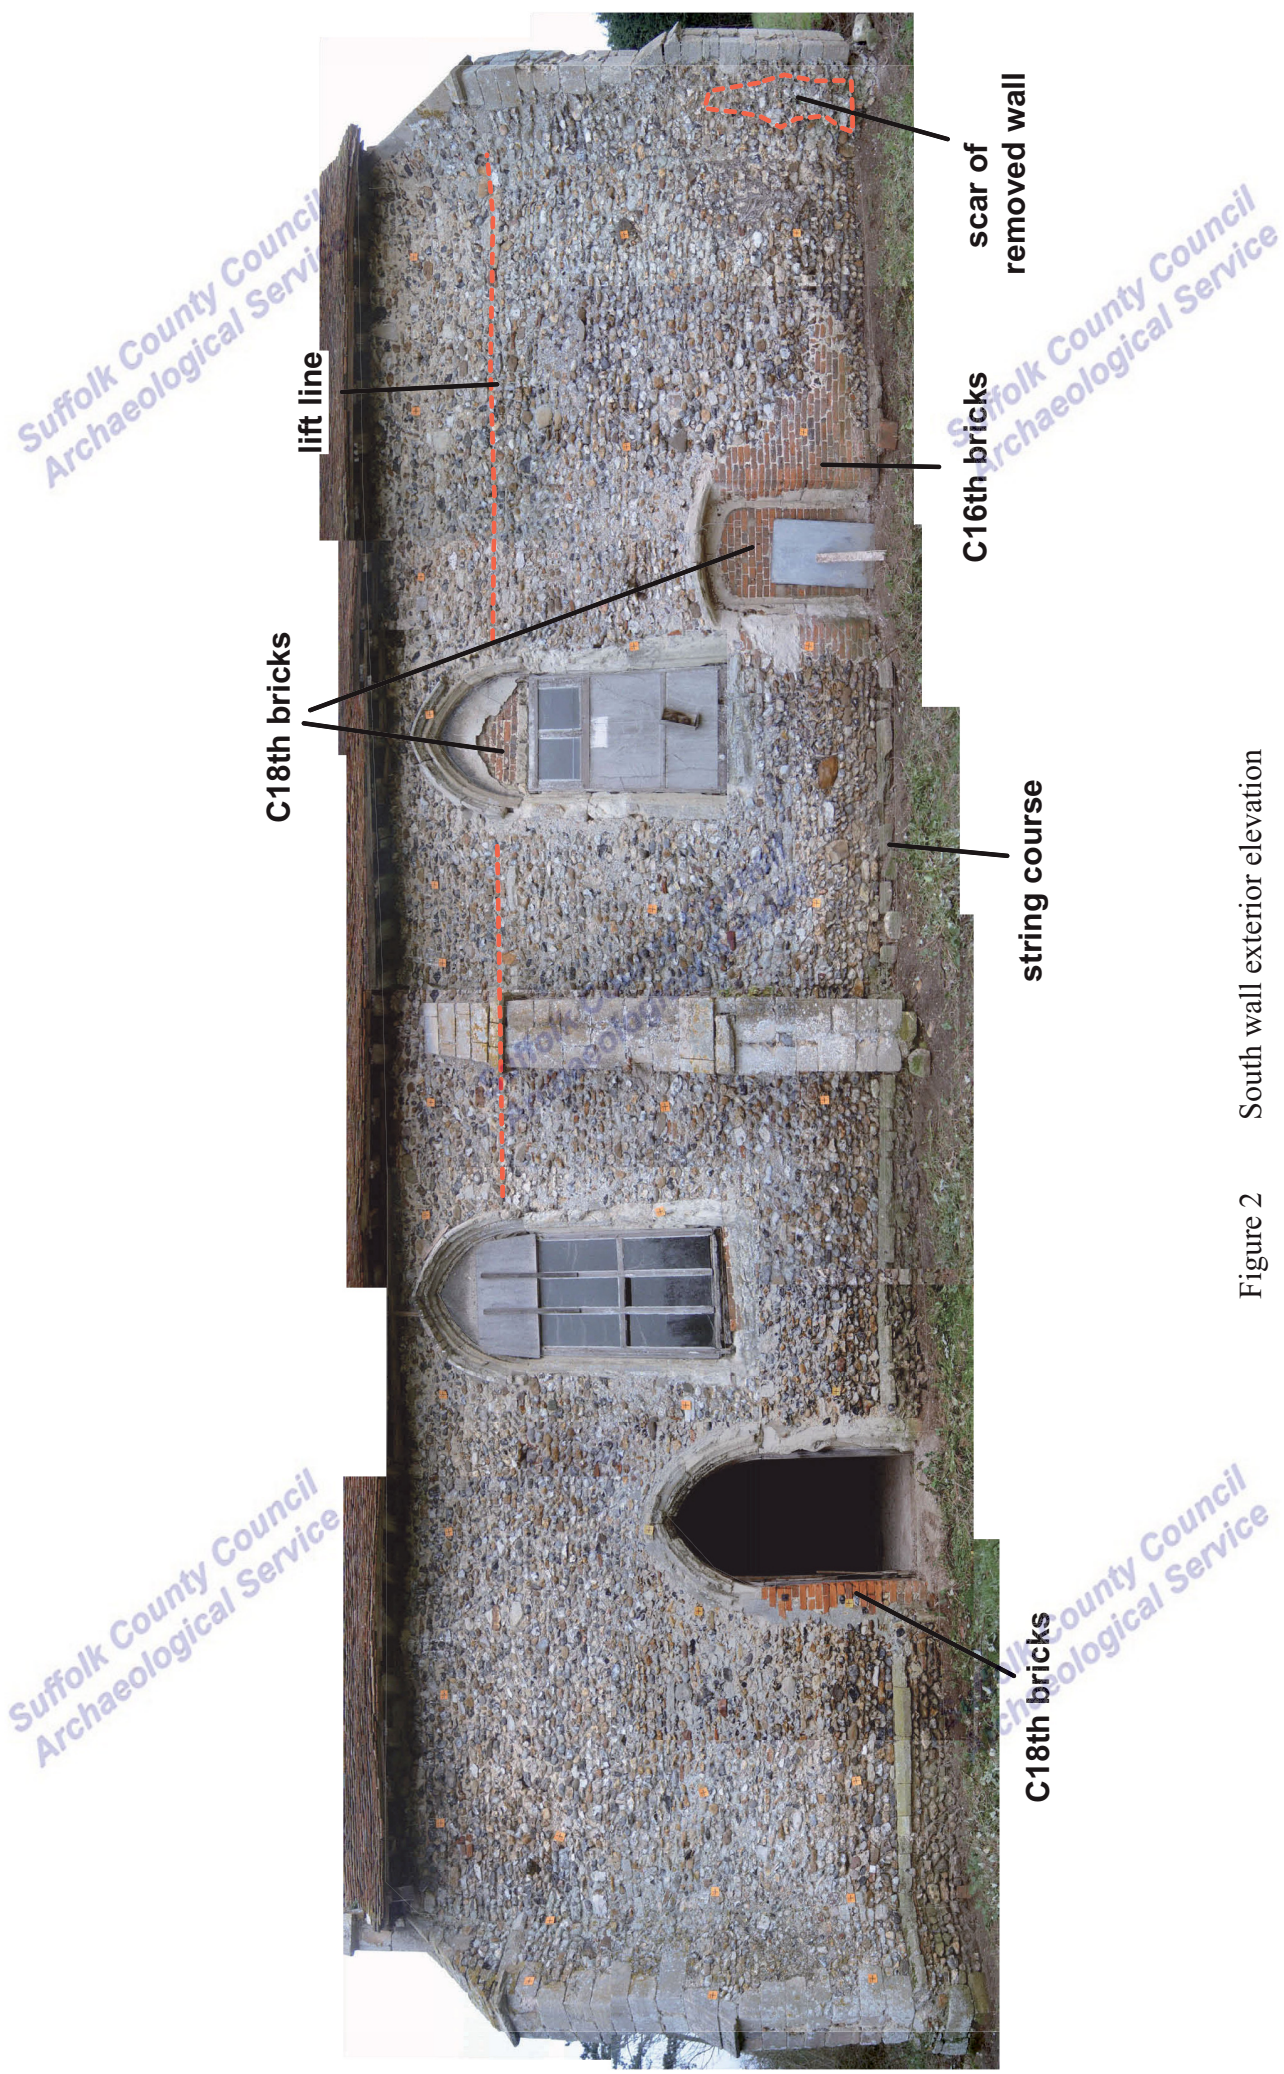
Figure 2 South wall exterior elevation

The south wall is constructed in mixed medium to large un-worked brown and black flints (mainly brown) with very occasional Tudor bricks and re-used limestone. The flints are uncoursed but their general uniformity suggests they have been sorted for size. The wall appears to be one phase of build but there is a striking lift line at the level of the base of the window arch.

The wall is buttressed at its mid-point and this, together with diagonal buttresses at each corner, was raised at the same time as the rest of the wall. The south face of the buttress at the eastern end of the building has a scar where a flint wall, contemporary with the build of the chapel, has been removed. Towards the base of the wall there is a horizontal string-course which has been stepped up at the eastern end of the building to accommodate the sloping ground. Some areas of facing below the string-course and at the base of the central and east buttresses, are in poor repair and many of the stones of the string-course are dislodged.

There are two perpendicular windows, the stones of the surrounds and their settings are original. The stone is a soft clunch-type stone and badly weathered except where sheltered beneath the hood moulding. One of the hood-moulding stones on the western window has been replaced, the moulding has been faithfully reproduced but it is in a different, coarser, stone. The tracery has all but been removed and replaced with a simple square-headed wooden window. Above the window, the arch has been infilled with brick; these date to the 18th century, and are contemporary with the infilling of the chancel door. The surviving vestige of tracery, which can be seen from the inside of the building, suggests that it was a *flowing* or *curvilinear* form, perpendicular in date.

The entrance to the chapel is at the western end of the south wall. The settings and stones for the opening are original, except for west pier, which has been rebuilt in brick. The style of the moulding on the stone is as the windows, and very badly eroded. The bricks used in the repair of the pier are in a fine textured sandy fabric, firing to a red-brown. They measure 9"x 4¼"x 2½" and date to the 18th century.

There is a second, small door at the eastern end of the wall into the chancel, the door seems improbably close to eastern window; the stones of the surrounds of each actually butt against one another, and the initial impression is that the door is a later insert. Evidence from within the building however demonstrates that the door was part of the original build and that the window was built to fit around it. The actual door opening is at the back of a reveal originally framed with clunch-type stone but has now largely been rebuilt in brick. The door has a depressed four-centred arch and the arch of the reveal is a segmental form. The bricks used to repair the opening

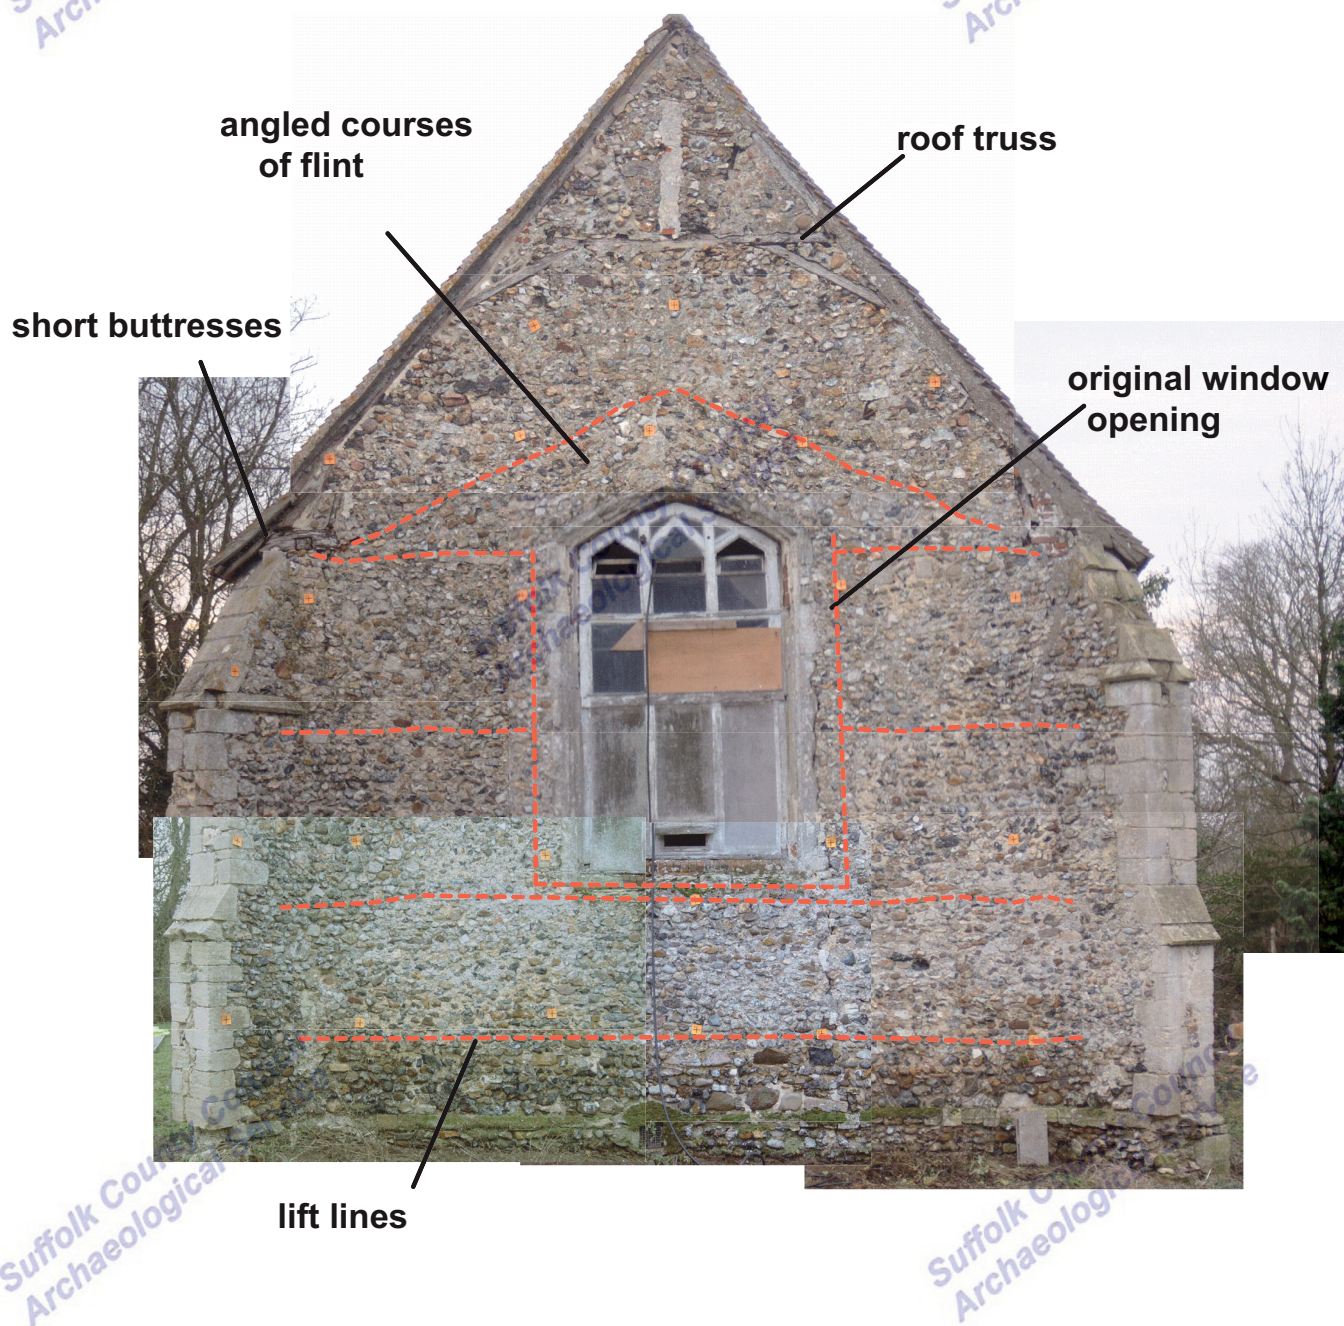
Figure 3. East wall exterior elevation

The east wall is made up of mixed black and brown un-coursed flints. At the base of the wall large flints have been used and the build includes large sandstone pebbles, this build extends to 1m from the ground level with small mixed flints above. The flints are bonded with pale fine textured mortar with fine sand and large chalk inclusions. There are identifiable lifts at the levels of the putlocks holes; from the approximate mid-height there are occasional pieces of re-used limestone within the build, below this there is none. The buttresses, quoins and string-course are in a coarse oolitic limestone, probably Barnack, and contrast with the windows.

The large central window is in a soft clunch-type stone and has been remodelled. It has been reduced in width but the original dimension can be seen in the stones that make up the cill which have remained unaltered. The parts of the masonry that make up the sides of the window have been reconstructed in brick and rendered over to simulate the stone. The bricks measure 8 $\frac{3}{4}$ "x 4 $\frac{1}{4}$ "x 2" and are similar to those used to repair the chancel door.

Around the window the original opening has been infilled with flint and the mortar, which is more yellow and contrasts with that of the wall build. The flintwork immediately above the window has been laid following the pitch of the earlier window head. These angled courses look like evidence of an earlier, lower roofline but this is misleading and it probably represents the end of a lift where the window masonry has been tied into the wall.

The final truss at this end of the roof is built into the wall, exposed within the elevation and with the end pair of rafters sitting on top of the gable. The whole cross-section of the roof can be seen and shows that the horizontal sole pieces and the wall plate onto which it is jointed sit directly on top of the buttress weathering. The east wall is effectively shorter than the west and the section of vertical quoining which occurs above the weathering at the west end does not exist here. There is a vertical linear patch of mortar, which runs from the apex of the roof to the collar, suggesting the position of a timber, this arrangement is exclusive to this truss and is not repeated on the trusses within the chapel.

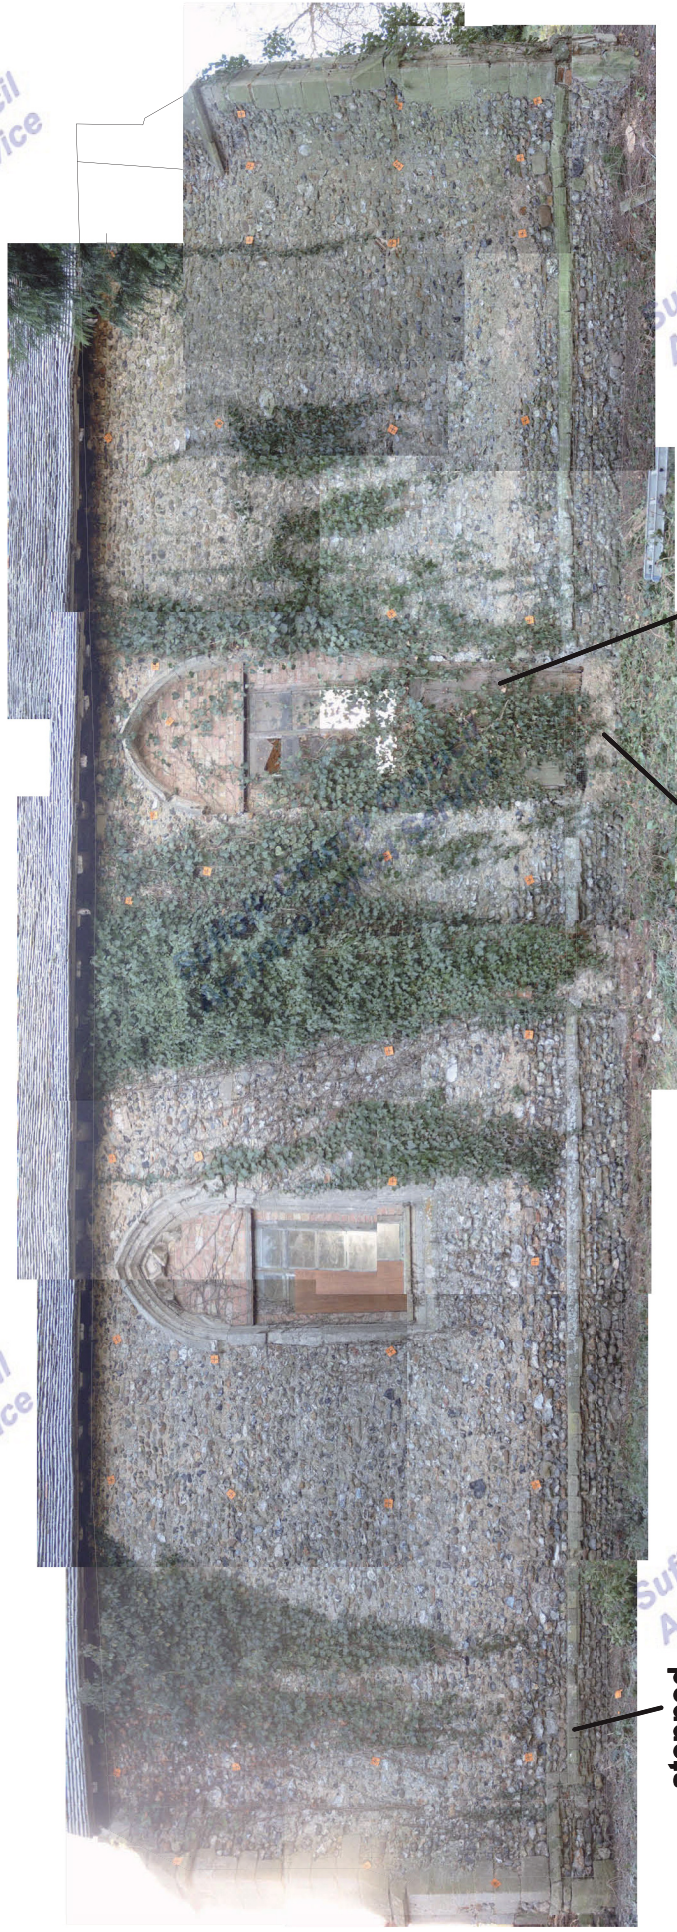
Figure 4 North wall exterior elevation

legged and
braced door

cob infill

stepped
string course

The north wall has a similar pattern of materials to the east, with mixed medium to large, black and brown, uncoursed flints with notably large flints used at the base of the wall (possibly suggesting the use of un-sorted field flints). The flints are bonded with a fine sandy mortar with large chalk nodules. The pointing is flush with the flint face, as with the east wall, but different from the south and west walls where the flints are proud. The wall is generally in better repair than the other elevations and was constructed in a single phase of build.

The wall is buttressed and fenestrated like the south wall and the settings and stones of these features are original. The string-course mirrors that on the south, being stepped at the eastern end.

The west window has been completely removed and only the hood moulding remains. The wall below the window has been chopped out to within a couple of flint courses of the ground to create a door opening. There is a short softwood legged and braced door, and an inserted

cill/step, made of a chalky cob infills a gap at the bottom of the opening where the door is too short. Above the door the window arch has been blocked in with modern brick.

The east window has had the tracery removed, but otherwise the stone is in the best condition of all of the windows. The fragment of remaining tracery is a *flowing* or *curvilinear* form. The windows on this side of the building have been blocked from the inside in contrast to the south, and infilled with C20th bricks.

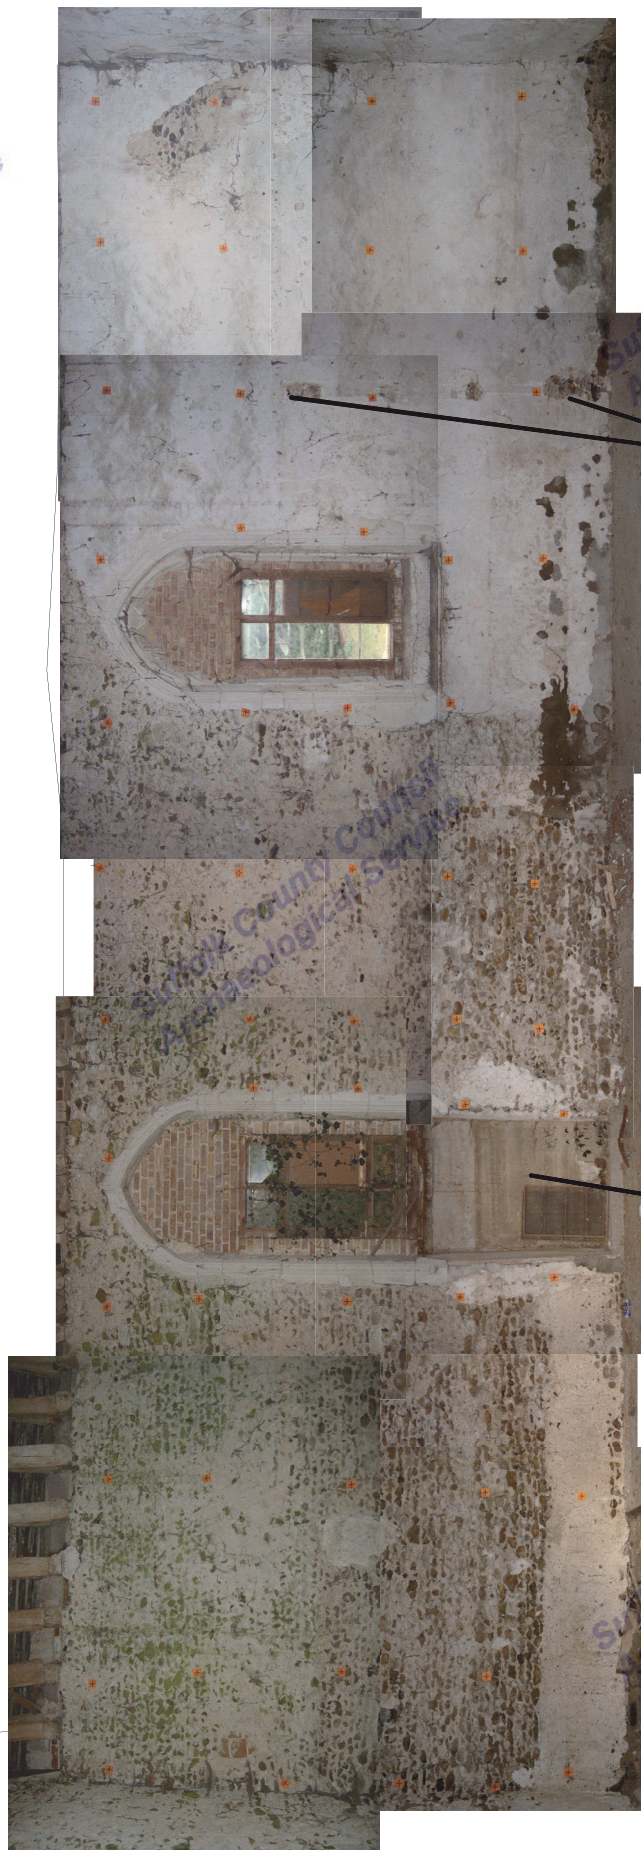
Figure 6 North wall interior

The inside of the building has been stripped and now has a concrete floor. It has been used in a barn and there is evidence of where animal stalls were attached to the north wall, but it is now an empty space (Figure 6).

wall chopped out
to create door

attachment for animal stalls

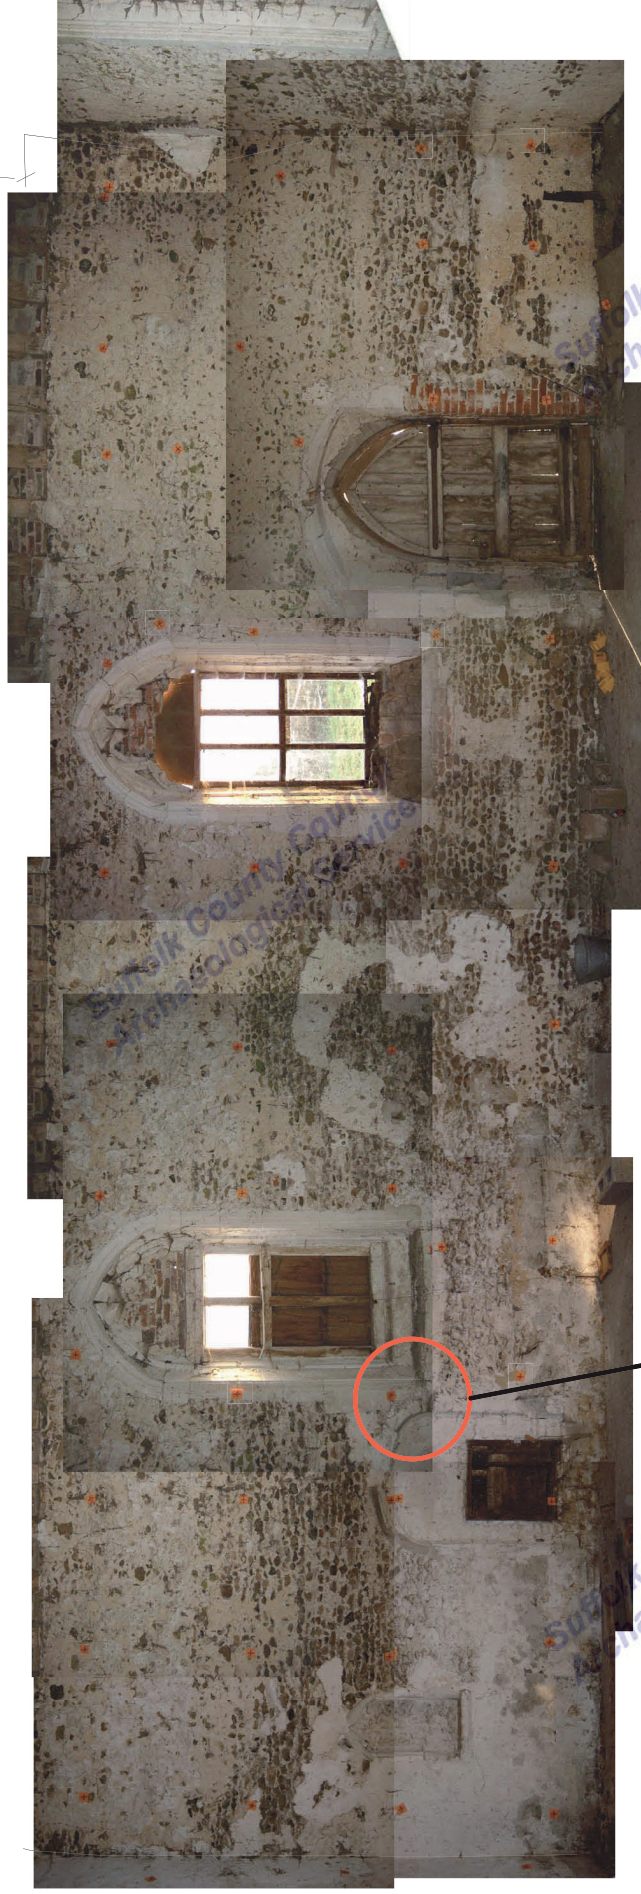
Figure 7. South wall interior elevation

window cut to fit around the door

The easternmost window on the south wall has been placed so close to the Chancel door that the stones have been shaped to fit around the head of the door, illustrating that the two are at least contemporary if not well planned.

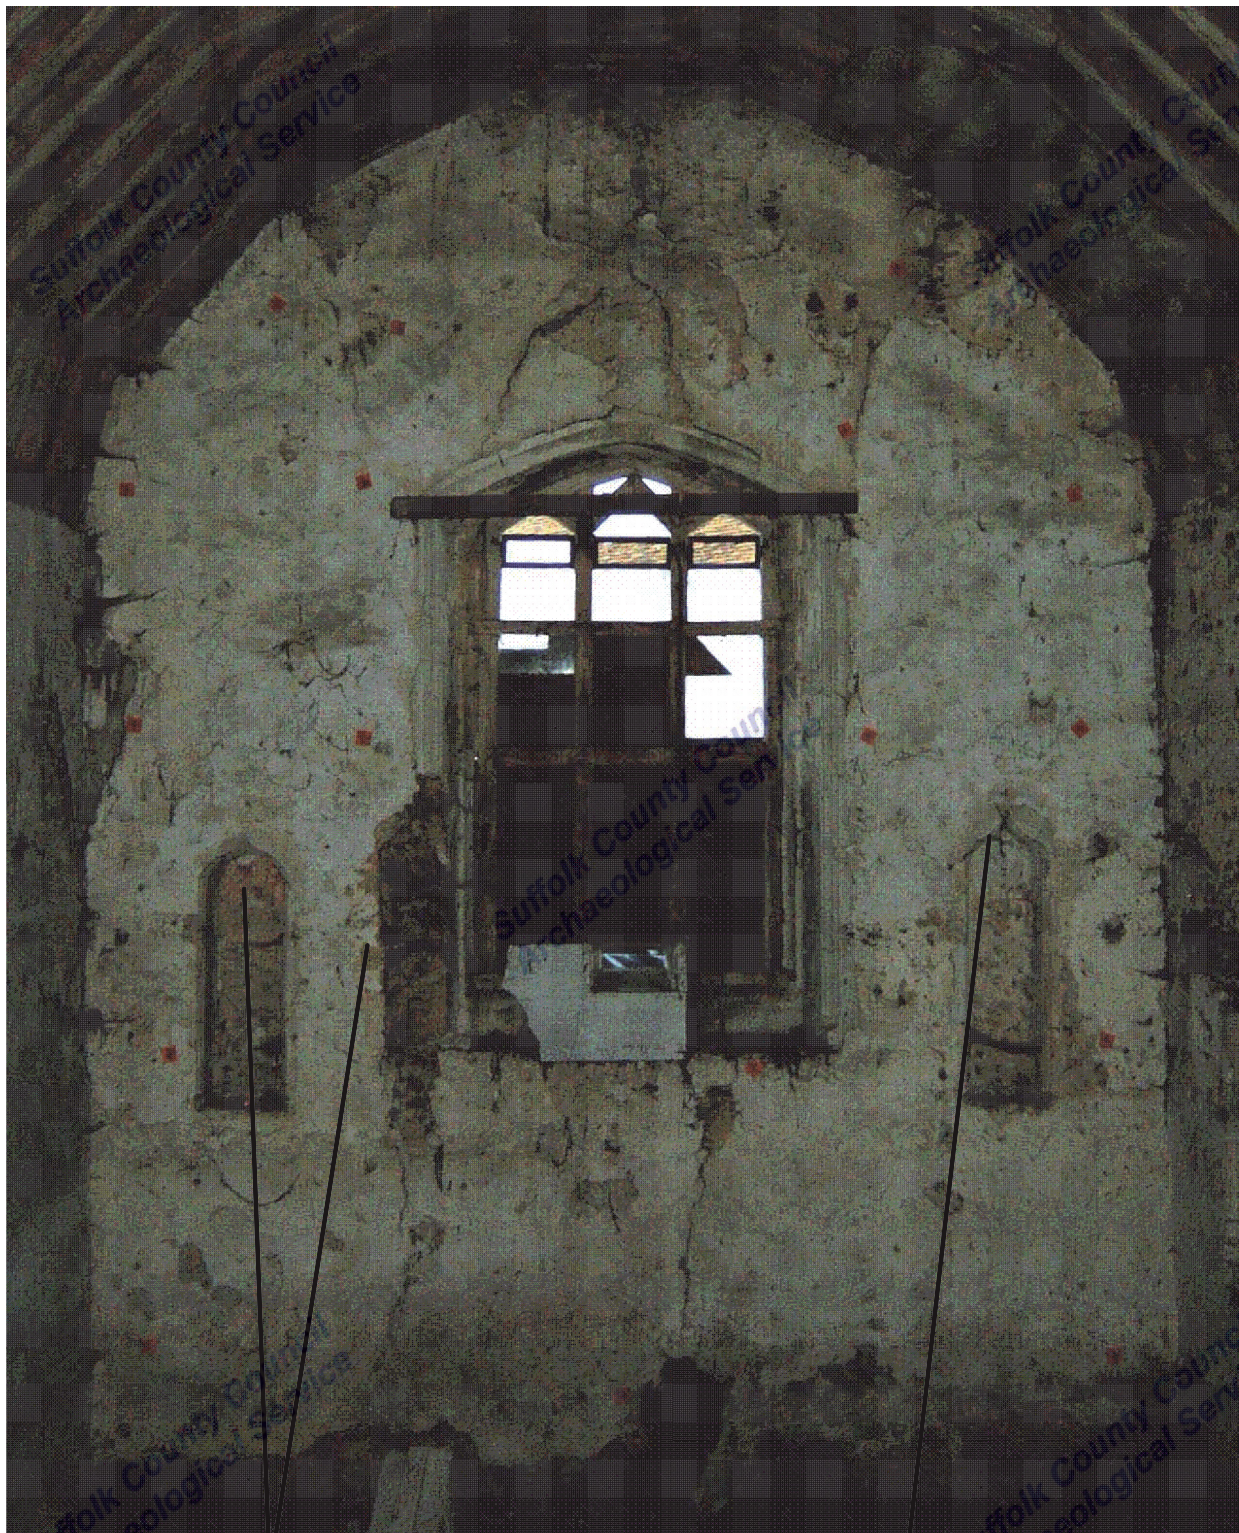
Figure 9. East wall internal

There are two ogee headed niches in the east wall (Figure 9), one either side of the window, and a piscina in the south wall (Figure 7). The niches and, in particular the piscina, are positioned high on the wall and this is probably evidence of a raised floor level within the chancel. The piscina has two shallow wells in a scalloped pattern, in its cill

painted plaster

**ogee headed
niches**

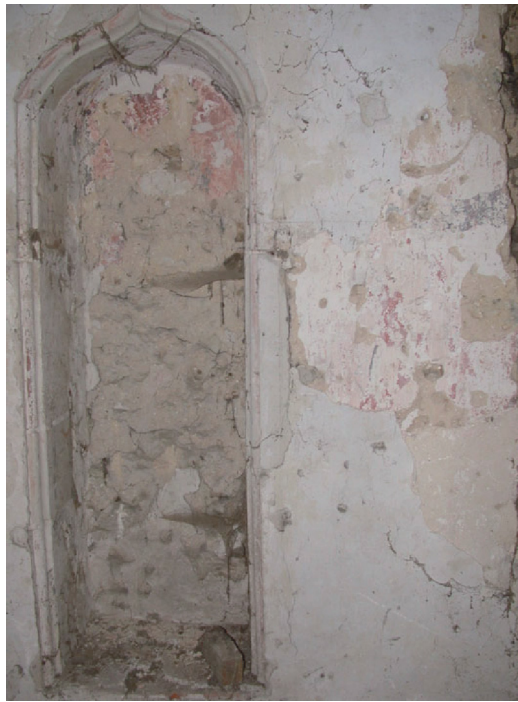
Figure 10. Painted plaster

plaster in the chancel and on the east wall, the earlier one was painted (Figure 10). The painting included the niches and was completed in reds and purples although at the time of the survey not enough was revealed to postulate on the motif.

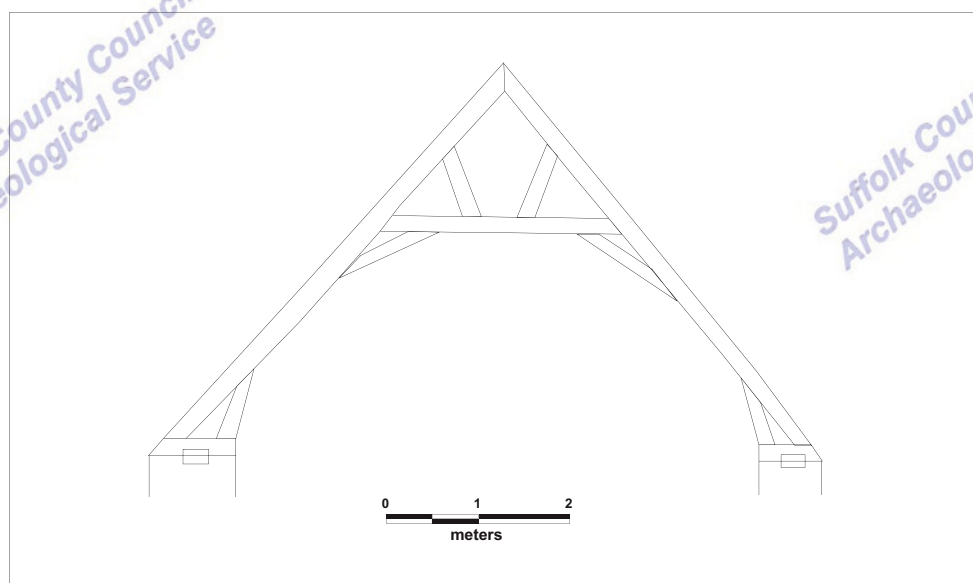
Figure 11 Section of single framed and braced roof

The roof is a single framed and braced type made of in chestnut (architect Jonathan Weatherly pers comms) with paired common rafters joined by a collar near the apex. The collar is braced and there is also bracing between the rafter and the sole piece. The trusses are not joined by a ridge piece and the trusses lean towards the west end of the building. At the eastern end of the building, over the chancel there are remains of a *Canopy of Honour*. The wide planking from which it is made has acted as a longitudinal brace to the roof and the rafters have remained

vertical. Later, diagonal wind braces, which join groups of rafters together, have been added to remedy the lean, these are in insubstantial sawn pine. The underside of the tiles is visible and the long (?) wooden pegs, which hook over the battens to hold them on, can be seen.
