## **STRUCTURAL RECORDING REPORT**

SCCAS REPORT No. 2010/027

# **Hengrave Lock, Culford CUL 046 Cavenham Lock, Lackford LKD 034**

**R. Brooks**  
© February 2010  
[www.suffolkcc.gov.uk/e-and-t/archaeology](http://www.suffolkcc.gov.uk/e-and-t/archaeology)

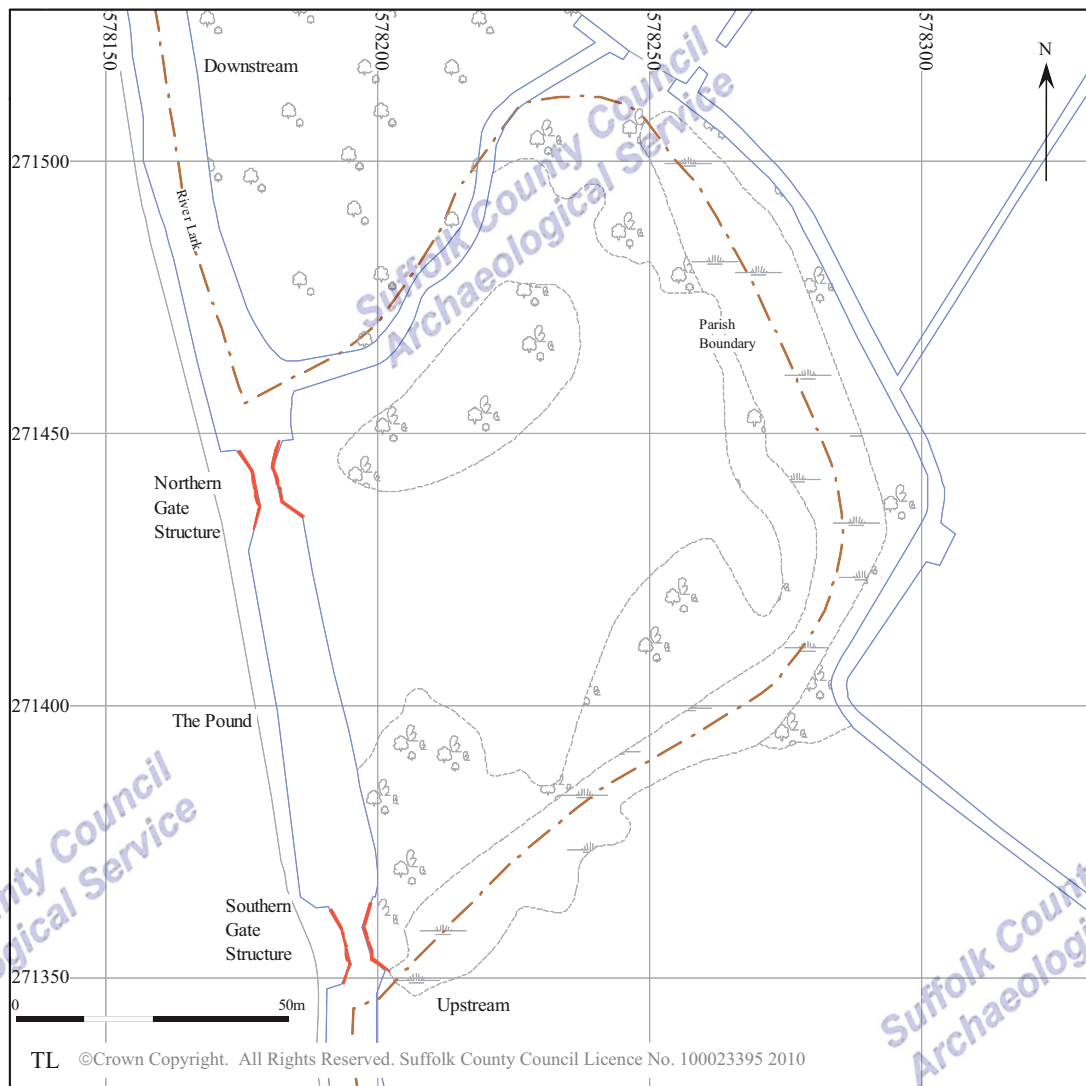
Figure 4. Cavenham Lock, LKD 034

Both of the lock gates and their superstructures had been somewhat damaged by the erosive and mechanical effects of the river and by the encroachment of vegetation. However, many of the original walls were still standing, and the base in each gate compound had survived partially, revealing how they were built, how they had been repaired and partially how they functioned. The results of this analysis were put together into a composite plan as shown on Figure 5.

The full dimensions of the wall structures as they survived, and measured from the points most distant points of A and B were, c.13.8-14.5m (NNW-SSE) x c.9-9.7m (WSW-ENE). According to the composite plan, the actual dimensions may have originally been closer to c.14.7m (NNW-SSE) x c.9.8m (WSW-ENE).

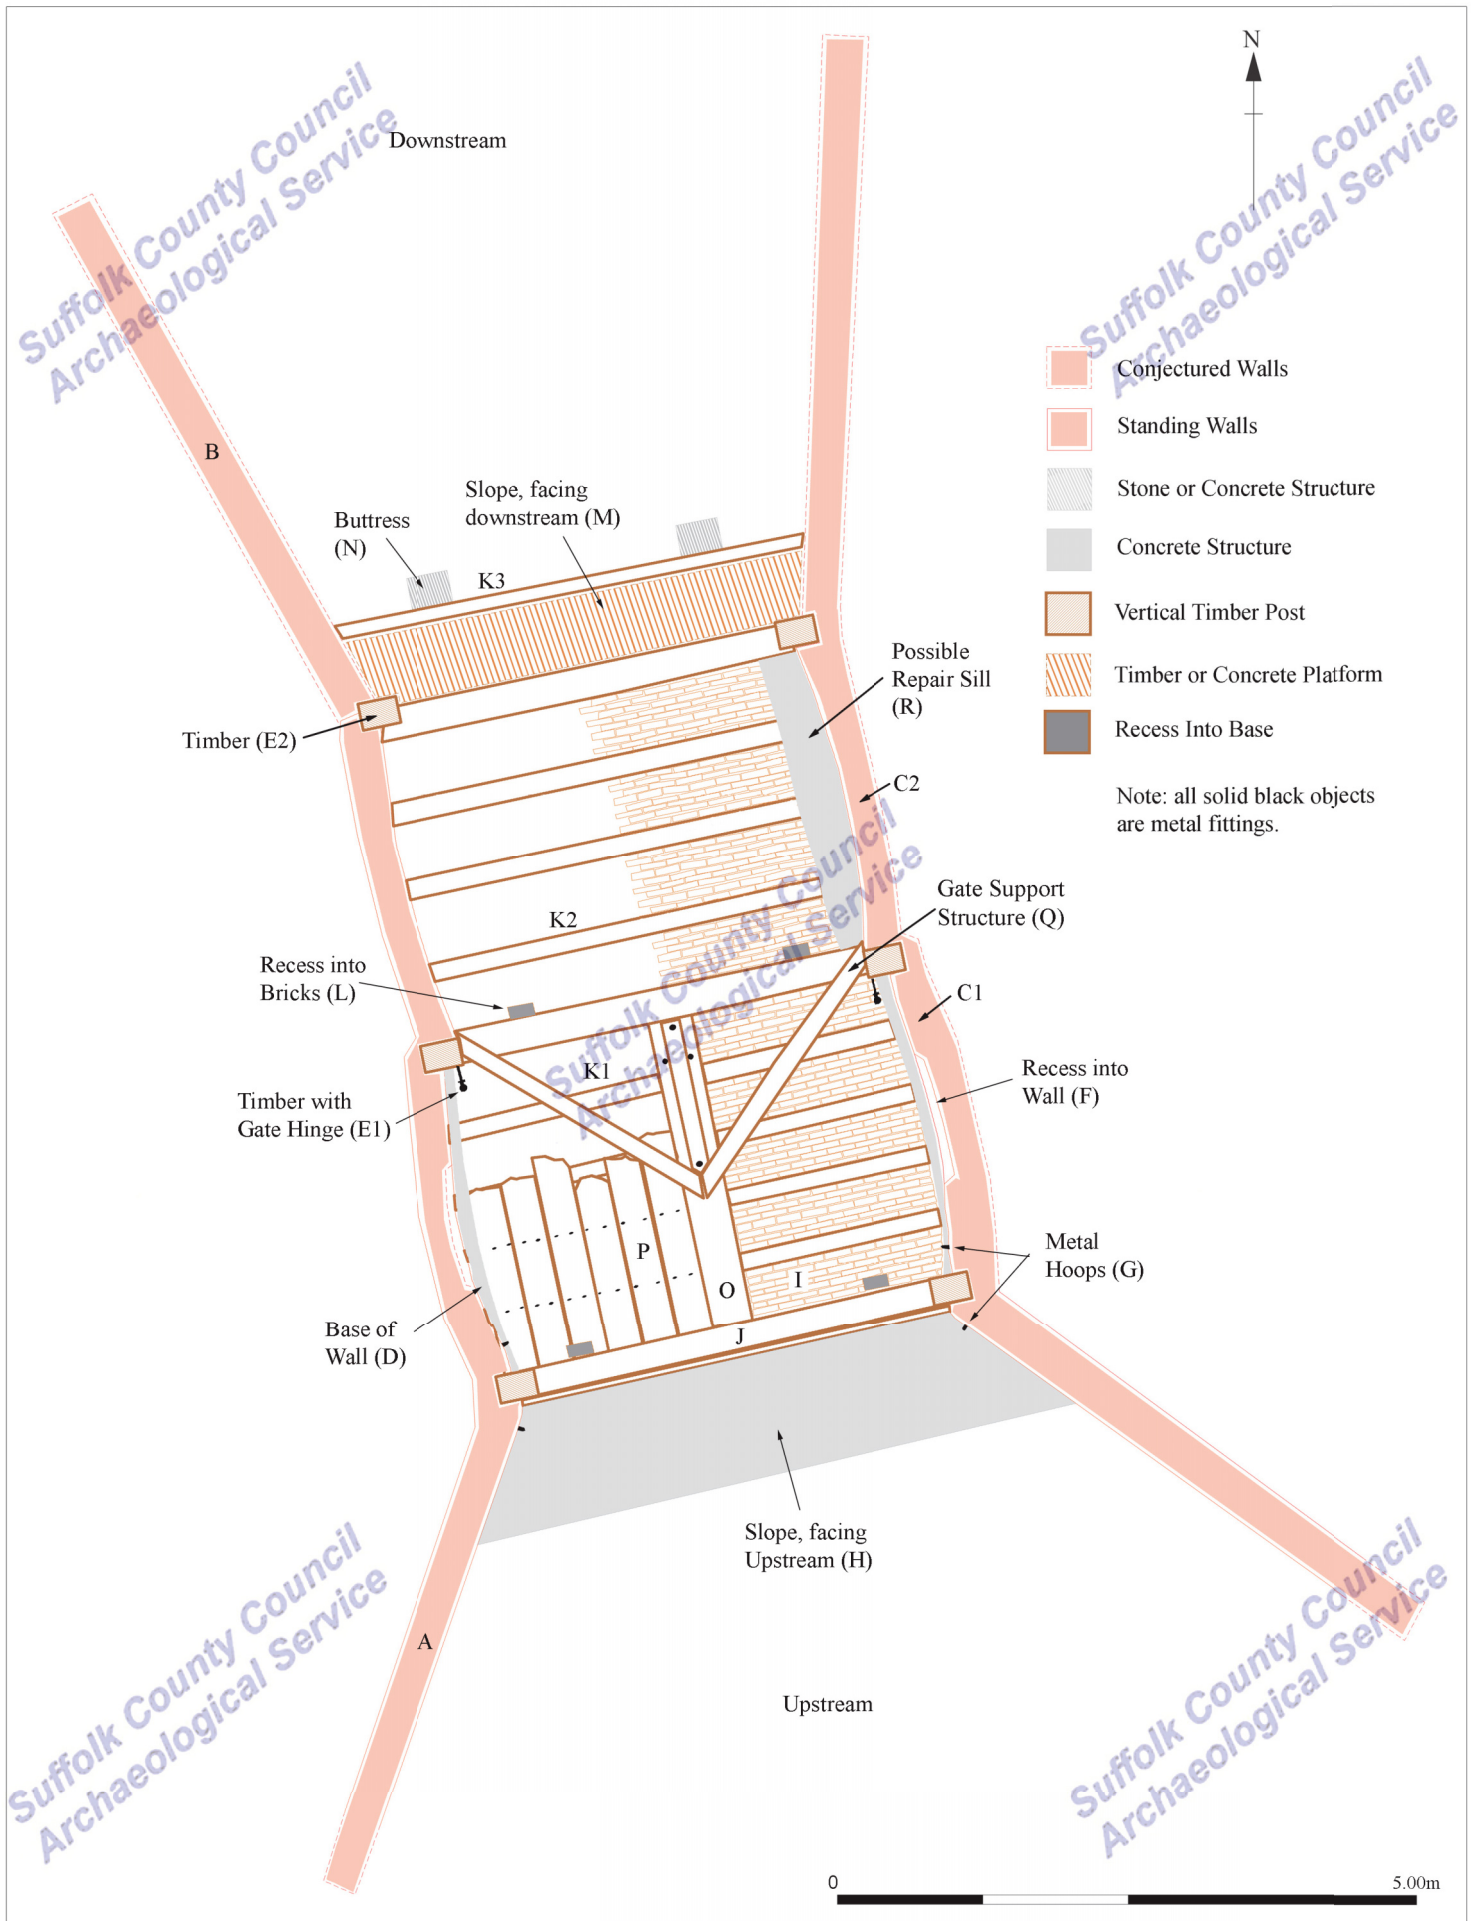
Figure 5. Composite plan of northern and southern lock structures for LKD 034

The upstanding parts of the lock gate structures consisted of two splayed brick 'arms' at each end (Fig. 5 – *A* and *B*), which channelled the water into and out of the main body (*C1* and *2*). This area was made up of two walls that both curved out gently at two points along their respective lengths. These measured 1.95m from the top brickwork to the water line. At the base of *C1* and *C2* was a concrete foundation/lip that emerged slightly from the face of the bricks (*D*). Where the walls both initially first curved out on *C1*, a recess was visible that was c.0.5m deep and ran from approximately halfway up the wall to below the waterline, at c.1m wide x >1.05m tall (Figs. 5 and 6 - *F*). It is assumed that this recess may have housed part of the lock gates when they were open and thus abutting the wall. Set into the southern end of *C1* were

The northern and southern gate structures had bases made up of wooden, brick, concrete, metal and possibly stone components (Fig. 5, *H-P*). At the southern end of each was concrete ramp (*H*). This extended 1m from the main brick and timber structure of the base. At its highest point it was c.0.2m lower than the rest of the surviving base. At the northern end of each structure was another sloped platform, on this occasion facing downstream (*M*). It is uncertain whether this was made up of timber or concrete and it emerged c.0.6m from the northern *J* timber. Bounding the end of this structure was timber *K3*, which itself was then held in place by two stone or concrete buttresses (*M*). The floor of the lock structure was higher than the river bed and the sloping ramps at the entrance and exit to each lock gate helped channel the water through. The upstream ramp would have prevented eddying water from scouring out the river bed and undermining the lock and was made of concrete, suggesting it was a recent repair. The downstream ramp would have aided the entrance of the barges.

The gate structures were floored with wooden boards (*P*), which ran longitudinally. The floor boards were attached with pairs of nails to closely spaced sill beams (*K*), which ran across the width of the lock and were secured between panels of bonded brickwork (*I*). The timber flooring survived only partially in the northern structure, but the presence of the various sill beams across the lock bases suggests that the entire floor of the structures was once boarded over. The use of floor boards across the base of the locks would have both protected the hull of the boats and the lock base and were probably replaced regularly. The bricks were laid out in a stretcher bond and measured 0.225m long x 0.045m tall (*I*). In the southern half of the base the bricks were laid in 7 courses. Elsewhere it was unclear. Four recesses were seen within the bricks (*L*). It is assumed that these functioned as the fixing point for some feature, such as a stud to secure the large *J* timbers.

Forming part of the frame around the bricks were three large timbers (*J*), which joined to the base of the vertical timbers *E1* and *2*. They measured c.0.25m wide x >3.6m long. On the same alignment were several other timber struts (*K1-3*). Those in the southern half of each structure were the smallest, as they abutted timber *O*, measuring c.0.15m (NNW-SSE) x c.1.85 (WSW-ENE) (*K1*). Those in the northern half also measured c.0.15m (NNW-SSE), but stretched the full width of the base at c.3.8m (WSW-ENE) (*K2*). *K3* was at the far northern end of the bases and was c.0.14m (NNW-SSE) x 4.1m (WSW-ENE).

Running perpendicular to the *K* and *J* timbers was timber *O*. It abutted the central and southern *J* timbers. With the central *J* timber, *O* formed the primary fixing structure for the gate support structure (*Q*). *O* measured c.0.3m (WSW-ENE) x c.2.65m (NNW-SSE).

The uppermost structures in the bases were the three timbers that made up the Gate Support Structures (*Q*). These formed the shape of an arrow pointing upstream and would have helped to support the base of the gates, secured to *E1*, when they were shut. The central timber of this structure was secured to timber *O* with two large metal rods. It is likely that the two other timbers were similarly fixed to *O* and the central *J* timber in order to withstand the high mechanical pressure applied by the gates.

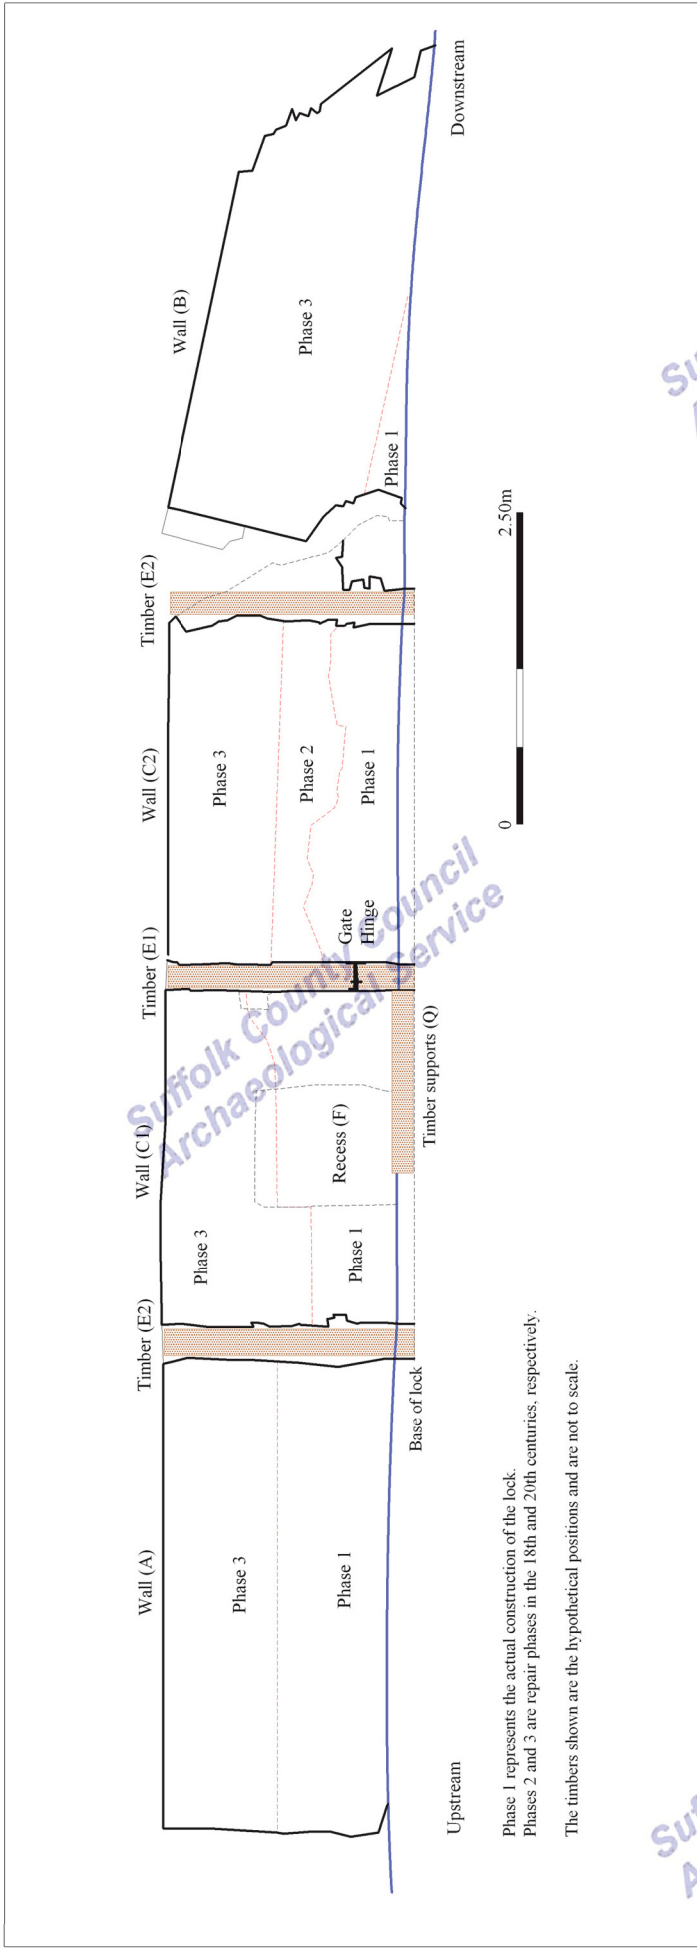
Figure 6. Elevation of Cavenham Lock, Southern structure, West side phasing

The bricks in the second phase of construction are likely to be of late 18th century date, measuring  $9" \times 4^{1/4"} \times 2^{1/2"} (0.23\text{m} \times 0.11\text{m} \times 0.06\text{m})$  (Floyd, 1925). This date coincides with the period during which Sir Thomas Gery Cullum had inherited the river and started repairs on many of the existing structures. As such it is probable that Phase 2 was part of Cullum's repair programme. Although only partly visible, the amount of repair work needed seems to have been quite substantial, as is shown by the depth of the repairs on Wall C2, Figure 6.

A third phase of work is also visible in the Cavenham Lock. The bricks are clearly of early-mid 20th century date, being London Brick Company Flettons. These repairs were obviously as extensive, if not more so, than those in Phase 2, as again shown by the large depth of bricks that were required in Wall B, Figure 6.

At some point another undated repair also took place on the Cavenham Lock. It may well have been part of Phase 3 but cannot be fully identified. This involved the replacement of the presumably damaged *P* boards with a concrete sill *R* (Fig. 5). Whilst this did not run across the full width of the base, it would have served to keep the *K1* and *K2* boards in place. It is thought to be a repair rather an original feature because it showed no timber impressions.

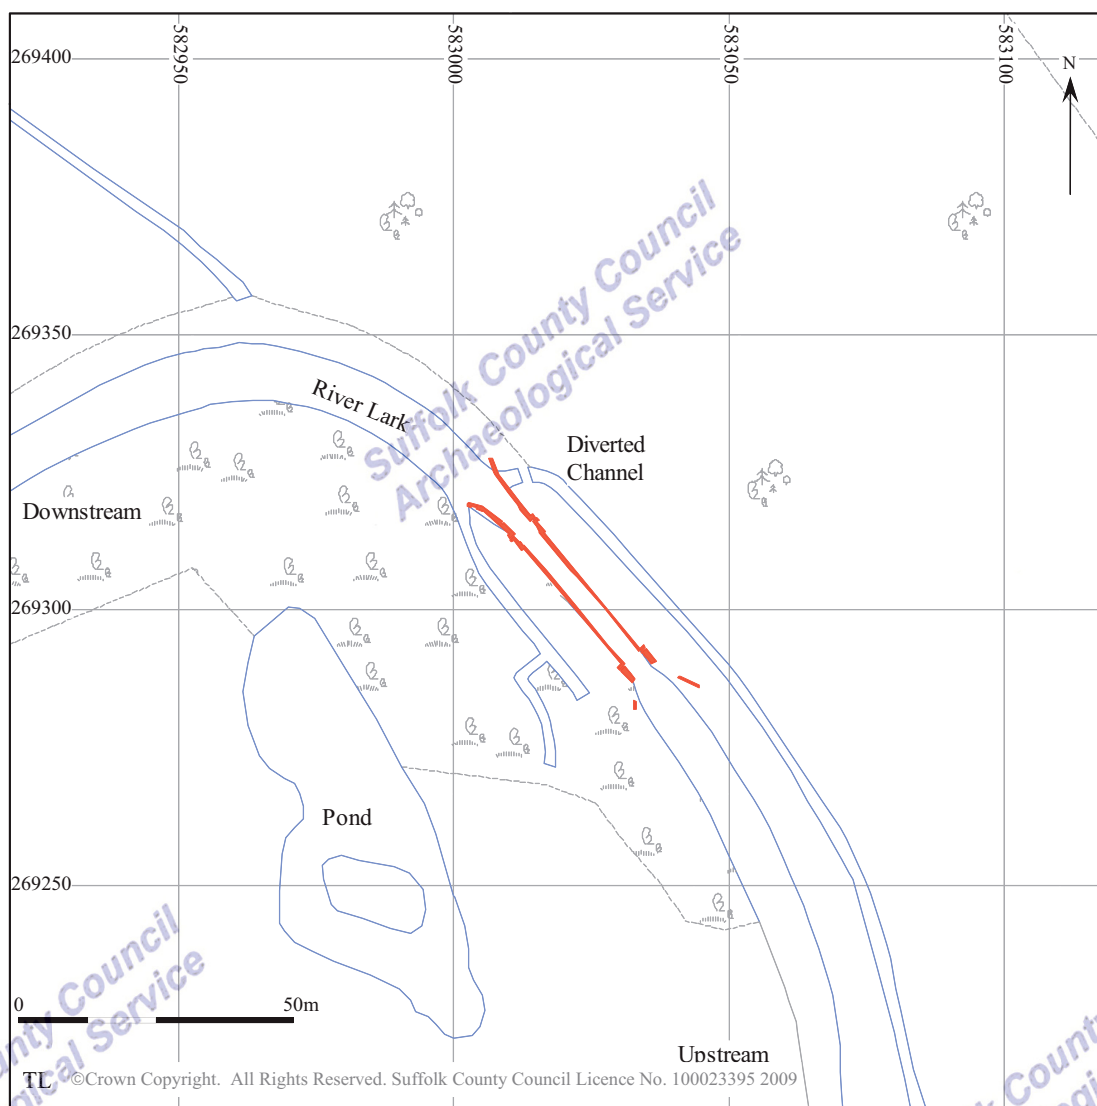
Figure 7. Hengrave Lock, CUL 046

Significant parts of the end walls of the Lock had been damaged by water movement. However, the path of the walls at the northern end could both still be seen, but much of the southern end had collapsed, and as a result the plan of the structure is partly based on assumption.

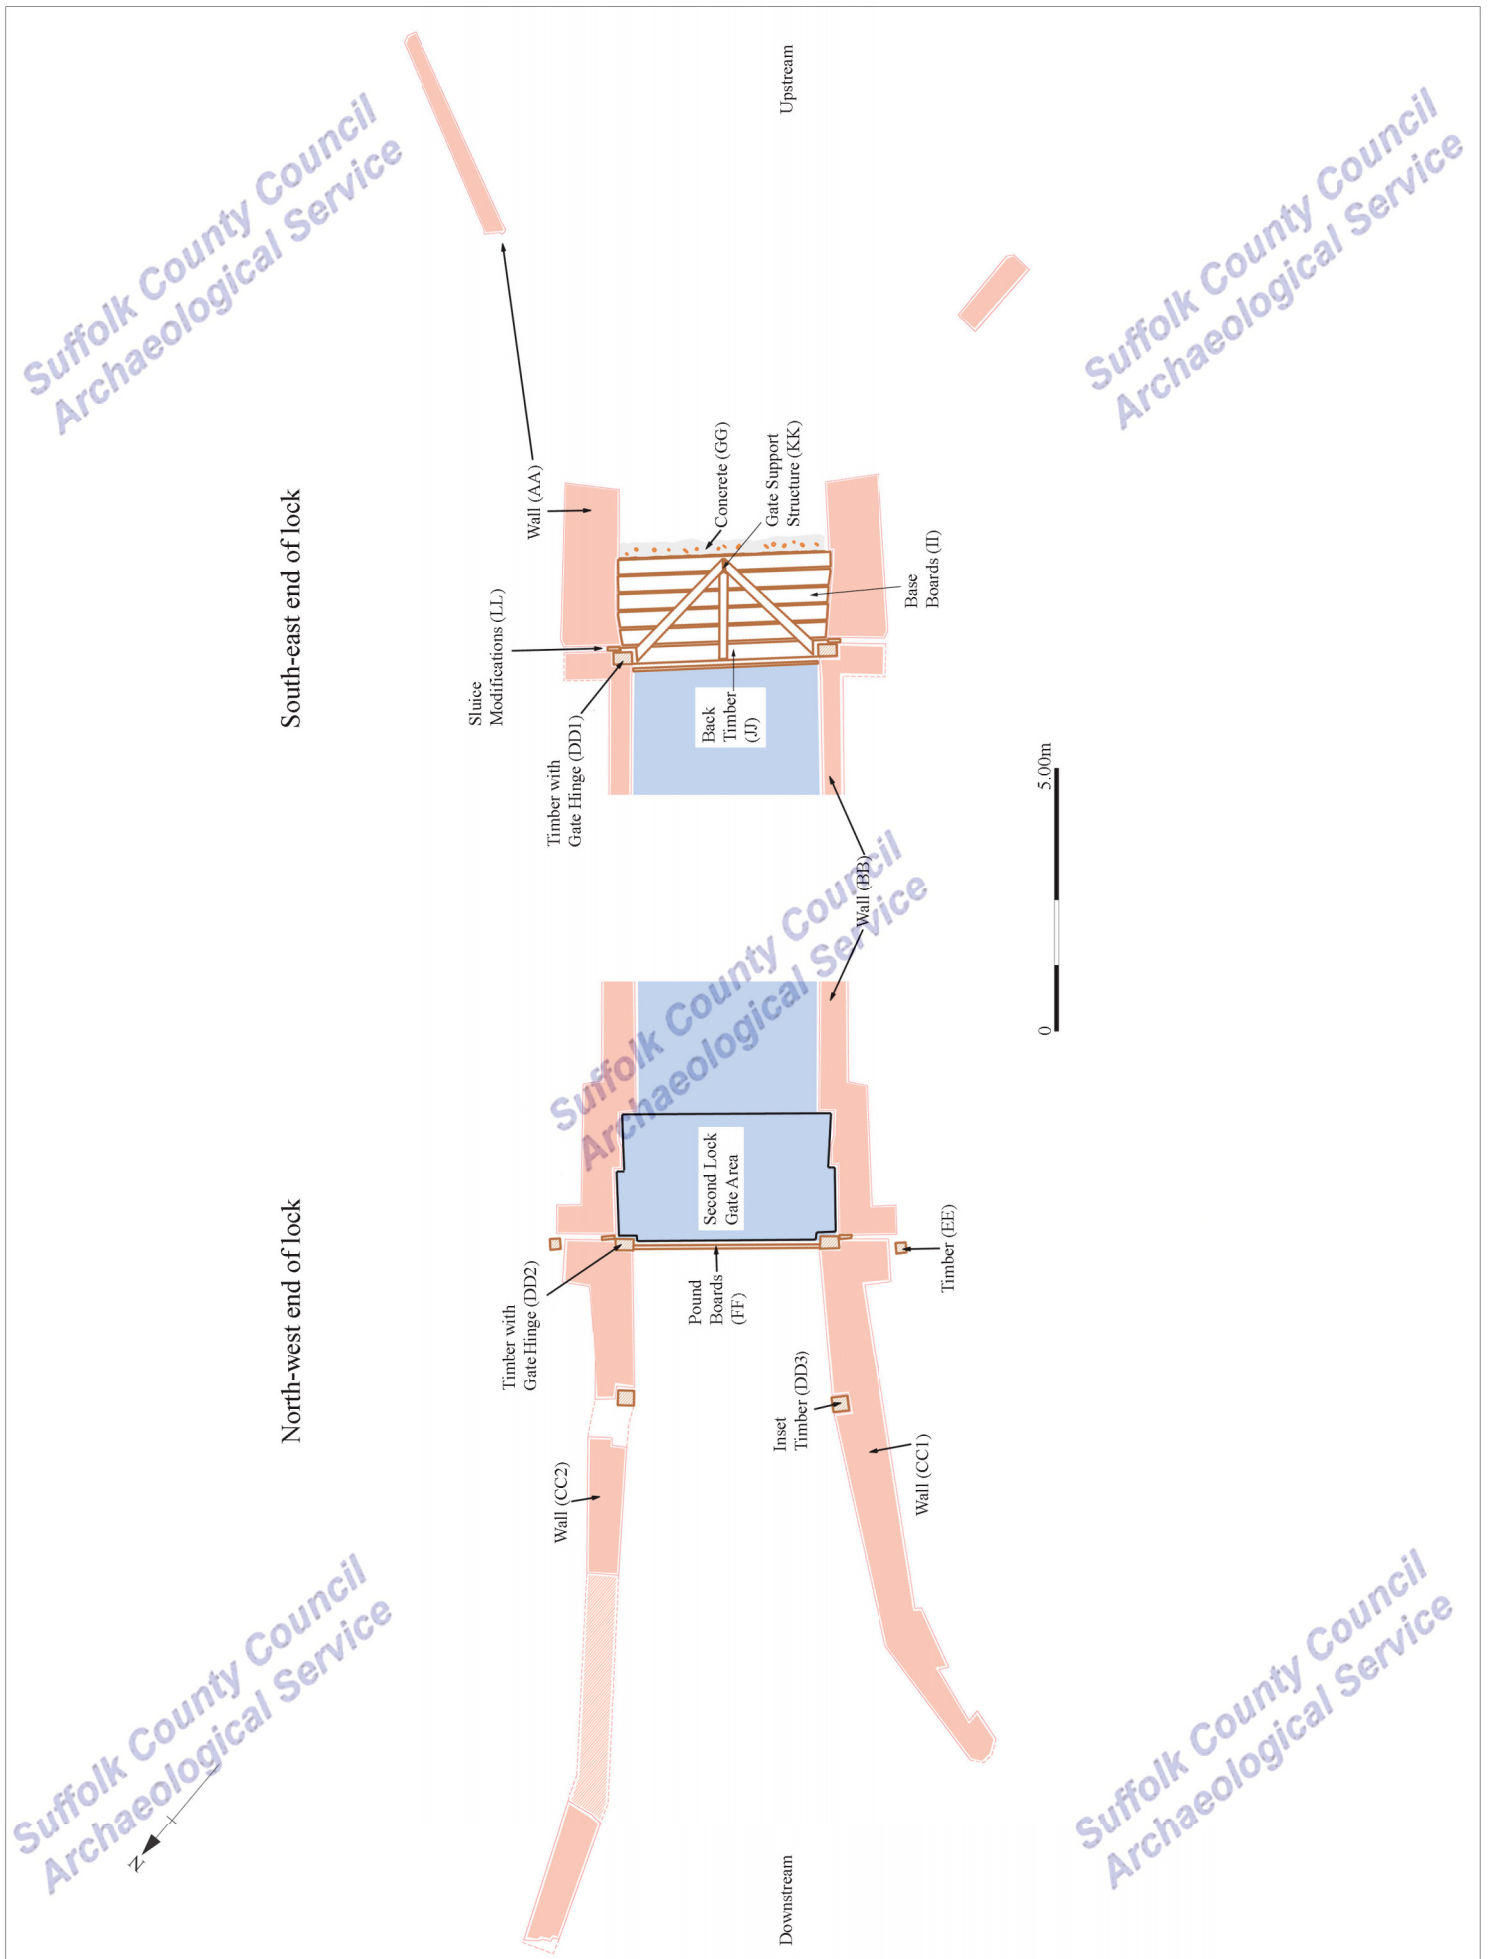
Figure 8. Plan of NW and SE ends of Hengrave Lock Gate Structures

The walls running along each side of the lock made up the main upstanding structures. Each was made up of three sections of wall, including the splayed and heavily damaged south-eastern walls (Fig. 8 - AA). These had been largely broken up by water movement and their original layout was uncertain. However, it is likely from the remaining structures that the end of the north-eastern wall was c.12.3m long and extended c.12m from the parallel *BB* wall, whilst the south-western wall was at least 8.2m long and extended c.7.7m from the *BB* wall. There were no other details clearly visible on the *AA* walls although their main function was to channel the water into the lock body.

The main length of the lock was made up of the parallel *BB* walls. At the surface these appeared to be separated from the *AA* and *CC* walls by a slight gap. They measured c.30.9m (NW-SE) x c.0.35-0.6m thick (SW-NE). Although the Pound area of lock contained a high quantity of rubble and refuse, and was heavily silted up, it is clear that the *BB* walls were >2m tall. The depth of the water in this area, along with the material making up the base of the lock made it too dangerous to physically enter and record the lock between these walls. However, the TST survey of the north-west end of the Pound area clearly outlined a second lock gate area, identical in outline to that which was still intact at the south-east end. This area is shown on Figure 8.

The base of the lock was designed to create a structure strong enough to hold the gates when they were shutting and trying to withstand high water pressure. Although only one of these structures was seen at Hengrave Lock, it is certain that a second would have been present at the north-west end also.

The lowest section of the base was made of concrete with small stones inset (*GG*). This was irregular and could only be seen emerging slightly from the base of the timber structure. It would probably have worked as a foundation for the timber structures. Overlying this was the base timbers, (*II*). These were c.0.3m (NW-SE) x c.4m (NE-SW) a 0.12m thick, and fixed to the rest of the structure by a series of nails. On the north-west end of these was timber *JJ*. This was a substantial timber, similar to the *J* timber at Cavenham Lock. This was 0.28m (NW-SE) x c.3.95m (NE-SW). It functioned to secure the *DD1* and *DD2* timbers. Flush with the top of *JJ* was a series of thin horizontal slats (*FF*) than ran down to the base of the Pound enclosure. The dimensions of these were unclear. *FF1* represents part of the original structure. However, the *FF2* boards were more recent additions, at a higher level than the south-west gate base, which seemed to function to block entrance to that end of the lock.

The uppermost part of the gate structure was *KK*, the gate support. This, as with *Q* at Cavenham, was arranged in an arrow form, facing upstream and was also presumably fixed to the base in a similar manner. The central timber was 0.15m (NE-SW) x c.1.65m (NW-SE), whilst the other pieces were 0.2m (E-W) wide x c.2.4m (N-S) long.

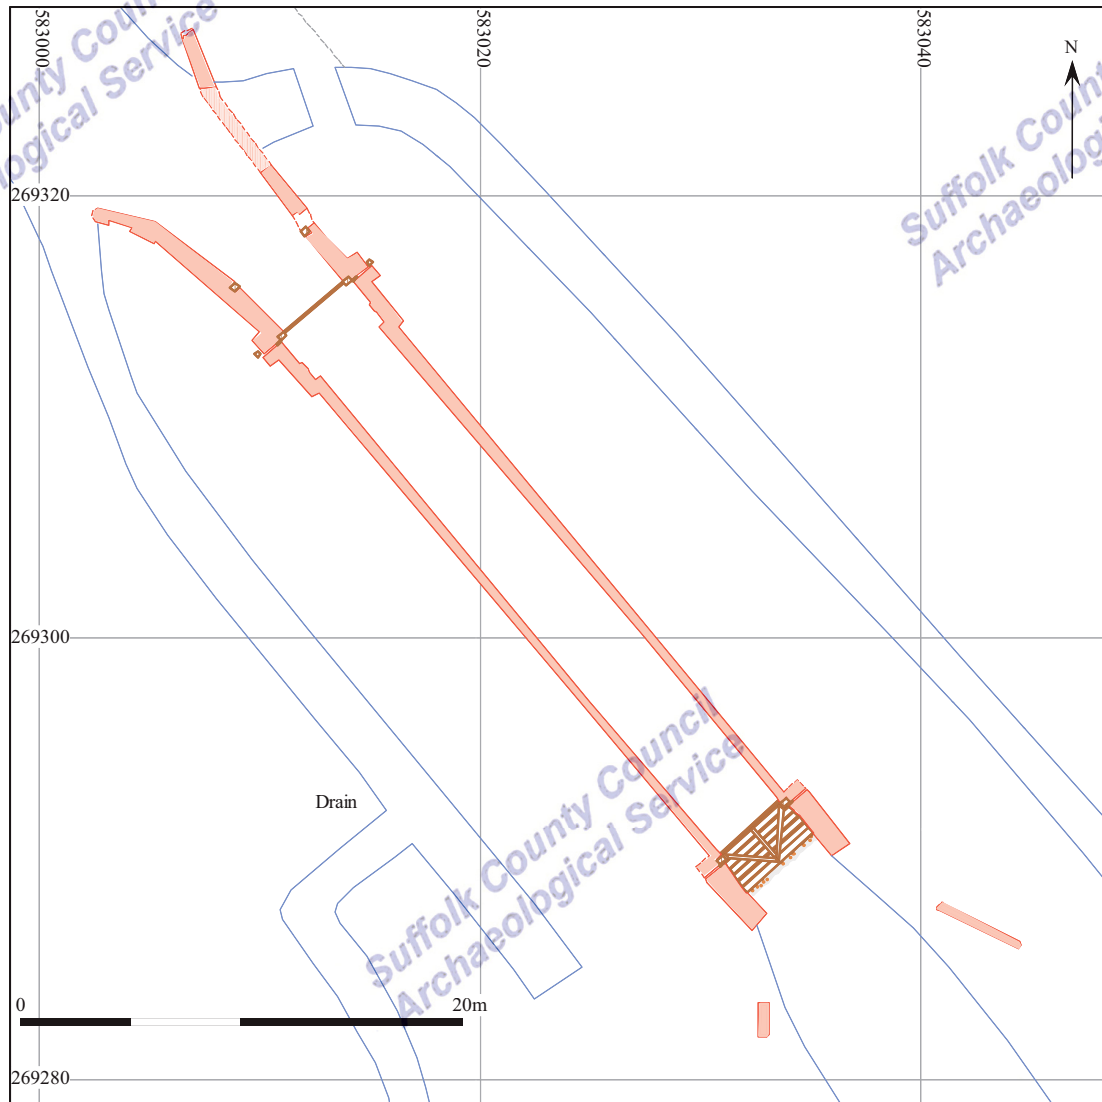
Figure 9. The full layout of the Hengrave Lock structure as it now stands

The final component of the Hengrave Lock was indicated by a series of rebates in the concrete, between walls *AA* and *BB*. These suggested the presence of horizontal boards running across the lock, measuring c.0.23m tall x c0.07m thick x c.4.4m long (*LL*). The purpose of such boards is unclear, although they probably represent part of the construction of the lock, functioning as a plank staunch to keep the rest of the Pound dry whilst the building works took place.

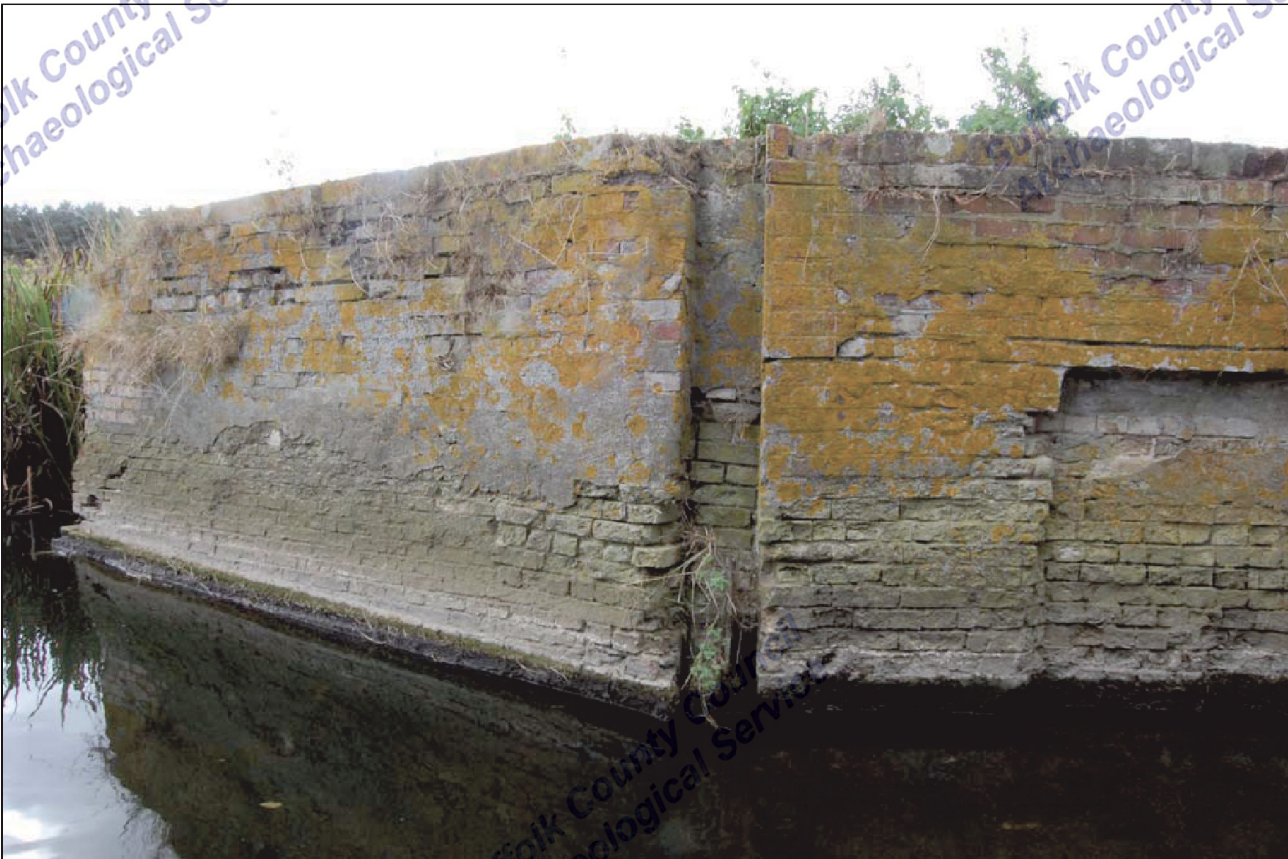
1. A-type wall, LKD 034, southern structure, western side

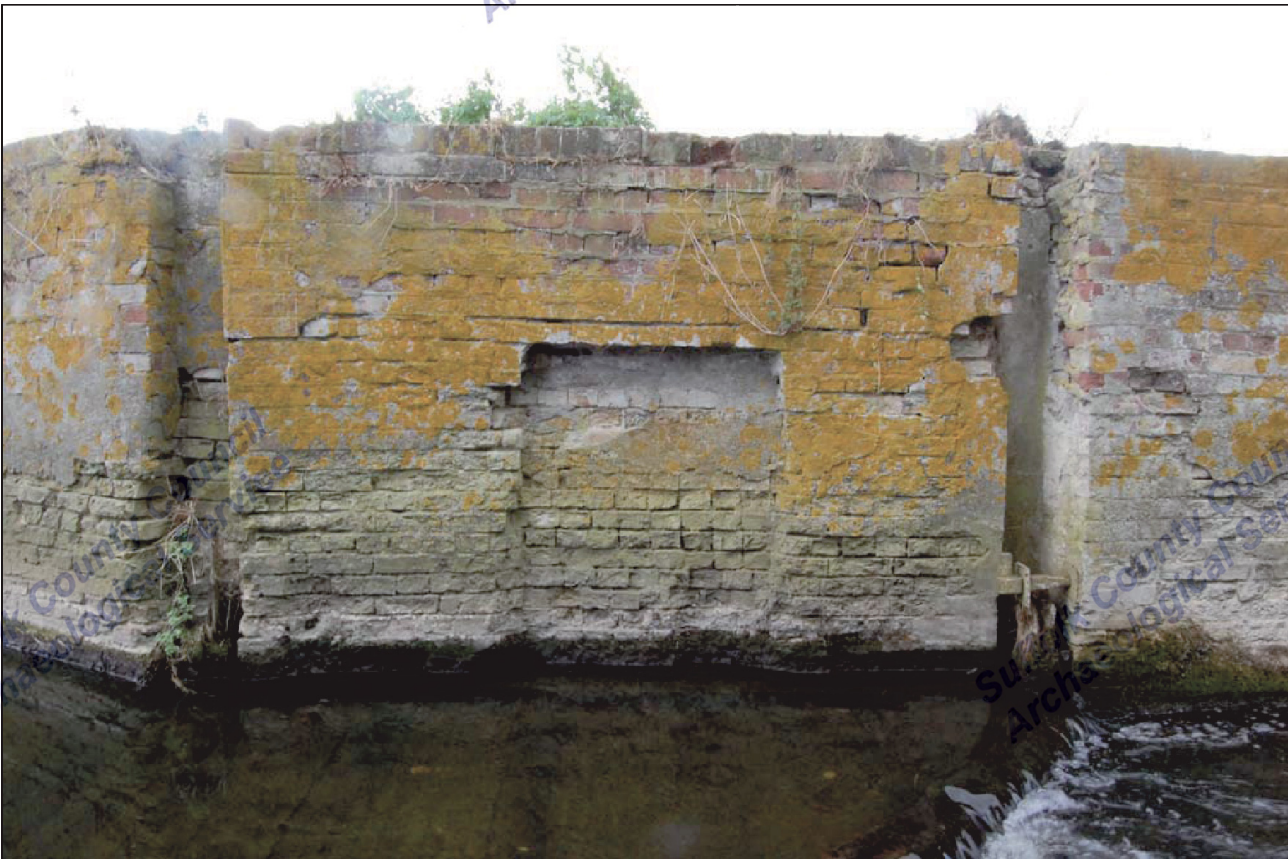
2. C1-type wall, LKD 034, southern structure, western side

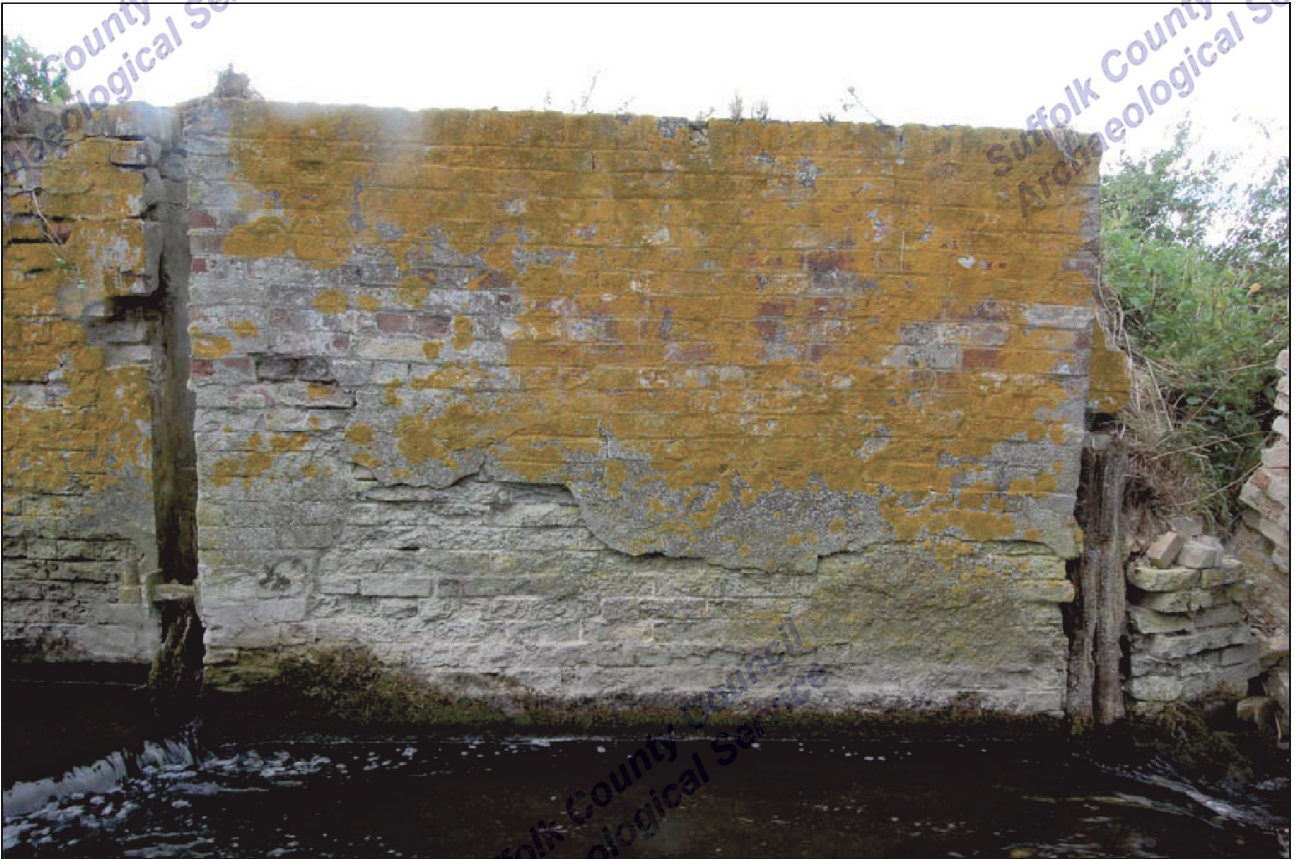
3. C2-type walls, LKD 034, southern structure, western side

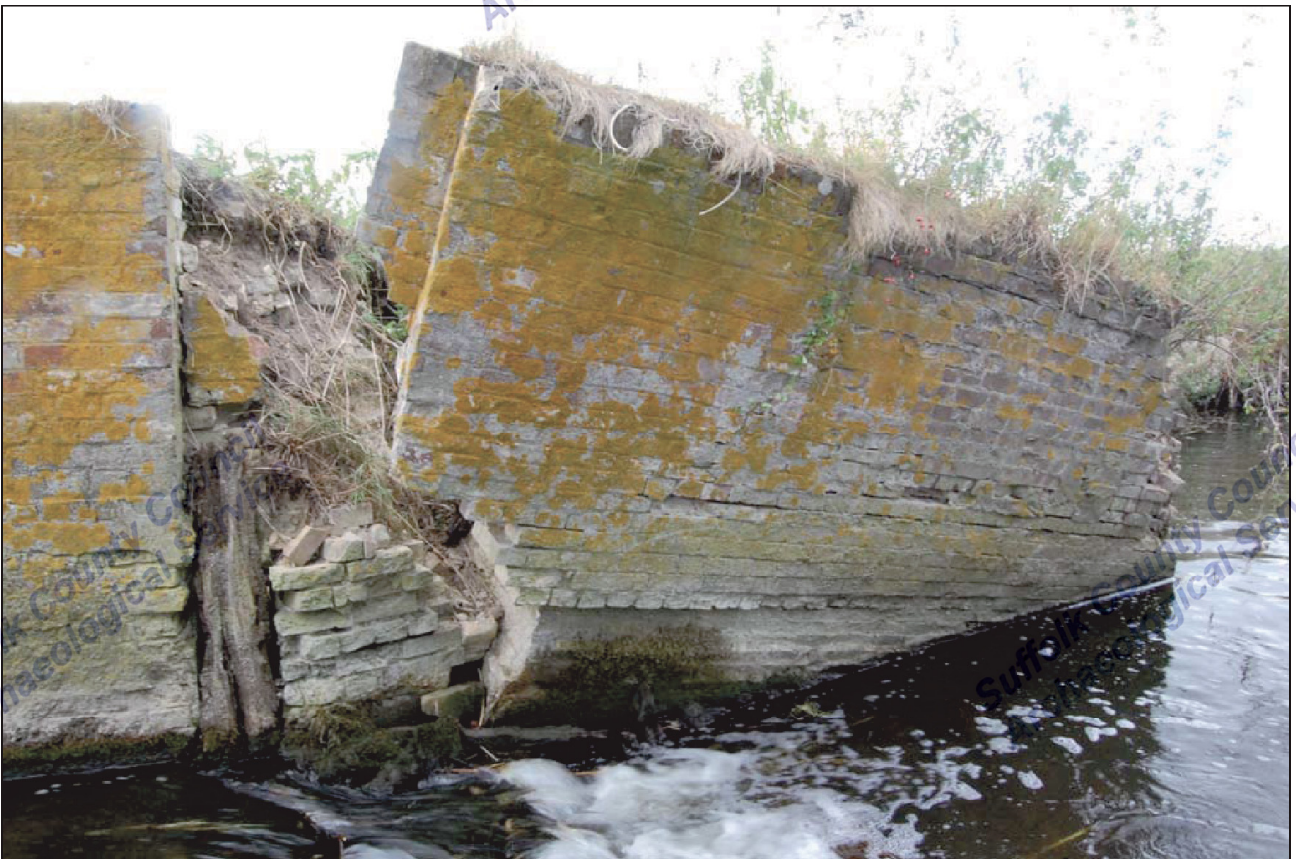
4. B-type walls, LKD 034, southern structure, western side

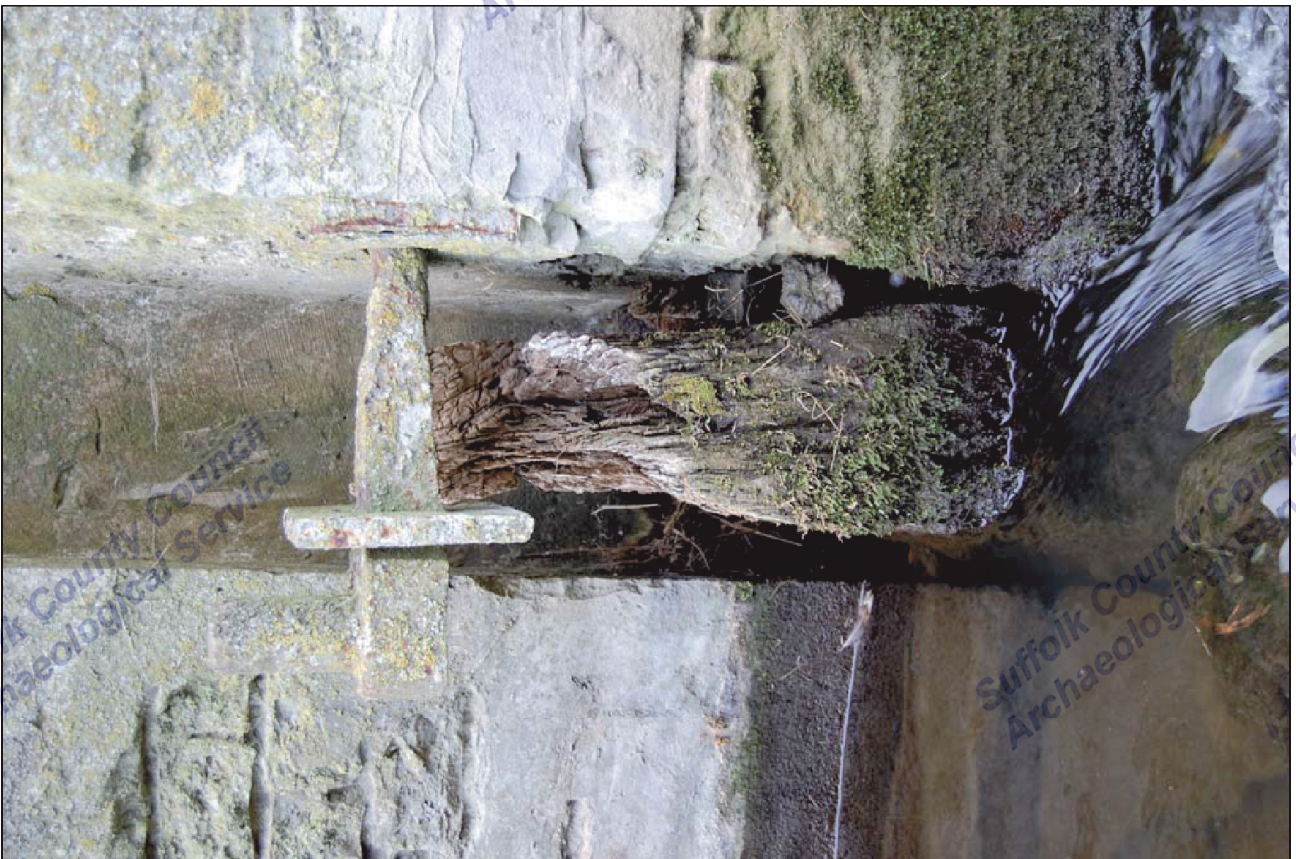
8. LKD 034, *In-situ* gate hinge, southern structure, western side

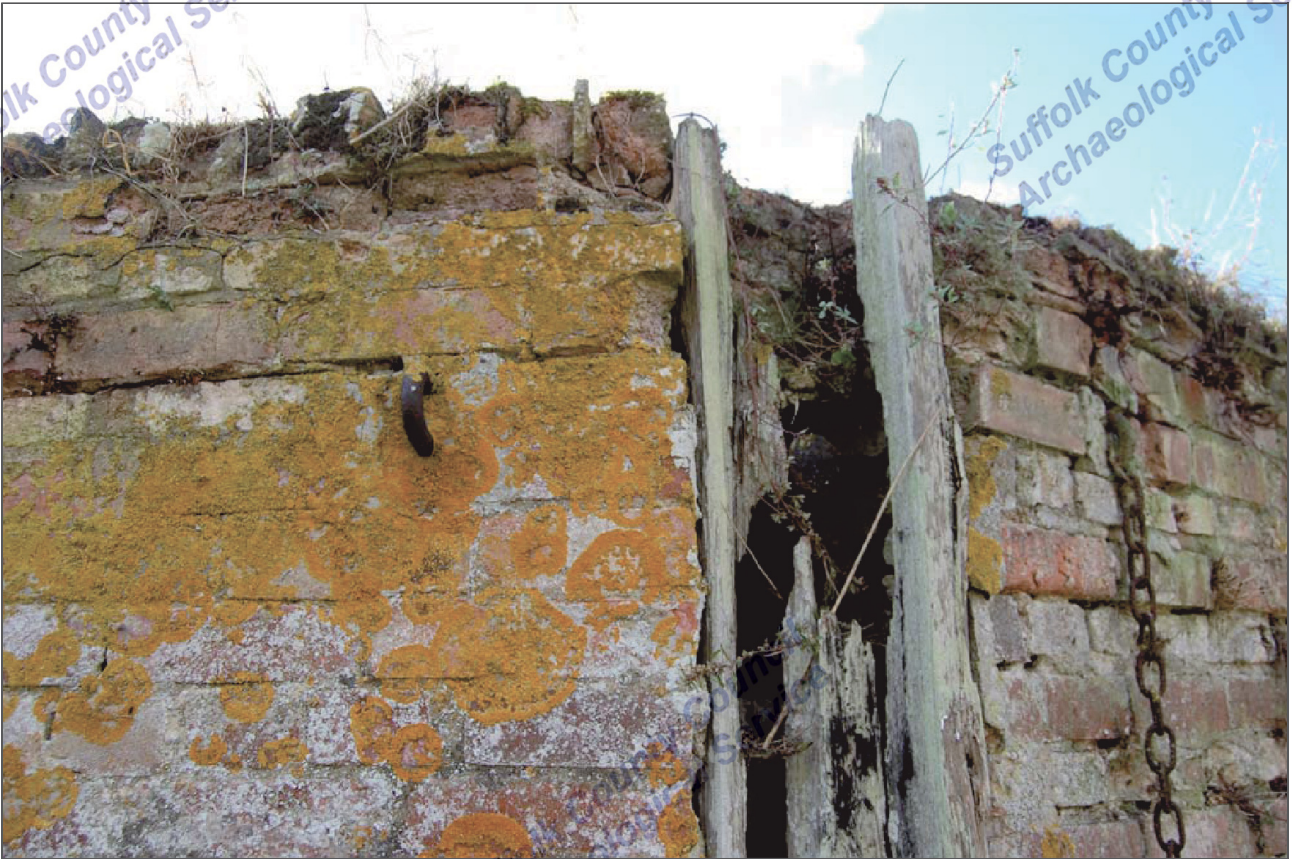
9. LKD 034, northern lock structure, western side, chain and hoop

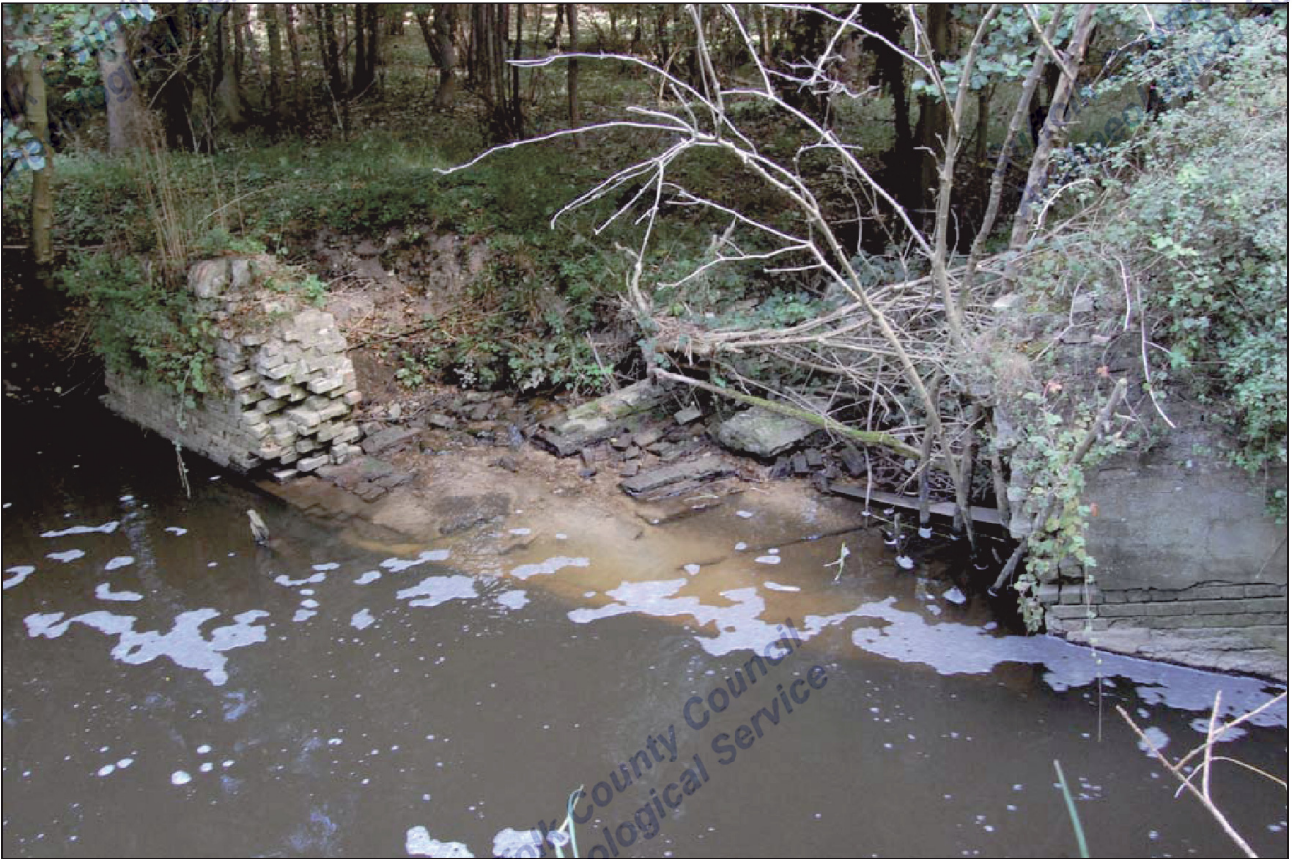
13. CUL 046, northern end, eastern wall damaged by secondary channel, looking NE

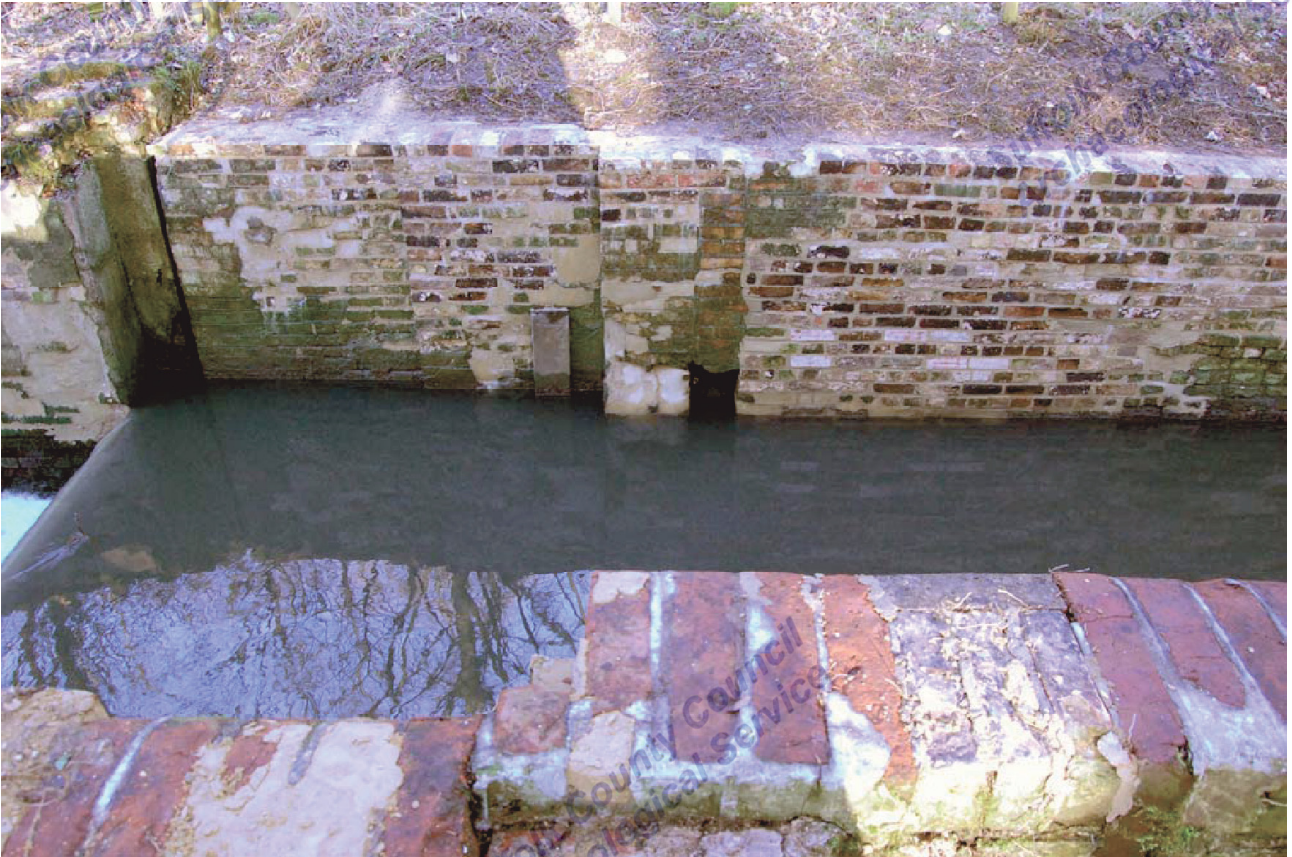
15. CUL 046, northern end, eastern wall timber recesses
