## **STRUCTURAL RECORDING REPORT**

SCCAS REPORT No. 2010/027

# **Hengrave Lock, Culford CUL 046 Cavenham Lock, Lackford LKD 034**

**R. Brooks**  
© February 2010  
[www.suffolkcc.gov.uk/e-and-t/archaeology](http://www.suffolkcc.gov.uk/e-and-t/archaeology)

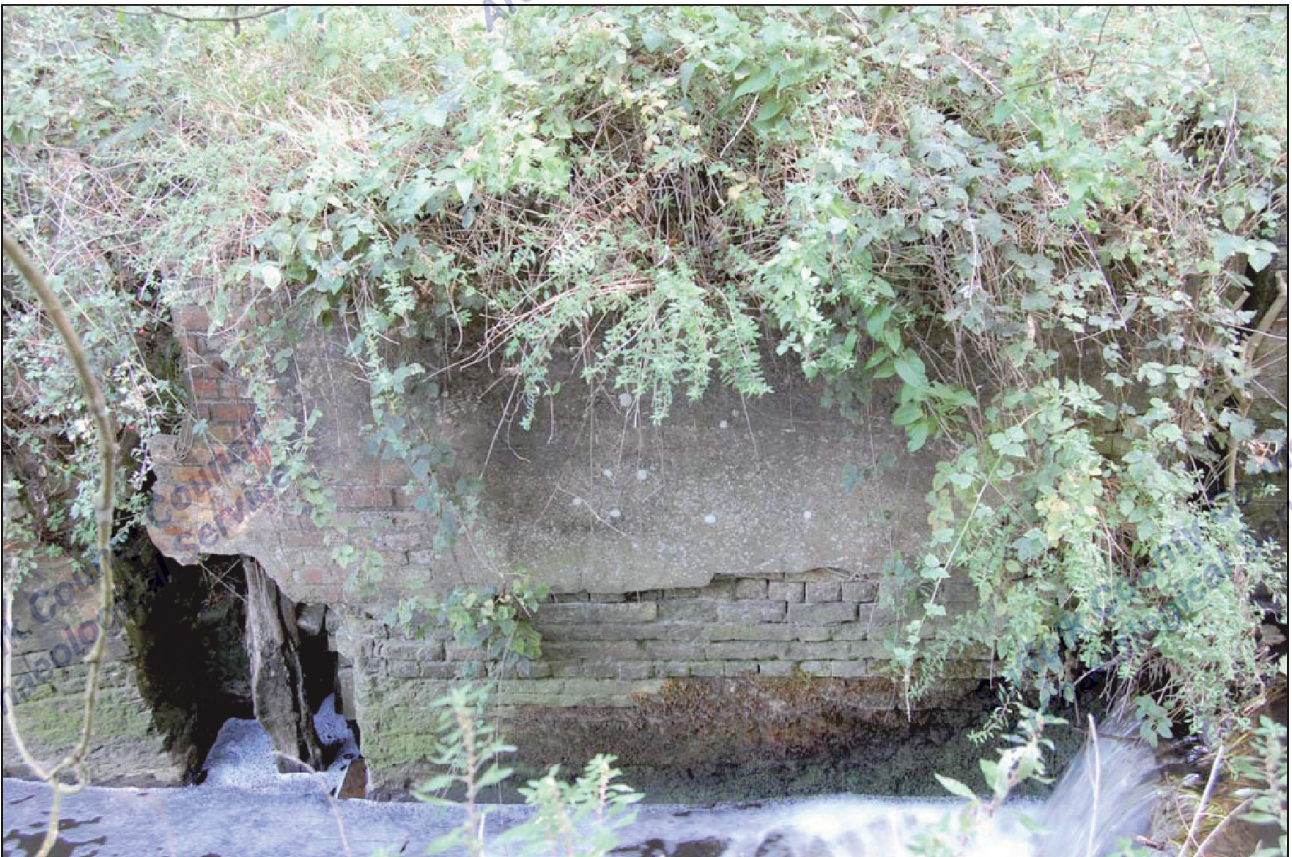
Timber *DD3* was inset within wall *CC2*. It was only visible where the wall had split, which was probably as a result of the structural weakness caused by the timber. The size and function of the post are unclear and it is uncertain whether it was present in *CC1*, although it is assumed that it was, as there appeared to be a corresponding area of damage on this wall also. It was covered with a layer of bricks and plaster and may have operated as a reinforcing rod.

16. CUL 046, northern end, eastern wall, exposed reinforcing timber

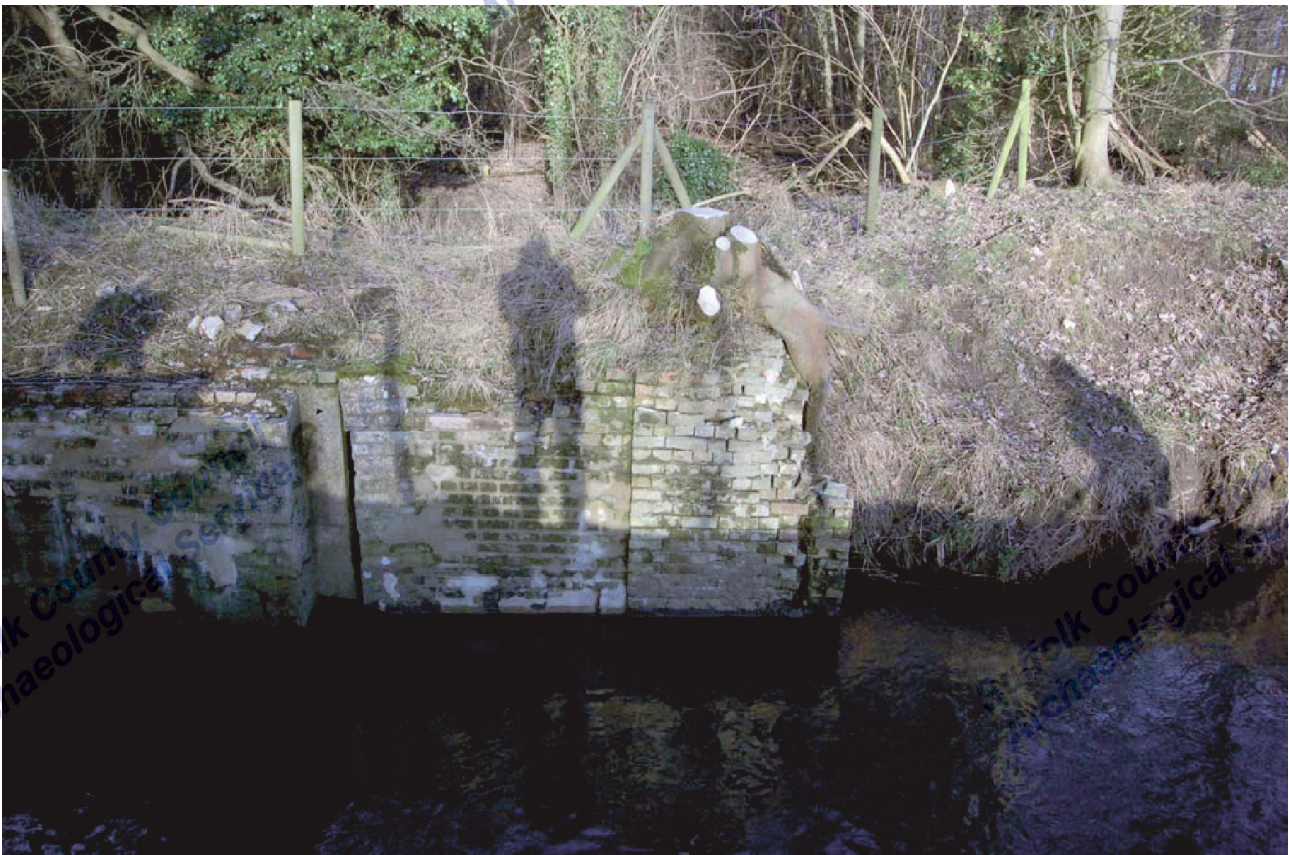
18. CUL 046, southern end, eastern side, timber recesses after cleaning
