## **STRUCTURAL RECORDING REPORT**

SCCAS REPORT No. 2010/027

# **Hengrave Lock, Culford CUL 046 Cavenham Lock, Lackford LKD 034**

**R. Brooks**  
© February 2010  
[www.suffolkcc.gov.uk/e-and-t/archaeology](http://www.suffolkcc.gov.uk/e-and-t/archaeology)

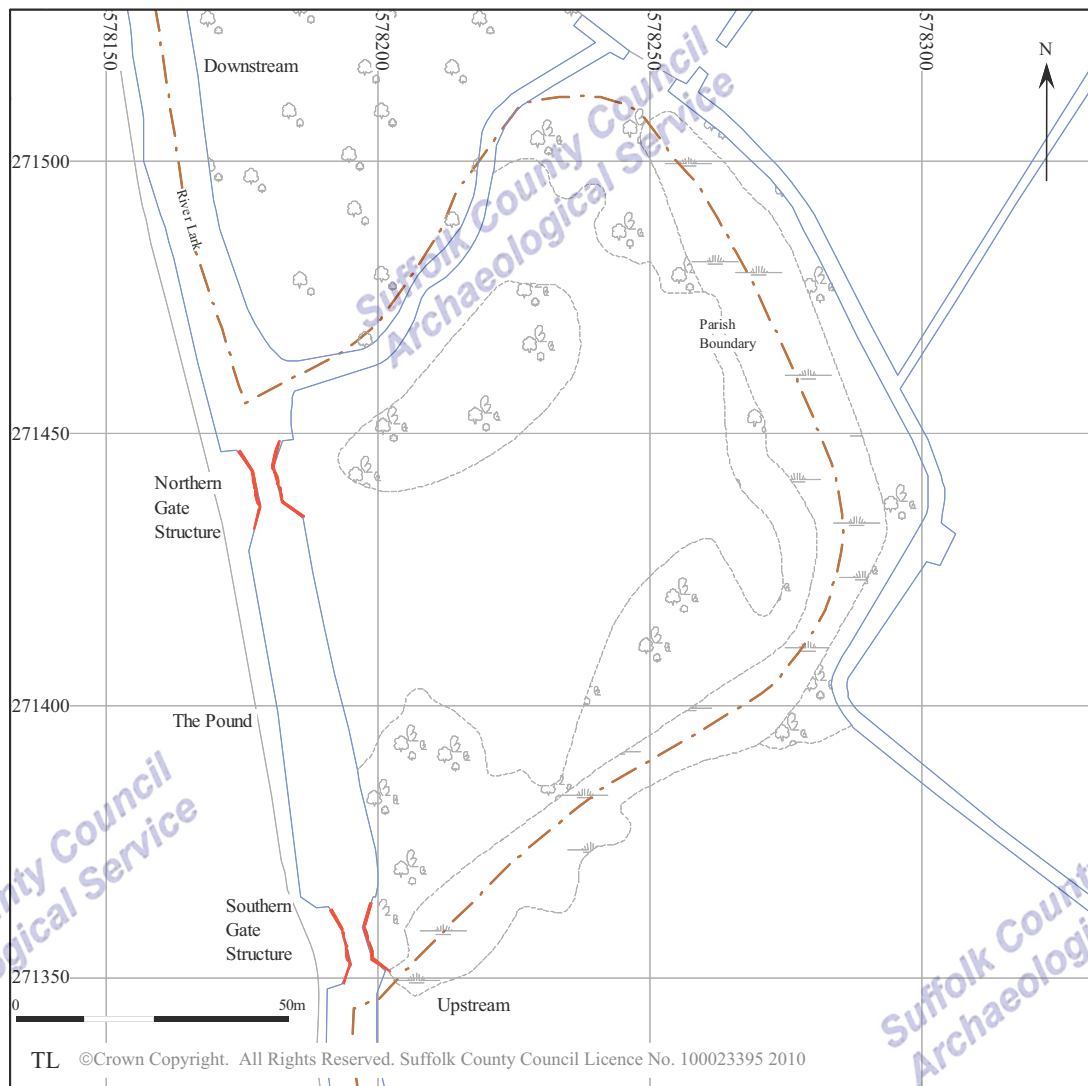
Figure 4. Cavenham Lock, LKD 034

Both of the lock gates and their superstructures had been somewhat damaged by the erosive and mechanical effects of the river and by the encroachment of vegetation. However, many of the original walls were still standing, and the base in each gate compound had survived partially, revealing how they were built, how they had been repaired and partially how they functioned. The results of this analysis were put together into a composite plan as shown on Figure 5.

The full dimensions of the wall structures as they survived, and measured from the points most distant points of A and B were, c.13.8-14.5m (NNW-SSE) x c.9-9.7m (WSW-ENE). According to the composite plan, the actual dimensions may have originally been closer to c.14.7m (NNW-SSE) x c.9.8m (WSW-ENE).

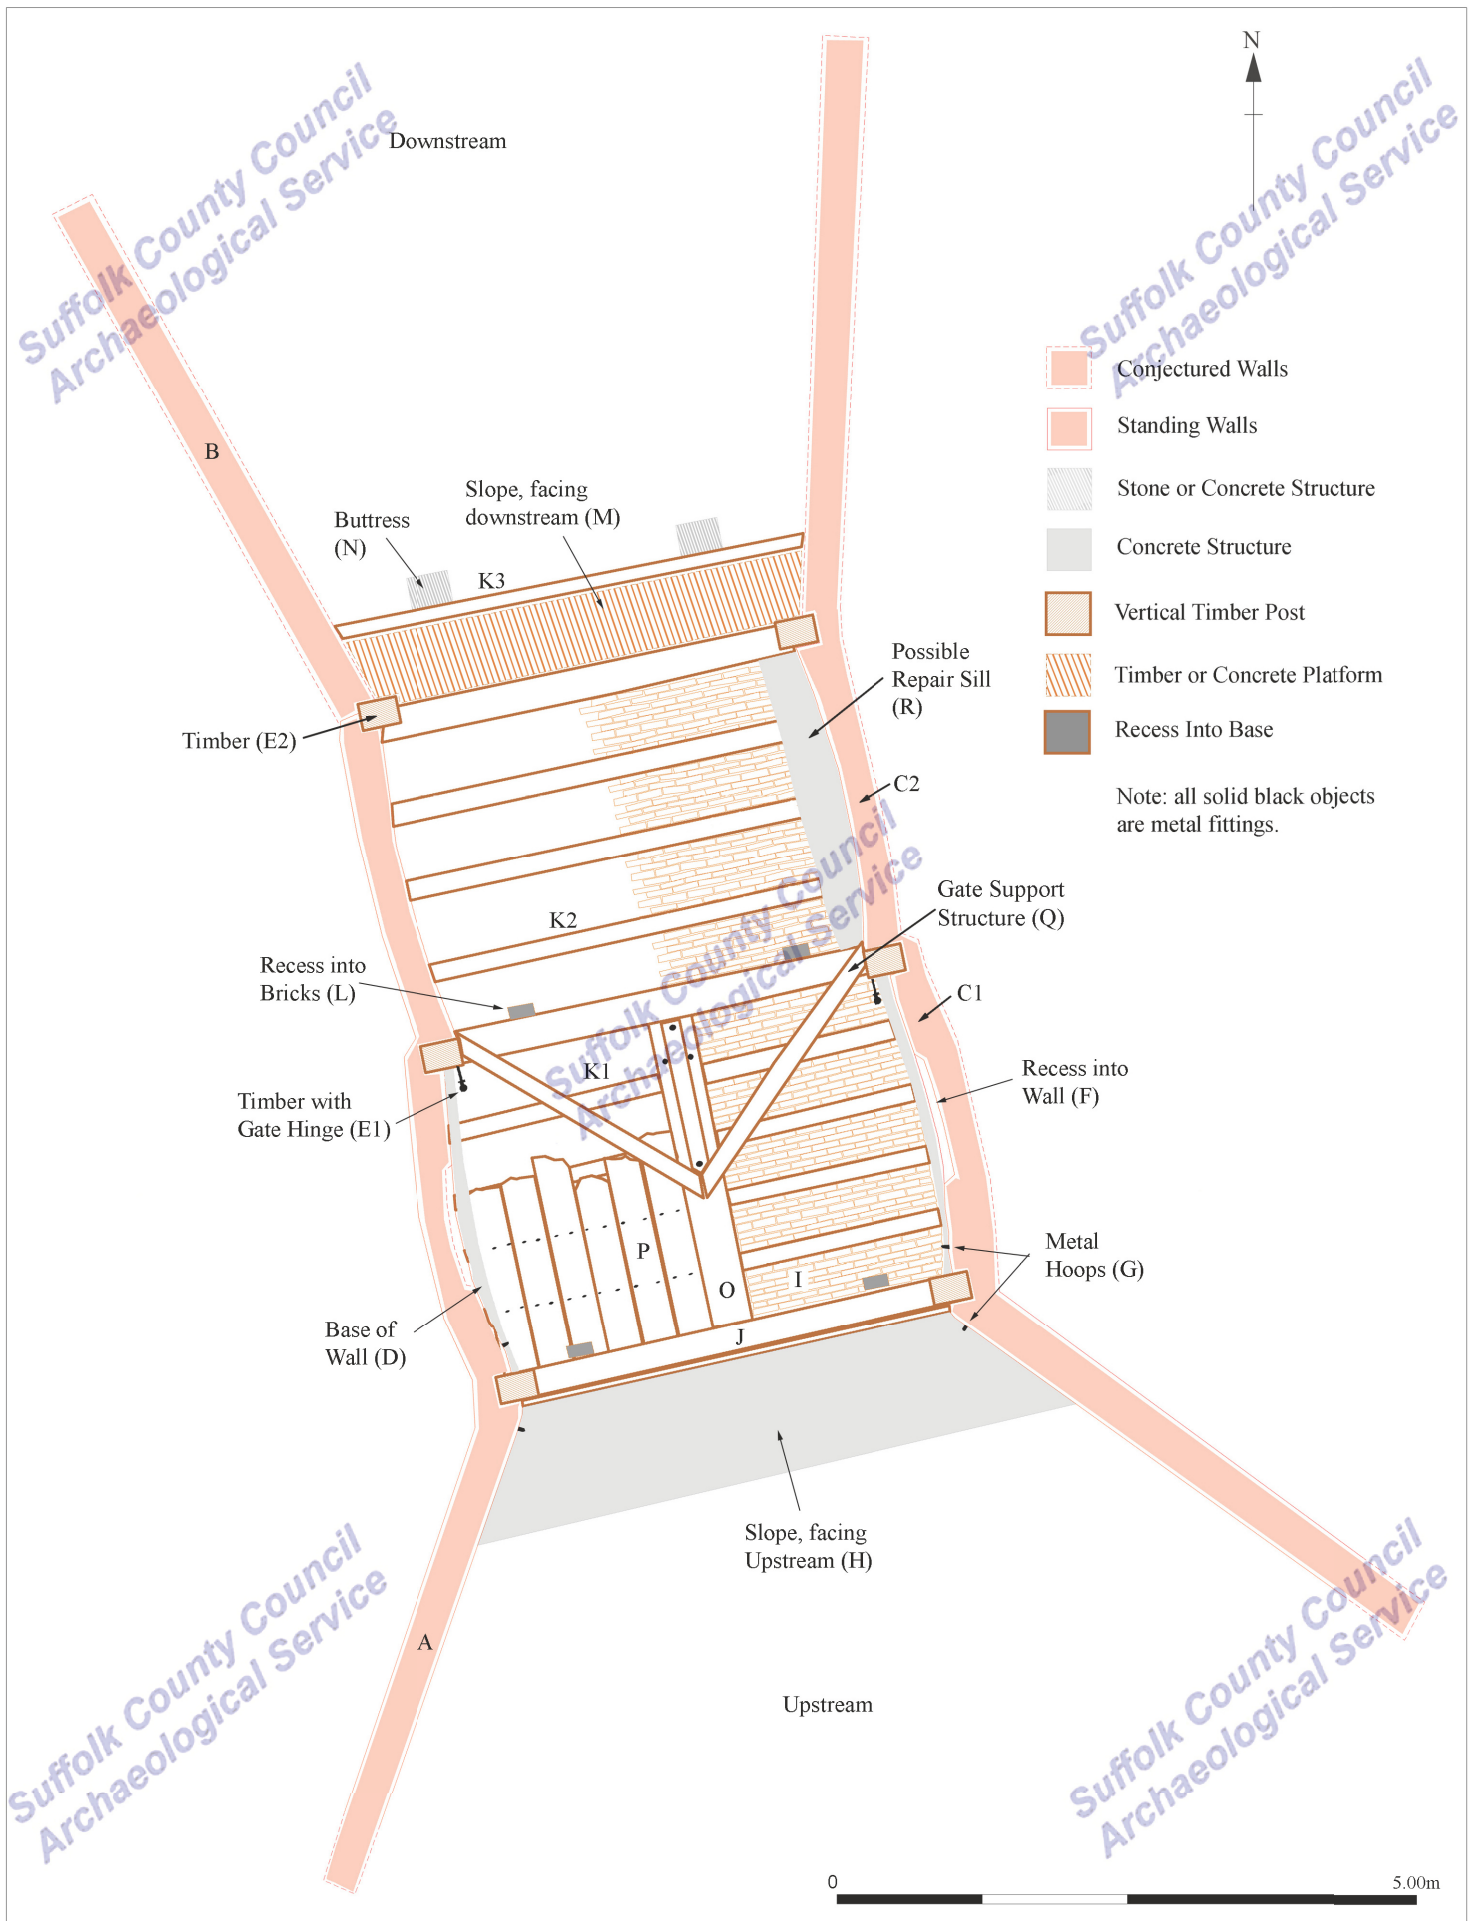
Figure 5. Composite plan of northern and southern lock structures for LKD 034

The upstanding parts of the lock gate structures consisted of two splayed brick 'arms' at each end (Fig. 5 – *A* and *B*), which channelled the water into and out of the main body (*C1* and *2*). This area was made up of two walls that both curved out gently at two points along their respective lengths. These measured 1.95m from the top brickwork to the water line. At the base of *C1* and *C2* was a concrete foundation/lip that emerged slightly from the face of the bricks (*D*). Where the walls both initially first curved out on *C1*, a recess was visible that was c.0.5m deep and ran from approximately halfway up the wall to below the waterline, at c.1m wide x >1.05m tall (Figs. 5 and 6 - *F*). It is assumed that this recess may have housed part of the lock gates when they were open and thus abutting the wall. Set into the southern end of *C1* were

The northern and southern gate structures had bases made up of wooden, brick, concrete, metal and possibly stone components (Fig. 5, *H-P*). At the southern end of each was concrete ramp (*H*). This extended 1m from the main brick and timber structure of the base. At its highest point it was c.0.2m lower than the rest of the surviving base. At the northern end of each structure was another sloped platform, on this occasion facing downstream (*M*). It is uncertain whether this was made up of timber or concrete and it emerged c.0.6m from the northern *J* timber. Bounding the end of this structure was timber *K3*, which itself was then held in place by two stone or concrete buttresses (*M*). The floor of the lock structure was higher than the river bed and the sloping ramps at the entrance and exit to each lock gate helped channel the water through. The upstream ramp would have prevented eddying water from scouring out the river bed and undermining the lock and was made of concrete, suggesting it was a recent repair. The downstream ramp would have aided the entrance of the barges.

The gate structures were floored with wooden boards (*P*), which ran longitudinally. The floor boards were attached with pairs of nails to closely spaced sill beams (*K*), which ran across the width of the lock and were secured between panels of bonded brickwork (*I*). The timber flooring survived only partially in the northern structure, but the presence of the various sill beams across the lock bases suggests that the entire floor of the structures was once boarded over. The use of floor boards across the base of the locks would have both protected the hull of the boats and the lock base and were probably replaced regularly. The bricks were laid out in a stretcher bond and measured 0.225m long x 0.045m tall (*I*). In the southern half of the base the bricks were laid in 7 courses. Elsewhere it was unclear. Four recesses were seen within the bricks (*L*). It is assumed that these functioned as the fixing point for some feature, such as a stud to secure the large *J* timbers.

Forming part of the frame around the bricks were three large timbers (*J*), which joined to the base of the vertical timbers *E1* and *2*. They measured c.0.25m wide x >3.6m long. On the same alignment were several other timber struts (*K1-3*). Those in the southern half of each structure were the smallest, as they abutted timber *O*, measuring c.0.15m (NNW-SSE) x c.1.85 (WSW-ENE) (*K1*). Those in the northern half also measured c.0.15m (NNW-SSE), but stretched the full width of the base at c.3.8m (WSW-ENE) (*K2*). *K3* was at the far northern end of the bases and was c.0.14m (NNW-SSE) x 4.1m (WSW-ENE).

Running perpendicular to the *K* and *J* timbers was timber *O*. It abutted the central and southern *J* timbers. With the central *J* timber, *O* formed the primary fixing structure for the gate support structure (*Q*). *O* measured c.0.3m (WSW-ENE) x c.2.65m (NNW-SSE).

The uppermost structures in the bases were the three timbers that made up the Gate Support Structures (*Q*). These formed the shape of an arrow pointing upstream and would have helped to support the base of the gates, secured to *E1*, when they were shut. The central timber of this structure was secured to timber *O* with two large metal rods. It is likely that the two other timbers were similarly fixed to *O* and the central *J* timber in order to withstand the high mechanical pressure applied by the gates.

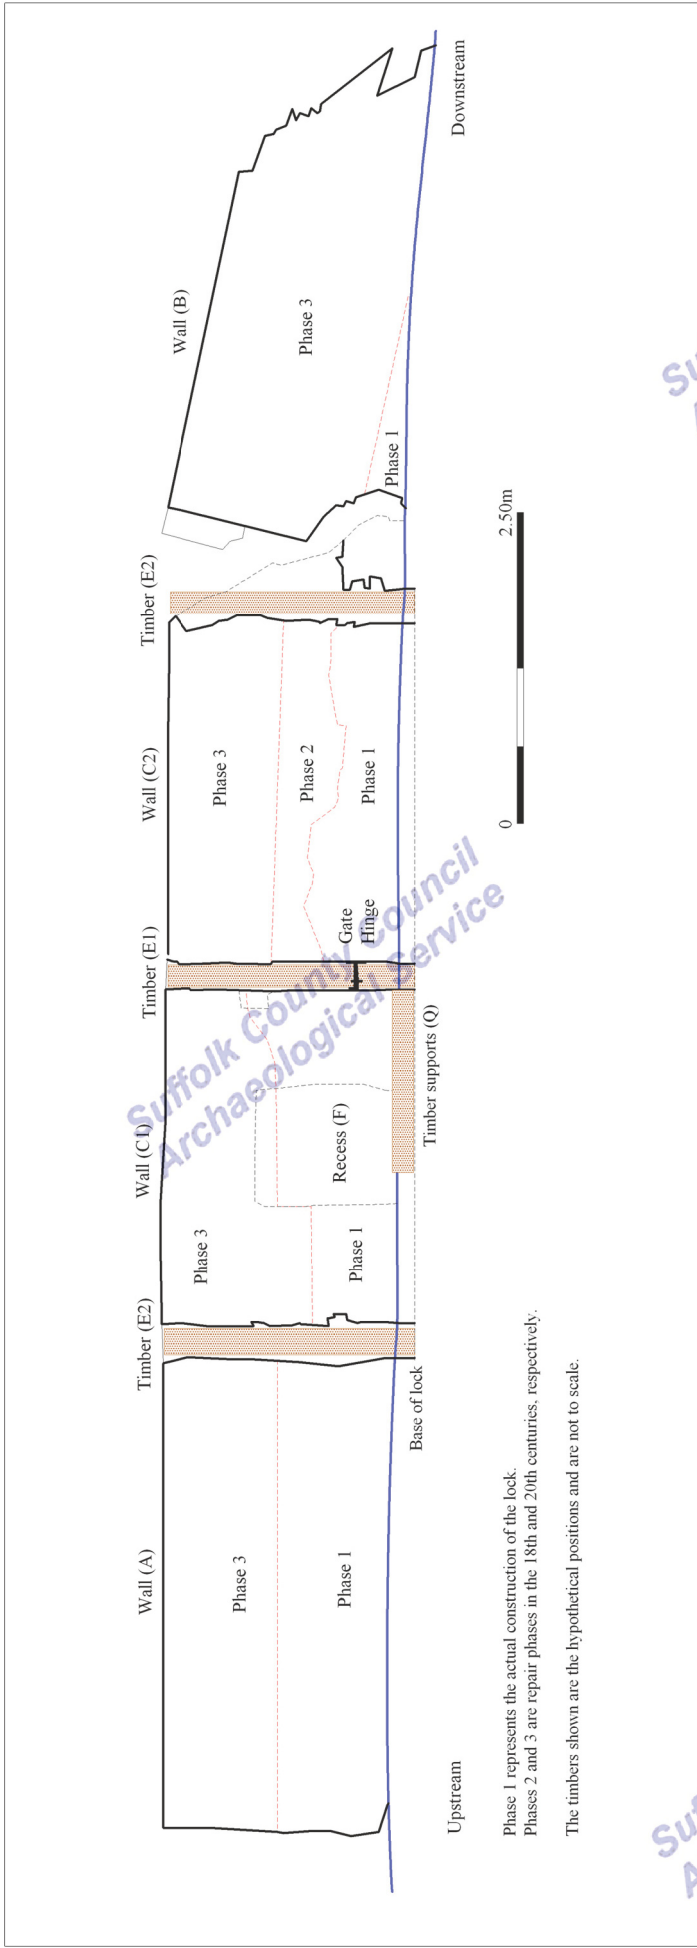
Figure 6. Elevation of Cavenham Lock, Southern structure, West side phasing

The bricks in the second phase of construction are likely to be of late 18th century date, measuring 9" x 4<sup>1/4</sup>" x 2<sup>1/2</sup>" or 0.23m x 0.11m x 0.06m (Floyd, 1925). This date coincides with the period during which Sir Thomas Gery Cullum had inherited the river and started repairs on many of the existing structures. As such it is probable that Phase 2 was part of Cullum's repair programme. Although only partly visible, the amount of repair work needed seems to have been quite substantial, as is shown by the depth of the repairs on Wall C2, Figure 6.

A third phase of work is also visible in the Cavenham Lock. The bricks are clearly of early-mid 20th century date, being London Brick Company Flettons. These repairs were obviously as extensive, if not more so, than those in Phase 2, as again shown by the large depth of bricks that were required in Wall B, Figure 6.

At some point another undated repair also took place on the Cavenham Lock. It may well have been part of Phase 3 but cannot be fully identified. This involved the replacement of the presumably damaged *P* boards with a concrete sill *R* (Fig. 5). Whilst this did not run across the full width of the base, it would have served to keep the *K1* and *K2* boards in place. It is thought to be a repair rather than an original feature because it showed no timber impressions.

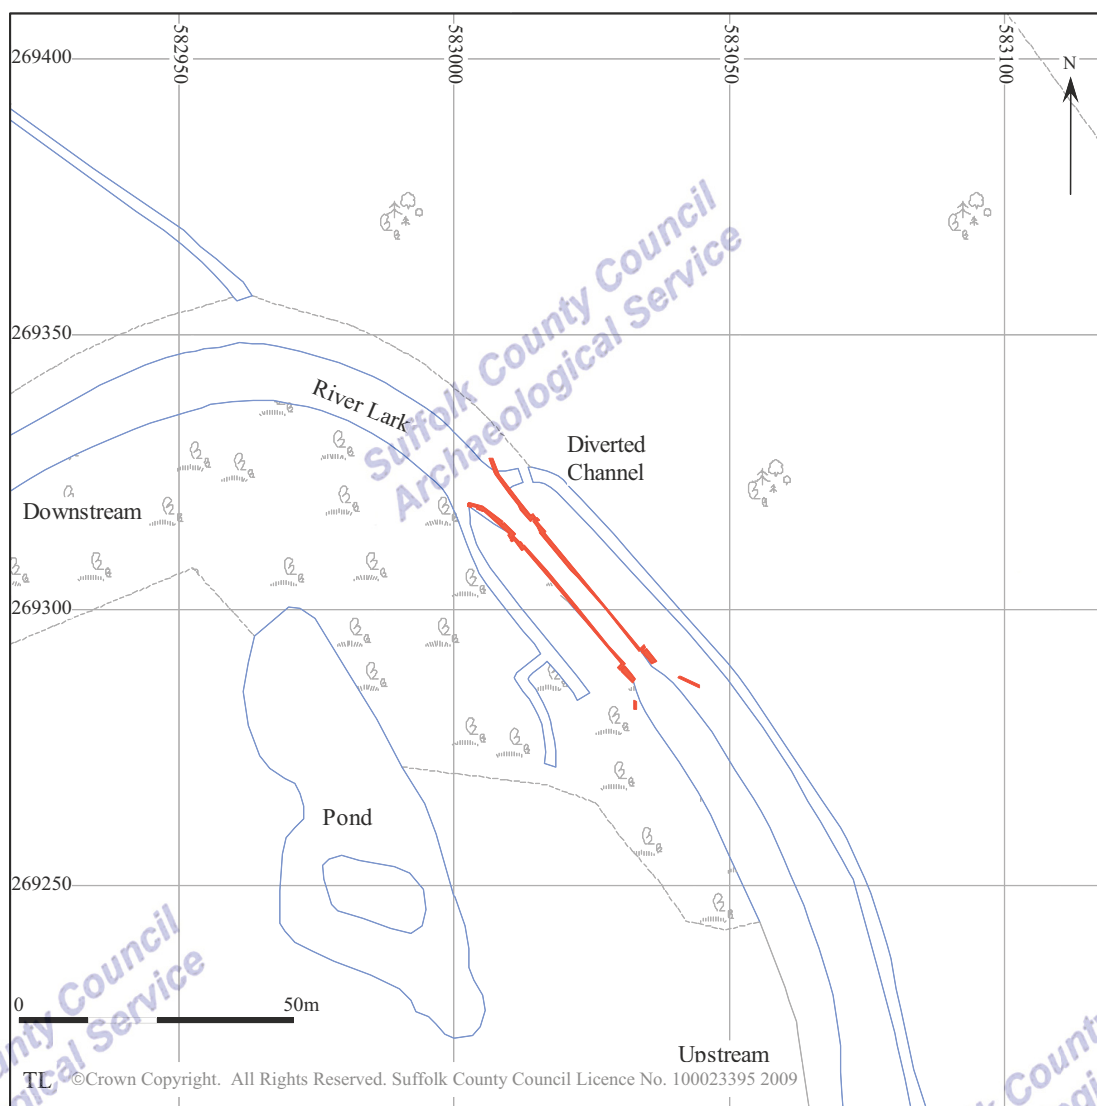
Figure 7. Hengrave Lock, CUL 046

Significant parts of the end walls of the Lock had been damaged by water movement. However, the path of the walls at the northern end could both still be seen, but much of the southern end had collapsed, and as a result the plan of the structure is partly based on assumption.

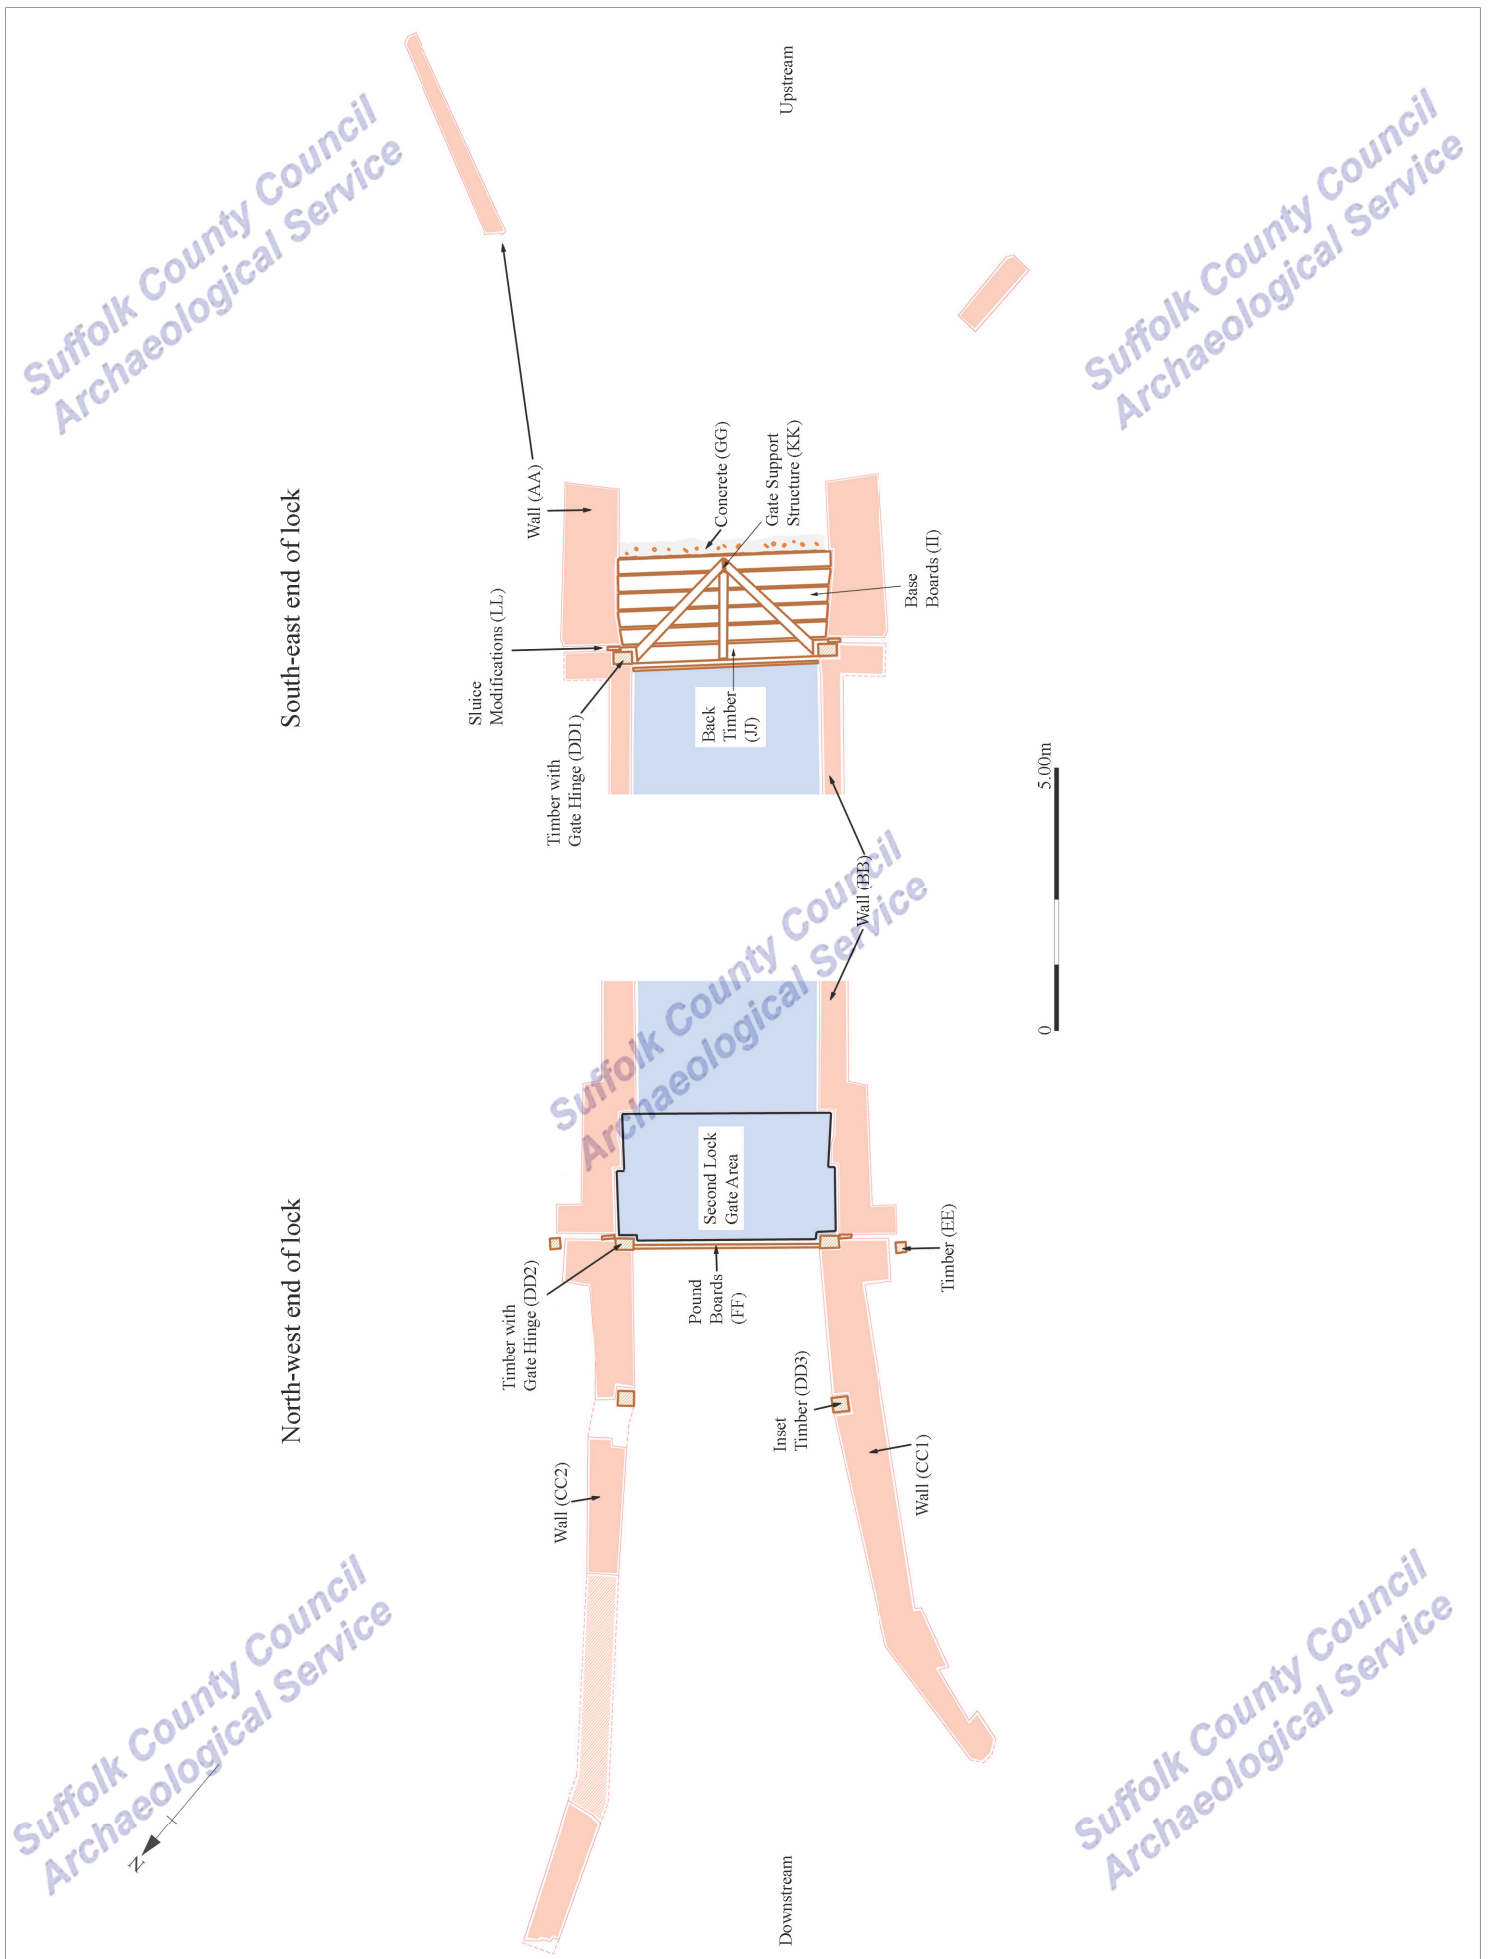
Figure 8. Plan of NW and SE ends of Hengrave Lock Gate Structures

The walls running along each side of the lock made up the main upstanding structures. Each was made up of three sections of wall, including the splayed and heavily damaged south-eastern walls (Fig. 8 - AA). These had been largely broken up by water movement and their original layout was uncertain. However, it is likely from the remaining structures that the end of the north-eastern wall was c.12.3m long and extended c.12m from the parallel *BB* wall, whilst the south-western wall was at least 8.2m long and extended c.7.7m from the *BB* wall. There were no other details clearly visible on the *AA* walls although their main function was to channel the water into the lock body.

The main length of the lock was made up of the parallel *BB* walls. At the surface these appeared to be separated from the *AA* and *CC* walls by a slight gap. They measured c.30.9m (NW-SE) x c.0.35-0.6m thick (SW-NE). Although the Pound area of lock contained a high quantity of rubble and refuse, and was heavily silted up, it is clear that the *BB* walls were >2m tall. The depth of the water in this area, along with the material making up the base of the lock made it too dangerous to physically enter and record the lock between these walls. However, the TST survey of the north-west end of the Pound area clearly outlined a second lock gate area, identical in outline to that which was still intact at the south-east end. This area is shown on Figure 8.

Various vertical timbers were either secured to the walls of the lock, or appeared to be physically inset (*DD1-3*). The rebates for the *DD1* timbers were still clearly visible within the south-eastern end of the structure, measuring 0.34m (NE-SW) x 0.22m (NW-SE). At the base of these slots, a mortice was also visible where these timbers fixed partially into the brick and concrete of the lock and also into one of the base timbers (Figs. 8 and 10 – *DD1*). This is probably also how the vertical *J* timbers at Cavenham Lock were fixed to the base. It is likely that these *DD1* timbers also functioned as the gate supports at this end. The *DD2* timbers were probably identical to the *DD1* posts. However, because the area where they were located at near the north-west end of the structure was completely overgrown, it was impossible to see the presence of any posts or rebates.

Timber *DD3* was inset within wall *CC2*. It was only visible where the wall had split, which was probably as a result of the structural weakness caused by the timber. The size and function of the post are unclear and it is uncertain whether it was present in *CC1*, although it is assumed that it was, as there appeared to be a corresponding area of damage on this wall also. It was covered with a layer of bricks and plaster and may have operated as a reinforcing rod.

The lowest section of the base was made of concrete with small stones inset (*GG*). This was irregular and could only be seen emerging slightly from the base of the timber structure. It would probably have worked as a foundation for the timber structures. Overlying this was the base timbers, (*II*). These were c.0.3m (NW-SE) x c.4m (NE-SW) a 0.12m thick, and fixed to the rest of the structure by a series of nails. On the north-west end of these was timber *JJ*. This was a substantial timber, similar to the *J* timber at Cavenham Lock. This was 0.28m (NW-SE) x c.3.95m (NE-SW). It functioned to secure the *DD1* and *DD2* timbers. Flush with the top of *JJ* was a series of thin horizontal slats (*FF*) than ran down to the base of the Pound enclosure. The dimensions of these were unclear. *FF1* represents part of the original structure. However, the *FF2* boards were more recent additions, at a higher level than the south-west gate base, which seemed to function to block entrance to that end of the lock.

The uppermost part of the gate structure was *KK*, the gate support. This, as with *Q* at Cavenham, was arranged in an arrow form, facing upstream and was also presumably fixed to the base in a similar manner. The central timber was 0.15m (NE-SW) x c.1.65m (NW-SE), whilst the other pieces were 0.2m (E-W) wide x c.2.4m (N-S) long.

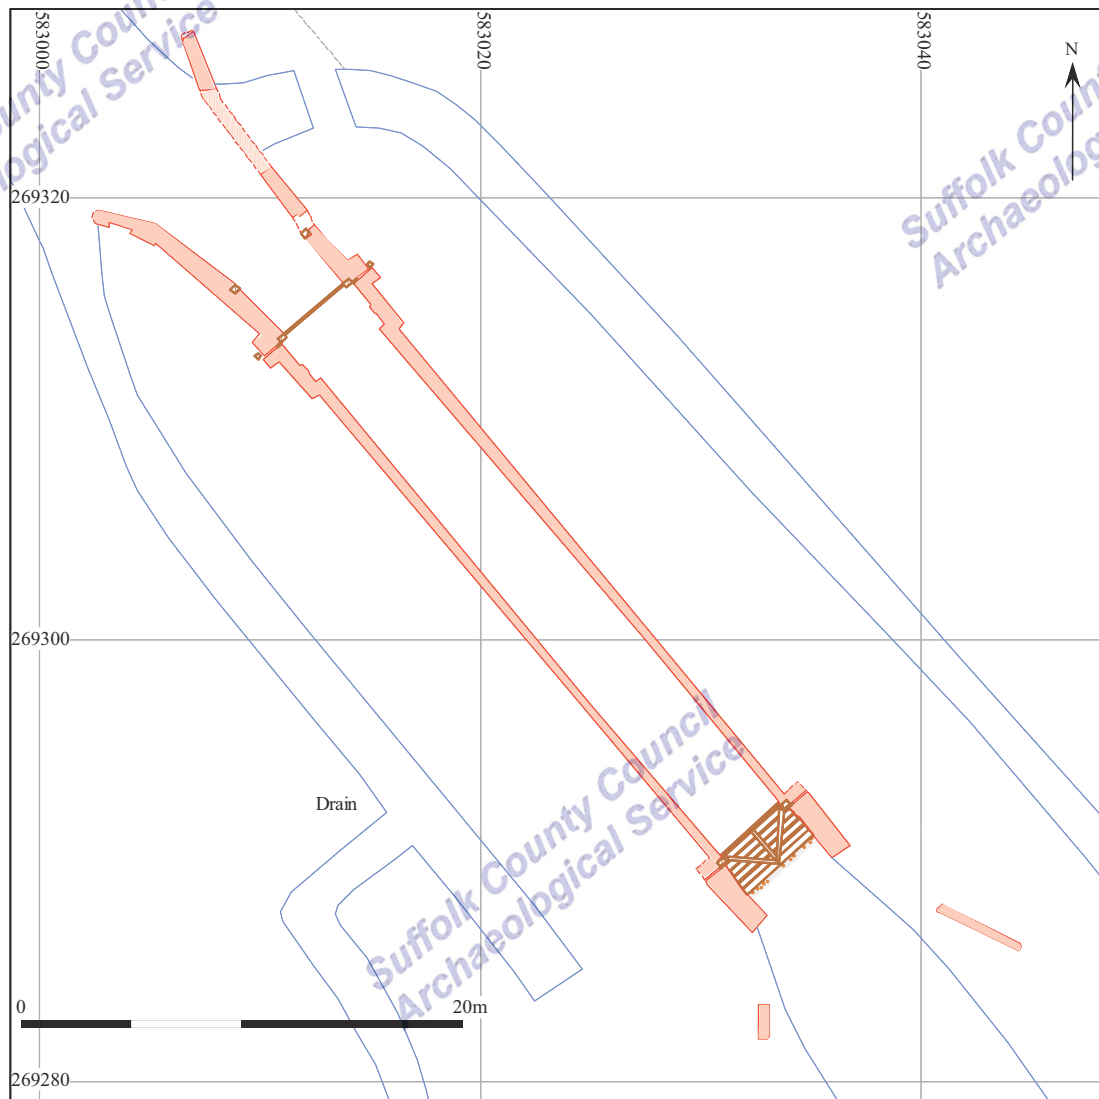
Figure 9. The full layout of the Hengrave Lock structure as it now stands

The Hengrave Lock structure measures 56.2m (NW-SE) x >12.5m (NE-SW) (Figs. 7 and 8). Although a single structure, the lock is made up of three abutting but separate sections. These consist of the two gate areas, including splayed walls, and the central pond. As at Cavenham Lock, the gates had either been destroyed or removed. The lock is asymmetrical with the north side splaying walls being longer than those on the southern end and this is thought to be an attempt to control the side channels and to respect and utilise the shape of the river bank.

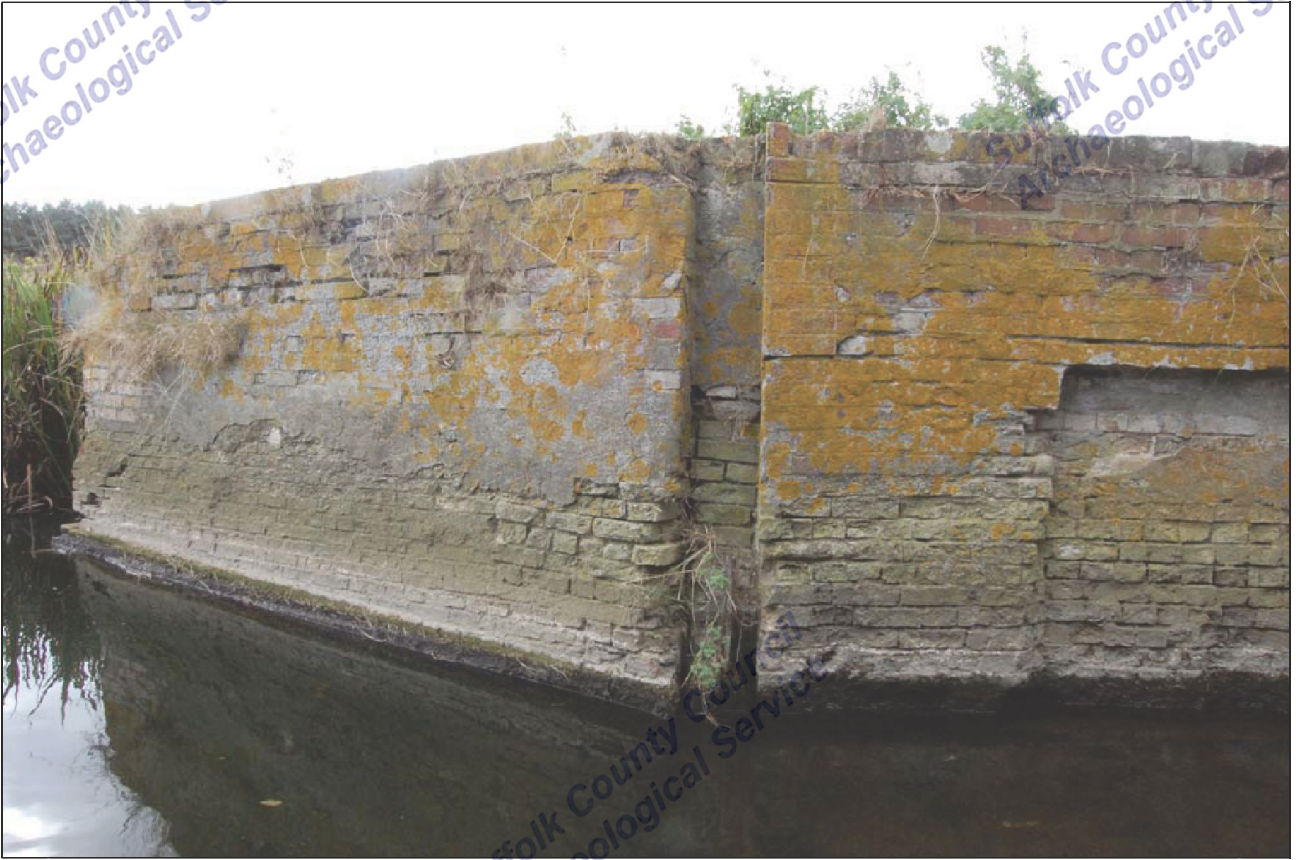
1. A-type wall, LKD 034, southern structure, western side

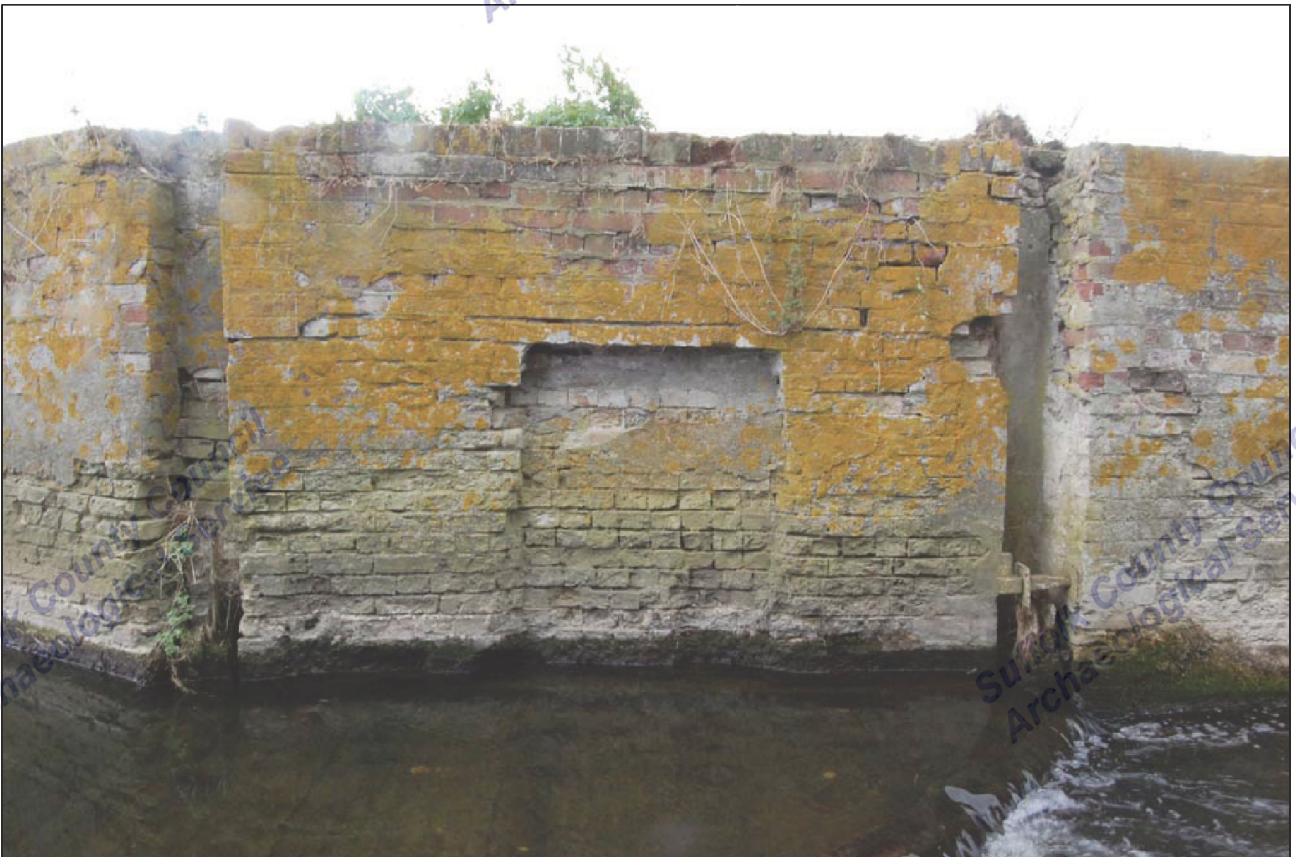
2. C1-type wall, LKD 034, southern structure, western side

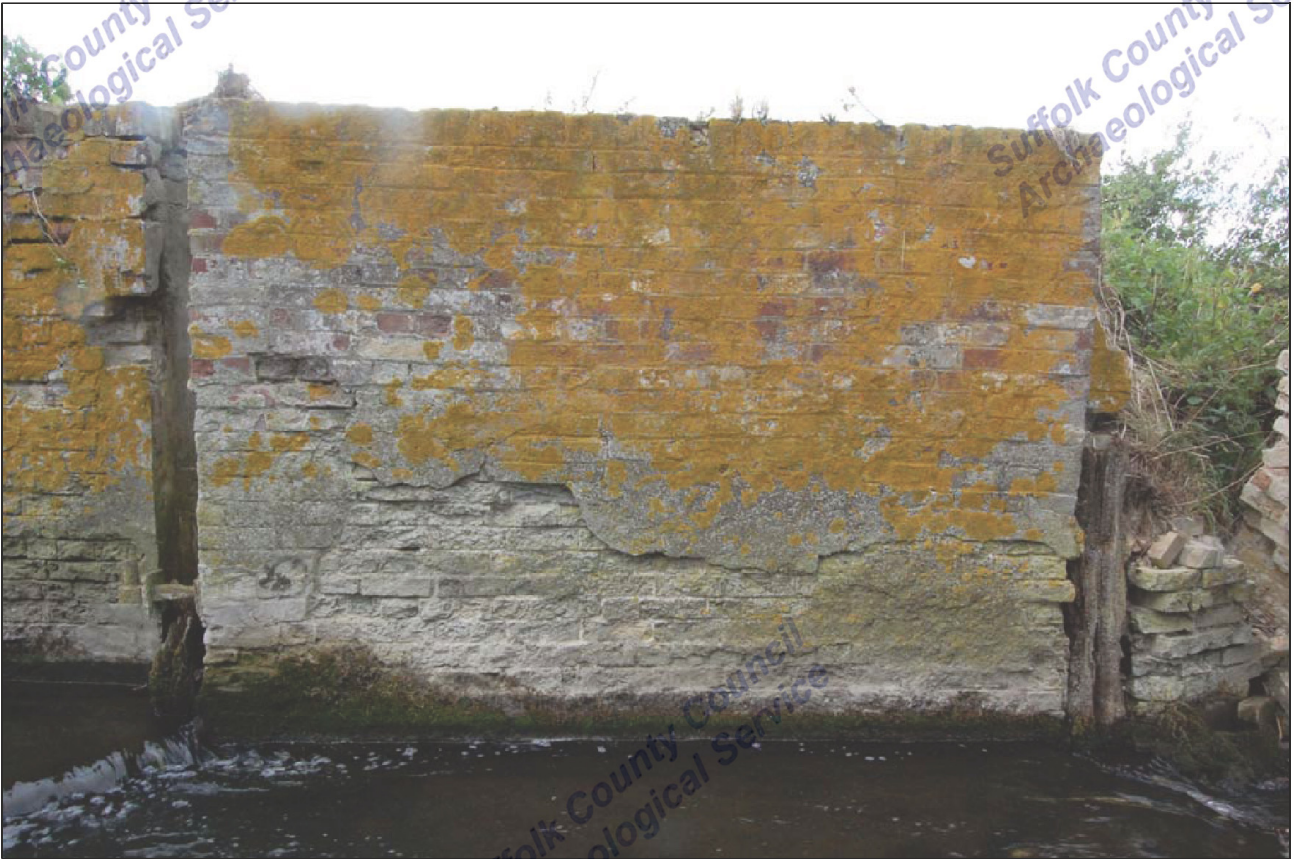
3. C2-type walls, LKD 034, southern structure, western side

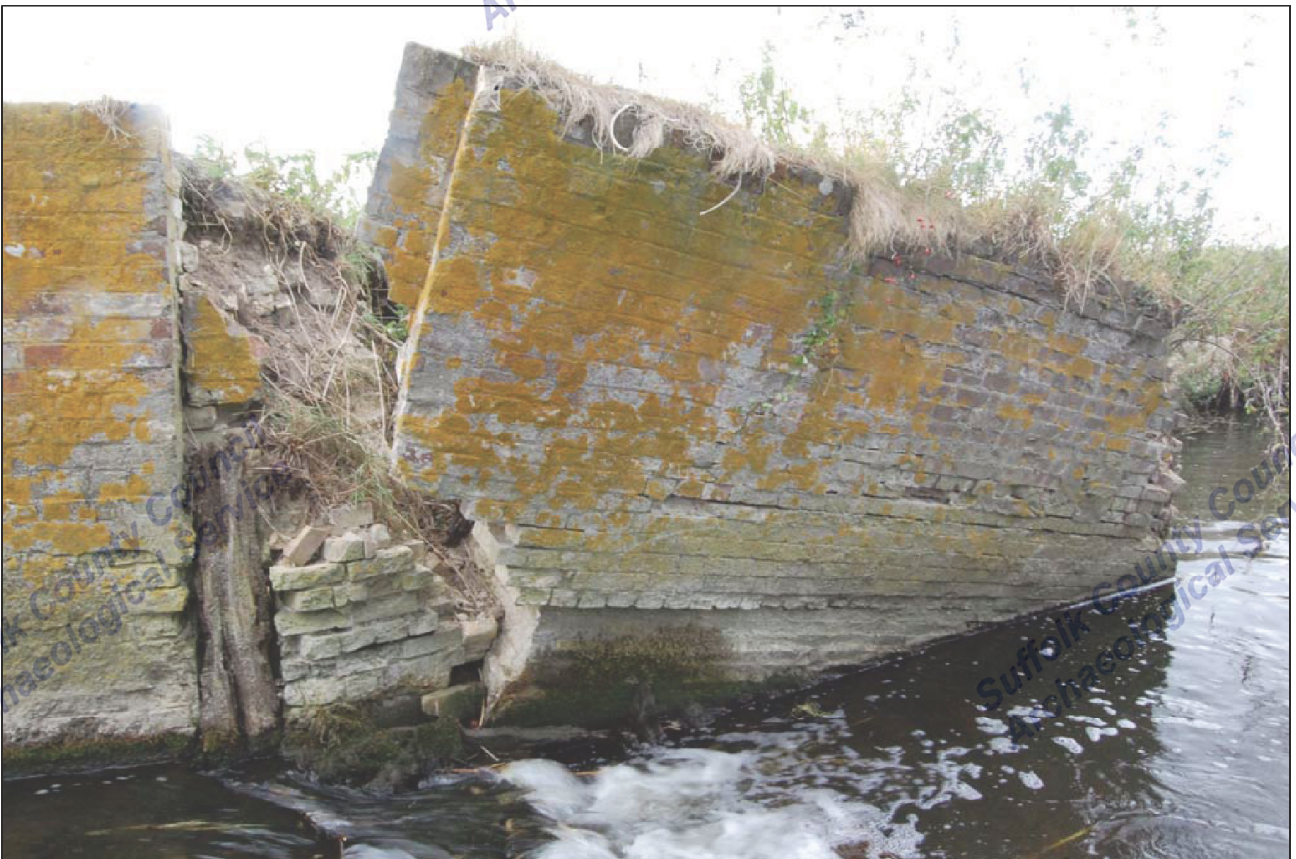
4. B-type walls, LKD 034, southern structure, western side

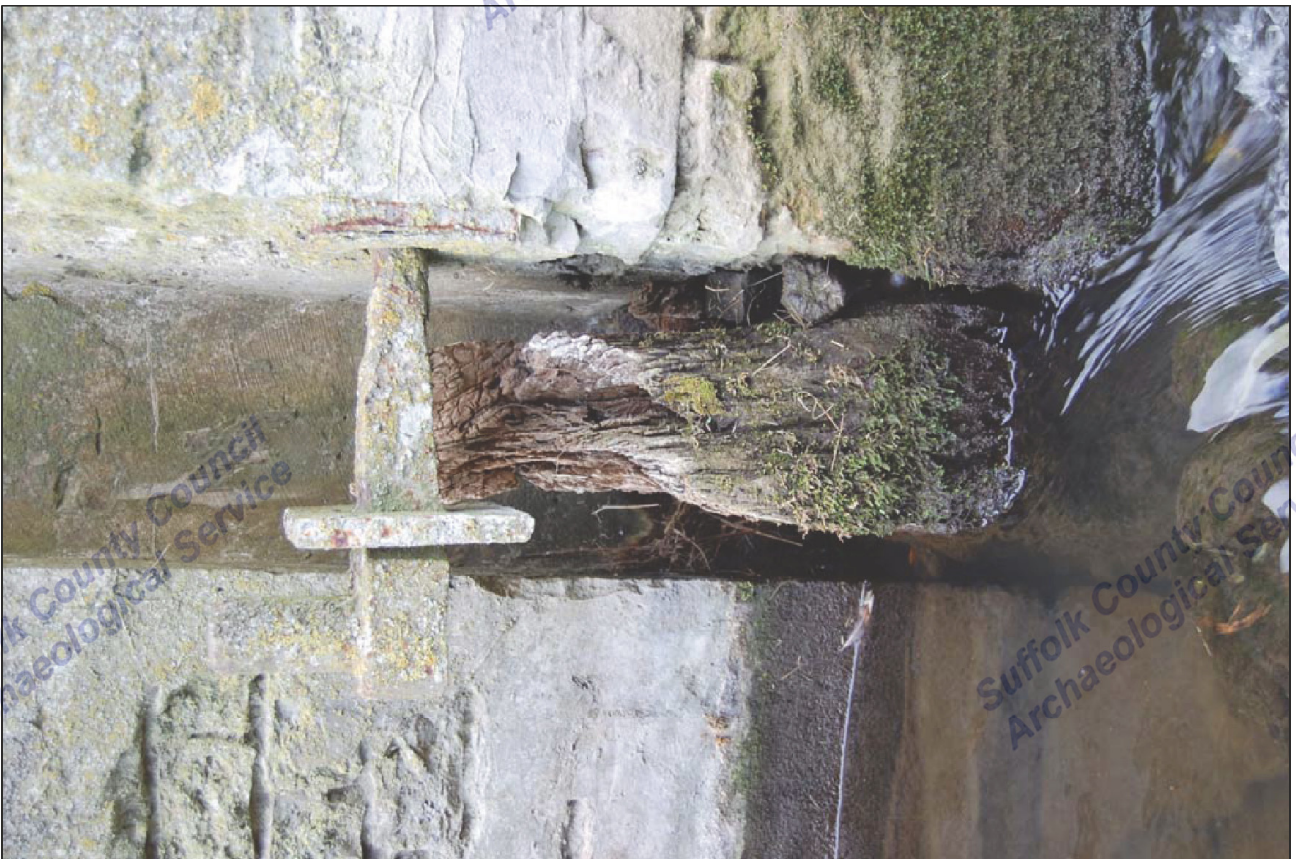
8. LKD 034, *In-situ* gate hinge, southern structure, western side

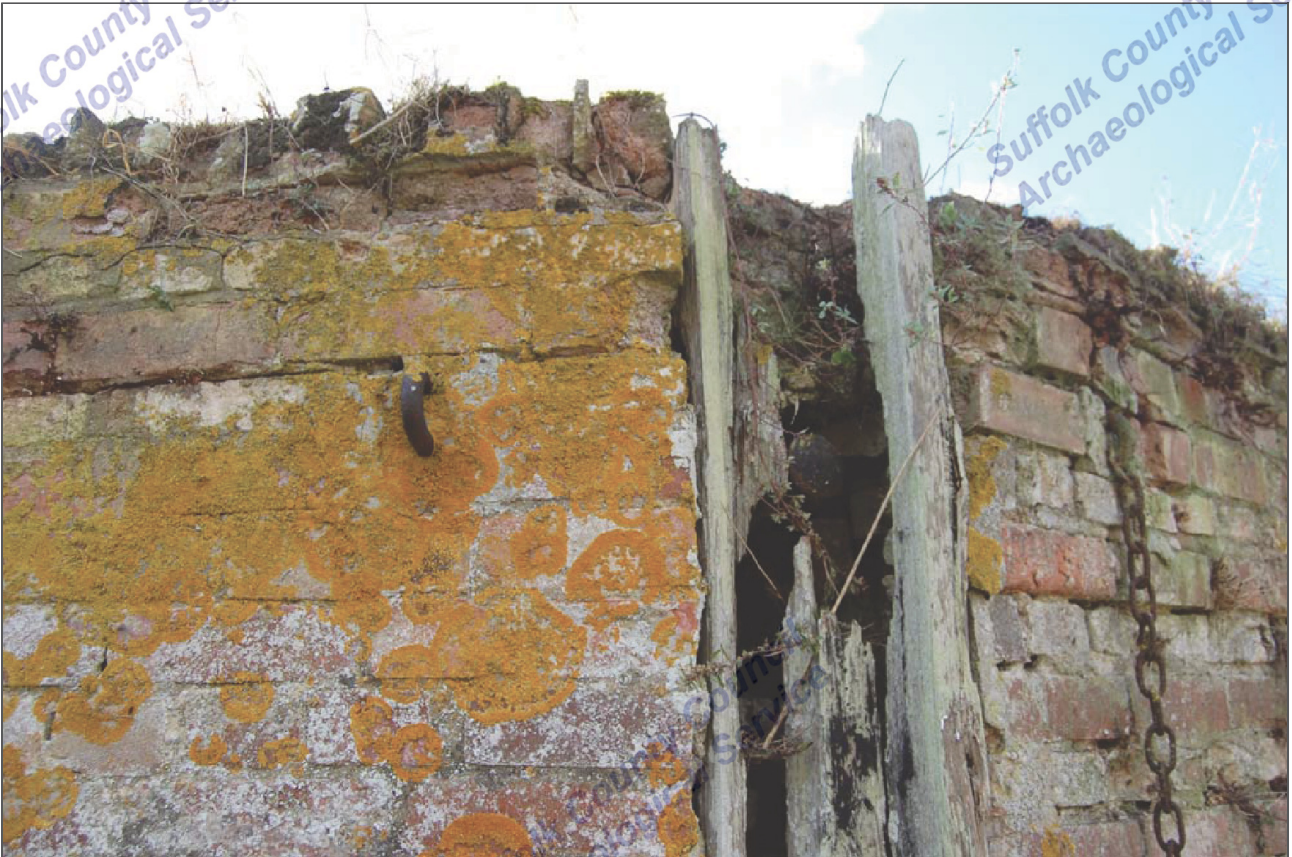
9. LKD 034, northern lock structure, western side, chain and hoop

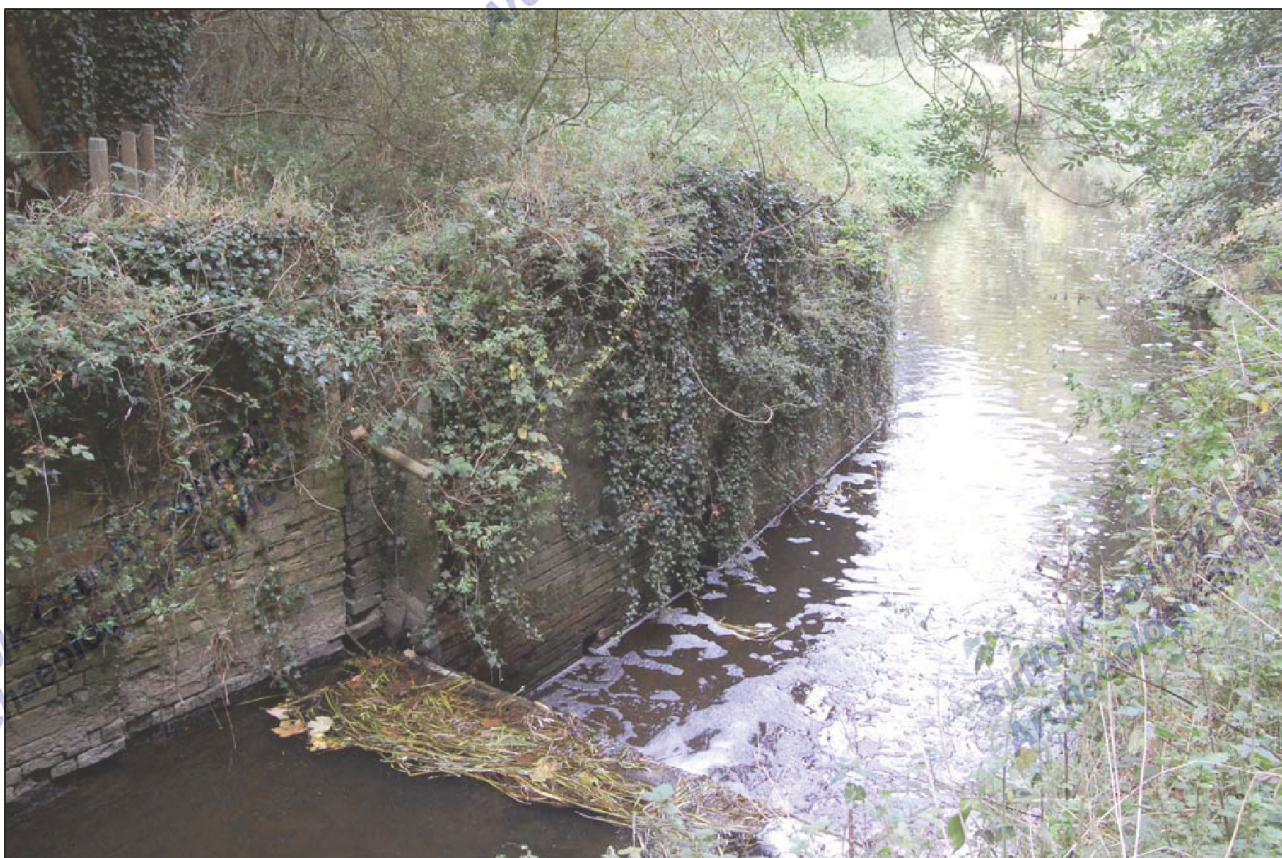
12. CUL 046, Lock structure, northern end, intact wall, looking NW
