## **STRUCTURAL RECORDING REPORT**

SCCAS REPORT No. 2010/027

# **Hengrave Lock, Culford CUL 046 Cavenham Lock, Lackford LKD 034**

**R. Brooks**  
© February 2010  
[www.suffolkcc.gov.uk/e-and-t/archaeology](http://www.suffolkcc.gov.uk/e-and-t/archaeology)

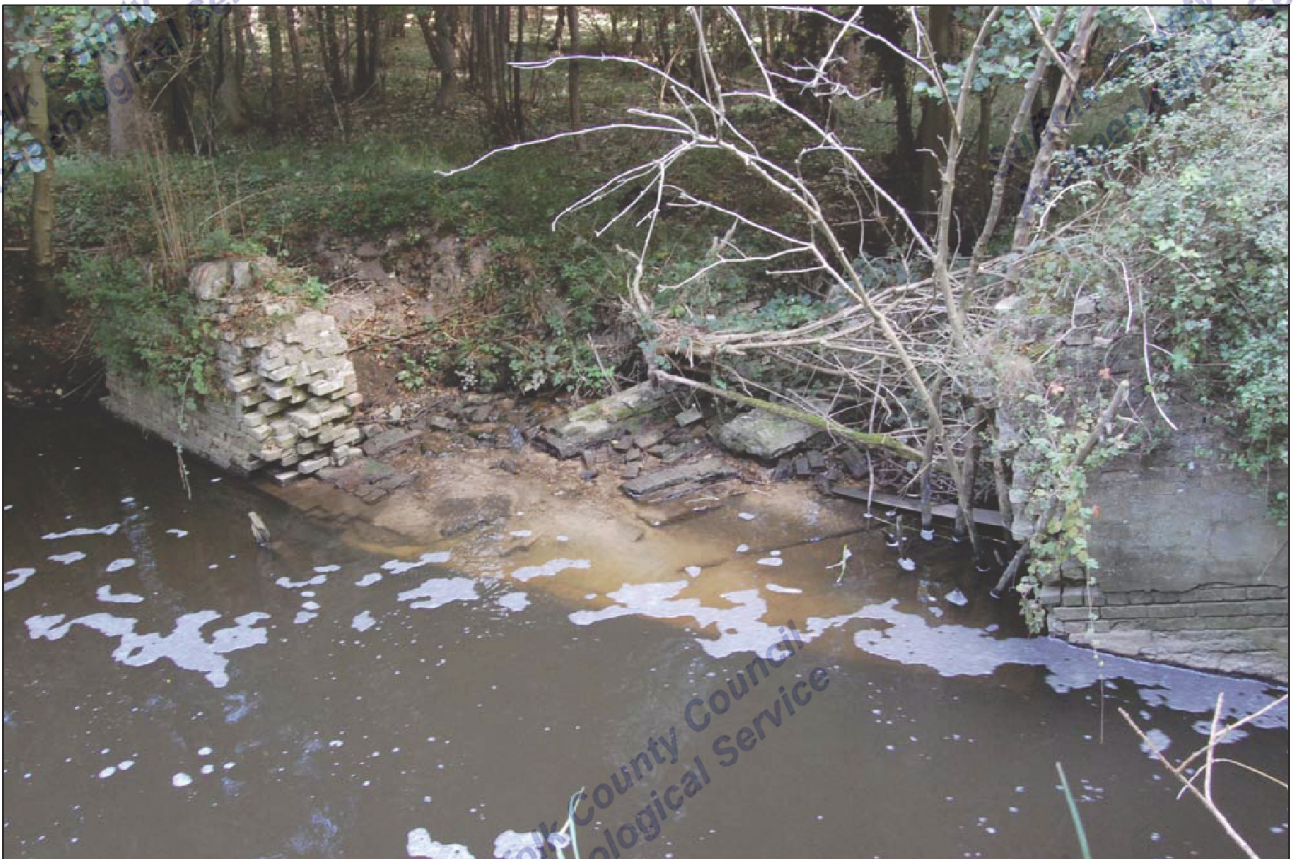
13. CUL 046, northern end, eastern wall damaged by secondary channel, looking NE

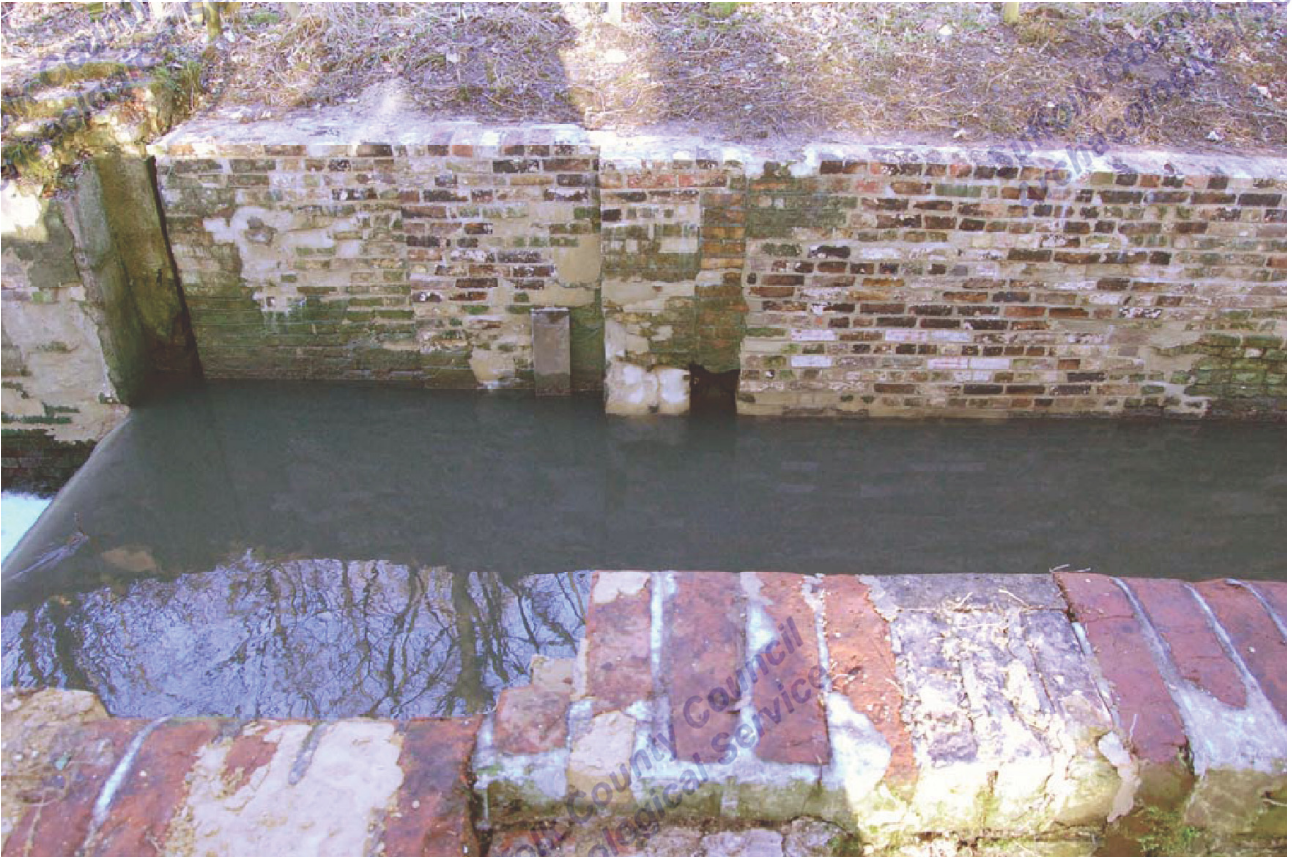
15. CUL 046, northern end, eastern wall timber recesses

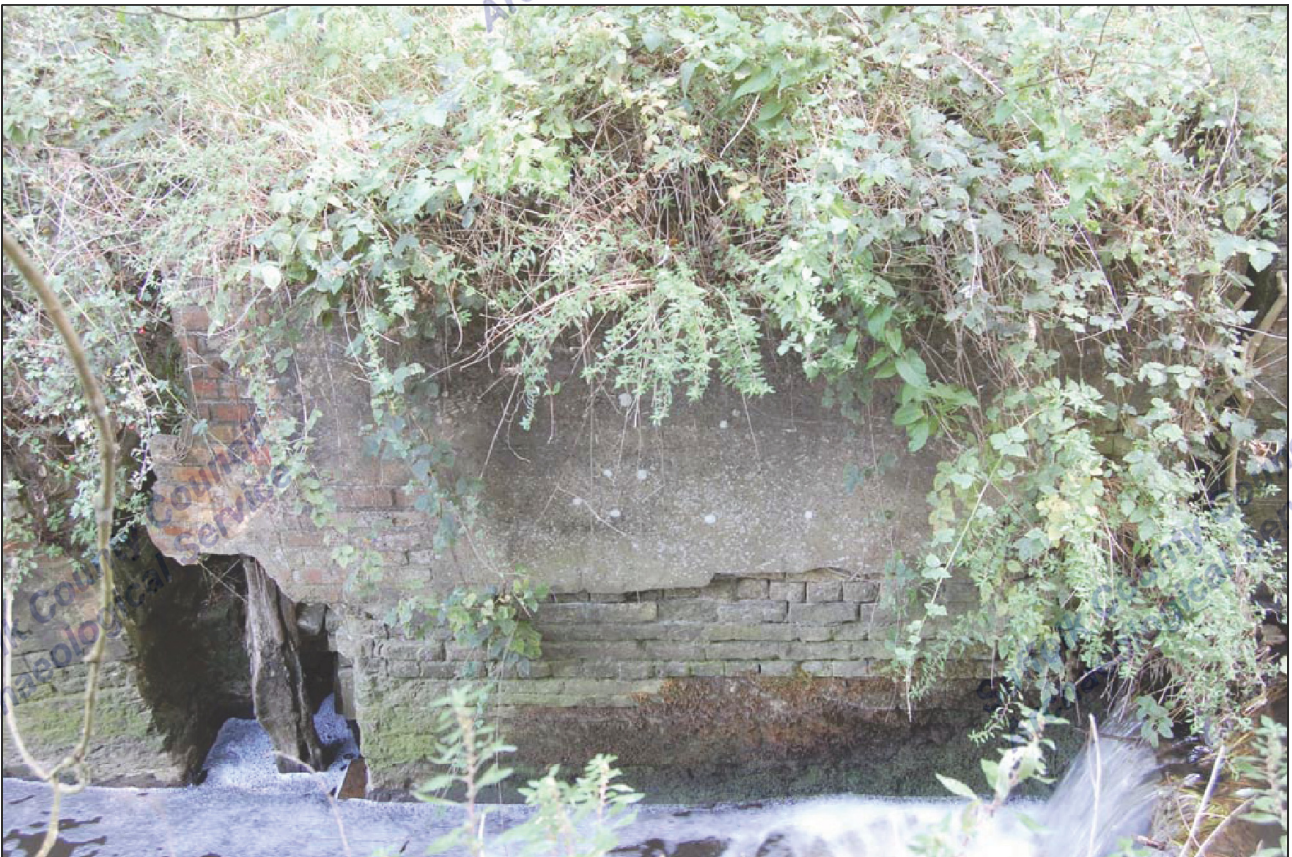
Timber *DD3* was inset within wall *CC2*. It was only visible where the wall had split, which was probably as a result of the structural weakness caused by the timber. The size and function of the post are unclear and it is uncertain whether it was present in *CC1*, although it is assumed that it was, as there appeared to be a corresponding area of damage on this wall also. It was covered with a layer of bricks and plaster and may have operated as a reinforcing rod.

16. CUL 046, northern end, eastern wall, exposed reinforcing timber

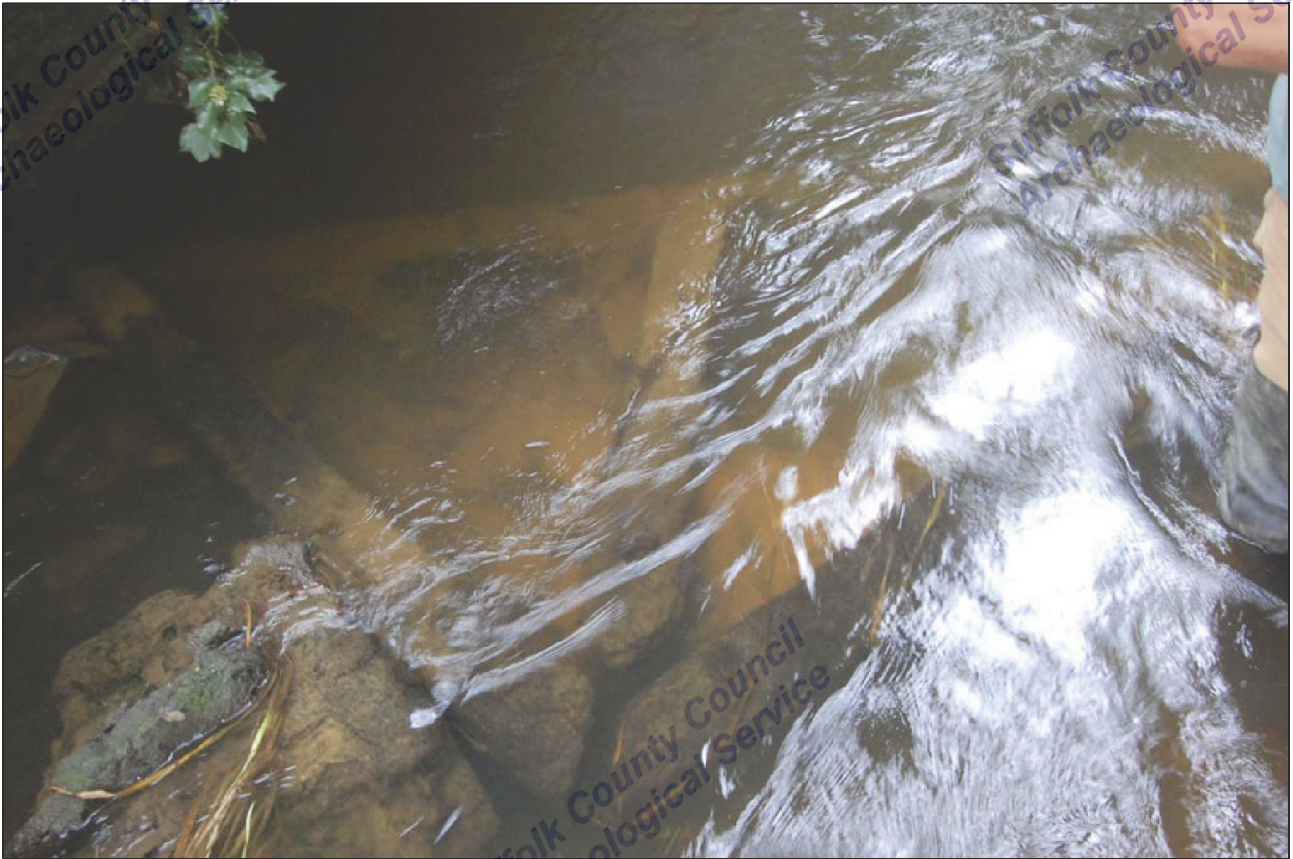
17. CUL 046, southern end, lock base

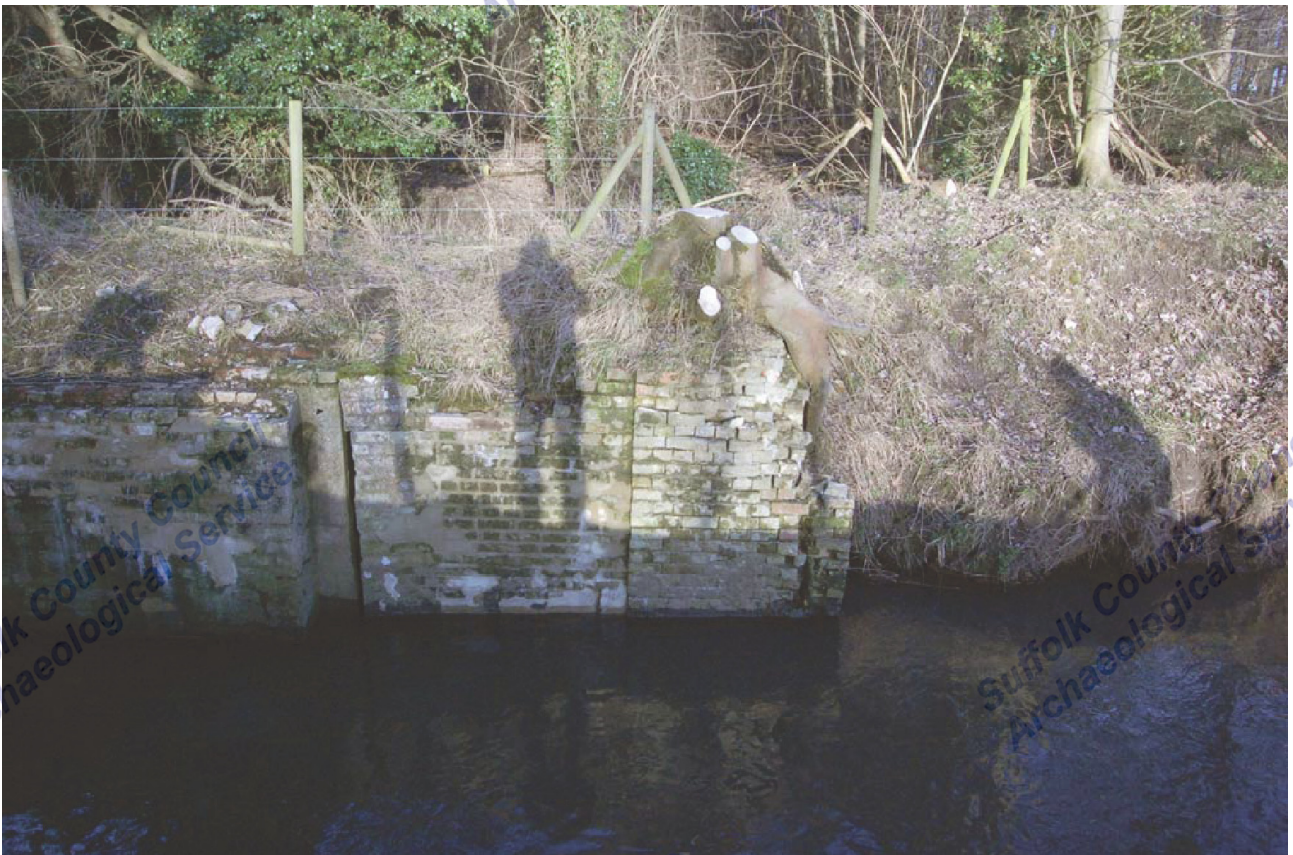
18. CUL 046, southern end, eastern side, timber recesses after cleaning
