BUILDING RECORDING REPORT

SCCAS REPORT No. 2009/233

Air-raid shelter, bulk fuel installation and water tank, RAF Feltwell NHER 4942

Suffolk County Council
Archaeological Service

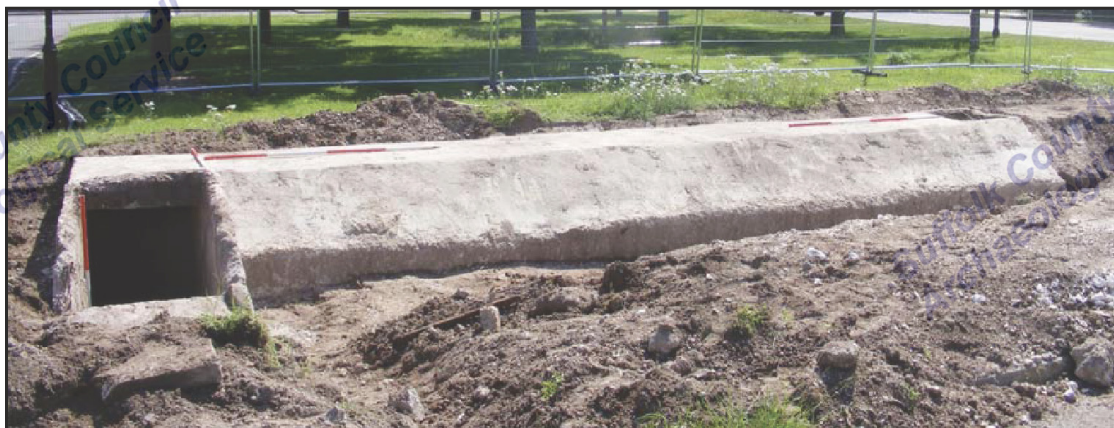
Plate 1. The air-raid shelter, looking east

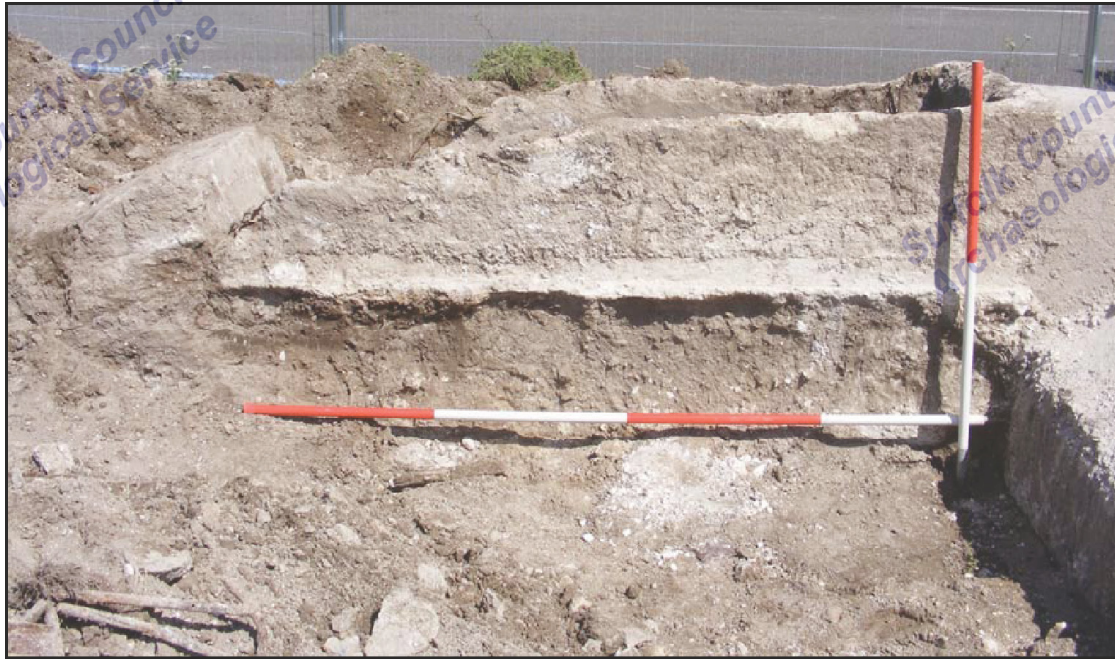
The air-raid shelter is located 1.6m south of Stirling Road and the main length of the structure runs north-south, following the line of the car park (Fig. 1). At the northern end of the feature on the western side was the entrance (Plate 1). The shelter was constructed of concrete that had been reinforced with c.0.01m thick metal rods. It appears that the concrete for the stairwell wall had possibly been poured *in-situ* up to the height of the top and second step. This was shown by the concrete lip left along the exterior of the entrance walls where the concrete had apparently spilt over the top of the construction trench or mould (Plate 2 and Section 1, Fig. 3). Use of this technique would explain the presence of the undisturbed chalk abutting the structure at its foundations. Otherwise, the concrete lip may represent a screed used to level the wall before the upper walls of the stairwell were constructed.

Plate 2. Construction lip on exterior entrance wall, looking north

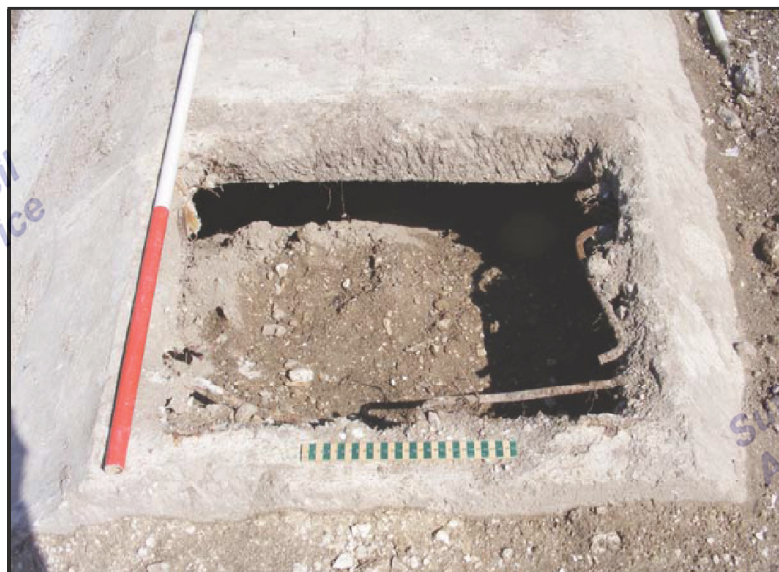
At the south end of the structure was an opening, which was c.0.65m (E-W) x c.0.65m (N-S). Reinforcing rods (c.0.02m diameter) and a metal mesh emerged partially from the sides of the hole and appeared to have covered it at some point. A rough concrete border surrounded the hatch. This is either evidence of the slab that had been used to cover the opening (that was removed during the archaeological evaluation of the site) or is evidence of some other feature, such as a wall (Plate 3). The removed slab was thought to be a post-war addition to seal off the feature. The hatch functioned either as a

Plate 3. Hatch, looking north

ventilation hole, (hence the mesh and reinforcing rods that may have run across the feature), or as an emergency escape. Such secondary exits are seen on many similar shelters and would have consisted of a ladder inside a square structure that emerged several c.1m from the soil that covered the main body of the shelter.

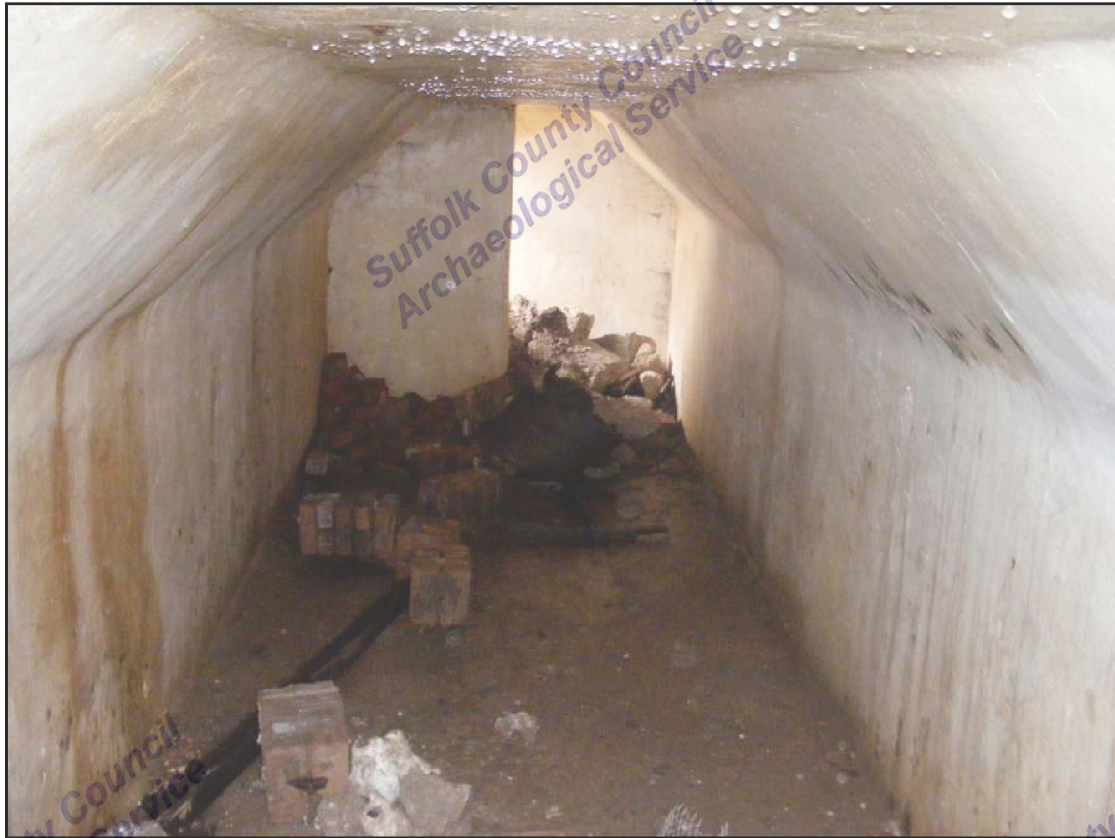
Plate 4. Internal view of structure from opening, looking north

No internal features were still *in-situ* within the shelter, although several blocks of bricks and mortar were still visible, as were several pieces of wood and part of an oil drum (Plate 4).

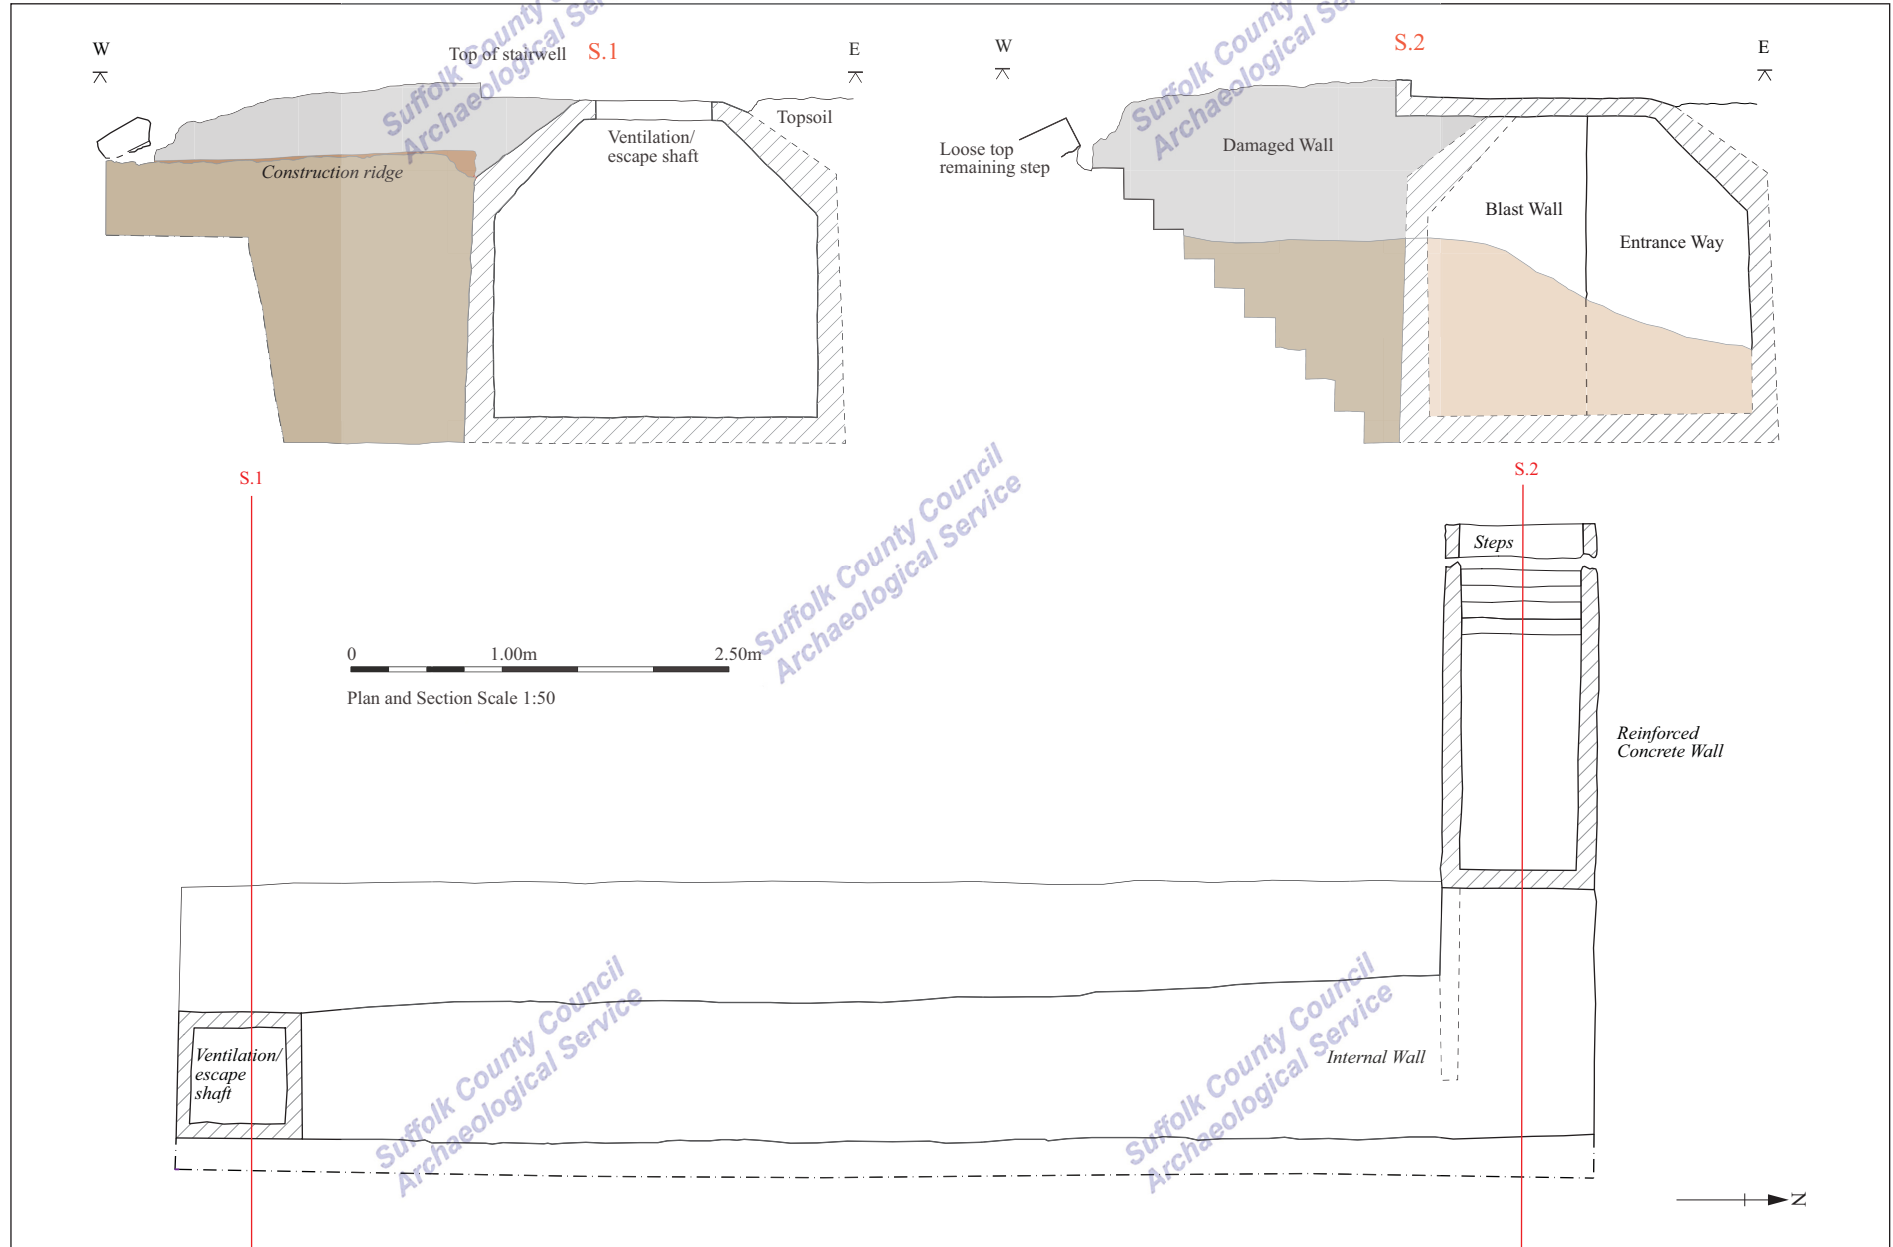
Figure 3. Plan and sections of air-raid shelter

In plan the air-raid shelter was 'L' shaped with the main body of the structure measuring c.2.6m east-west x c.9.35m north-south (Fig. 3). The entrance-way extended c.2.2m west from the main structure and was c.1m wide north-south. The external height of the structure from the top of the main body to the base of the floor slab was 2.3m. The thickness of the walls, ceiling and floor varied. The walls to the entrance and the areas where the roof was flat measured c.0.1-0.12m thick. The sloping portion of ceiling became visibly thicker further down the structure and was calculated to vary from c.0.14-0.25m. The side walls also increased in thickness from c.0.14-0.19m. The base/floor is thought to be c.0.18m thick (Fig. 3).

Entrance to the shelter would have been via nine steps that had c.0.2m treads x c.0.2m risers and were c.0.8m wide. The top four stairs were uncovered by hand excavation. The walls to the entrance were reinforced with metal rods and mesh. The main length of the structure consisted of one main chamber with a wall that ran from the west wall halfway across the structure and was flush with the entrance wall (Plate 4 and Section 2, Fig. 3).

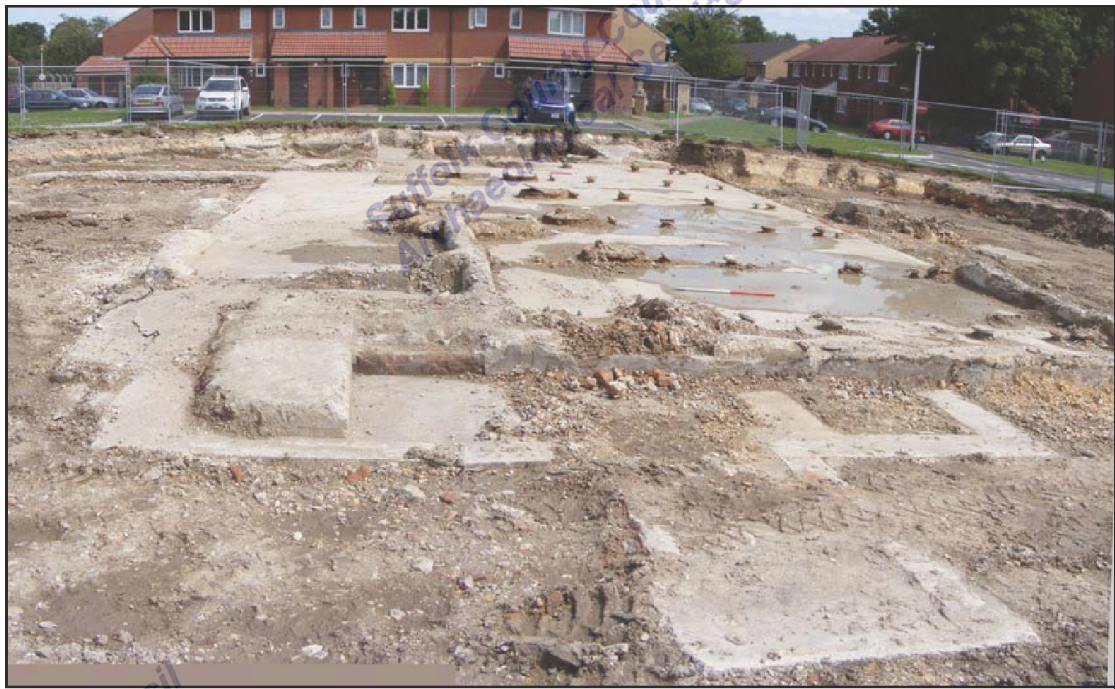
Plate 5. Composite photo of the BFI, looking north

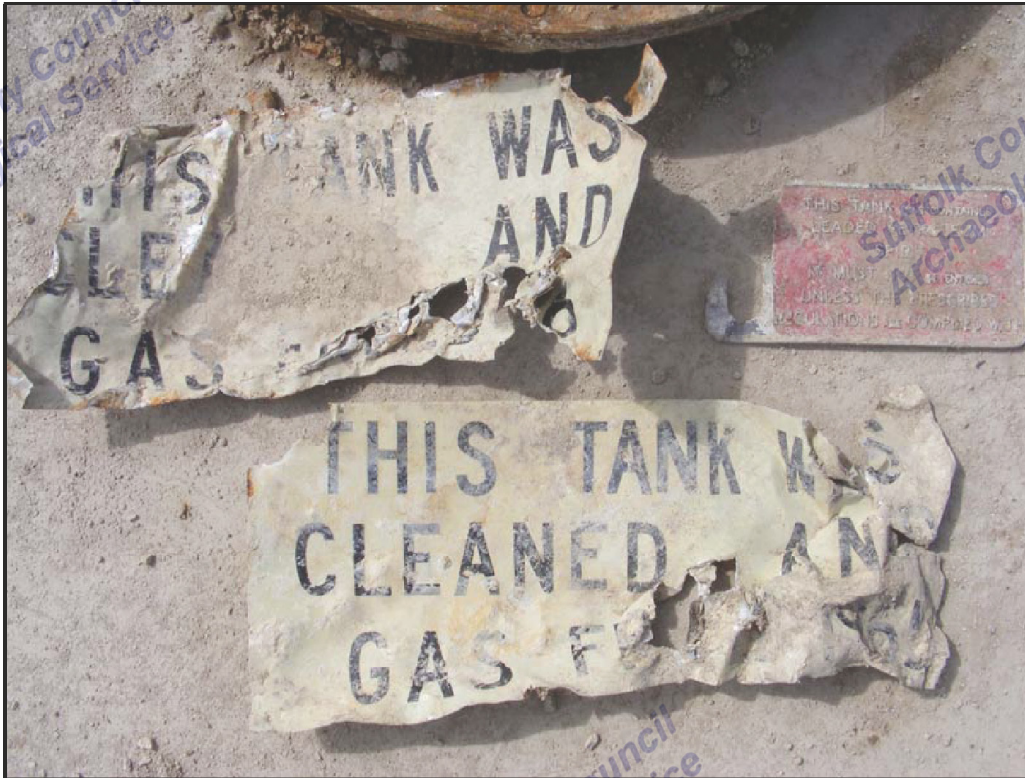
Plate 6. Signs from tank manholes detailing cleaning of the tanks

Several features were found which are associated with the decommissioning of the BFI. The first of these were the signs attached to the type 'B' pipe plates (Plate 6). These read:

'THIS TANK IS FILLED WITH WATER' and;

'THIS TANK WAS CLEANED AND GAS FREED 1965'

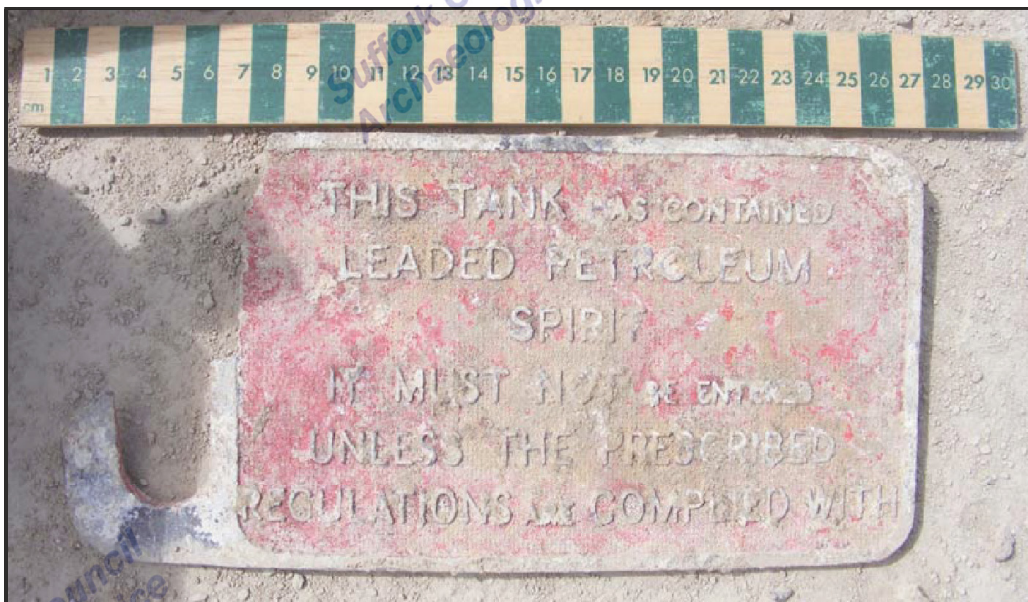
Plate 7. Sign found during machine stripping of tanks

‘THIS TANK HAS CONTAINED
LEADED PETROLEUM SPIRIT
IT MUST NOT BE ENTERED
UNLESS THE PRESCRIBED
REGULATIONS ARE COMPLIED WITH’

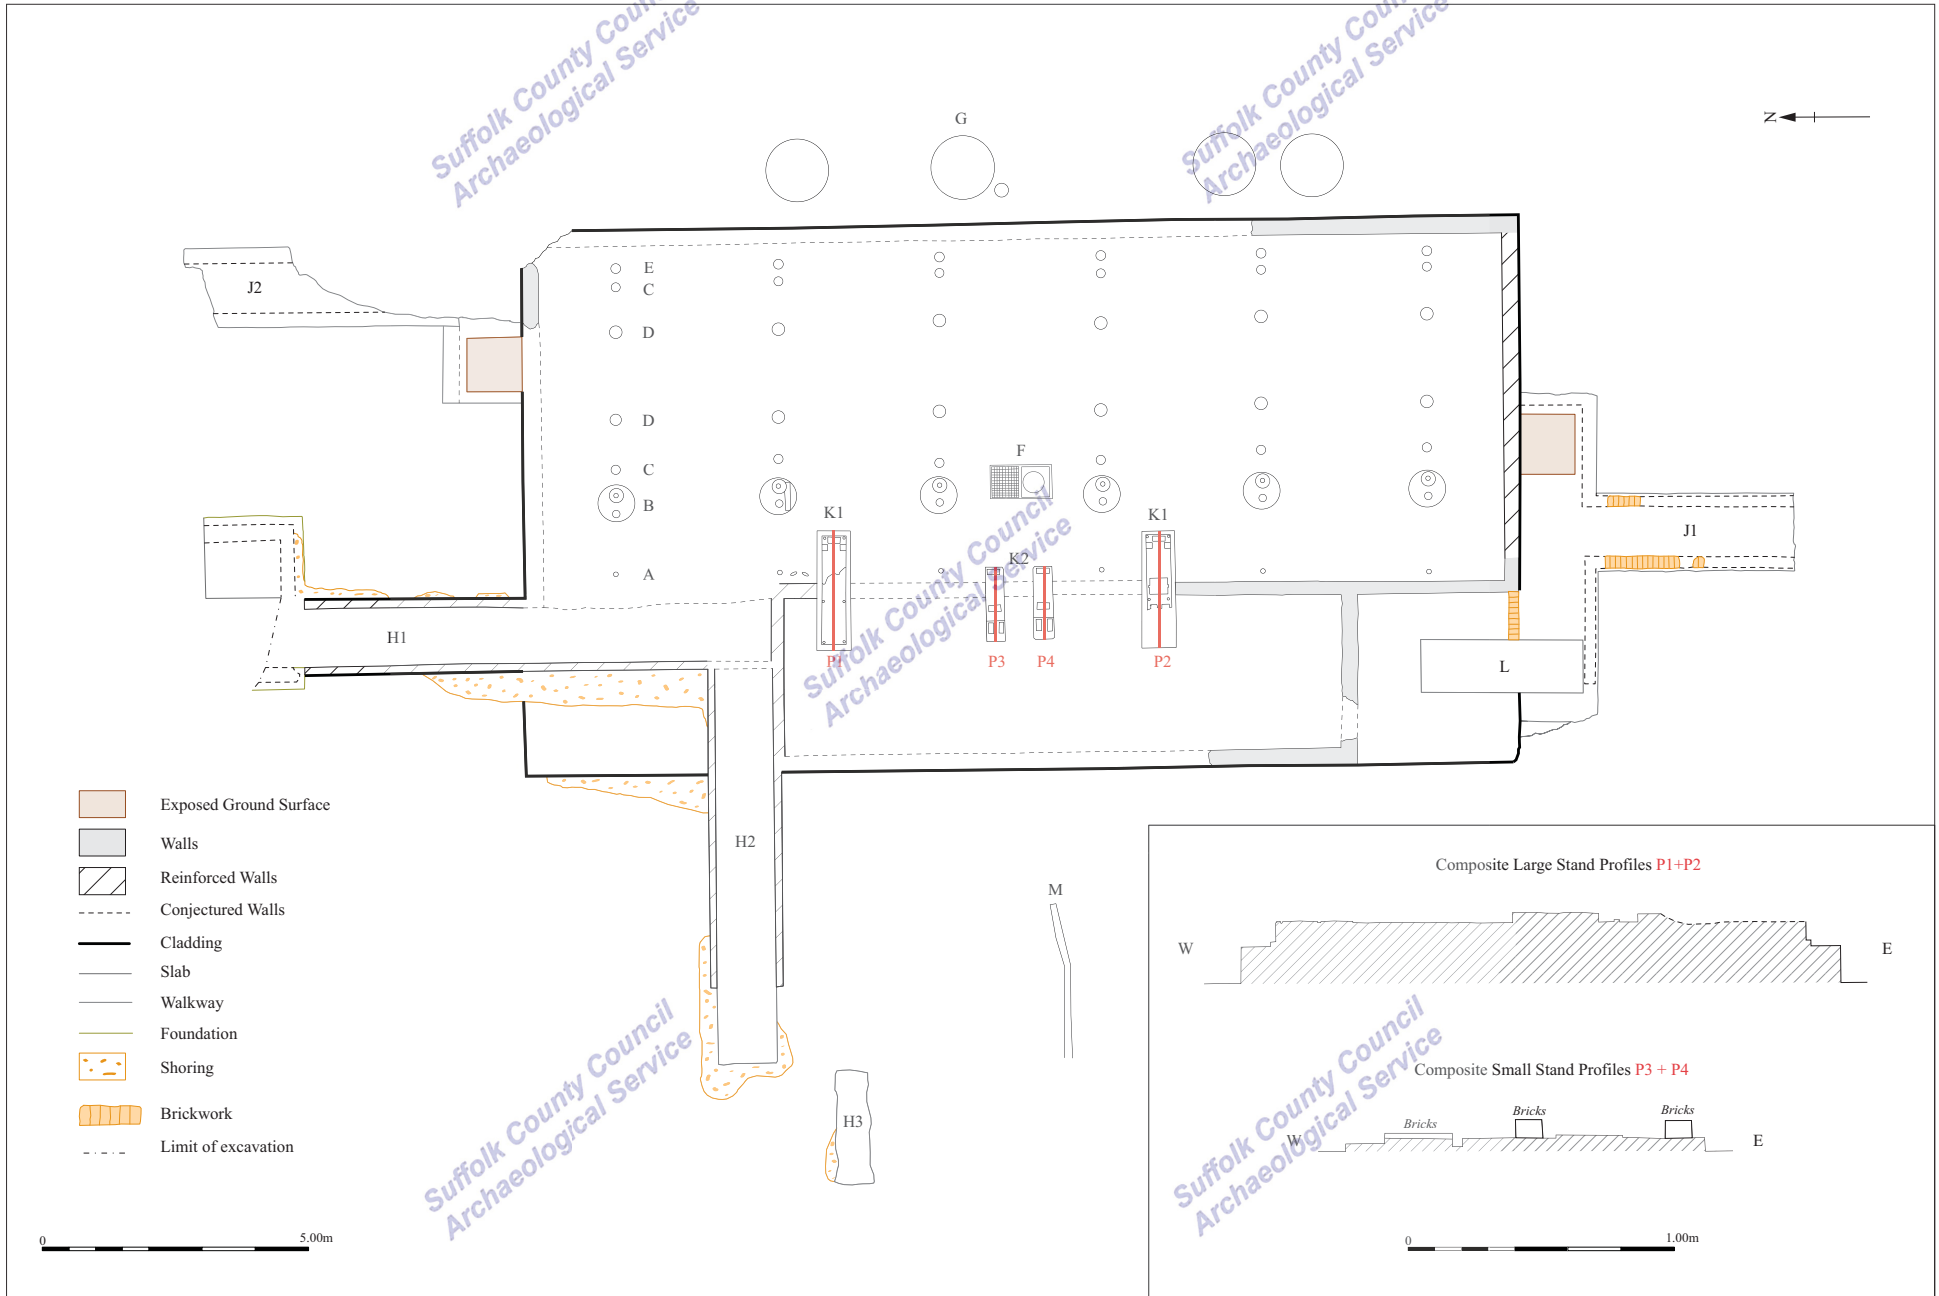
Figure 4. Bulk Fuel Installation plan and profiles

Between Tanks 3 and 4 on the surface of the top slab was an area of grating (Fig. 4 – F). This measured 1.15m (N-S) x 0.65m (E-W) and consisted of two individual grates. One of these was broken during the cleaning process and revealed a fixed round metal disc similar to the pipe covers described in Table 1. It had a diameter of 0.4m. It was surrounded by concrete rubble that had been tipped into the tank during the decommissioning process. As such its function was unclear.

Running along the east edge of the top slab were four rings with external diameters of 1.15m, which were made of c.0.5m thick concrete (Plate 10 and Fig. 4 – G). Two of these seemed to be associated with Tanks 2 and 3, although they were offset to the south. The third ring was aligned with Tank 5, although this was offset to the north. The ring associated with Tank 3 had a metal pipe on its south-east edge. This had a 0.25m external diameter. A fourth concrete ring was exposed after the removal of the main tank structure and was positioned just south of ring 3. It is uncertain as to whether these features were associated with the main fuel tanks, or were perhaps soak-aways performing some other function. Although their proximity to the tanks does suggest a connection with them, their irregular positioning is hard to explain, as is the difference in the colouration of the concrete compared to the rest of the structures. It is possible that they were features added at a later date to improve the functioning of the BFI.

Near the south-west corner of the main tank structure was a concrete block (Fig. 4 – L). This measured 3.05m (N-S) x 1m (E-W) and was 0.22m higher than the surrounding concrete. It was largely undamaged and appeared to have no distinguishable features.

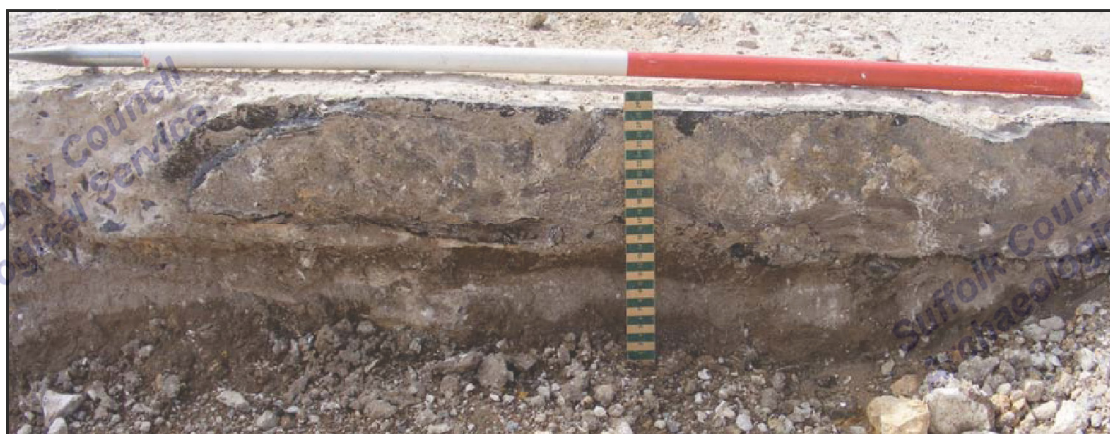
Plate 8. Bitumen cladding

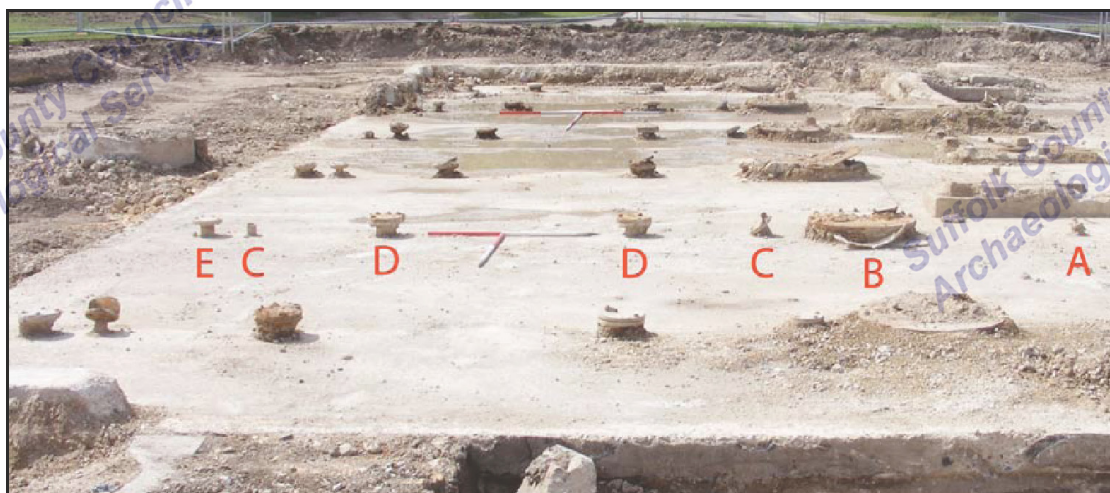
Associated with each tank was a set of seven capped metal pipes of five different types, which have been classified by their height and diameter as per Plate 9 and Figure 4 and detailed in Table 1. All of types 'B'-'E' had pipes that extended 0.08-0.1m from the concrete. Mounted on top of these were plates which were bolted to the pipes. The total height from the concrete slab to the top of the capping plates was 0.12m for each type.

Plate 9. Tank pipes, looking south

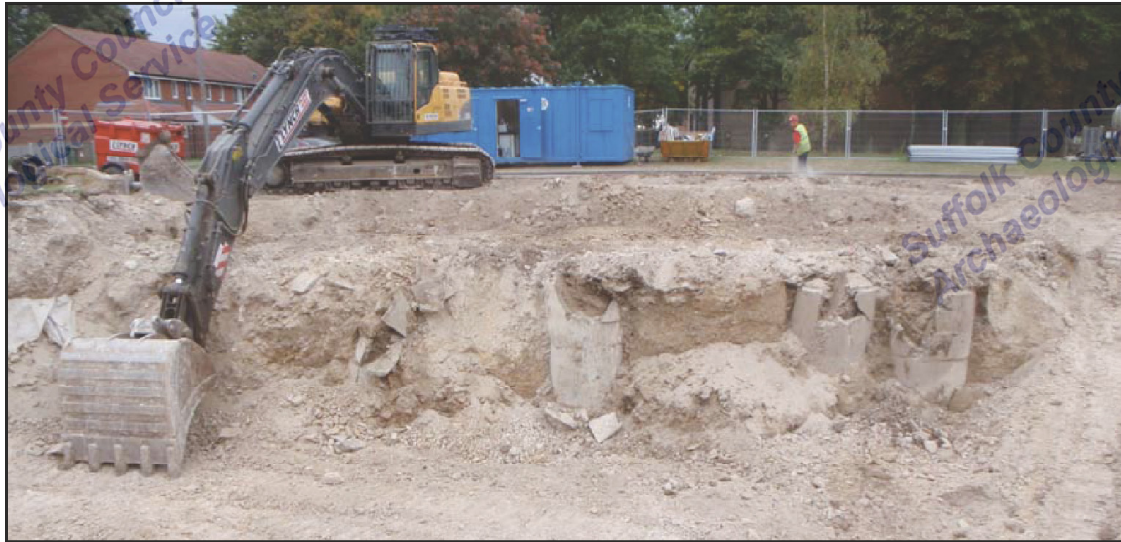
Plate 10. Concrete rings after main tank removal

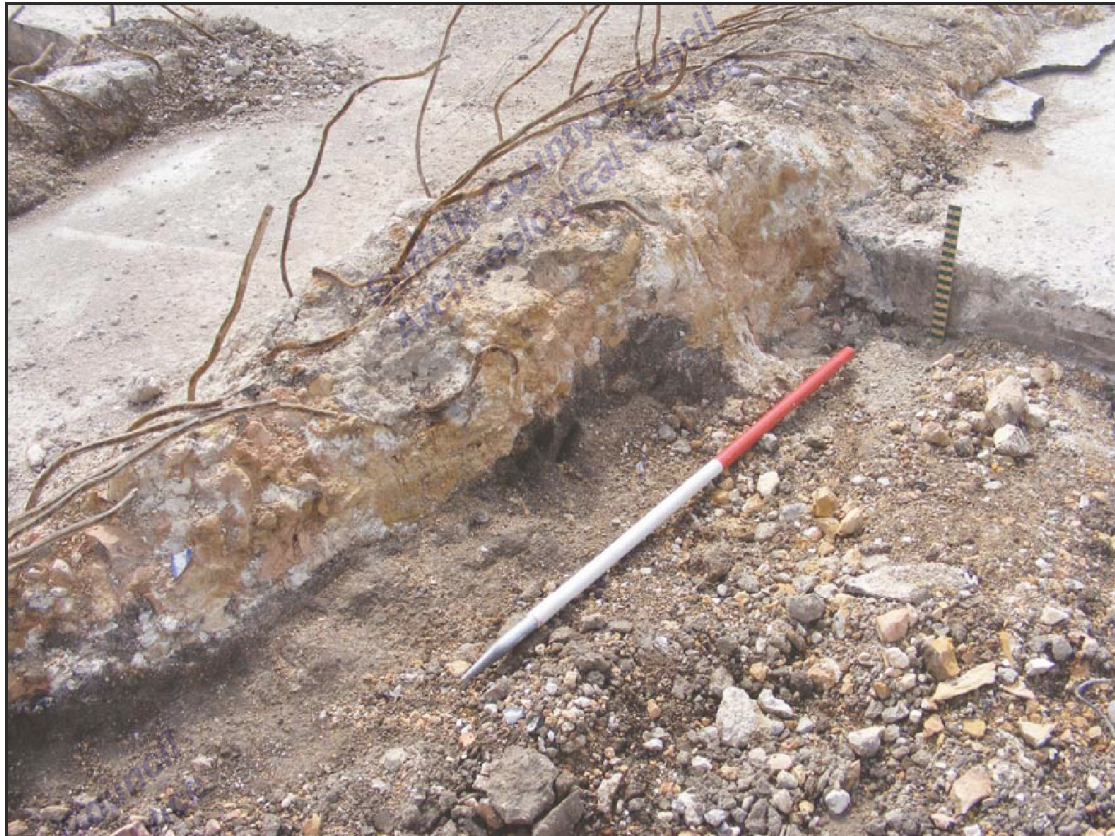
Running along both walkways and also on the north-western corner of the tank structure was a compacted chalk, plaster and mortar compound (Plate 11). It had presumably been applied to further strengthen the walls, perhaps suggesting that these were the most exposed parts of the BFI.

Plate 11. Reinforced and shored walls

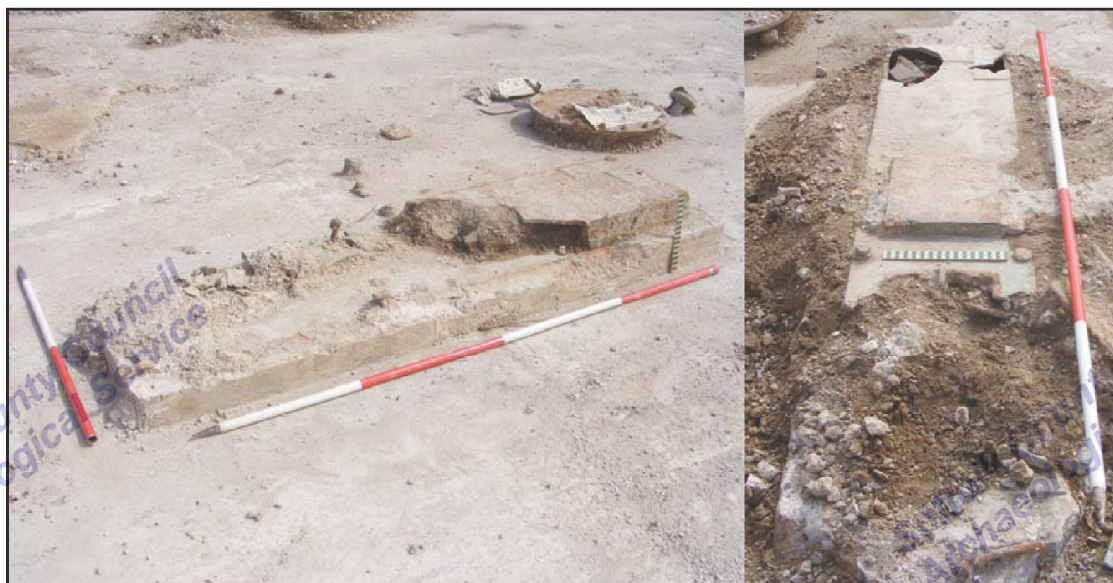
In total four metal casts were found on the top of the main structure (Fig. 4 – K1 and 2). Of these, four were two distinct types but all were set perpendicular to one of the demolished walls that ran N-S over the structure. The two larger examples (K1) were located north and south of the two smaller ones (K2) and were made of cast iron set on concrete bases. They measured 2.25m (E-W) x 0.56m (N-S) (Plate 12). The main body of the stand was 0.23m tall. The functions of the stands were unclear. However there were 3 pairs of nuts and bolts that secured the features to the concrete. At the eastern end of each were three rectangular forms that were almost flush with the main body. Further down was a larger, more prominent square that appeared to be a sealed hatch. Just west of this was a grate with two openings. Many of these details had been damaged during decommissioning and cleaning.

Plate 12. Larger casts

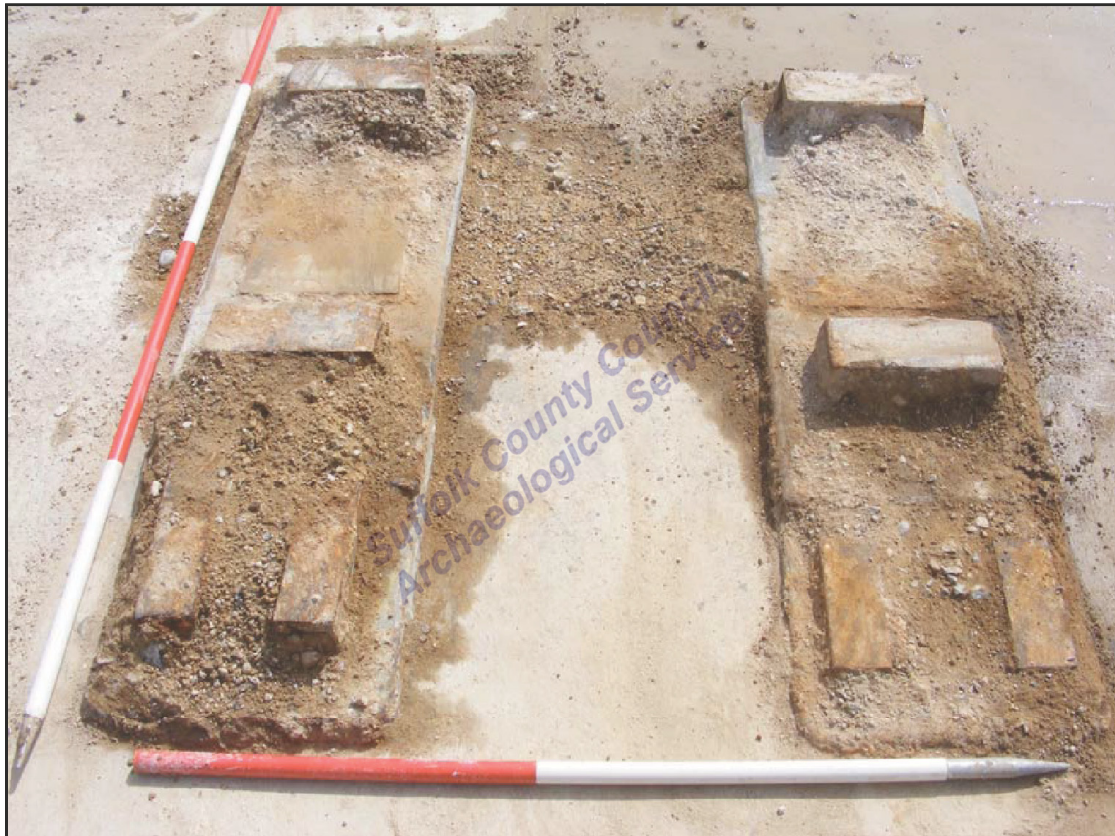
The two smaller points were solid cast iron structures fastened directly to the concrete slab (Plate 13). These measured 1.35m (E-W) x 0.38m (N-S). The most prominent features on these points were the two largest metal 'bricks' aligned on a perpendicular angle to the main body. Two further, smaller bricks were located at the western end of the stands at right angles to the first bricks. A square of metal was located between the two larger bricks and was almost flush with the main body.

Plate 13. Smaller casts, looking east

The purpose of the four casts is uncertain. It seems that the two smaller points may well have functioned as fixing stands for a pump or some sort of monitoring equipment, for example. However the larger casts do not appear to have features that would be particularly effective for fixing equipment to. It is worth noting that some of the pipe work shown on Figure 2 runs very closely to the K1 and K2 points, suggesting an associated function.

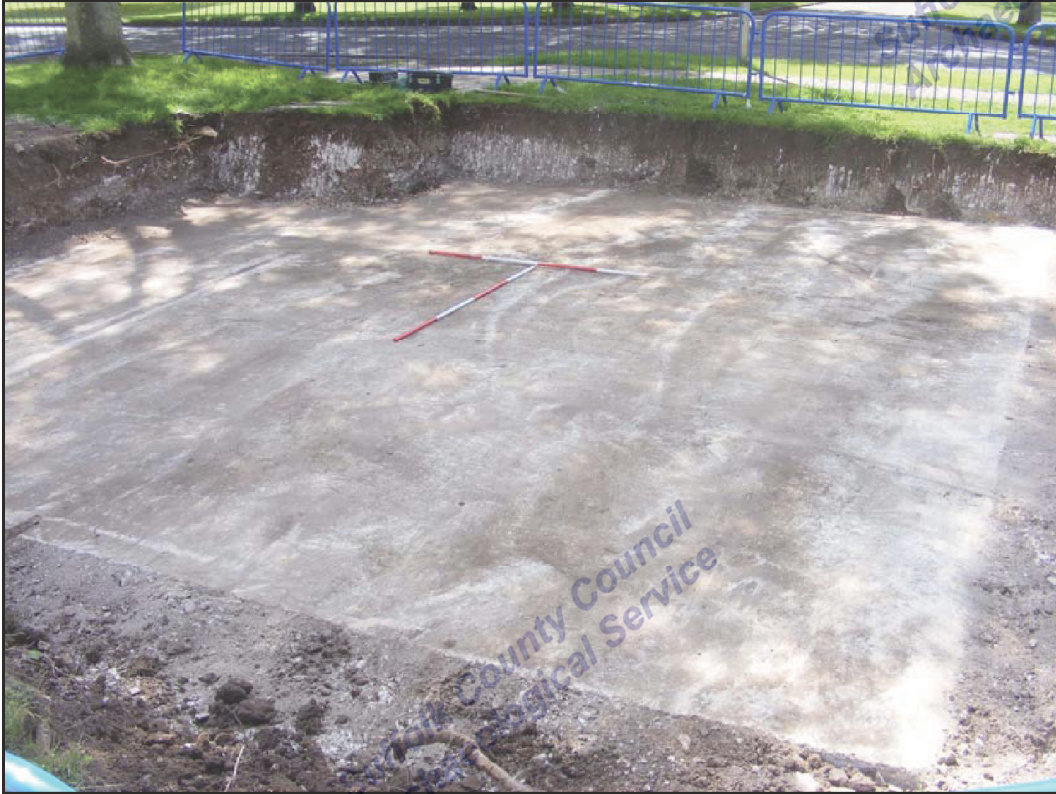
Plate 14. Water tank, looking south-east

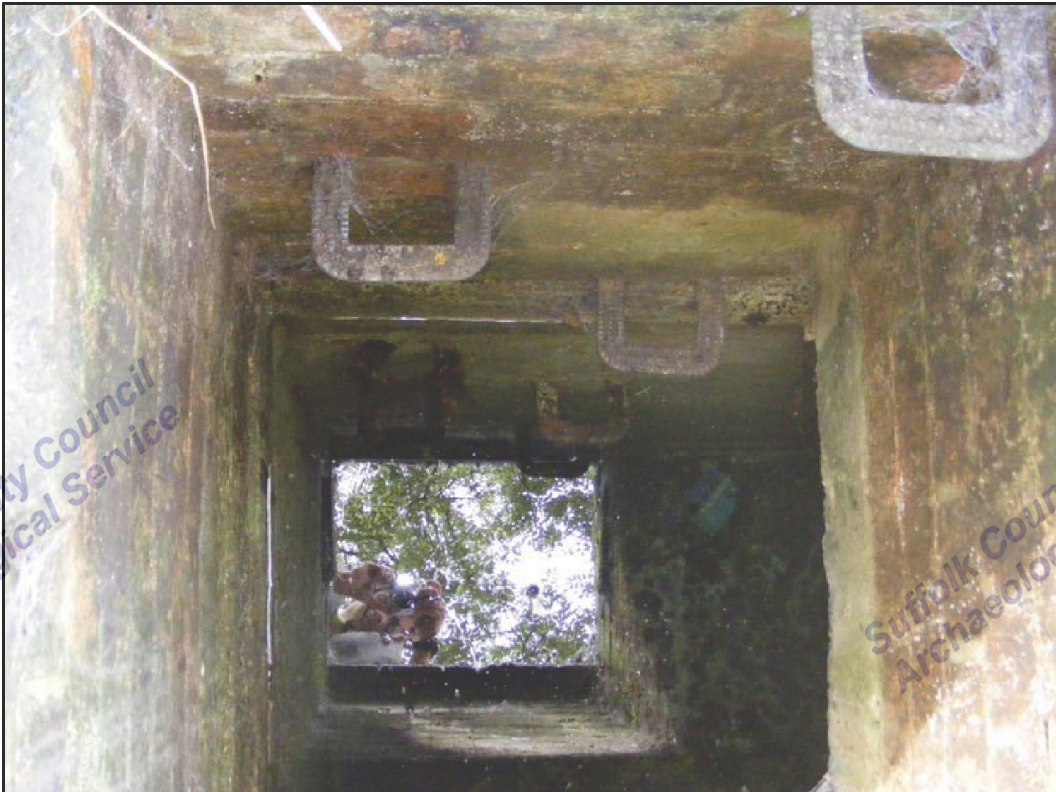
The water tank was located c.70m NNE of the old parade ground and 6.35m north of the main east-west road on the base, which is c.65m south of and parallel to Oxford Road (Fig. 1). It was buried beneath 0.85m of topsoil and consisted of a square of concrete that measured 7.88m SSW-NNE x 7.88m WNW-ESE (Plate 14). There was a manhole in the south-east corner which was flush with the topsoil level. Removing the manhole revealed a series of rungs for entry to the tank (Plate 15).

Plate 15. Manhole and rungs

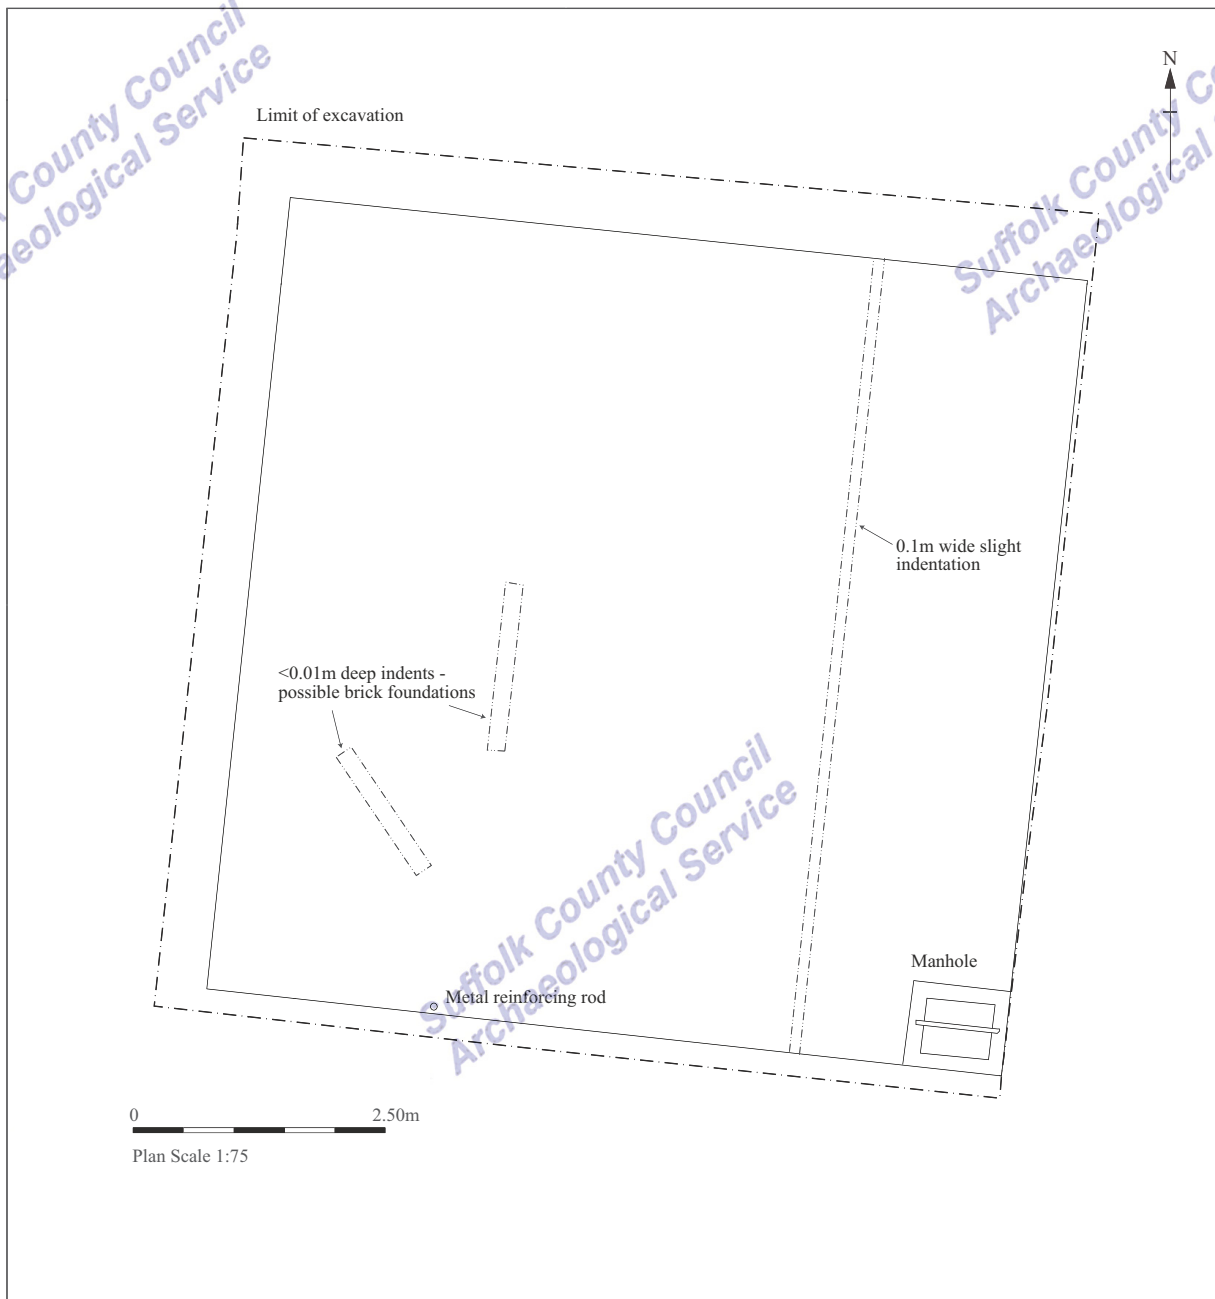
Figure 5. Water Tank plan

There were several small features in the top of concrete (Fig. 5). The first two of these were indentations near the south-west corner of the tank. They were both 0.17m wide and <0.01m deep. One was aligned NW-SE and measured 1.43m long, whilst the other was aligned N-S and was 1.65m long. A further 0.1m wide indent ran N-S up the full length of the tank, 2m from the eastern side and was also <0.01m deep. These may not have been significant

features, although they do appear to have been stand points of some sort, or may be linked to the construction of the tank. A metal reinforcing rod was also located along the southern edge of the slab, 2.2m from the south-west corner.
