**Barn at Burnham Cottage,
Old Newton,
Suffolk
ONW 023**

Historic Building Record

October 2009

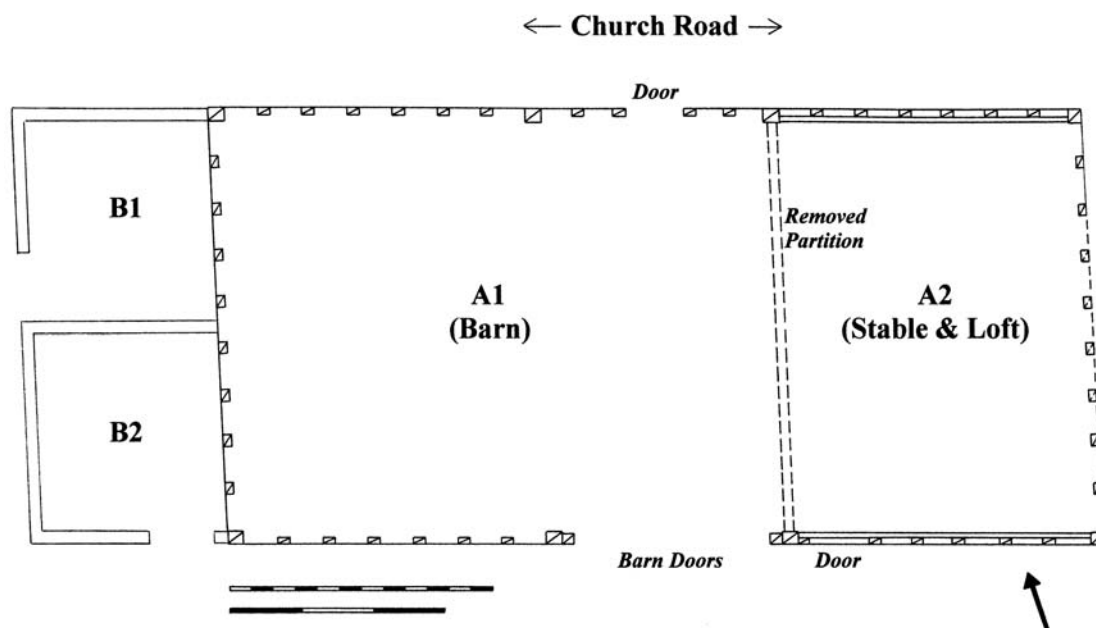
Figure A
Ground Plan of the barn showing its original layout.

The original timber-framed structure (A) contained three bays with full-height barn doors in the southern elevation of the central bay (facing the house) and a smaller door in the rear elevation immediately opposite. There is evidence of a ceiling and separate door to the eastern bay (A2), which was originally partitioned to form a stable and hay loft (the latter open to the barn). A clay-lump lean-to shed (B) of 2.75 m (9 ft) in length with a central partition and a slate roof was added to the western gable in the mid-19th century. Note the building's unusual skewed outline.

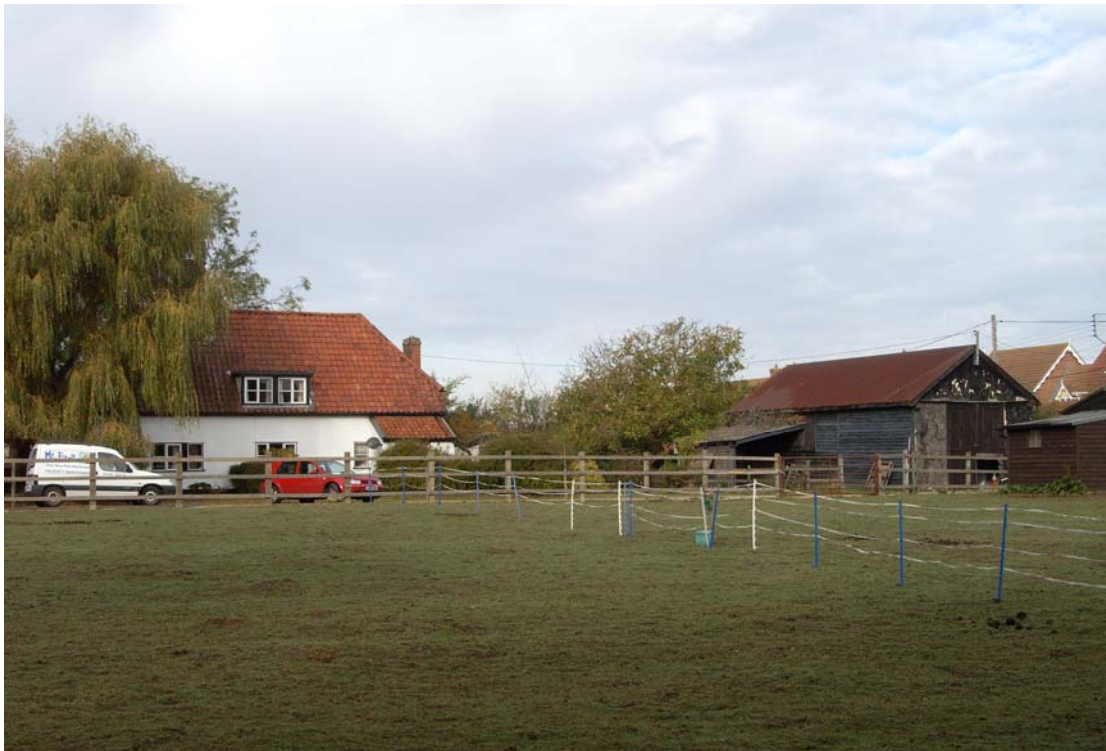
A2.1 General view of site from paddock to west showing proximity of roadside barn to right & Burnham Cottage to left

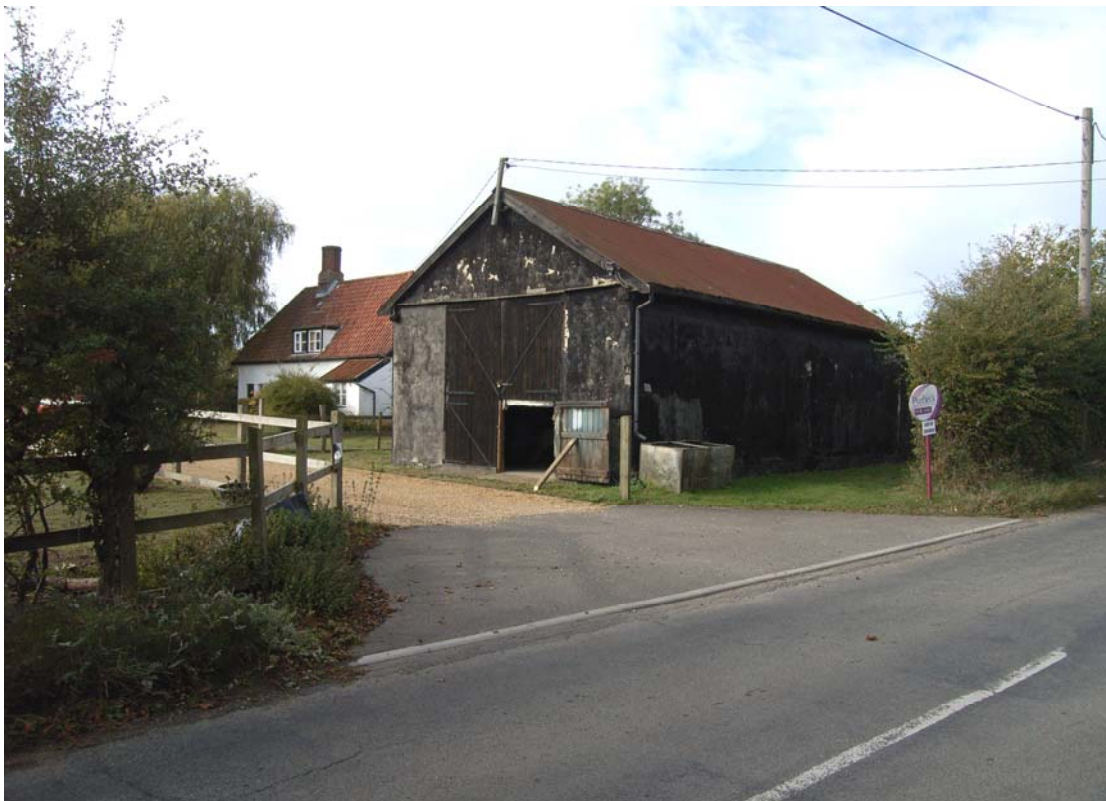
A2.2 General view of site entrance from Church Road to north-east, showing barn to right & Burnham Cottage to left

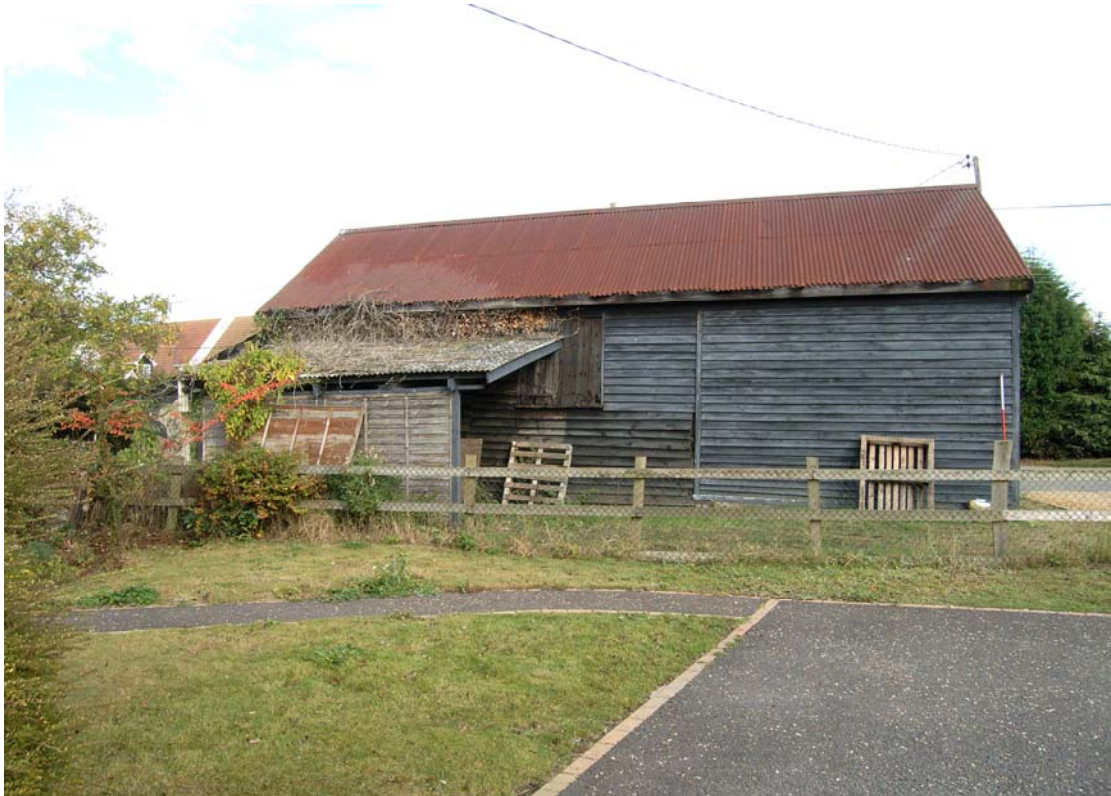
A2.3 Weatherboarded southern external elevation showing corrugated iron roof covering and remnant of central double-hung barn doors

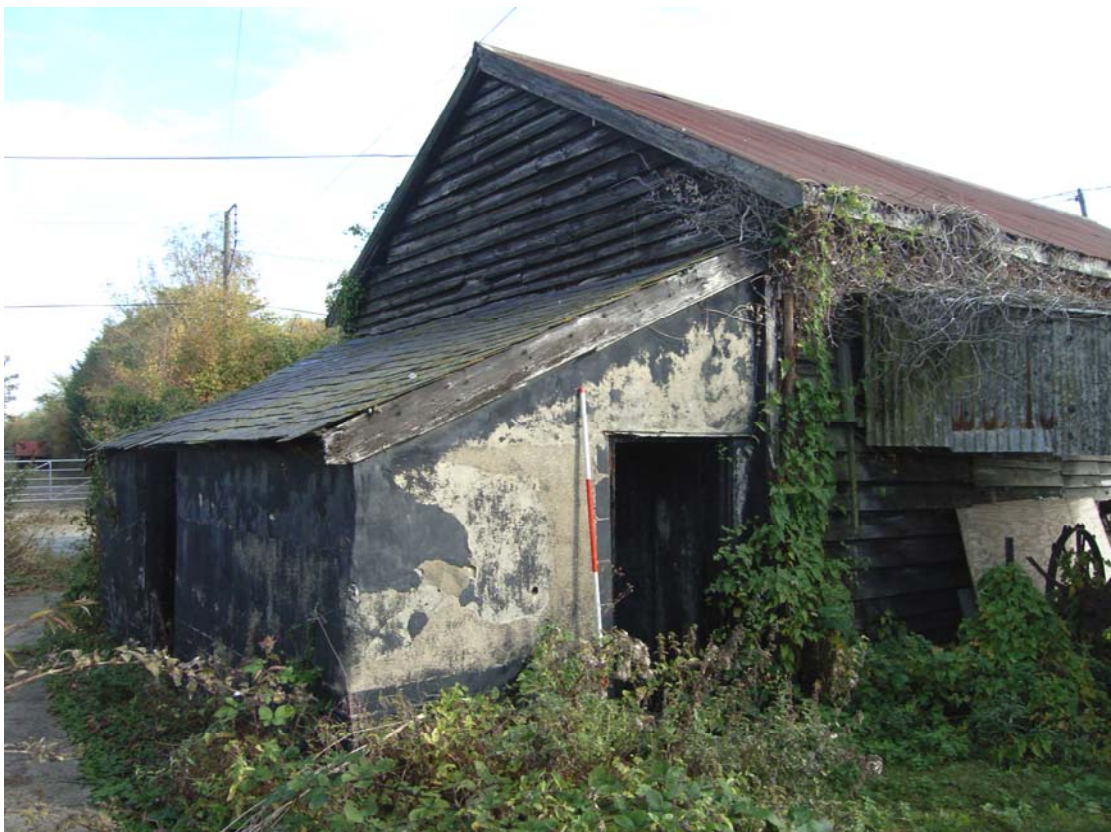
A2.4 Western external gable from south-west showing 19th century clay-lump slated lean-to shed (B)

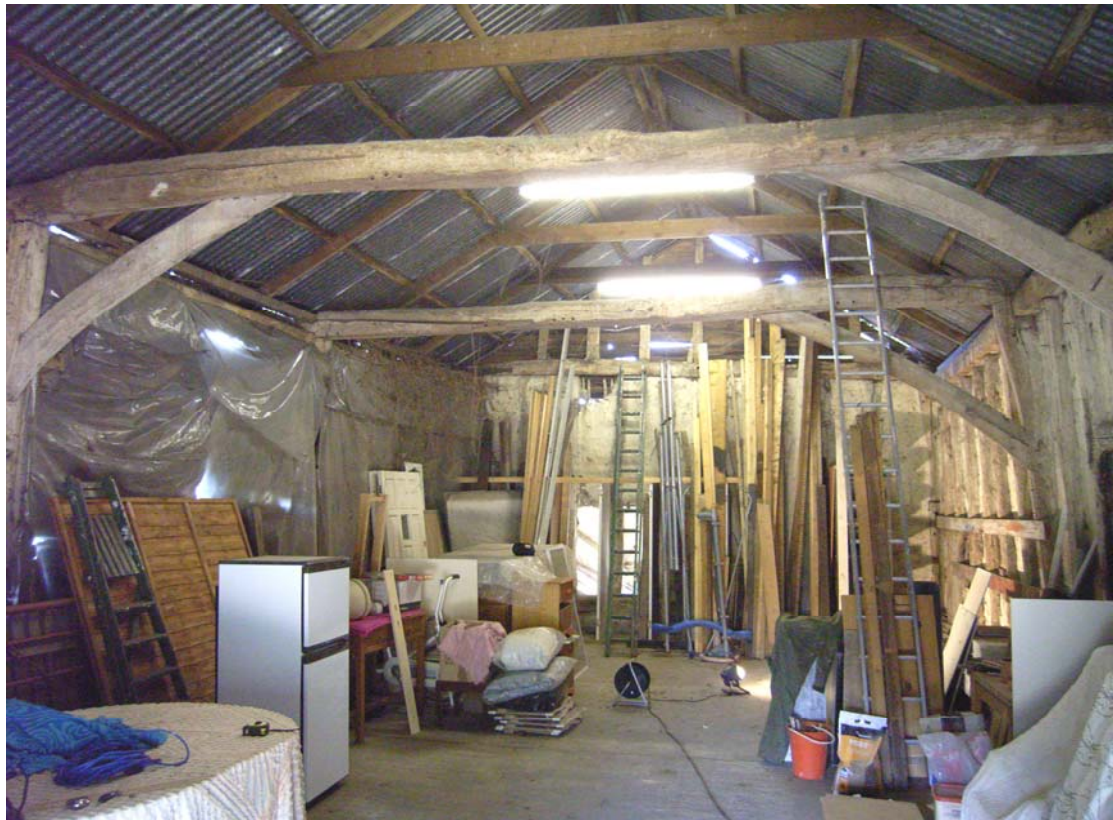
A2.5 General internal view of barn from eastern gable showing original arch-braces and tie-beams beneath rebuilt 20th century roof structure.

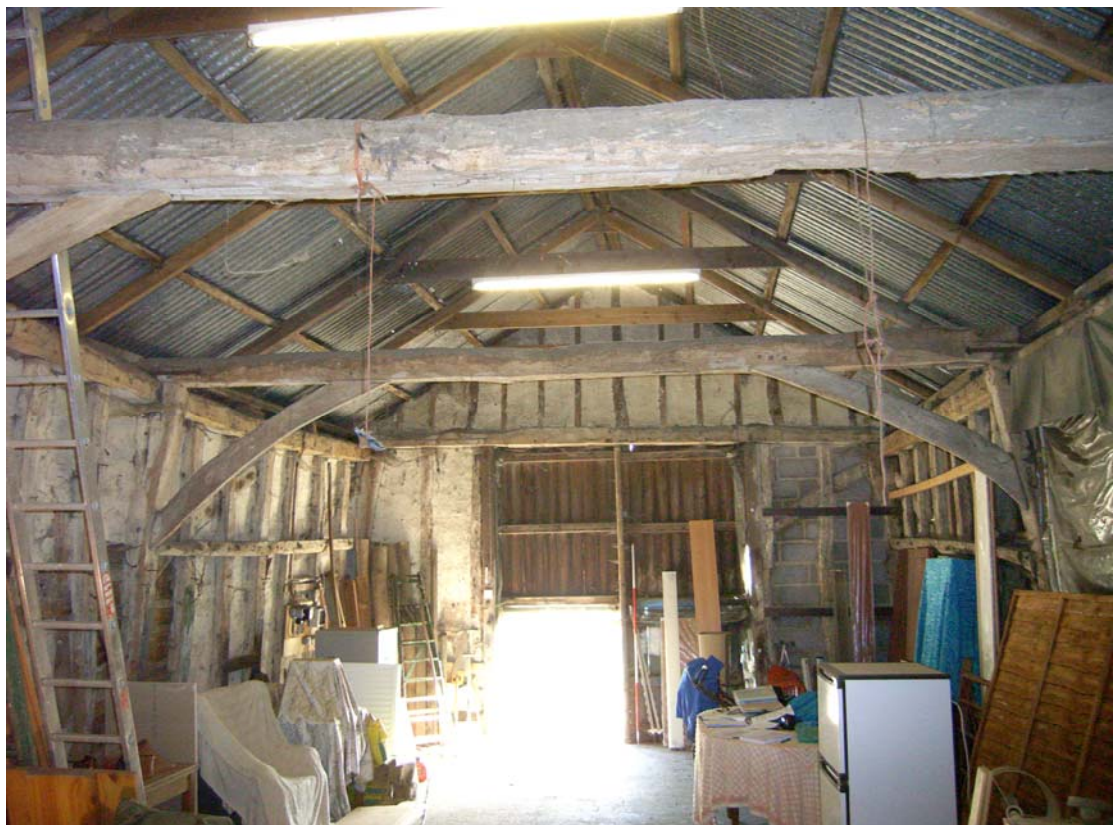
A2.6 General internal view of barn from west showing rails of former hay loft in eastern bay and 20th century vehicle doors in eastern gable

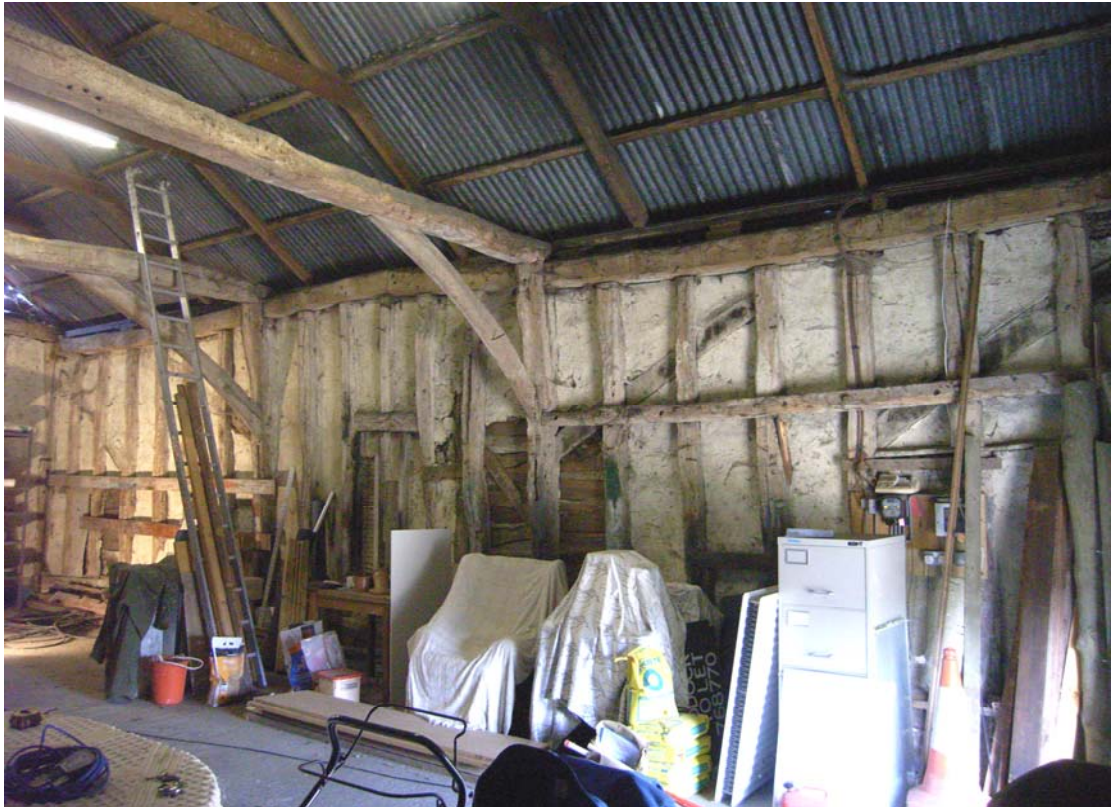
A2.7 Northern internal elevation showing unusual double wall braces in outer bays (externally trenched) and narrow door of central bay

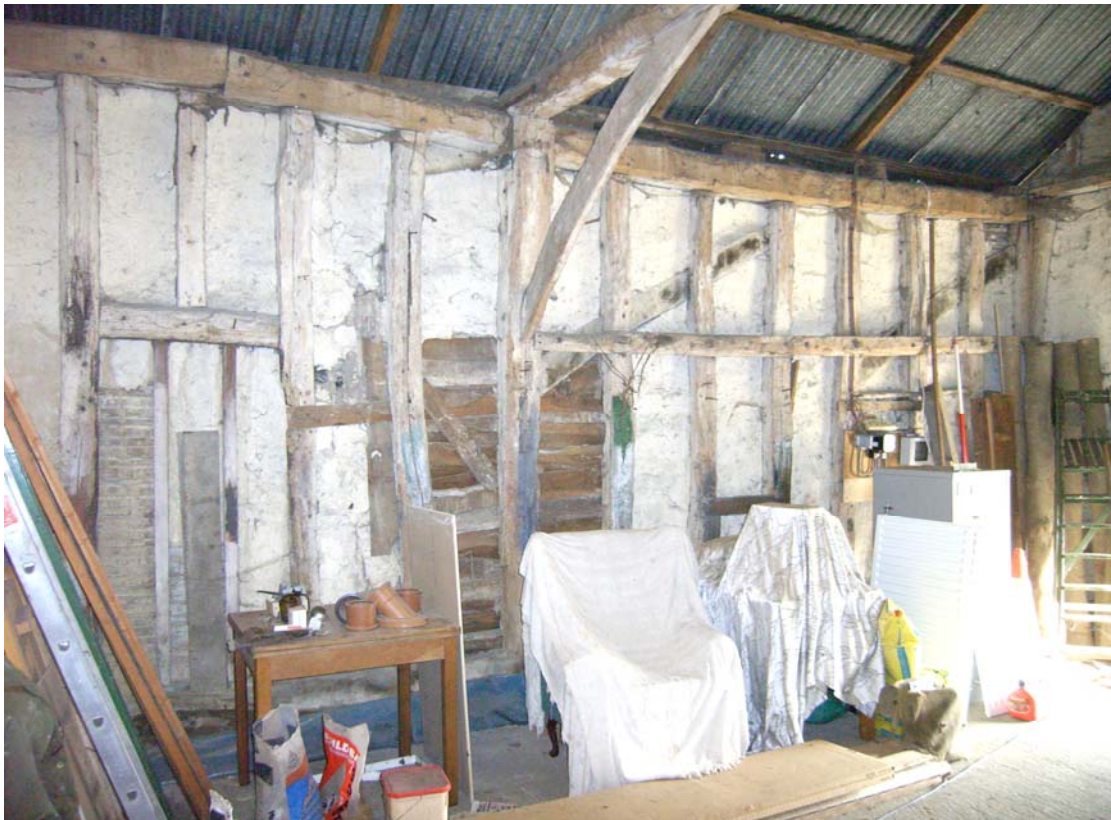
A2.8 Eastern half of northern internal elevation showing central door with raised lintel to left & clamp of removed stable ceiling to right

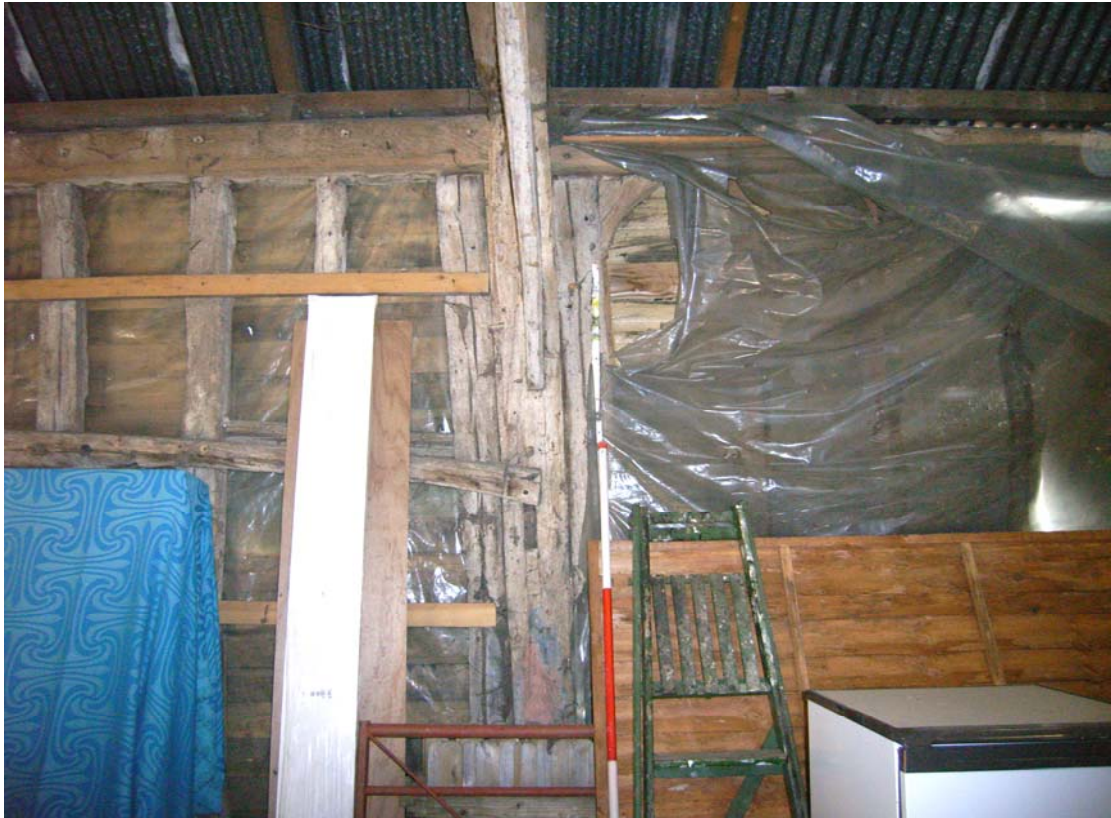
A2.9 Detail of internal southern elevation showing eastern storey post of central bay flanked by jambs of blocked stable door to left and main barn doors to right. The post contains the truncated rail of a removed lateral partition.

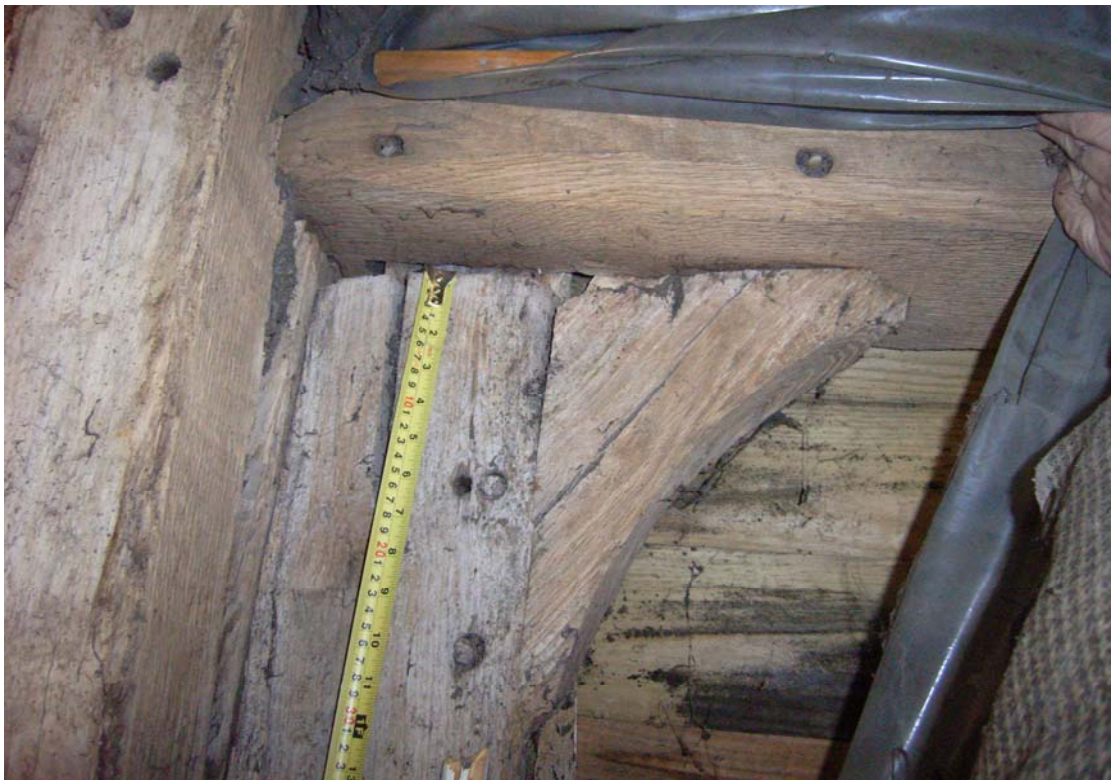
A2.10 Detail of tenoned corner bracket and jamb of main barn door to east of southern central bay

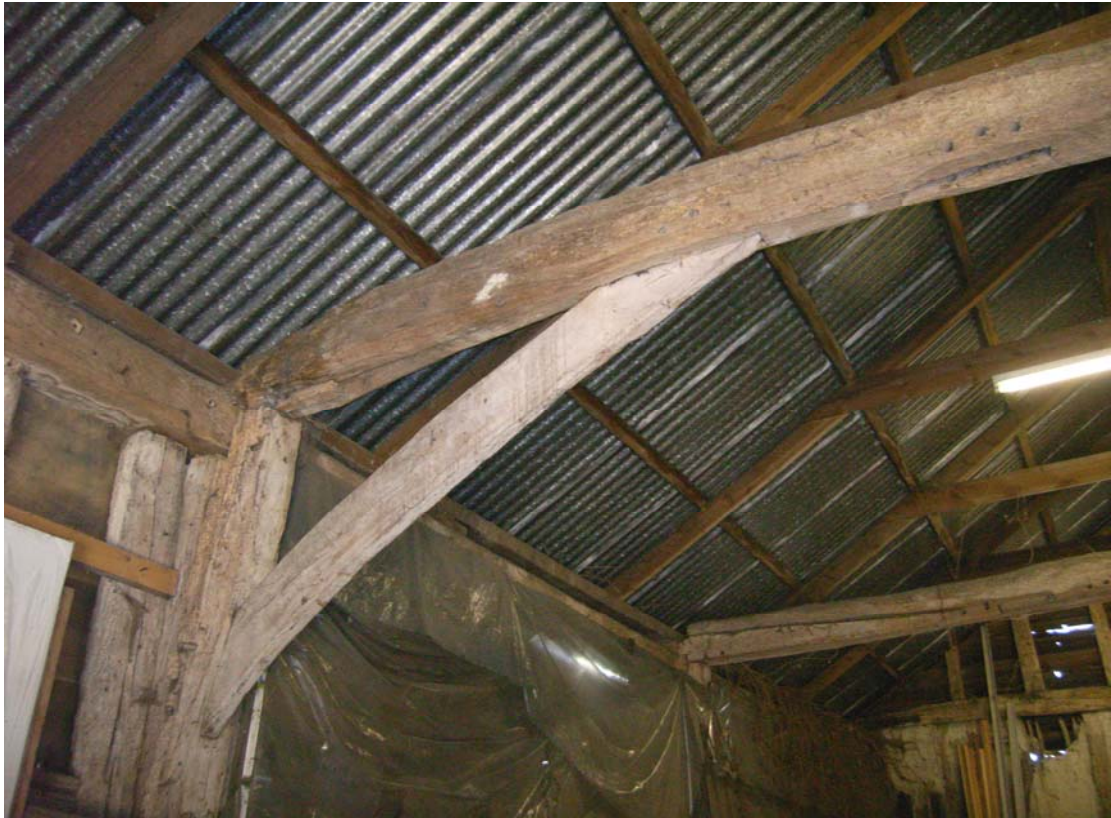
The tie-beams of the open trusses contain additional mortises for arch-braces that do not relate to the present structure and have clearly been re-used from an earlier barn of wider span, as have all but one of the storey posts (including the corner posts). The tie-beam of the western gable is also re-used, but the roof-plates and the tie-beam of the eastern gable were cut for the present barn and bear neat chamfers with run-out stops.

A2.11 Southern end of re-used eastern tie-beam showing empty arch-brace mortise to right of existing brace (seen from east)

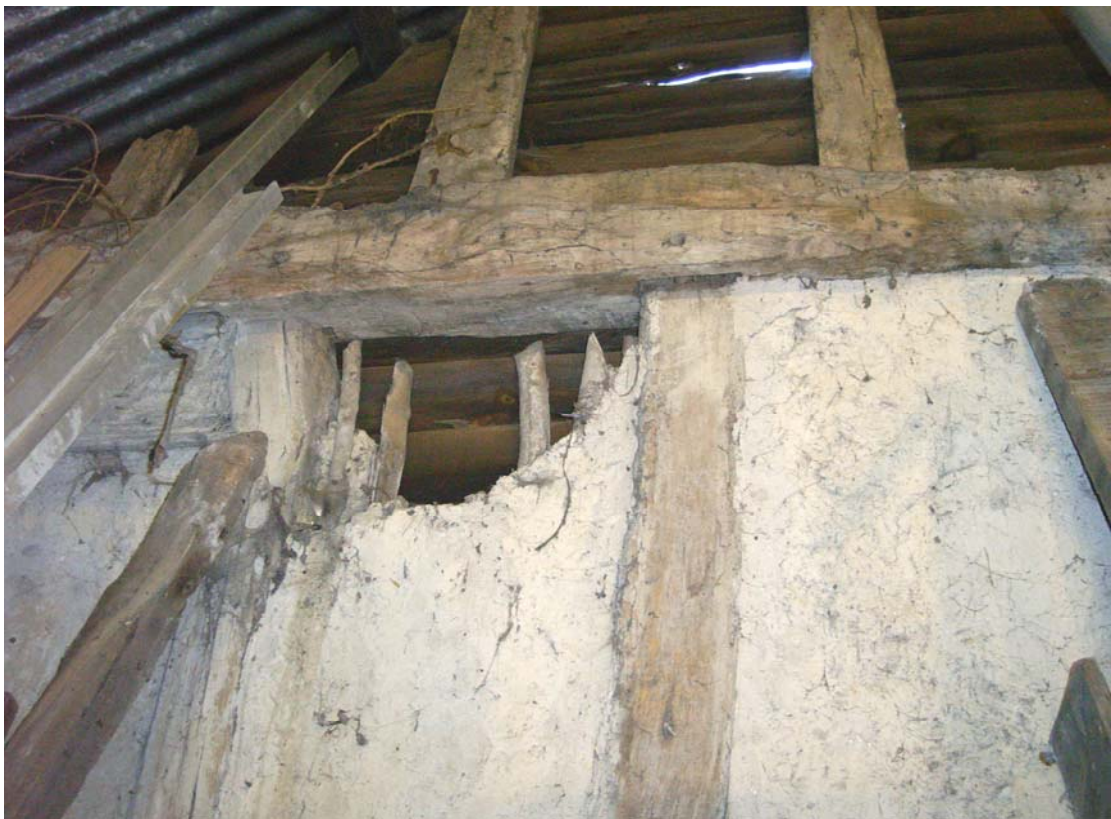
original, with vertical coppice poles between the studs and external laths nailed and trenched to their exteriors. The external daub has remained unpainted where it is protected by the western lean-to (B), revealing the barn's original appearance. A single panel of wattle-and-daub also survives in the northern elevation of the central bay, but the remaining daub of this elevation was replaced in the 18th or 19th century and does not fill the panels. The daub has been entirely lost from the southern elevation which is currently clad chiefly in late-20th century weatherboarding with earlier boards of the 18th or 19th century in parts of the western bay.

A2.12 Detail of original wattle-and-daub infill of western internal gable
