**The Farm Buildings,
Rise Hall,
Akenham,
Suffolk
AKE 036**

Historic Building Record

**Farm Buildings at
Rise Hall,
Akenham,
Suffolk,
(TM 1465 4870)**

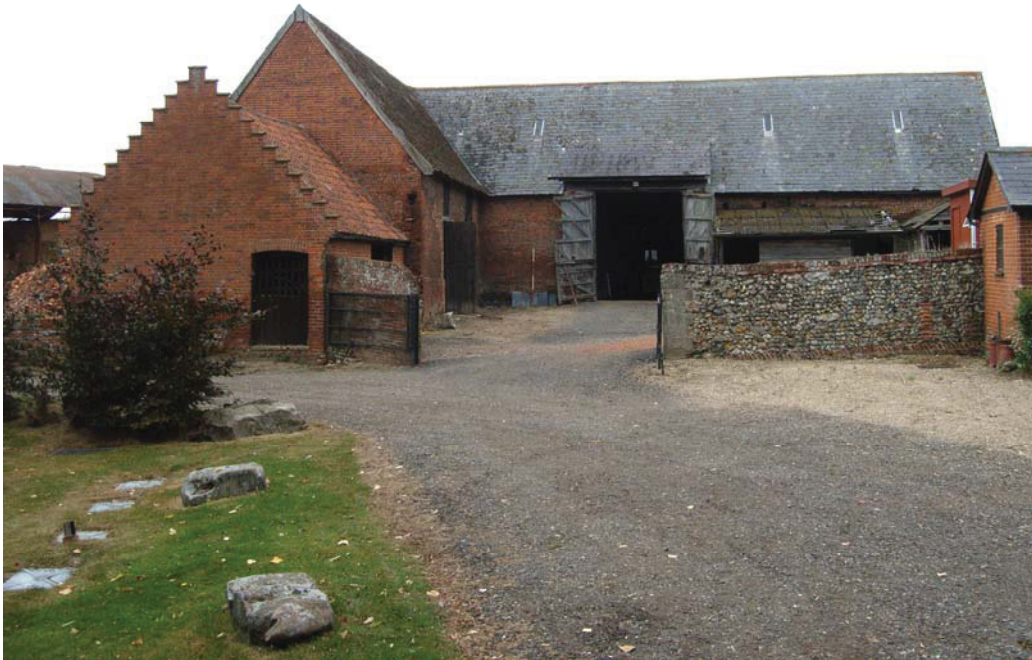
A2.1 General view of yard entrance from south showing the brick barn and contemporary stable wing with later crow-stepped shed to left. A similar wing originally projected from the right-hand side of the barn but has been demolished

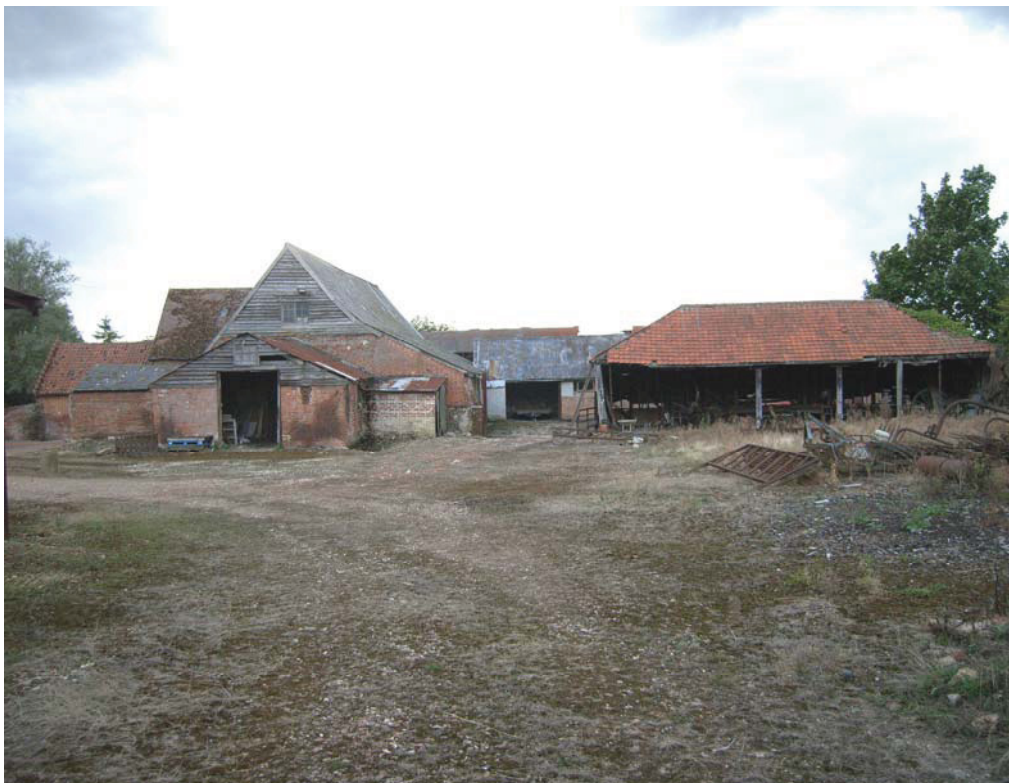
A2.2 General view of site from east showing the barn and attached sheds to left, the entrance to the northern yard in centre and the shelter shed of the eastern yard (N) to right

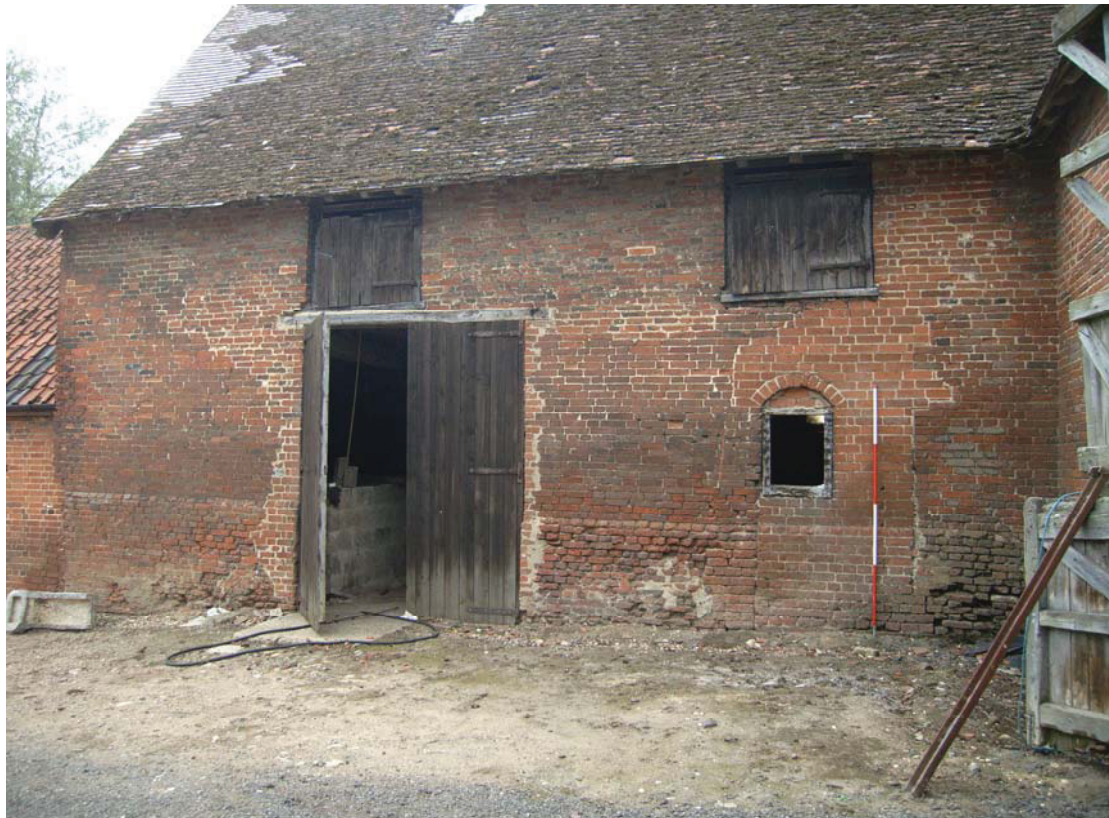
A2.3 Eastern façade of stable wing (B) showing blocked original door to right. The existing entrance is a recent insertion and the upper courses of brickwork which incorporate the hay loft hatches are also secondary

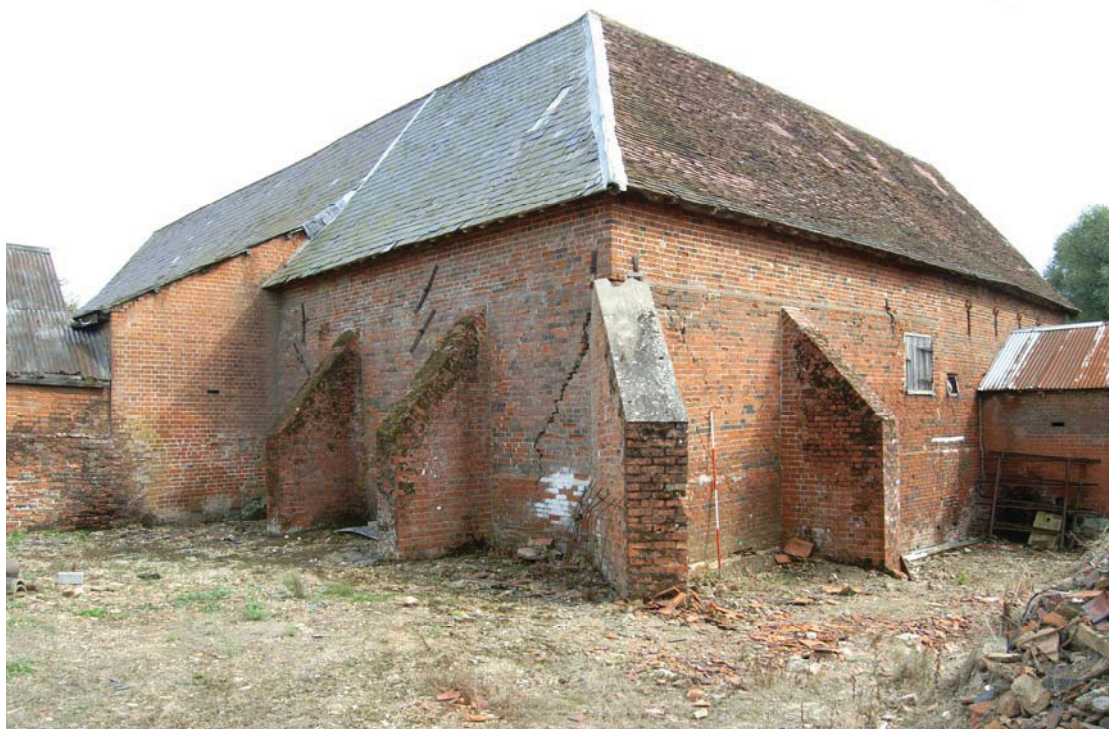
A2.4 The barn and the stable wing from the north-west, showing the slate roof of the barn to left and the peg-tiled stable to right. The buttresses are secondary, and the upper brick courses of the barn have been rebuilt along with both roof structures

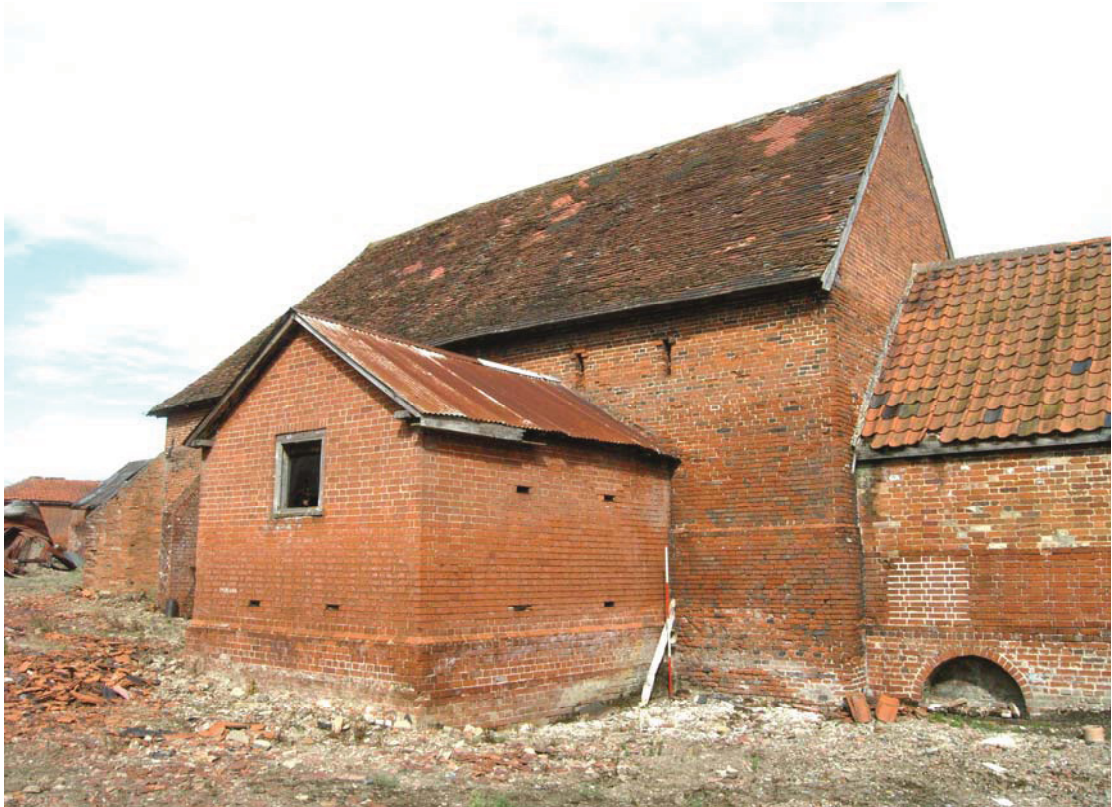
A2.5 Western external elevation of the stable (B) showing its original ventilation slits and the secondary tack room (C) in the foreground. The vehicle shed (D) is shown to the right with an arched plinth that may relate to a yard drain.

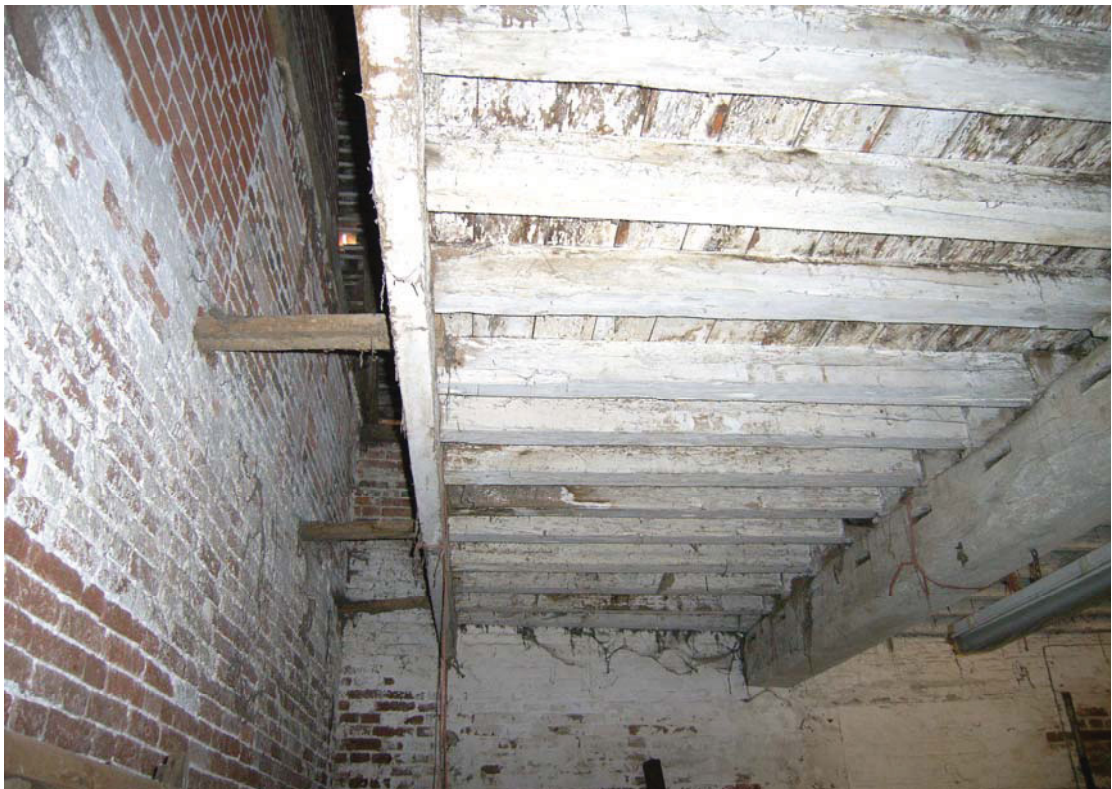
A2.6 The southern end of the original ceiling in the stable (B) seen from the east, showing the loading vent above the removed hay rack. Note the re-used binding joist to right.

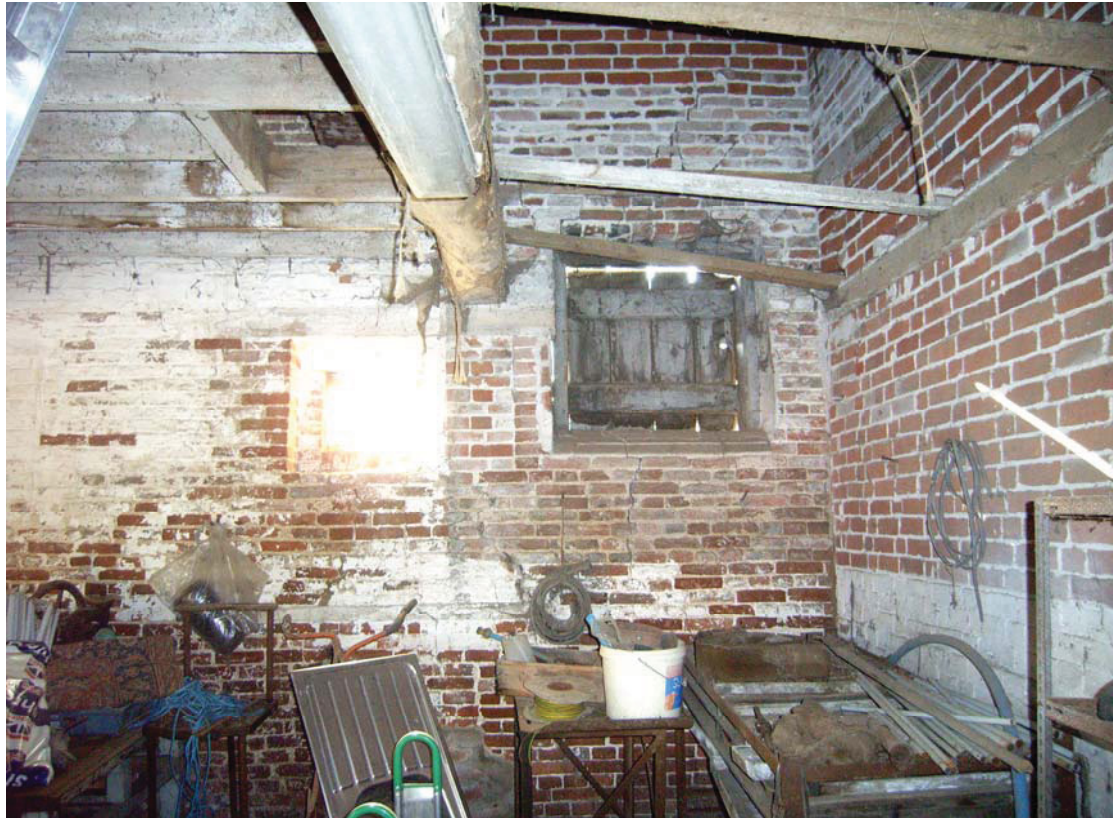
A2.7 The northern end of the stable's western internal elevation, showing the position of the removed chaff house with external loading hatch.

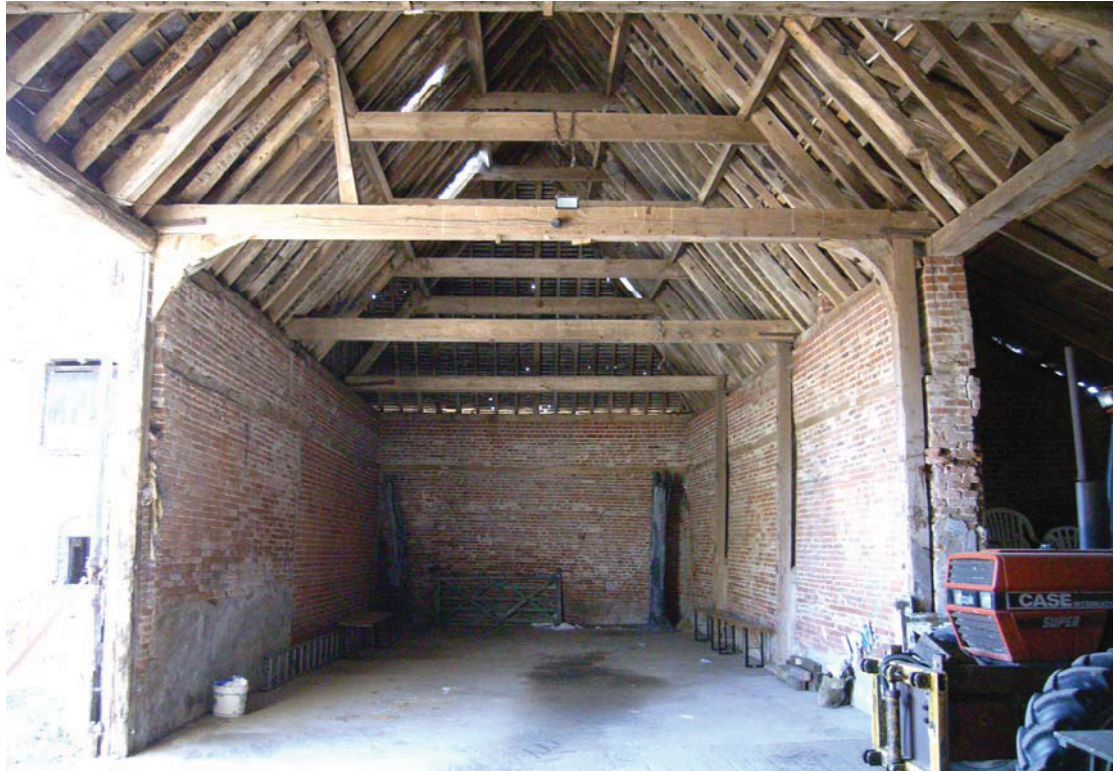
A2.8 Interior of barn from east, showing secondary lean-to porch to right and southern central entrance doors to left. The brickwork and roof structure at this end of the barn has been rebuilt above the timber rails set into the internal walls.

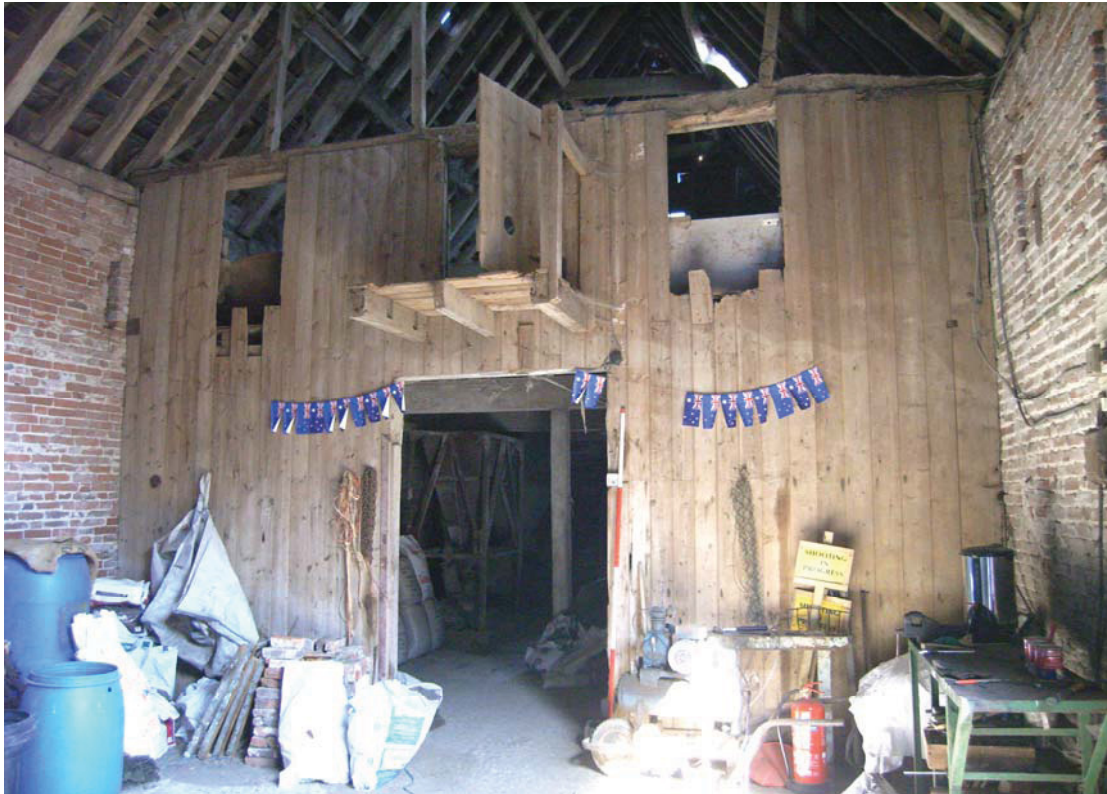
A2.9 The boarded partition of the 20th century grain and milling floor at the eastern end of the barn. Note the original ventilation slits to left and right.

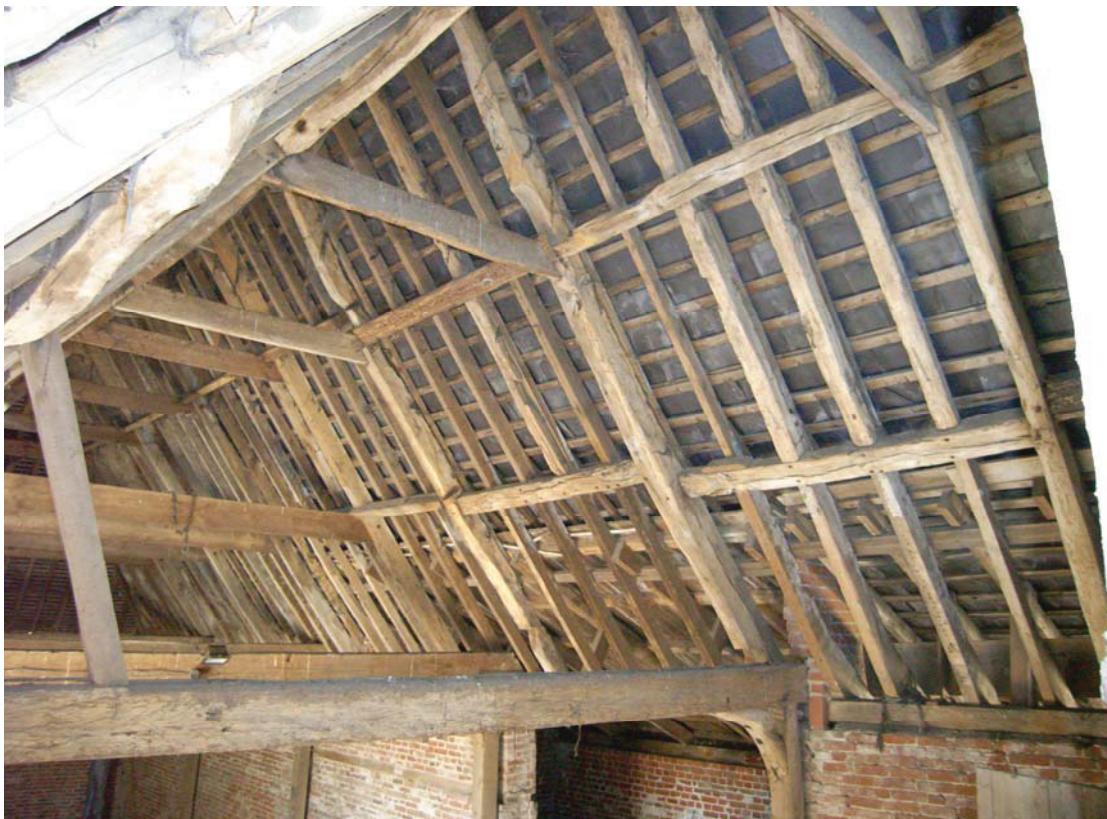
A2.10 Northern elevation of barn roof from south-east, showing the original structure of clapped and staggered butt-purlins to the right and the rebuilt 19th century section to left.

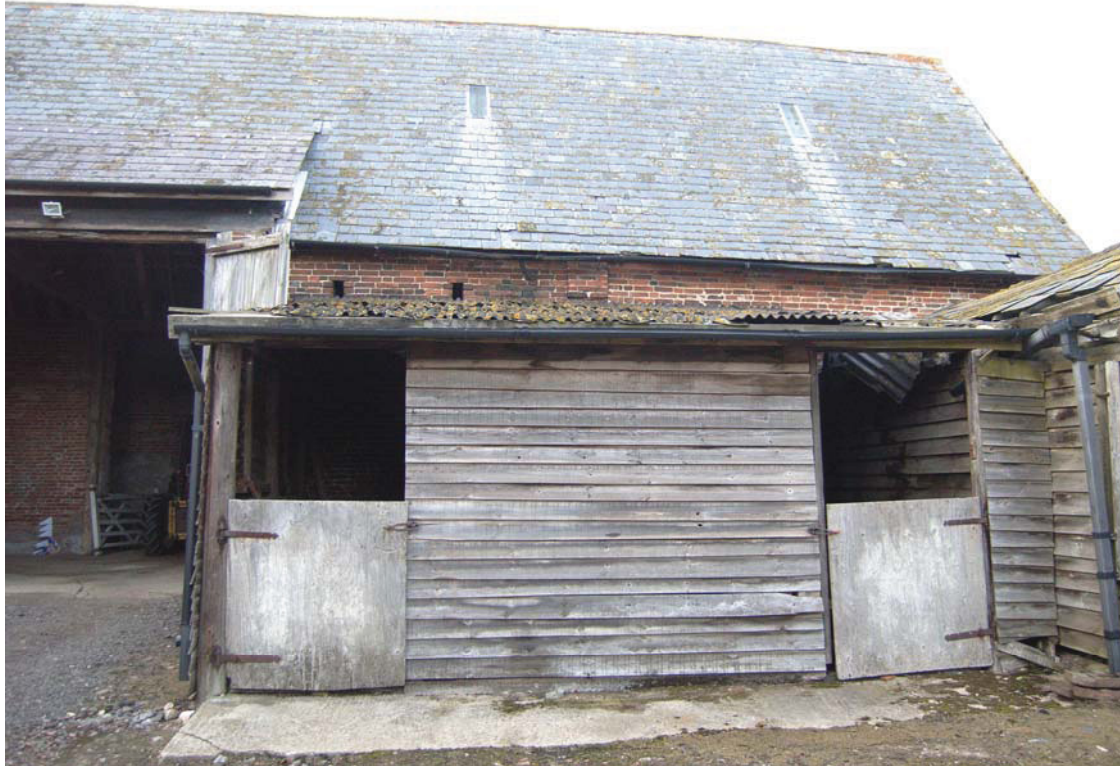
A2.11 Eastern half of barn's southern elevation above the 20th century loose box (E) with two ventilation slits in the original brickwork to the left and secondary brickwork to the right where the barn abutted a demolished eastern wing

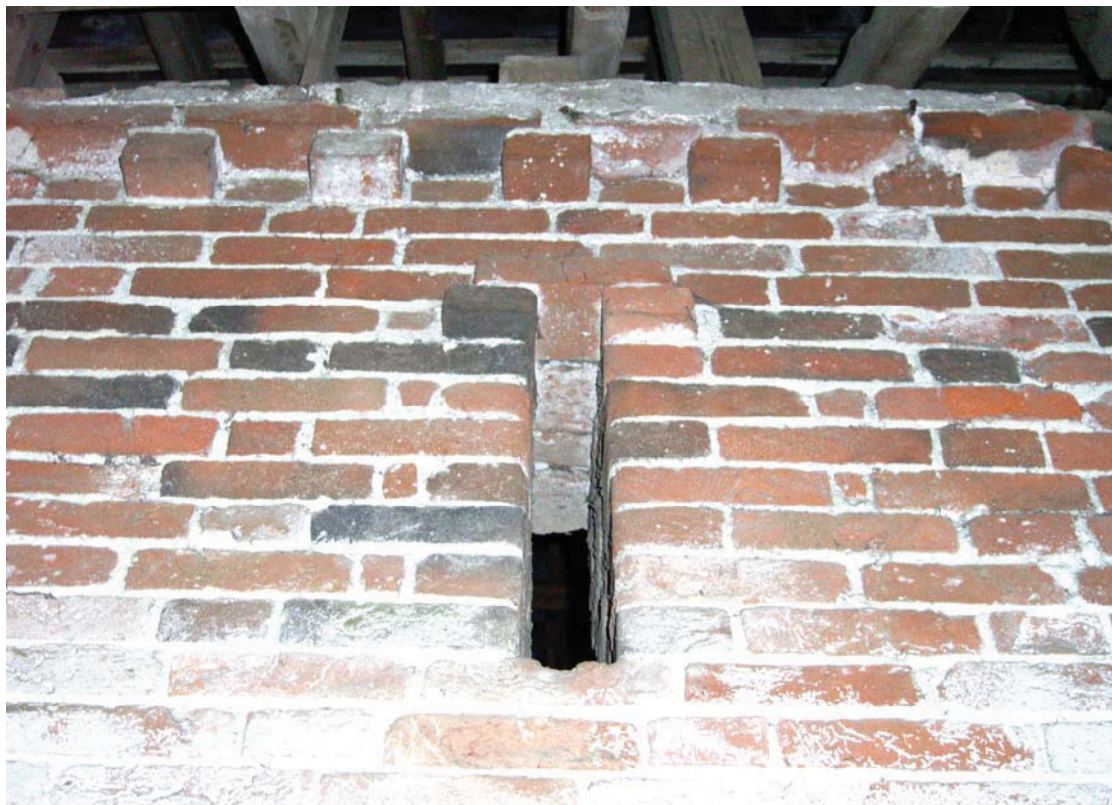
A2.12 An original hooded ventilation slit in the eastern half of the barn's northern exterior. Note the dentil cornice above.
