**The Farm Buildings,
Hall Farm,
Bruisyard Hall,
Suffolk
BUD 006**

Historic Building Record

October 2009

Farm Buildings at Hall Farm, Bruisyard Hall, Hall Road, Bruisyard, Suffolk,

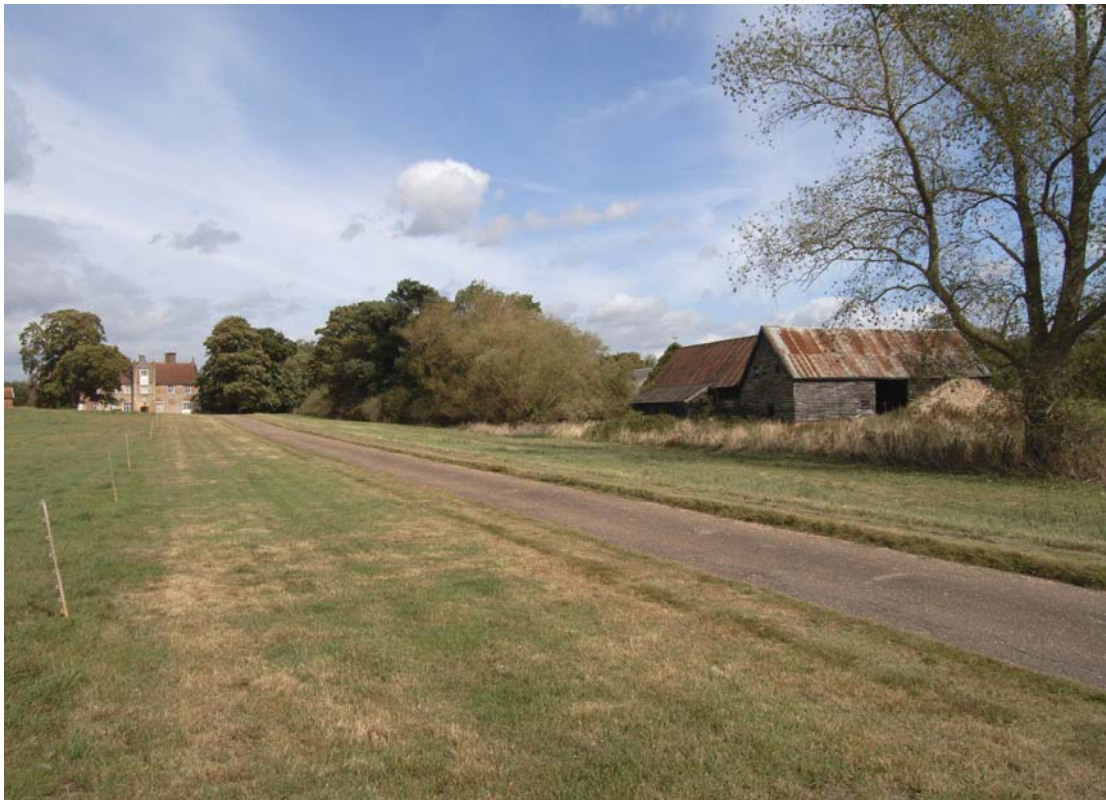
A2.1 General view of site from south-west showing position of barn to right of approach to Bruisyard Hall (left)

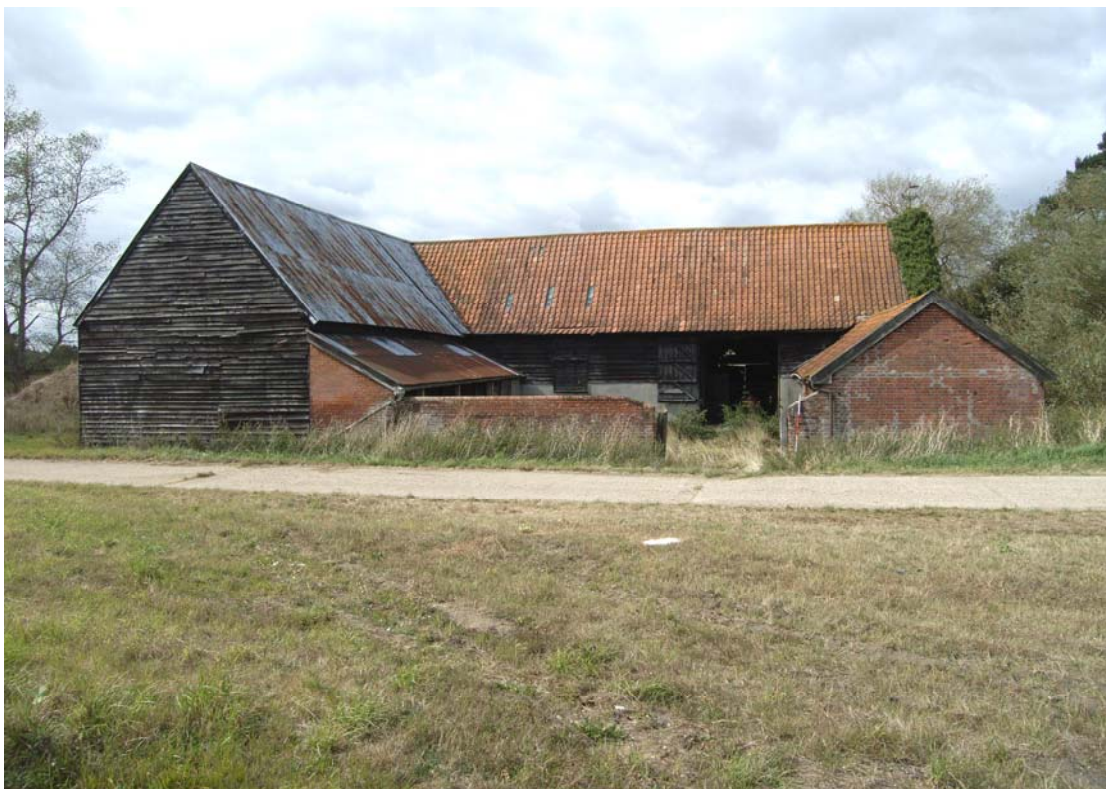
A2.2 Exterior of complex from east showing 19th century yard entrance in foreground, 19th century barn (3) to left and 16th century stable range later converted into a barn (1) in rear

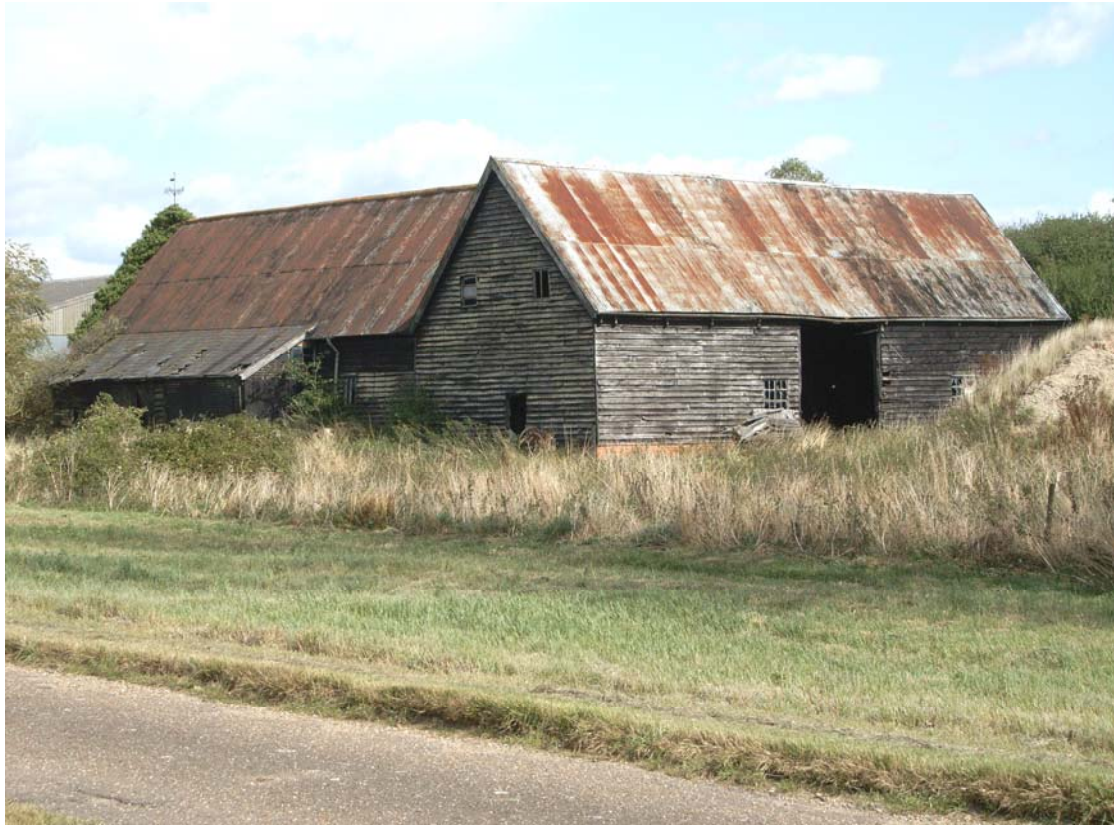
A2.3 Exterior of complex from south-west showing approach to hall in foreground, 19th century barn (3) to right & 16th century stable range (1) & slate shed (2) to left

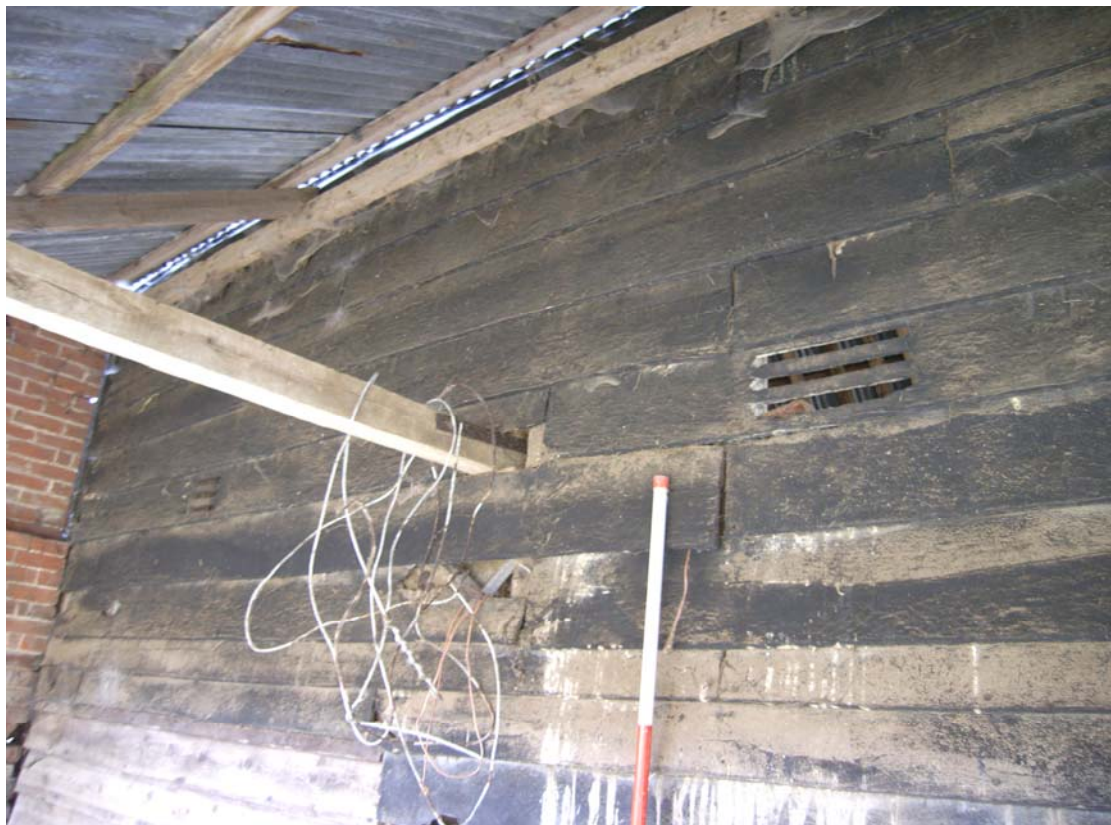
A2.4 Unusual horizontal ventilation slits in tarred external northern weatherboarding of 19th century barn (3) seen from lean-to shelter shed (5).

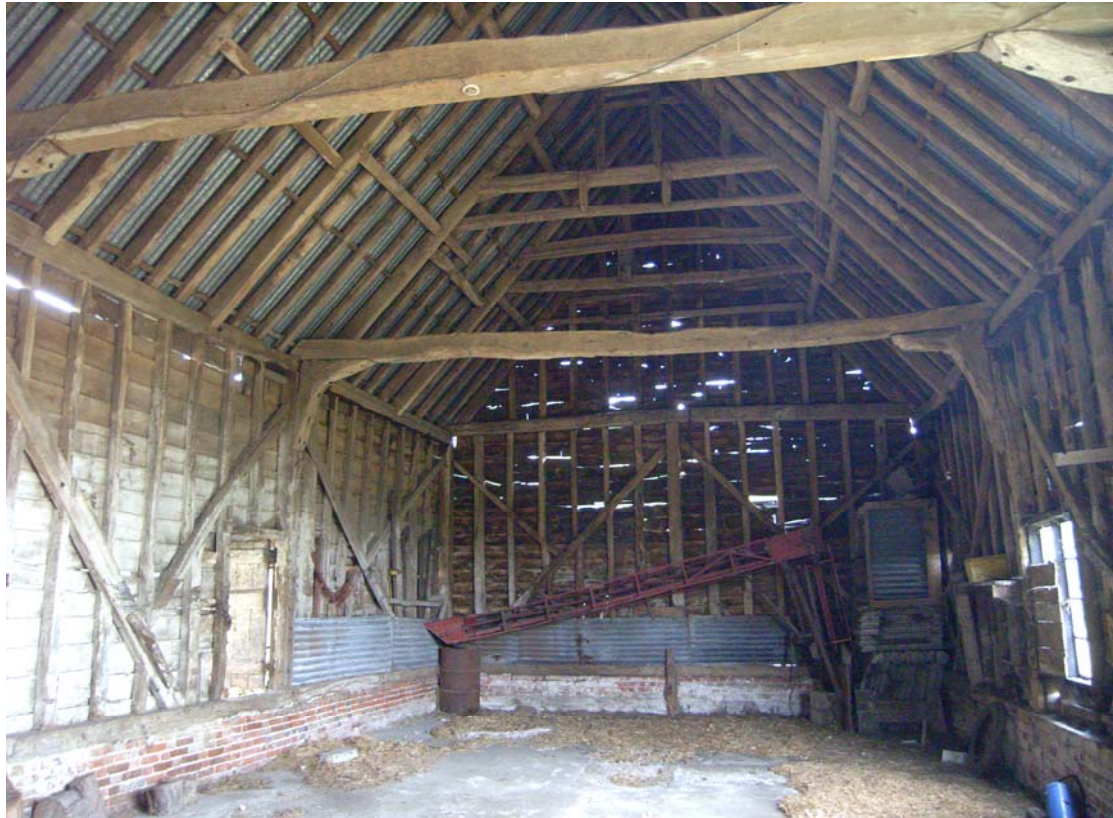
A2.5 Interior of 19th century barn (3) from west showing original primary wall-bracing, bolted knee-braces to tie-beams and staggered butt-purlin roof structure

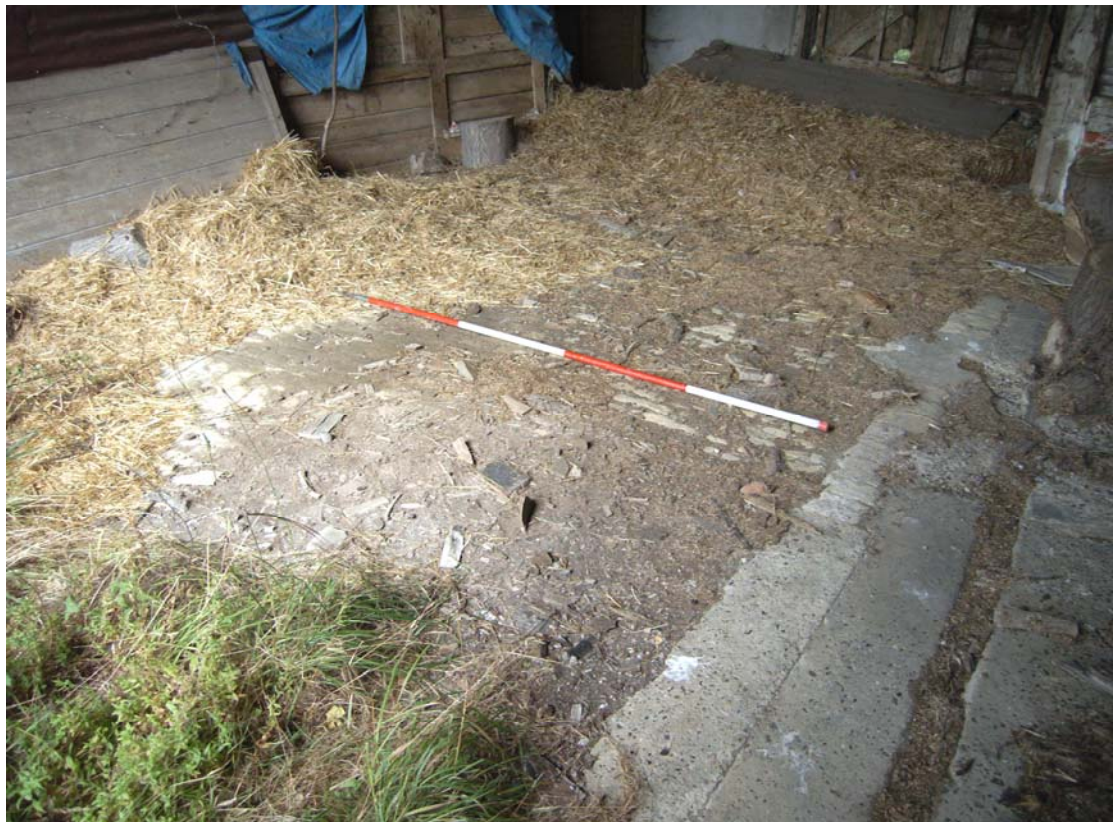
A2.6 Threshing floor of white brick in central bay of 19th century barn (3), viewed from southern entrance.

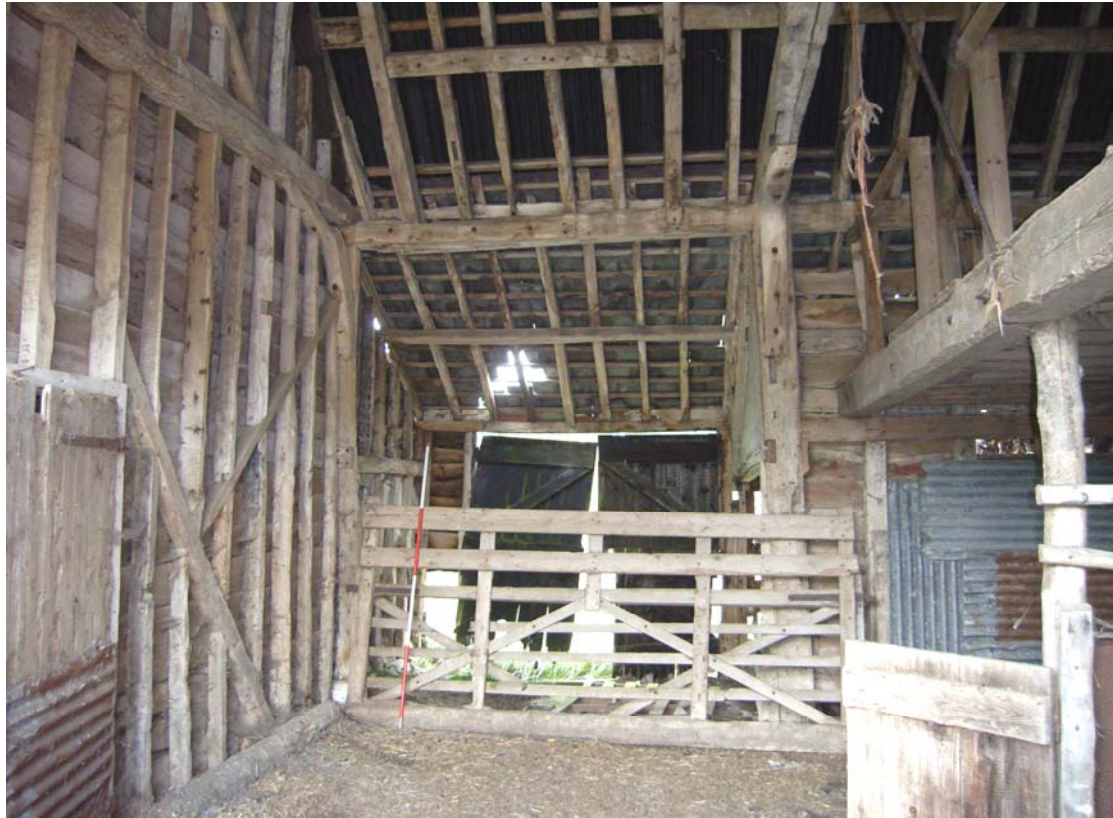
A2.7 Interior of 16th century stable from east showing 20th century loft and cattle stalls to right, entrance to lean-to porch (2b) in centre and 19th century internal partition to left.

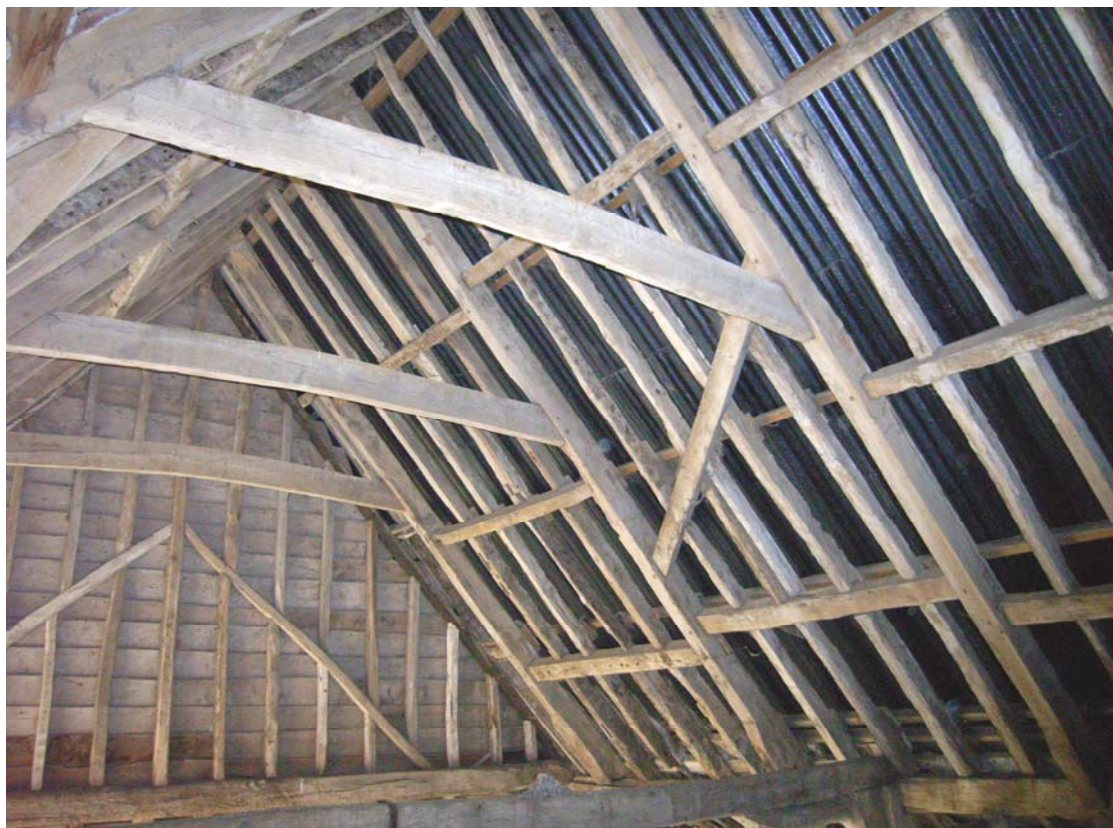
A2.8 Early-19th century roof structure of staggered butt-purlins to former 16th stable seen from northern bay and showing internal partition to southern compartment (1a) left.

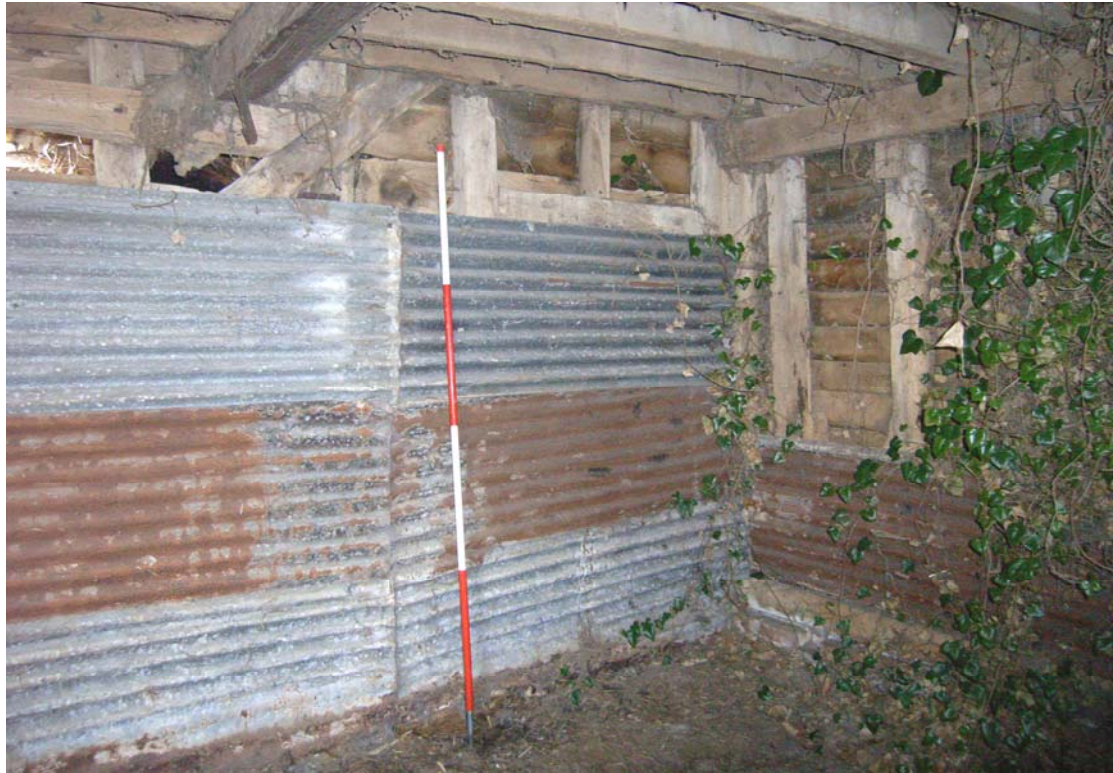
A2.9 Internal north-western corner of barn (1b) showing the intact jambs and lintel of an original door to the left of the corner post (E) and the intact jambs with mortises for a missing similar lintel in the northern gable to its right. Much of the original framing is hidden by boarding or corrugated iron as here.

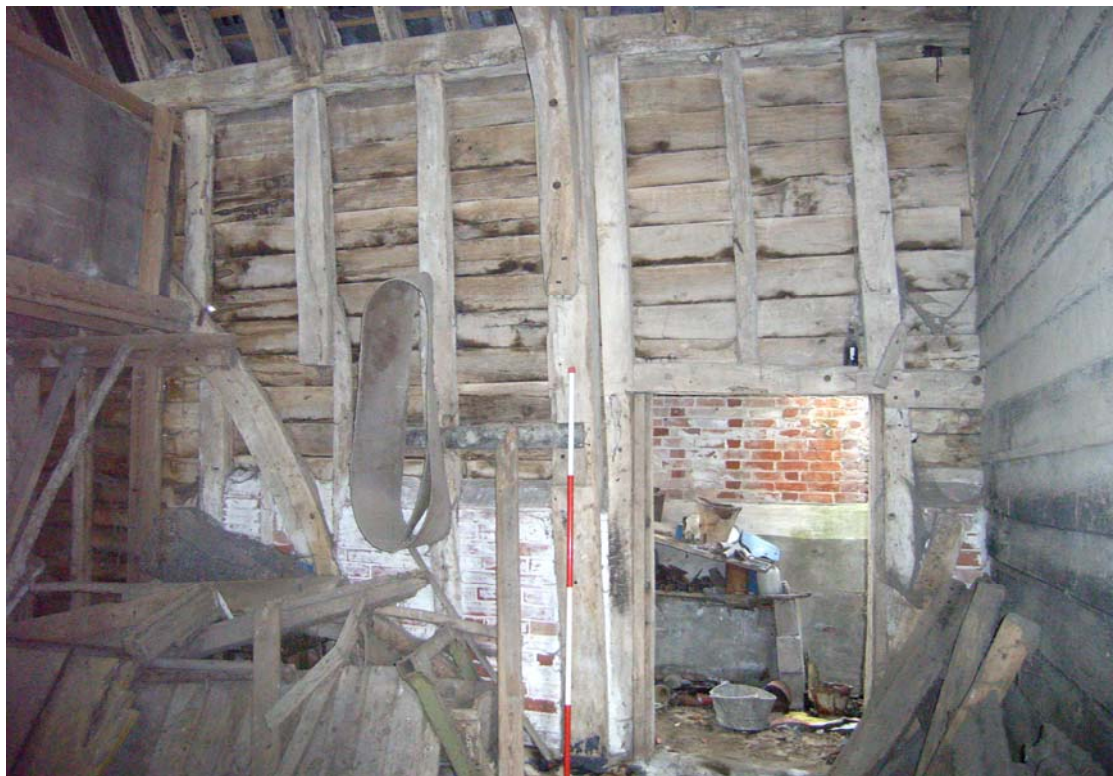
A2.10 Western internal elevation of 16th century stable (1a) showing storey post C with framing of original door to right (now opening into 19th century lean-to shed (2a)). The curved primary wall brace to the left is secondary.

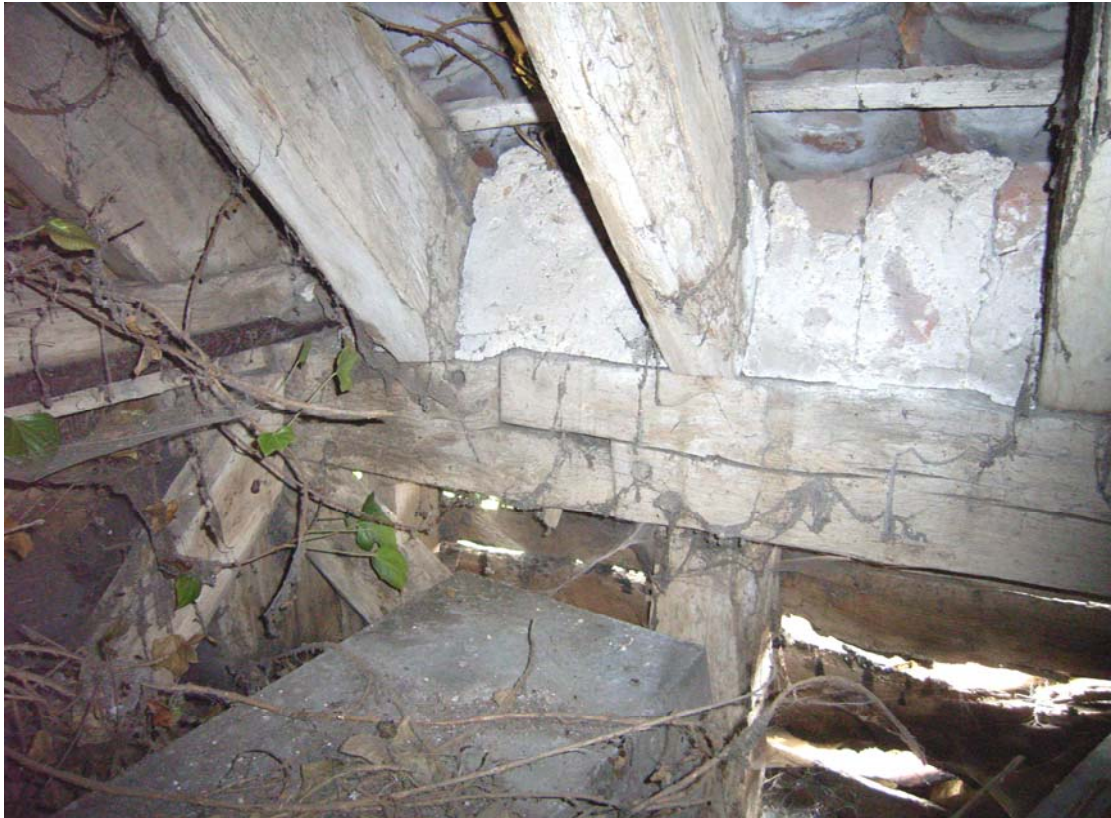
A2.11 Detail of short edge-halved and bridled scarf joint at northern end of eastern roof plate (1b), showing original door jamb and tie-beam of northern gable to left.

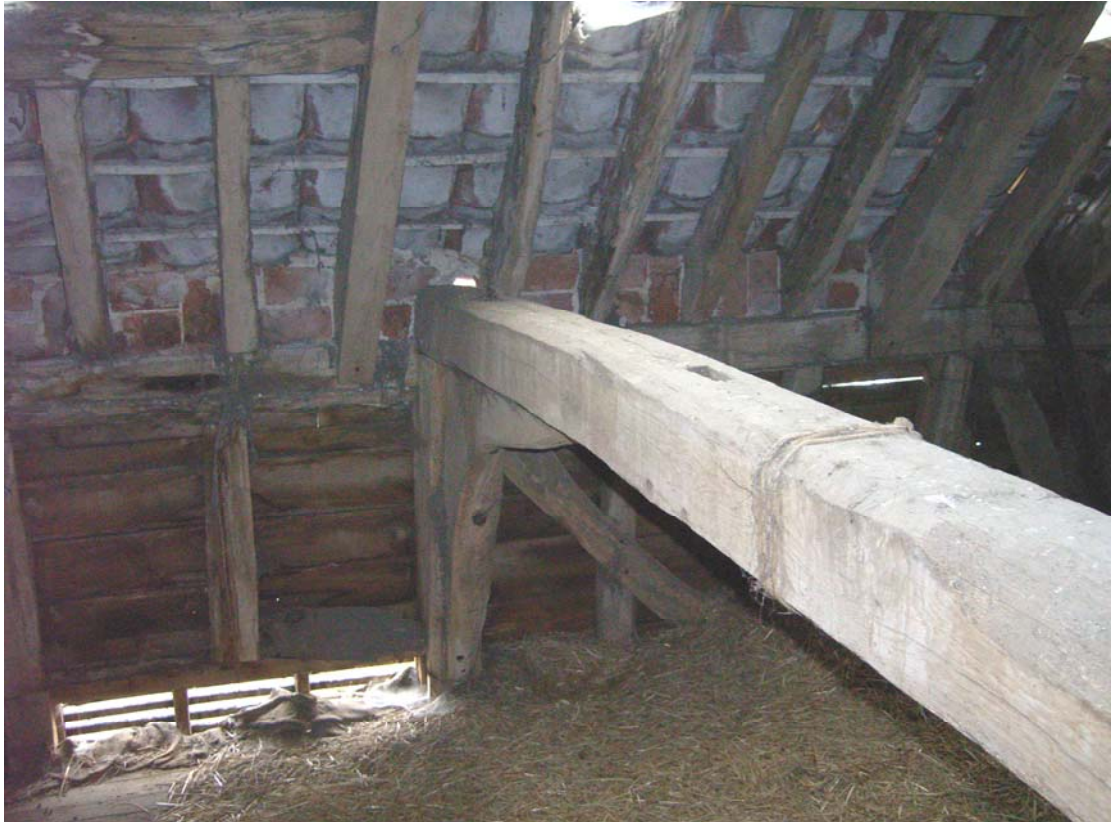
A2.12 Detail of tie-beam of open truss B-G from east, showing mortise of original queen-post or queen-strut in upper surface and bolted knee-brace replacing arch-brace.
