ARCHAEOLOGICAL SURVEY REPORT

SCCAS REPORT No. 2010/012

Tower Survey St Andrew's Church, Wissett WSS 012

A survey to record the internal and external details of the round tower of St Andrew's Church, Wissett was undertaken during May 2009. The survey was undertaken in advance of the replacement of the 15th century bellframe which would necessitate some alteration of the original fabric of the tower.

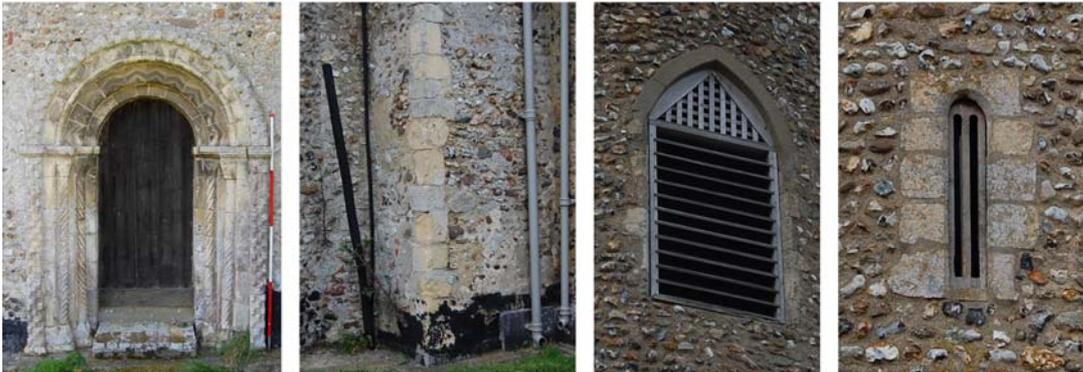
The slit and belfry windows are finished in freestone. The stone used on the slit windows is a durable, fine-grained, pale yellow stone similar to those produced by the Lincolnshire quarries at Ketton or Clipsham which matches that used on the nave north door. The stone on the belfry windows is more like that of the quoins on west corners of the nave and although it looks superficially similar to the stone used in the Norman built phases, is a softer stone resulting in both the belfry windows and the nave quoins suffering a greater degree of erosion (Fig 4).

Figure 4. Durable stone used on the door and first floor windows contrast with the softer stone used on the later quoins, the belfry windows are made up of a mixture of both

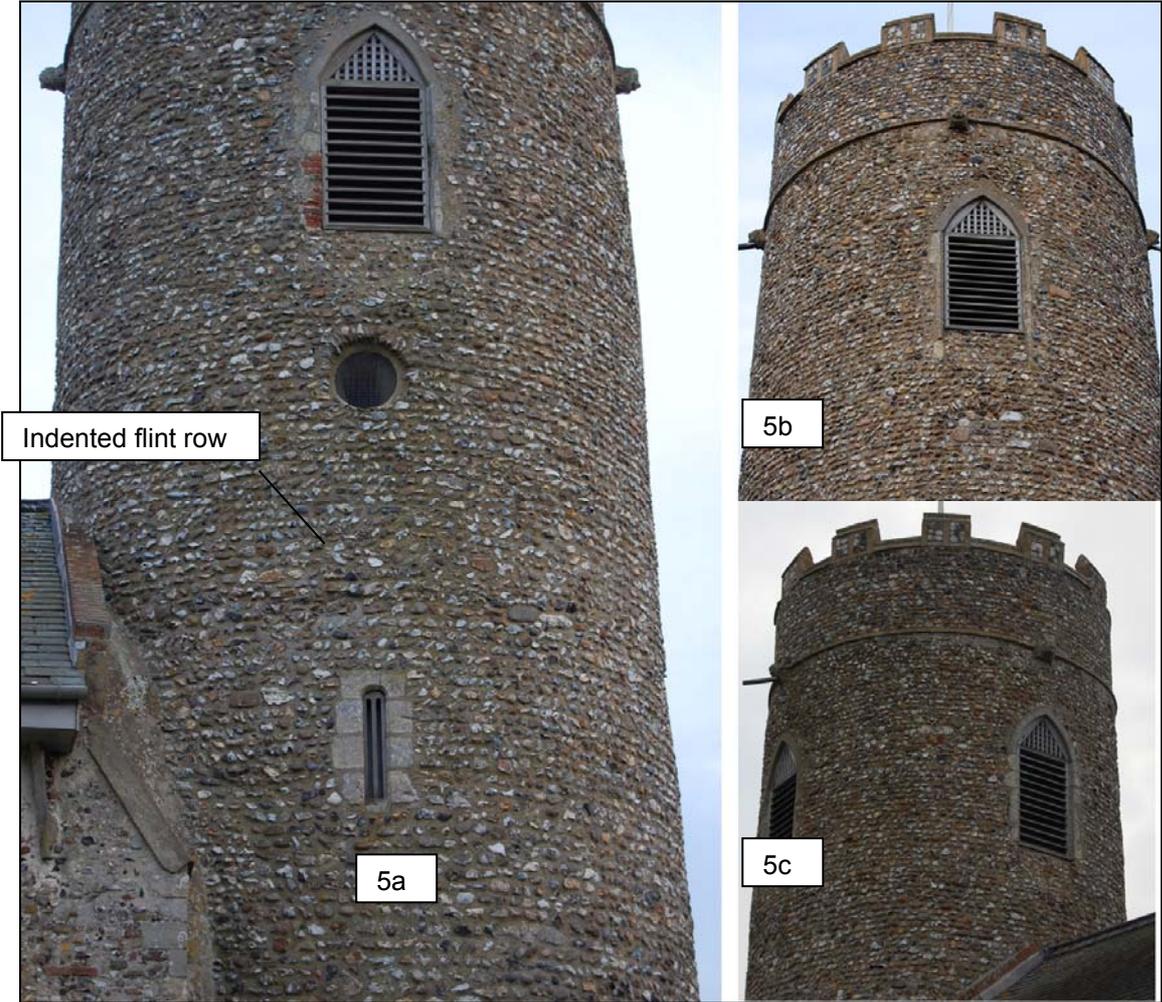
dressed stone suggest that the stone edging here is an original feature (Fig. 5b). However this is not so conclusive on the other openings where the surrounding flintwork has been heavily re-pointed or in the case of the north opening reworked as part of a repair. The dressed stone that frames the windows, despite appearing similar to that used on the slit windows is a softer stone and more like that of the later quoins on the nave corners and it is possibly contemporary with the remodelling of the nave.

Figure 5. Treatment of Phase 3 windows.

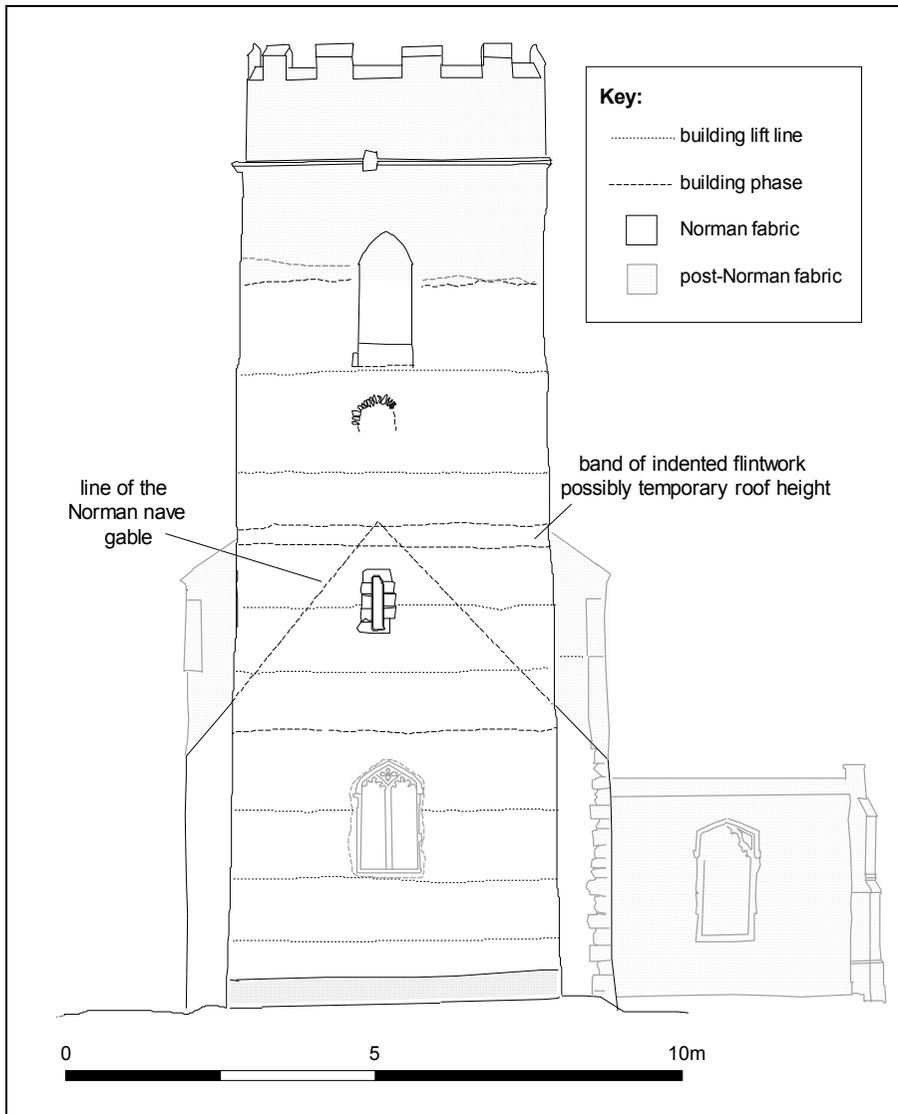
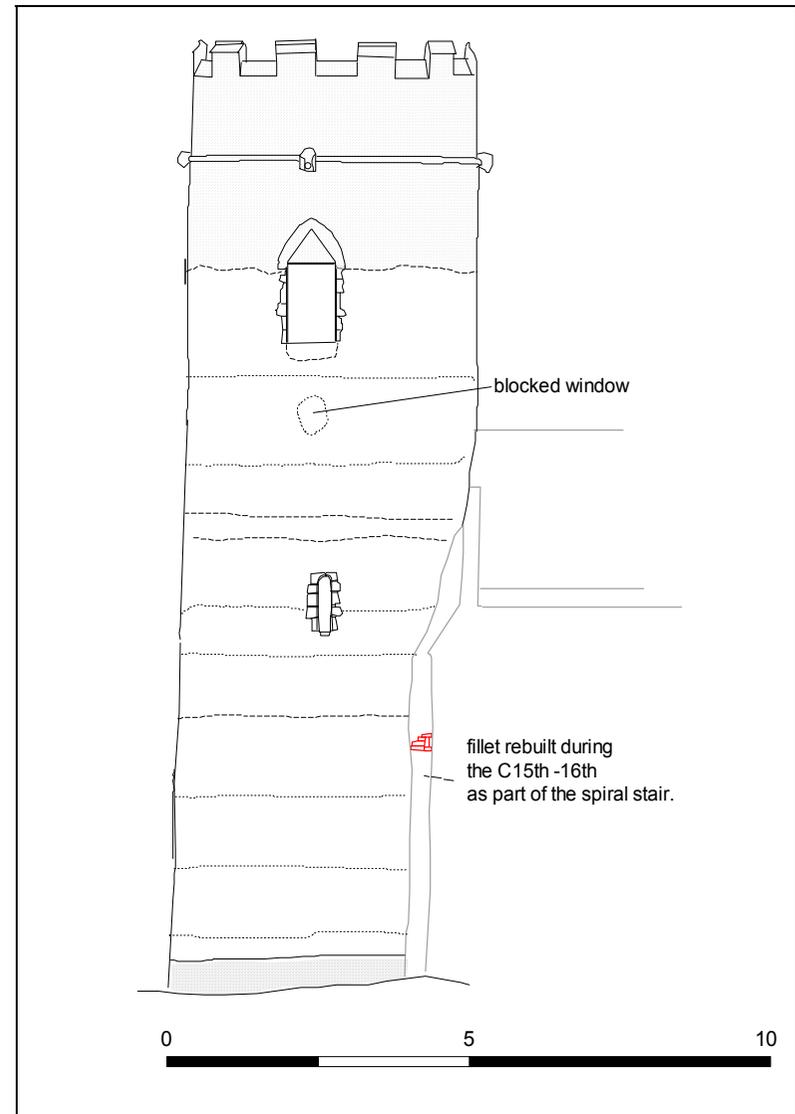
The flints of the first phase of work are well coursed at a rate of c.12 courses per metre. The flints are regularly spaced and appear to have been sorted for uniformity of size. The top of this phase can be identified by a row of very small flints which are distinct from the row of large rounded sandstone pebbles with which the second phase of construction starts. In the first phase of work the builders achieved a tower height of 4.42m, completed in four building lifts, bringing the tower to first floor level.

During the second phase the tower room was completed in four lifts each of c.8 rows of flint which lifted the tower to a height of 7.5m. This is equivalent to the estimated ridge height of the original nave roof and part of the gable and the east side of the tower are a shared wall. Externally the top of the phase can be identified by a slightly inset band of flintwork, 2-3 courses wide, which gives the profile of the tower a slightly indented appearance at this point (Fig.5a).

Figure 6. West and south elevations

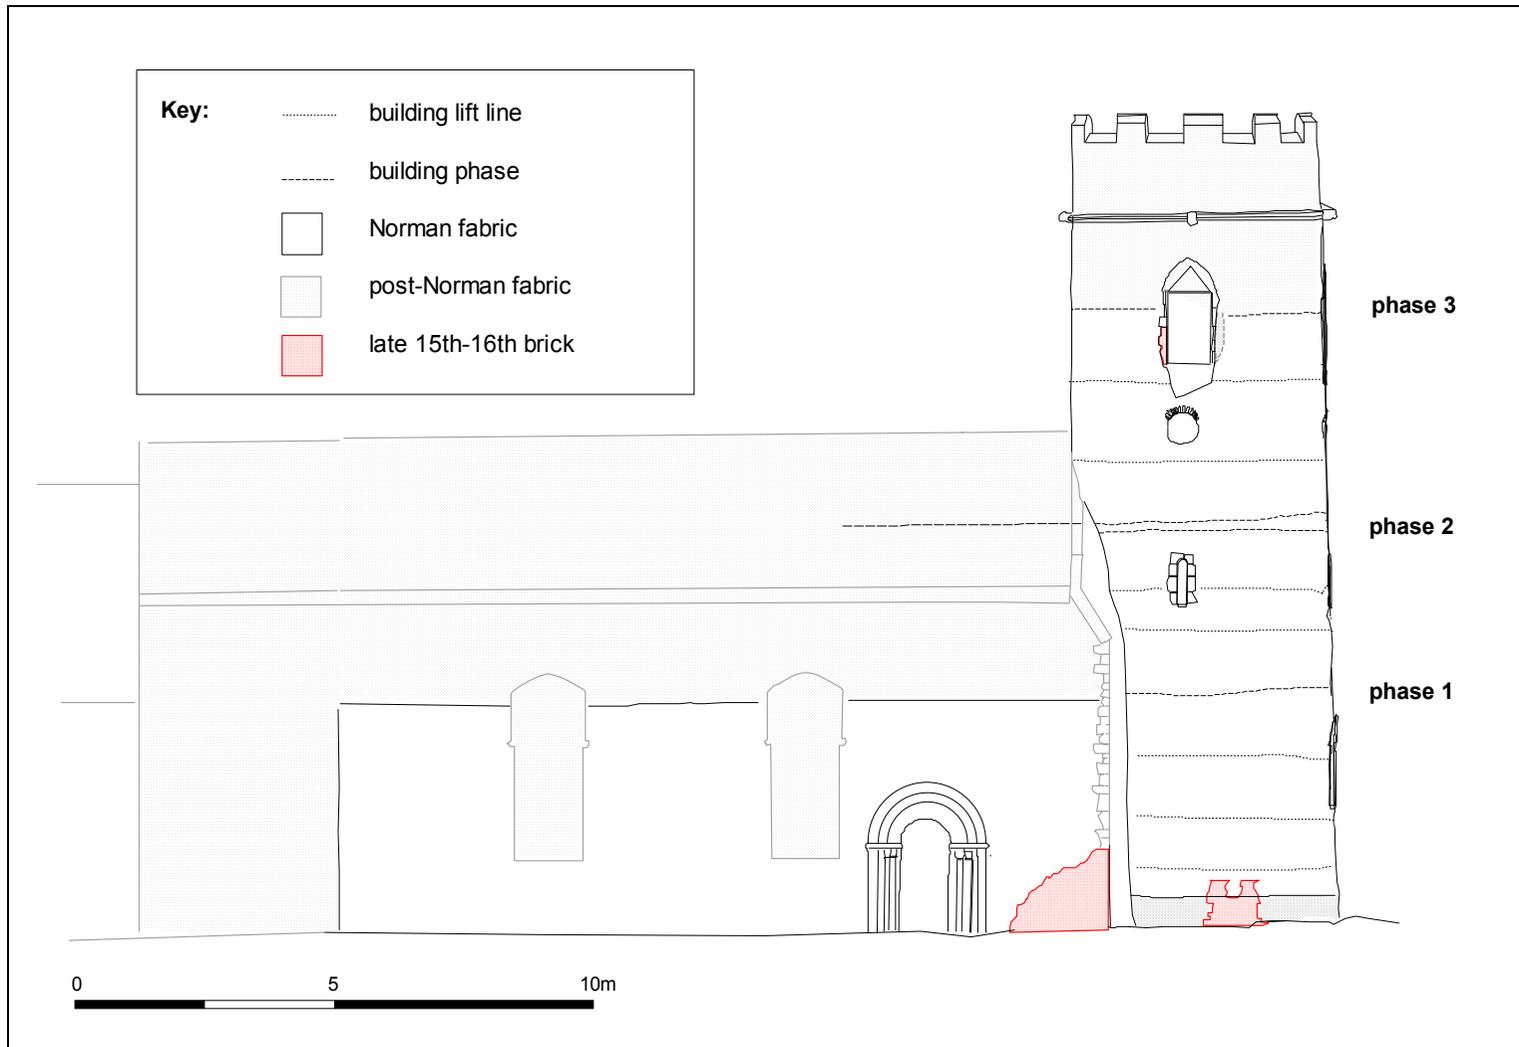
Figure 7. North elevation

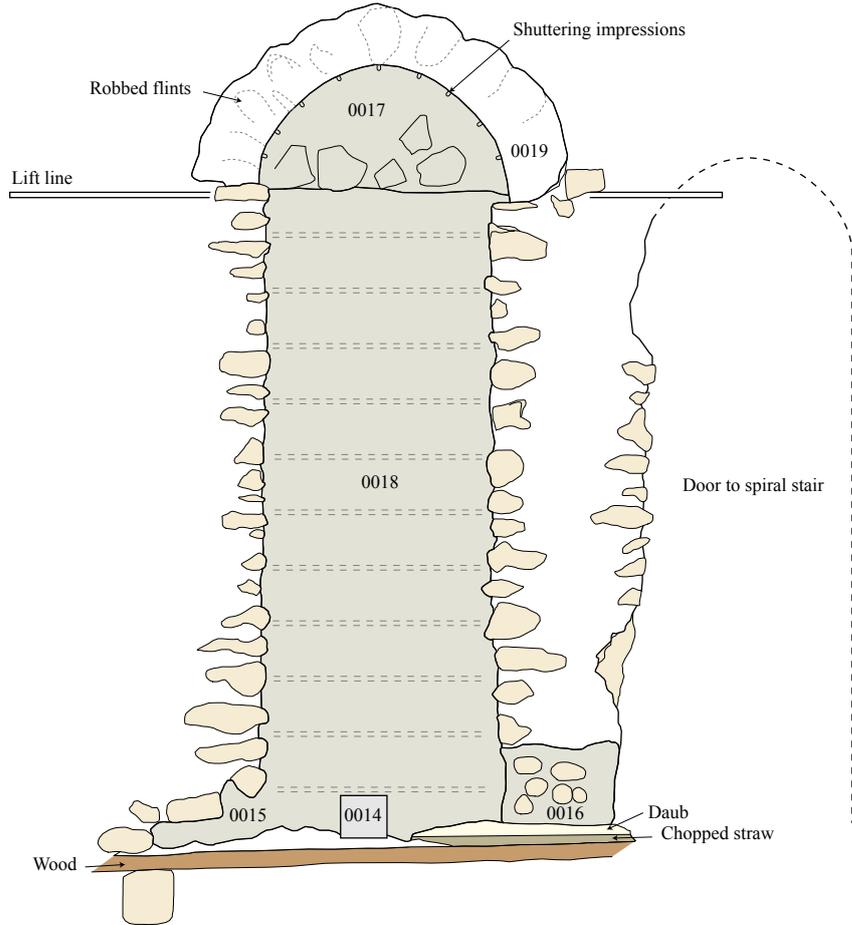
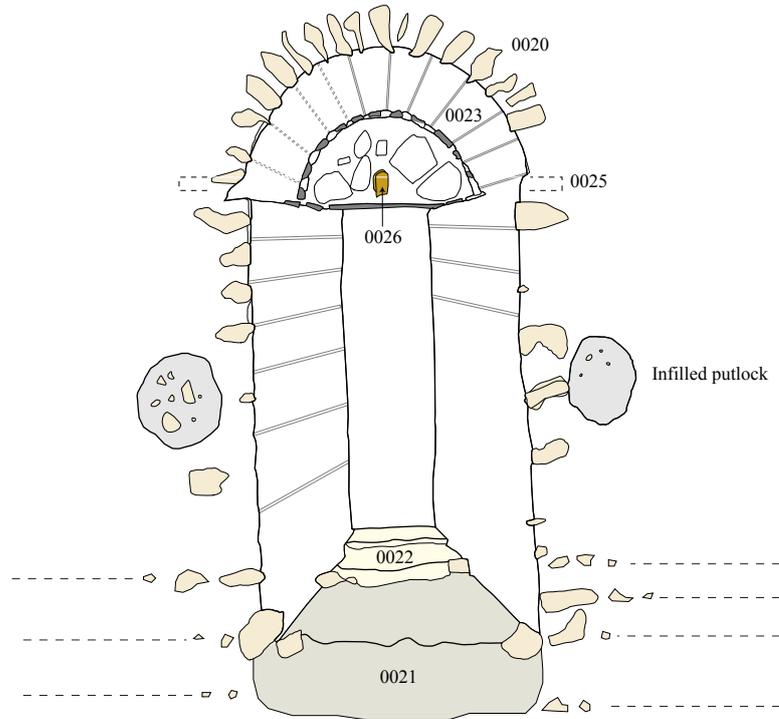
Entry to the tower room was originally, presumably via a ladder, by a door through the gable of the nave. This has now been blocked and can no longer be seen from the body of the church. Within the tower room the former doorway appears as a 0.85m deep alcove. The arch at the top of the door is a round headed form; the opening is 0.6m wide and 2.05m tall. The edge of the opening, both for the verticals and the face of the arch is formed using large flint cobbles and no freestone is used. The facing flints over the arch, 0019, have been robbed leaving a 0.15m deep recess over the door (Fig. 8). The interior of the arch is parallel sided, unlike those of the windows which open out to an internal splay. The underside of the arch displays impressions of wooden shuttering; part of the temporary centering over which the arch was constructed (Fig. 8 and 9b). The shuttering was made up of 12 narrow boards/slats which were not of uniform size. The depth of the impressions suggests a variable thickness to the timber and the widths vary from between 60-120mm. The span of the arch is slightly wider than the doorway creating a 40mm ledge at the springing point on each side of the door onto which the timber centering was set. The arch springing point occurs at

Figure 8. Tower room: Interior

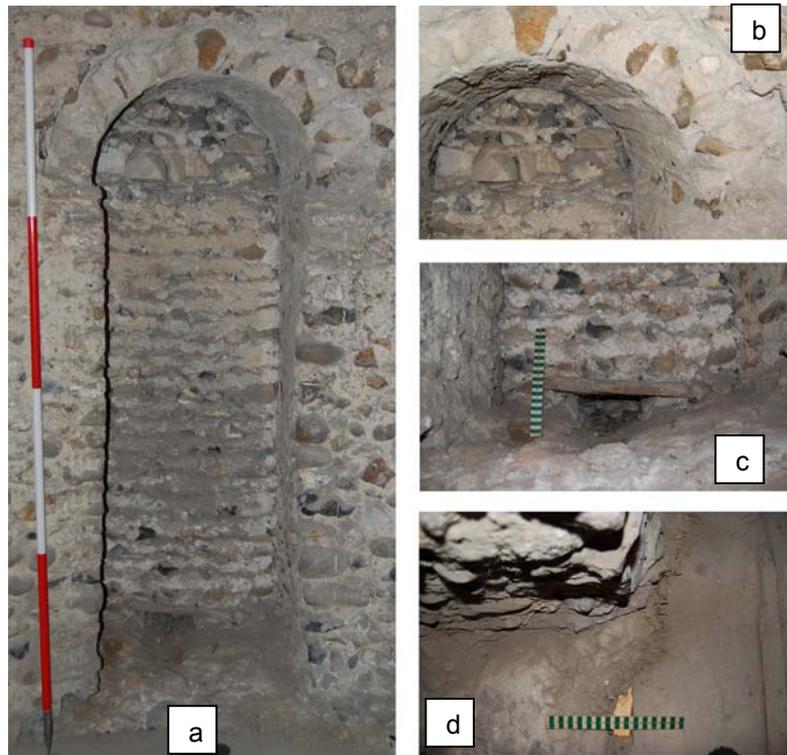
The doorway was blocked on the east side with a single thickness flint wall, 0018, probably when the spiral stair was added. The flints of the infill are laid neatly in rows similar to the Norman work but have been set dry into a thick bed, and there is no mortar between the vertical joints. The mortar is a white lime mortar unlike the Norman mix and it has been flattened suggesting that the infill material was built against shuttering and constructed from the east side.

The threshold of the doorway is slightly higher (about 50mm) than the surface of the floor within the tower room and is not level. In the main it is uneven and made up of rough flints, and there are the remains of a 5cm deep screed in the rear corners of the alcove but otherwise it is simply a cross section through the core of the wall. At the base of the doorway opening there are cut-outs or sockets, 0015, for timbers (Fig 8). As there is no other evidence of a door frame or any indication of a closable door, it seems most likely that this is a joist setting for a suspended wooden floor through the doorway. There is also a central joist hole, 0014, at the base of the infill on the nave side of the door. The wooden lintel which spans the hole appears contemporary with the infill material but the socket below is set into original fabric and predates the closing off of the door.

The socket on the south side of the door opening has been infilled with mortared small rounded pebbles, 0016, and the mortar is similar to that used in the blocking of the door so the two events are possibly related. Sealed beneath the rebuilt section and overlying the floor boards of the tower room is a layer of daub and chopped straw (Fig. 9d). This seals the gap between the edge of the floor and the wall. It projects up to 80mm into the room and with a diminishing thickness 250mm back into the alcove of the door. At its thickest the layer is 50mm deep but its internal edge has been truncated, and the full extent and as to whether it extended around the whole floor is unknown. The surviving extent of the material follows closely the depth of the infilled socket and its relationship with the original fabric of the building is uncertain.

Figure 9. Door details

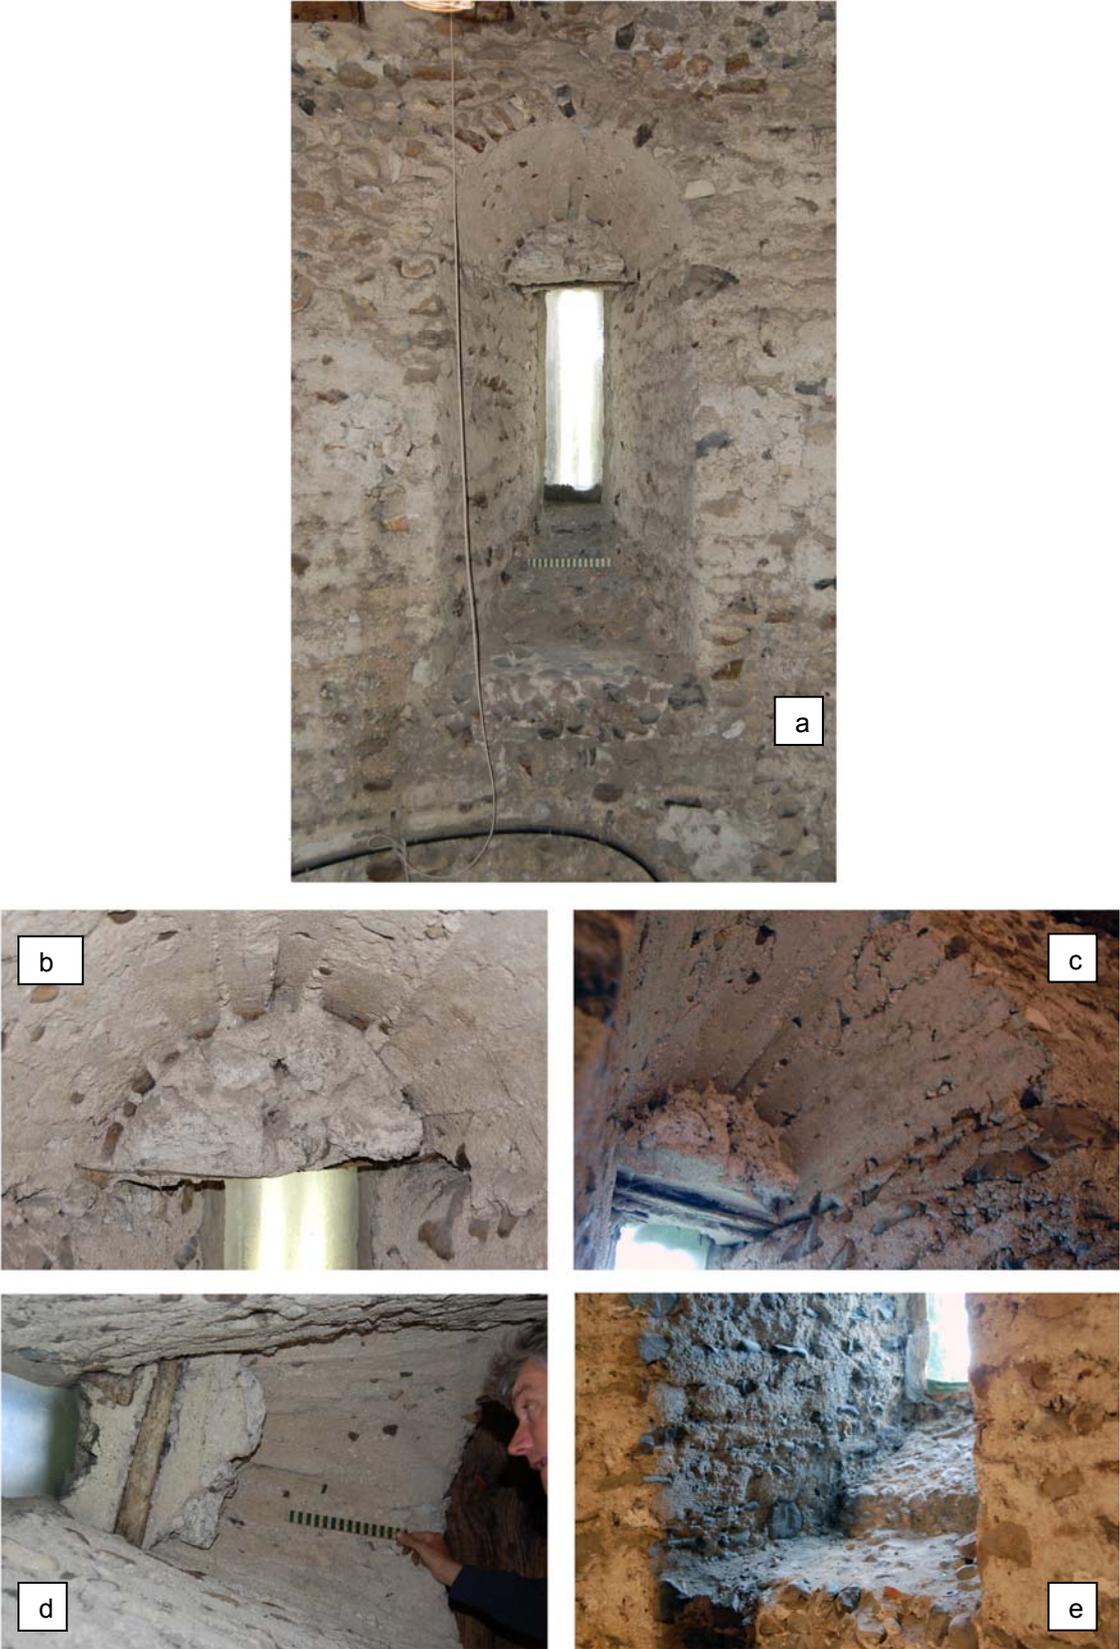
Impressions of the timber centering, 0023 used to create the arches are visible at the top of the reveals (Figs. 10b and c) and, remarkably, part of this formwork has been left in place in the north window to give a unique insight as to how the Norman mason worked. At the head of the window, there is a lump of poorly mixed mortar and chalk, 0024, which was held up on a platform of narrow wooden slats that bridged across the width of the reveal (Fig 10d). Two of the slats remain in place whilst the impression of others along the line of the arch springing point show that this temporary platform extended right to the front of the reveal. The mortar lump was fashioned into semi-circular tapering block (half a longitudinally divided cone) which formed the basic shape of the arch and provided support for the timber centering. The longitudinal slats were laid over the mortar, whilst it was still wet, to form a pattern for the underside of the arch and it also created a barrier between the mortar mould and the bedding mortar of the flintwork above to prevent the two from sticking together. The fact that they *have* become bonded demonstrates how quickly the masons worked as the mortar of the formwork clearly had no time to go off. Trapped between the two mortars the broken off ends of the radiating slats remain *in situ*.

Figure 10. Window details

On the south and west facing windows there are cracks running from the outer edge of the wall to the inner on the centre-line of the arch; the west window has been repaired with an ill-matched grey cement.

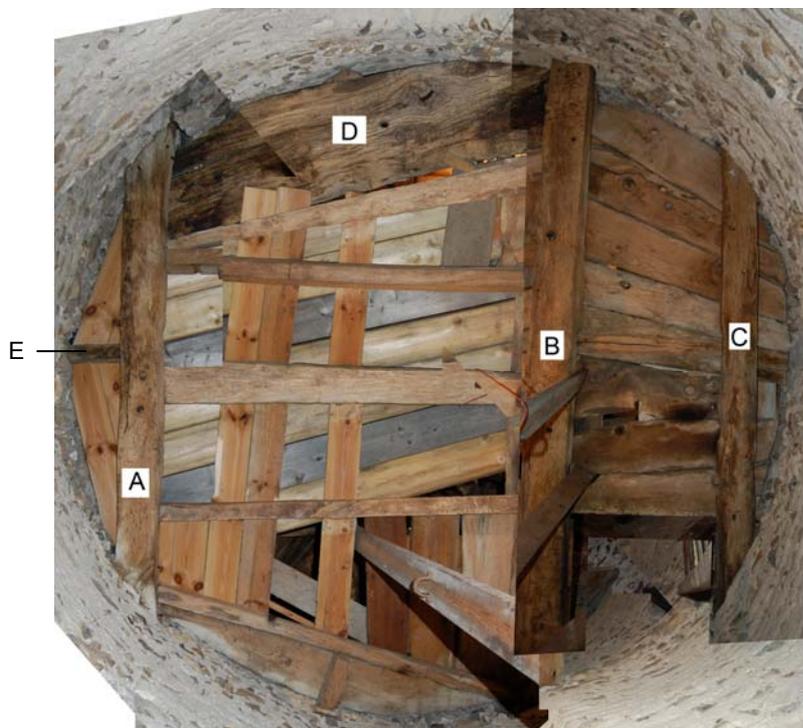
The original floor was supported on four parallel joists that ran north–south spanning the tower and three of these (labelled A, B and C on Fig. 11) remain in place. One of the central joists has been removed, which was probably to create space for the large bells that were introduced into the tower and raised through the floor. Most of the floor boards are thought to be secondary but an original board (D) still survives.

Timbers A, B and D had been previously sampled for dendrochronology (Bridge 2004), which failed to produce an absolute date, following which the samples were radiocarbon dated. Analysis of these results suggested that the timbers were felled in cal AD1145-1205 (82% probability – Bayliss et al. 2006)

Figure 11. Former ringing chamber floor from below

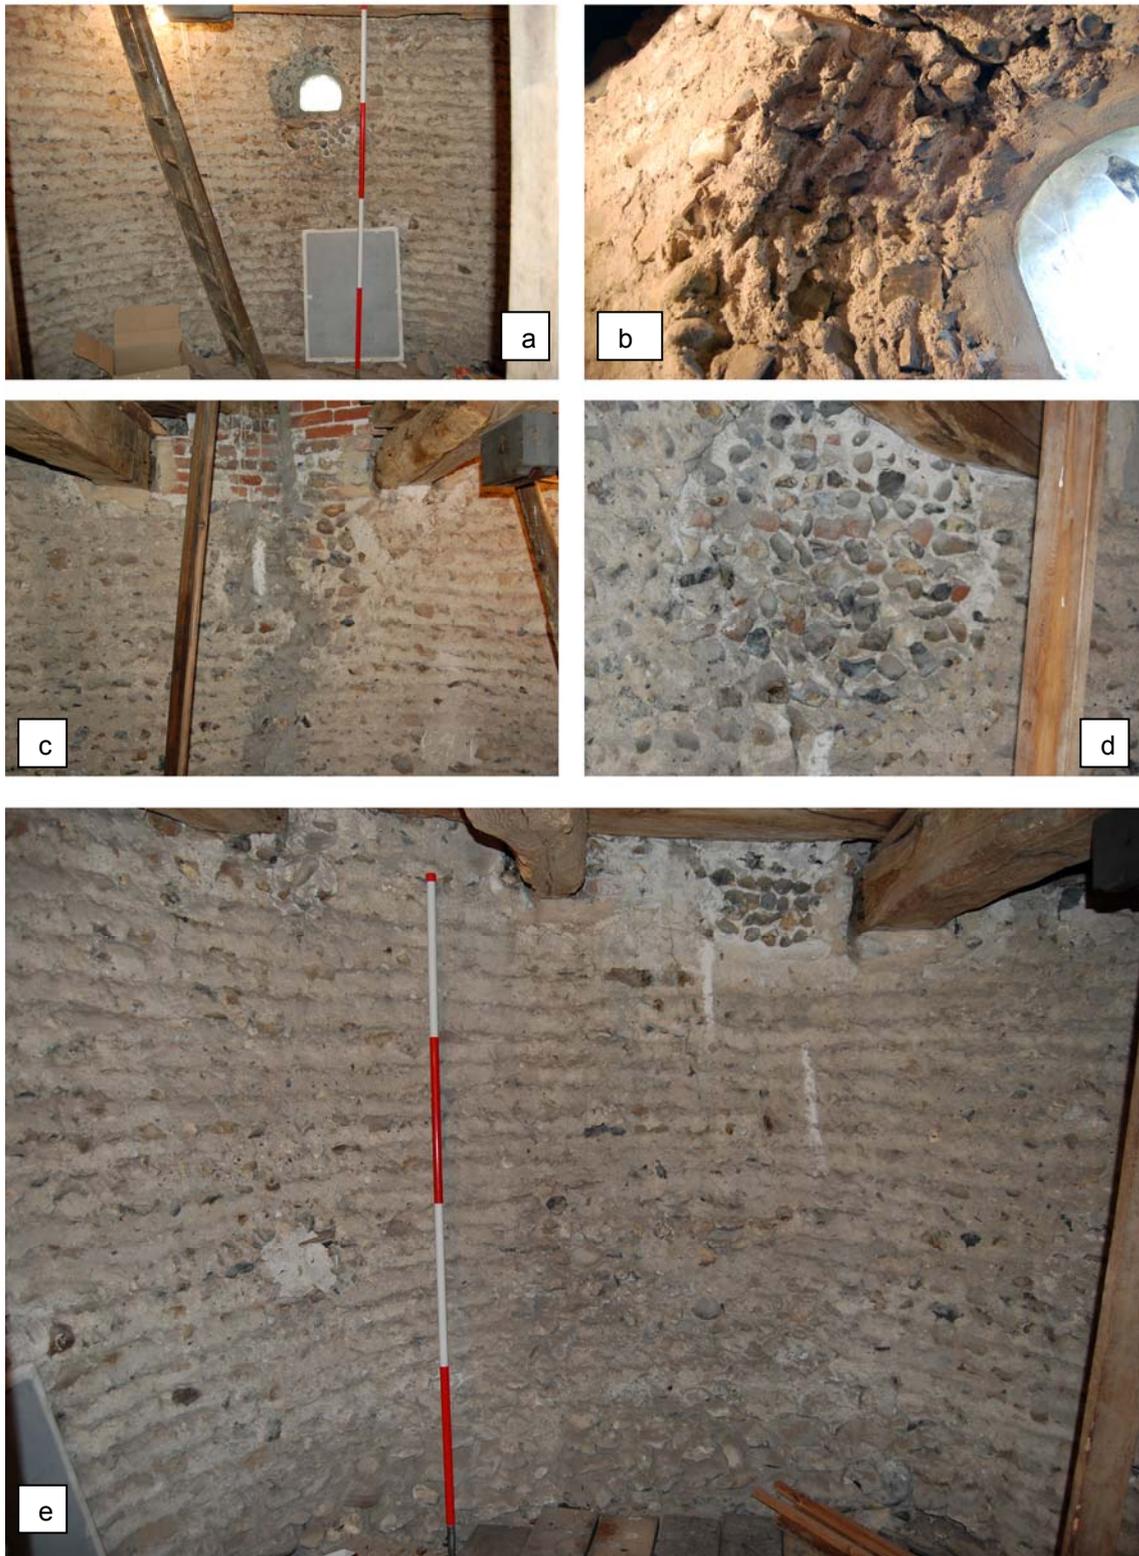
The second floor room is less lofty than the tower room below with a ceiling height of just over 2m and its original function is believed to have been the ringing chamber (Fig. 12). The curious surface finish to the wall, created by thick horizontal mortar beds is similar to the room below, but the effect here is more pronounced. The mortar has the appearance of having been squeezed out from between the flint, much as the jam from an over-filled sandwich, and then flattened off with some form of float. The float has been worked horizontally as there is no evidence that the mortar has been dragged up or down the wall by vertical strokes; the mortar has however started to drop, in places forming a slight overhang. On the east side of the tower there is a small area where the full pointing style does not exist. Here larger flint cobbles have been used and the pointing around the flints is deeply recessed and it is also at this point that the line of the wall strays outside the arc of the circle described by the rest of the tower and becomes ovoid slightly in plan. This may suggest that the excess mortar has been struck with a large bladed tool curved in the same radius as the tower which missed this eccentric part of the tower.

Figure 12. Former ringing chamber; second floor

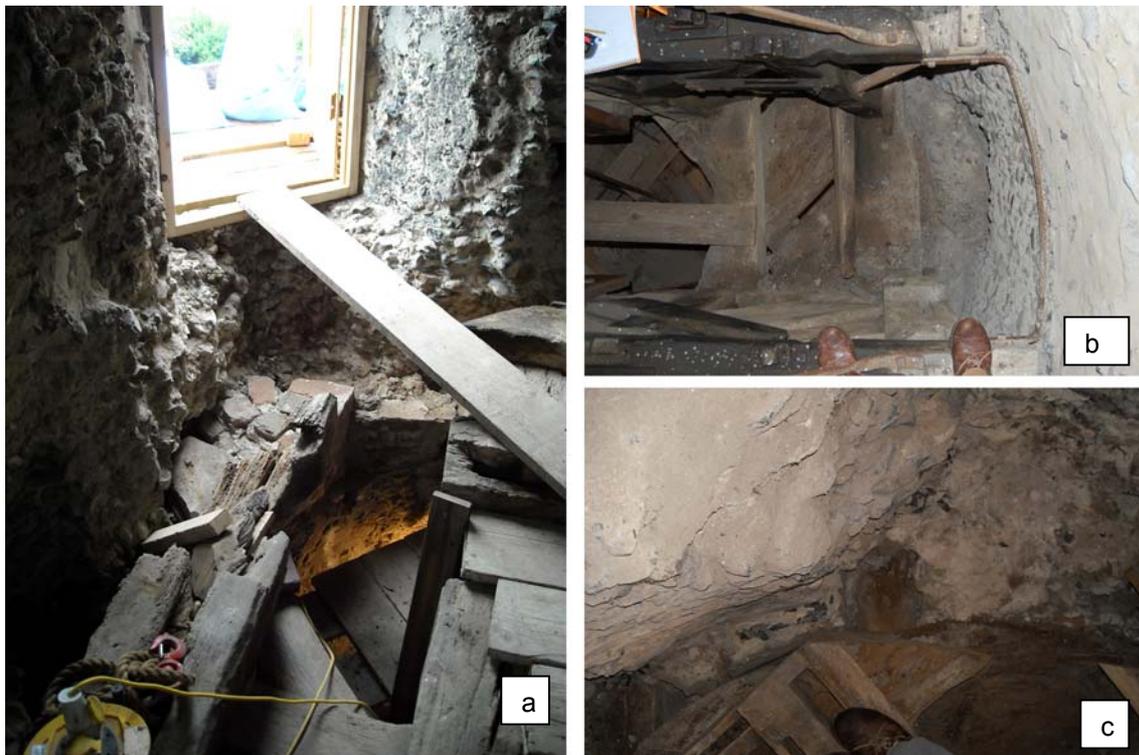
In a later repair the southern timber was been shortened, presumably to remove rotting wood, and as a consequence it was no longer able to span the tower. This was overcome by re-angling the timber and creating a new socket in the side of the south window. The former setting for the timber can be seen to the north of the timber end as an open hole.

The beams support very large floor boards 600mm wide and 70mm thick. The boards have been pierced to allow the bell ropes to pass through and in addition to this there are small diameter peg-holes; these are now redundant but two contain the remains of pegs. The peg-holes do not relate to the current floor supports and their function is unknown; the floor boards are loose and not pegged down. There is a stepped change in the thickness of the walls at the level of the belfry floor, creating a 150mm wide ledge around the inside of the tower. Curiously it has not been used to support the floor and the floor boards are set inside the ledge so that the surface of the boards is flush with it (Fig.13 b and c).

Figure 13. Alteration to the belfry floor.

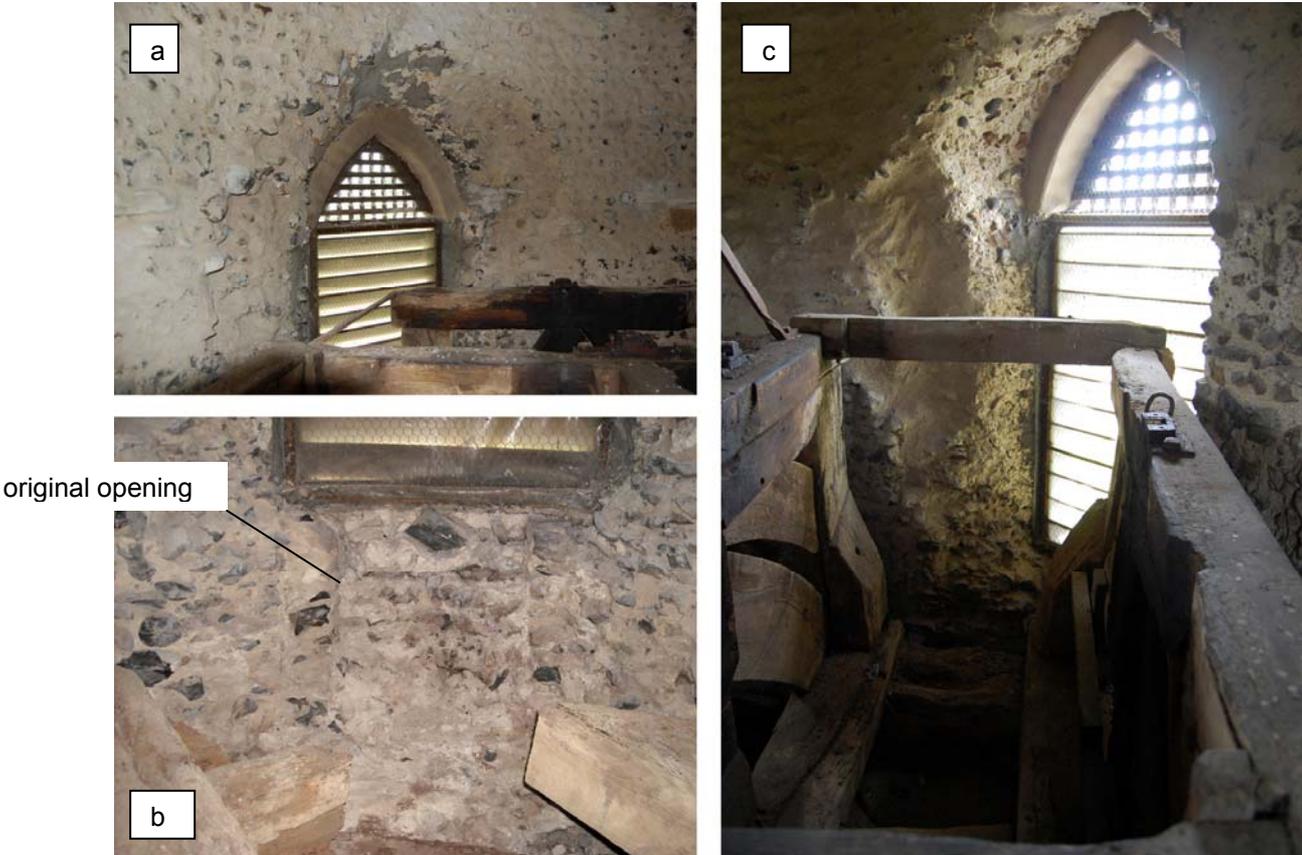
Since its installation the bellframe has been modified and partly rebuilt to hold an increasing number of bells from the original four to five, and latterly, six bells (Joyce 2007). The bellframe has not only been partly rebuilt, slightly increasing its size, but the foundation timbers on which it sits have been either replaced or re-set and the interior of the belfry has been remodelled extensively in order to accommodate these changes (Fig 14a).

As part of the alterations and the repairs to the bellframe the window sills have been roughly lowered to drop the bellframe to the requisite height and the splays of the window reveals chopped back, to open them out and enable the frame to fit (Fig 14c). The cutting away of the wall face has been most severe on the south and west sides and to a lesser extent the north belfry window. The east opening has been left relatively unscathed and best displays the shape of the medieval openings although the sill height has been lowered. The original curve of the interior wall can only be seen below bell frame level but even here masonry has been chopped out to facilitate the replacement and re-setting of the floor joists below (Fig 14c).

Figure 14. Re-modelled belfry windows and remains of Norman openings

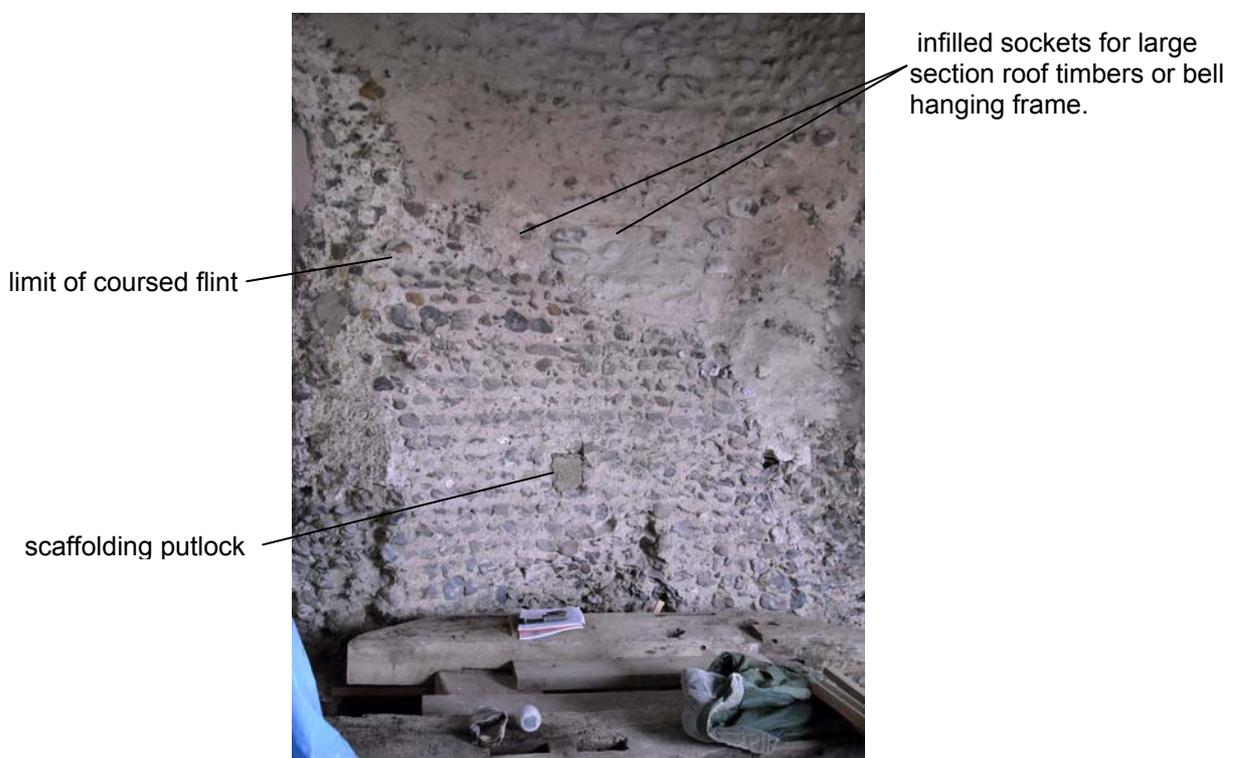
There are paired sockets in the wall between each of the belfry windows (Fig.15.); these would have supported the ends of beams arranged to form a square frame that spanned the width of the tower. They are set in the medieval flintwork at the junction with the Norman fabric and are larger than the putlogs used to support the scaffolding. Some possibly contain the remains of timber, suggesting that they were cut off, but the holes have been rendered over and are difficult to determine. Their location at the junction of the two phases of build might suggest they are part of the Norman roof but the pattern is unlike the arrangement of joists that support the floors or the current roof so this uncertain. Alternatively they are part of the original bell hanging or mechanism by which the later phase was built.

Figure15. Interior of the belfry after the removal of the bell frame, showing the extent of the coursed flintwork suggesting the top of the Norman tower.
