**Barns at Vale Farm,
Sutton,
Suffolk,
SUT 216**

Historic Building Record

**Barns at Vale Farm,
Sutton,
Suffolk,
(TM 319 453)**

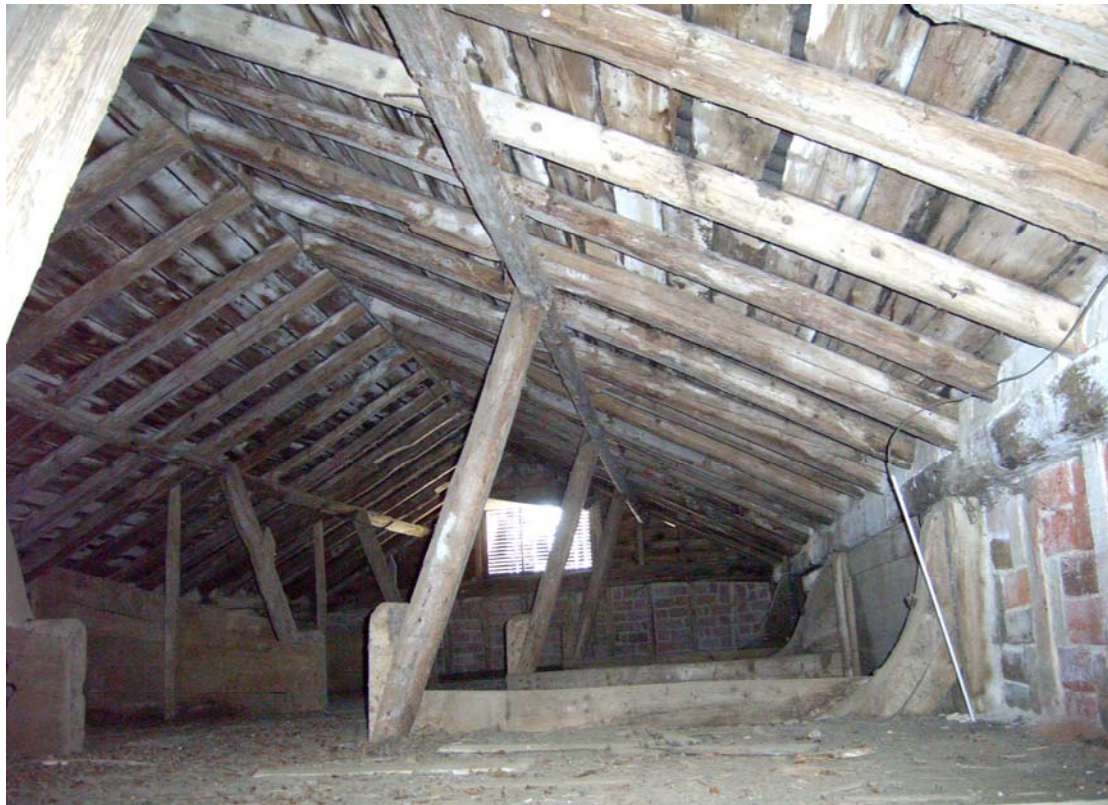
A2.9 Cart Lodge (4). Interior of first-floor granary showing remains of grain bins with axial passage to left

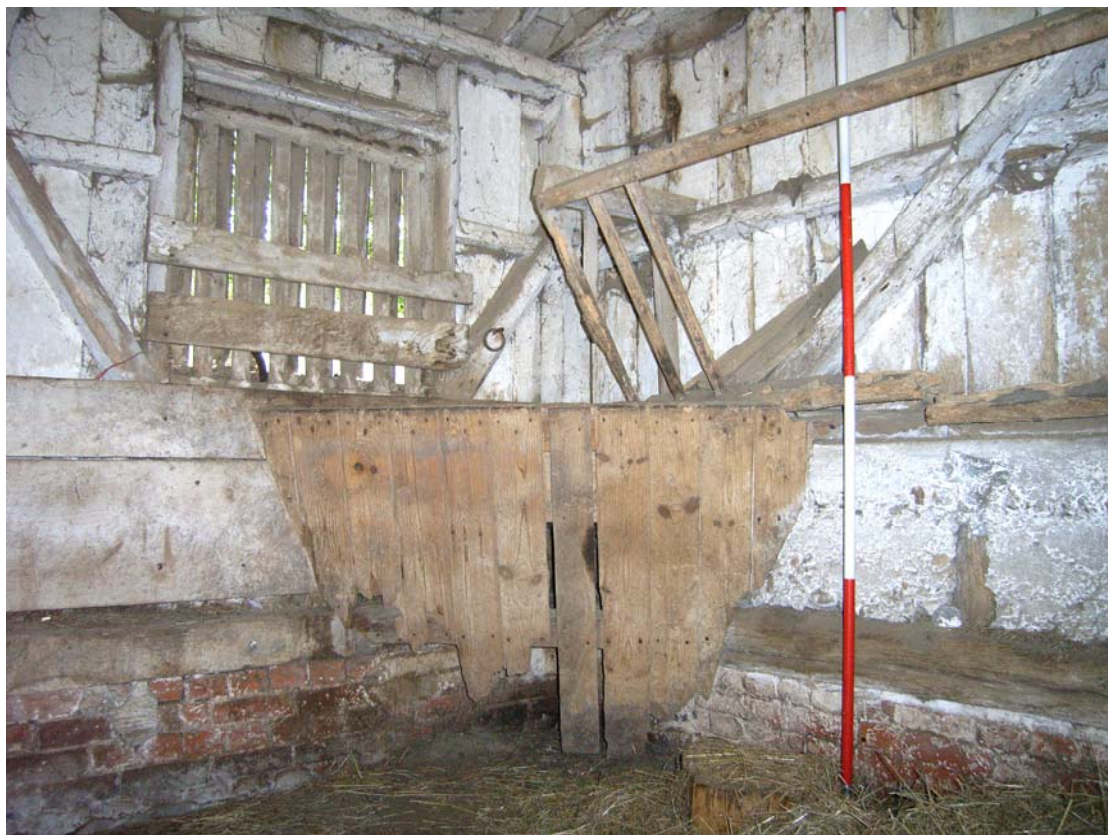
A2.10 Roadside stable (5a). Detail of boarded manger in south-western internal corner with low hay rack to right and slatted window to left.

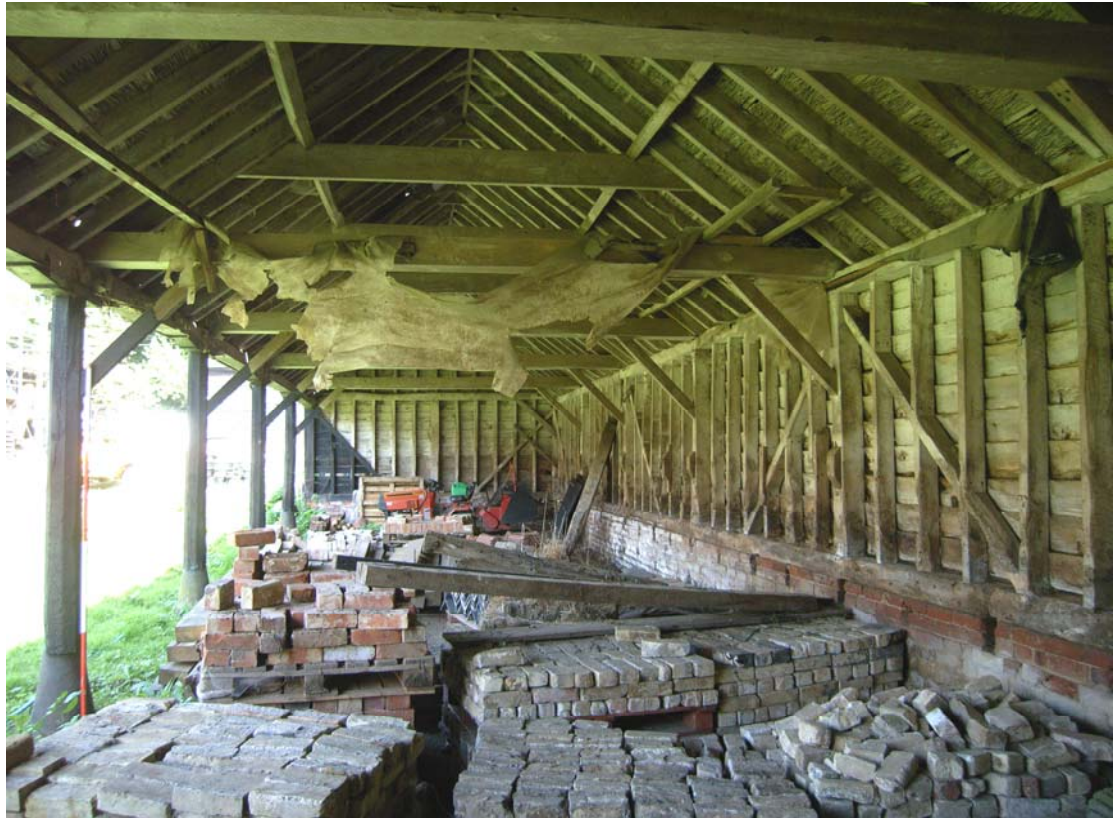
A2.11 Roadside shelter shed (6). Interior from west showing wall framing with octagonal arcade posts abutting central yard to left.

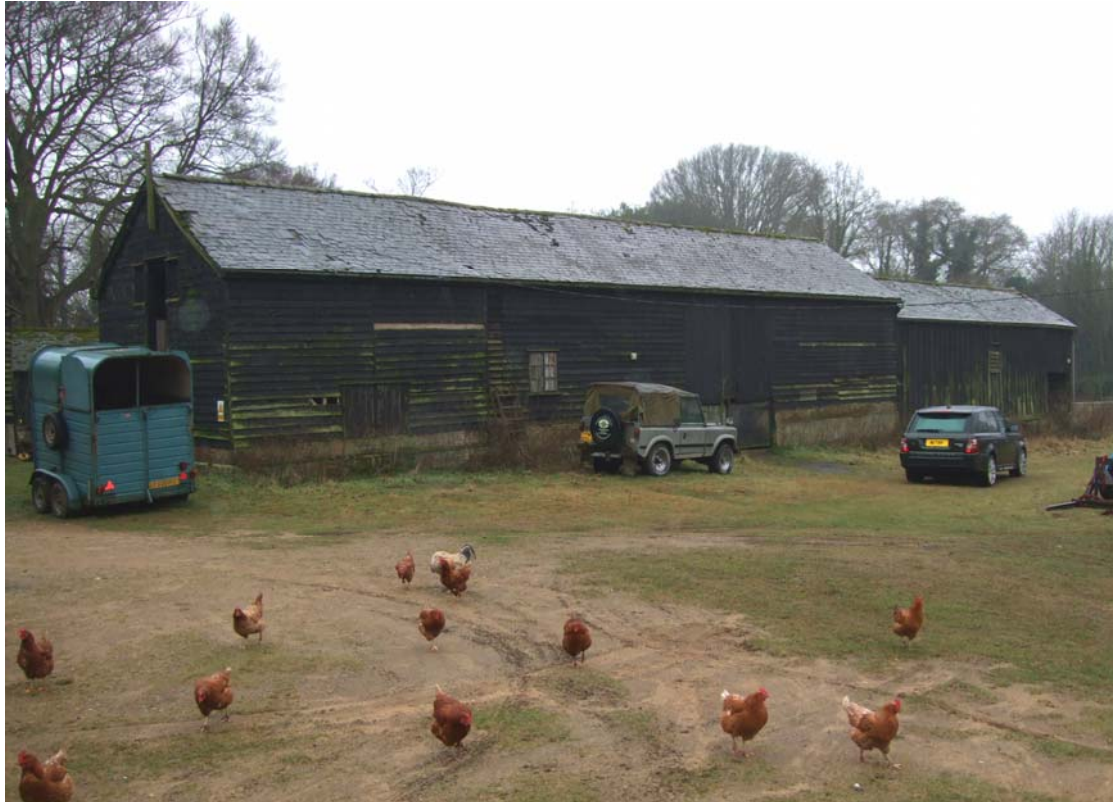
A2.12 Jan 2009. Exteriors of granary (3), barn (1) and stable (2) from left to right, seen from north before conversion work commenced. Note original slate roofs.

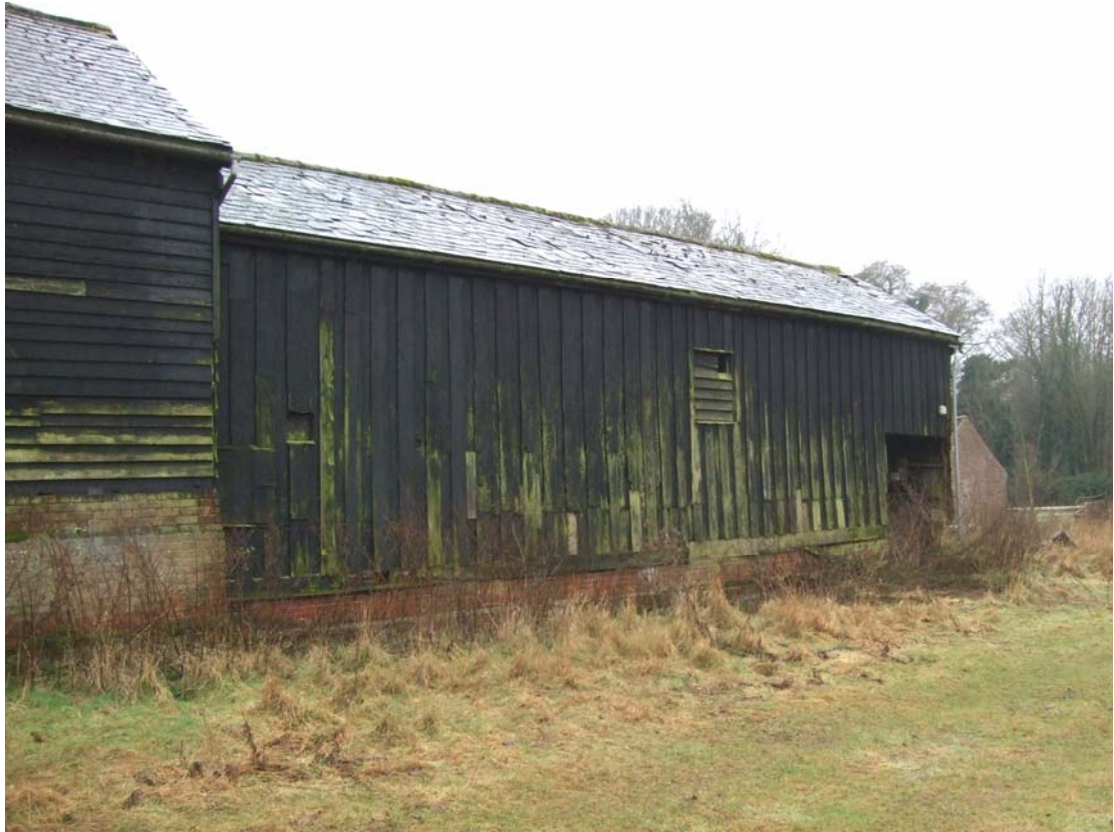
A2.13 Jan 2009. Northern external elevation of stable (2) showing vertical boarding with barn (1) to left.

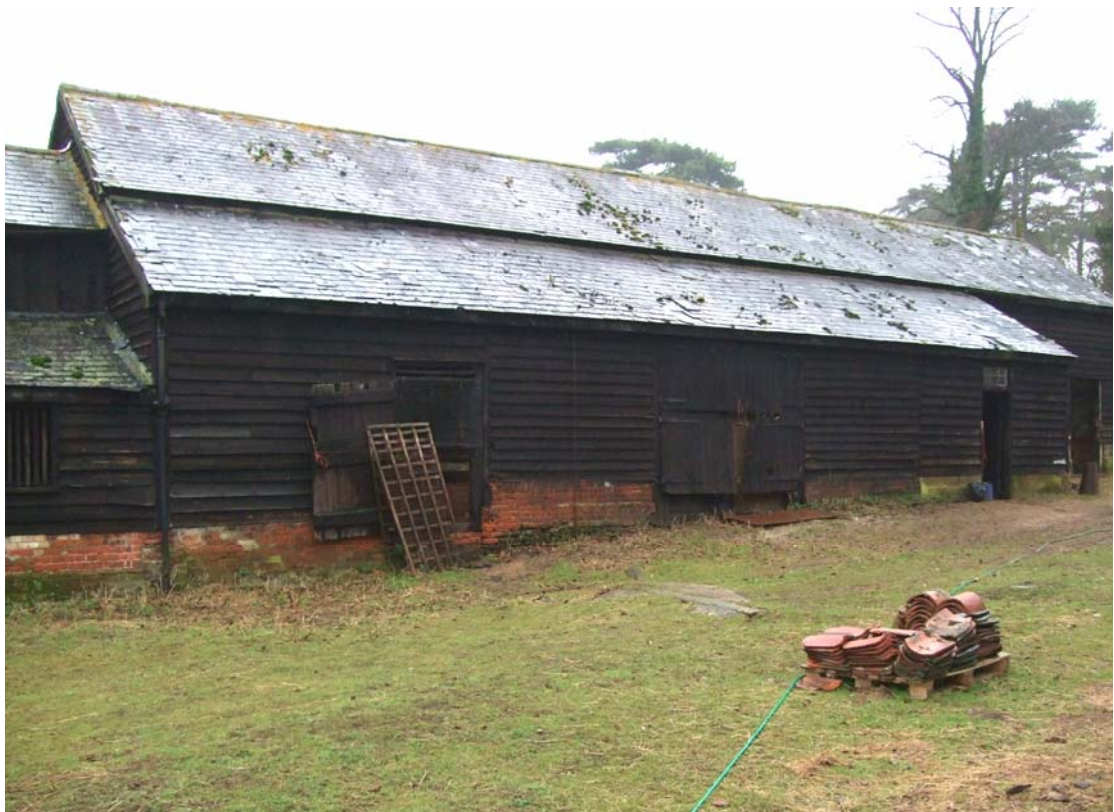
A2.14 Jan 2009. Southern external elevation of barn (1) showing lean-to porch and sheds adjoining central yard with stable and lean-to tack room (2) to left and granary (3) to right.
