ARCHAEOLOGICAL SURVEY REPORT

A REPORT ON THE ARCHAEOLOGICAL SURVEY, 2005

SCCAS Report No. 2005/40

A survey was conducted ahead of a proposed development at Gorse Motors Ltd., Gorse Industrial Estate, Barnham. This area was formerly an atomic bomb store and servicing facility known as RAF Barnham. The site is one of only two of these purpose built structures and as such is a Scheduled Ancient Monument (Number 30608). The survey was of a concrete surface, probably forming the base on which a fuel tank sat, between the two standby generator buildings for the base.

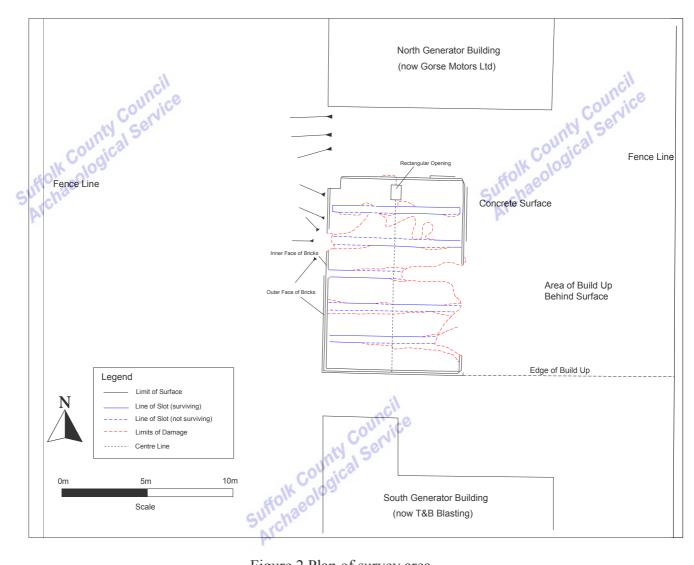
Figure 2 Plan of survey area

The concrete surface measures 11.6m long, 8.2m wide and 0.15m deep. It is located 4m to the south of the northern building and 2.5m north of the southern building. The surface has been cast in two halves with the division being along the long axis. The surface is then laid on top of a level platform built into the natural slope between the two generator buildings. The area to the north and east of the platform is built up to form a level surface outside the concrete surface. It is unclear how much of this levelling took place as part of the construction of the concrete surface and how much is more recent work to produce a level yard outside the existing building (Figures 3 to 6).

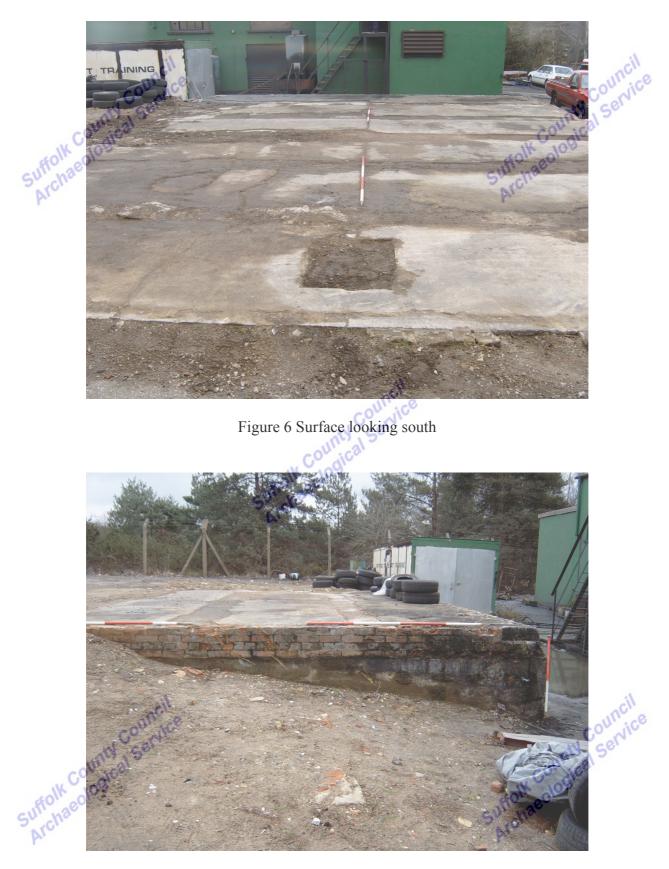
Figure 7 South-west corner of platform

The platform on which the concrete surface sits is faced with large concrete blocks, measuring 0.45m by 0.23m, under a facing of bricks, measuring 0.22m long, 0.11m wide and 0.07m deep (Figure 7 and 8). The large concrete blocks appear to form a retaining wall for the platform. The facing was only visible along the southern edge and the southern half of the western edge of the platform. This brick facing was only one brick wide and appeared to continue above the level of the concrete surface. As the outer bricks continued above the concrete an inner face of bricks were laid on the outer edge of the concrete surface. This would have created a wall, two bricks wide, around almost the entire surface. This wall has now been truncated to the level of the concrete to form a level space outside the building.

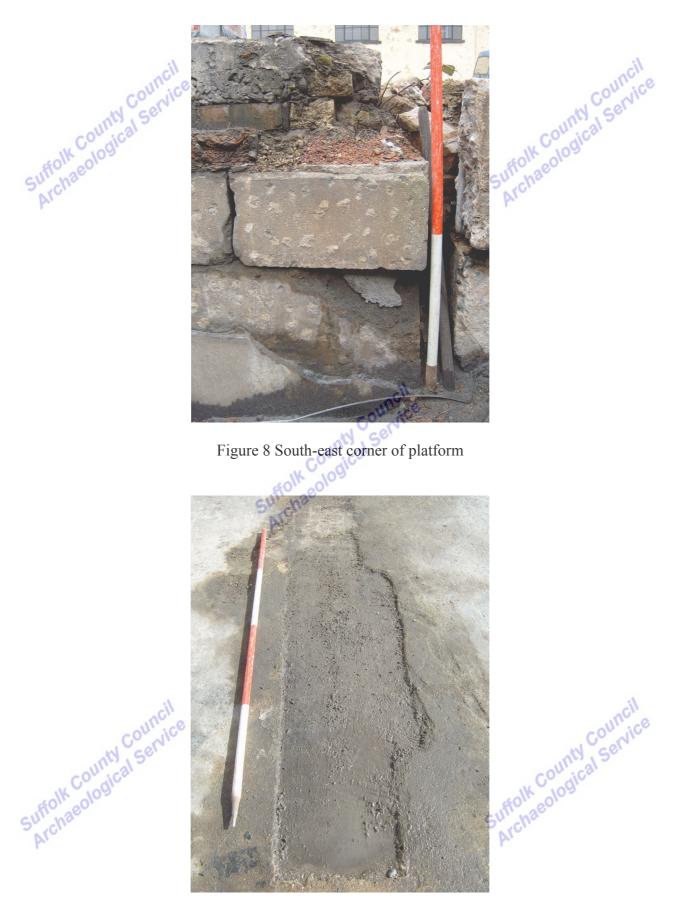
Figure 9 Slot detail west end

The surface contained several internal features, the most notable of which were a series of five parallel slots running across almost the entire width of the surface. The best preserved of these was the most northerly one (Figures 9 and 10). The slots, measuring 7.5m by 0.4m, appear to have originally contained further concrete possibly forming the supports for a fuel tank.

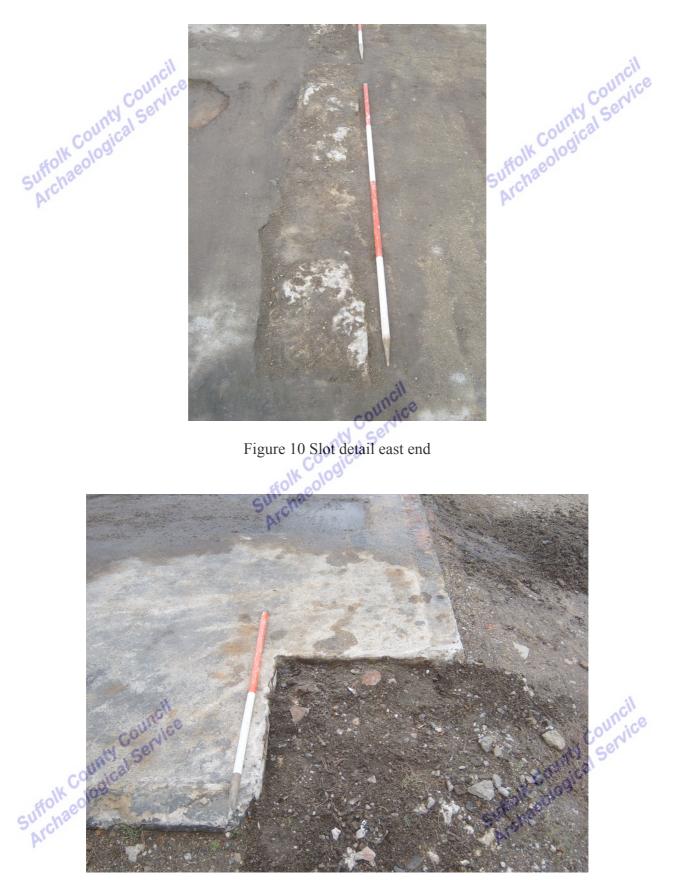
Figure 11 North-west corner detail

The north-west corner of the surface is cut away and is the only area of the surface without any. brick walling (Figure 11). This may well have given access to the walled off area and to the fuel tank itself. Another internal feature was a rectangular opening near the northern edge of the surface (Figure 12). The opening measured 0.9m by 0.6m and may well have been to allow for .0' outlet pipes for the fuel tank.

Further work on the concrete surface and its platform would also be beneficial. More could be understood about how the site functioned and was constructed. Excavation within the rectangular opening and around the cut away corner at the northern edge of the surface would help in the understanding how the site functioned. Furthermore if pipes exist in this area this may have County Countice implications on the development and the identification and recording of these would minimise their impact on the new building.

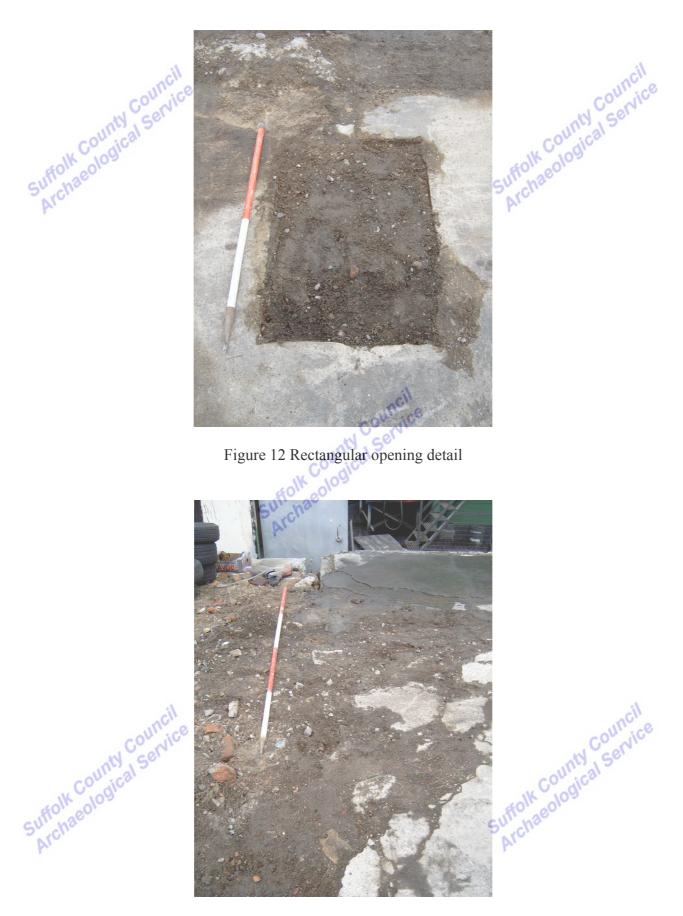
Figure 13 South-east corner damage

During the survey the extent of damage to the concrete surface was also recorded. There is extensive damage across the entire surface, which appears to be from general usage. However, there is also considerable damage along the eastern edge of the surface where over half of the eastern edge has been destroyed (Figure 13).

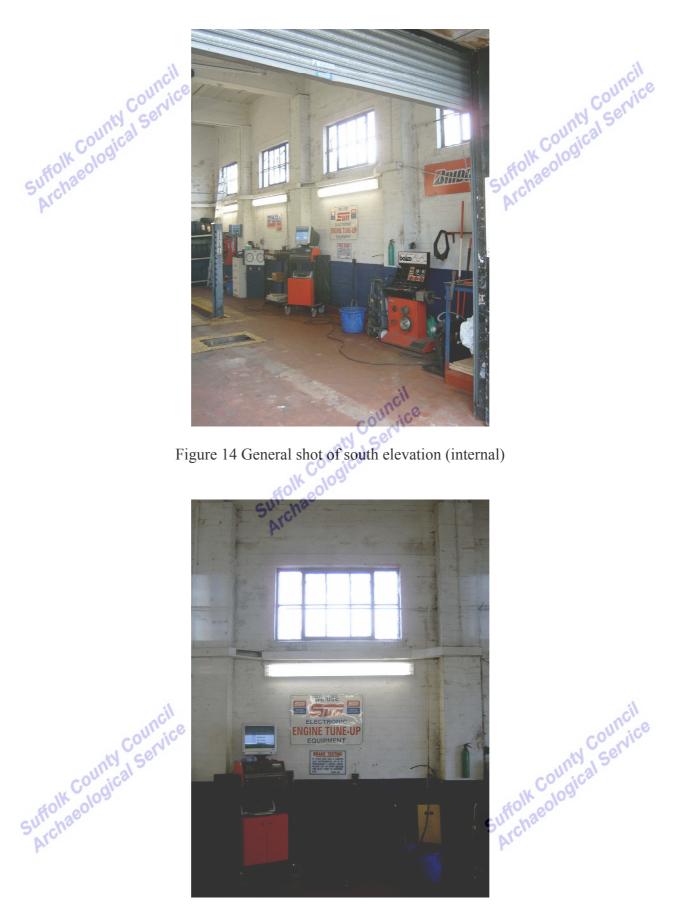
Figure 15 Close up of bay (internal)

The internal elevation of the south wall of the north building (now Gorse Motors Ltd) is made up of four bays (Figure 14). Each bay is identical with a single window per bay (Figure 15). Within the proposed development a doorway will be inserted through one of these bays to connect to a new building to the south.

Any work directly affecting the standing building to the north of the platform would require monitoring. The insertion of a doorway will destroy part of the fabric of the building and should be recorded. D/

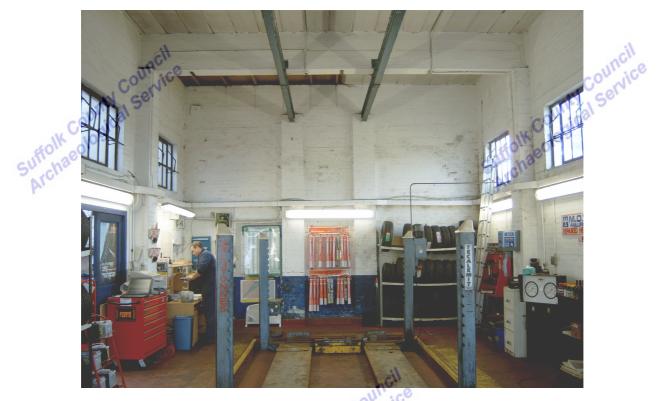
Figure 16 East wall (internal)

Record photographs were also made of the internal face of the east wall (Figure 16). The door to the new building may not placed in the south wall, if so, then it may be inserted through the east wall. The east wall, at the time of the survey, is covered in the machinery of the existing garage and a full photographic record could not be completed.

If, as briefly mentioned earlier, the link to the new building goes through the east wall instead of the south wall then this will impact not only on the fabric of the standing building but also the now largely demolished extension. If this became the preferred option then work should be undertaken to identify and record any remains on the eastern side of the building.

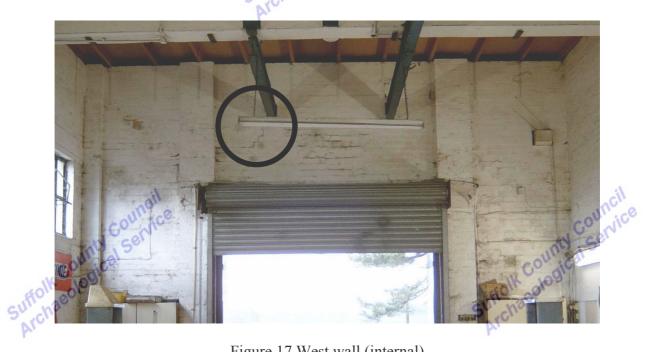
A photographic record was also made of the internal face of the west wall (Figure 17). This record was made to indicate the large cracks in the building fabric above the main garage entrance. This appears to have been caused by the insertion of steel beams extending from the east wall to the west wall.

Figure 17 West wall (internal) (area of cracking highlighted by the circle)

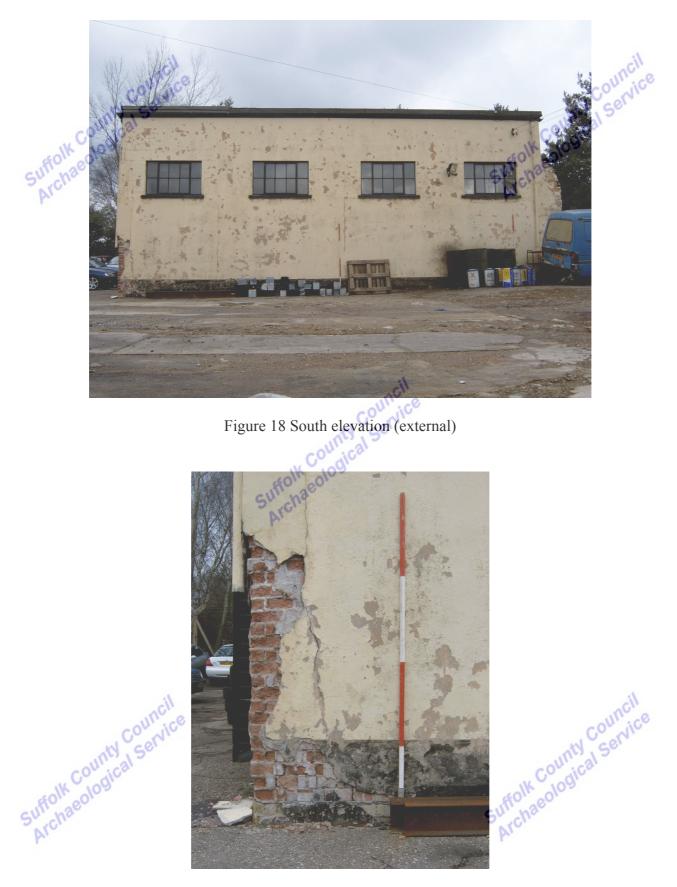
Figure 19 South elevation detail (external)

A record of the external face of the south elevation on the northern building was also made (Figure 18). However, the elevation is fully rendered and the only identifiable features were the windows. On the south-west corner of the building some of the render had fallen off and the underlying brick work was visible (Figure 19). The brickwork was too damaged to allow detailed recording.

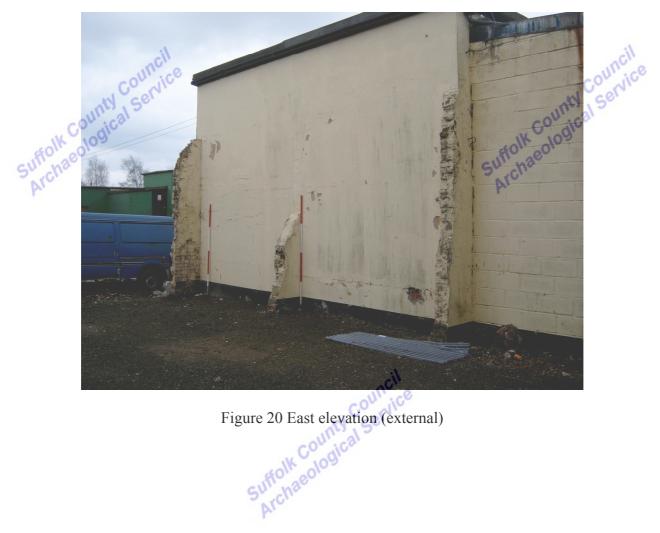
A record was also made of the external face of the east wall (Figure 20). The remains of an extension to the building are clearly visible though the extent is unknown. However, the proximity of the fence line gives at least an indication of its maximum size.

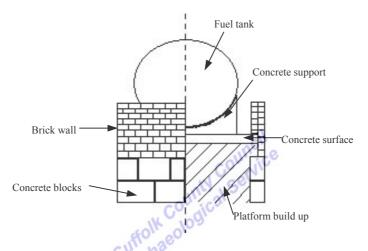
Figure 21 Reconstruction sketch of fuel tank and concrete surface

The proposed fuel tank appears to have rested on five concrete supports built into the surviving concrete base. This concrete base also had an opening, probably for an outlet pipe. The fuel tank and the concrete surface it sat on were surrounded by a brick wall. The original height of the wall is unknown though it seems likely that this was an enclosing low wall rather than a full structure, possibly designed to contain fuel spillages (Figure 21).

The concrete surface sat on a platform surrounded by a retaining wall of large concrete blocks (Figure 21). The exact nature of the platform could not be determined during this survey. The platform may be built by terracing the natural slope or it may be formed using a build-up of dumped material or a combination of both. There is also the possibility that the platform was free-standing as the extent of the concrete block retaining wall has not been determined.
