**Castle Farm,
Wingfield,
Suffolk,
WGD 030**

Historic Building Record

Castle Farm Barns, Vicarage Road, Wingfield, Suffolk

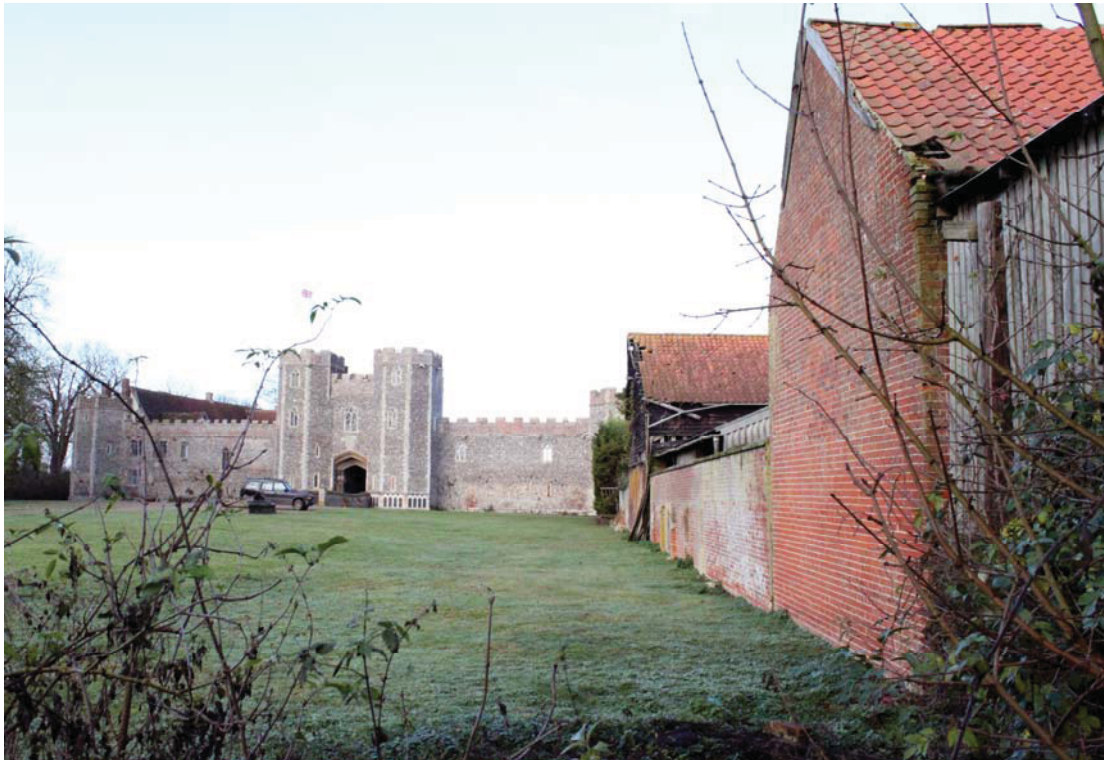
A2.1 Southern façade of Wingfield Castle showing its close proximity to the gables of the barn (1) & the brick cartlodge/granary (6) to the right. The southern elevation of the barn was probably designed to form a dramatic visual extension to the castle approach.

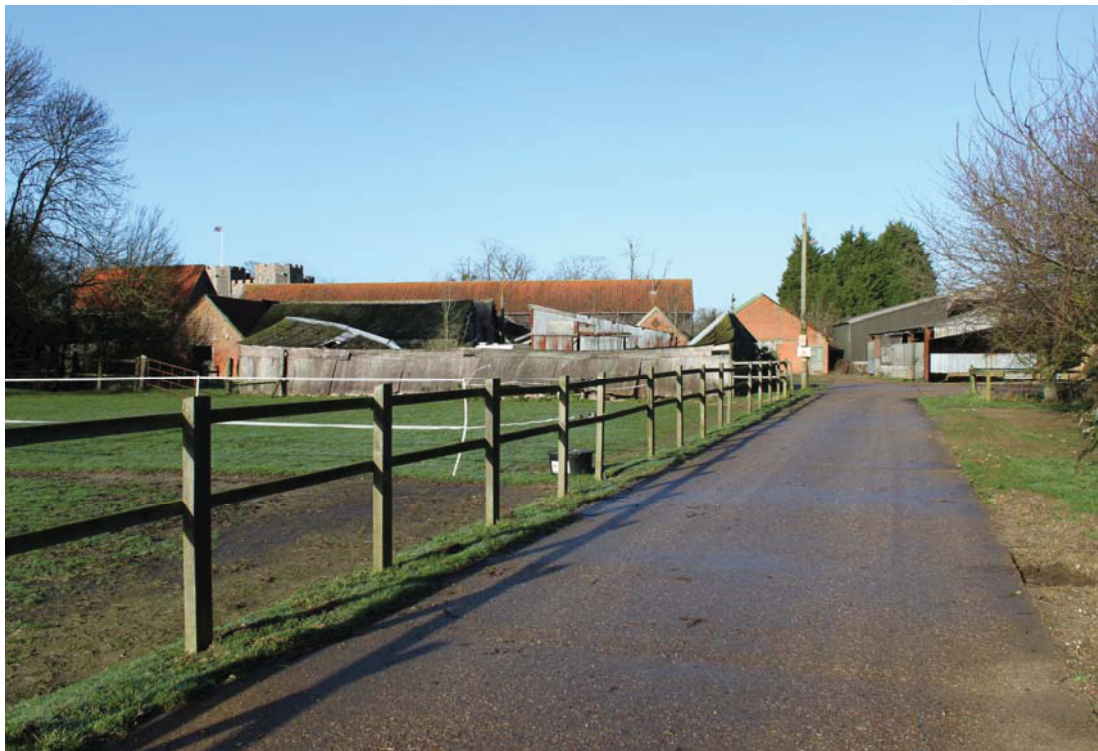
A2.2 The 20th century southern track to the farm complex showing the castle towers behind the pantiled roof of the barn (this replaced the original entrance south of the castle).

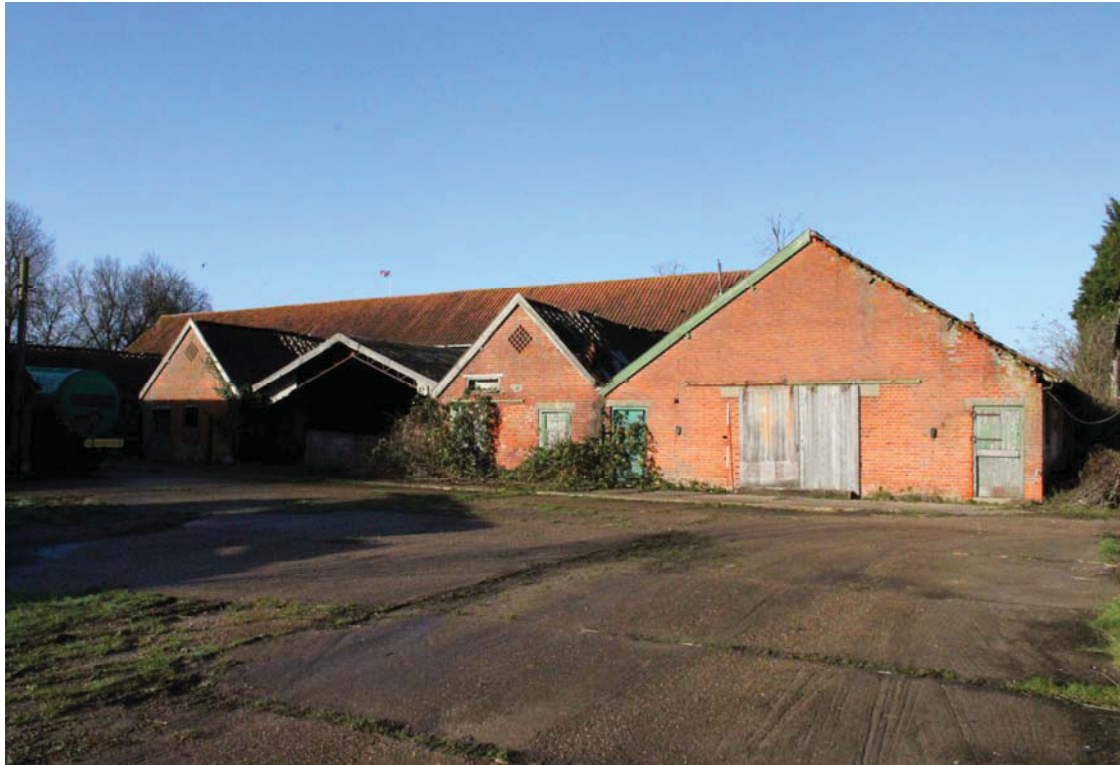
A2.3 Southern exterior of barn (1) showing two of the three mid-19th century brick yard shelter-sheds to the left (3 & 4, each with an enclosed southern feed store with a lozenge-shaped ventilation aperture at its gable) and the early-20th century cow shed or covered cattle yard (5) to right.

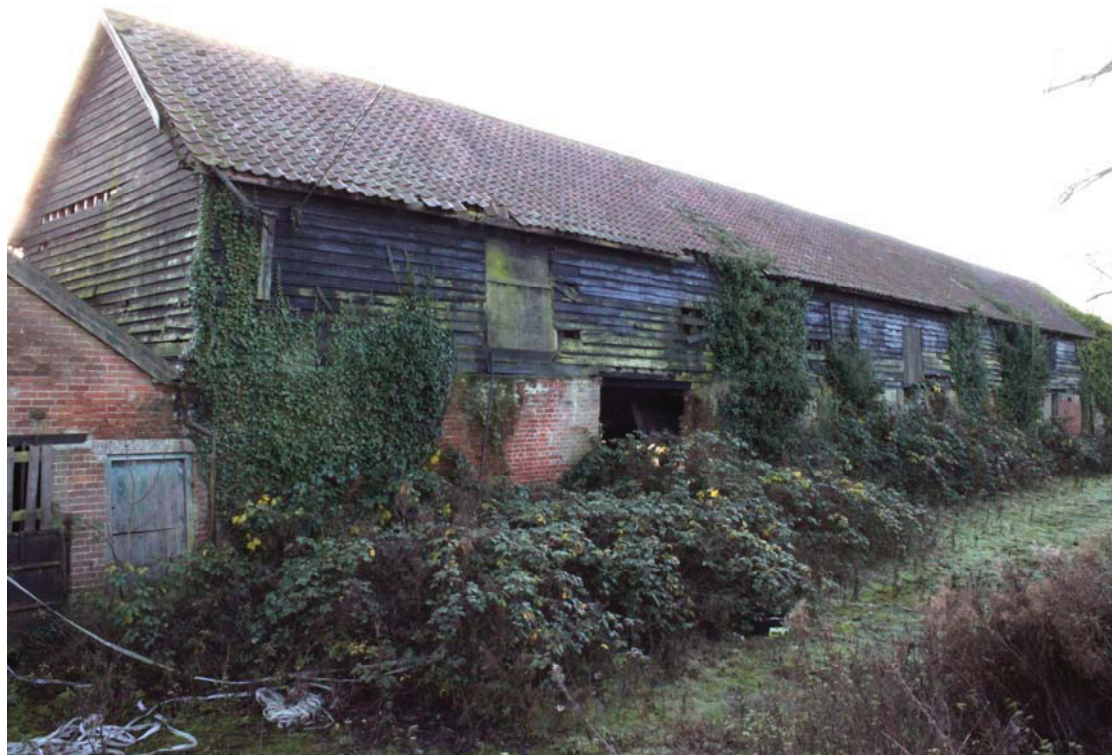
A2.4 Northern exterior of barn (1) from north-east showing the gable of the brick cow shed (5) to left. The two left-hand (eastern) bays of the barn were added in the mid-19th century when the original roof was replaced and the lower storey rebuilt in brick.

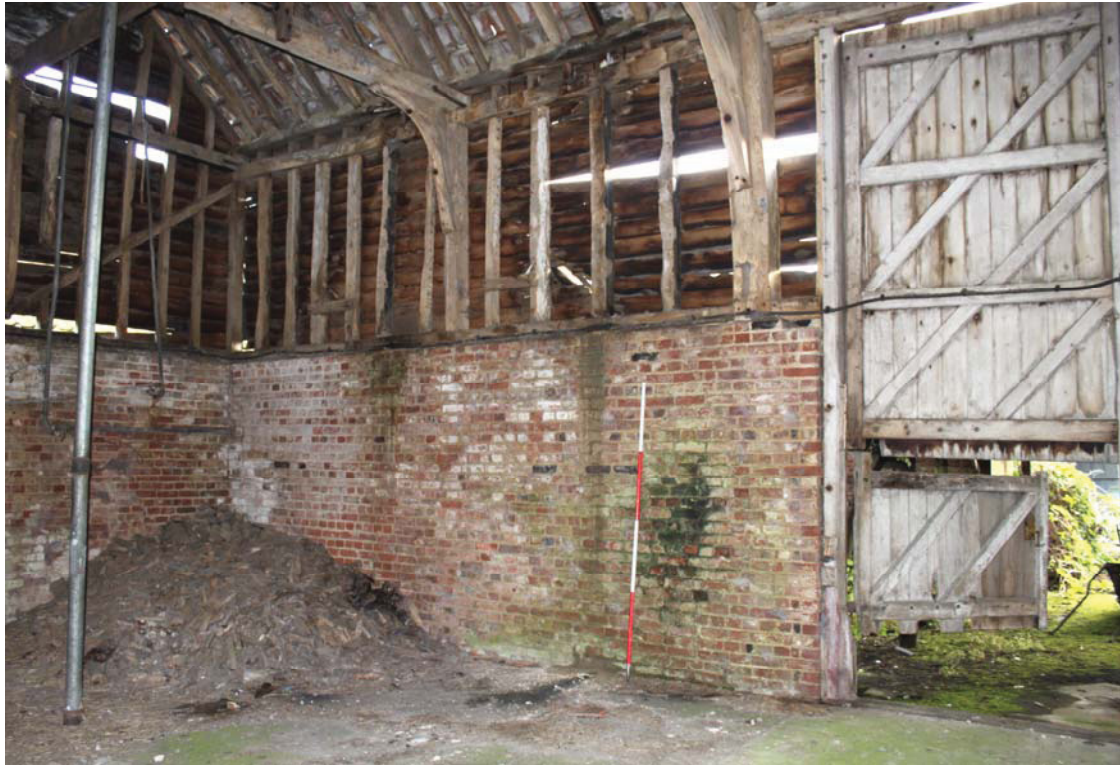
A2.5 Interior of barn showing the south-eastern corner of its eastern section (1c) with the two 19th century bays to left & the 19th century barn doors in the original end-bay (J) to right. The storey post and tie-beam to the left of the doors contain the 14 empty stud mortises of the late-16th century barn's eastern gable.

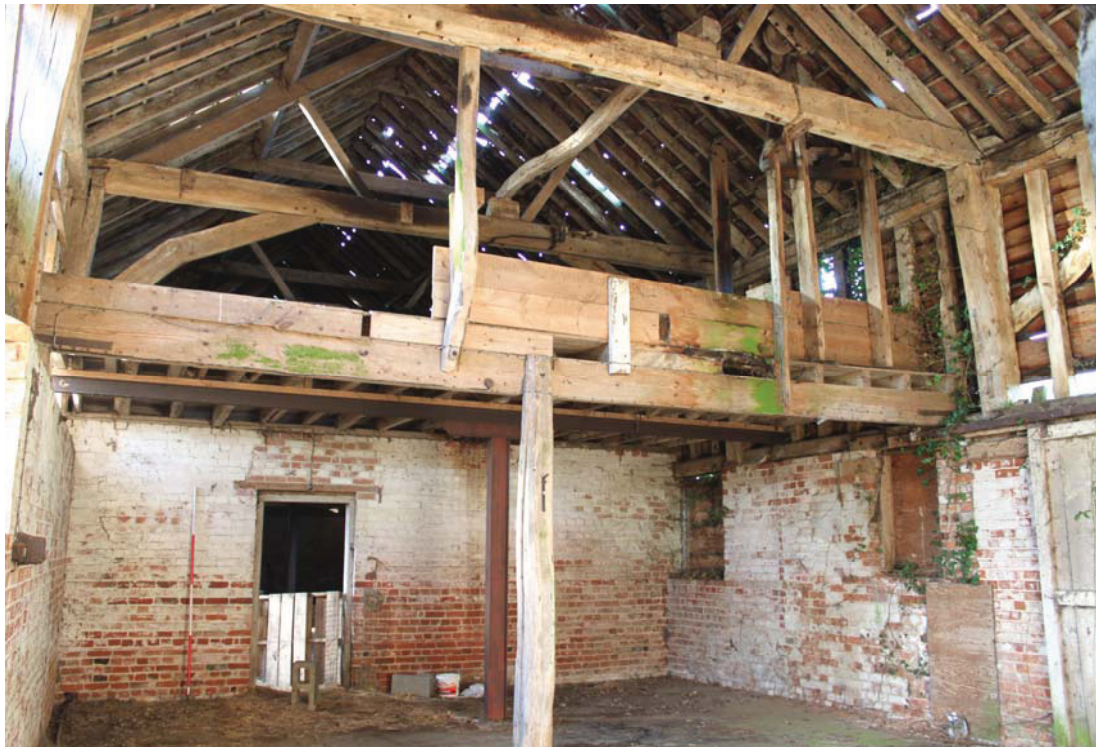
A2.6 Interior of central section of barn (1b) from east showing the 19th century grain floor which extends above the stable (1a) to the western gable. The tie-beam contains 12 empty stud mortises for the original partition dividing the three-bay barn from the four-bay barn.

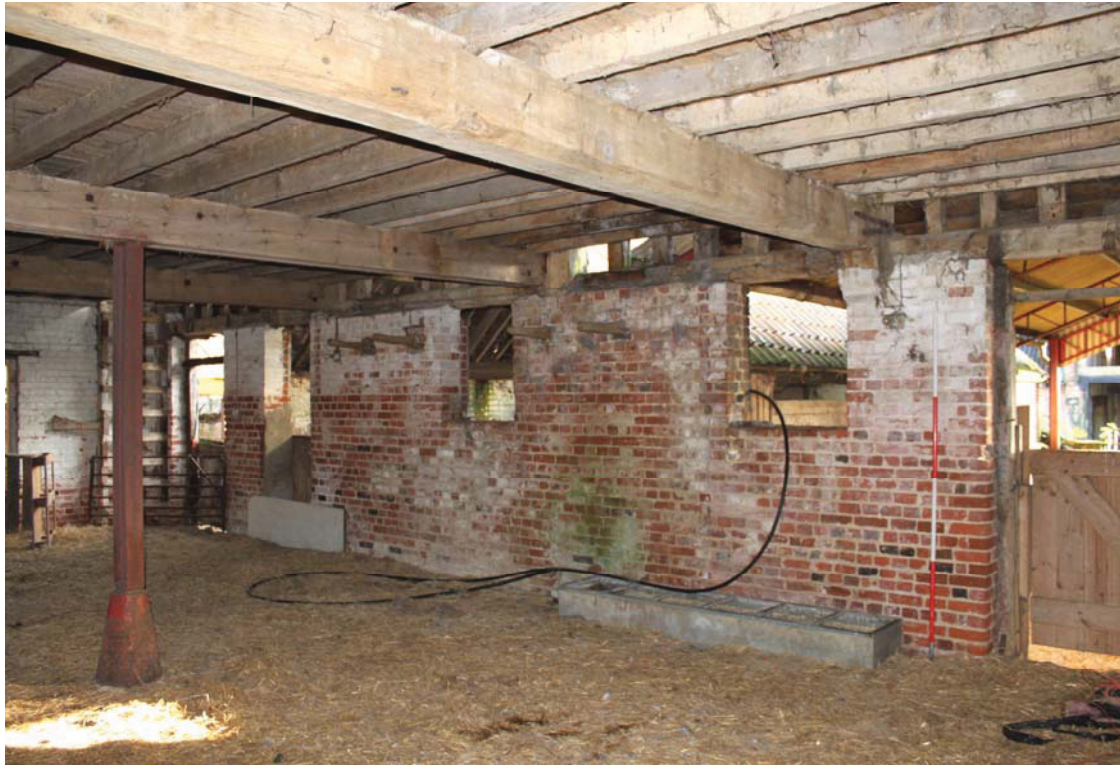
A2.7 Internal southern elevation of the 19th century stable (1a) at the western end of the barn, showing the doors and windows to the southern yards. The principal ceiling joist in the foreground is original to the late-16th century frame, but the rest are 19th century insertions.

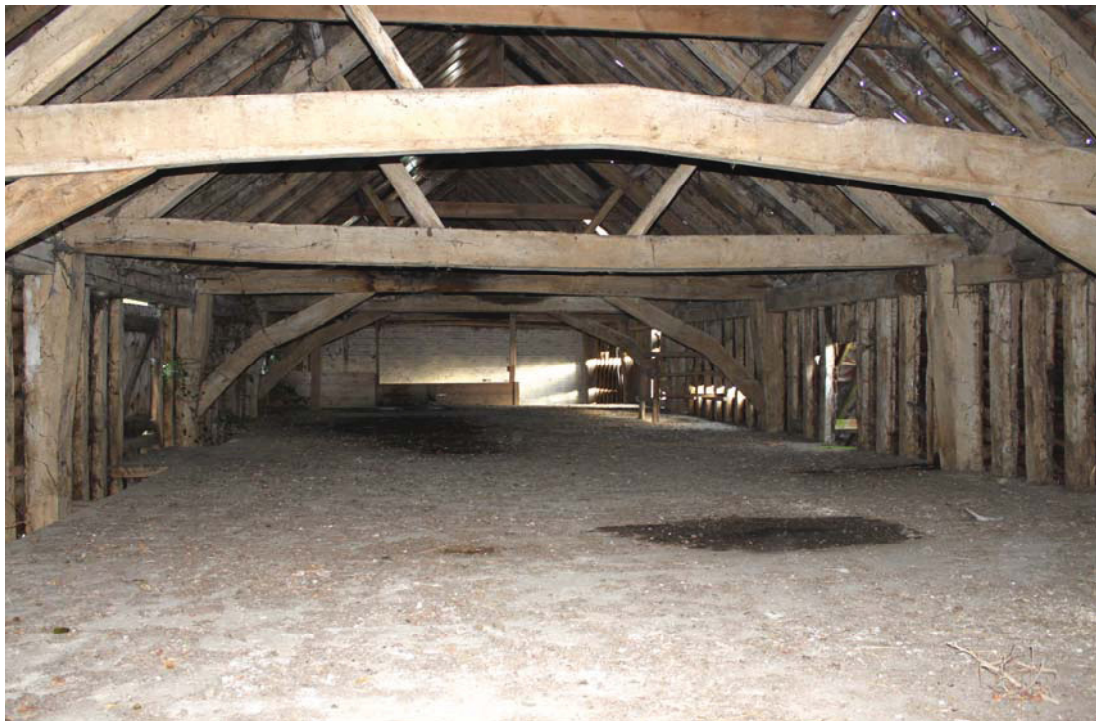
A2.8 Interior from west of the grain floor/hay loft above the 19th century stable, showing the original tie-beams and cranked arch-braces beneath the 19th century roof structure. The loading vent above the former hay rack is visible to the left, spanned by 'bridges' in front of each external loading doors in the northern elevation. Note the cambered tie-beam of the original hay loft in the foreground and the horizontal barn tie-beams in the rear.

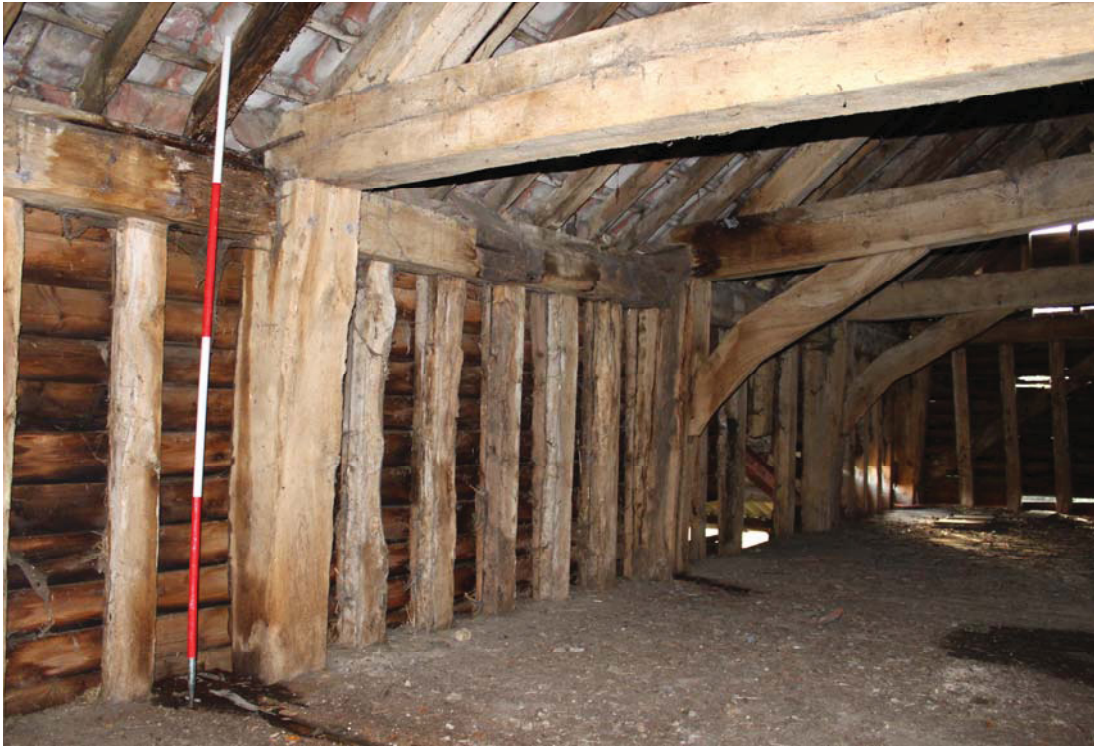
A2.9 Detail of from north-east of the open truss between bays C and D which consists of a storey post and tie-beam (both without chamfers) but lacks arch-braces. The tie-beam contains 10 stud mortises in its upper surface but none beneath. A brick partition at this point would have divided the original stable and loft from the open barn.

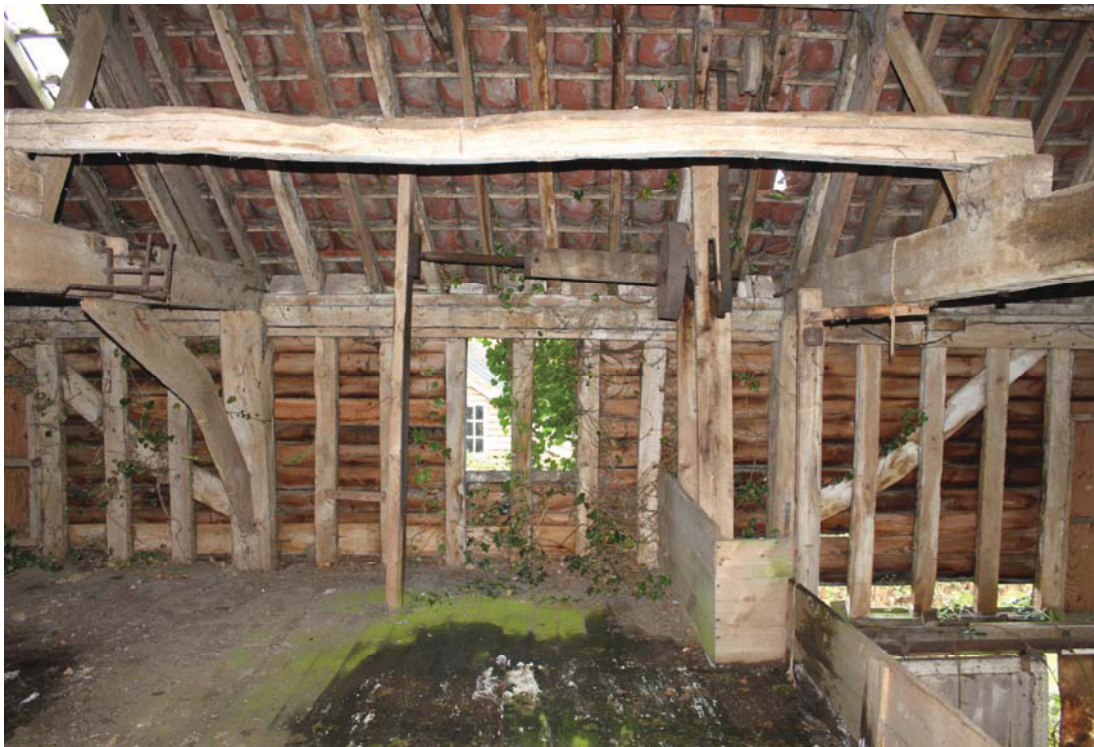
A2.10 Northern interior of bay F (above section 1b) showing the externally trenched braces which radiated from the original barn's rear door. Note the feed milling mechanism to the right (consisting of a drive shaft, wooden belt axle and iron wheel)

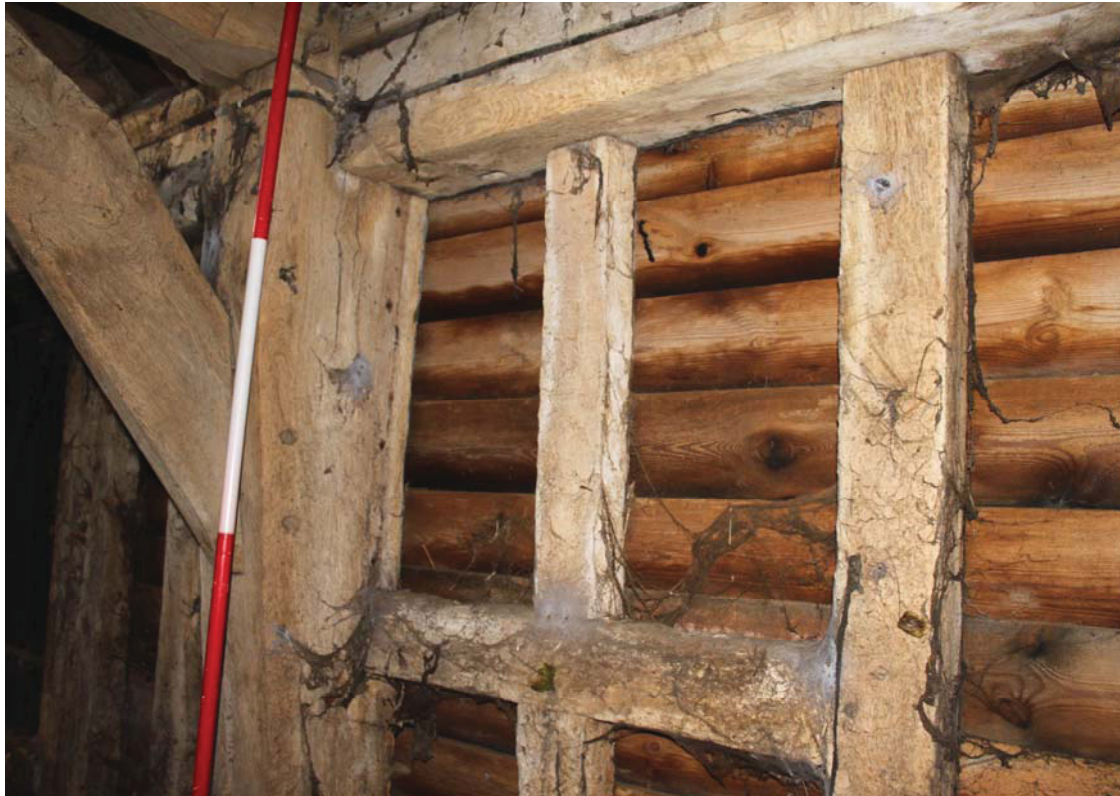
A2.11 Detail of Original loft window in northern internal elevation of bay C showing rectangular mullion mortises and original sill.

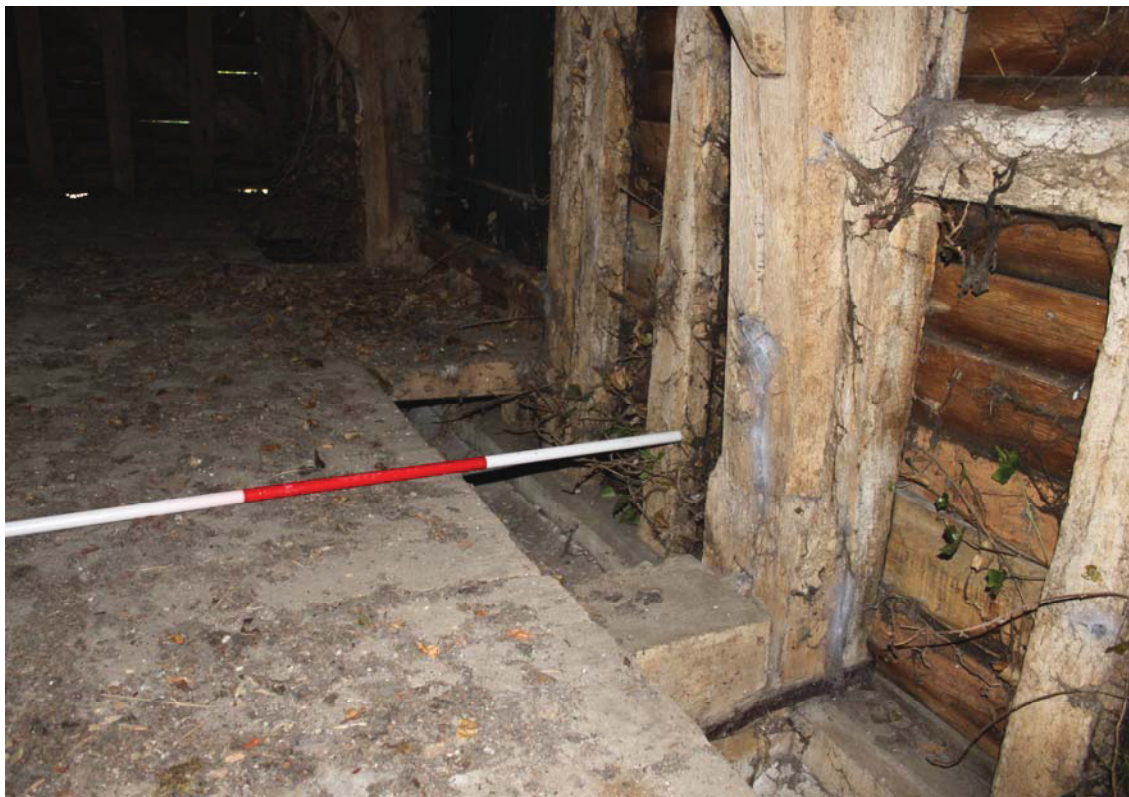
A2.12 Loading vent in floor above former hay rack (section 1a), showing the northern elevation of bay C to right with a 'bridge' to the 19th century loading door in bay B in centre rear

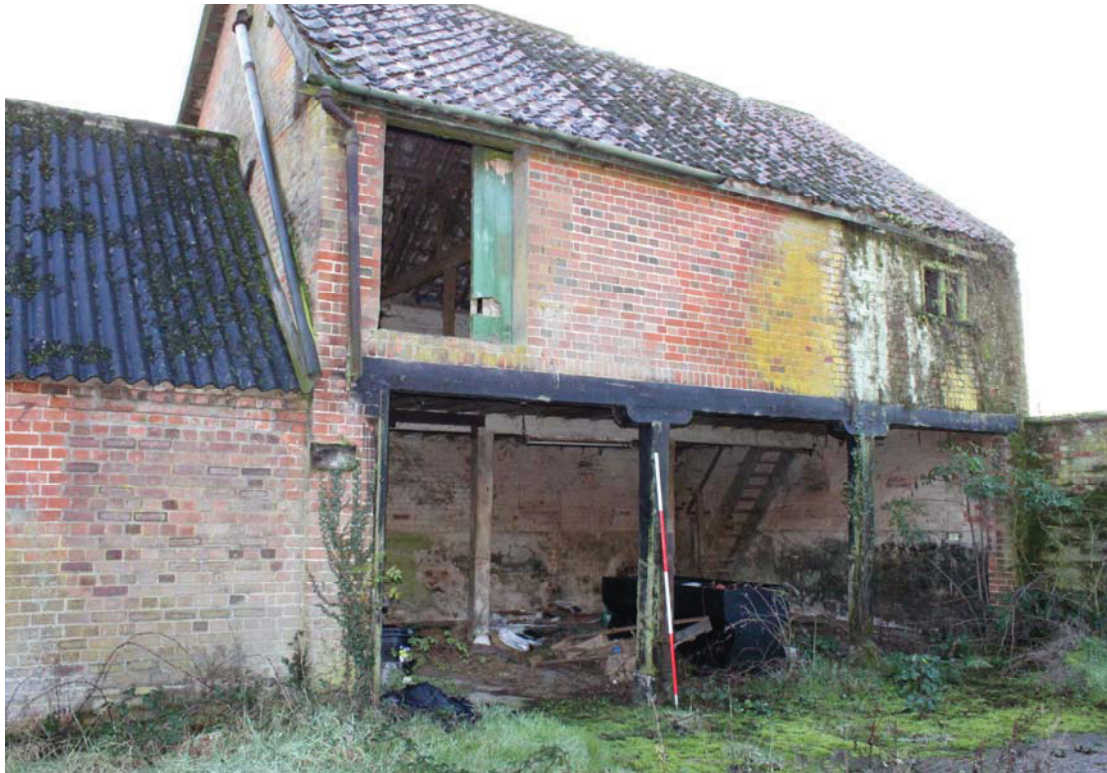
A2.13 Northern exterior of mid-19th century cartlodge/granary (6) showing original open arcade and inserted loading door to first-floor (converted from a window). The original access from Wingfield Castle has been blocked by the 20th century wall shown to the right, and the shelter shed now converted into a milking parlour (7) is visible to the left.

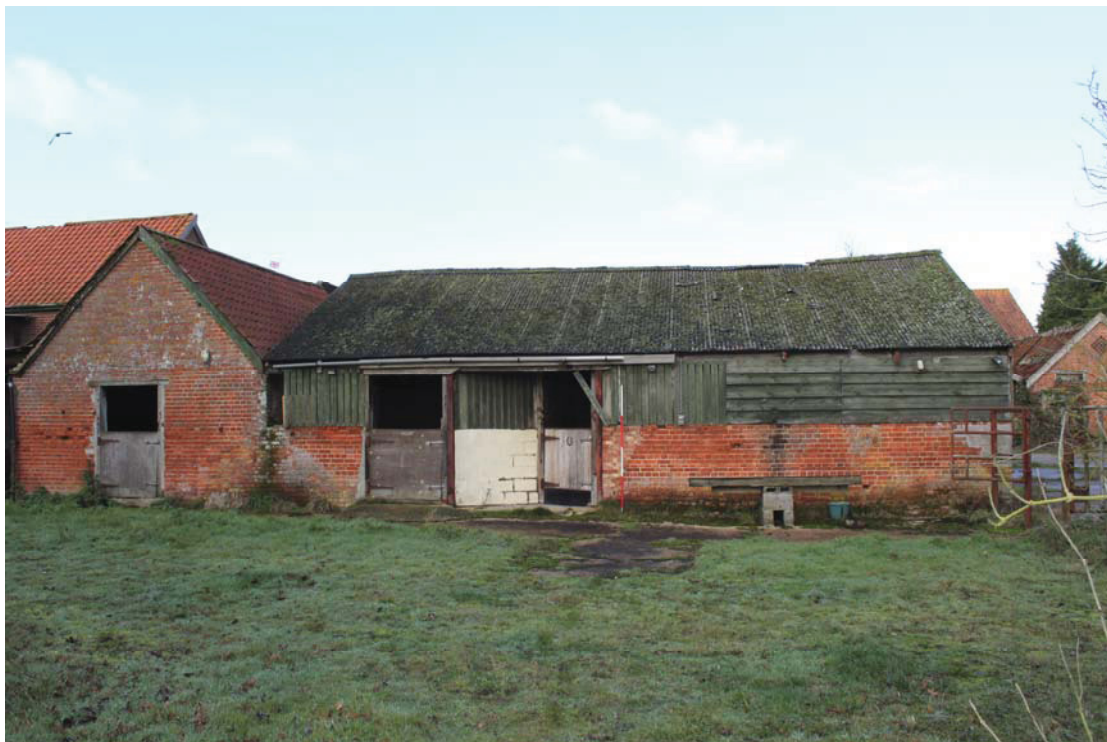
A2.14 Southern exterior of cow shed and covered yard (9) recently converted into block-work stable units, showing the cartlodge/granary (6) in rear to left and the eastern end of the barn to the right.
