**‘Barn’ at
Lane Farmhouse,
Wilby, Suffolk
WBY 020**

Historic Building Record

OASIS ID: Suffolkc1-77126

This report provides a written and photographic record at English Heritage (2006) Level 2 of a redundant farm building within the cartilage of a grade II-listed farmhouse. The building is known for planning purposes as a barn but was last used as a stable and cow-house. It has been prepared to a brief written by Suffolk County Council’s Archaeological Service (Edward Martin, 18th November 2010, ref. SpecHBR(EM)LaneFmhse_Wilby_Pre_09), and is intended to inform and accompany a planning application for conversion.

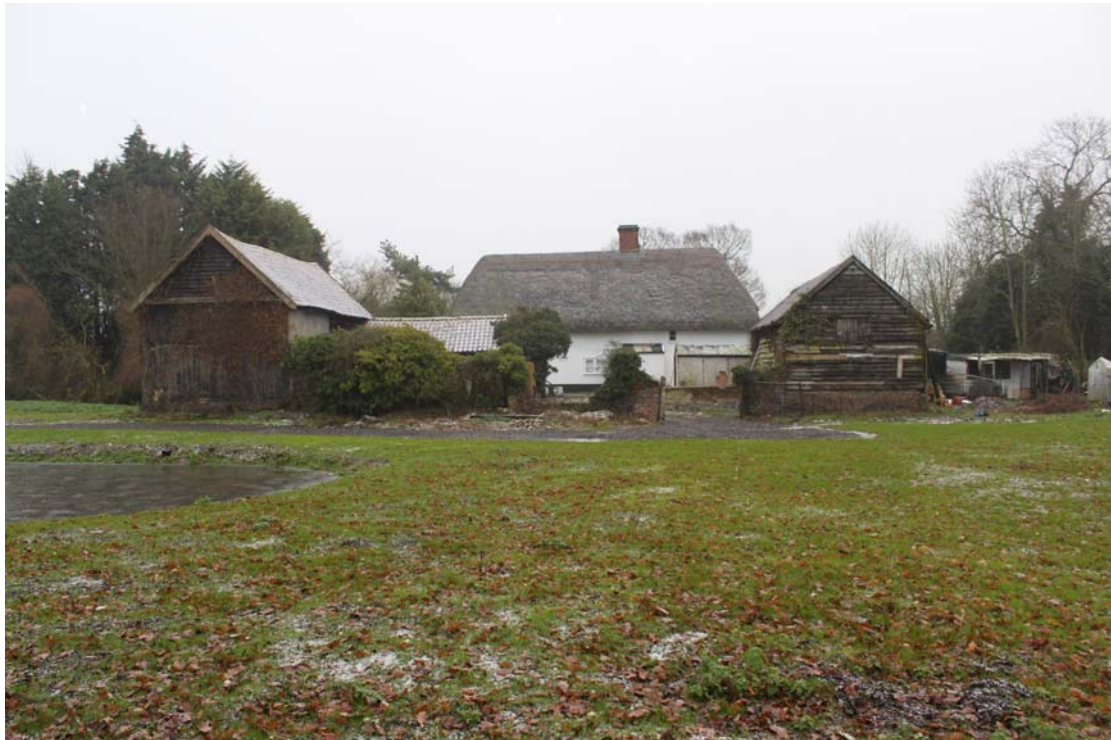
Illus. 1. General view of site from west showing stable (1) to right, farmhouse (2) in centre & barn (3) left.

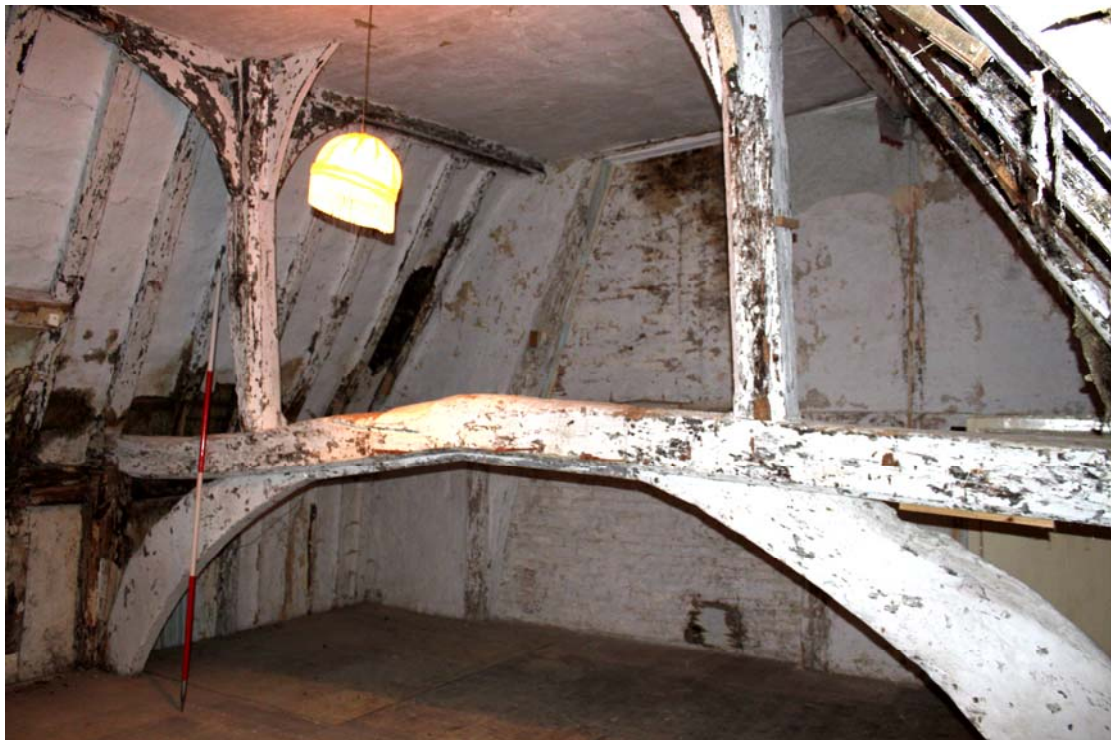
Illus. 2. The queen-post open-truss of the 15th century open hall in the farmhouse (2) seen from the low-end to the north-west. The whitewash conceals heavy sooting. Included for site context.

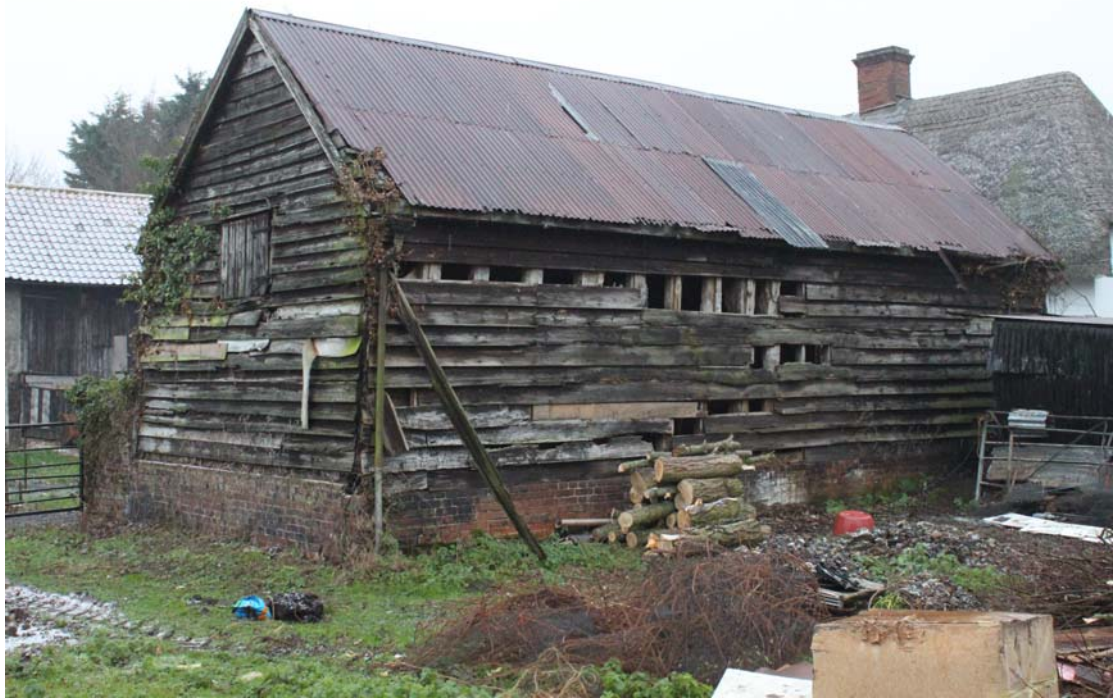
Illus. 3. Exterior of stable (1) from south-west showing loft loading hatch in western gable to left and farmhouse to right.

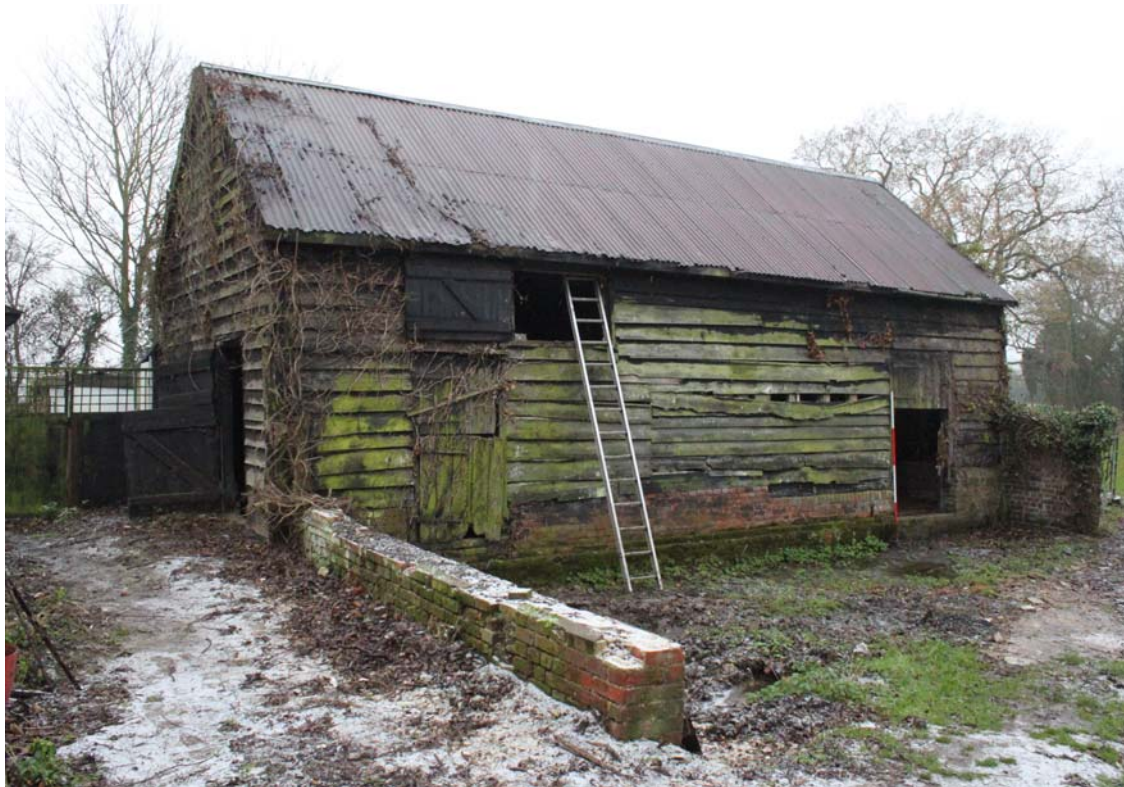
Illus. 4. Exterior of stable from north-east showing half-hung entrance doors to yard, loading door to eastern loft and door in eastern gable to left.

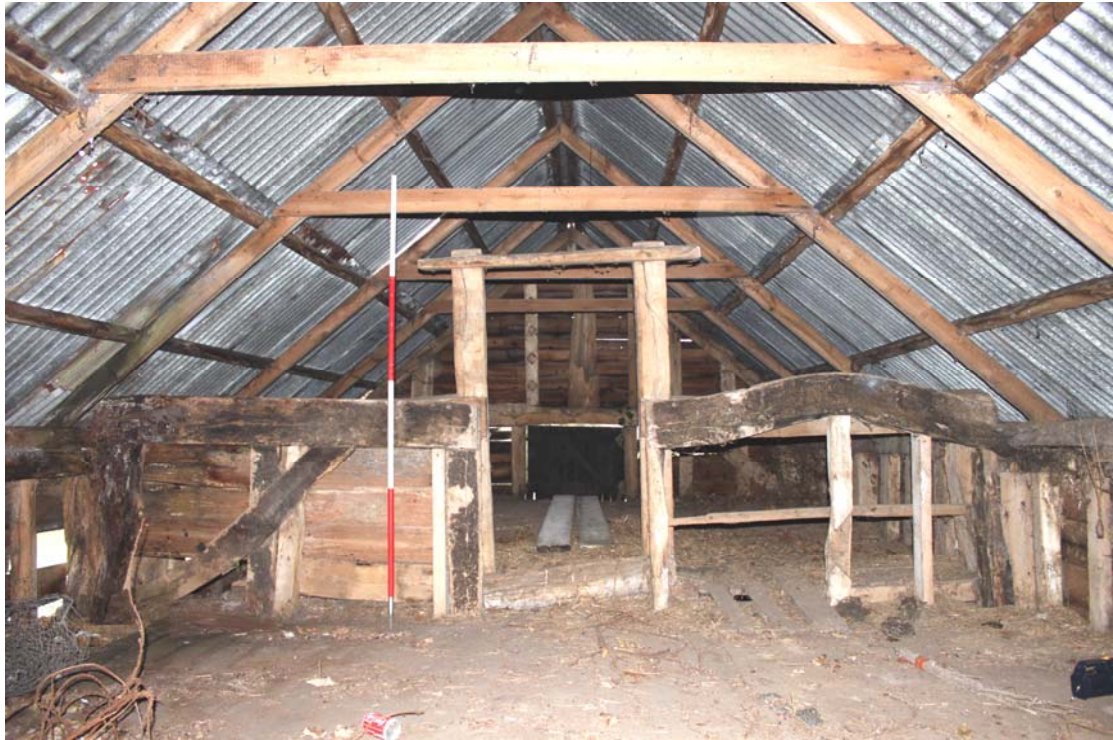
Illus. 5. Interior of eastern loft from east showing the upper part of the sooted medieval 'high-end' partition which divides the building into two halves. Note the original wall brace to the left and the bow in the tie-beam to right. This bow would have reflected an original doorway beneath, which explains the absence of a right-hand wall brace. The central door is an insertion of the 17th century and the roof is modern.

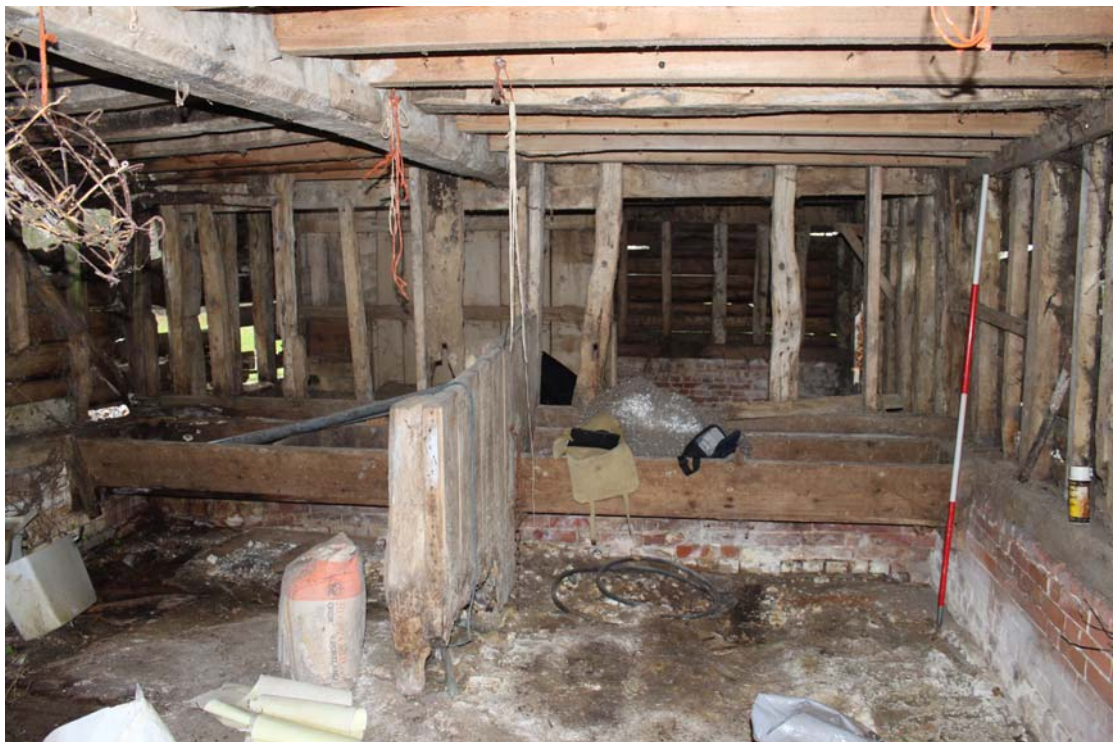
Illus. 6. Internal 'high-end' partition from east showing the low cattle manger and axial stall divider on the ground floor.

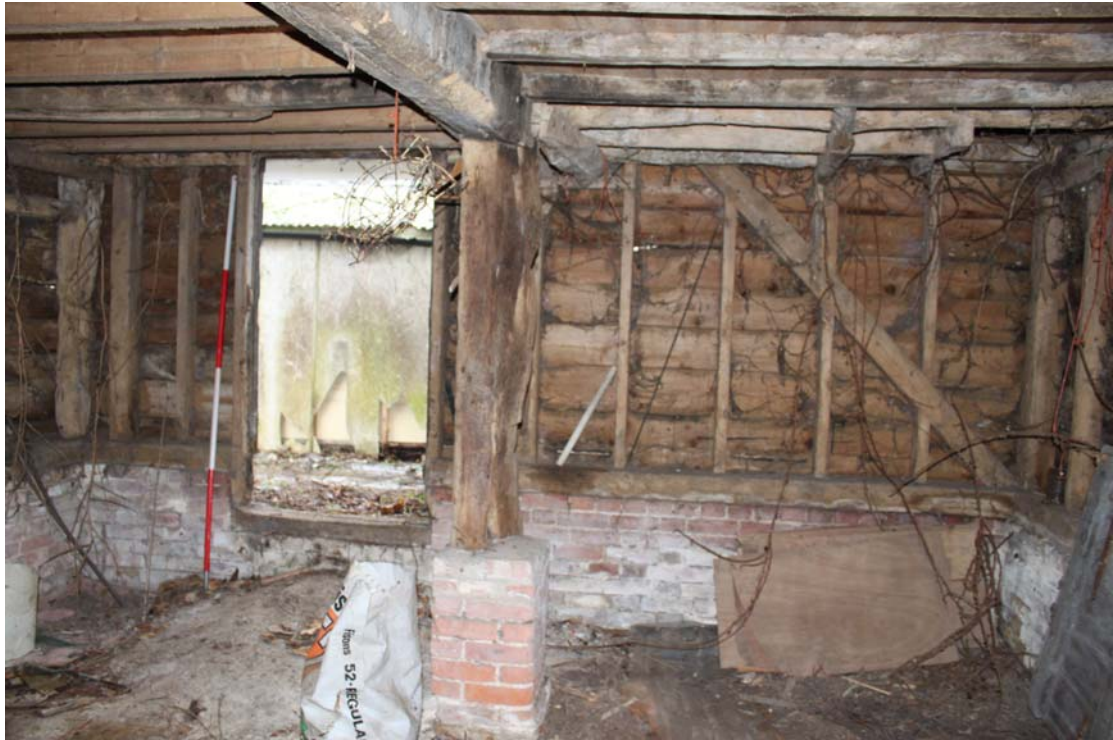
Illus. 7. Eastern internal gable showing 20th century framing with a door opening towards the farmhouse. The central post is an insertion of the 19th century which supports the end of the 17th century axial ceiling joist where it would formerly have abutted a chimney.

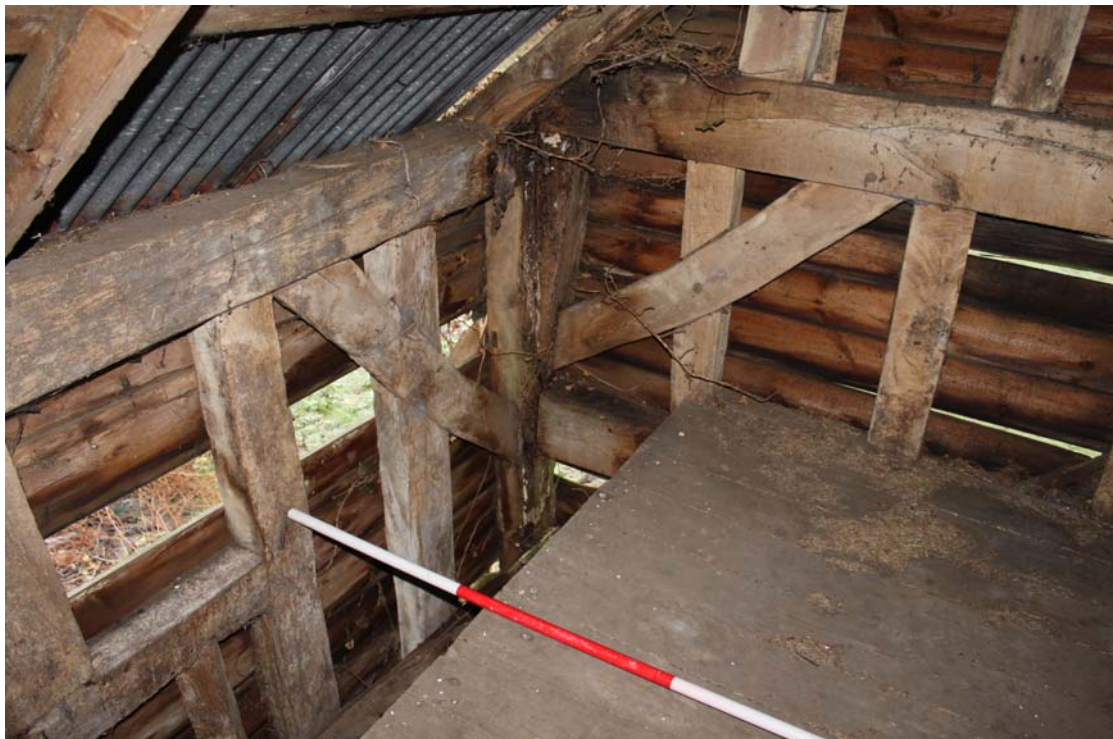
Illus. 8. Internal south-western corner of western loft showing corner braces & original diamond-mullion window to left. The left-hand mullion (not visible here) is the only original mullion to survive in situ. The western half of the building dates from the late-16th century in contrast to the 15th century eastern half.

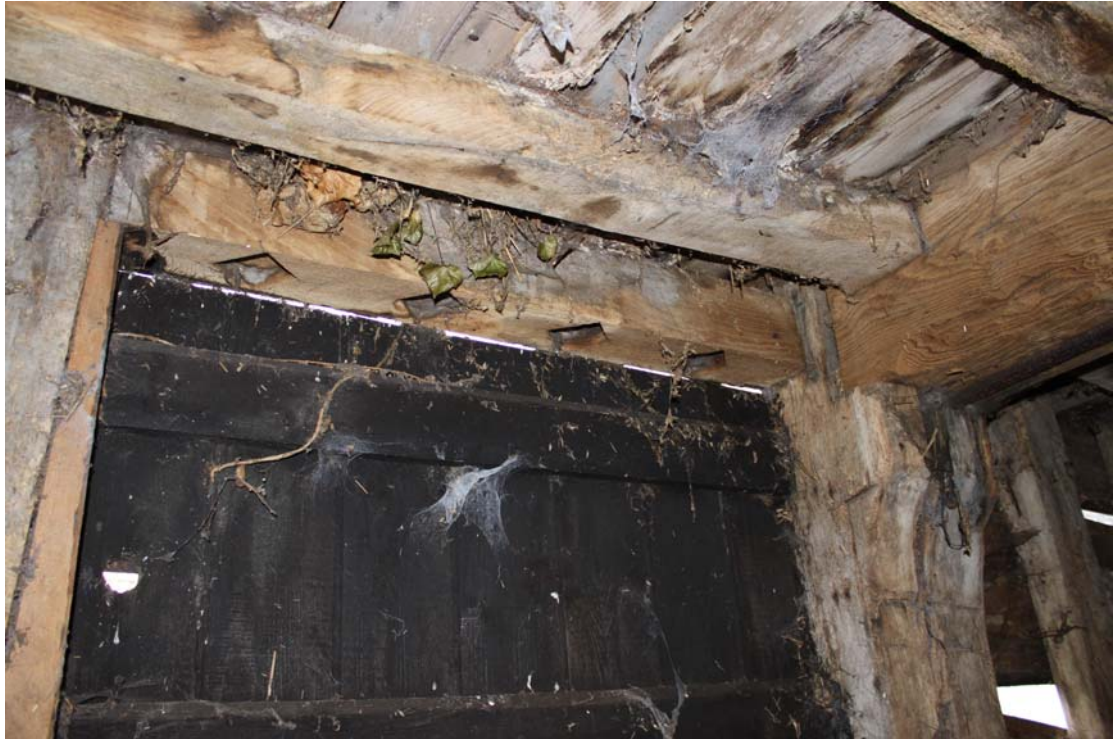
Illus. 9. Detail of the original diamond mullion mortises in the lintel of the northern door of the western stable. The step-stop chamfered binding joist with a neatly-cut corbel block is visible to the right.

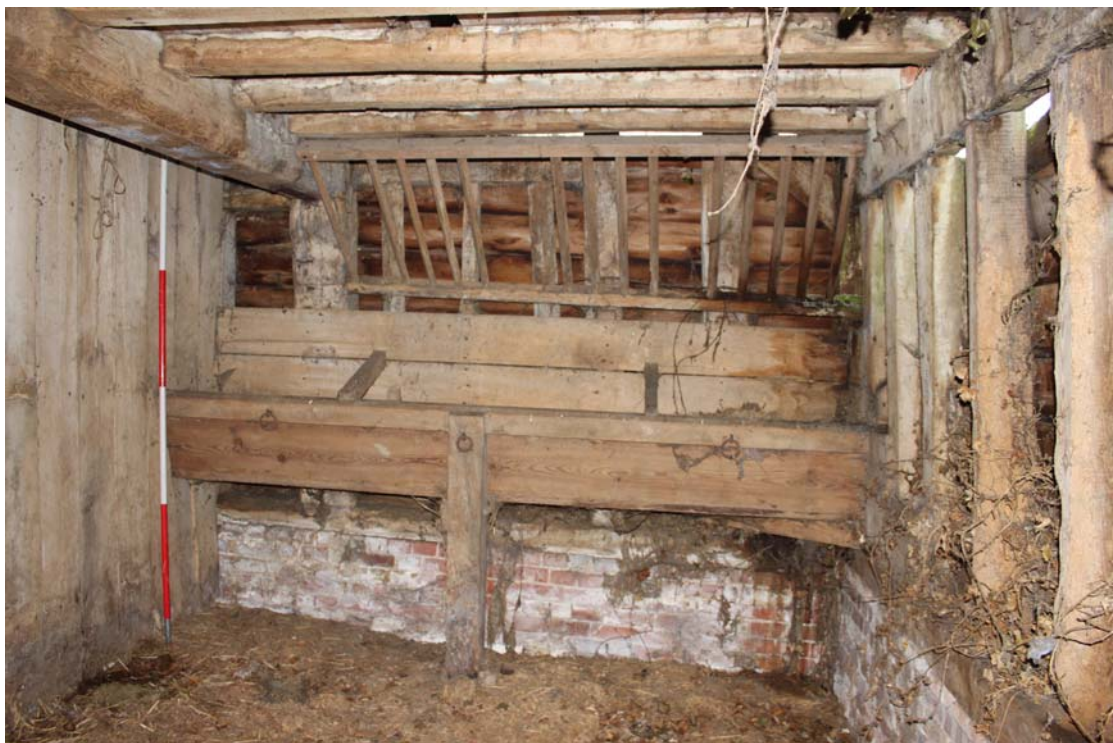
Illus. 10. The feeding trough and hay rack at the western end of the southern internal elevation (at horse height), showing the western gable to the right. Note the original diamond mullion window behind the rack, and evidence for additional mullions in the gable. The boarding to the left is a stall divider.
