**Barn at  
St Jacob's Hall,  
Laxfield, Suffolk**  
LXD 058

**Historic Building Record**

# **Barn at St Jacob's Hall, Rowe's Hill (B1117), Laxfield, Suffolk**

## **Historic Building Record**

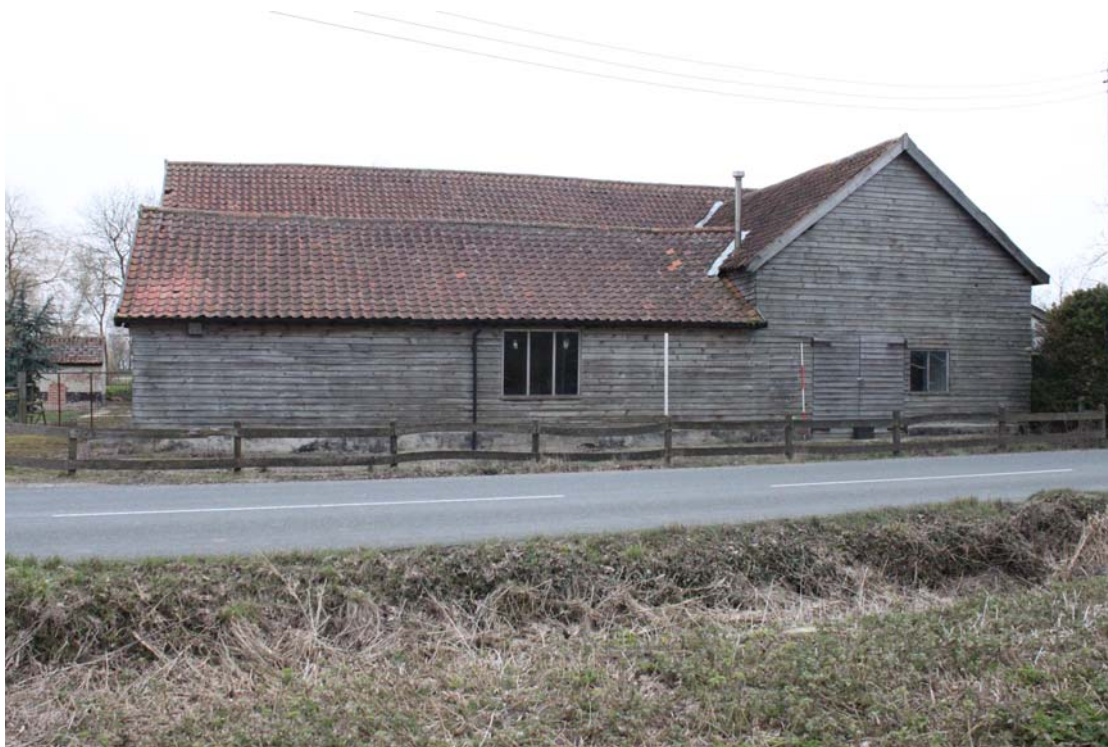
**Illus. 2. Eastern external elevation showing gabled porch (2) to right and lean-to shed (3) left. The right-hand half of the lean-to shed was originally an open-sided cart lodge. The roof of the main barn (1) is visible in the rear.**

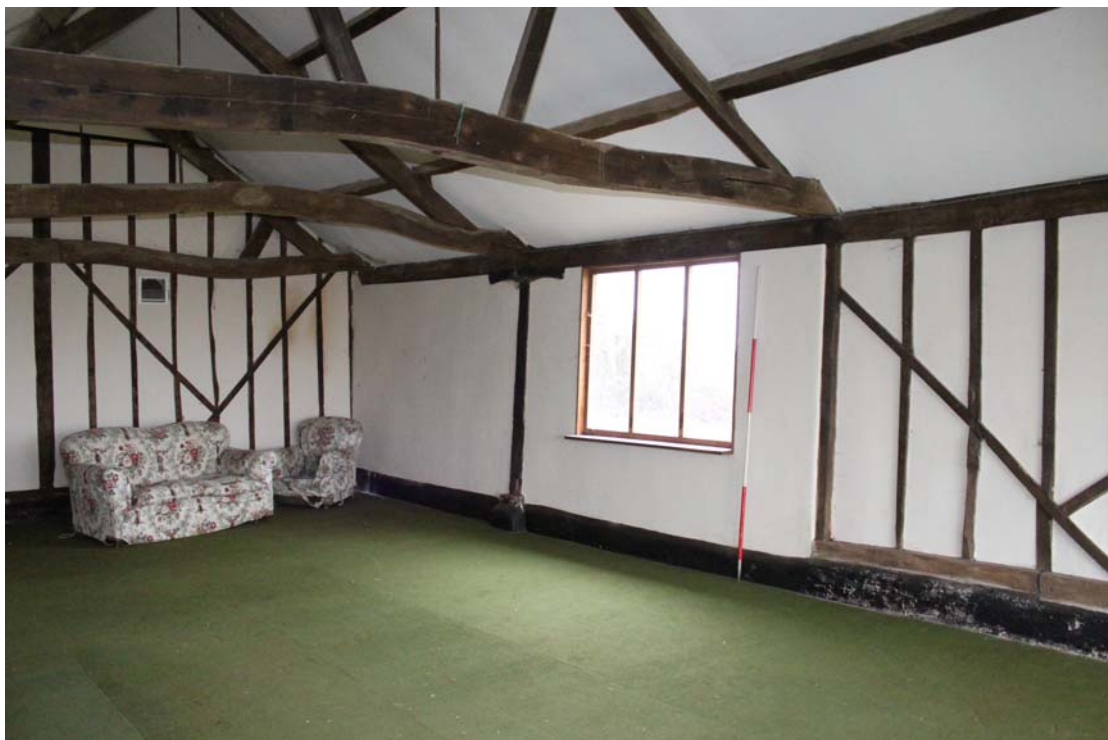
**Illus. 4. Interior of eastern shed (3) from south-west showing the arcade-post of the originally open-sided northern half of the eastern internal elevation in the centre. The missing partition beneath the tie-beam which divided this roadside cart shed from the enclosed shed in the foreground is still shown on the modern Ordnance Survey (figure 1).**

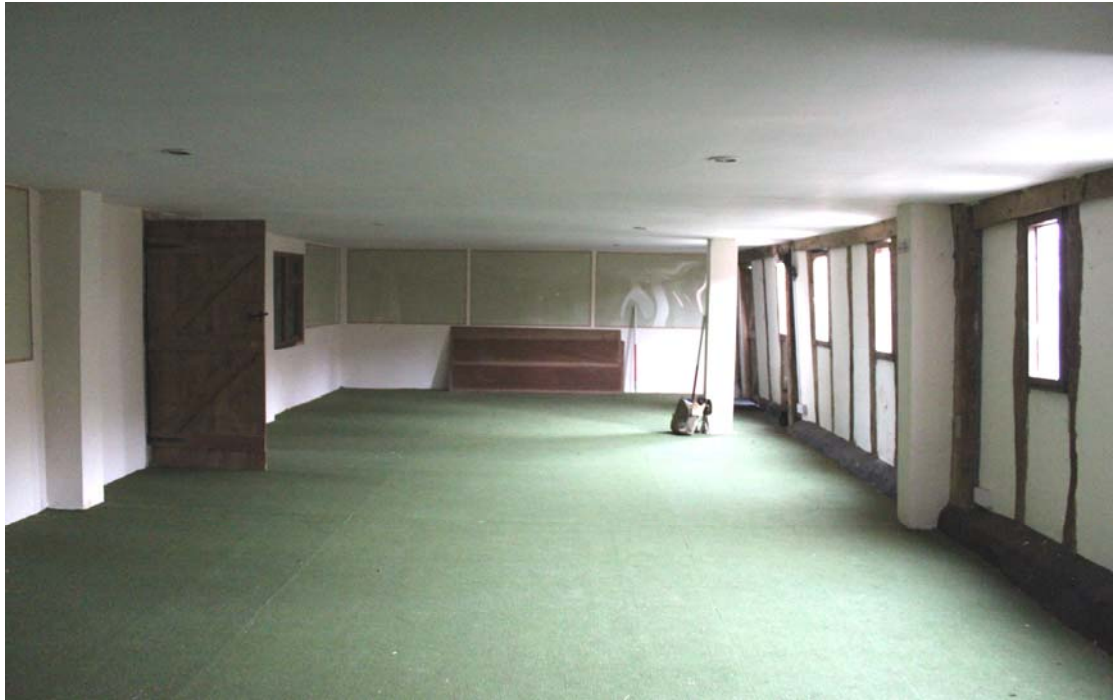
**Illus. 5. Interior from north of central section of barn (1) showing modern ceiling and windows with original framing in western elevation to right. The partition to the left is a modern insertion forming an internal corridor against the barn's eastern elevation.**

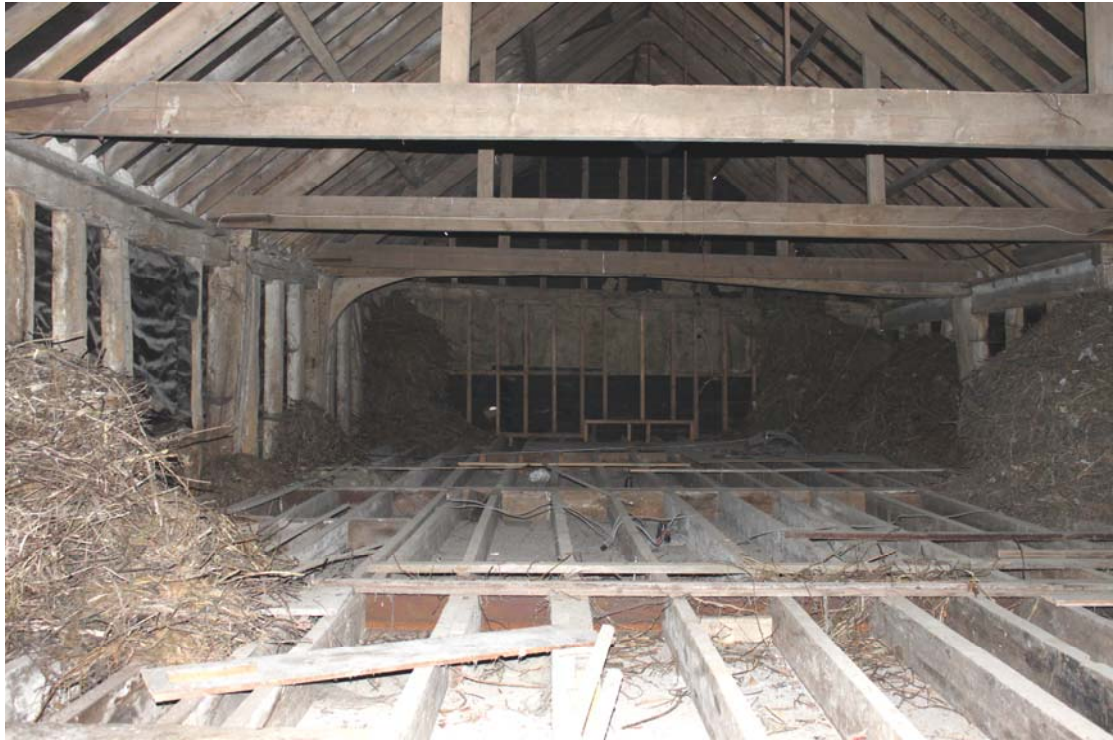
**Illus. 7.** General view from north of barn (1) above its ceiling of 20<sup>th</sup> century tall-sectioned softwood joists, showing the early-20th century tie-beams and roof structure with original 16<sup>th</sup> century framing to left & right and 20<sup>th</sup> century rebuilt southern gable in rear.

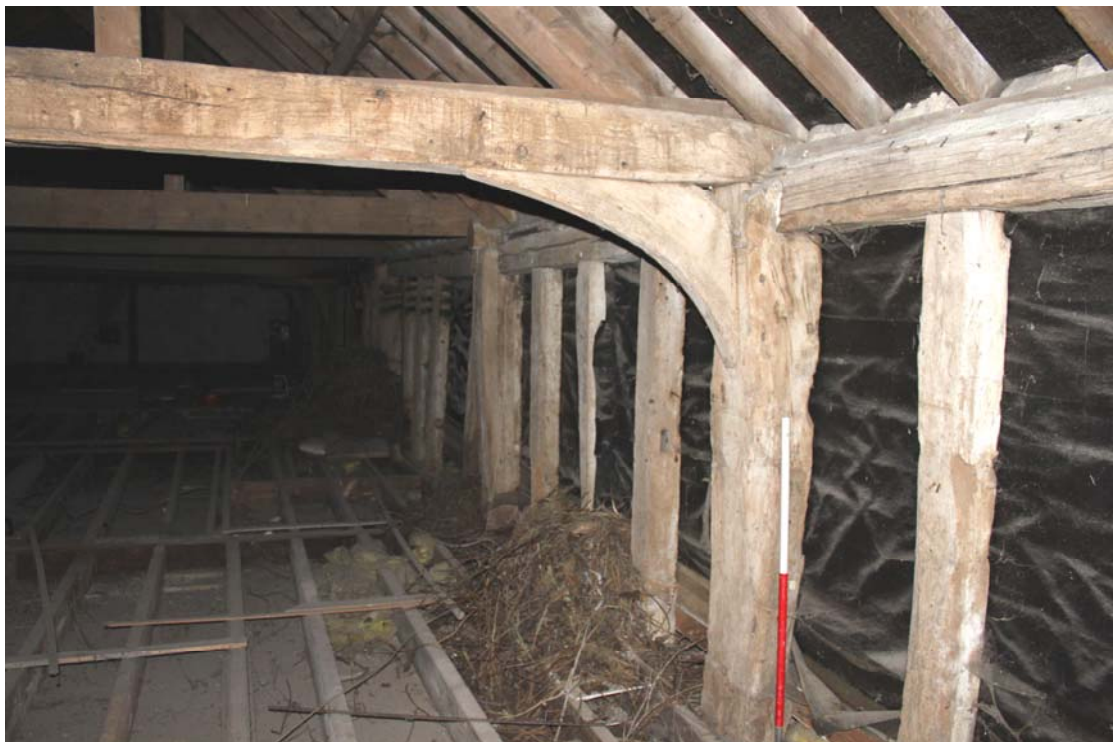
**Illus. 10. The original tie-beam and brace between the two bays of the former hay loft, as seen from the south (i.e. above the ground-floor WCs). The opposite (western) brace has been removed.**

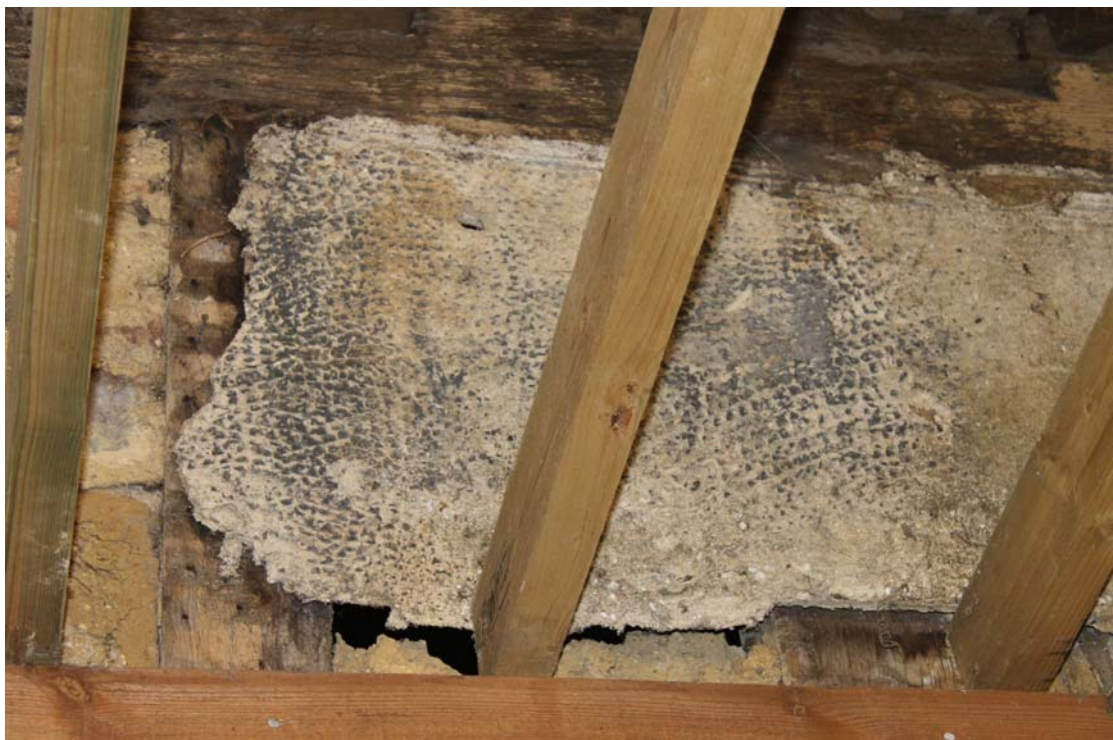
The present external weatherboarding dates only from the late-20<sup>th</sup> century commercial conversion, and an area of earlier lath-and-plaster survives at the northern end of the western elevation (protected within a 19<sup>th</sup> century lean-to vehicle shed). This bears textured pargeting in the style of the late-17<sup>th</sup> or 18<sup>th</sup> century but is probably secondary as the studs and storey posts beneath are heavily weathered and were evidently exposed externally for some time. The absence of fixing notches for wattle-and-daub suggests the walls may have contained ostentatious brick nogging. The 18<sup>th</sup> century plaster lies above a contemporary lower tier of external weatherboarding: many local barns were partly rendered and partly boarded in this way during the 18<sup>th</sup> and early-19<sup>th</sup> centuries.

**Illus. 12. Textured pargeing to western exterior of barn's northern bay, seen through the modern ceiling joists of the lean-to shed (5) and showing the roof-plate above. This decorative plasterwork probably dates from the 18<sup>th</sup> century and lies above a lower tier of weatherboarding. The weathering to the studs suggests they were originally exposed externally.**
