**Barn at
St Jacob's Hall,
Laxfield, Suffolk
LXD 057**

Historic Building Record

April 2010

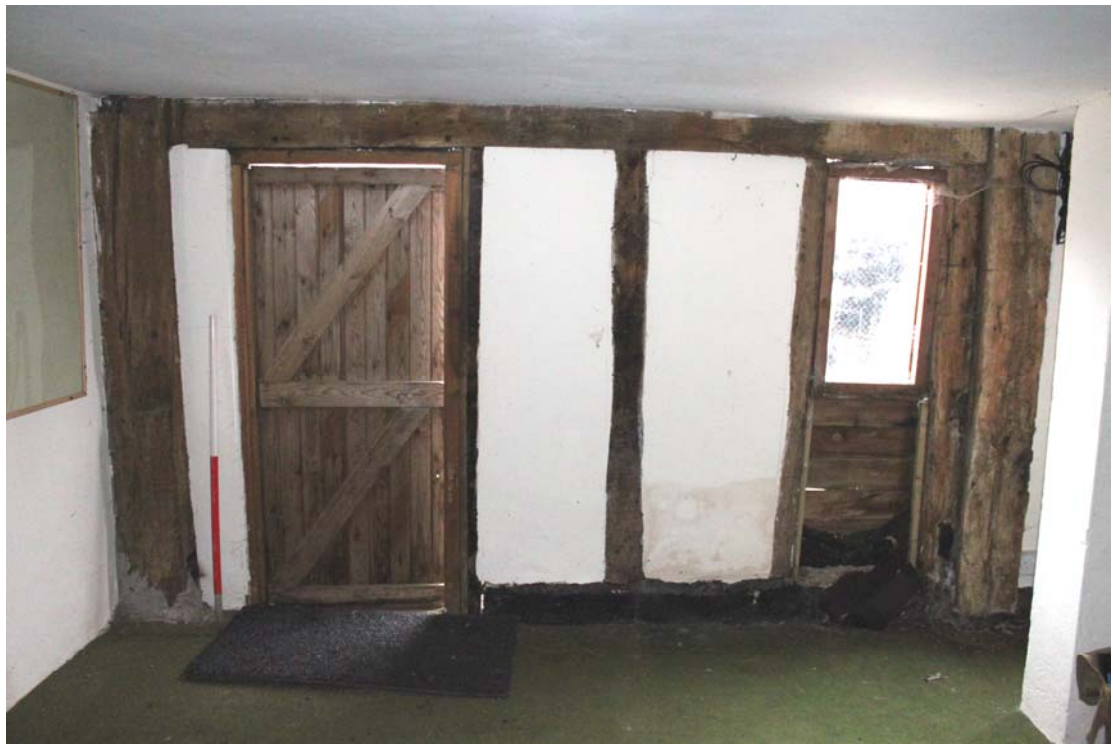
Illus. 6. Western interior of penultimate southern bay of barn (originally the northern bay of a two-bay integral stable) showing the inserted modern yard door to the left and the position of the original stable door to right (as indicated by a pegged and tenoned jamb abutting the storey post and a corresponding gap of 106 cm (3.5 ft) to its left). The southern bay beyond the modern left-hand partition forms a pair of WCs with no exposed framing.

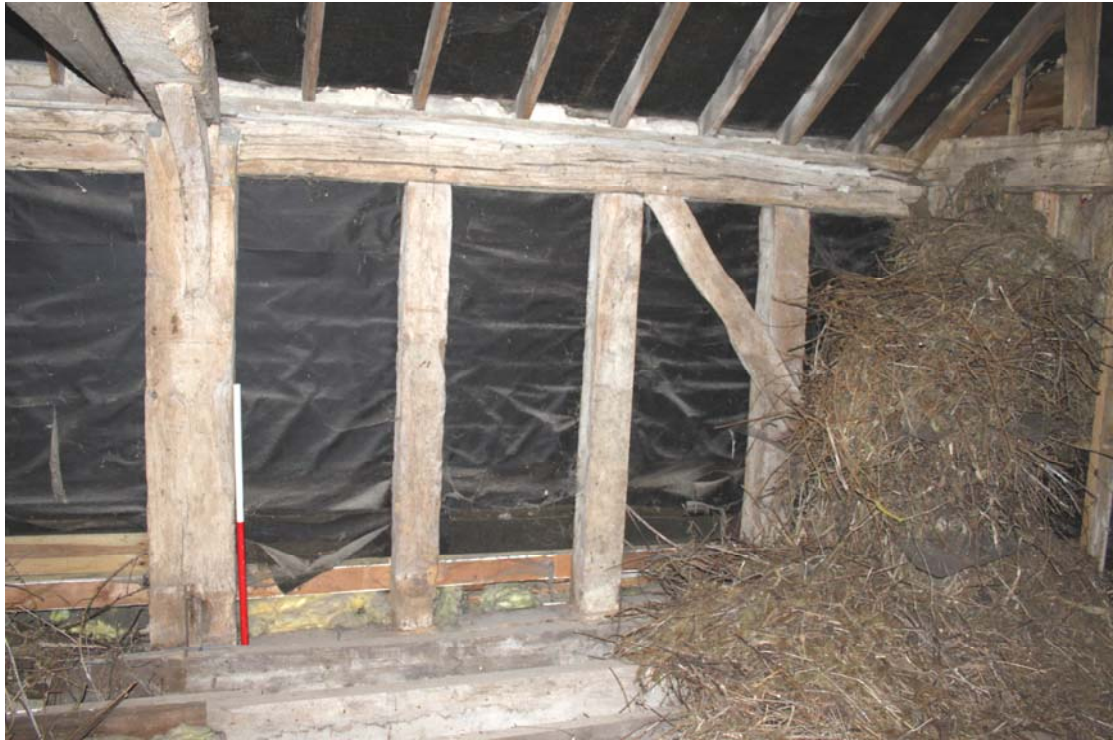
Illus. 11. Southern bay of eastern internal elevation of barn (1) showing the original internally trenched corner brace to right and the open truss of the two-bay stable to left. An identical brace survives at the southern end of the western elevation.
