**Barn at  
St Jacob's Hall,  
Laxfield, Suffolk  
LXD 057**

**Historic Building Record**

**April 2010**

## **Historic Building Record**

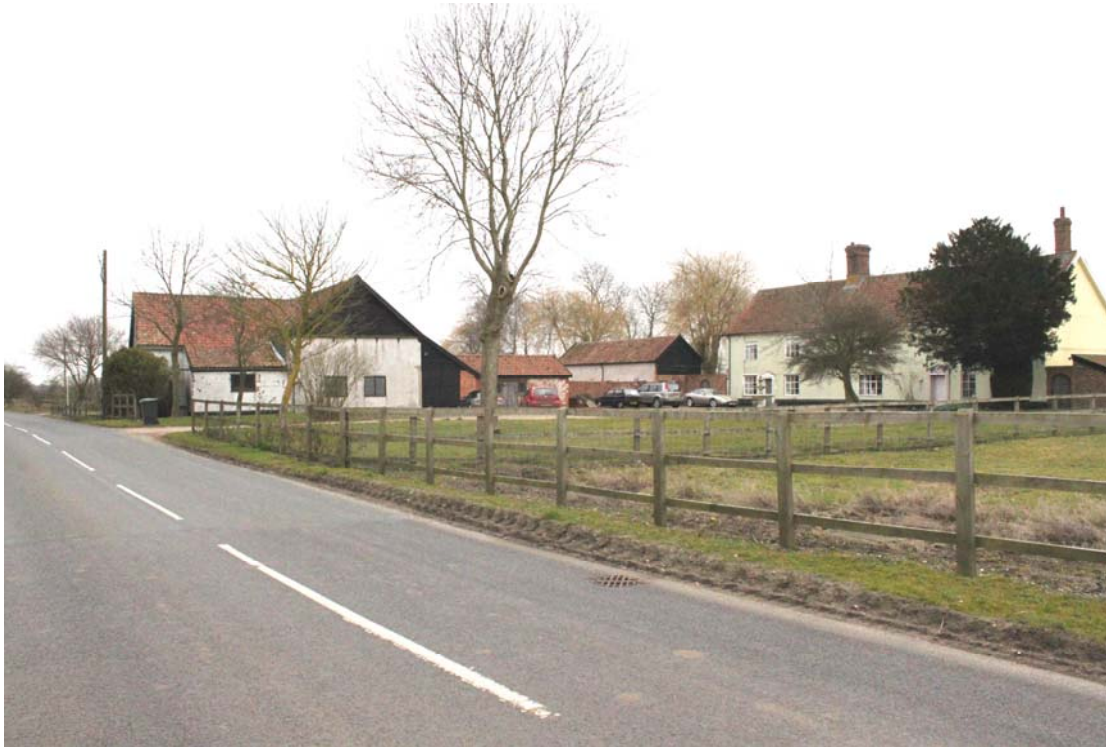
**Illus. 1. General view of site from B1117 (Rowe's Hill) to the north showing the 16<sup>th</sup> century farmhouse to the right and the late-16<sup>th</sup> century roadside barn to left.**

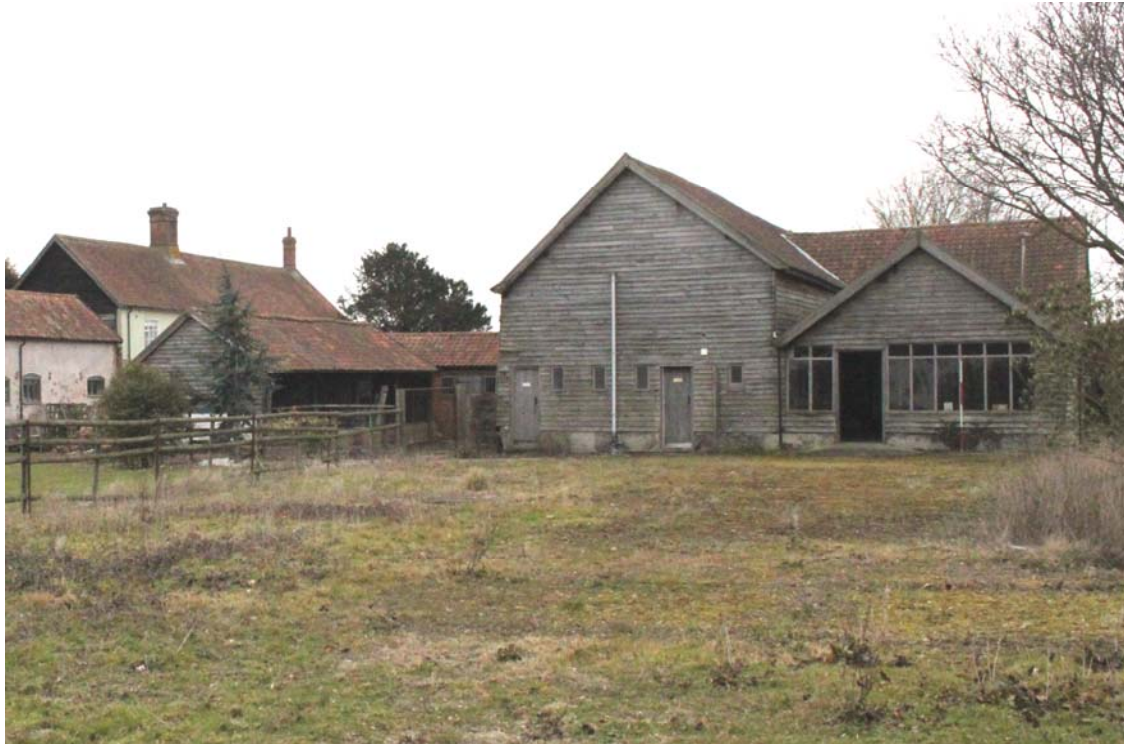
**Illus. 3. External southern gable showing doors to public lavatories in end-bay of main barn to left and parallel shed (3) to right. The shelter shed (4) is visible to the left with the farmhouse in the rear.**

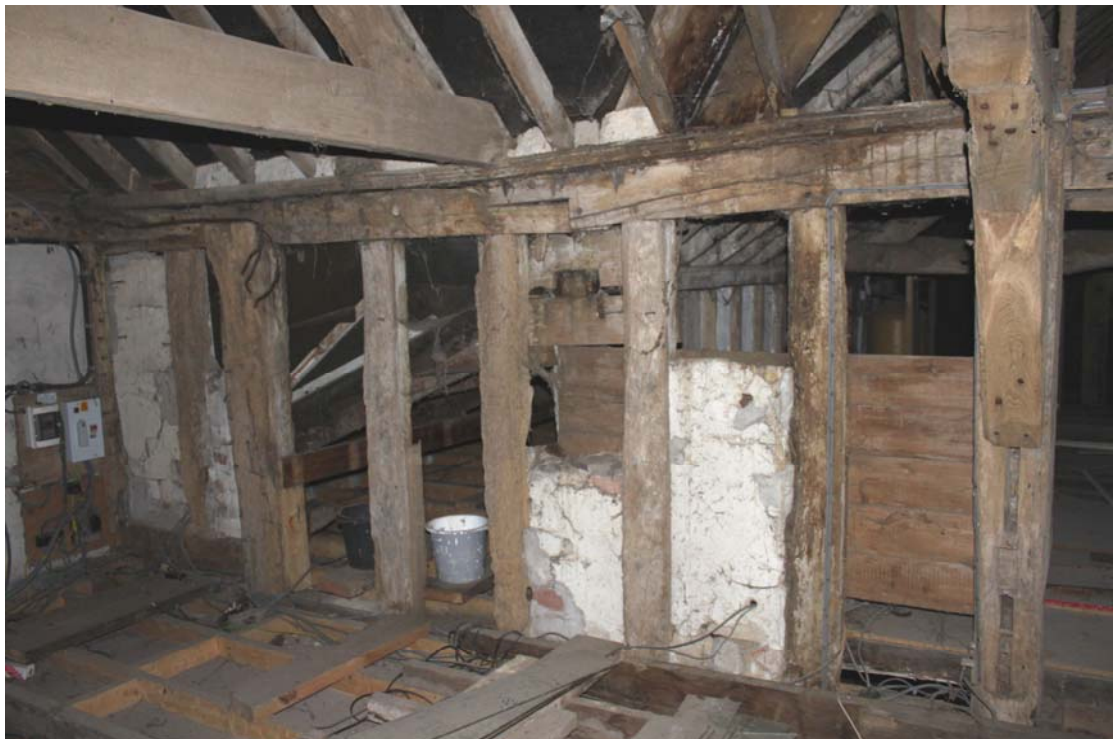
**Illus. 8.** Northern end of eastern internal elevation of barn (1) showing to left the narrow truncated bay with an original door lintel immediately above the modern ceiling and the original entrance bay to right. Note the edge-halved and bridled scarf joint in the roof plate and the empty mortises of the re-used storey post.

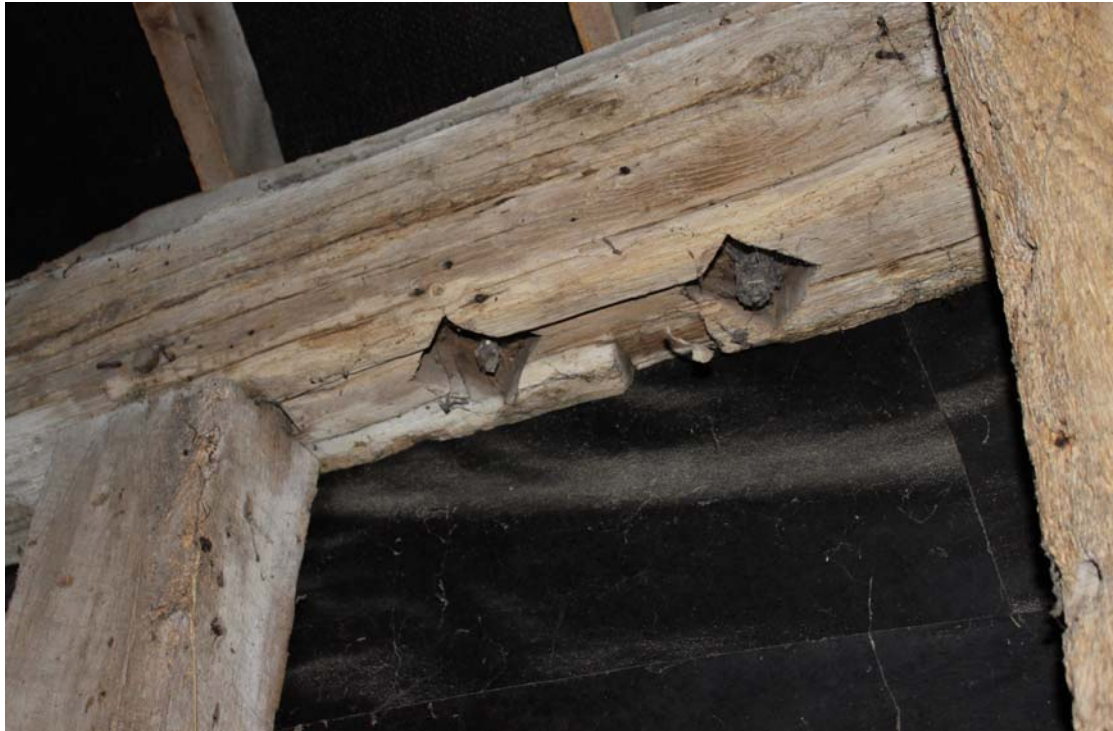
**Illus. 9. Detail of eastern roof plate showing the diamond mullion mortises of the hay loft window in the penultimate southern bay (with storey post of central open truss to right). An identical three-light window adjoined the other (southern) side of the same truss in the western elevation, and the tie-beam of the southern gable contains six mullion mortises.**

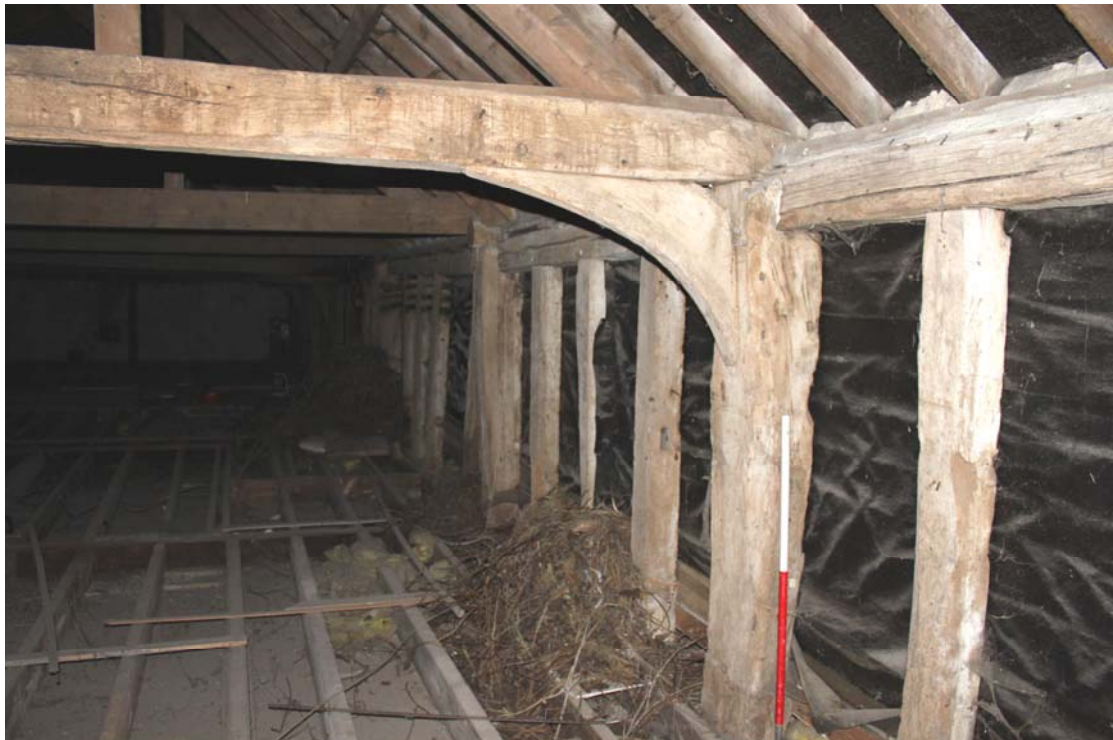
**Illus. 10. The original tie-beam and brace between the two bays of the former hay loft, as seen from the south (i.e. above the ground-floor WCs). The opposite (western) brace has been removed.**

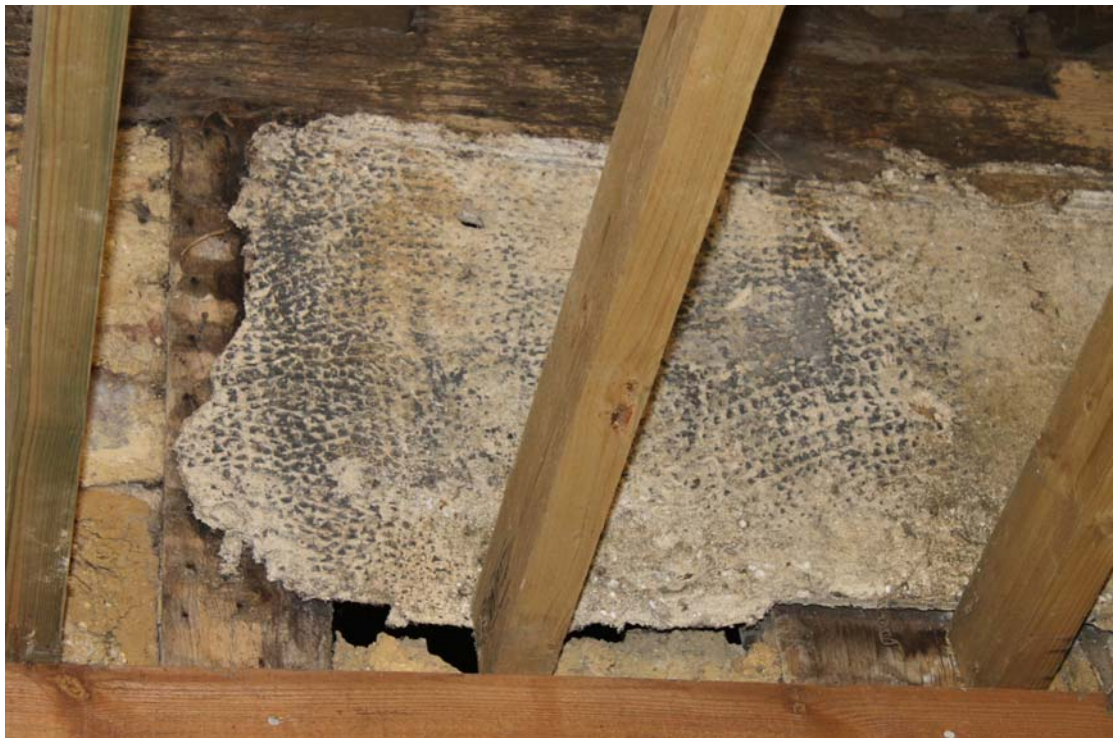
The present external weatherboarding dates only from the late-20<sup>th</sup> century commercial conversion, and an area of earlier lath-and-plaster survives at the northern end of the western elevation (protected within a 19<sup>th</sup> century lean-to vehicle shed). This bears textured pargeting in the style of the late-17<sup>th</sup> or 18<sup>th</sup> century but is probably secondary as the studs and storey posts beneath are heavily weathered and were evidently exposed externally for some time. The absence of fixing notches for wattle-and-daub suggests the walls may have contained ostentatious brick nogging. The 18<sup>th</sup> century plaster lies above a contemporary lower tier of external weatherboarding: many local barns were partly rendered and partly boarded in this way during the 18<sup>th</sup> and early-19<sup>th</sup> centuries.

**Illus. 12. Textured pargeing to western exterior of barn's northern bay, seen through the modern ceiling joists of the lean-to shed (5) and showing the roof-plate above. This decorative plasterwork probably dates from the 18<sup>th</sup> century and lies above a lower tier of weatherboarding. The weathering to the studs suggests they were originally exposed externally.**
