**Dairy Farm Barn,  
Brightwell Street,  
Brightwell, Suffolk  
BGL 047**

**Historic Building Record**

# **Dairy Farm Barn, Brightwell Street, Brightwell, Suffolk**

## **Historic Building Record**

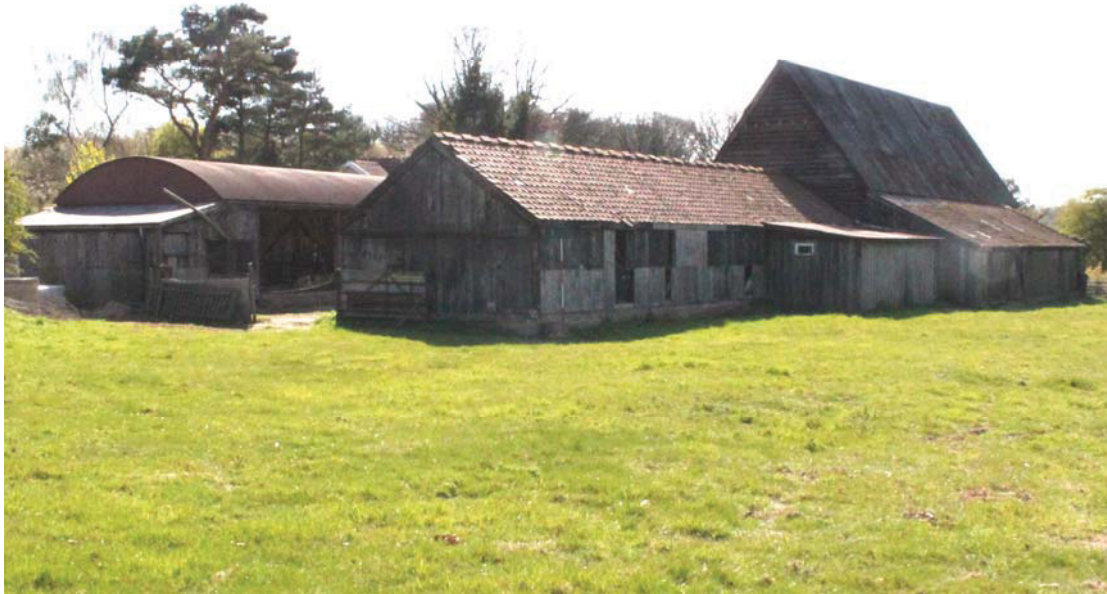
**Illus. 1. General view of site from north-east showing the early-19<sup>th</sup> century barn (1) to right with late-19<sup>th</sup> century lean-to sheds (2 & 6) and early-20<sup>th</sup> century pantiled milking parlour (5) in centre. The cattle shed (9) is visible in the rear.**

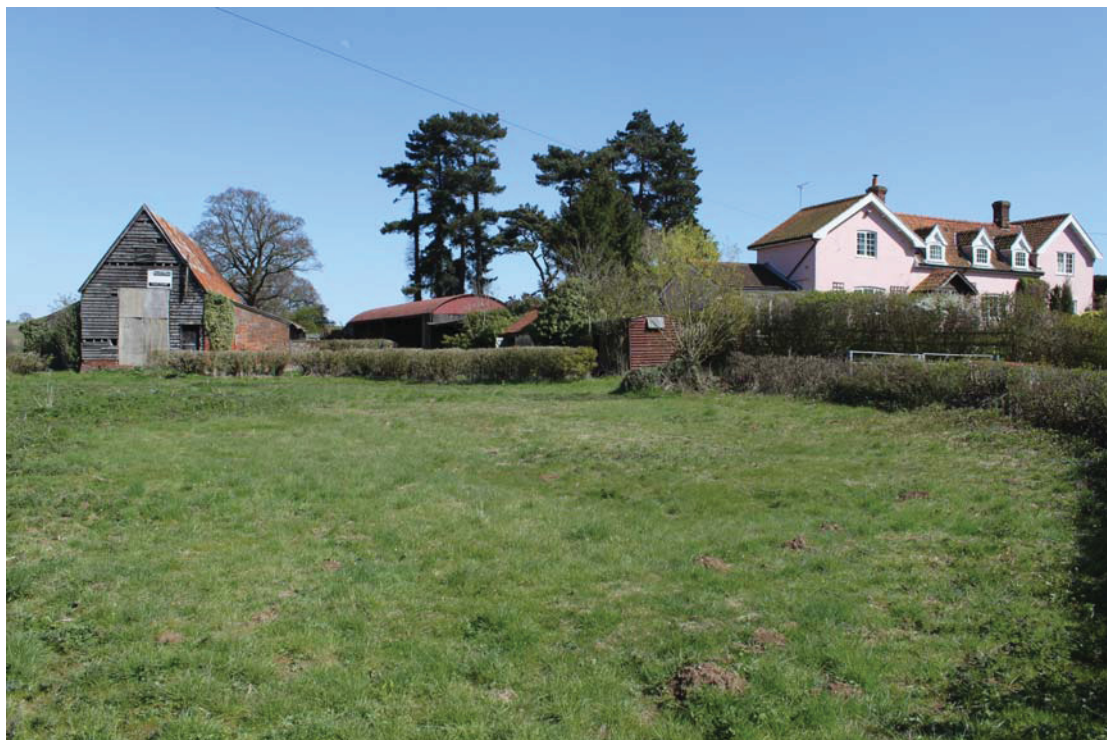
**Illus. 2. General view of site from west showing farmhouse (11) to right and barn (1) to left. The house was ostensibly rebuilt in *circa* 1920 but occupies the site of a predecessor shown on 19<sup>th</sup> century maps and may contain earlier fabric.**

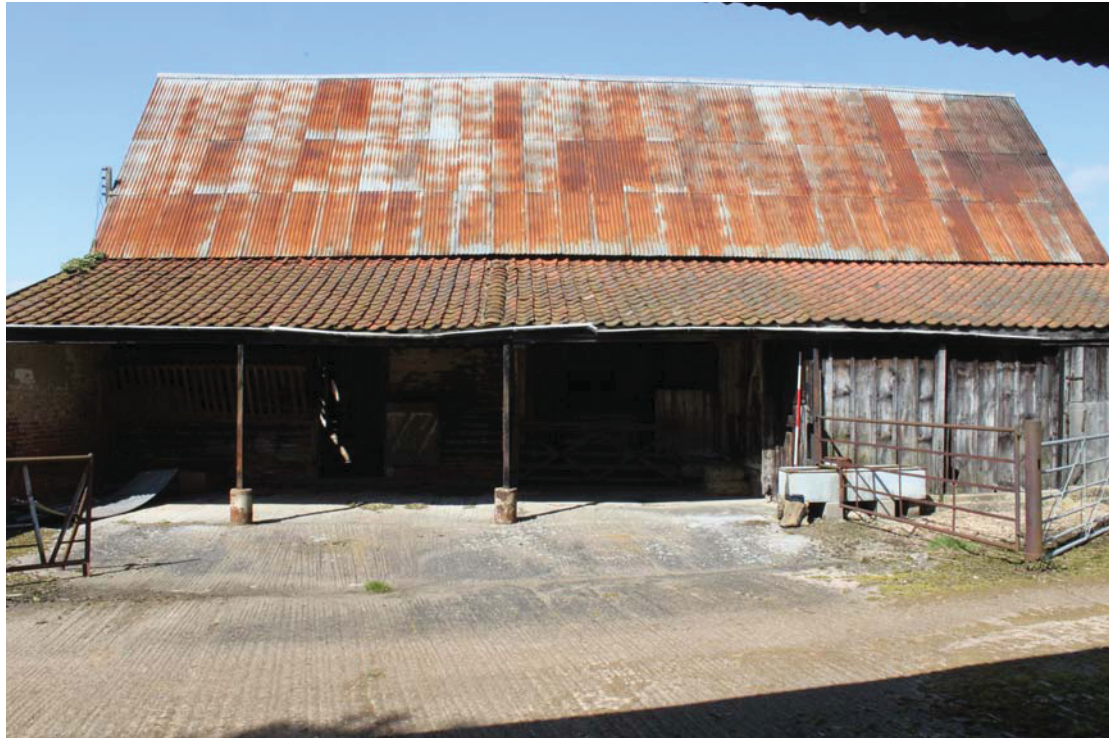
**Illus. 3. Exterior of barn (1) from south showing the 20<sup>th</sup> century shelter shed (3) to left and the enclosed 20<sup>th</sup> century loose boxes (4) to right. The Ordnance Survey of 1927 appears to show a central porch flanked by open shelter sheds here.**

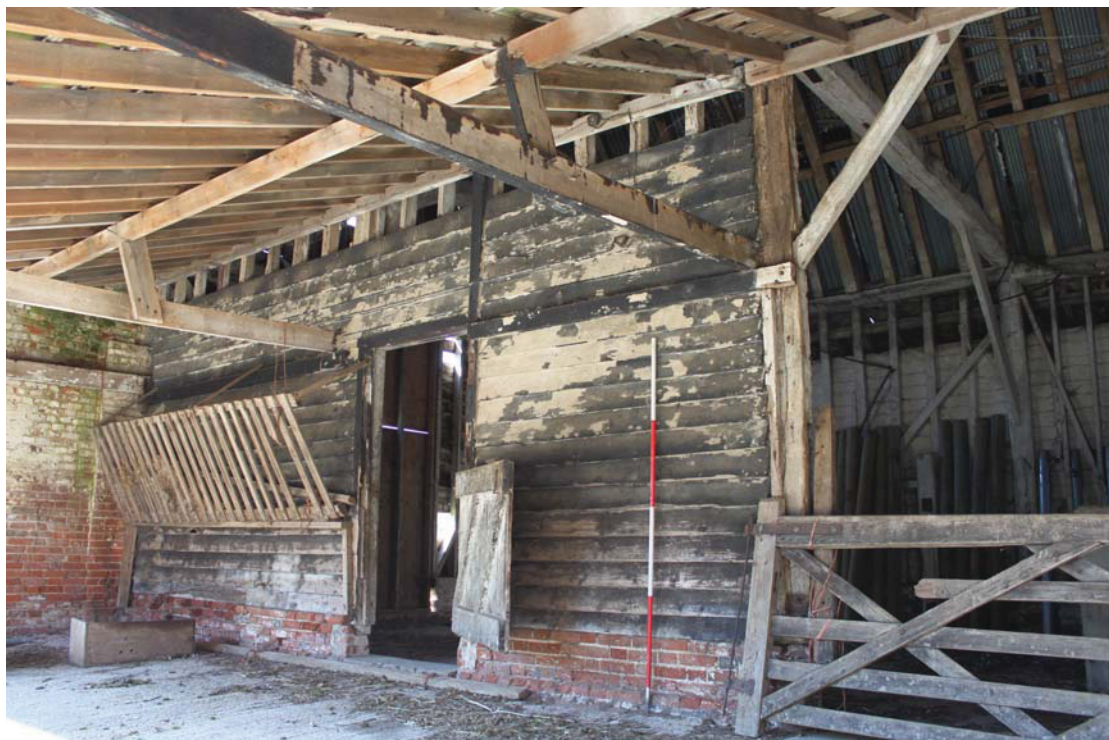
**Illus. 4. The western end of the barn's southern external elevation within the 20<sup>th</sup> century lean-to shelter shed (3), showing the principal entrance to right and a secondary door to the left. Note the 20<sup>th</sup> century hay rack for cattle and the grey pigment to the apparently original weatherboarding**

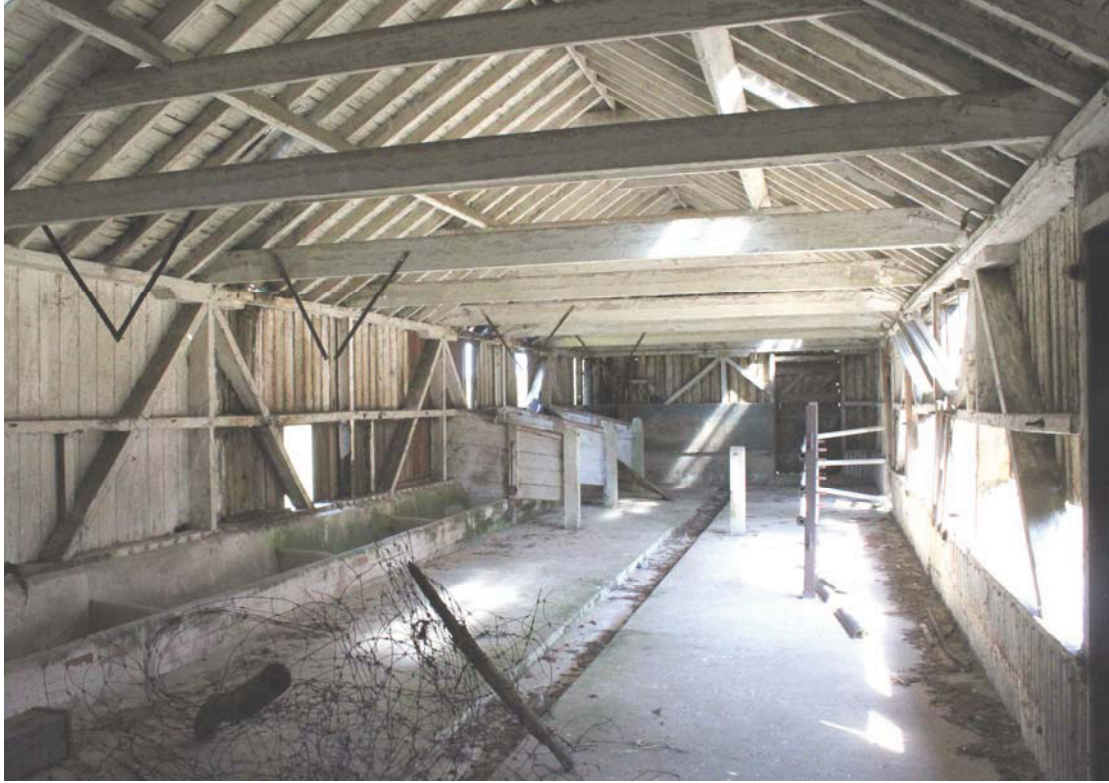
**Illus. 5. Interior of early-20th century milking parlour (5) from west showing the original wooden stalls and secondary concrete feeding trough to left.**

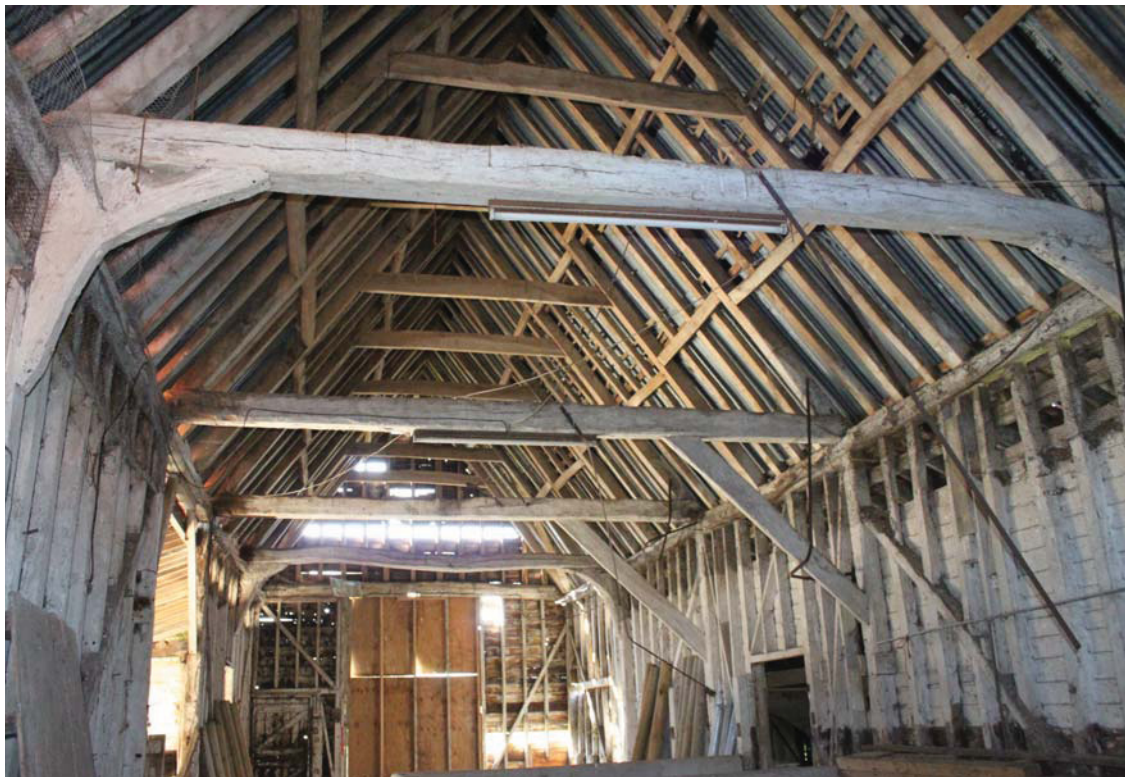
**Illus. 6. Original roof structure of barn (1) seen from the east and showing the arch-braces to the tie-beams flanking the central threshing bay combined with bolted knee-braces to the outer trusses. The arch-braces to the south (left) have been removed.**

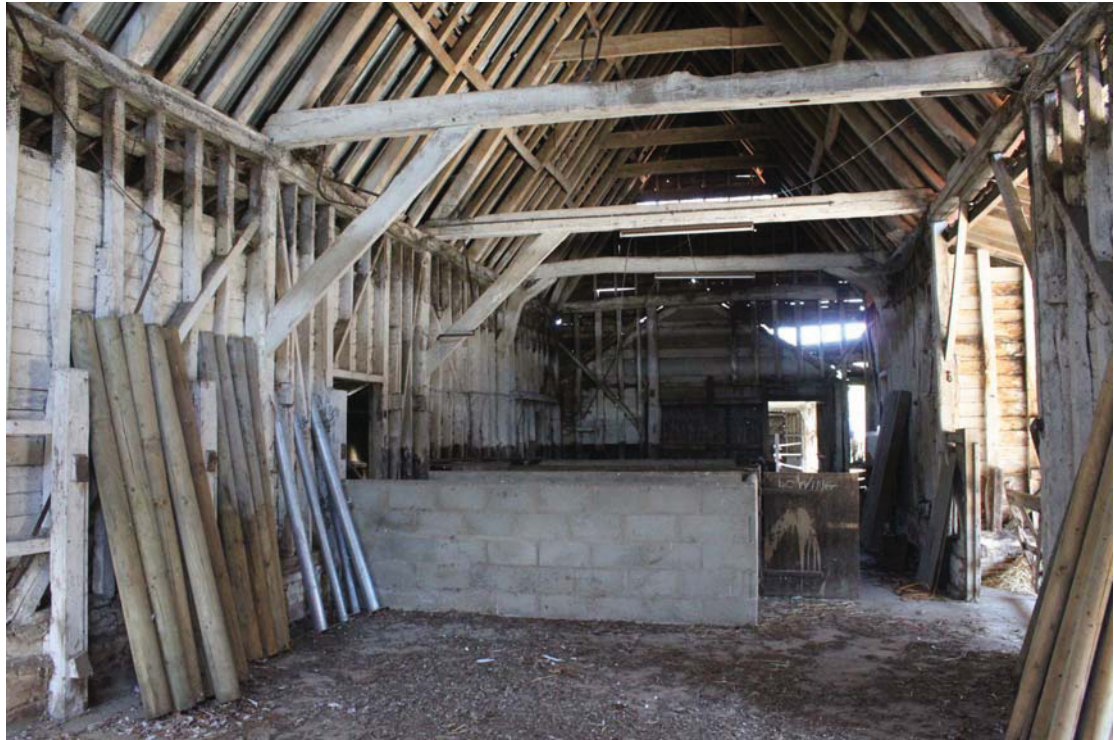
**Illus. 7. Interior of barn (1) from west showing southern entrance to right and arch-braces of threshing bay to left. Note the empty mortises in the tie-beams for the missing southern braces and the inserted cement-block loose boxes for pigs or calves.**

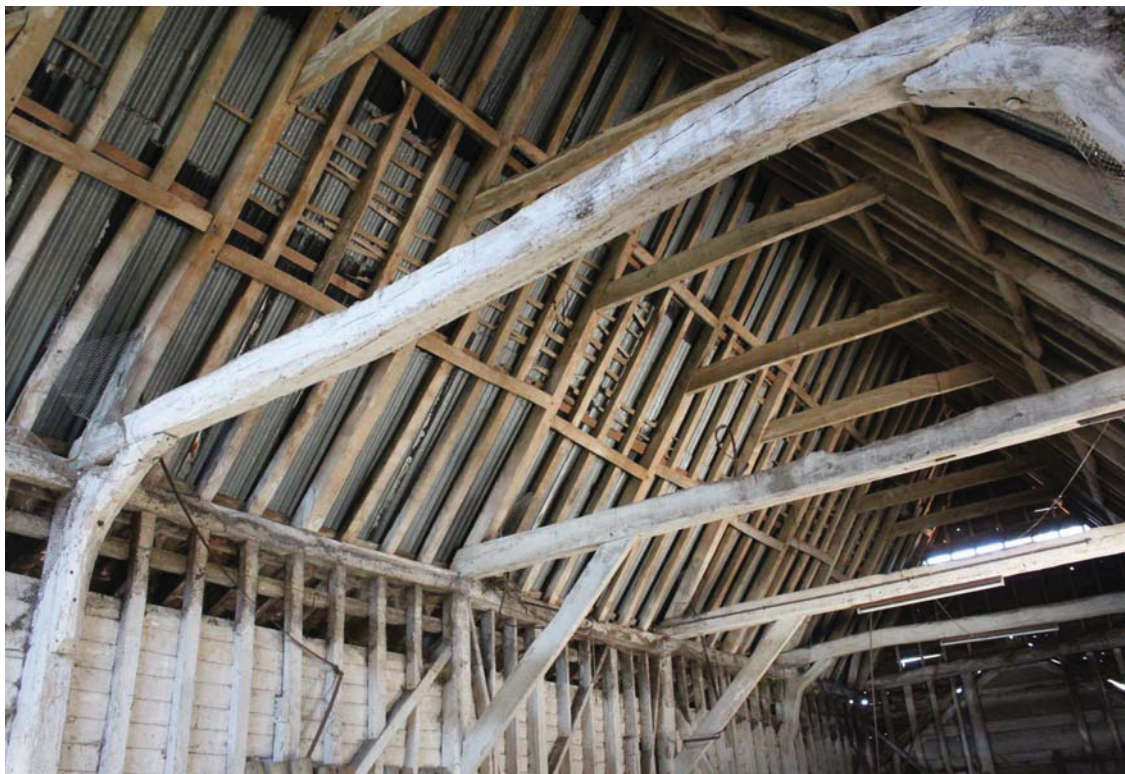
**Illus. 8. The intact and impressive staggered butt-purlin roof structure of the barn (1) seen from the south-west and showing the central arch-braces between the original knee-braces of the outer bays. Note the surviving thatch battens beneath the 20<sup>th</sup> century corrugated iron.**

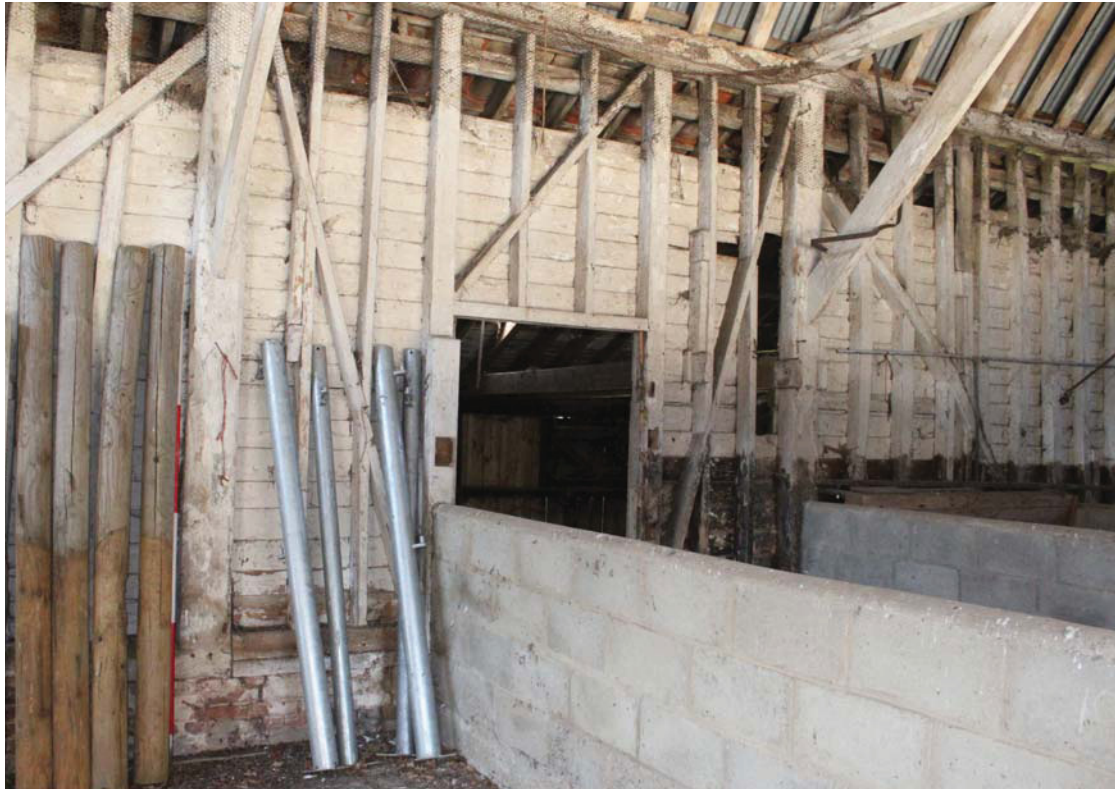
elevation represents a later alteration: the framing of the northern bay is of smaller scantling than elsewhere and is secured by a secondary wall-plate (beneath the roof-plate) having been inserted in the mid- or late-19<sup>th</sup> century. The brickwork of the plinth also differs from that elsewhere in the barn and the ground sills are interrupted. Opposing full-height doors are rare before the mid-19<sup>th</sup> century, when, ironically, smaller rear doors such as the existing northern example were the norm (designed to create a through-draught for winnowing but not as vehicle thoroughfares): it therefore seems likely that one of the openings originally abutted either a gabled or lean-to porch. The outline of a wide northern porch is shown on the Ordnance Survey of 1904 and its existing 20<sup>th</sup> century replacement preserves part of a gault (white) brick threshing floor adjoining the relevant central bay (threshing floors usually extended into porches in this way).

**Illus. 9. Central bay of northern internal elevation of barn (1) showing the narrow, secondary timbers of the late-19<sup>th</sup> century which block the original full-height doorway in this position (matching that to the south). The original ground sill to the left terminates at the storey post.**

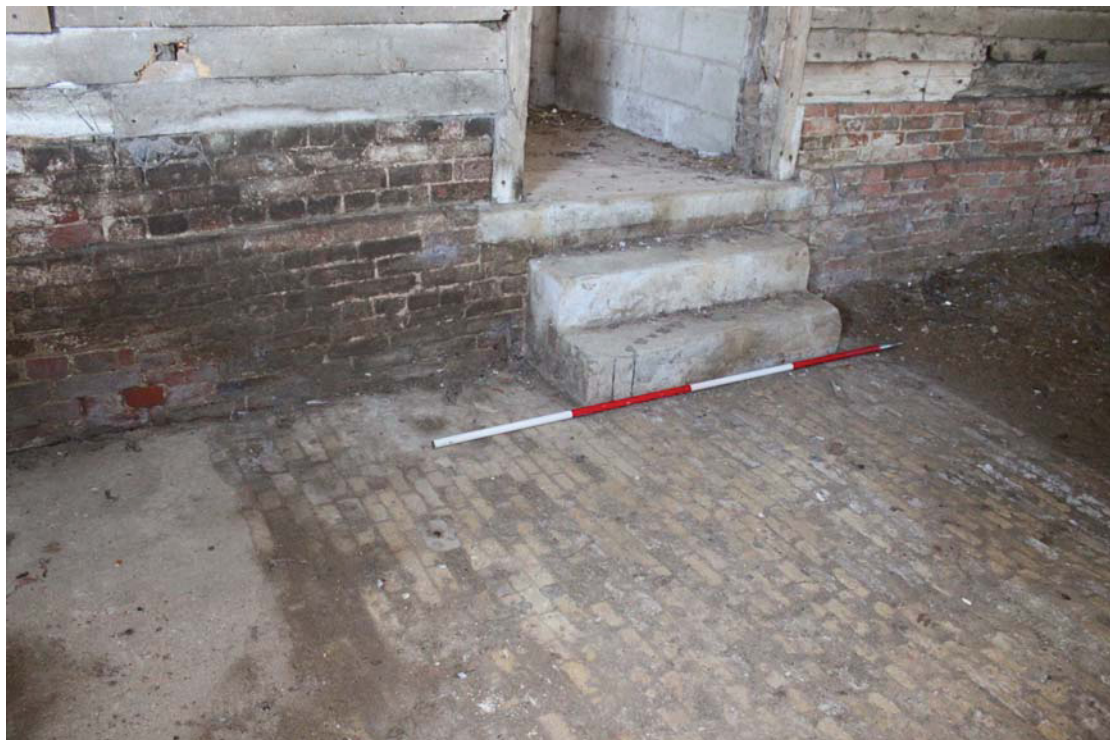
**Illus. 10. Detail from north of the brick threshing floor in the lean-to shed (2) with the secondary door in the barn's central bay to the rear.**
