**The Barn,  
Mount Pleasant Farm,  
Rendham,  
Suffolk  
RNM 019**

**Historic Building Record**

# **The Barn at Mount Pleasant Farm, Rendham, Suffolk**

## **Historic Building Record**

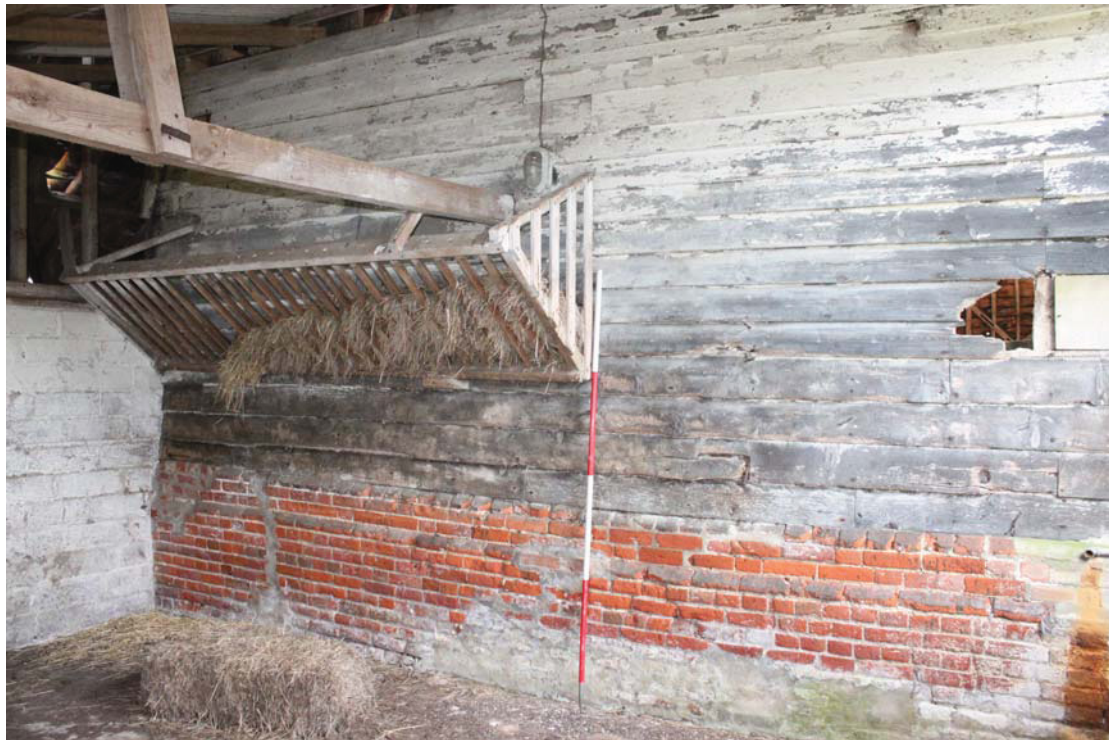
**Illus. 3. Eastern external gable of barn within the 20<sup>th</sup> century cement-block lean-to bullock shed, showing the hay rack and original grey pigment to the weatherboarding (beneath secondary whitewash).**

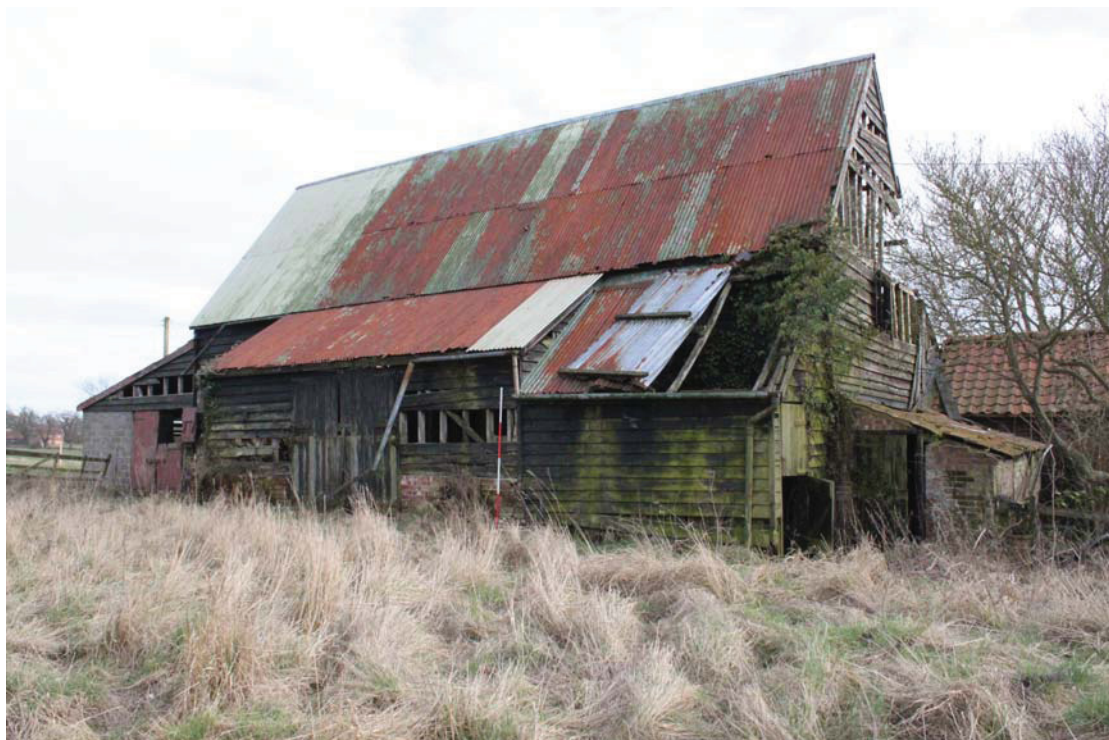
**Illus. 4. Exterior of barn from north-west showing the original central lean-to porch (1a) with secondary lean-to shed (12) to right. A similar shed to the left of the porch has been demolished. The lean-to pig sty (2) against the barn's western gable is visible to the right and the lean-to bullock shed (3) against the eastern gable to the left. The brick feed store is shown in the rear to the right.**

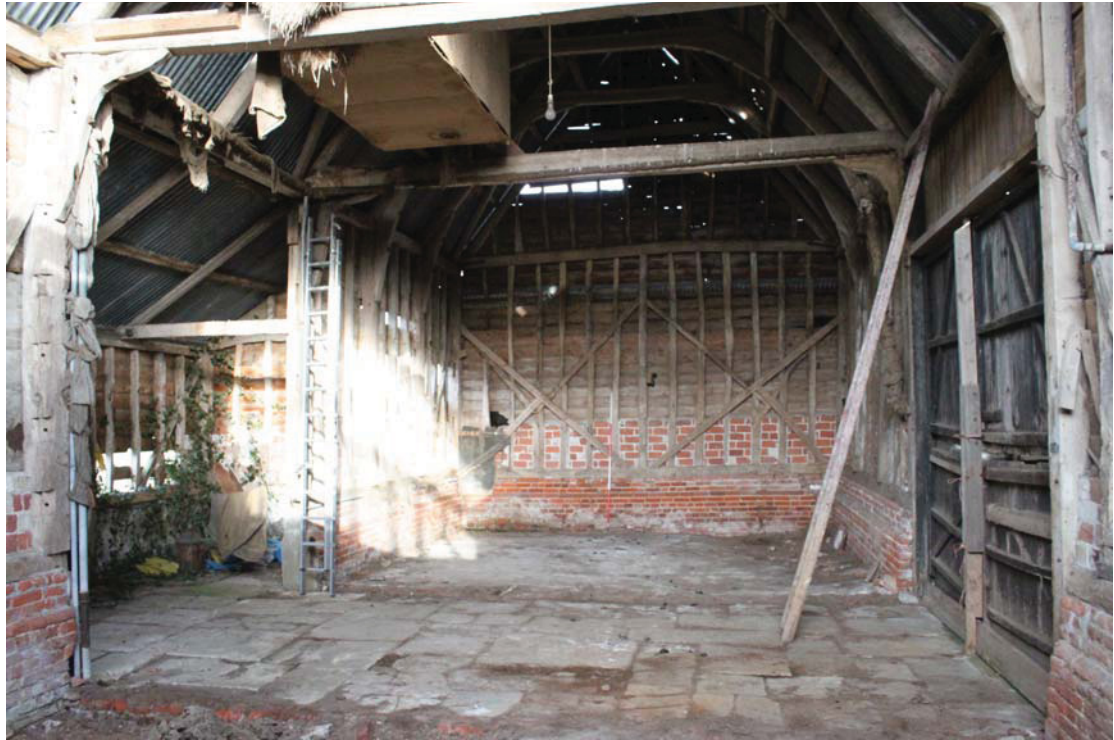
**Illus. 5. Interior of barn (1) from east showing central southern entrance to left and lean-to porch (1a) to right. The central bay is flanked by tie-beams with original bolted knee-braces. Note the floor of stone flags in the same bay (possibly a later hard-standing rather than a threshing floor) and the diagonal primary braces of the eastern gable in the rear.**

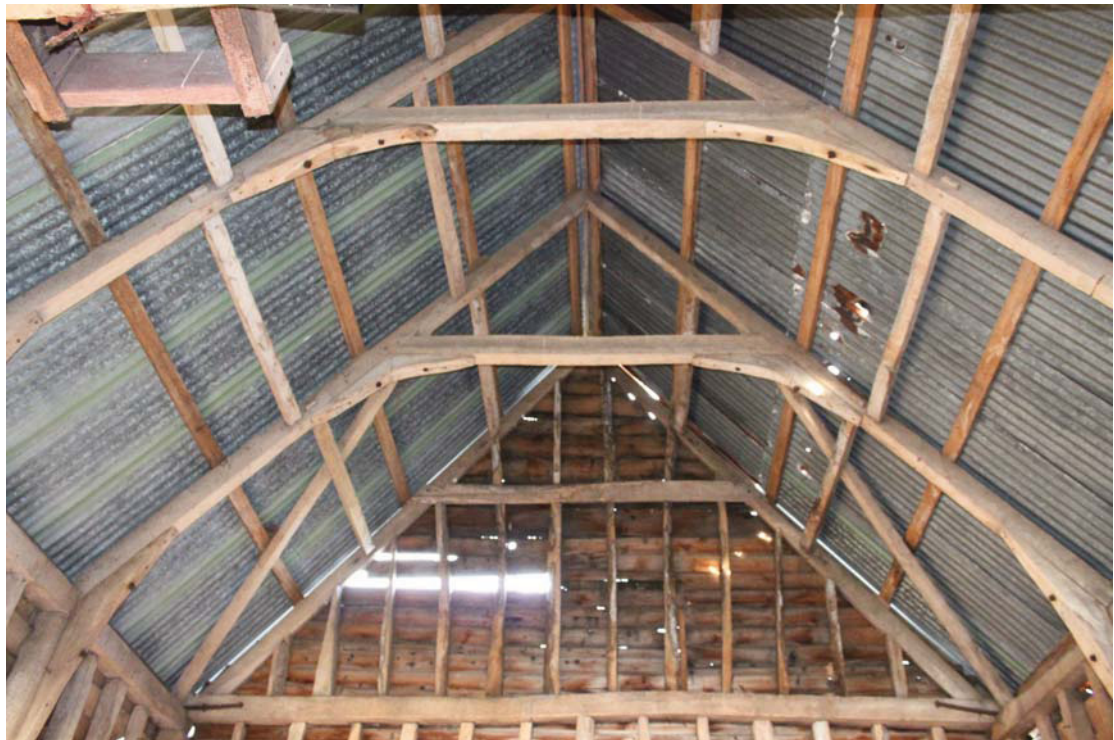
**Illus. 6. Eastern roof gable of barn (1) showing the A-framed roof trusses with bolted knee-braces found in both end-bays. Note the original staggered butt-purlins and the secondary rails of the corrugated iron which replaced the thatch.**

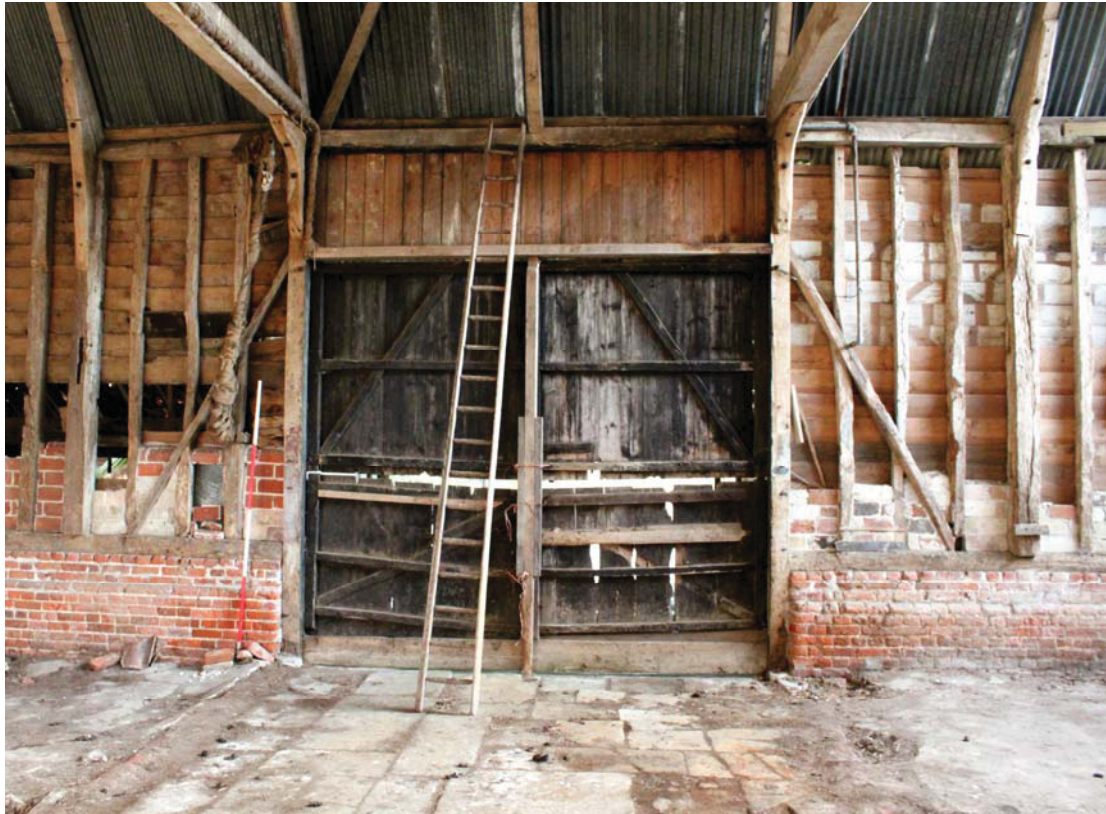
**Illus. 7. Interior of southern entrance doors in central bay of barn (1) showing the stone floor and double-hung doors with retaining board. The original doors rose to the roof-plate, as indicated by mortises for door jambs in the roof-plate.**

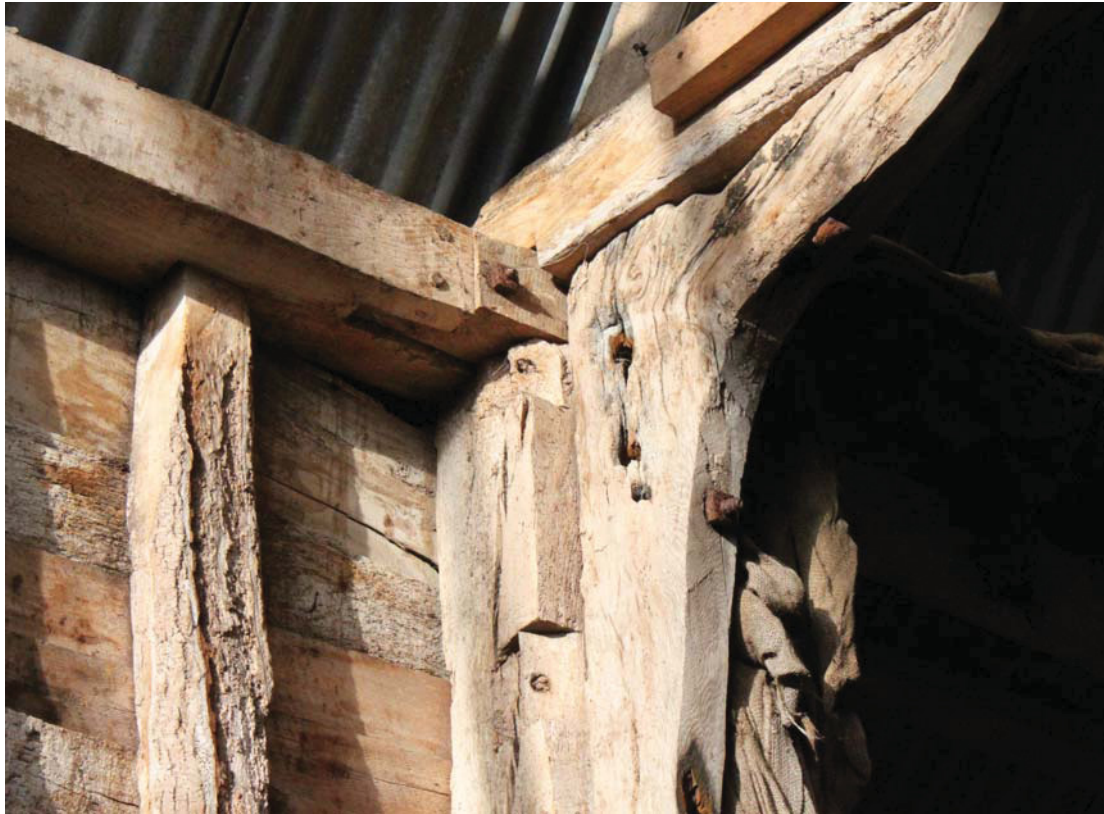
**Illus. 9. Detail of face-halved and bladed scarf joint of northern roof-plate behind knee-brace to west of central bay. Rafter housings are visible in the re-used storey post (originally a roof-plate).**
