**The Barn,  
Bendalls Farm,  
Mendlesham, Suffolk**  
MDS 155

**Historic Building Record**

# The Barn, Bendalls Farm, Hobbies Lane, Mendlesham, Suffolk

## Historic Building Record

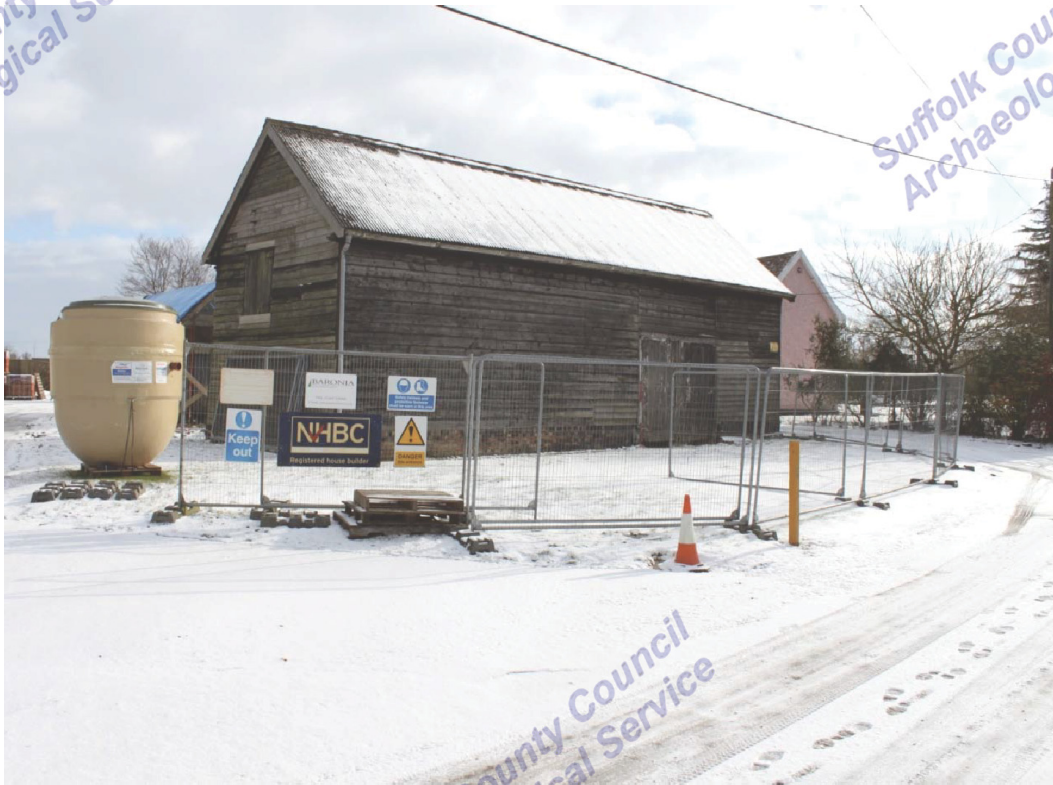
Illus. 1. General view of site from Hobbies Lane to north-west showing roadside barn with site entrances to left & right and western gable of farmhouse in rear

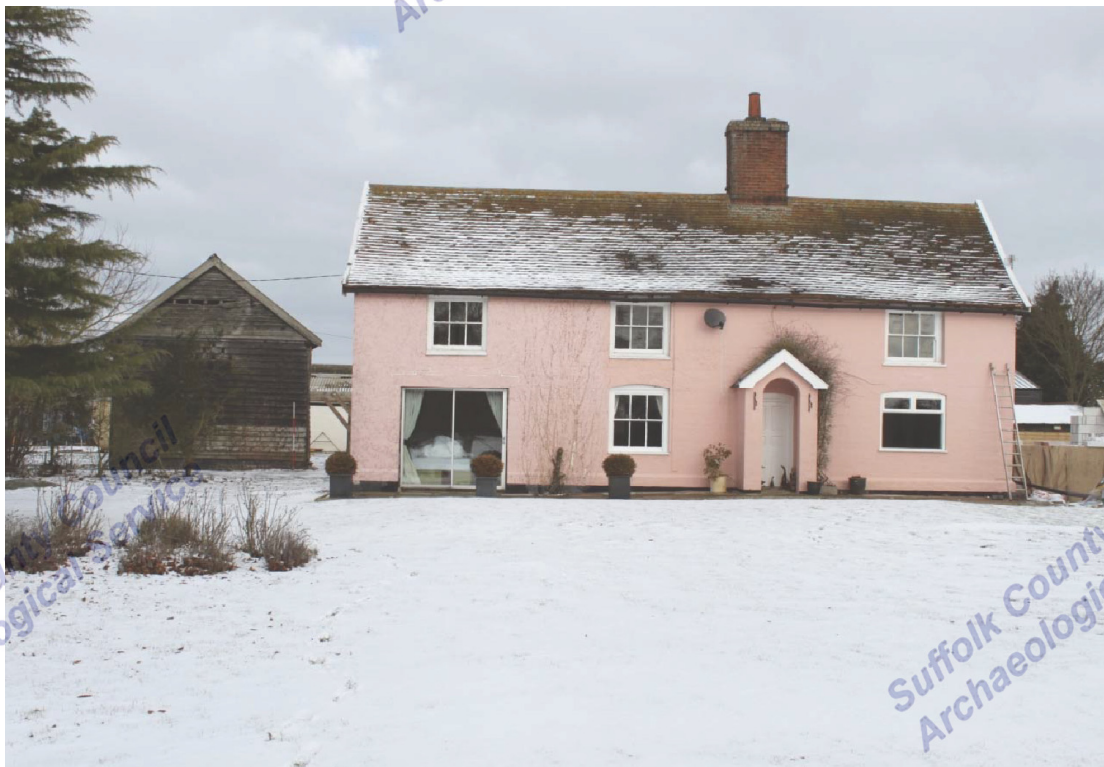
Illus. 2. Southern elevation of farmhouse showing gable of barn to left.

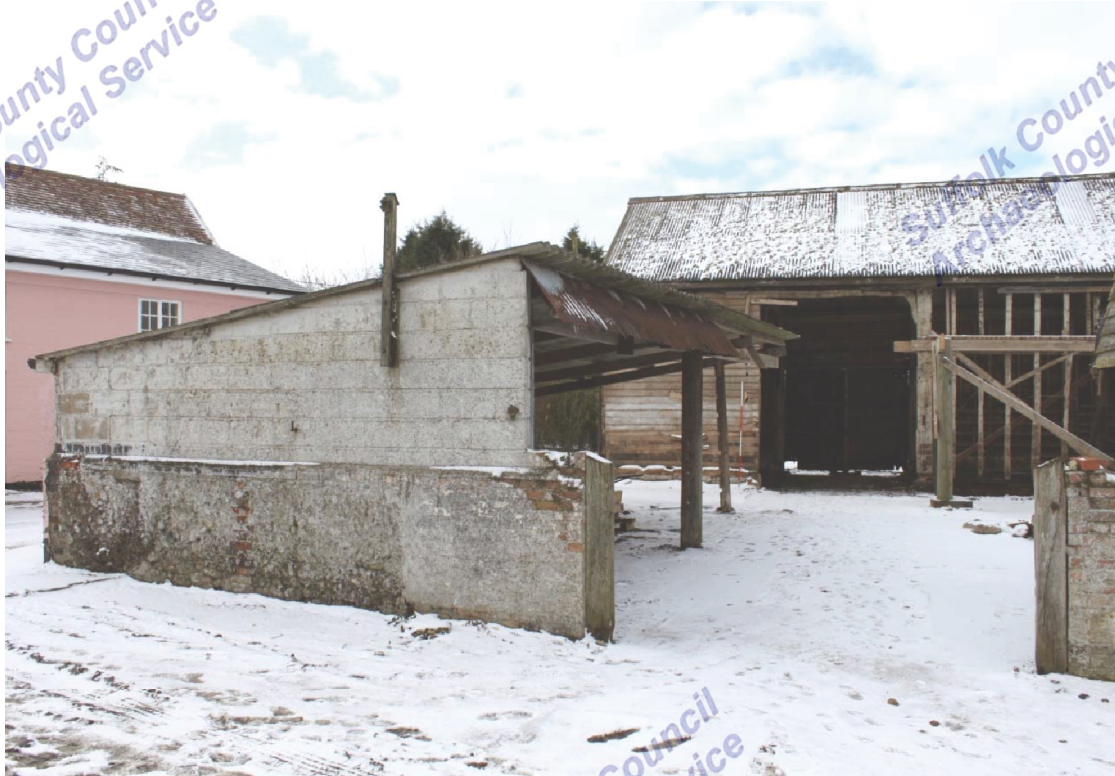
Illus. 3. Eastern yard entrance showing farmhouse & 20<sup>th</sup> century block-work shelter shed (4) to left with eastern exterior of barn in rear.

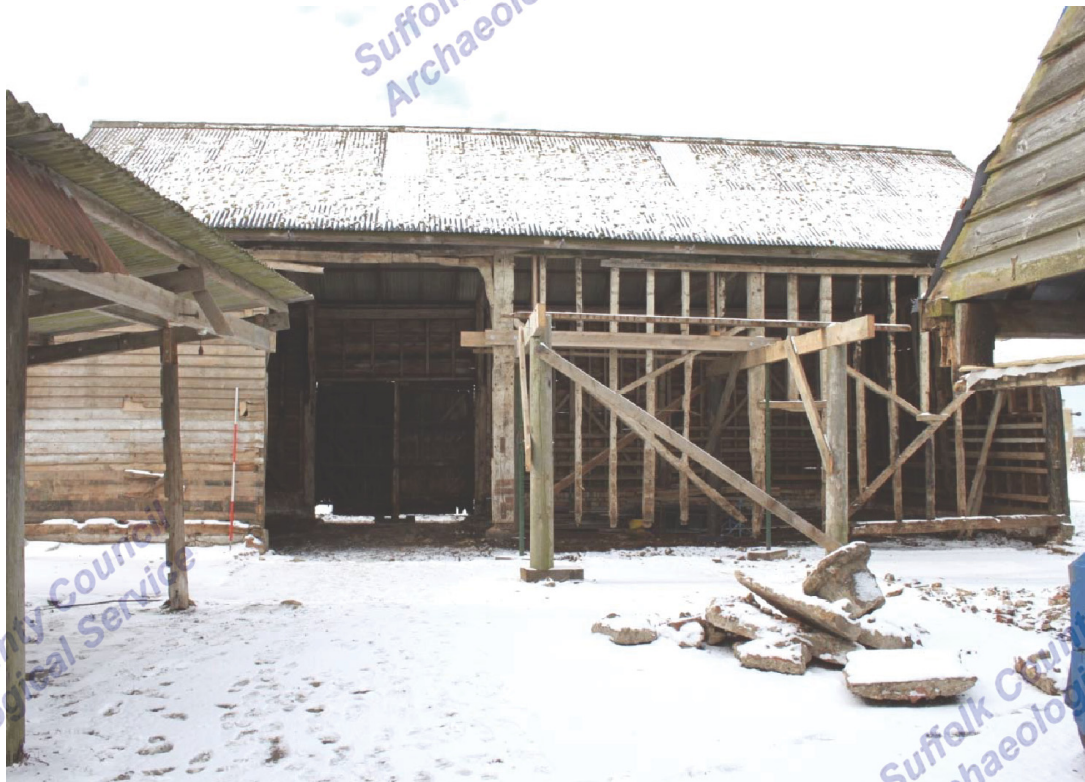
Illus. 4. Eastern exterior of barn with site of demolished lean-to (2) in foreground and sheds 3 & 4 to right and left respectively.

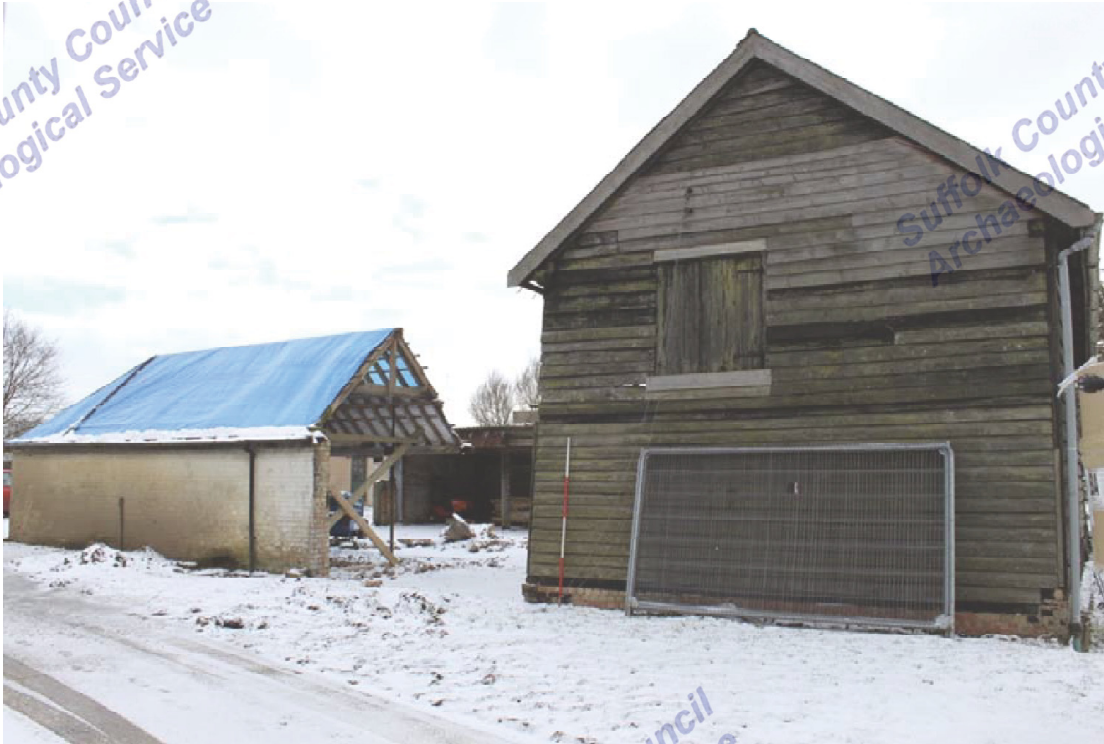
Illus. 5. Northern external gable of barn showing left loading door with brick shed (3) to left.

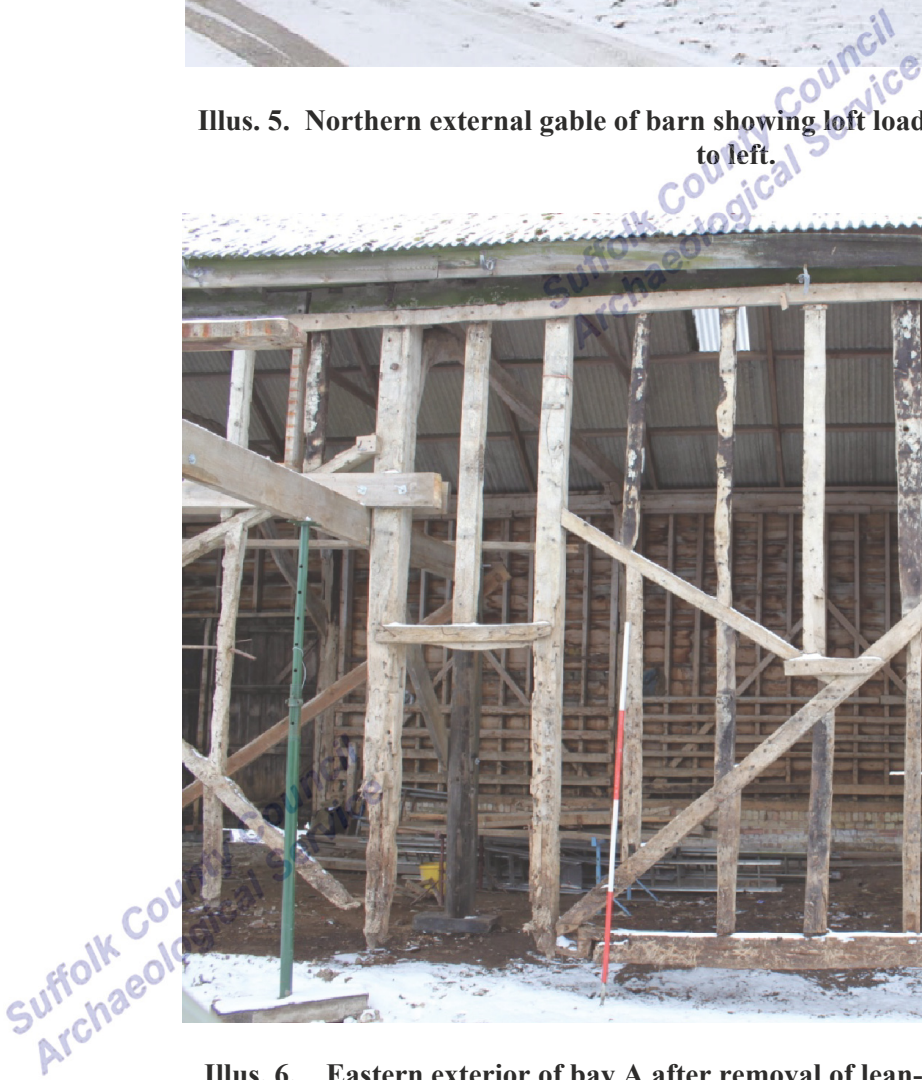
Illus. 6. Eastern exterior of bay A after removal of lean-to shed (2) showing original framing with re-used timber and stable door with raised lintel to left.

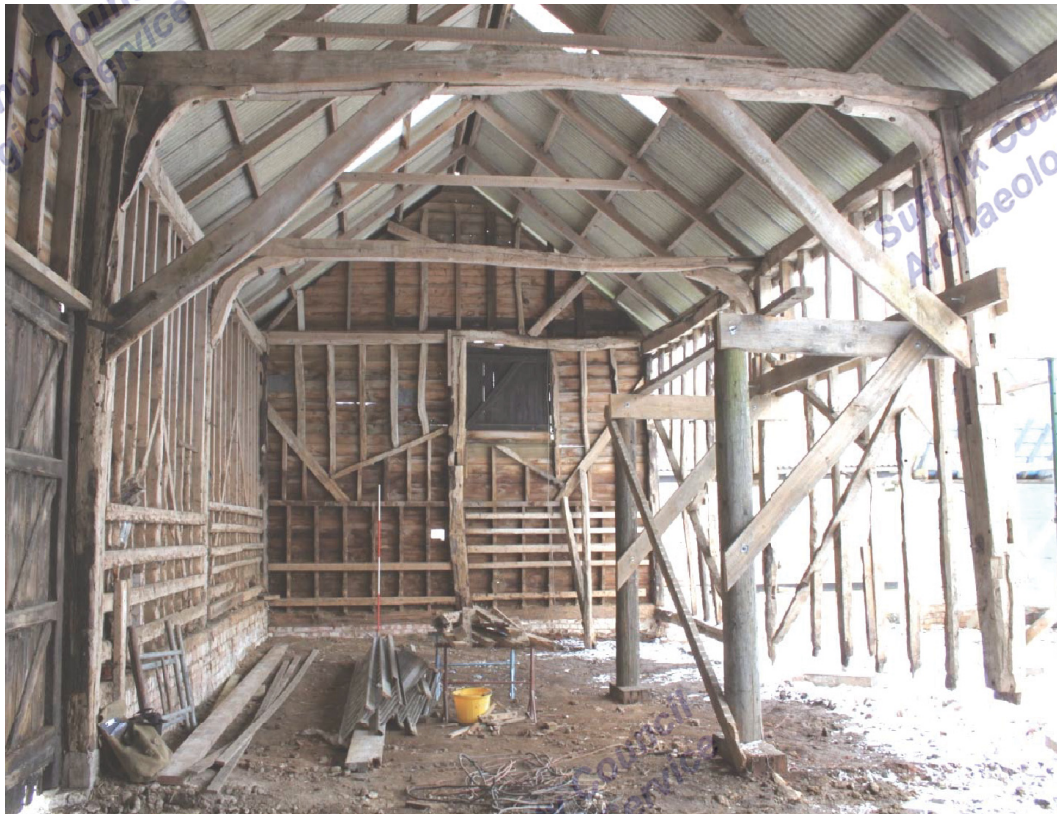
**Illus. 7.** General view of barn interior from south showing entrance bay C in foreground and the unusual combination of tenoned arch-braces and bolted knee-braces to its open trusses.

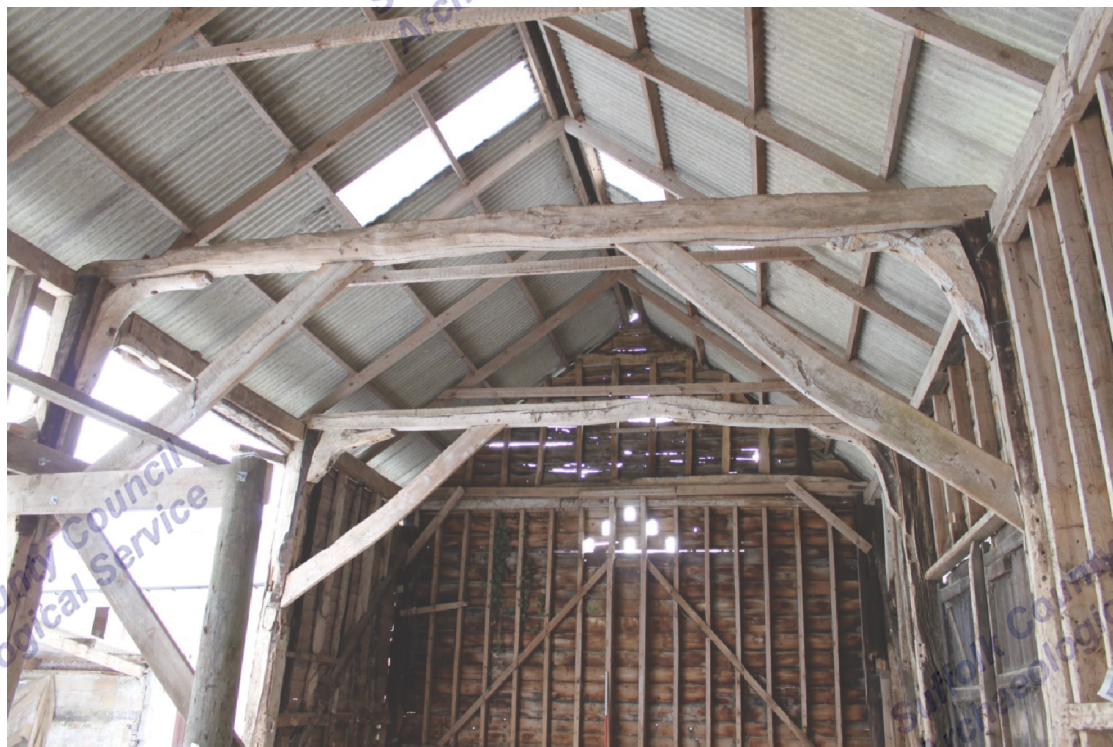
**Illus. 8.** Bolted knee-braces and reverse-cranked arch-braces of entrance bay C seen from north with 20<sup>th</sup> century roof and rebuilt southern gable in rear

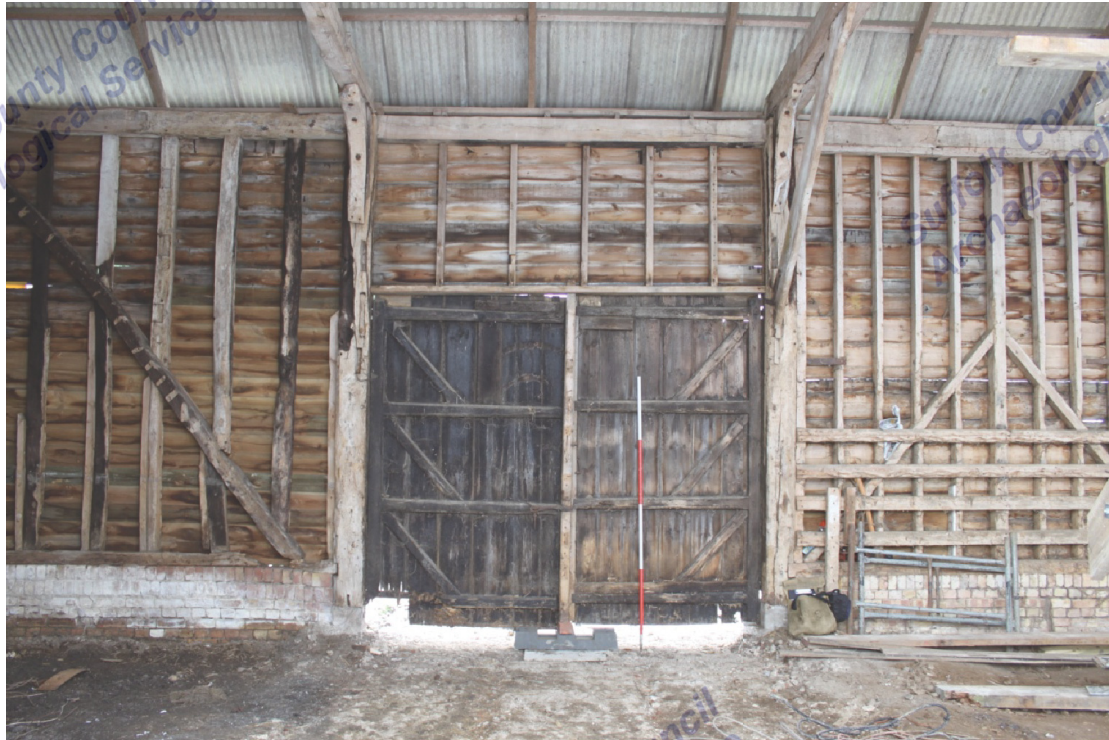
**Illus. 9.** Western interior of entrance bay C showing the reduced height of the entrance doors with original framing in bay D to left (with unusual re-used burnt timber) and rebuilt framing of the late-19<sup>th</sup> or early-20<sup>th</sup> century in bay B to right.

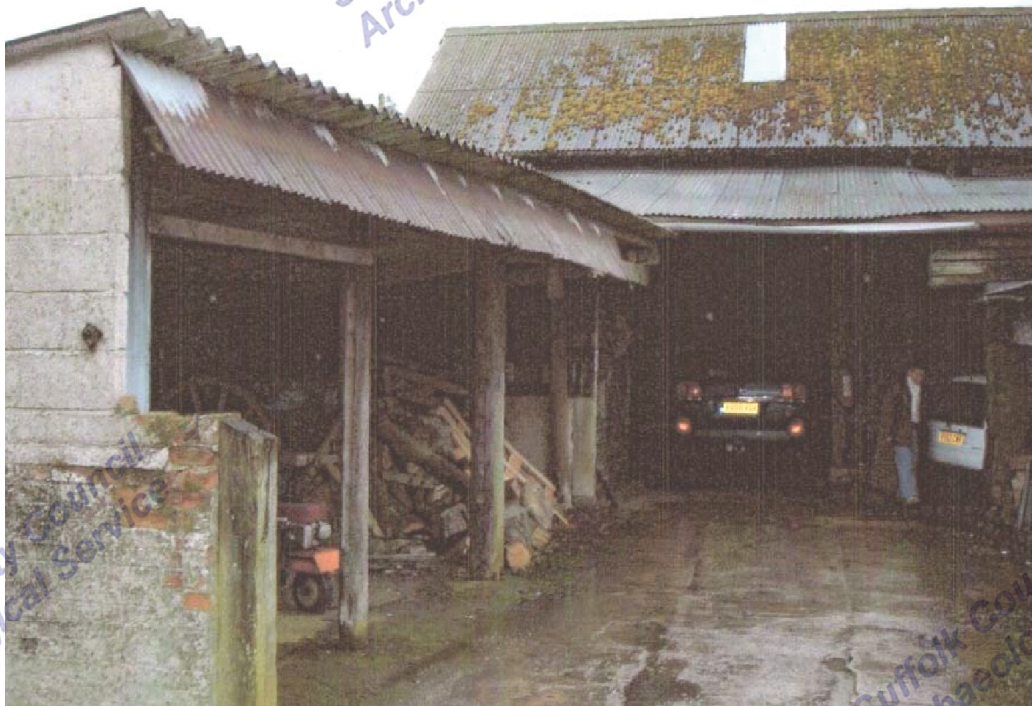
**Illus. 10.** Circa 2008. Eastern exterior of barn showing lean-to shed (2) with shelter shed (4) to left before demolition work began.
