**Street Farm,
Gislingham,
Suffolk**
GSG 036

Historic Building Record

Street Farm, Mill Street, Gislingham, Suffolk

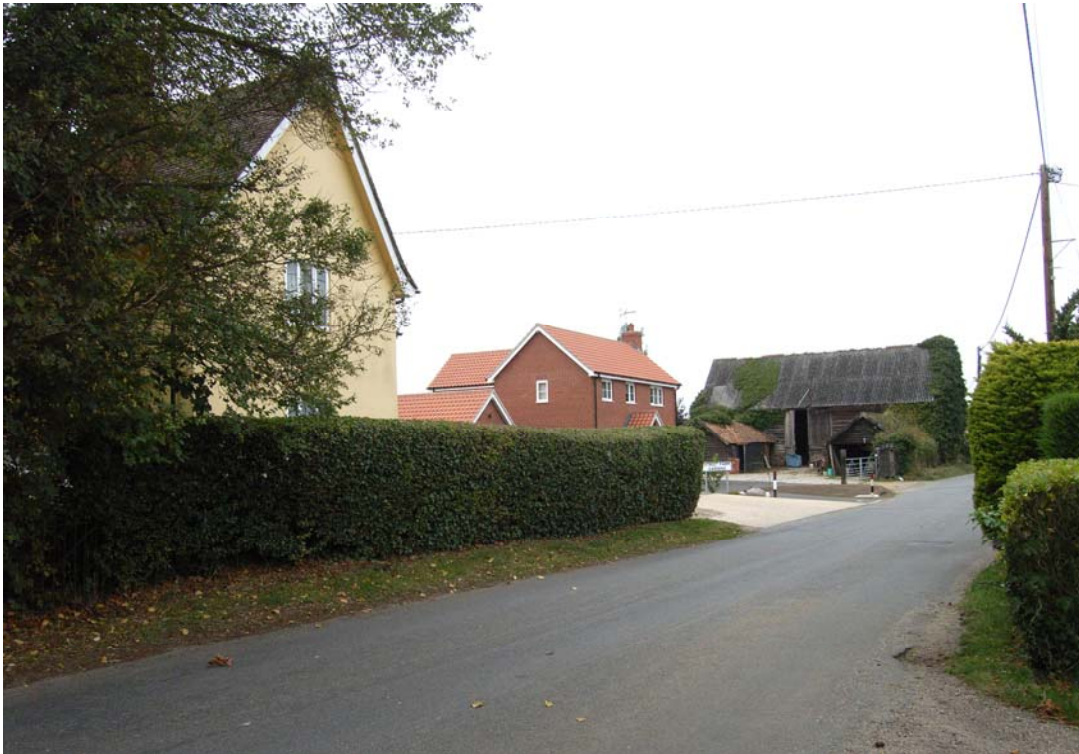
Illus. 1. General view of site from Mill Street to east showing the barn to right with the much restored grade II-listed former farmhouse now known as 'Mary Rose' to left. 'Hensyl House' is a new built red brick structure on the site of a former cattle yard between the two.

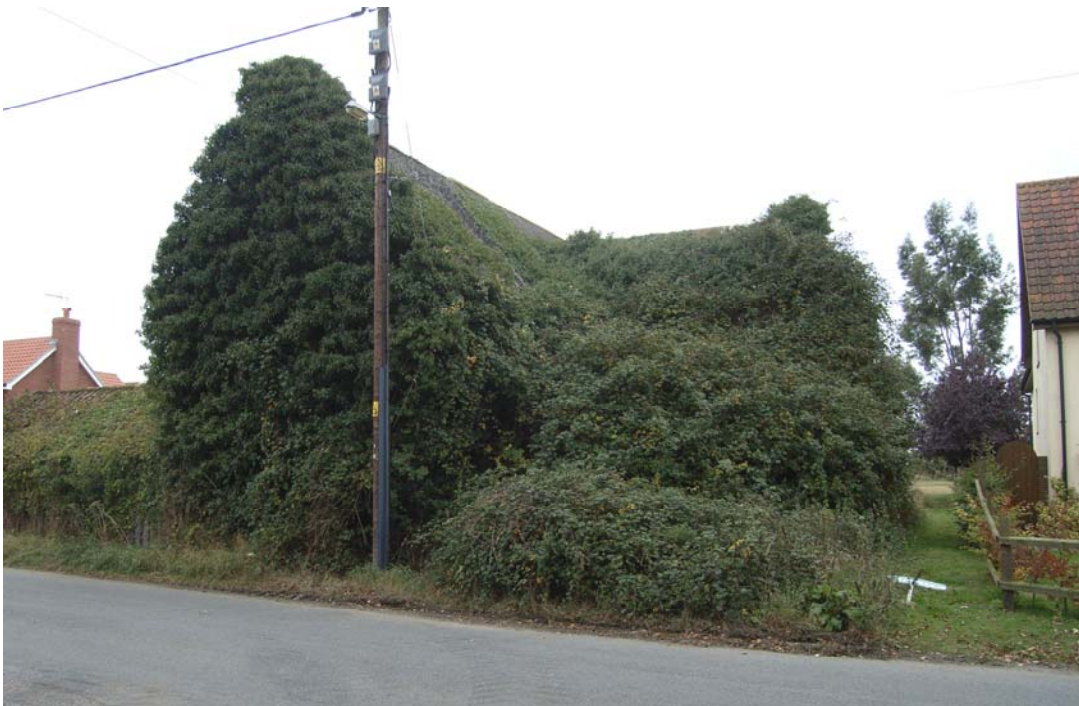
Illus. 2. Exterior from Mill Street to north showing the overgrown porch and lean-to shed (1a and 2) to the right. 'Hector's House' is shown in close proximity to the extreme right.

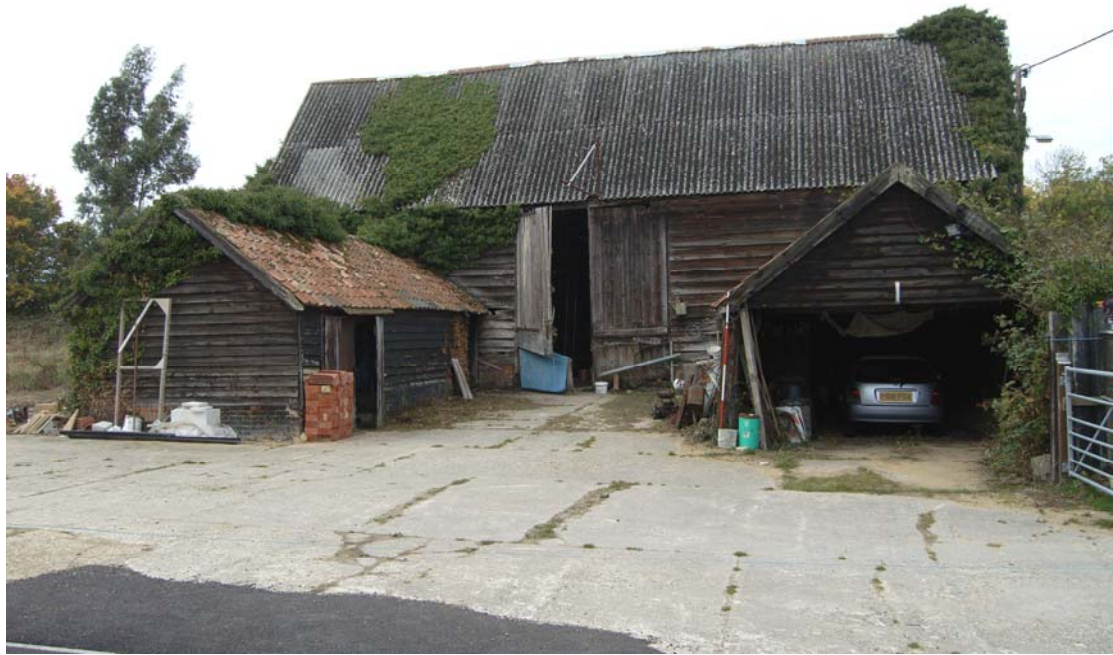
Illus. 3. Exterior of barn from east showing late-19th century single-storied sheds 3 and 4 to left and right respectively.

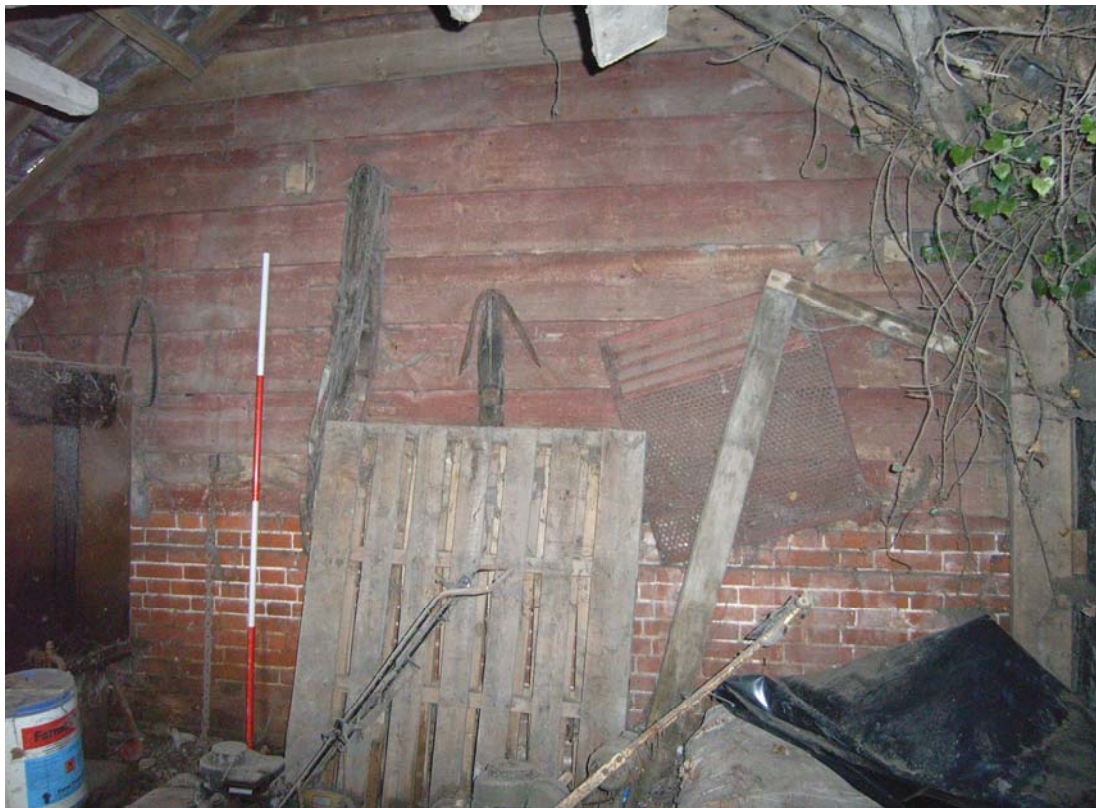
The external weatherboarding preserves unusually extensive areas of original red ochre pigment within the various attached sheds, although many individual boards have been renewed. Until the advent of tar as a cheap by-product of town gas production in the mid-19th century many local barns were painted in this way, and Red Barns are common in the documentary record (e.g. Maria Marten's famous murder in the Red Barn at Polstead in 1827). The northern yard shed (4 in figure 5) preserves the most complete section, perhaps as it partly replaced the earlier porch or shed shown in 1840. A good threshing floor of gault brick survives in the central bay, but a ceiling in the southern bay has been lost. This ceiling appears to have been a secondary feature as its axial joist was supported by a nailed bracket on the central post of the gable and the remains of its internal partition rail are crudely nailed to the storey posts. The space almost certainly formed a stable with a hay loft above, and was entered by a secondary door at the southern end of the eastern elevation. Many local barns were provided with stables in this manner, and the interpretation is confirmed by the presence of an adjoining yard and shelter shed on the tithe map and first edition Ordnance Survey. A grain floor in the porch is a 20th century addition.

Illus. 4. Eastern exterior of barn exposed within northern shed (4) showing the extensive and apparently original red ochre to the weatherboarding.

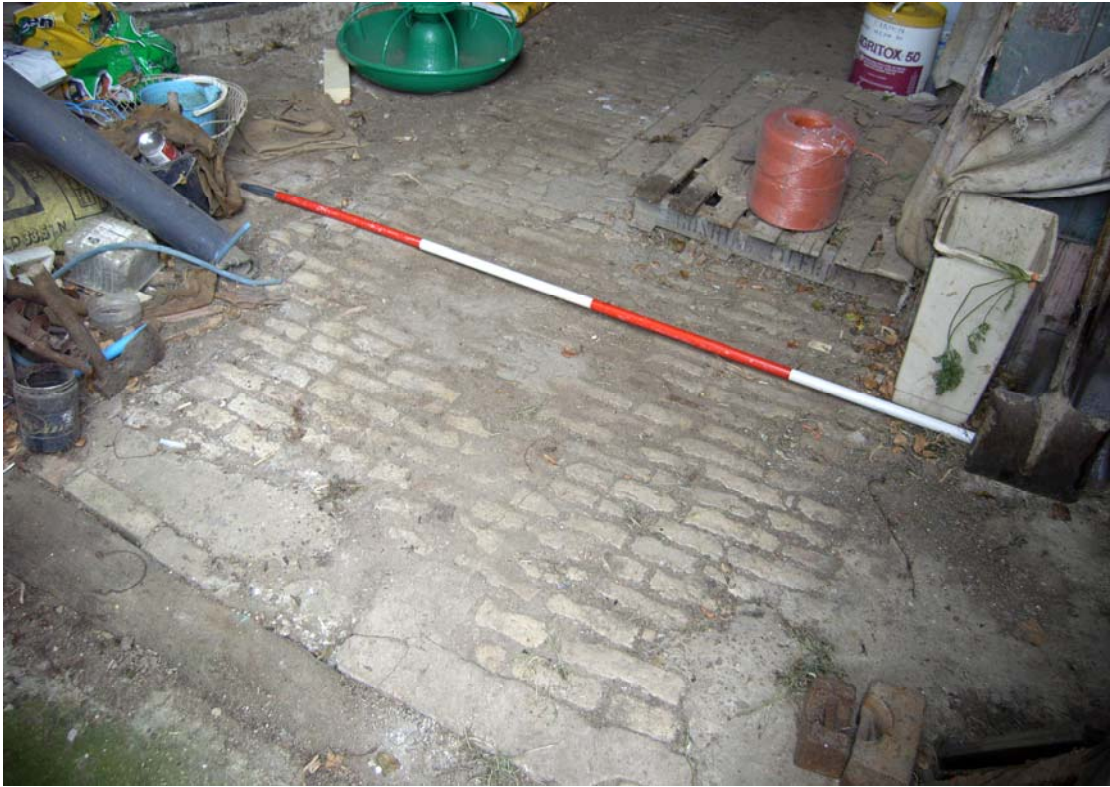
Illus. 5. Detail of gault brick threshing floor in central bay of barn seen from eastern entrance.

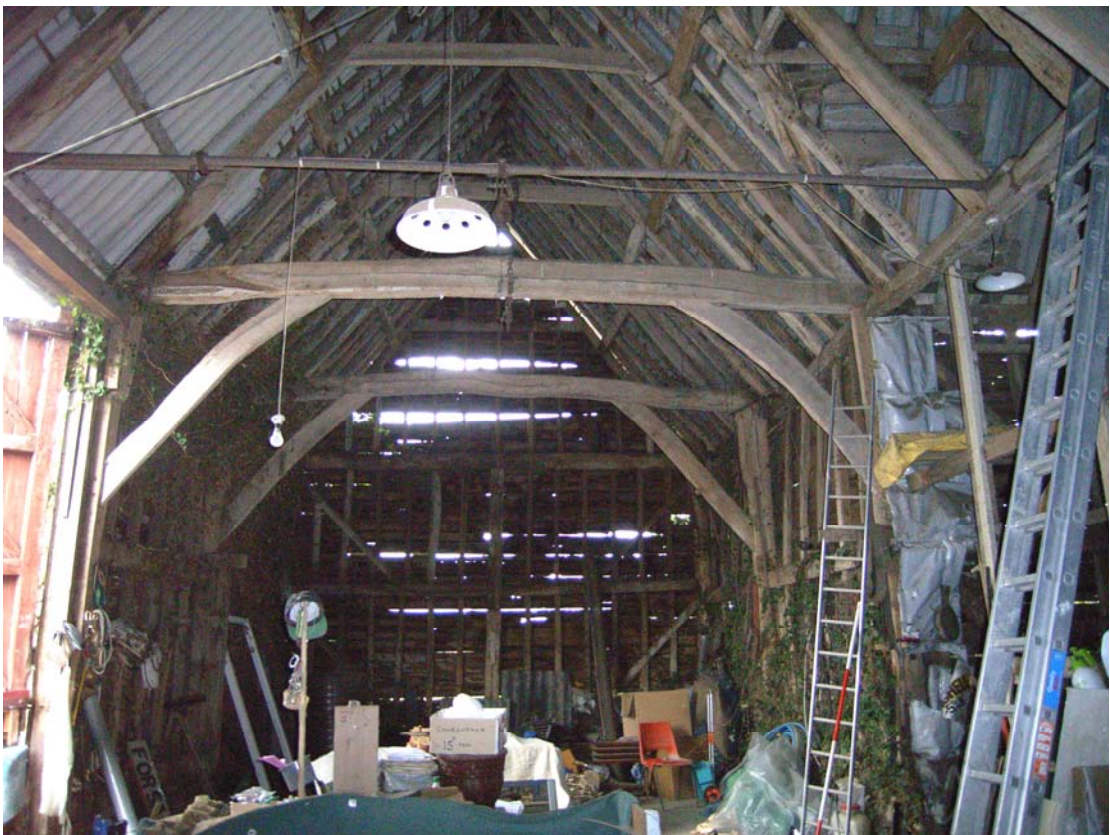
Illus. 6. General view of barn interior from north showing eastern entrance in central bay to left and intact arch-braces to tie-beams.

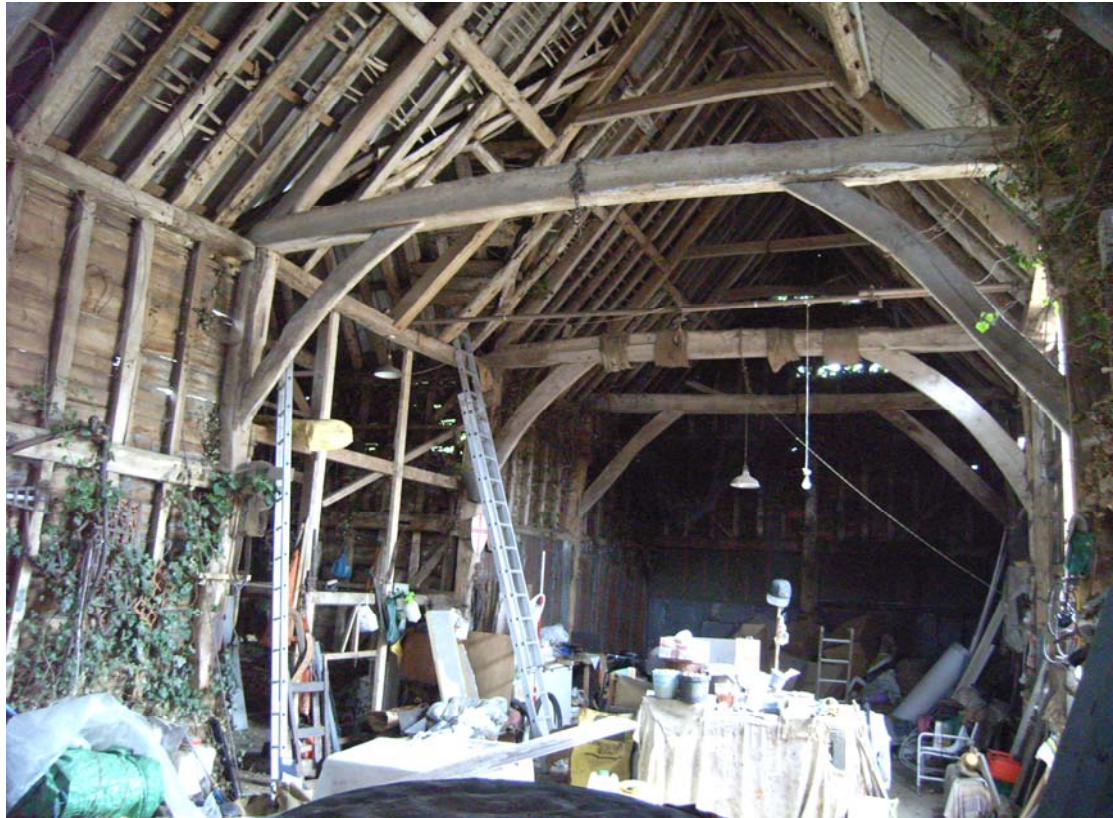
Illus. 7. Interior of barn from south showing central porch (1a) to left.

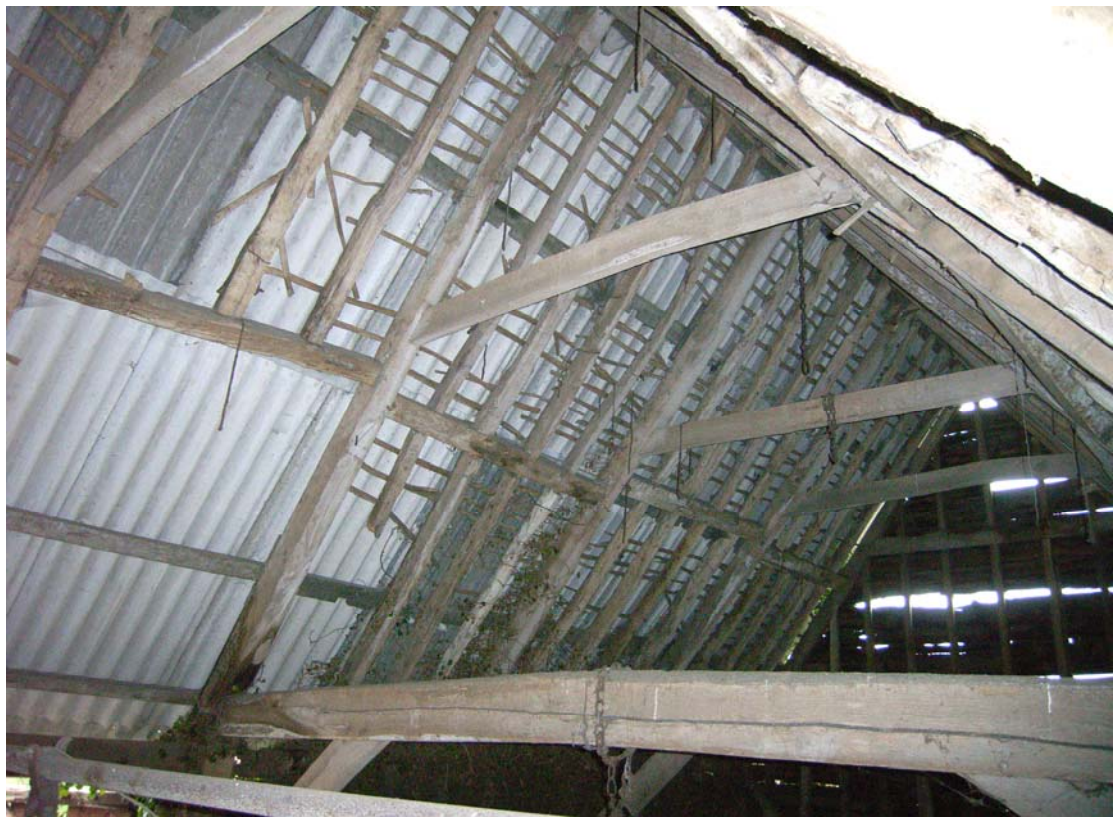
The roof contains a single tier of staggered butt-purlins with pegged and tenoned collars (also re-using numerous timbers) and the jowled storey posts are arch-braced to the tie-beams. The porch is a clasped-purlin structure with an arch-braced central tie-beam. At approximately 55 degrees the roof was designed for thatch, and retains many thatch battens beneath its present covering of corrugated asbestos. A gap in the rafters immediately above the eastern entrance probably indicates the point at which the roof abutted that of the additional porch (whether gabled or lean-to) shown on the tithe map of 1840.

Illus. 8. Original roof structure of staggered butt-purlins seen from north-west, showing thatch battens and gap above eastern entrance to left which may relate to the additional porch shown on the title map.

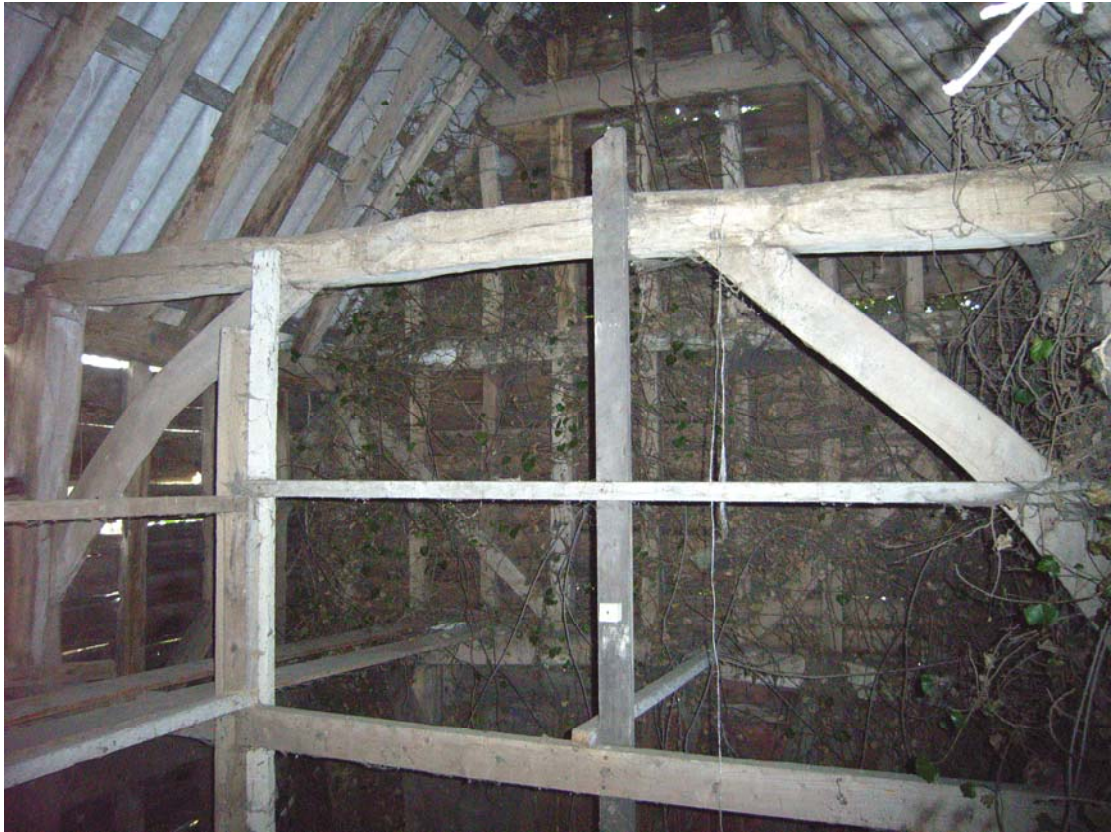
Illus. 9. Central open truss of two-bay porch (1a) seen from east.

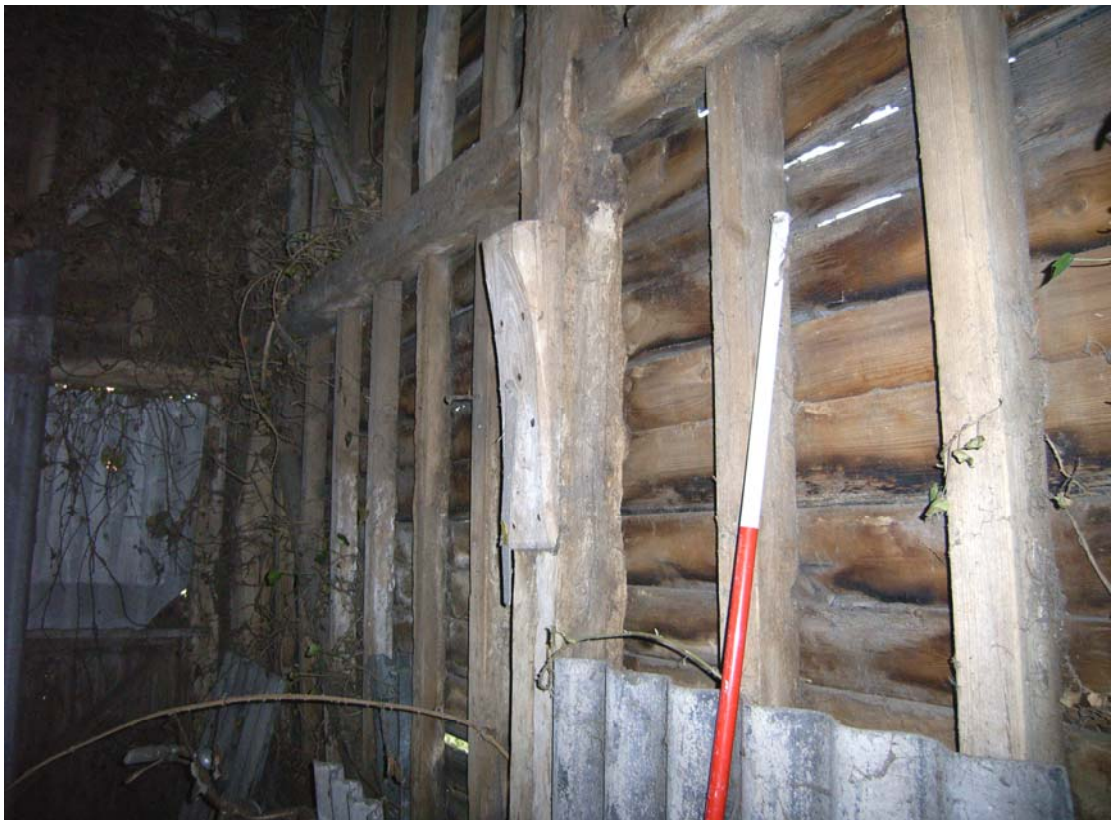
Illus. 10. Detail from west of nailed bracket on central post of southern gable for axial joist of removed stable ceiling, showing secondary stable door in eastern elevation to left.
