**Agricultural Buildings,
Abbey Farm,
Culpho, Suffolk
CUP 027**

Historic Building Record

This report provides a written and photographic record at English Heritage (2006) Level 2 of a complex of redundant agricultural buildings in the curtilage of a grade II-listed farmhouse. It has been prepared to a brief written by Suffolk County Council's Archaeological Service (ref. SpecHBR&Mon(EM)AbbeyFarm_Culpho_0191_09, Edward Martin, 26th October 2009), and is intended to fulfil a condition of planning permission for conversion (Suffolk Coastal District Council application C/07/0191/FUL, condition 9).

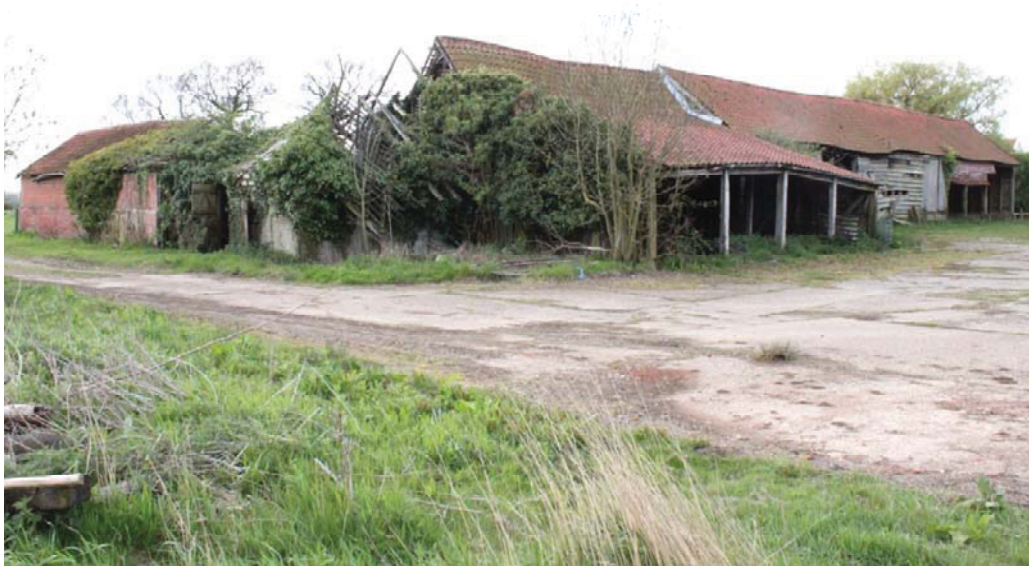
Illus. 3. Exterior of farm complex from north-east showing the partly collapsed early-19th century granary and stable range (4 & 5) to the left of the barn. Its steeply-pitched roof structure was probably designed for thatch and is the earliest to survive on the site.

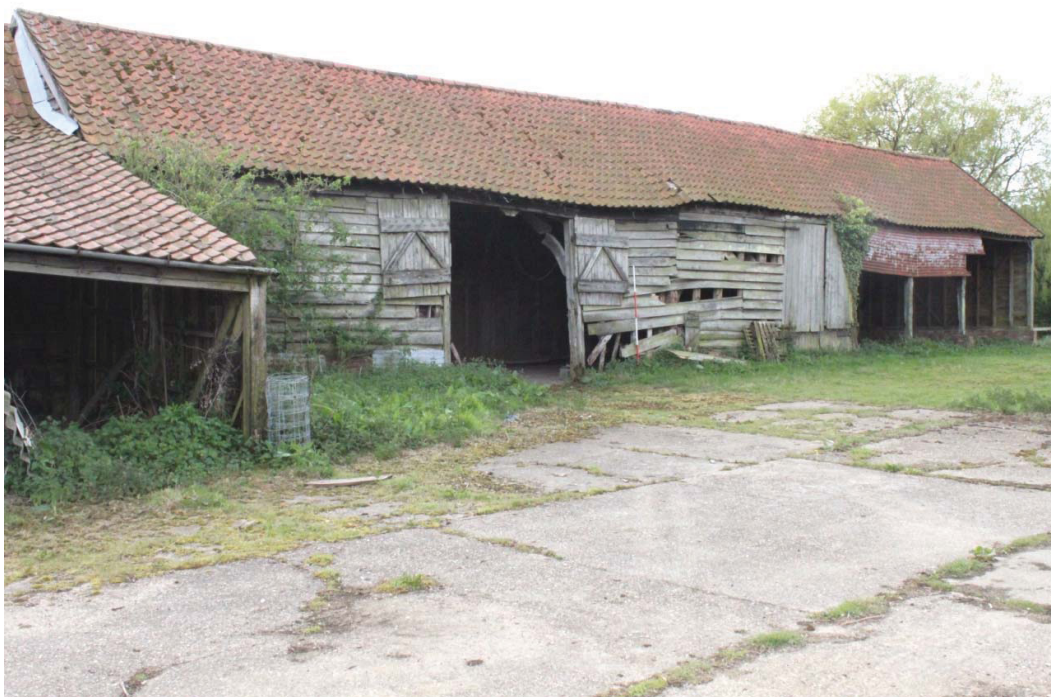
Illus. 4. Northern exterior of multi-phase barn with two entrance bays showing early-19th century bays to left (3) with early-17th century structures to right (1 & 2). The western bays have been converted into an open-sided vehicle shelter. The shallow-pitched pantiled roof is a later 19th century addition.

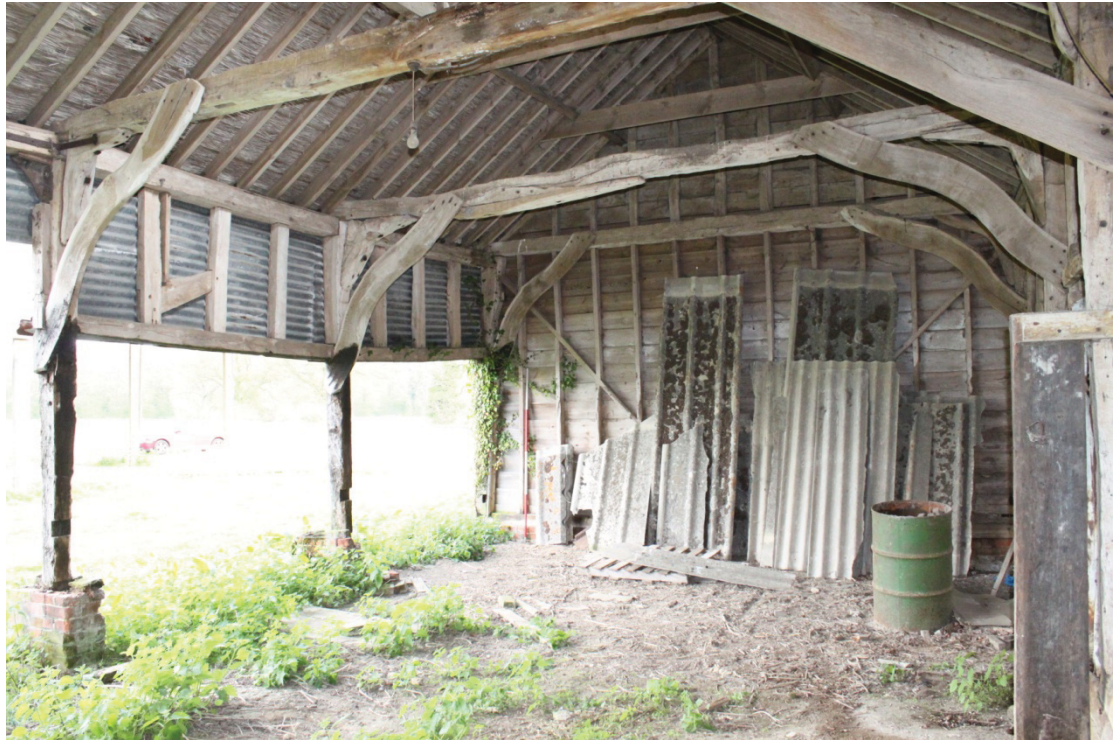
Illus. 5. Interior of the 17th century 3-bay barn (2a) from the west showing the later curved tie-beam braces and the empty mortises of the original western gable in the foreground. The 17th century studs and wall brace to the left were truncated in the 20th century to form a vehicle shed.

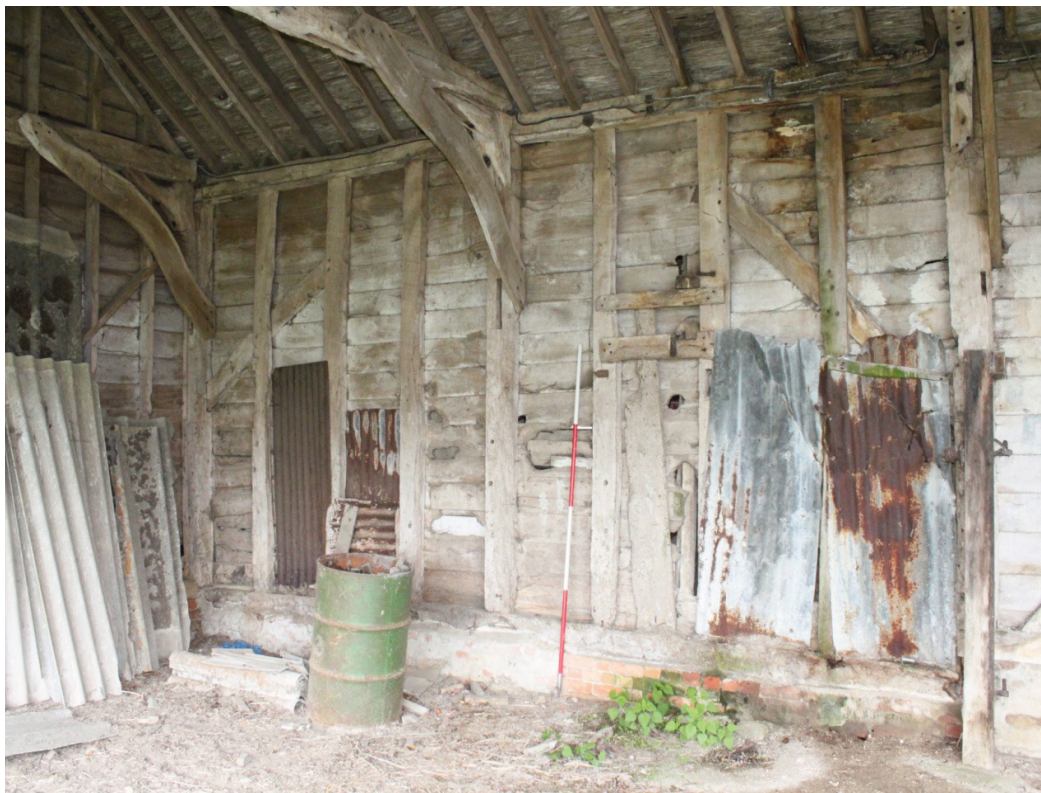
Illus. 6. Internal southern elevation of 17th century barn (2a) showing its externally trenched tension braces with the position of the original western gable to right.

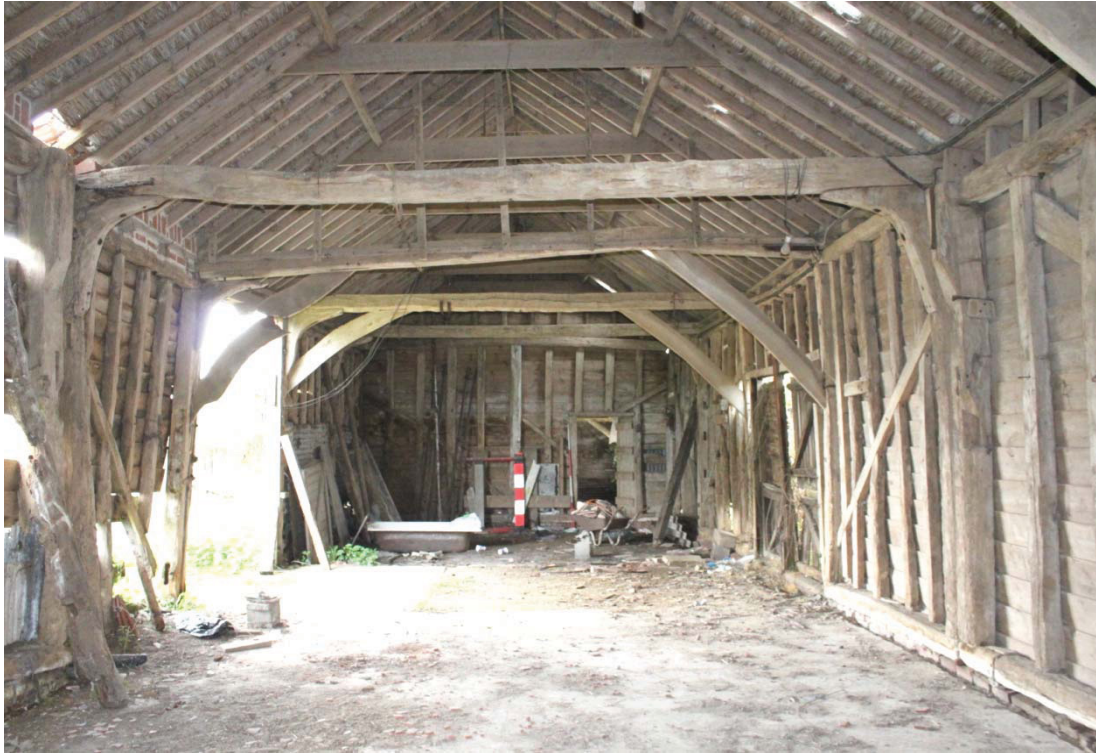
Illus. 7. Interior of main barn from 17th century bays (2b & 1) to west showing original arch-braces to threshing floor of 19th century barn (3) to right and later replacements to left. An original brick threshing floor survives between the two doors.

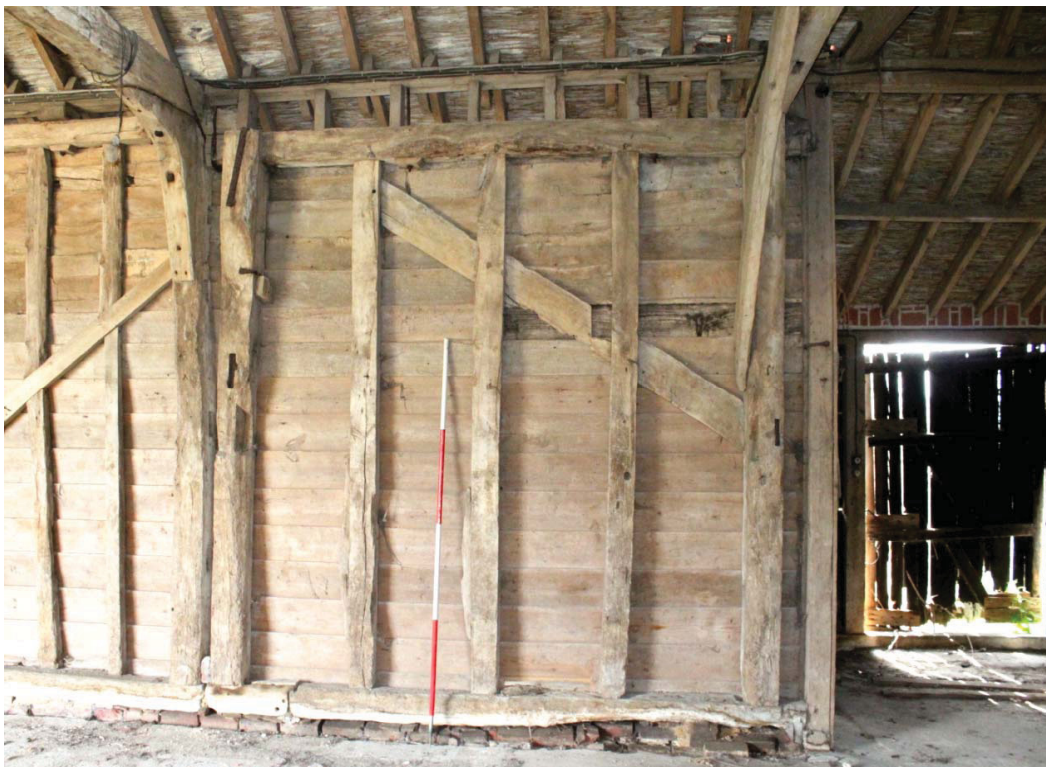
Illus. 8. Southern interior of single 17th century bay (1) showing 19th century bay to left (3) and rebuilt entrance bay with lean-to porch of 3-bay barn (2b) right. Note the externally trenched 17th century brace to the right and the primary brace interrupting the studs to the left.

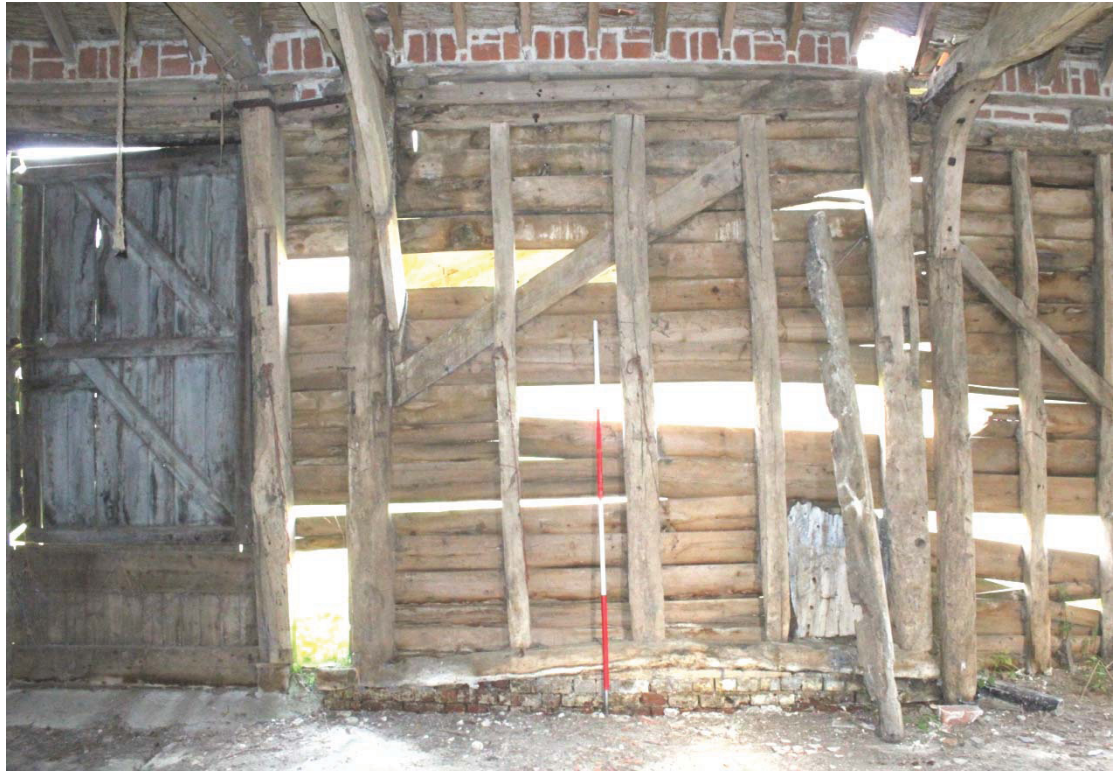
Illus. 9. Northern interior of single 17th century bay (1) showing stud mortises in tie-beam to left with entrance bay of 3-bay barn (2b) beyond.

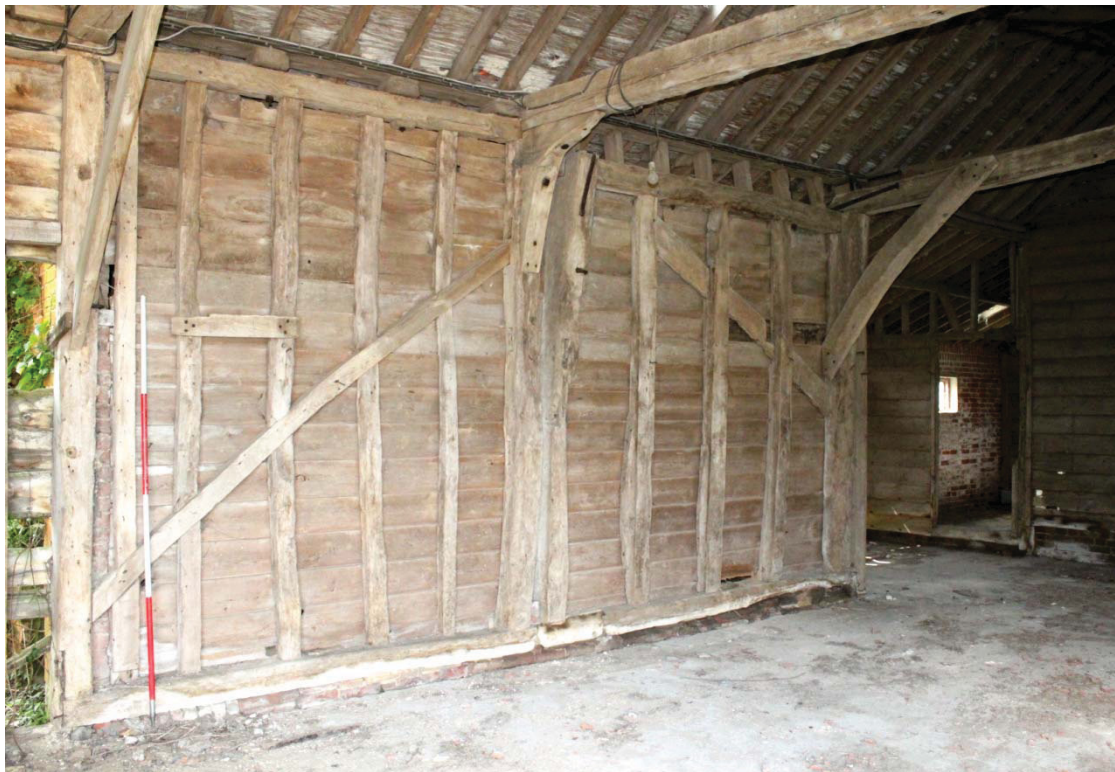
Illus. 10. Southern interior of western bay of 19th century barn (3) showing lowered entrance to left and single 17th century bay (1) to right with rebuilt southern entrance (2b) beyond. Each of the three bays is of a different period.

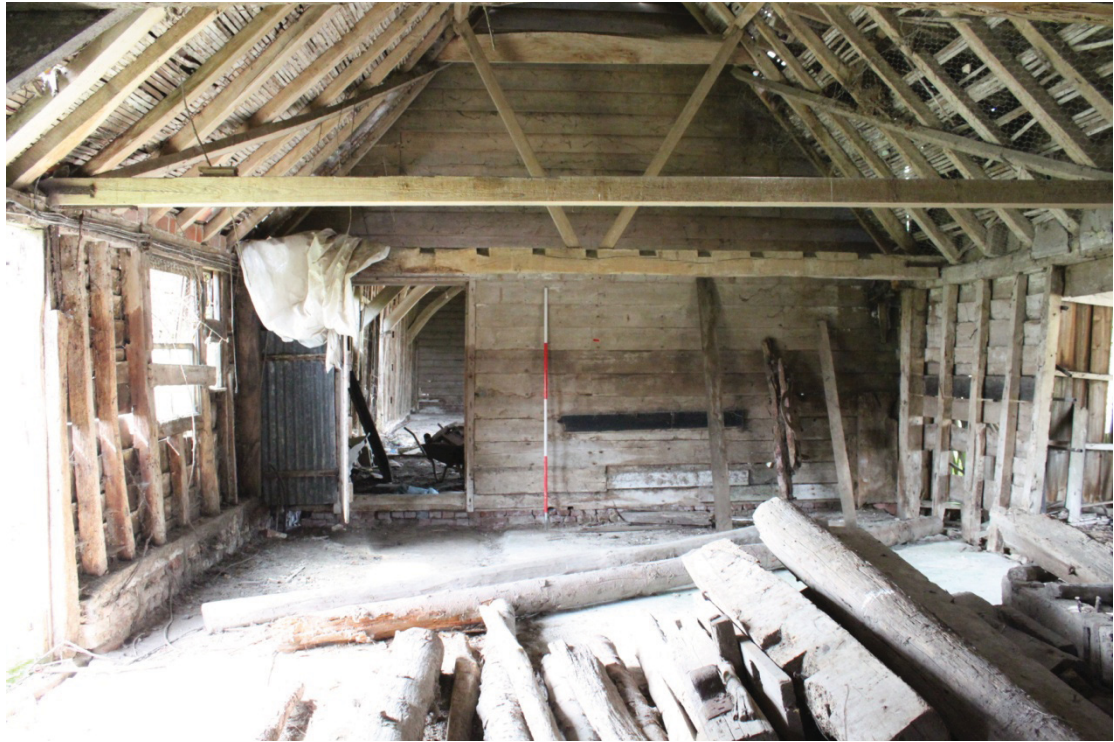
Illus. 11. Interior of stable (4) from east showing door to 19th century barn (3) in rear and notches of missing hay loft in original tie-beams. The roof is original to the early-19th century structure but the tie-beam in the foreground is an insertion.

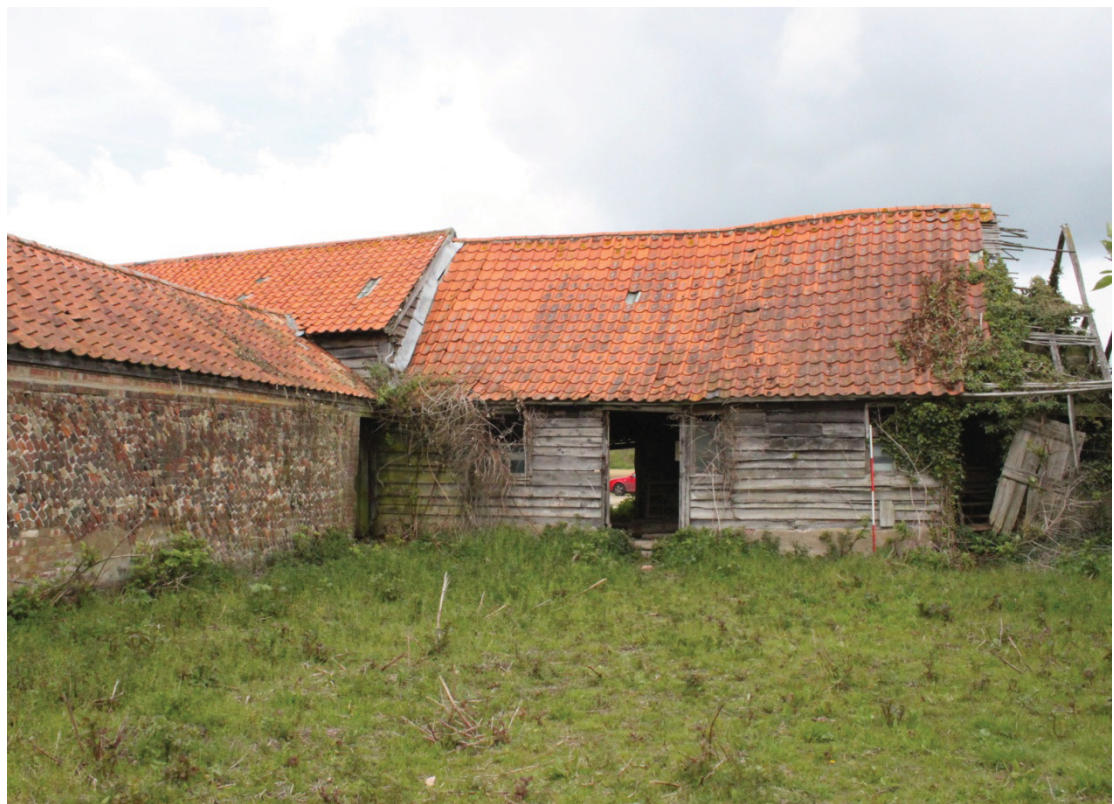
Illus. 12. Southern exterior of single-storied stable (4) from enclosed yard showing rear (eastern) exterior of the central shelter-shed (9) to left and collapsed granary (5) to right.

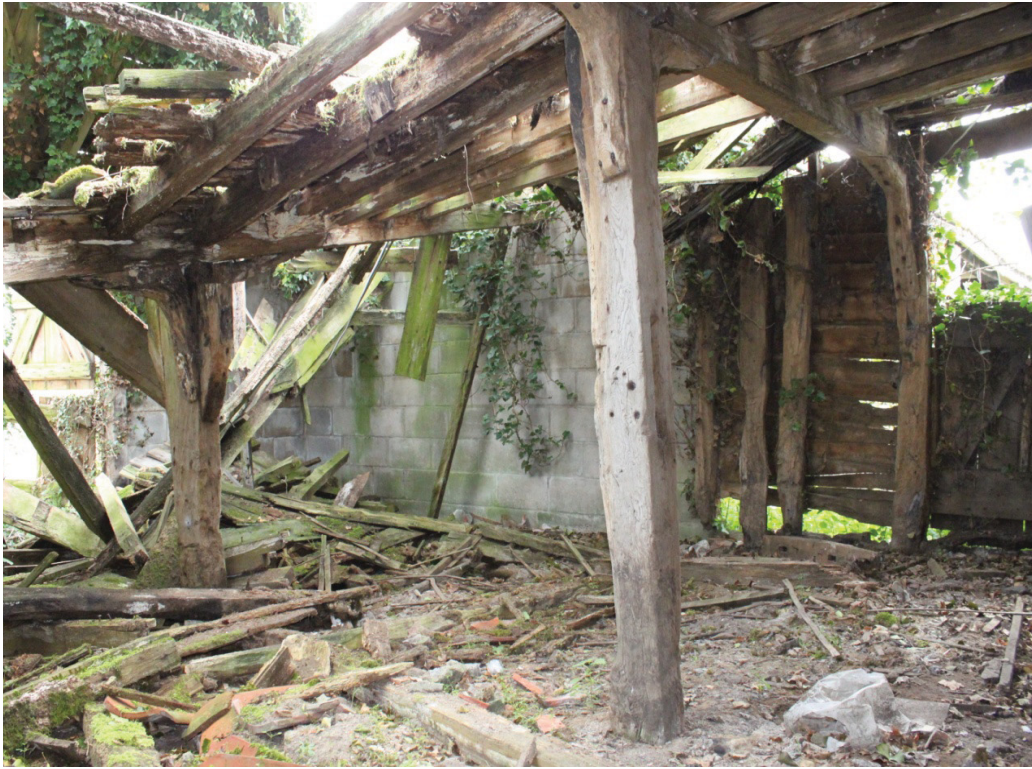
Illus. 13. Interior of collapsed granary (5) from north-west showing the Sampson posts supporting the loft ceiling and the rebuilt cement-block walls.

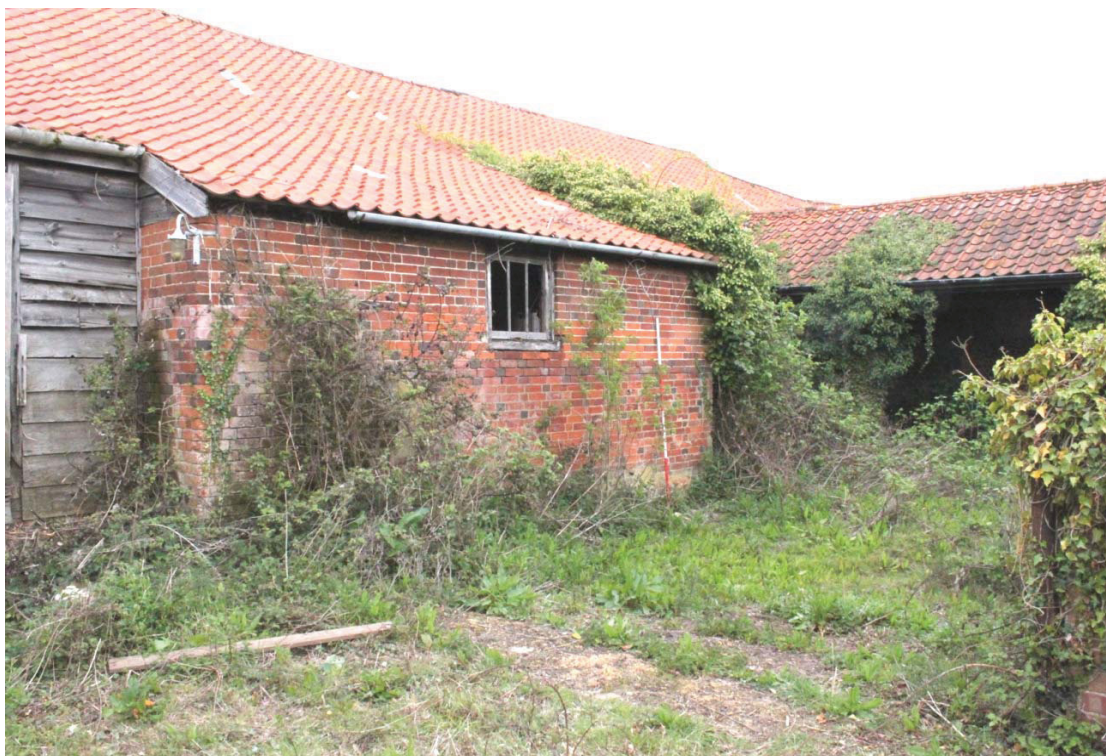
Illus. 14. Exterior of lean-to shed (10) from south-west showing the central shelter shed (9) in rear to right and the mid-19th century lean-to porch of the 17th century entrance (2b) to left.
