**The Farm Buildings,
Tannington Lodge,
Tannington, Suffolk
TNN 014**

Historic Building Record

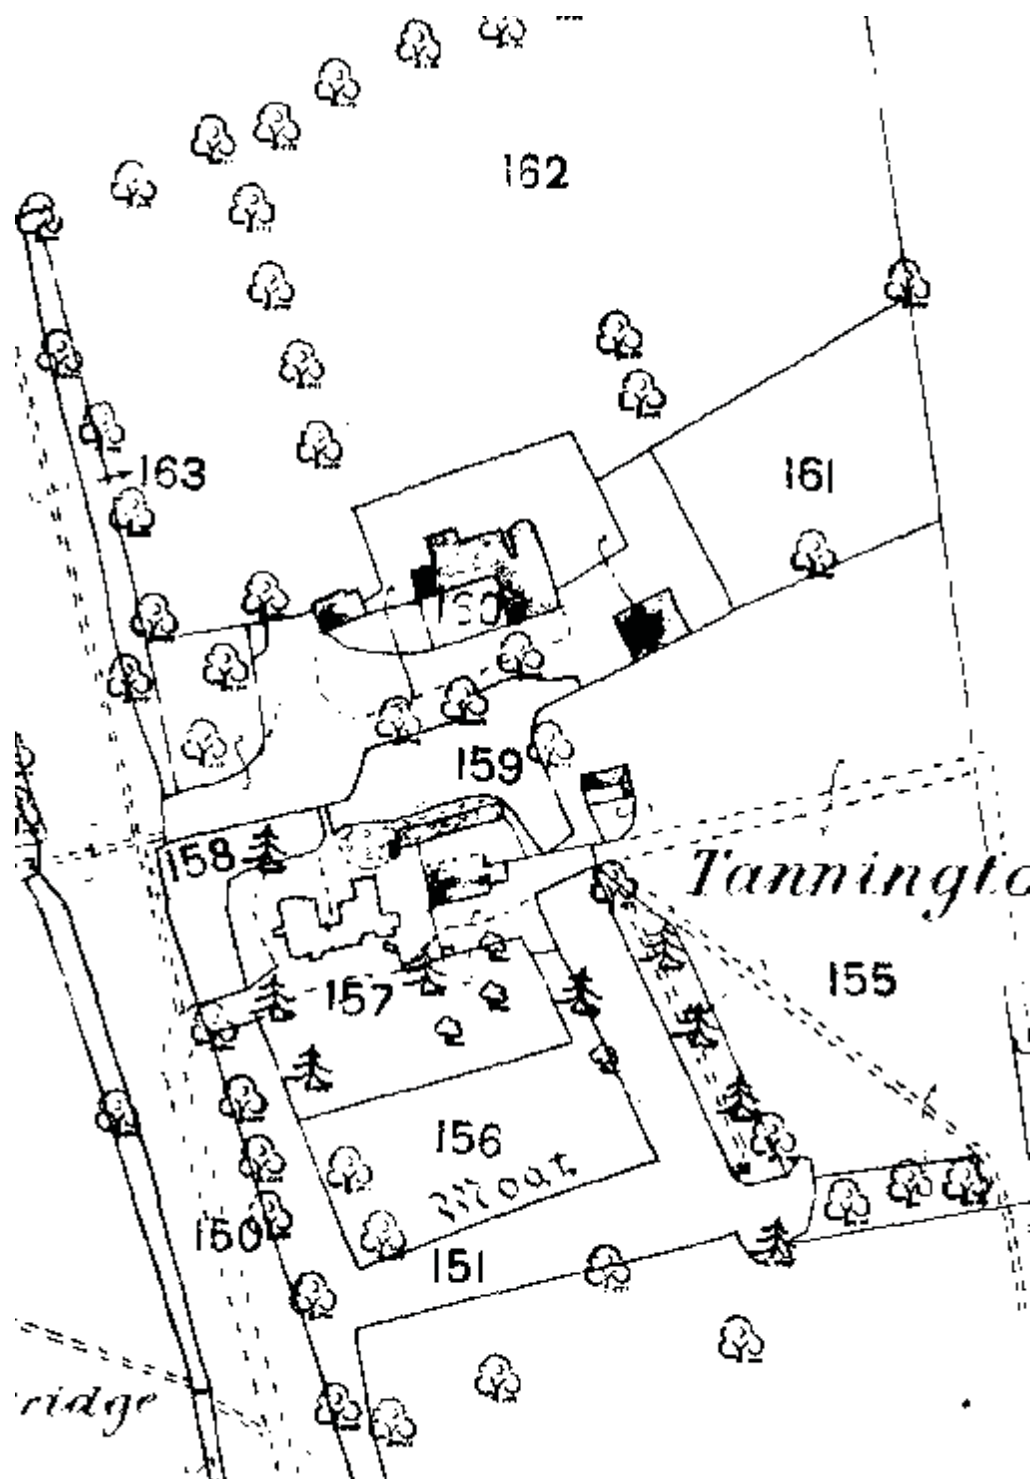
The new buildings of 1885 were shown in more detail on the second edition of 1904, with broken lines indicating open-sided structures such as animal shelters and cart lodges. The existing animal shelter to the west of the barn (3) had been built since 1885. Most local farms were enlarged or rebuilt to accommodate larger numbers of cattle in the mid-19th century, but the additions here are relatively small and the two yards may have accommodated horses. Cattle may have been kept in the new range of outbuildings within the moat, which was not inspected for the purpose of this report.

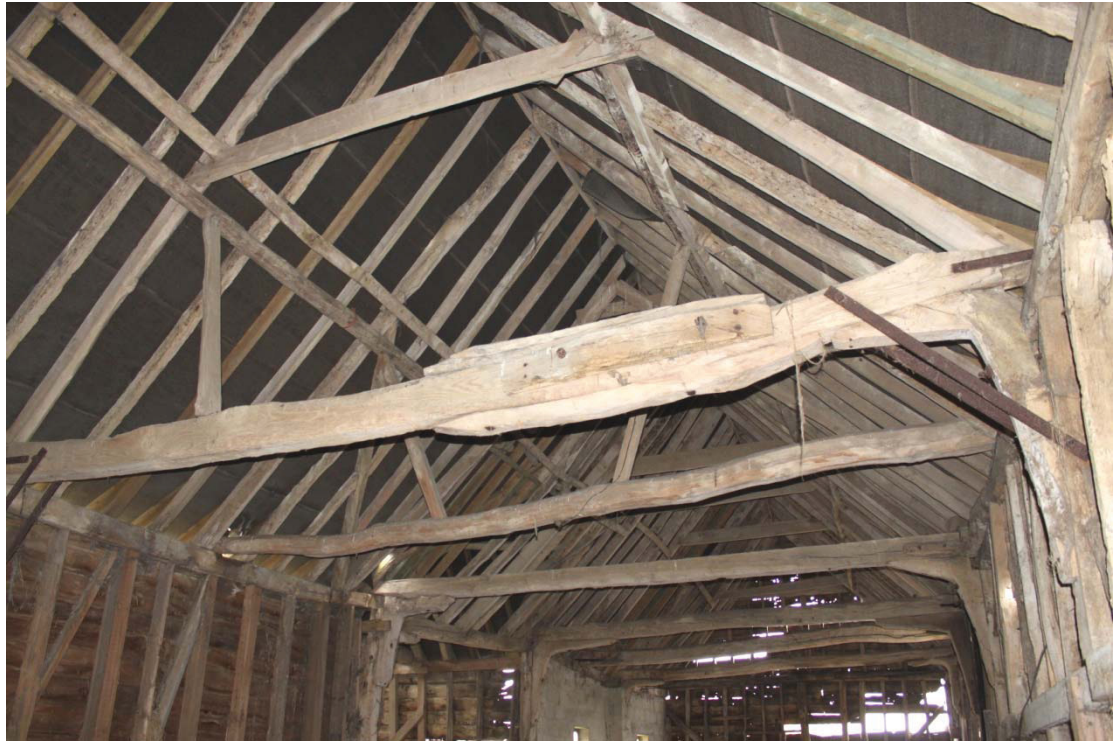
Illus. 5. Roof structure of barn (1) from west showing clasped-purlins of western half with butt-purlins of eastern half in rear. The snapped tie-beam in the foreground was repaired in the 19th century with bolted wooden plates.

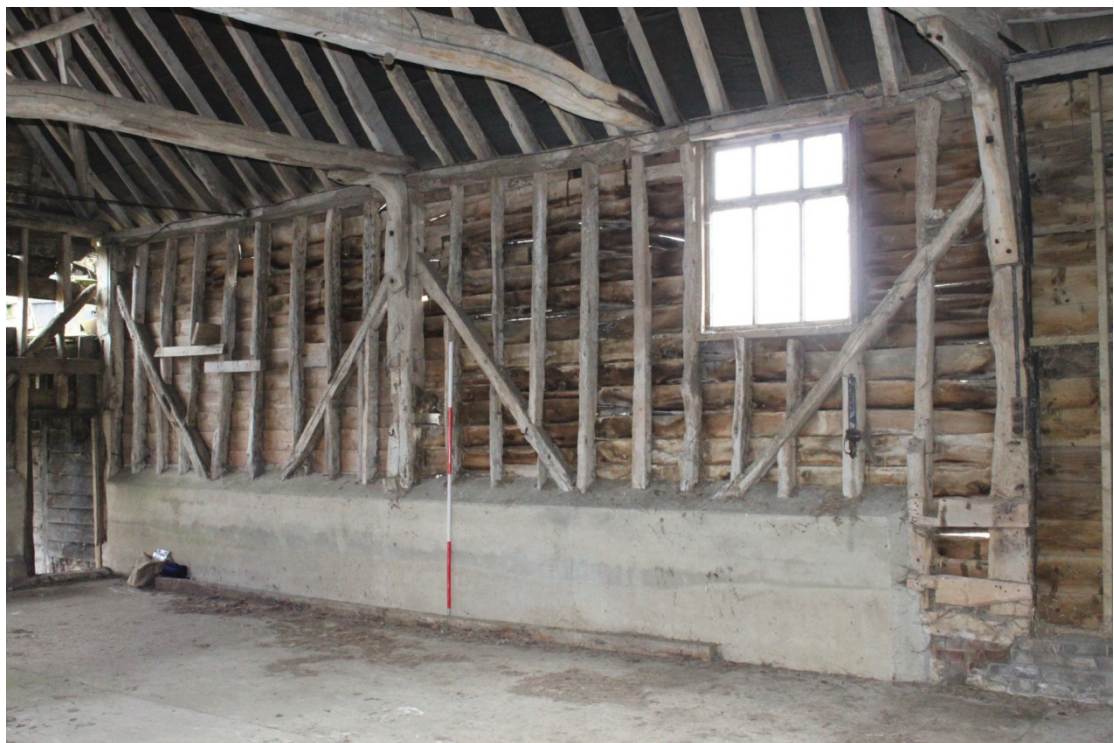
Illus. 6. Original framing of southern interior of eastern half of barn (1) showing primary bracing with position of entrance doors in central bay to right (now blocked with recent studwork) and side-door in eastern gable to left.

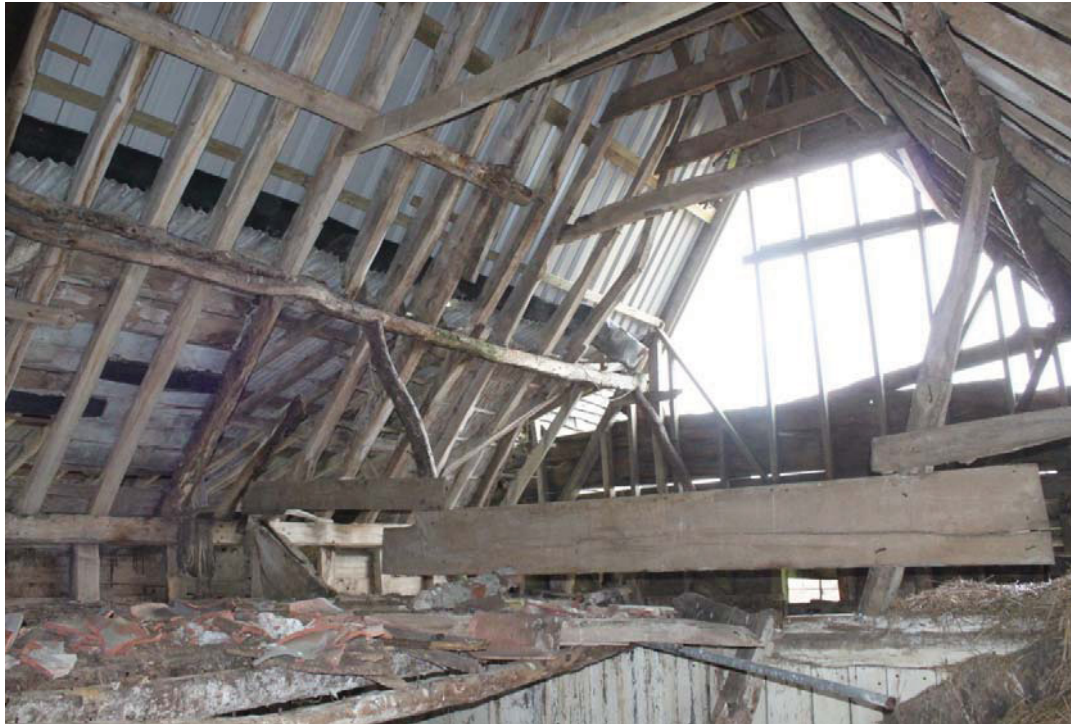
Illus. 11. Clasp purlin roof structure of stable (2) seen from south and showing an inverted bolted knee-brace to a binding joist to left. The rough-wood lower purlin is secondary with the original visible above. The broken pantiles on the loft suggest the original thatch had been replaced before the addition of the present metal sheeting.

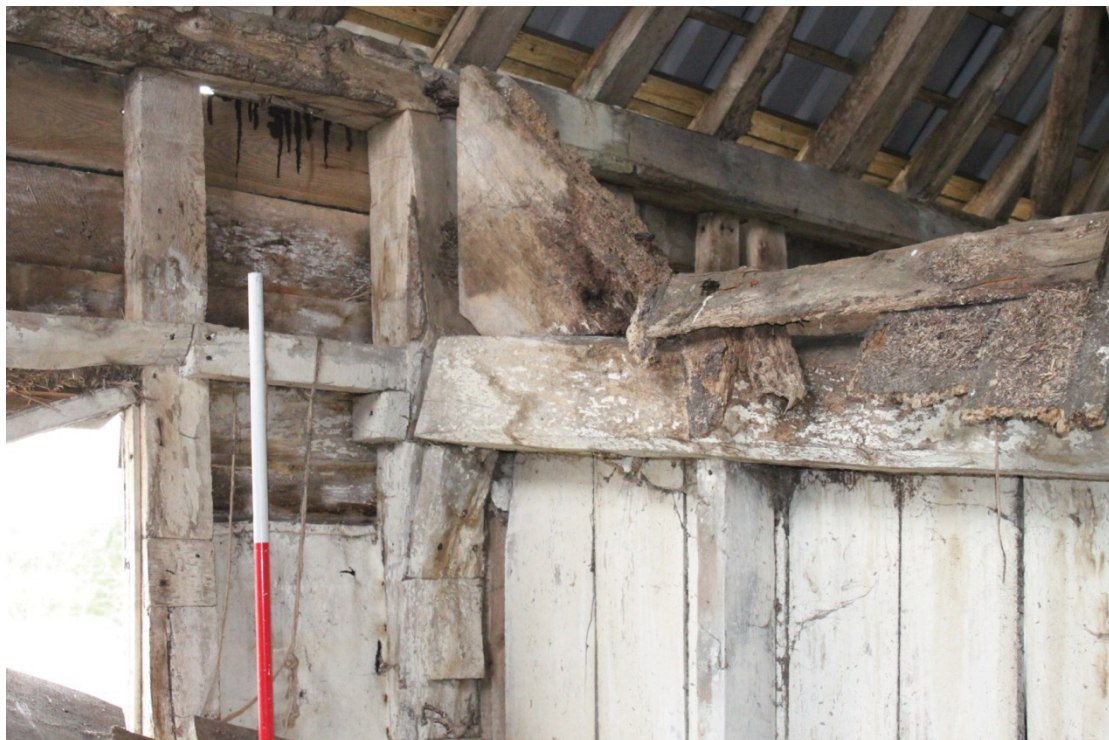
Illus. 12. Detail from north-west of central compartment of stable (2) showing inverted knee-brace to the binding joist of the collapsed hay loft ceiling and the boarded partition to the southern compartment to right. The ceiling has been raised by 0.25 m as shown by the wooden wedge between the joist and the corbel block on the storey post (and by the scar of an earlier clamp on the adjacent stud to left).
