**The Coach House,  
Poslingford House  
Poslingford,  
Suffolk  
PSG 019**

**Historic Building Record**

**July 2010**

## **Historic Building Record**

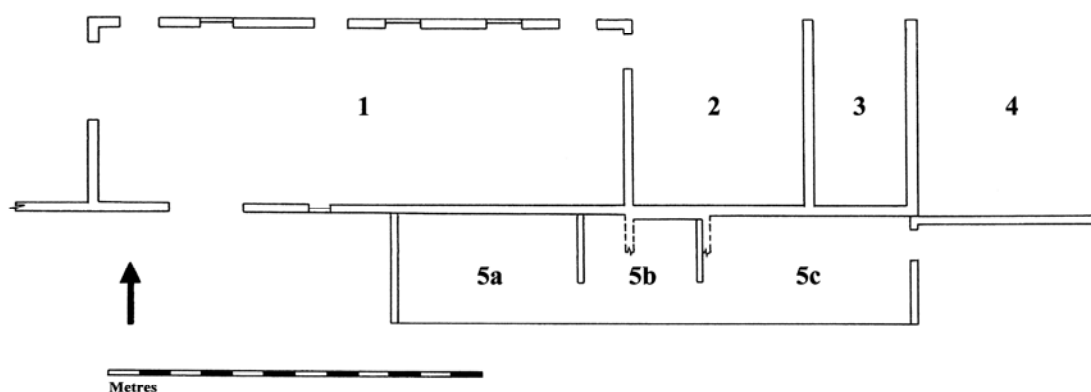
Figure 5  
Block Plan of Coach House

Identifying each area of the building with a number for ease of reference in the text and photographic record. The original building is an early-19<sup>th</sup> century single-storied red-brick structure with a hipped roof of 20<sup>th</sup> century corrugated asbestos represented by areas 1, 2 and 3.

1. Open shed with three original doors and three arched windows in its northern elevation. Now forming a single space with 20<sup>th</sup> century internal render and ceiling, but formerly divided into at least three compartments and probably designed as a stable with a hay rack and manger to the southern elevation. Secondary doors to both gables and to the western end of the southern elevation. Softwood clasped-purlin roof structure with ridge-piece.

2. Vehicle shed for carts or traps with replaced 20<sup>th</sup> century doors to north. Secondary 19<sup>th</sup> century internal door to stable compartment (1).

3. Narrow vehicle shed with replaced 20<sup>th</sup> century doors to north.
4. Lean-to corrugated iron vehicle shed of mid-20<sup>th</sup> century adjoining the eastern gable of the original coach house and a separate 19<sup>th</sup> century brick garden wall to the south.

5. Lean-to glass conservatory or greenhouse of late-19<sup>th</sup> or early-20<sup>th</sup> century with three internal compartments and pierced cast-iron brackets. Incorporating parts of an earlier glasshouse shown on the Ordnance Survey of 1904, and concealing evidence of a narrow original projection from the southern elevation of the coach house.

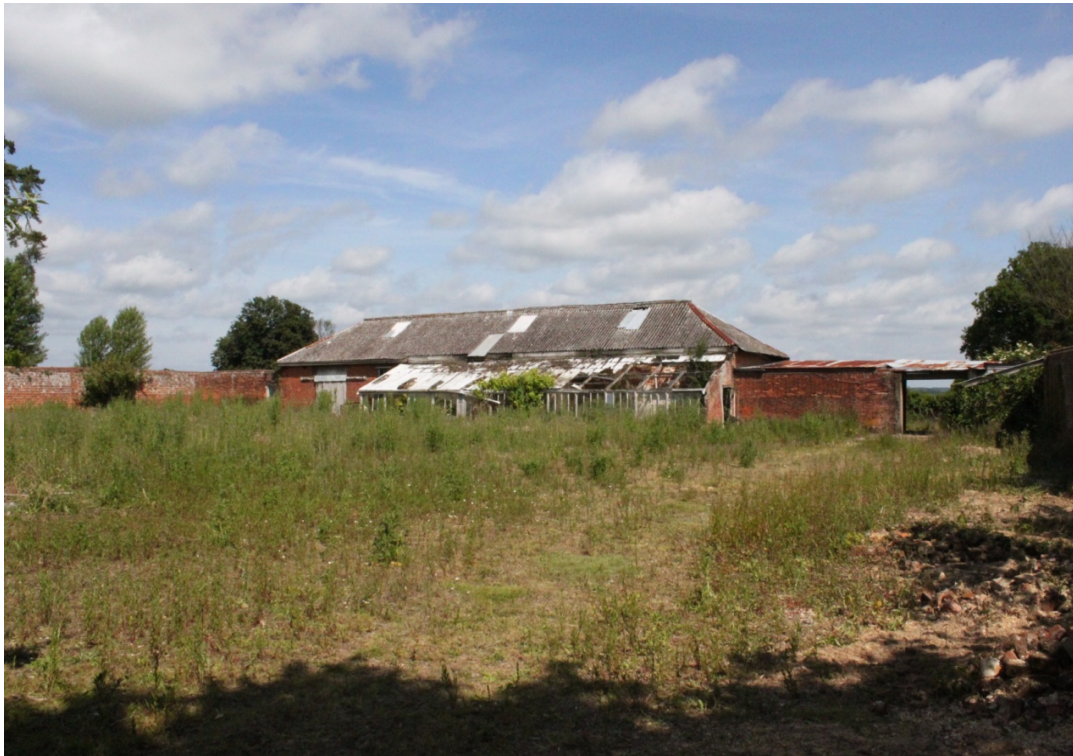
**Illus. 1. General view of site from south-eastern corner of walled garden showing coach house with lean-to conservatory in rear.**

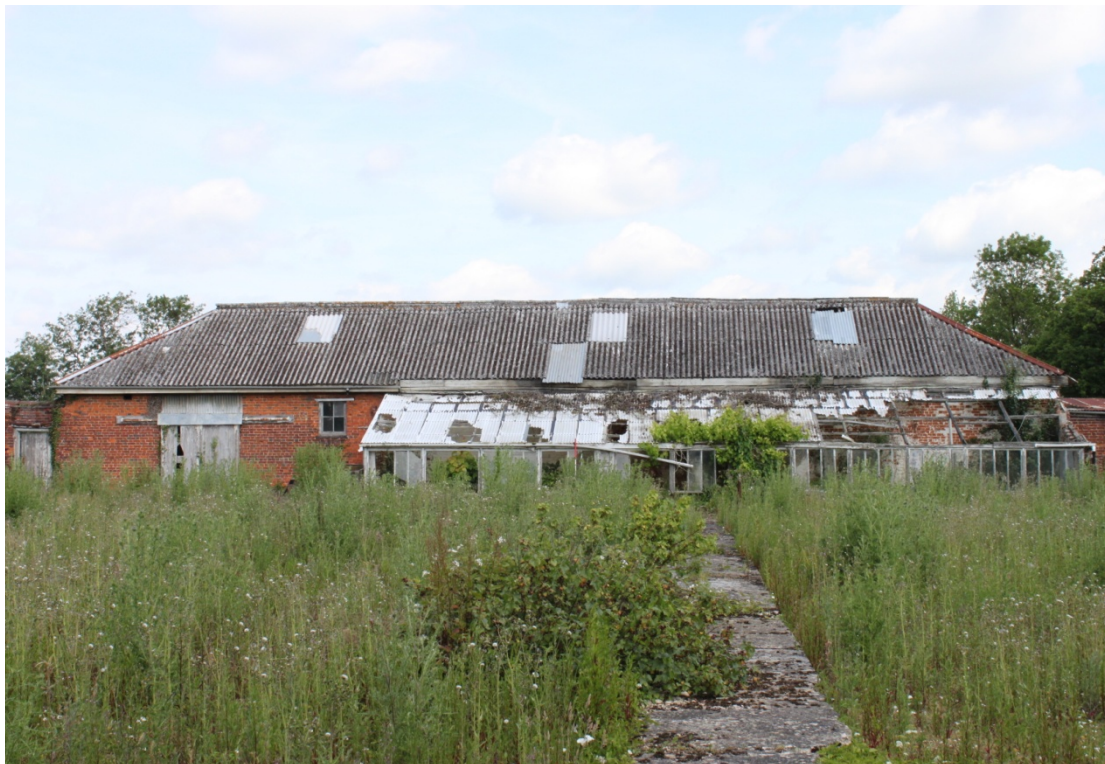
**Illus. 2. Southern exterior of coach house from walled garden showing hipped roof of corrugated asbestos with conservatory to right and inserted sliding door to left.**

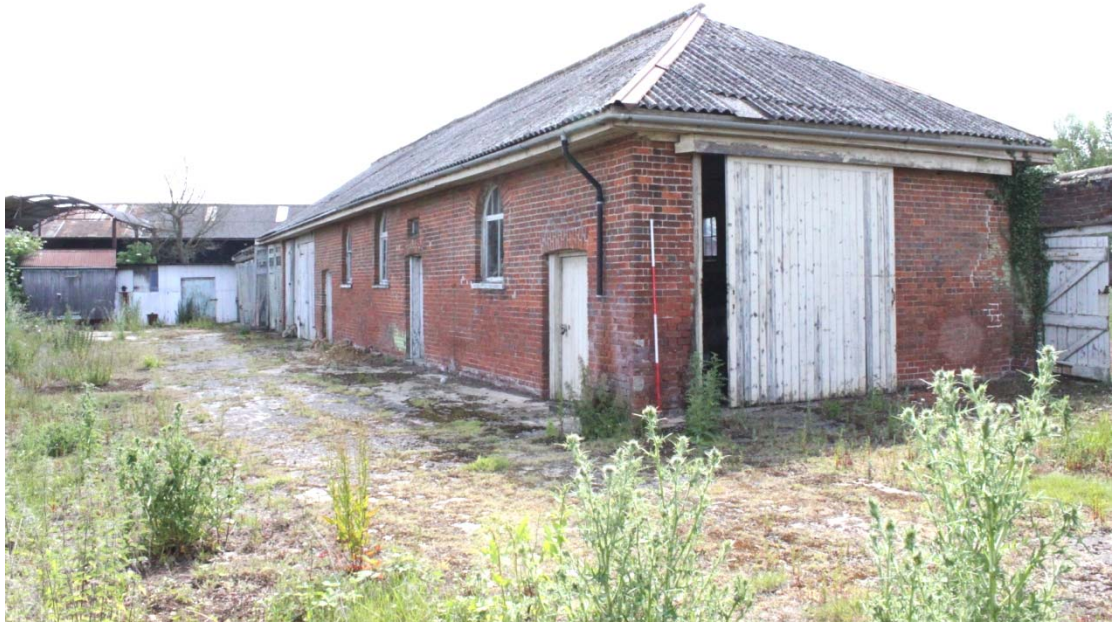
**Illus. 3. Exterior from north-west showing northern facade to left and secondary door in western gable to right. The barn of Shadowbush Farm is visible in rear to left.**

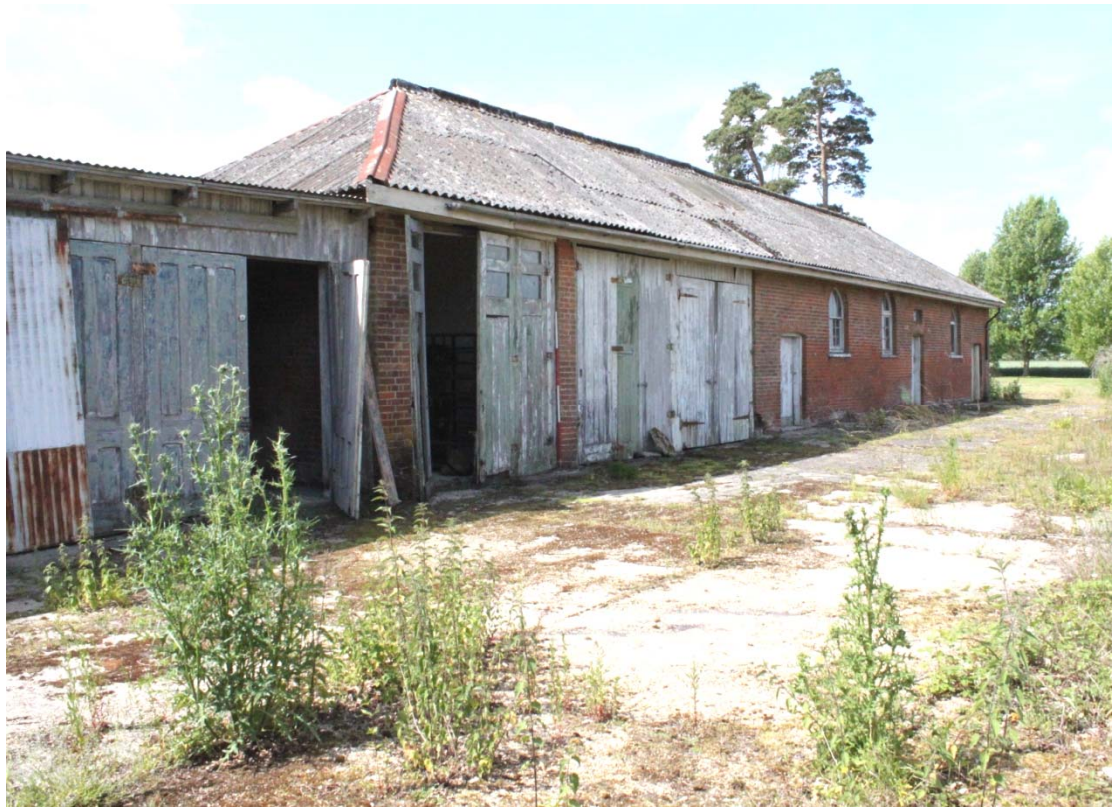
**Illus. 4. Exterior from north-east showing northern facade with doors to vehicle sheds (2 & 3) to left with 20<sup>th</sup> century lean-to shed (4) to extreme left.**

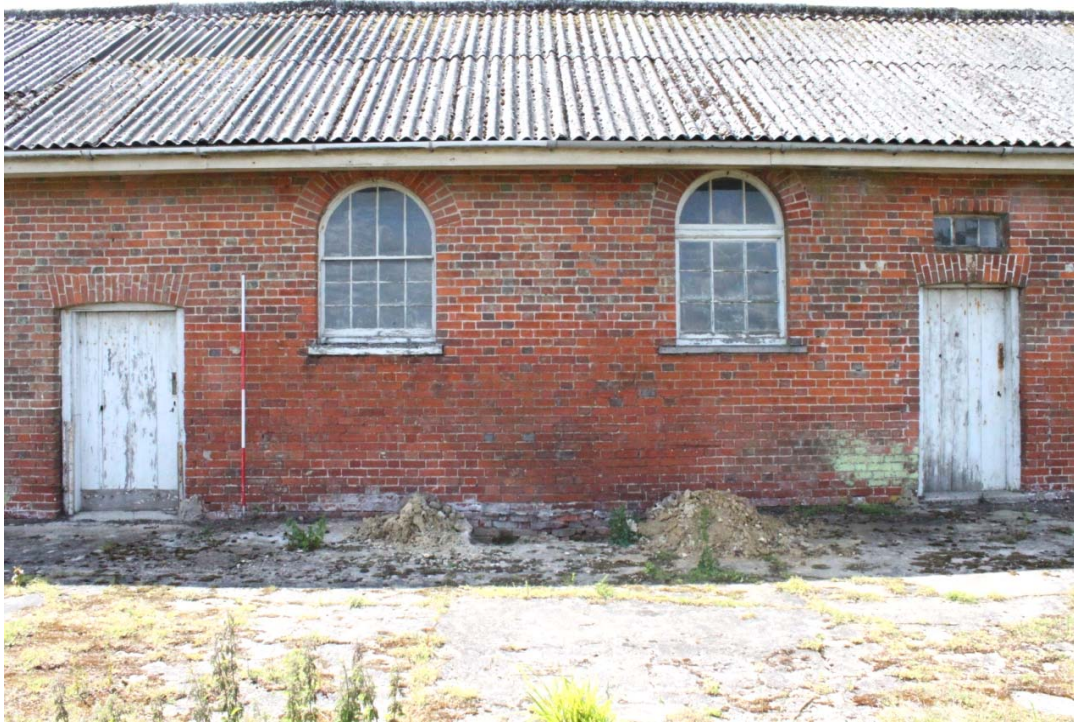
**Illus. 5. Detail of original arched windows and doors at southern end of northern facade.**

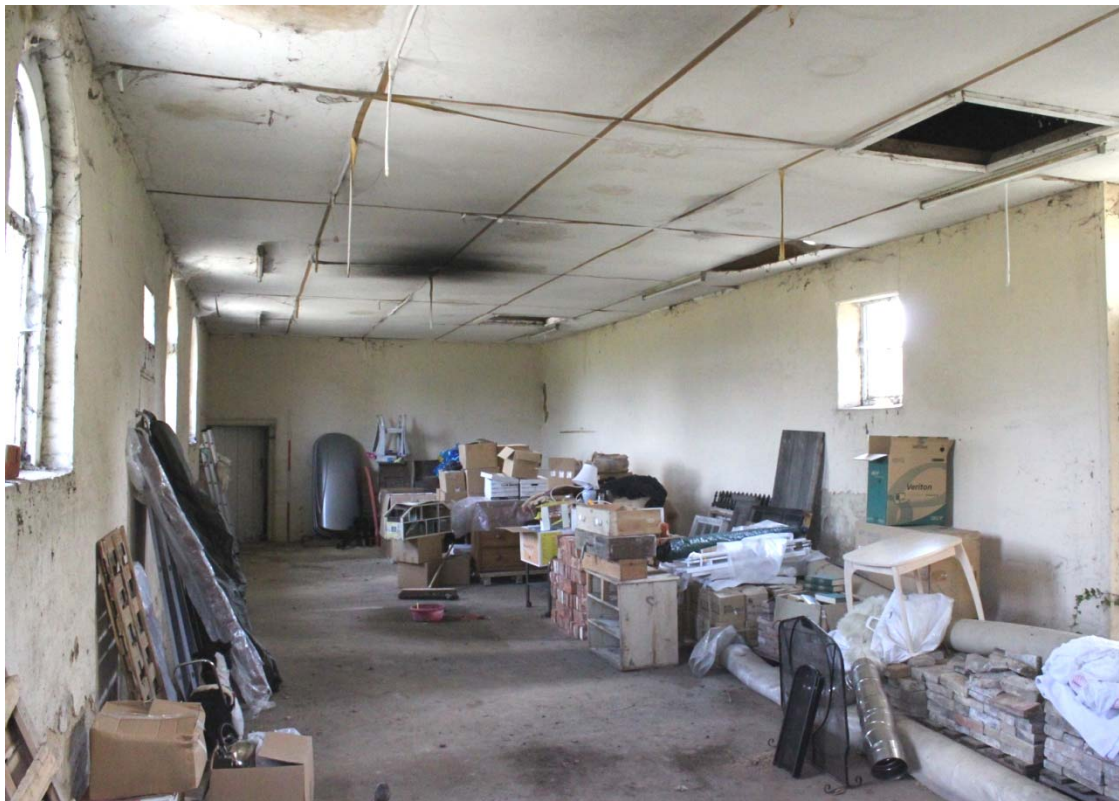
The interior of the building was largely gutted in the mid- to late-20<sup>th</sup> century, removing the original partitions to which the three doors of the northern facade related. The central door is slightly taller than its neighbours and was provided with a rectangular fanlight, suggesting it opened onto a tack room or chaff box dividing a pair of stables entered at each corner. The rear (southern) elevation lacks windows and would have secured hay racks and mangers in the usual manner. No relevant fixtures or fittings survive, and the roof is concealed above a modern flat ceiling. The surface of a cobbled northern yard some 10 cm beneath the present concrete yard was partly exposed at the time of the inspection. The two sheds to the east were always open to the north, although the existing doors are 20<sup>th</sup> century replacements, and would have accommodated vehicles such as carts and traps alongside the stable (one of 5.5 m in length (2) and one of 2.75 m (3), or 18 ft and 9 ft respectively). The structure was reached from the carriage drive to the south and was evidently built as a carriage stable and coach house.

**Illus. 6. Interior of coach house (1) from west showing modern ceiling and render. The space has been stripped of its original partitions, fixtures and fittings.**

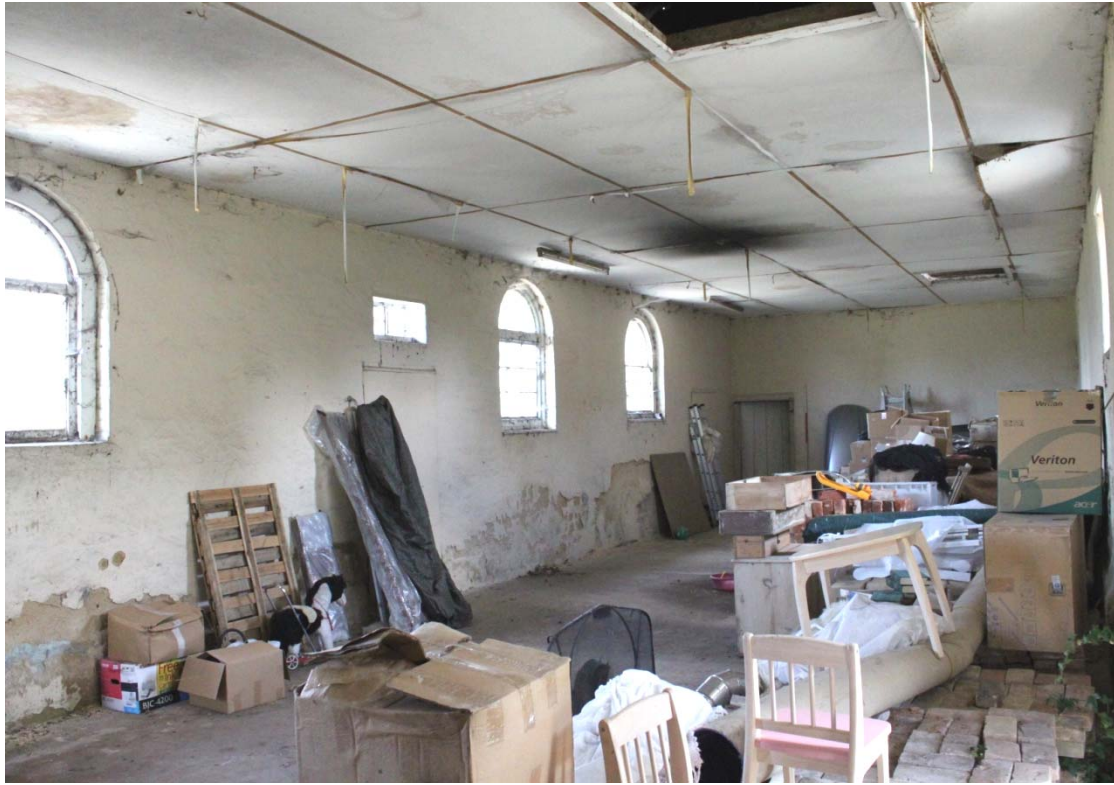
**Illus. 7. Interior of coach house (1) from west showing blocked doors of northern facade to left.**

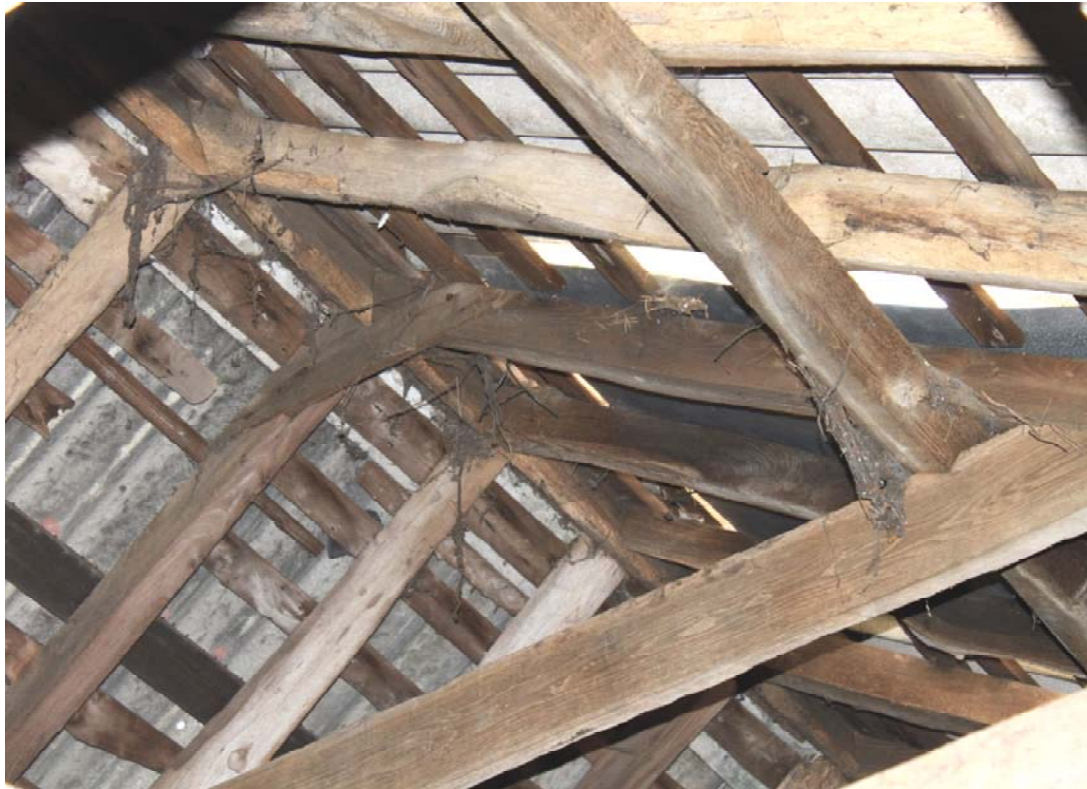
**Illus. 8. Detail of nailed softwood roof structure of coach house (1) above modern ceiling.**

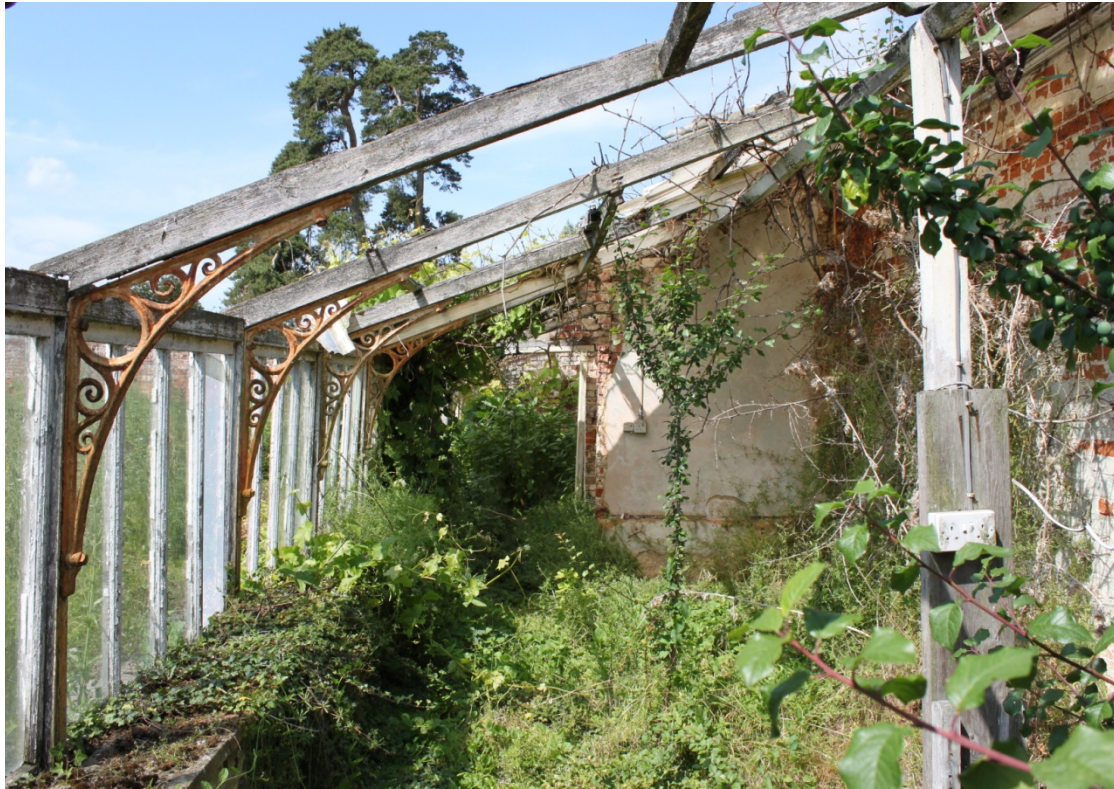
A glass-roofed conservatory had been added to the eastern end of the southern elevation by 1885, as shown in figure 3, but this had been truncated by 1904 and the present lean-to conservatory is a reconstruction of the 20th century. It incorporates a series of pierced cast-iron brackets that may have been re-used from its predecessor and retained a louver mechanism by Boulton and Paul at the time of inspection but was badly dilapidated. The interior is divided into three sections by poorly-built brick partitions as shown in figure 5. The interior of the stable was stripped of its partitions during the mid-20th century and its northern doors blocked, while new sliding doors were inserted to the western gable and the western end of the southern elevation adjoining the garden. These alterations suggest the space was adapted for the storage of garden produce. The two original vehicle sheds were provided with new doors at the same time, and a third shed of corrugated iron was added to the eastern gable (4). Some of these doors are reputed to have been purchased from a nearby military base and retain hinges bearing the stamps of the Henderson sliding door factory at Barking, Essex. The narrow door linking the stable to the larger vehicle shed (2), which retains its brick floor, is an insertion of the 19th century which interrupts the original brickwork and while the small window at the western end of the southern elevation may be an original feature it is probably also an insertion of the late-19th century. The frames of the arched windows to the former stables appear to have been renewed but their arched profiles are respected by the brickwork; they may have contained Mock Gothic tracery in the fashion of the early-19th century when first installed.

**Illus. 9. Interior of conservatory (5c) from east showing doorway to central section (5b) with decorative cast iron brackets to left.**

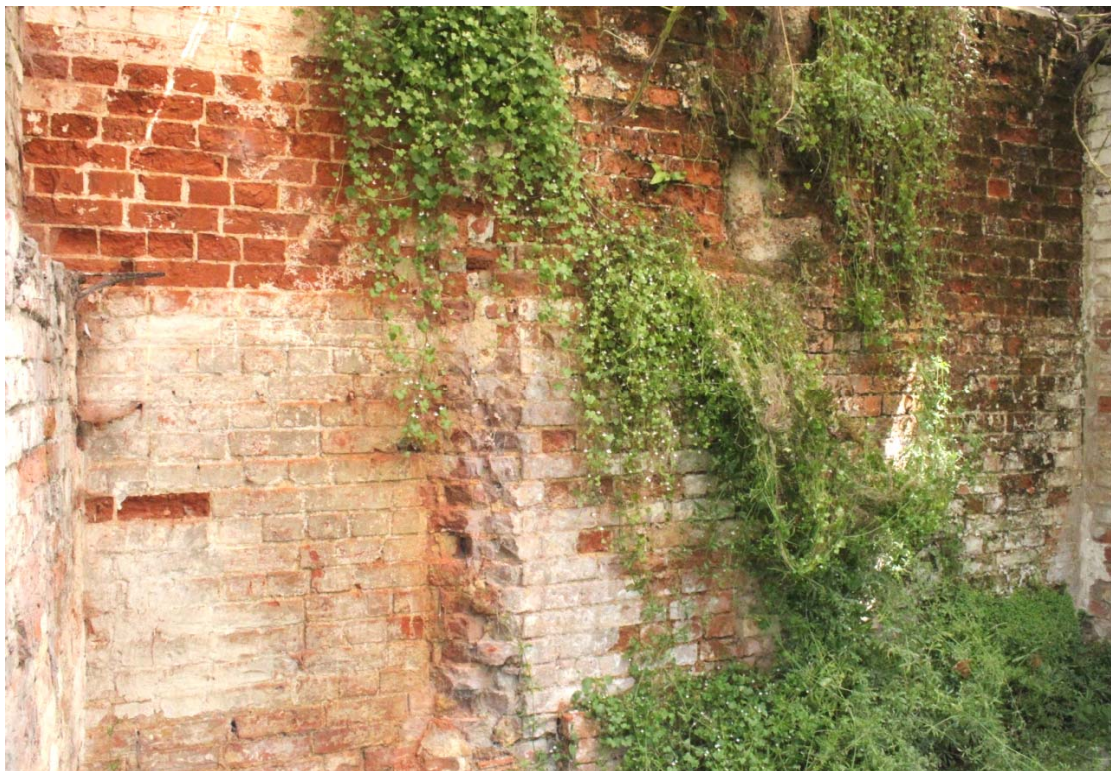
There is evidence of an additional original projection from the southern external elevation, as indicated by the scars of two vertical walls now exposed within the conservatory. The main wall here is slightly thicker than elsewhere, and contains evidence of a secondary window that appears to have been crudely inserted into the brick fabric. This feature was just 2.2 m in width and must have formed a narrow shed entered from the walled garden. It is not shown on the tithe map of 1842, however, and had presumably been demolished prior to this date.

**Illus. 10. Northern interior of central section of conservatory (5b) showing scar of demolished original projection from coach house wall.**
