**Granary and Barn,  
Grange Farm, Daisy Green,  
Great Ashfield, Suffolk  
ASG 019**

**Historic Building Record**

**July 2010**

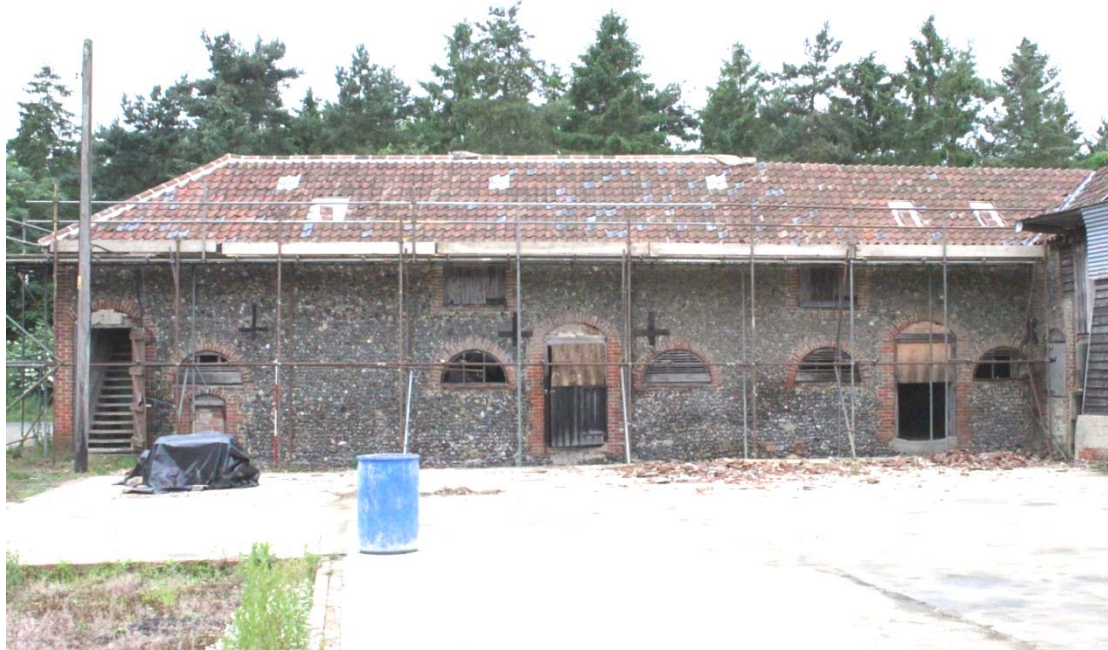
**Illus. 2. Eastern exterior of granary (1) showing its symmetrical arrangement with arched doors and windows dressed in red brick. The tall stair door lies to the left and the each stable entered by a central door flanked by windows on each side.**

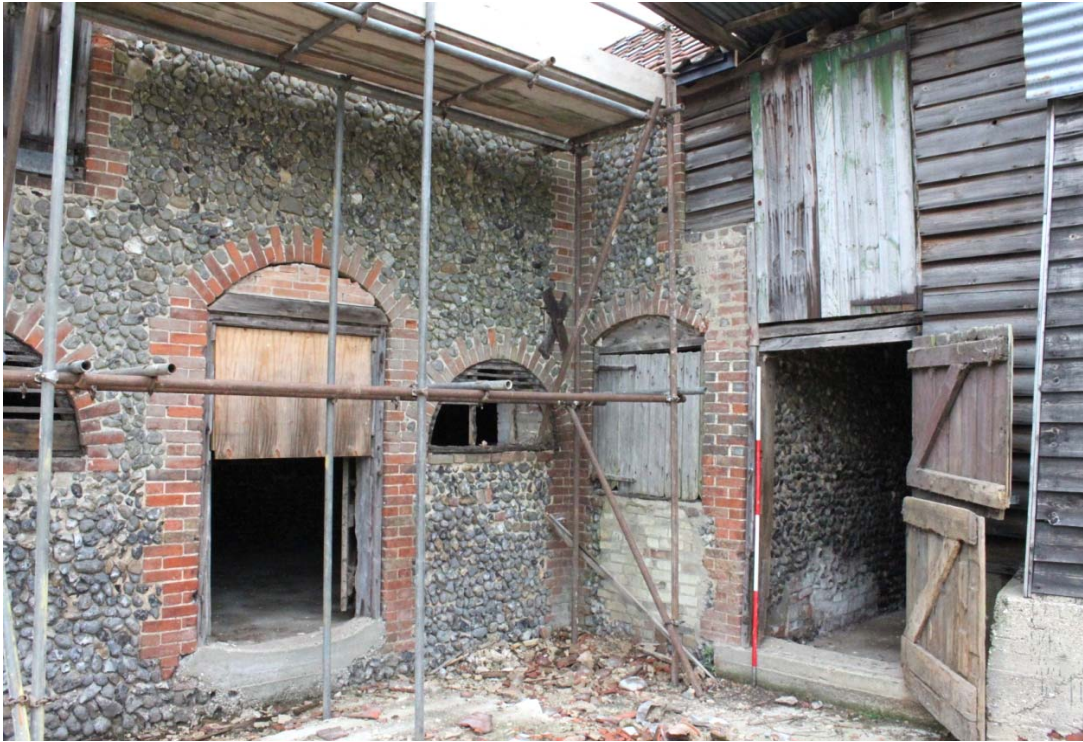
**Illus. 3. Junction of granary (1 left) and barn (4 right) from south-east showing the entrance to the northern stable (1c) left, the former hatch to the chaff house (1e) in centre (later converted into a door) and the covered passage between the barn and granary to the right (2).**

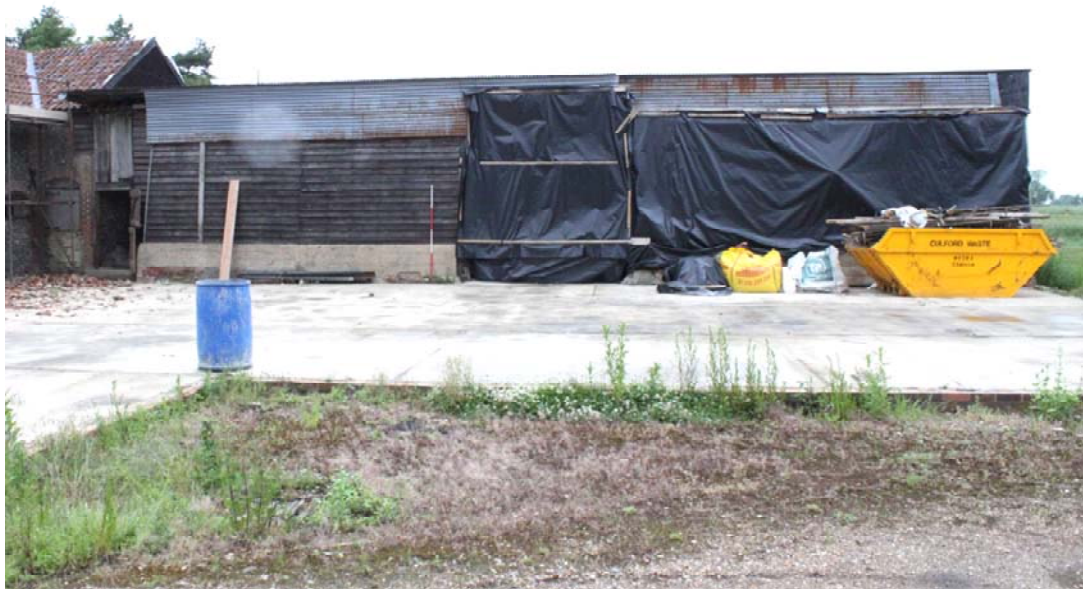
**Illus. 4. External southern elevation of the early-17<sup>th</sup> century timber-framed barn (4) barely recognisable beneath its 20<sup>th</sup> century single-slope roof and showing the granary (1) to left.**

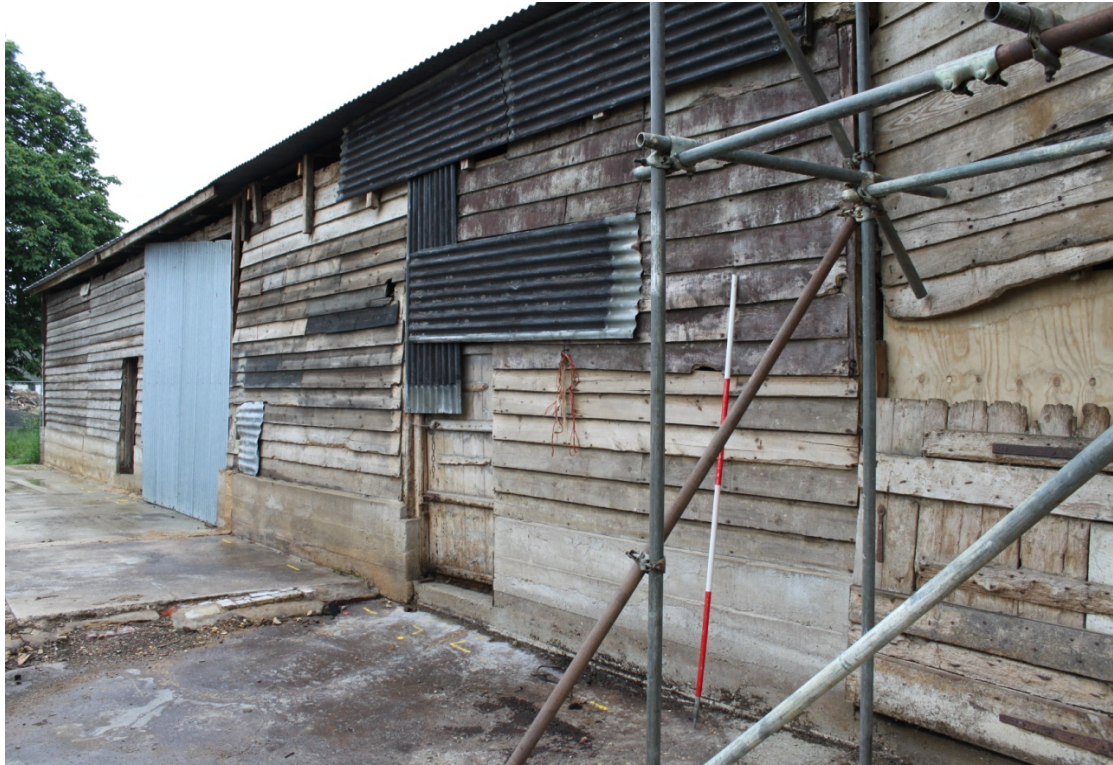
**Illus. 5. Northern exterior of barn (4) from the partly demolished brick shed to the north-west showing 18<sup>th</sup> or early-19<sup>th</sup> century redde (red-ochre pigment) to the boarding of the western bay (right).**

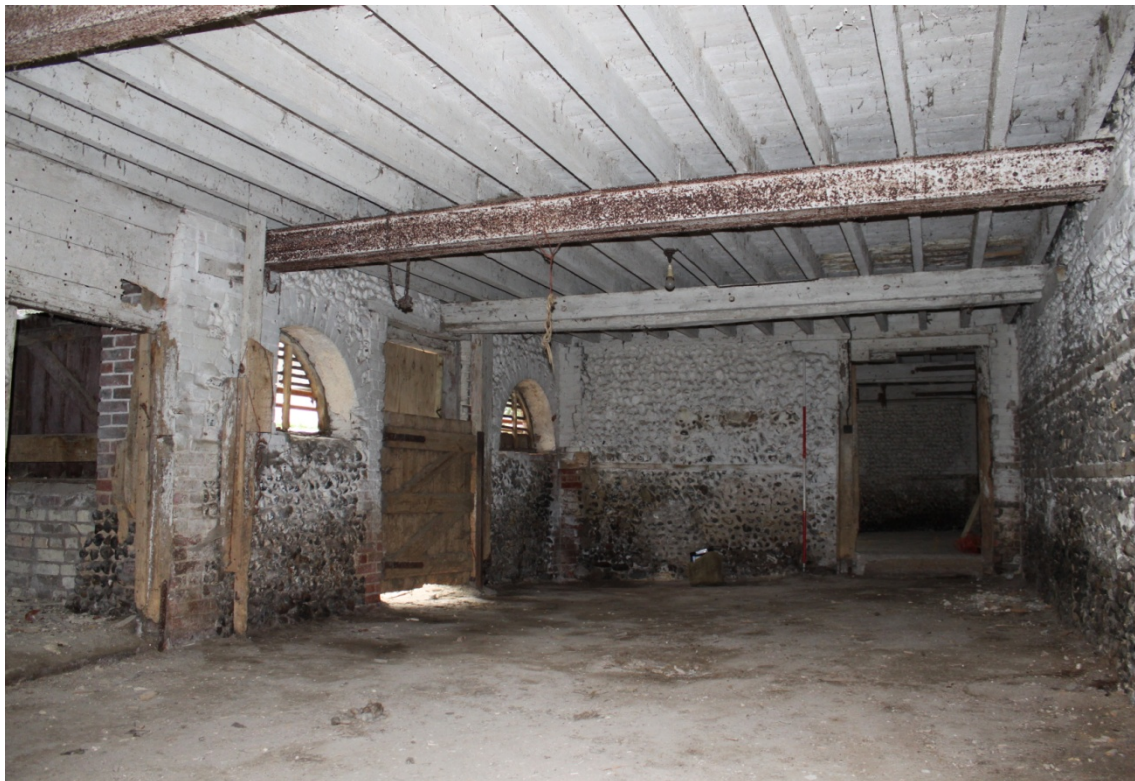
**Illus. 6. Interior of northern stable (1c) from north showing southern entrance to left and secondary door to central stable (1b) right. The boarded partition of the narrow chaff box is visible to the left and the ceiling is a late-19<sup>th</sup> century replacement.**

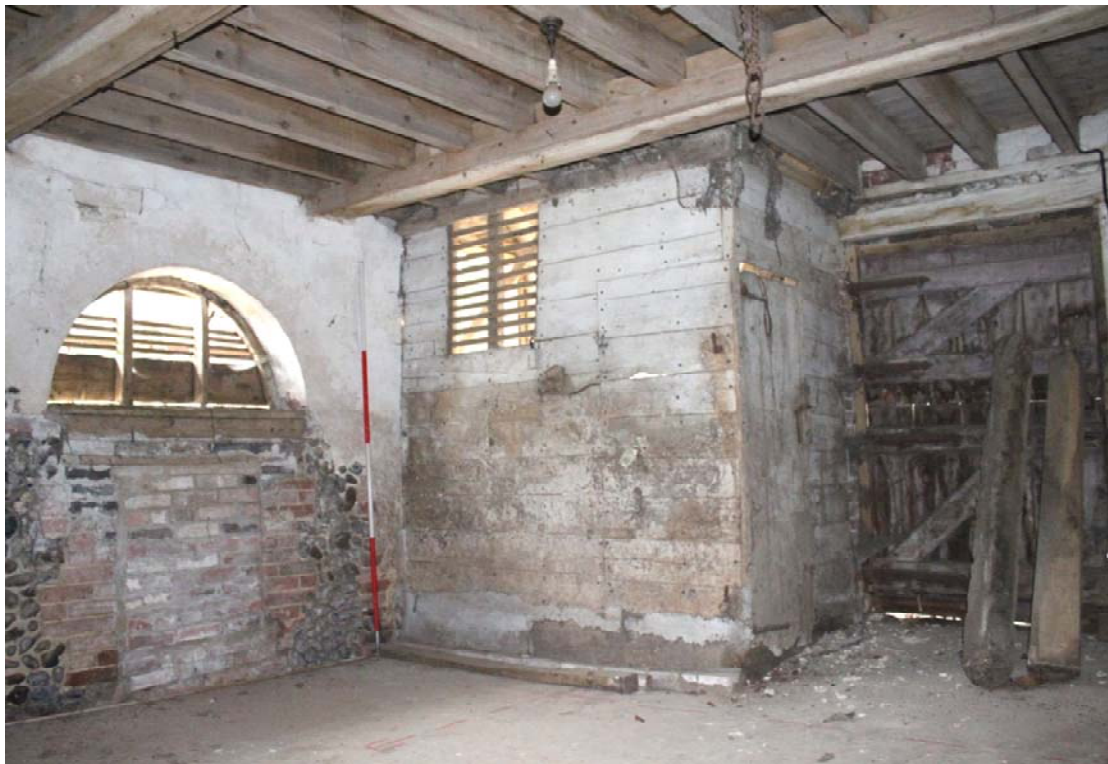
**Illus. 8. Boxed stair in south-eastern interior of southern stable (1a) with pintles for the door of demolished box in the foreground that would have been served by the secondary hatch beneath the window to the left (now blocked again).**

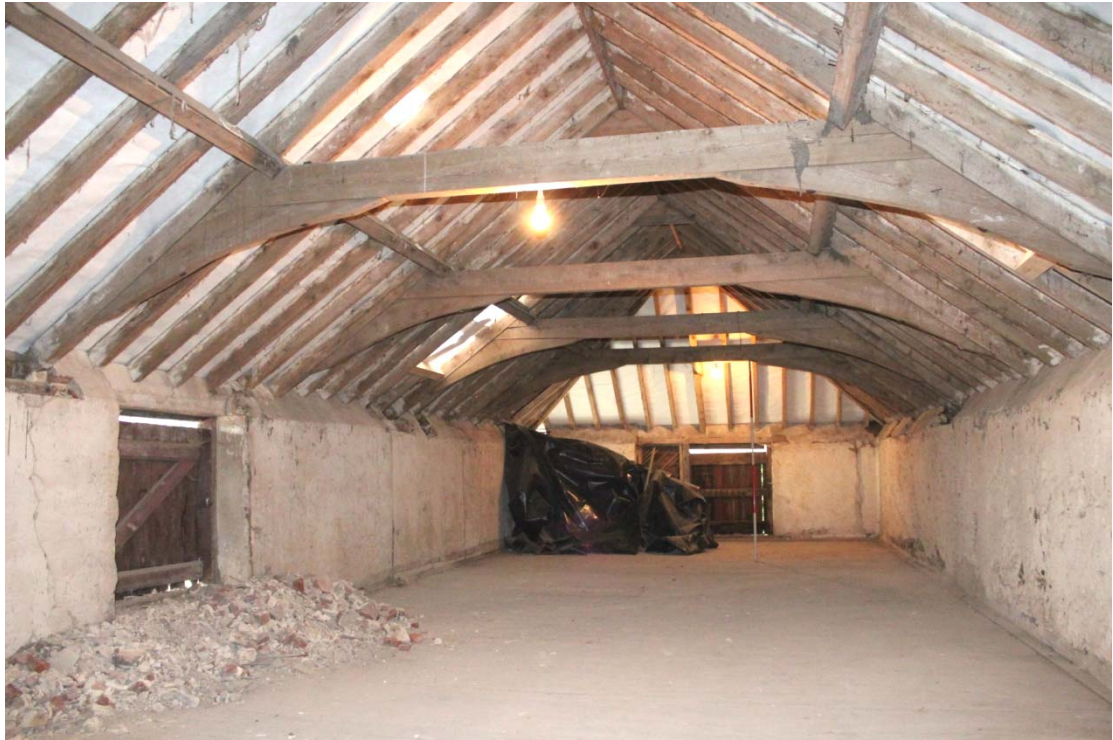
**Illus. 9. Southern granary loft seen from north and showing loading doors to the left and in the southern gable with the replacement clasped-purlin softwood roof structure of the late-19<sup>th</sup> century.**

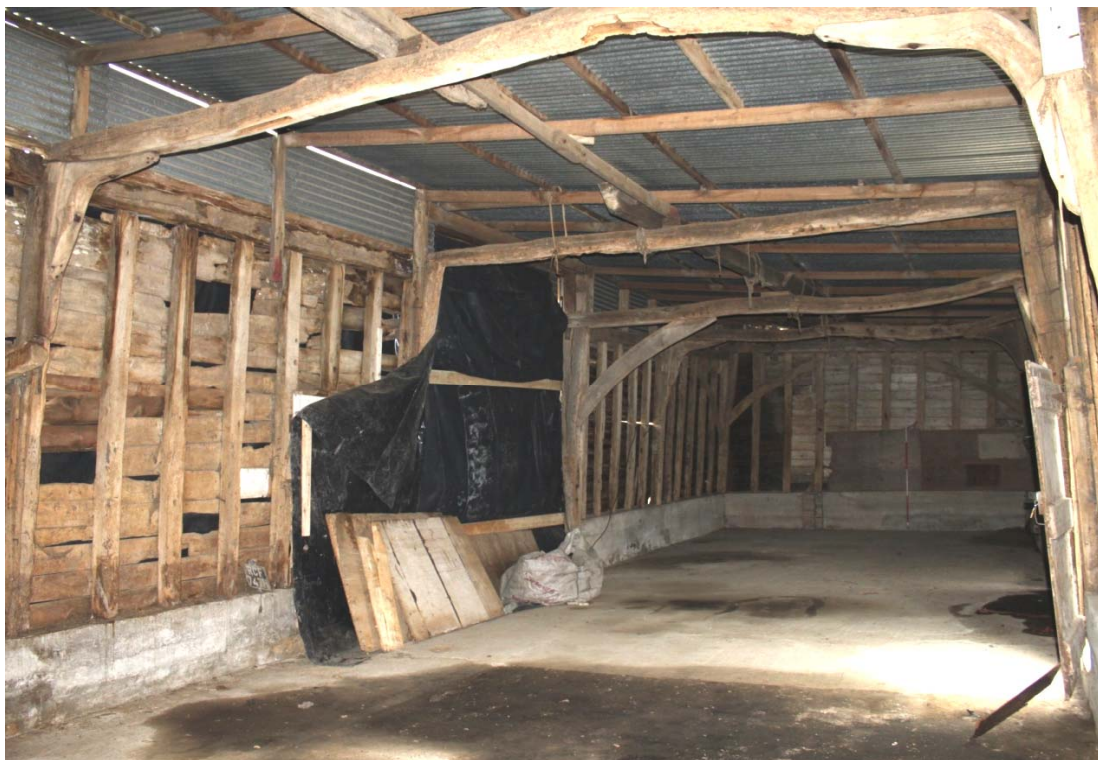
**Illus. 12.** Interior of the early-17<sup>th</sup> century five-bay threshing barn (4) from east showing southern elevation to left with a single original tie-beam arch-brace extant and a modern single-pitch roof.

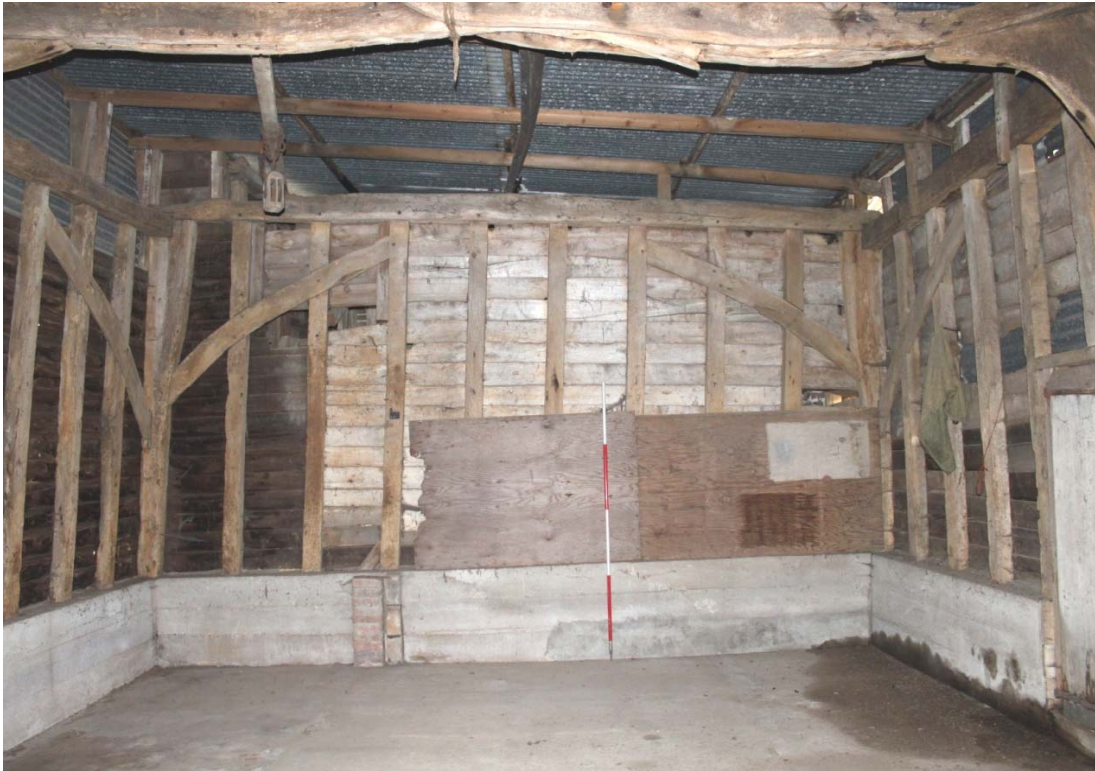
**Illus. 13. Internal western gable of barn (4) showing the intact original framing with internally trenced corner braces.**

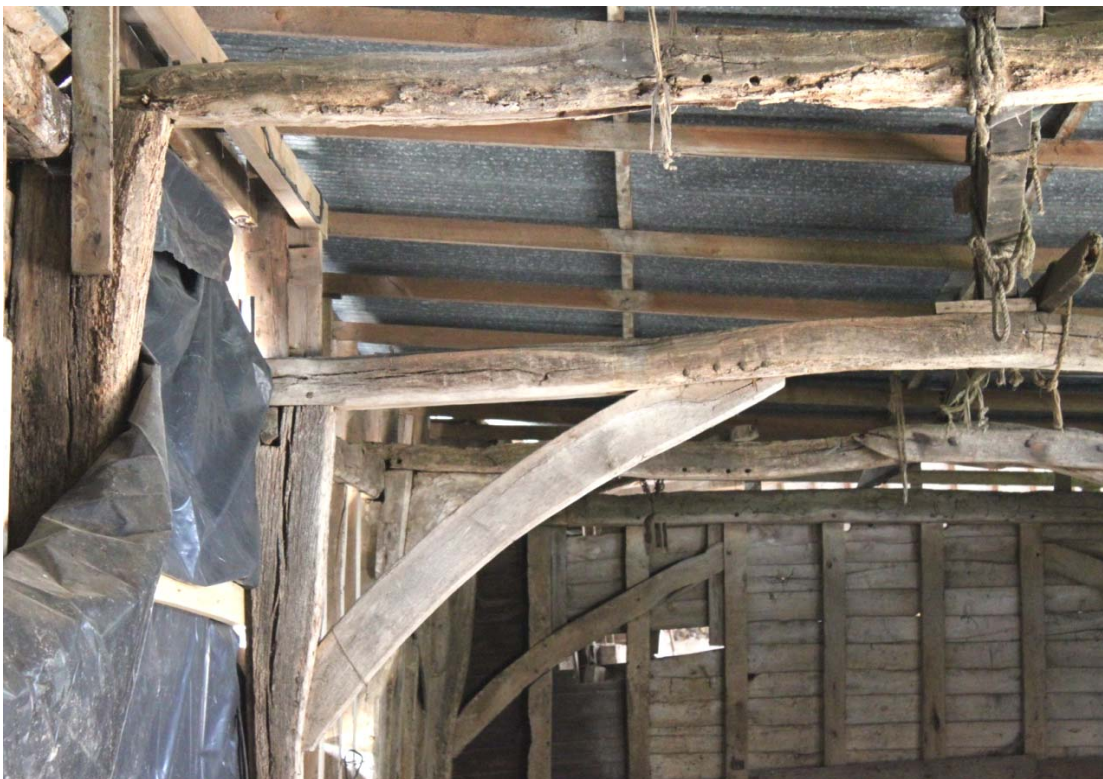
**Illus. 14. Detail of original arch brace to west of southern entrance of barn (4) seen from east with empty mortises for a second arch brace in the foreground.**
