**Barn at  
Pannington Hall Farm,  
Wherstead, Suffolk  
WHR 073**

**Historic Building Record**

**July 2010**

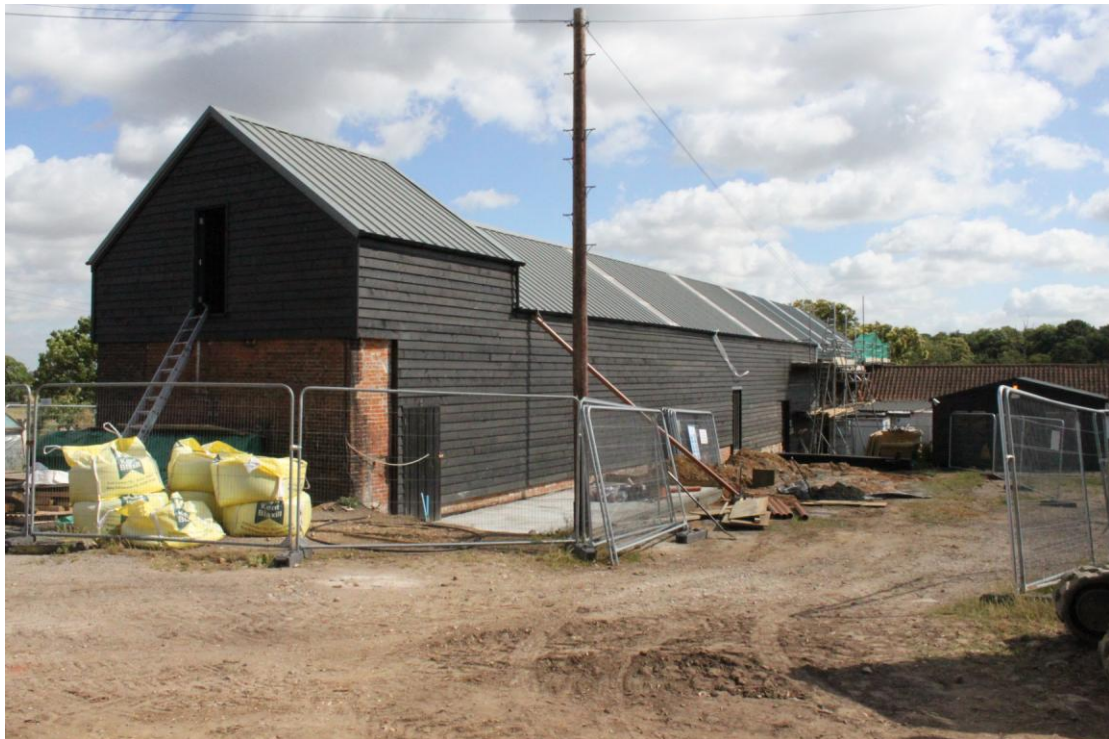
**Illus. 4. Exterior from south-west showing modern cladding of ongoing conversion with taller western bay of granary (3) to left.**

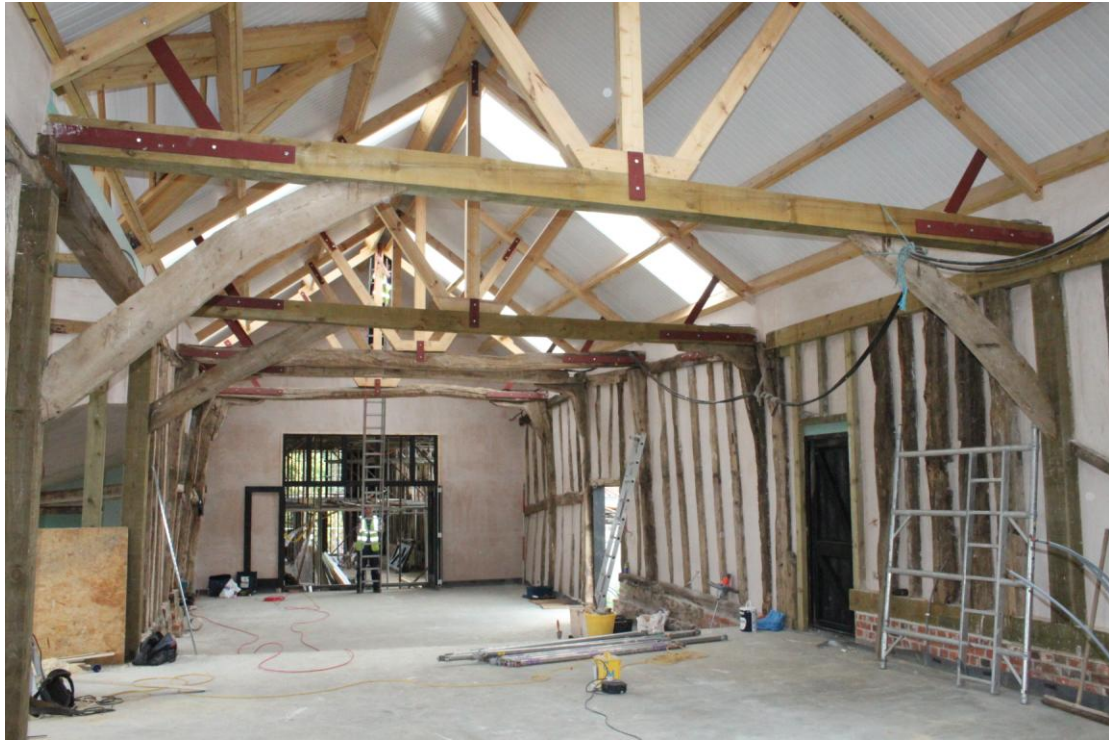
**Illus. 5. Western section of barn (2 & 1b) from west, showing partition to eastern section (1 & 4) in rear. The entire roof structure and many principal timbers have been replaced in softwood in recent months.**

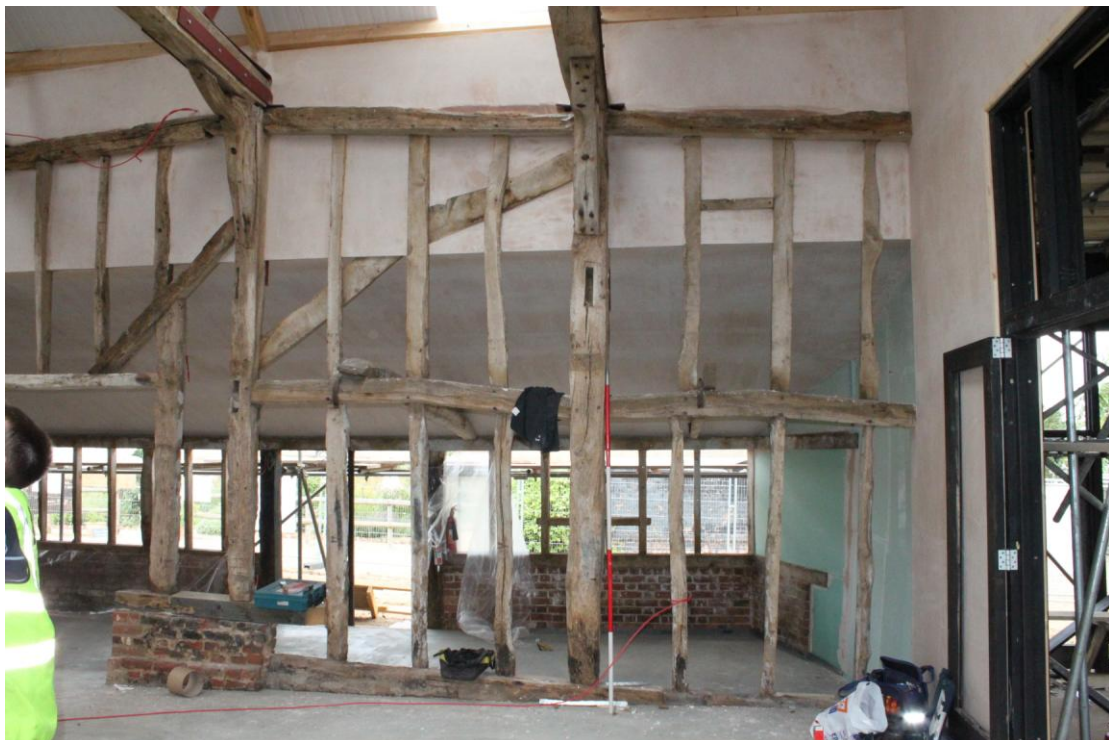
**Illus. 6. Western bays of northern interior of eastern barn (1b) showing an original trenched corner brace with the position of its missing western gable to left.**

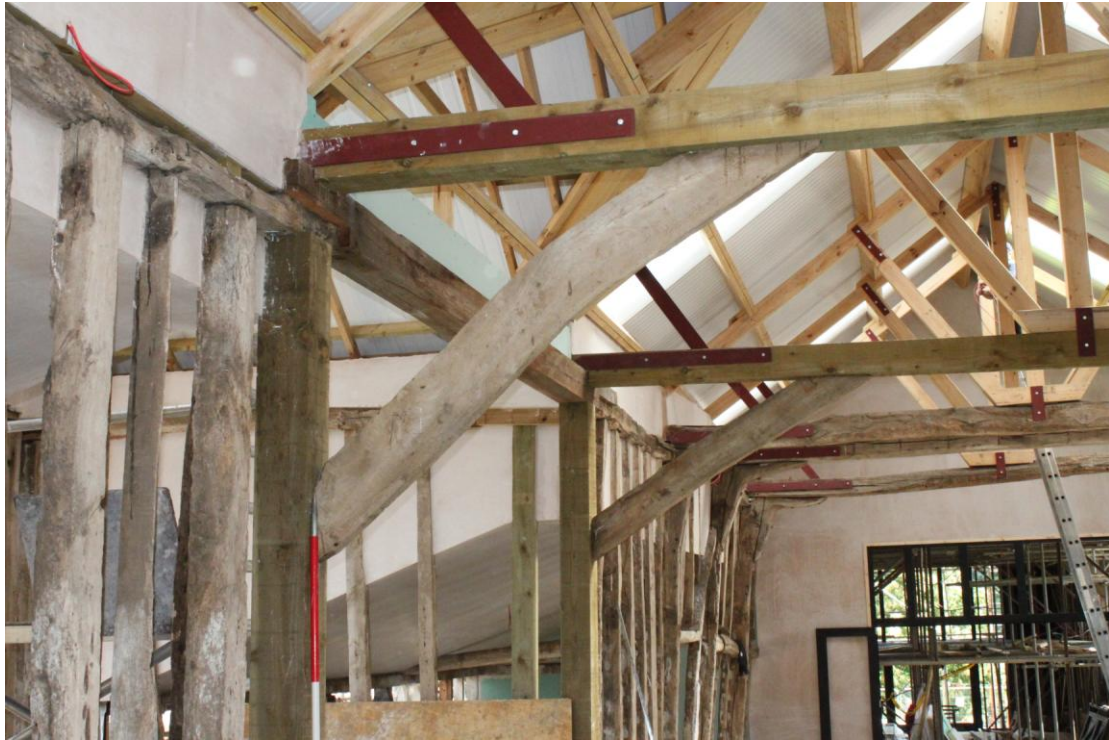
**Illus. 7. Detail from west of re-set arch-braces flanking porch (2a) of western barn (2). The tie-beams and storey posts are new softwood timbers, but the arch-braces are understood to have been reinstated in their former positions.**

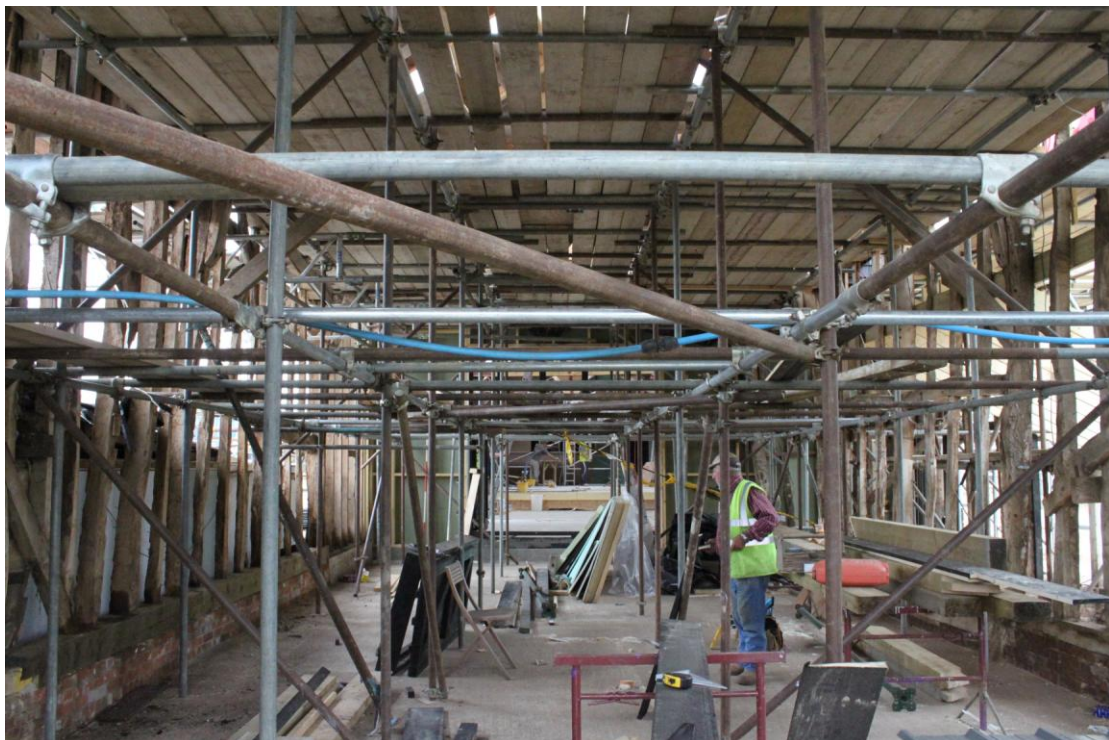
**Illus. 8. Interior of eastern barn (1 & 4) from eastern gable showing modern scaffolding.**

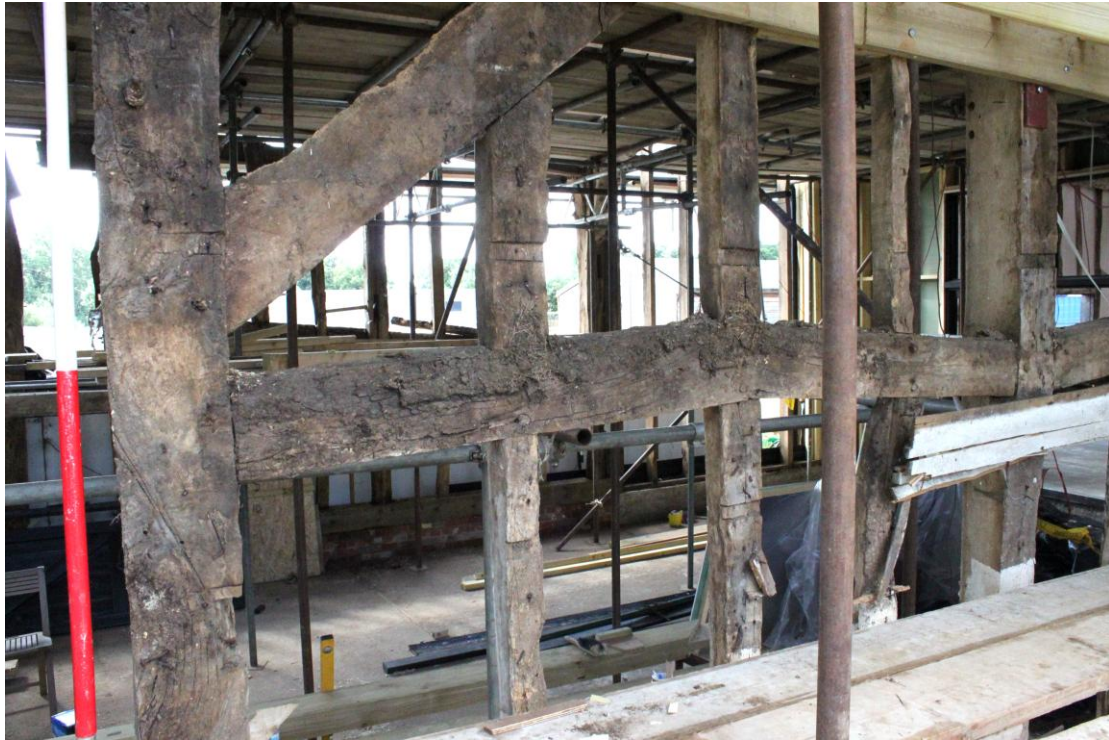
**Illus. 9. North-eastern external corner of eastern barn (1) showing wall brace with mid-rail and notches of original daub cladding.**

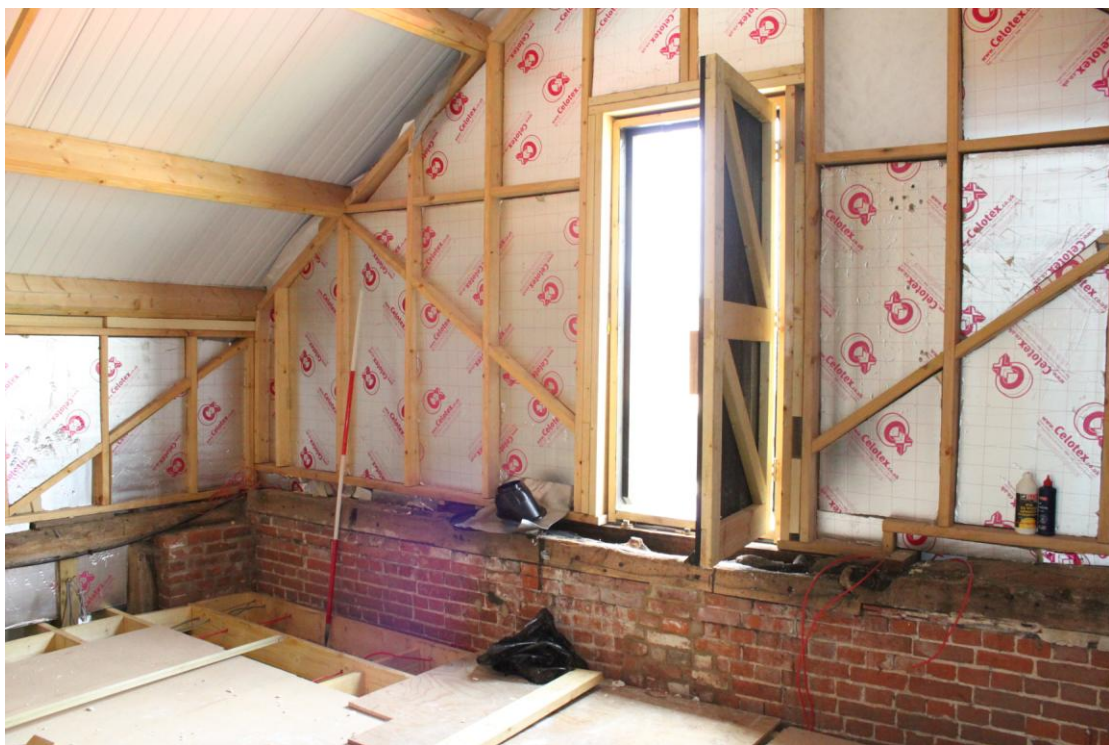
**Illus. 10. Internal south-western corner of two-bay first-floor granary (3) showing brick gable with upper walls of new softwood. The original roof-plate is visible to the left but the walls of the western bay have been raised.**
