**The Barn,  
Bridge Farm,  
Haughley New Street,  
Haughley, Suffolk  
HGH 044**

**Historic Building Record**

# The Barn, Bridge Farm, Haughley New Street, Haughley, Suffolk

## Historic Building Record

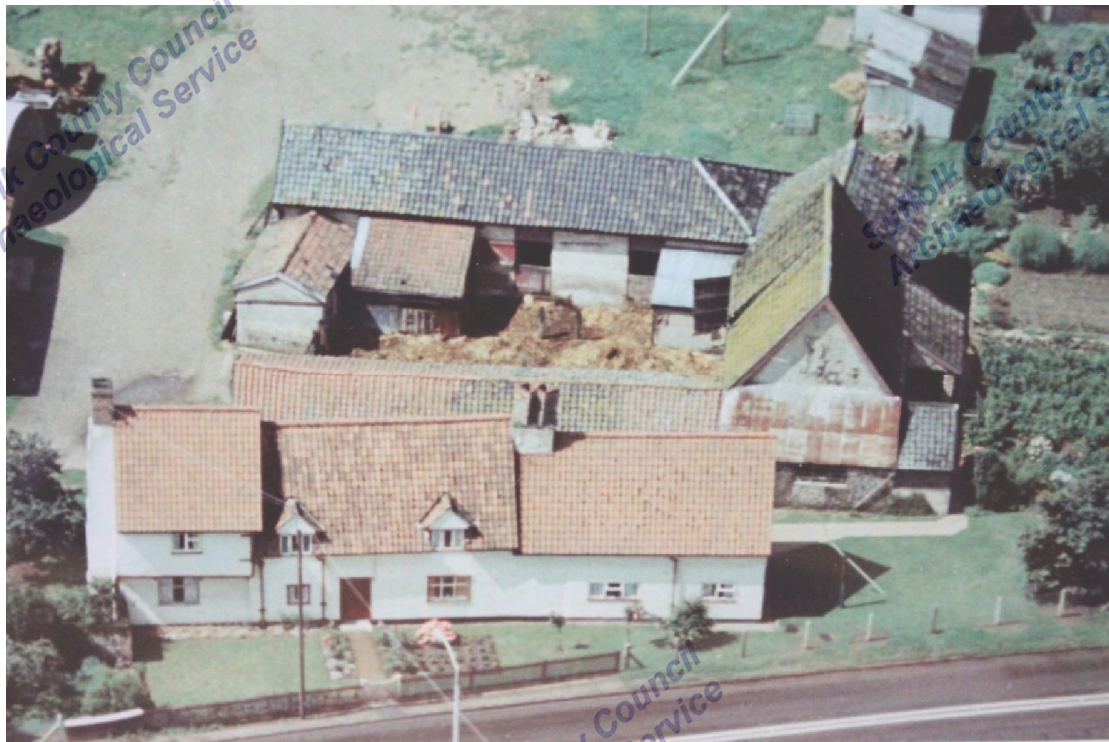
**Illus. 1.** Aerial photograph of site from east taken in *circa* 1970 and showing the farmhouse in the foreground with the enclosed cattle yard filled with straw to the south (left) of the barn. The different axis of the barn's western end is clearly visible (with lower roof in rear to right).

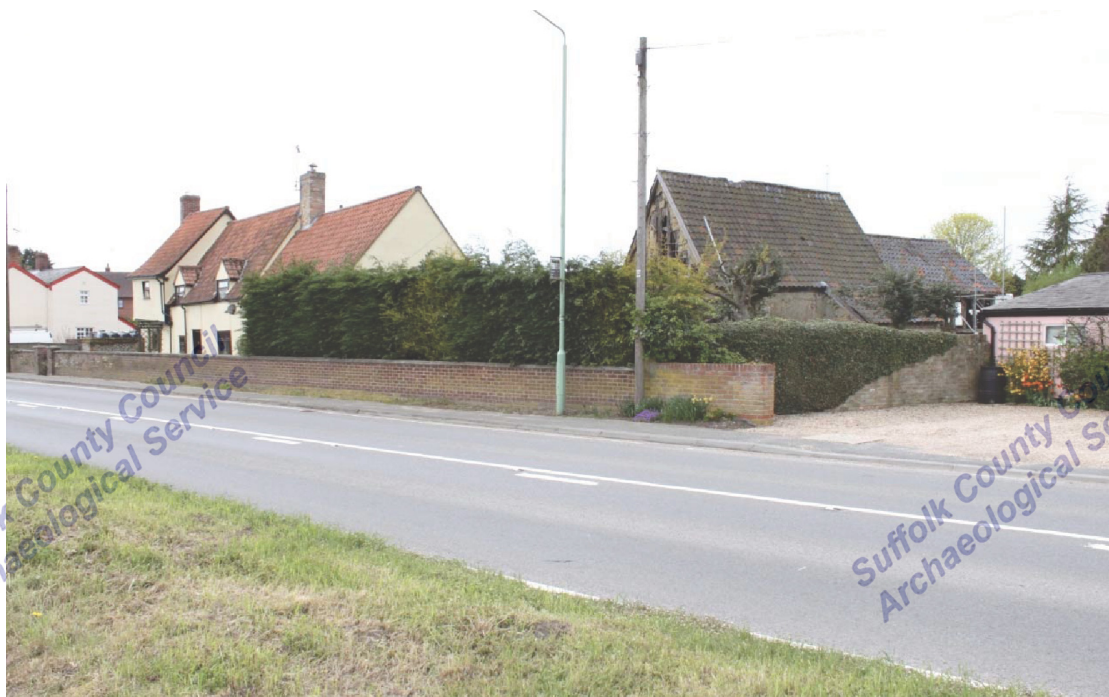
**Illus. 2.** General view of site from road to north-east showing the barn in rear to right and the farmhouse with a 15<sup>th</sup> century open hall in its centre to the left.

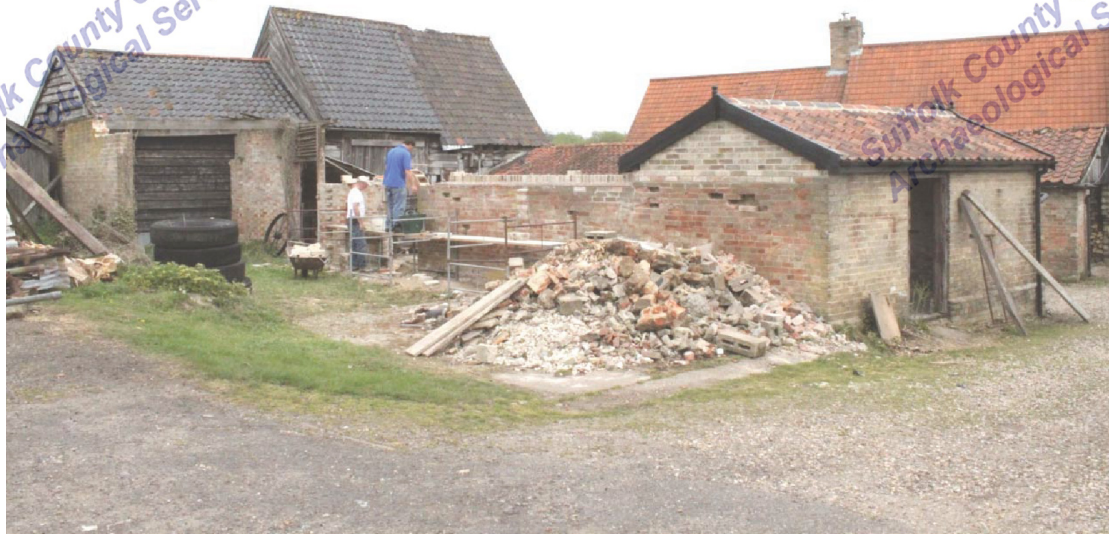
**Illus. 3. Exterior of southern yard complex from south-west showing barn in rear to left, brick feed shed (5) to right and site of demolished western range in foreground.**

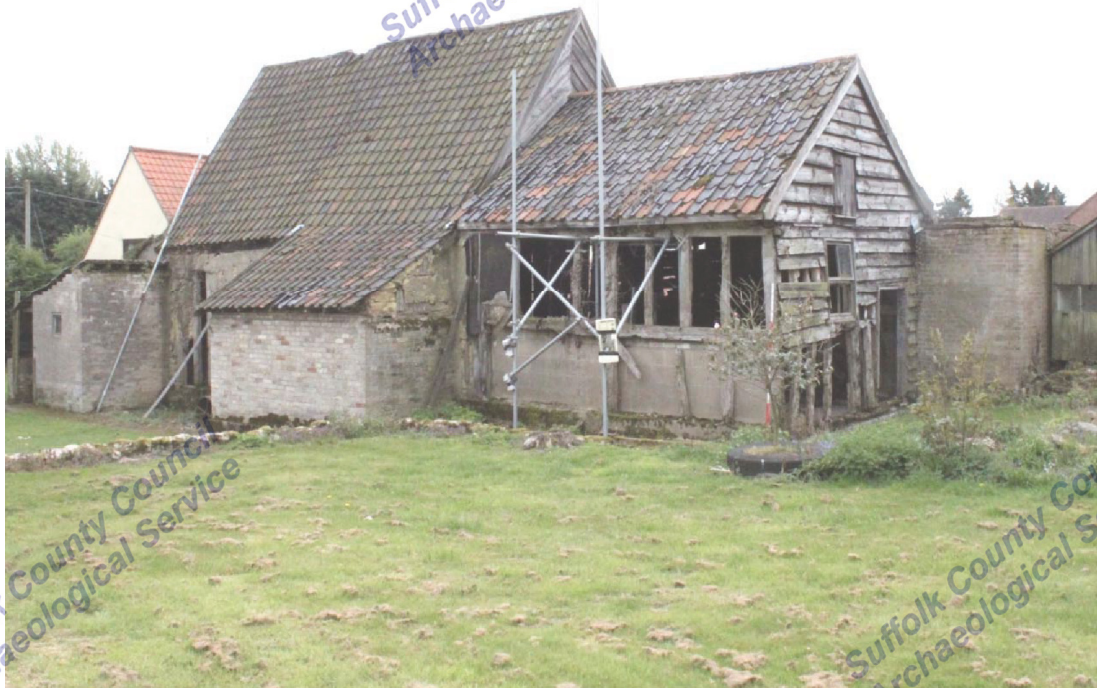
The two western bays extend to 5.6 m in length (18.5 ft) and lie beneath a low-pitched pantiled roof of clasped-purlins with nailed collars and a ridge board. The rafters rest on secondary roof-plates and the roof appears to be a mid-19<sup>th</sup> century replacement, but the open truss consists of storey posts without jowls or tie-beam braces of any kind and is unlikely to pre-date the beginning of the same century. Its studs are interrupted by mid-rails and diagonal primary braces in the typical 19<sup>th</sup> century manner but many individual timbers show signs of re-use from one or more buildings of the 17<sup>th</sup> century or earlier and some are encrusted with soot (indicating they belonged to a medieval hall house). The structure may have been designed as a stable with a loft supported on its mid-rails, as suggested by a glazed window, doorway and high loading hatch in the gable, but the walls have been much rebuilt in 20<sup>th</sup> century block-work and this is not certain. The two bays taper from 5.6 m in width to the east to 5.1 m at the western gable (18.5 ft to 16.75 ft) and lie on a slightly different axis to the rest of the barn, possibly reflecting the early field boundaries shown in figure 2.

**Illus. 4. Exterior of barn from north-west showing the low roof of the rebuilt western end to right and the formerly thatched steeply pitched 17<sup>th</sup> century roof of the central and eastern bays to left.**

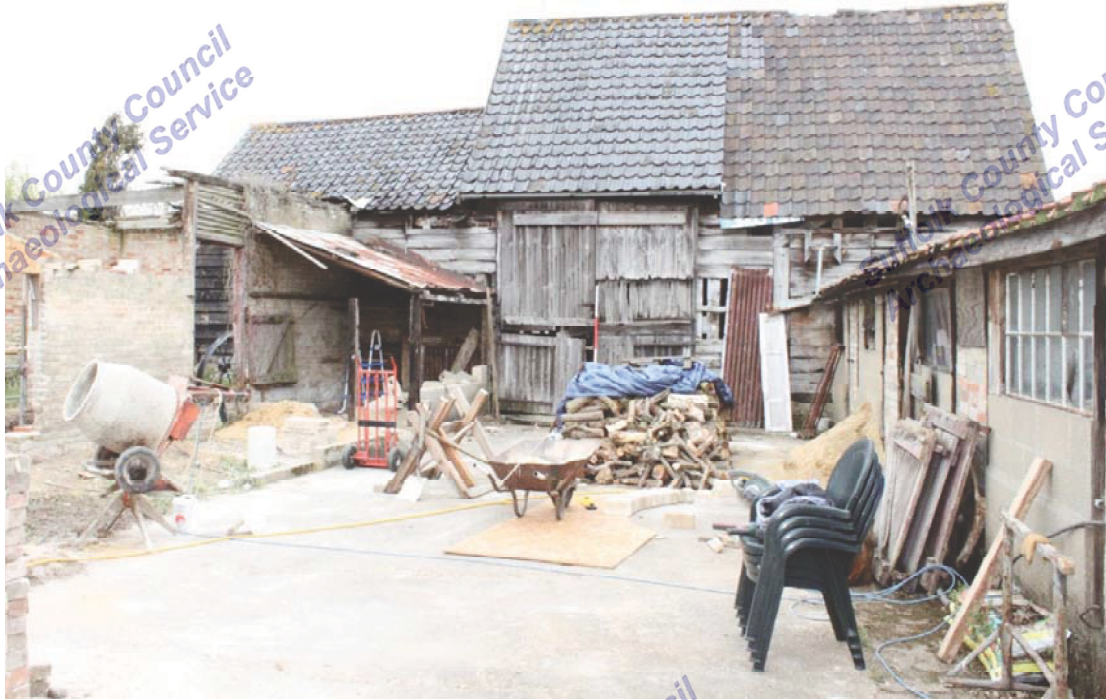
With 3.3 m between its storey posts (11 ft) the penultimate eastern bay is considerably narrower than its neighbour of 4.5 m (15 ft) and was clearly designed to accommodate the barn’s entrance. The southern roof-plate has been renewed at a higher level to increase headroom, and it contains late 19<sup>th</sup> century half-hung barn doors with original grey pigment to the interior. The northern plate is original and lacks mortises for both studs and door jambs: it now opens onto a lean-to porch which was rebuilt in brick beneath its roof-plate in the 20<sup>th</sup> century and now lacks the doorway normally found in this position. Its tie-beams are pegged to the storey posts and the studwork of its roof-gables contains infill of rendered wattle-and-daub, suggesting an origin at the beginning of the 19<sup>th</sup> century or before, but the porch is conspicuous by its absence from the tithe map of 1845. An original 17<sup>th</sup> century porch would certainly have been expected here given the lack of mortises in the adjoining roof-plate and it may have been hidden from the cartographer by lean-to sheds on both sides. A good mid-19<sup>th</sup> century threshing floor of gault brick extends into the present enclosed shed from the barn’s entrance bay, but the floors have been renewed in concrete elsewhere.

**Illus. 5.** Southern exterior of barn from cattle yard showing raised roof over central entrance doors and rebuilt western end to left.

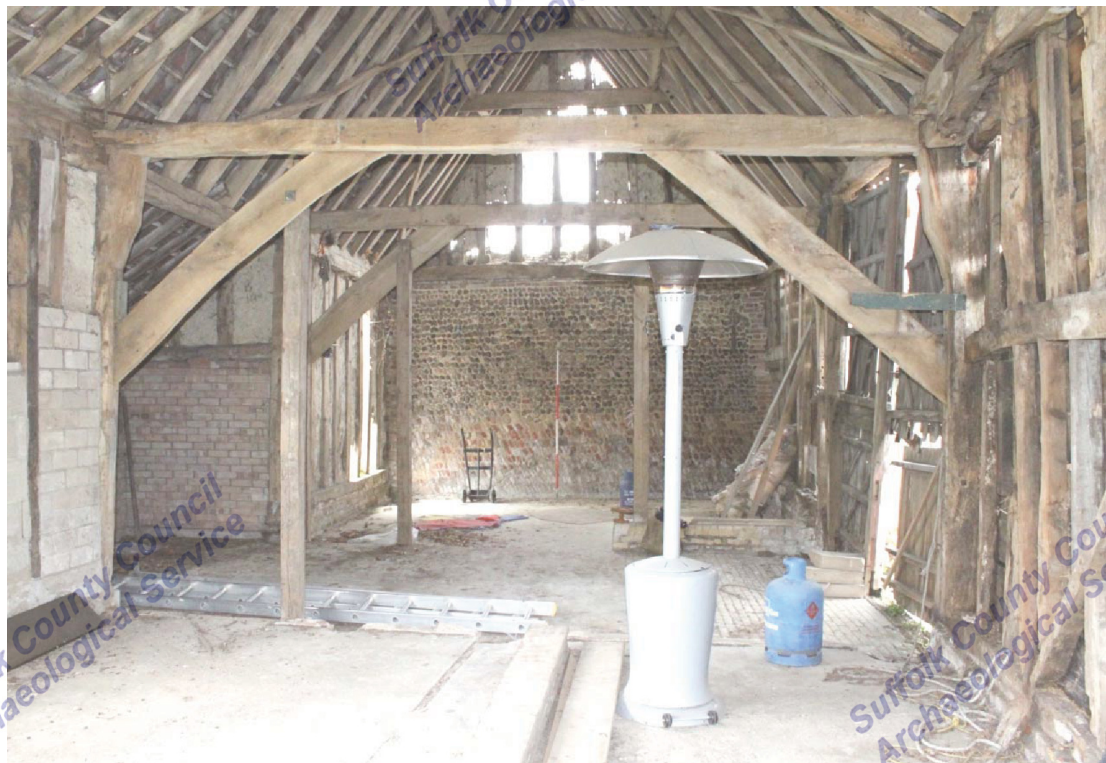
**Illus. 6.** Interior of barn from west showing 17th century arch-braces to tie-beams of central bay

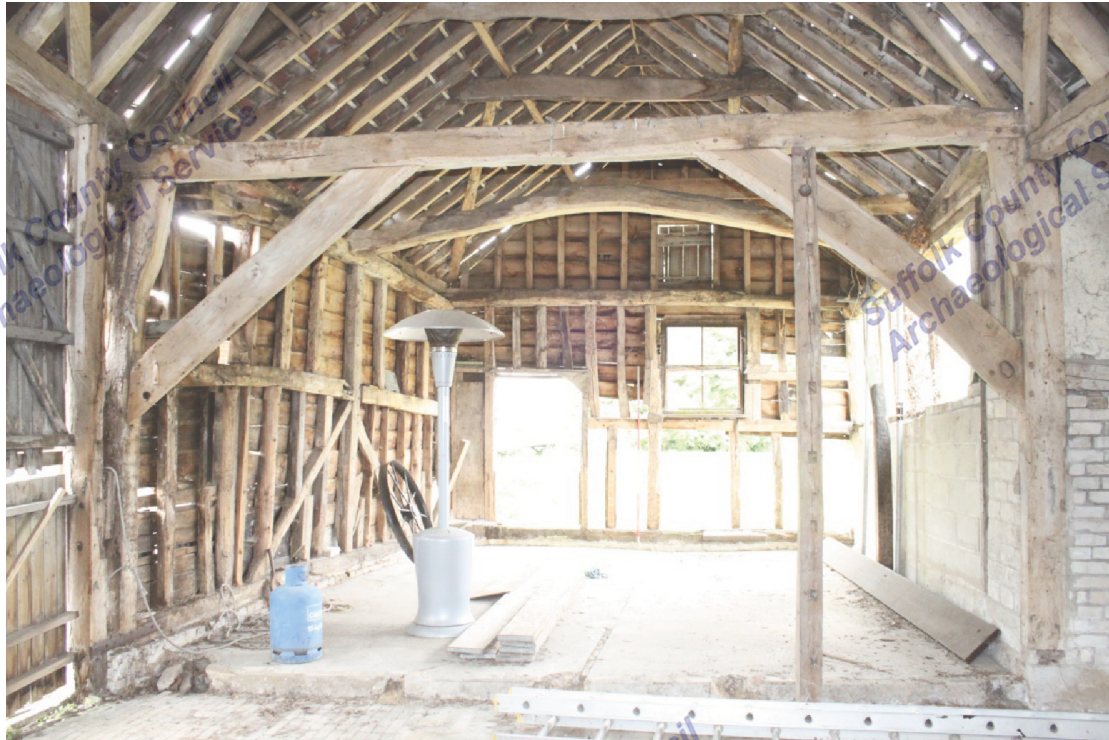
**Illus. 7.** Interior of barn from east showing rebuilt western end on different alignment with central threshing bay in foreground.

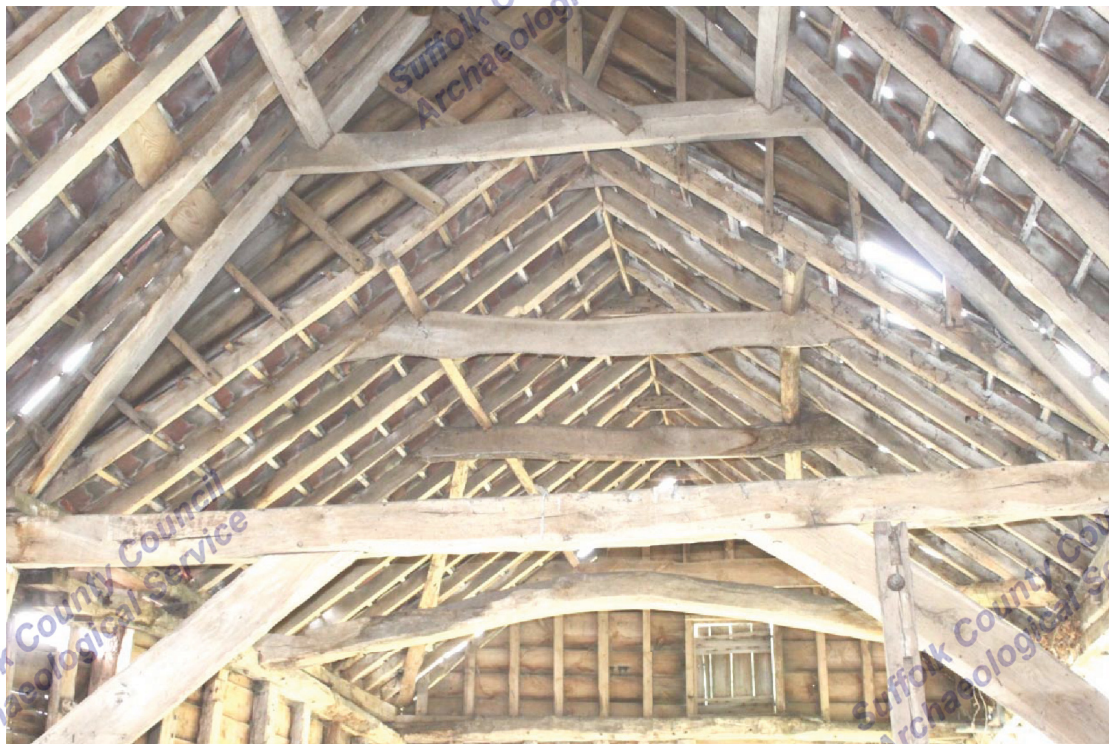
**Illus. 8.** Roof structure of barn from east showing steeply pitched 17th century roof in foreground and low pitch of 19th century western bays in rear.

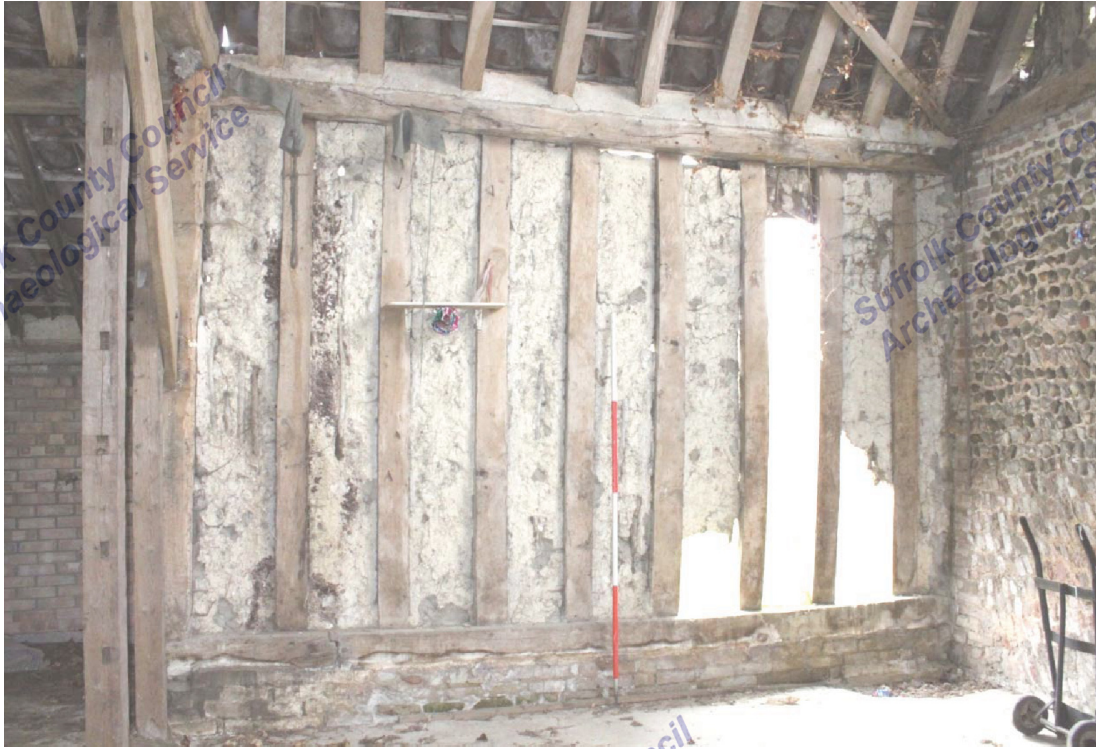
**Illus. 9.** Northern interior of eastern bay showing good-quality 17<sup>th</sup> century studs with externally trenched wall brace (top-right) and rebuilt 19<sup>th</sup> century flint gable to right.

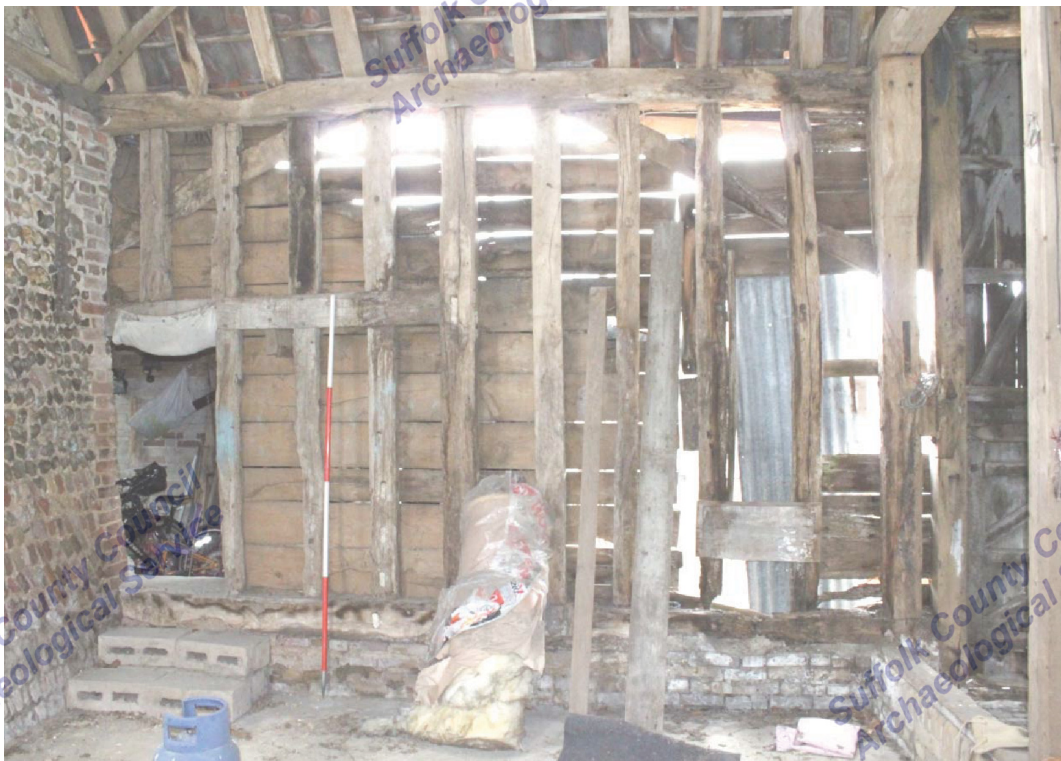
contains externally trenched braces to its oak studs of 2.6 m in height (or 8.5 ft between roof-plate and ground sill). The southern elevation also possesses two external braces but – unusually – a mid-rail extends from the corner post to its mid-point. The northern studs are not re-used, but those to the south are medieval timbers with evidence of sooting and diamond-mullion windows (i.e. diamond-shaped mortises for the mullions of a medieval window). The mid-rail was probably necessary to compensate for a deficit of old timber of sufficient height, and the better quality of the northern frame suggests it may have been exposed externally where the opposite wall was rendered: selective exposure of this kind was commonplace, with the ‘best’ facade designed to impress those approaching from the north (from which direction the barn is still clearly visible from the road). These various features indicate a date in the mid-17<sup>th</sup> century (trenched braces were quickly replaced by primary braces which interrupt the studs during the second half of the same century). The present decayed wattle-and-daub and external clay render to the northern elevation and the upper part of the eastern gable is probably an addition of the 18<sup>th</sup> century rather than an original feature. The northern elevation is boarded where it adjoins the yard.

**Illus. 10.** Southern interior of eastern bay showing re-used timber with unusual partial mid-rail to left and externally trenched wall braces.

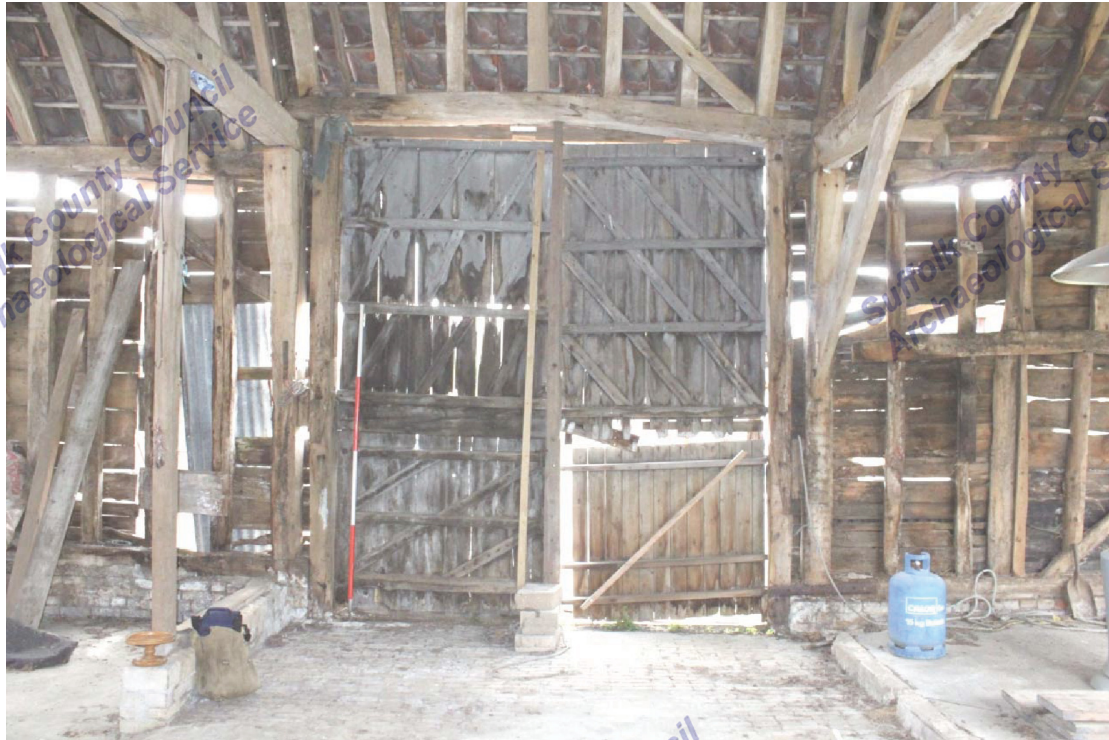
**Illus. 11. Southern interior of central bay showing brick threshing floor and grey pigment to barn doors. The original arch-brace to the left-hand tie-beam has been removed and the vertical post is a modern insertion.**

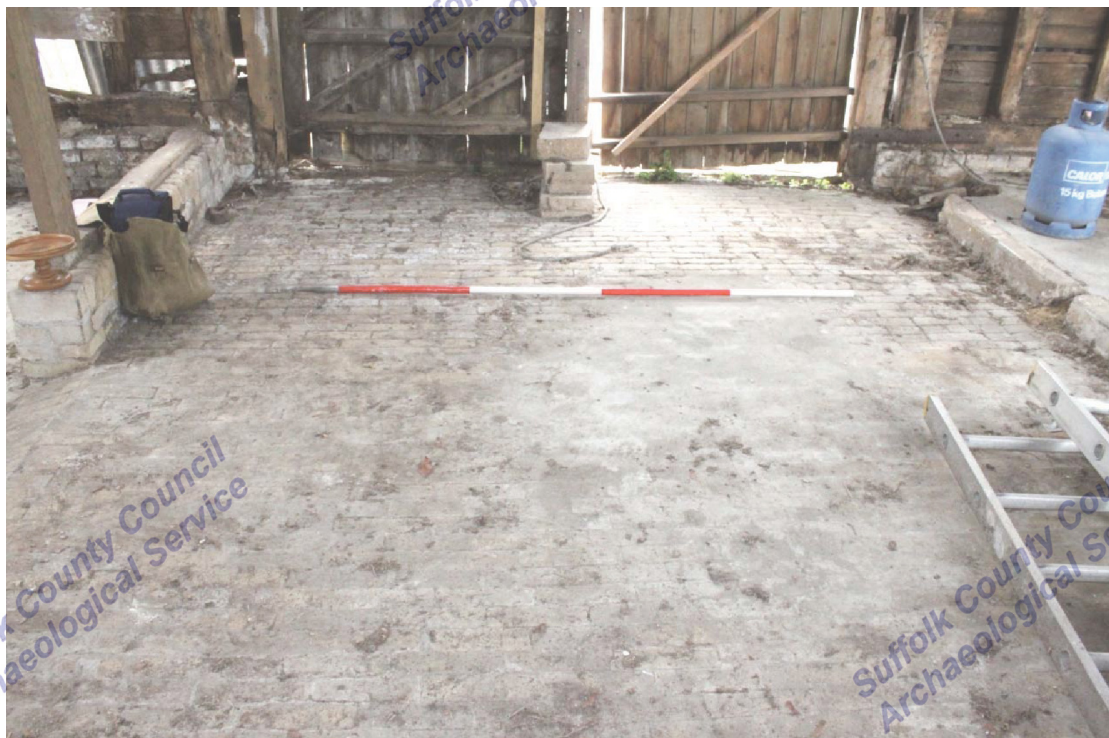
**Illus. 12. Gault (white) brick threshing floor to central bay of barn seen from north.**

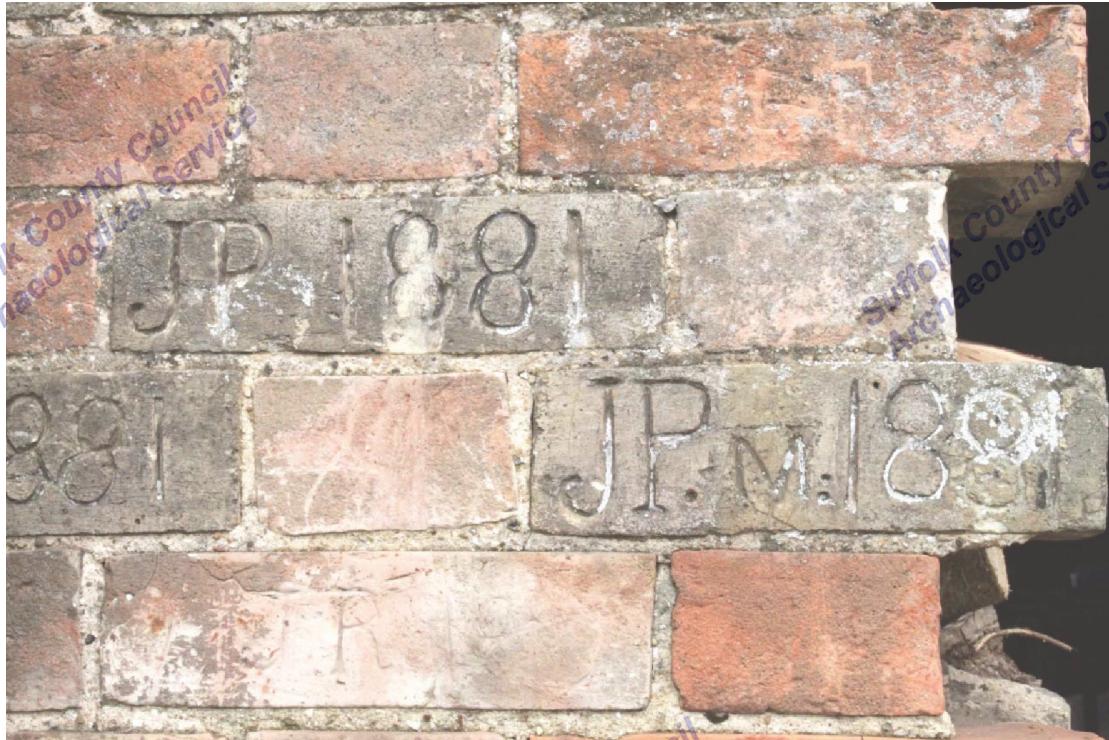
Illus. 13. Detail of the boldly incised initials and dates in the brickwork of the southern exterior of the eastern shed (3): 'J.P. 1881'. The shed is not shown on the Ordnance Survey of 1886 and the 'Woolpit white' bricks are probably re-used from an earlier building (they differ in colour from the surrounding red brickwork).
