**Barn at
West Hall Farm,
Rickingham, Suffolk
RKN 039**

Historic Building Record

OASIS ID: Suffolkc1-81287

August 2010

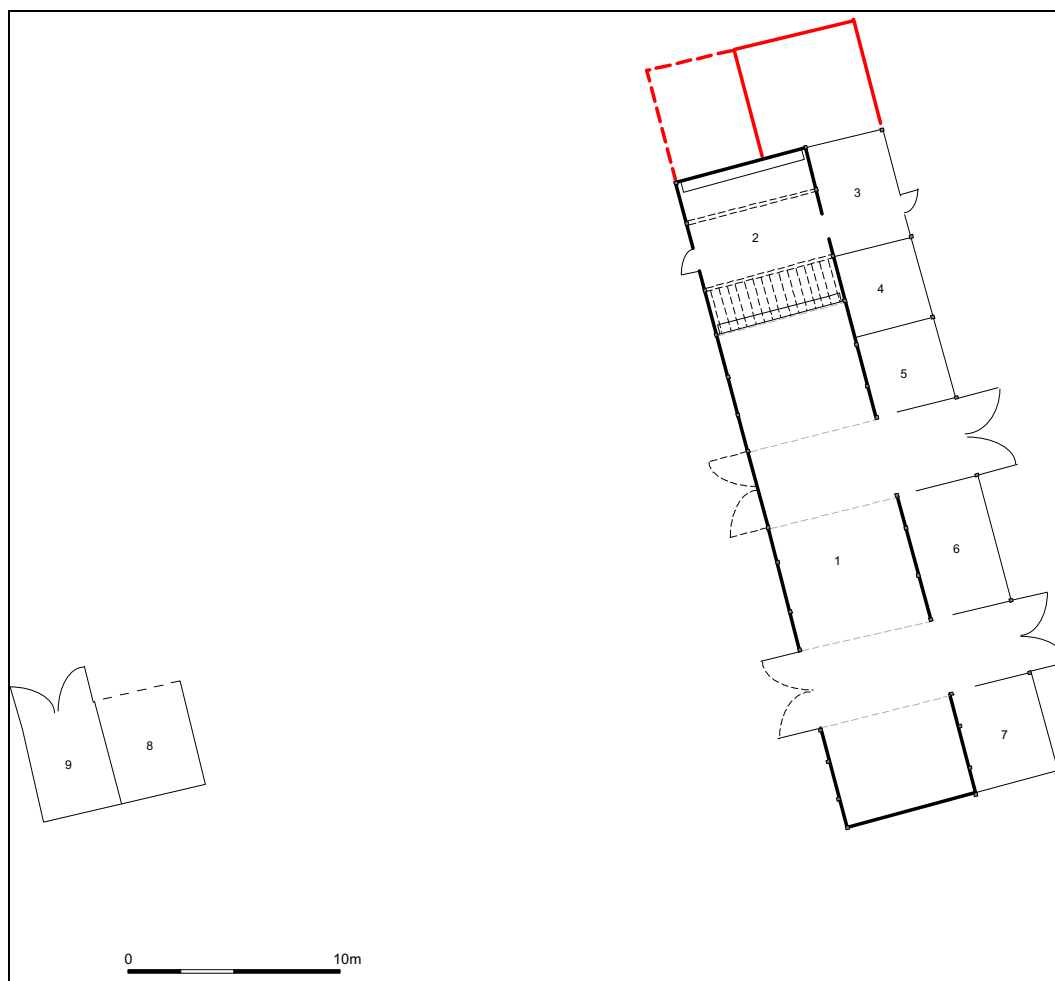
Figure 5

**Block Plan of Barn (showing the cartlodge/granary to the west).
Each historic area is identified by a number for ease of reference in the text and photographic record.**

1. Five-bay open barn with two threshing floors entered by full-height doors to the west with low eastern doors in lean-to rear porches.
2. Two-bay stable and hay loft with central cross-entry. Original boarded mangers to northern and southern gables with evidence of hay racks above. The ceiling of the southern bay remains intact but that of the northern bay has been removed.
3. Lean-to tack room retaining original bentwood harness hooks.
4. Lean-to chaff box (feed store) with hatches to tack room, hay loft and corner of open barn.
- 5-7. Lean-to grain stores flanking the lean-to porches which project from the two threshing bays.

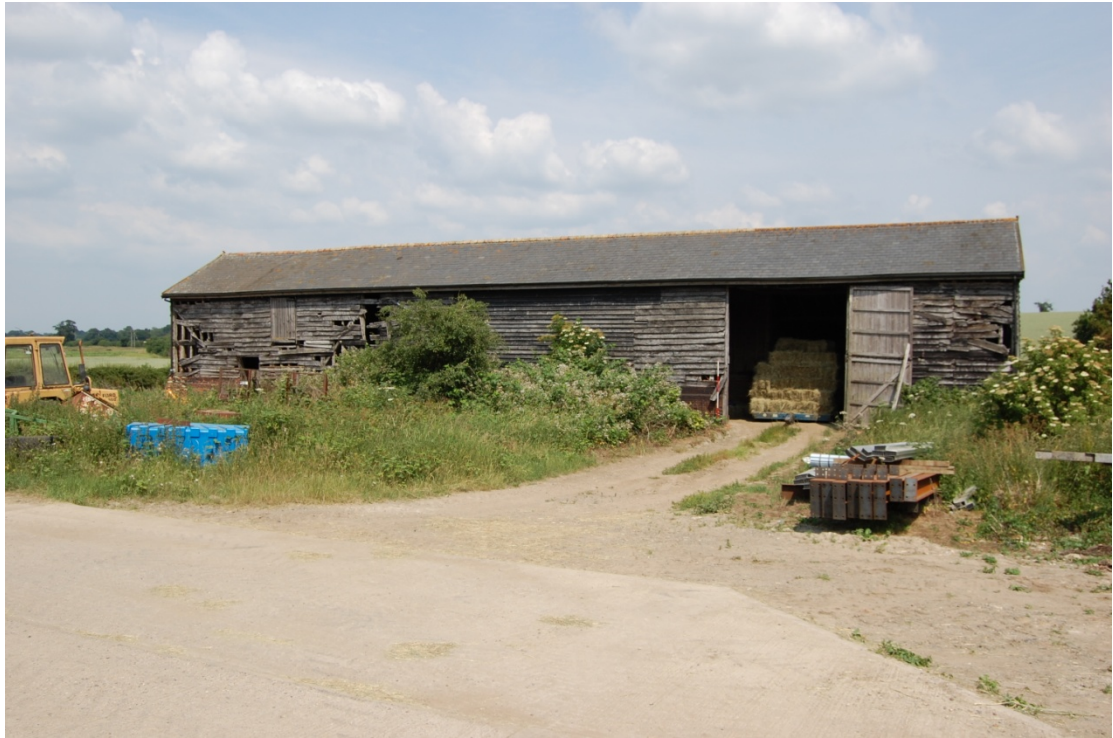
Illus. 1. General view of the barn's external western elevation showing the stable to the left and the twin entrances of the barn to the right

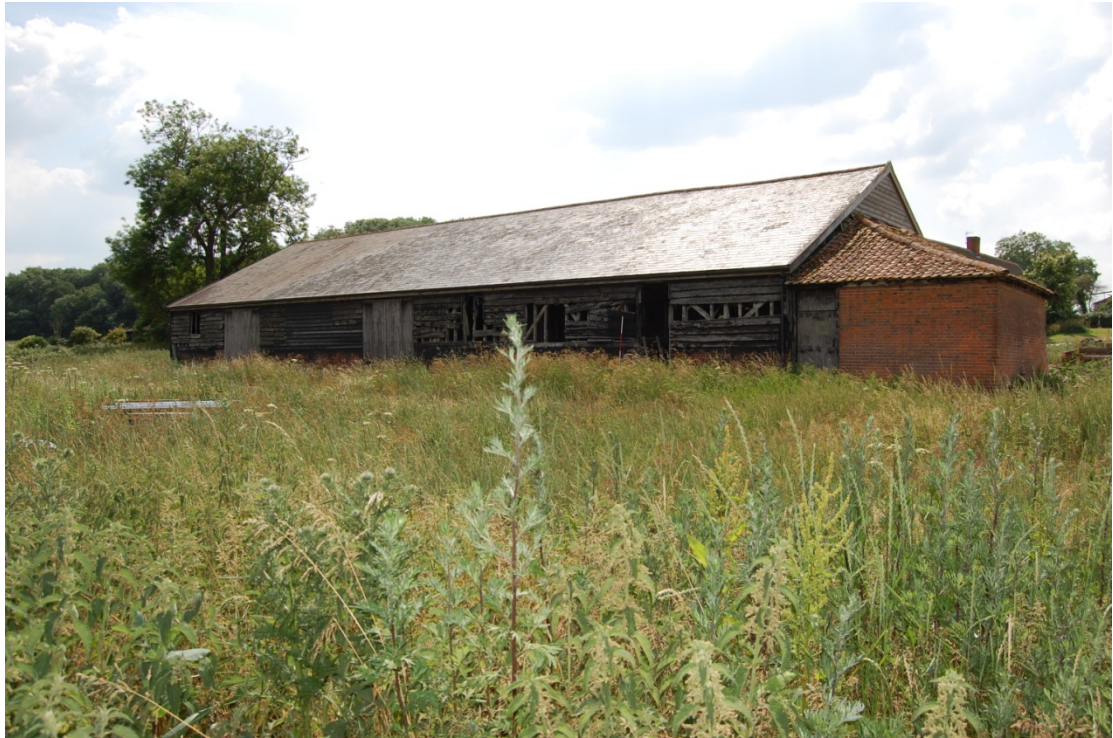
Illus. 3. General view of the barn exterior from the east showing the integral lean-to tack room (right) and store rooms to the rear elevation.

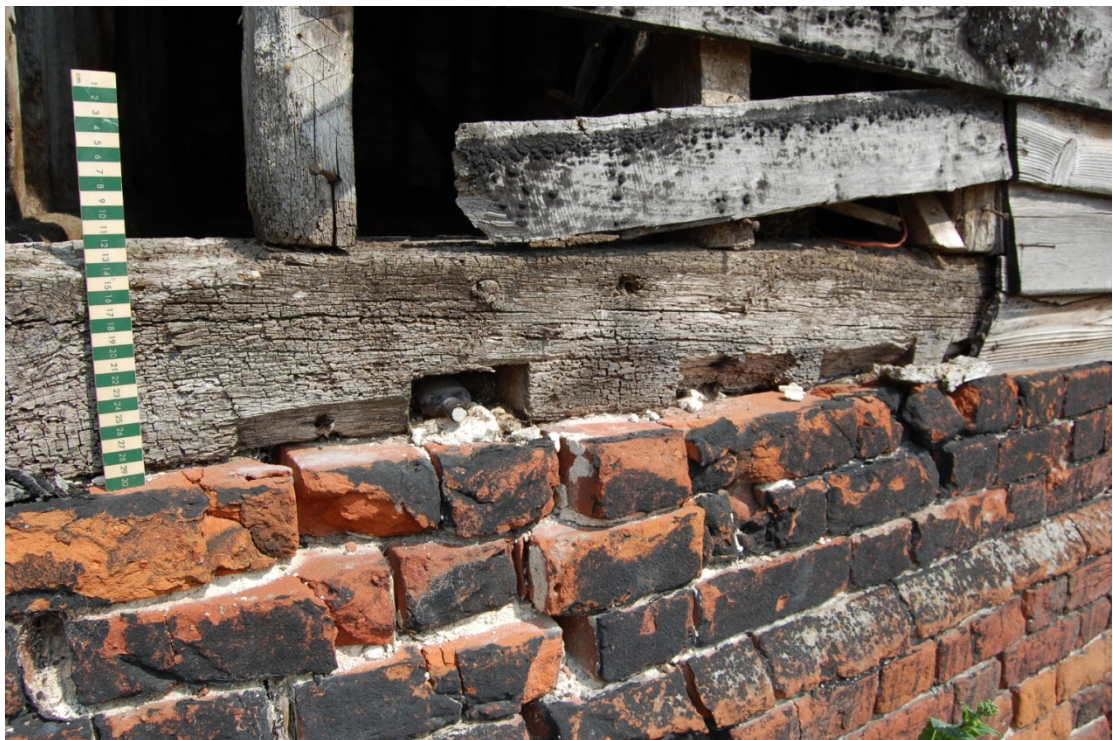
Illus. 4. NW corner sole plate made up of reused wall plate chamfered for rafters. Plinth damaged by impact.

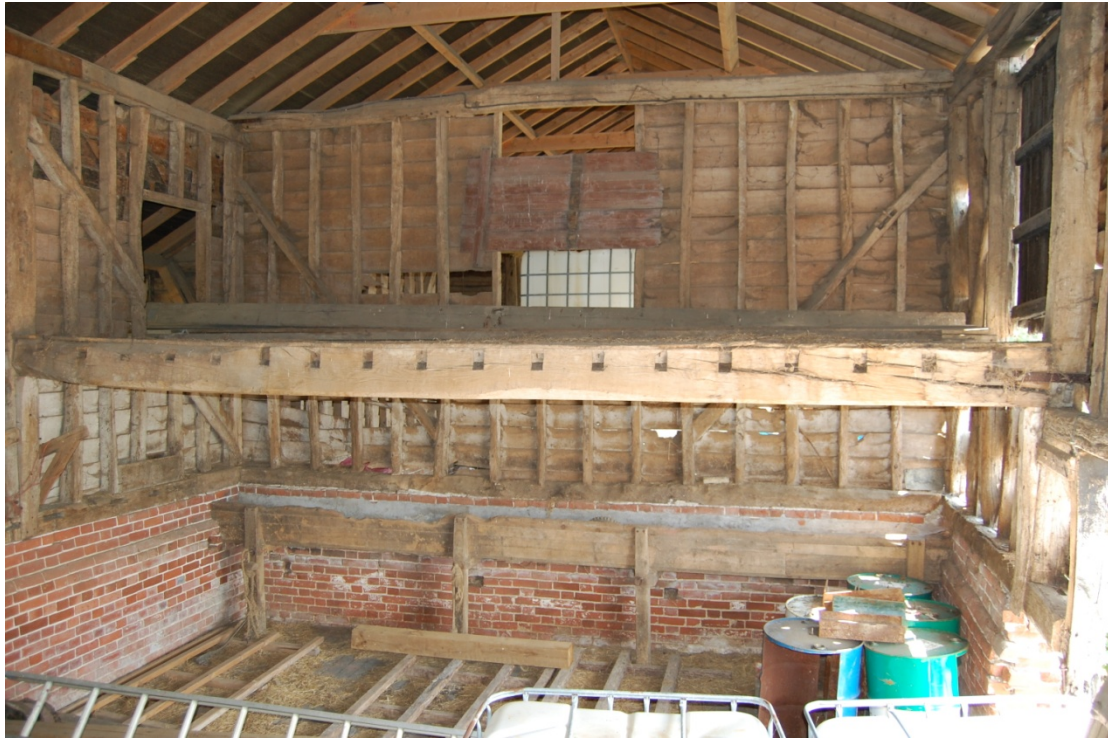
Illus. 5. Loft floor over stable (2) viewed from north, showing empty mortices where the floor has been truncated to the south.

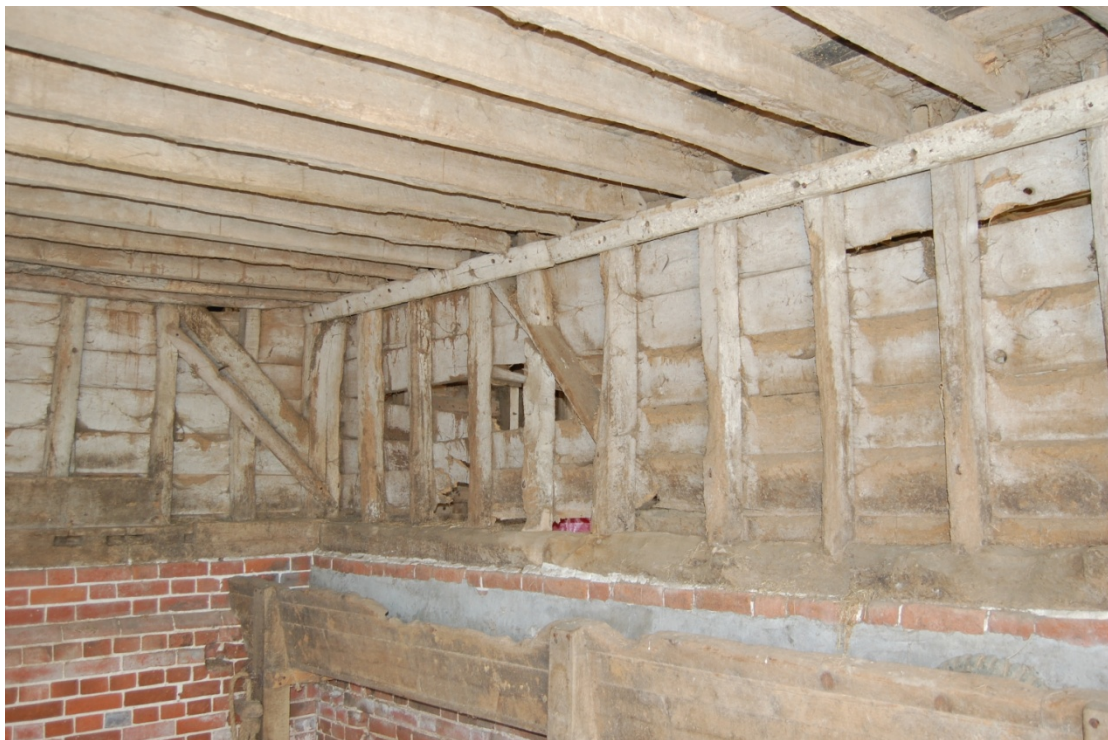
Illus. 6. South-eastern internal corner of stable (2) showing trough against southern interior and end-rail of missing hay rack. The joists of the loft are supported on a clamp nailed to the studs.

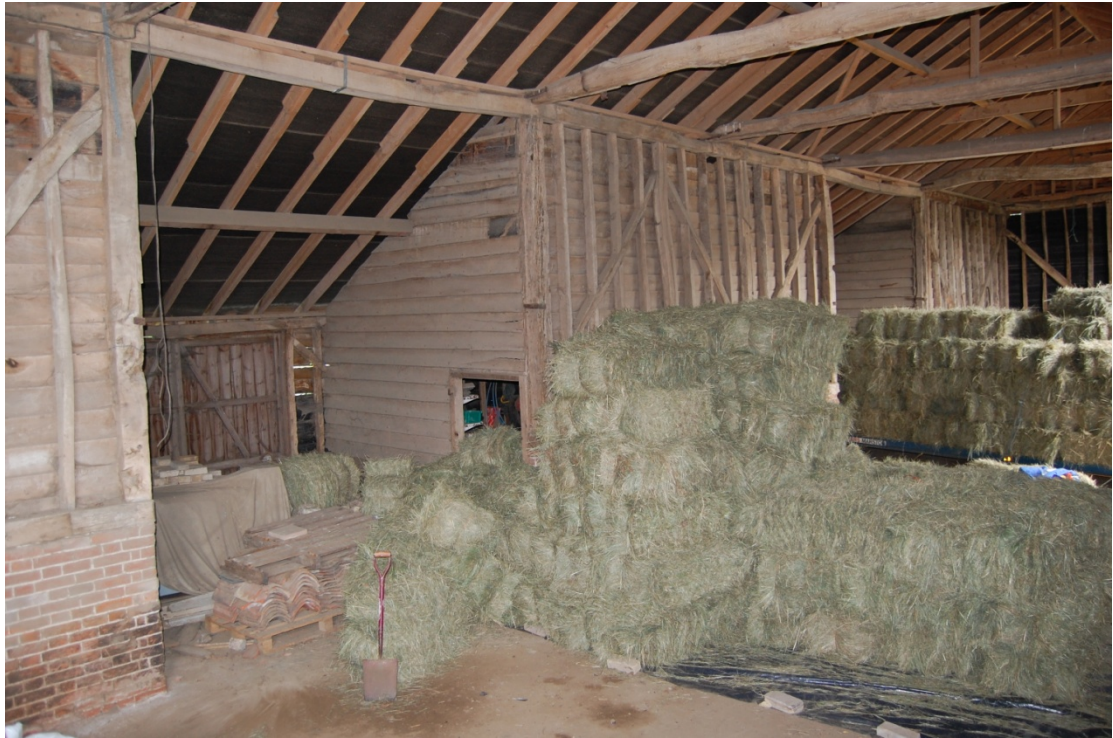
Illus. 7. Interior of the main barn showing the rear (eastern) doors of the two threshing bays linked by integral lean-to sheds. Note the recently renewed softwood roof structure.

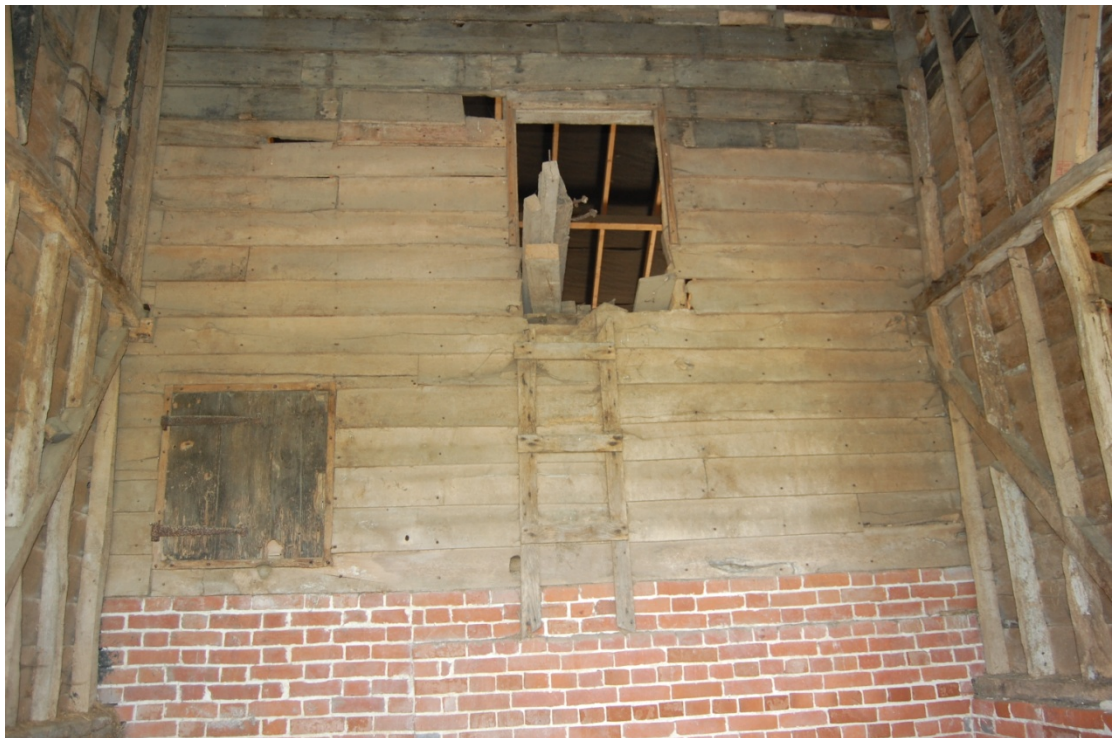
Illus. 8. Hatches connecting the barn and loft to the eastern feed store (4) seen from the feedstore.

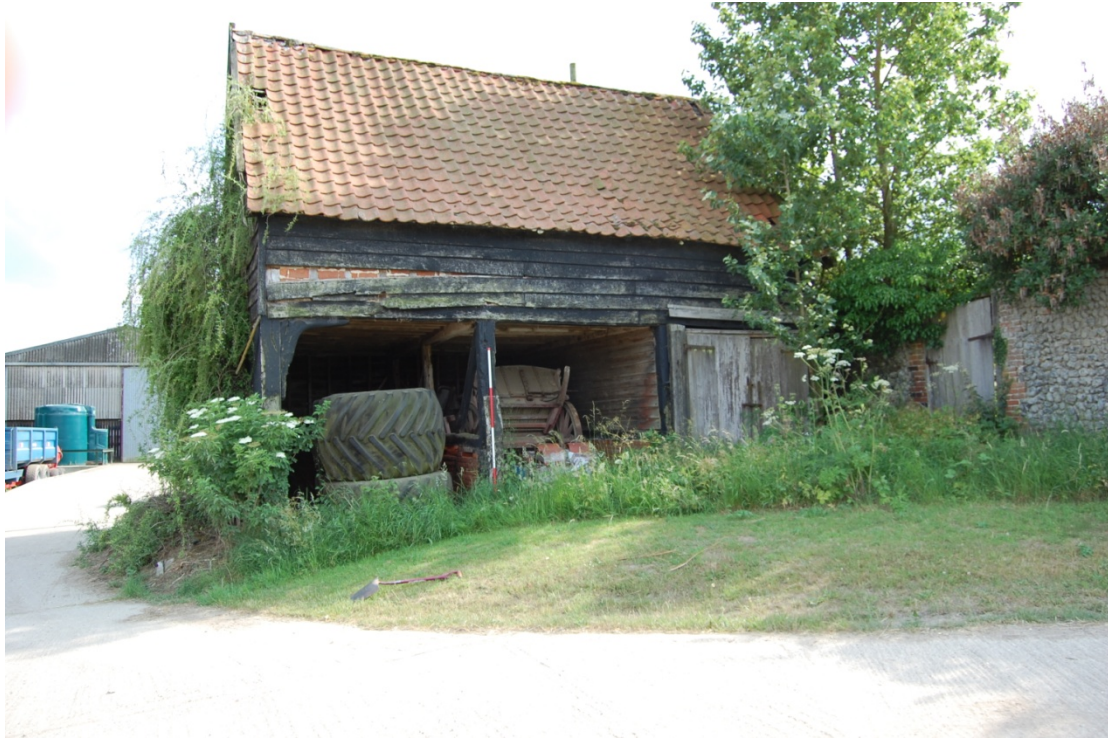
Illus. 9. The cartlodge and granary seen from the north, showing the enclosed shed (9) to the right and the open lodge (8) to the left.

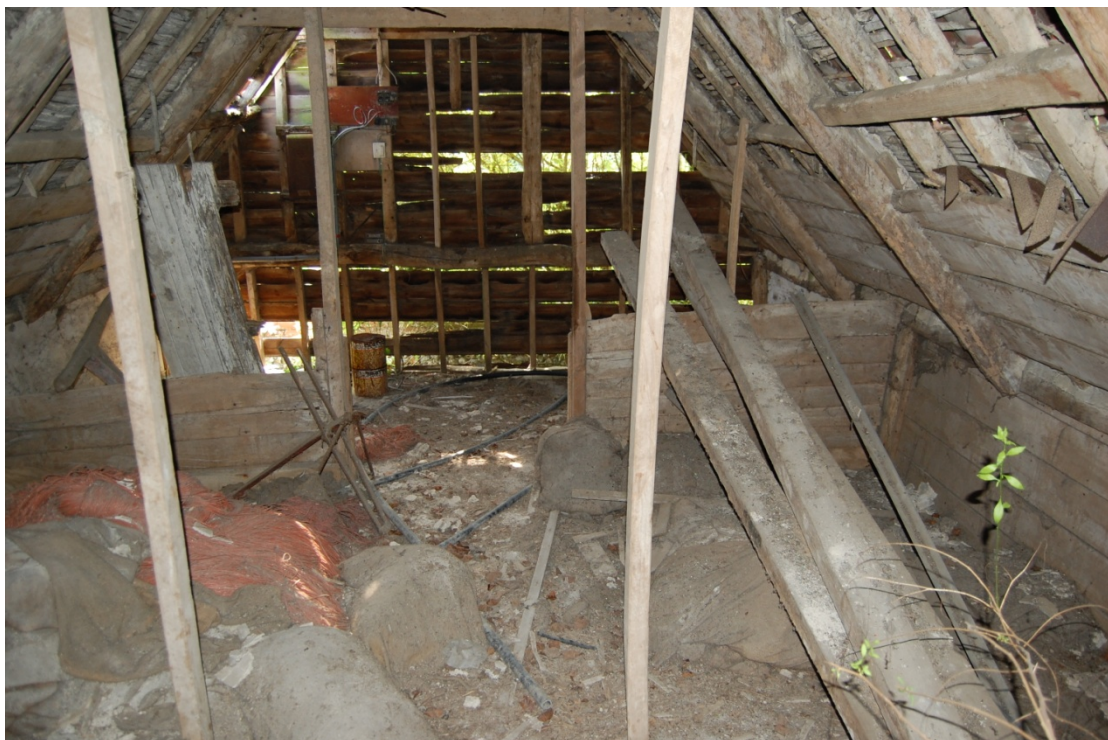
Illus. 10. First floor granary (8 & 9) viewed from the door in the eastern gable showing the staggered butt-purlin roof structure.
