**Tudor Lodge Farm,
Gestingthorpe,
Essex
GETL09**

Historic Building Record

Farm Buildings at Tudor Lodge Farm, Maplestead Road, Gestingthorpe, Essex

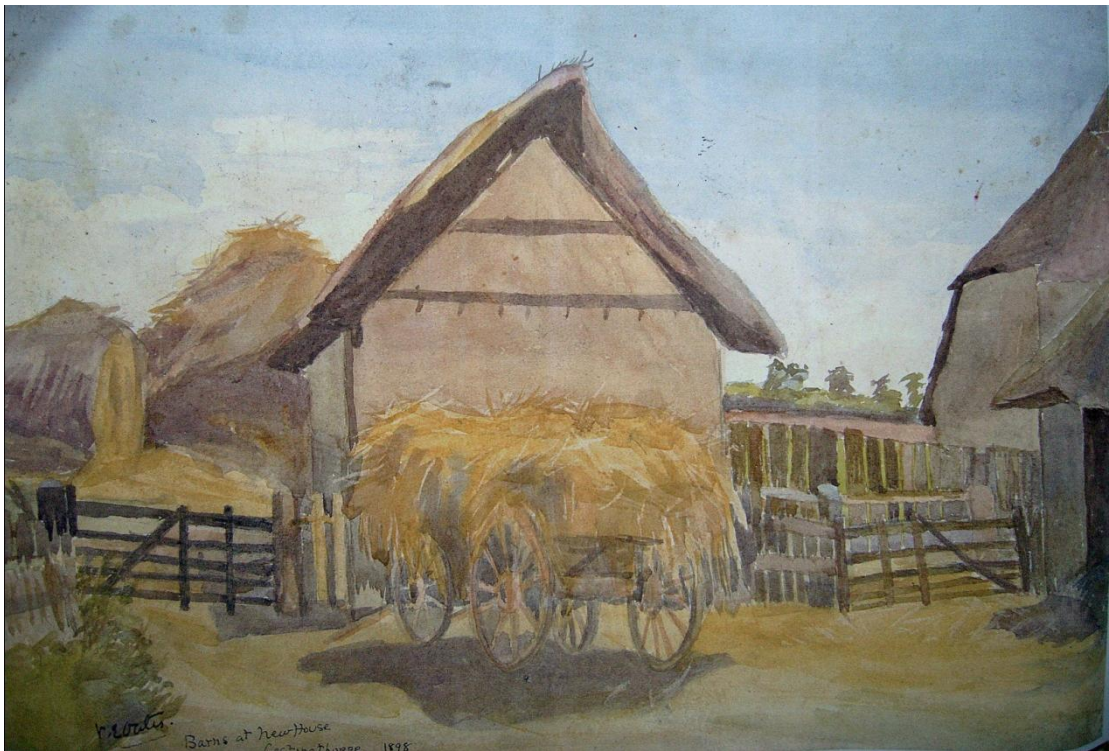
Illus. 1. Painting of site showing western gable of stable (2) with northern gables of barn (1) and shelter-shed (3) to right. All three roofs are thatched. Signed 'R.E. Oates (?): Barns at New House Gestingthorpe 1898'.

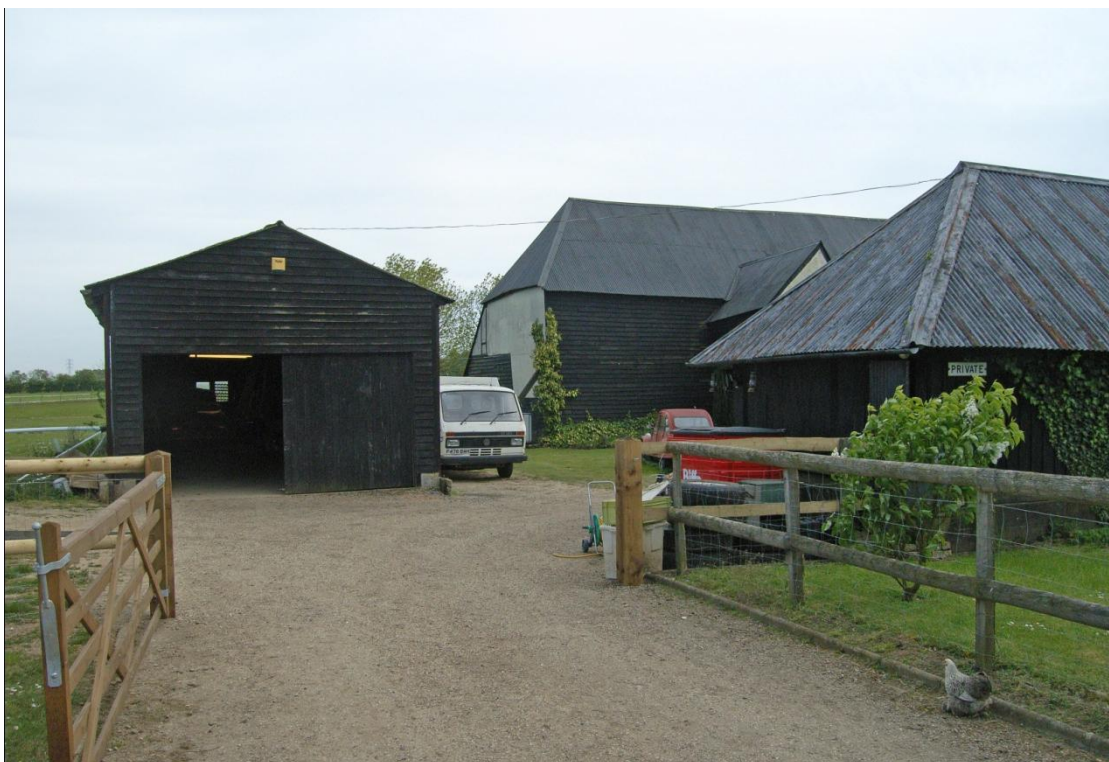
Illus. 2. Modern equivalent of 1898 painting showing stable (2) with replaced roof of reduced pitch to left to left with the barn (1) and shelter-shed (3) to right.

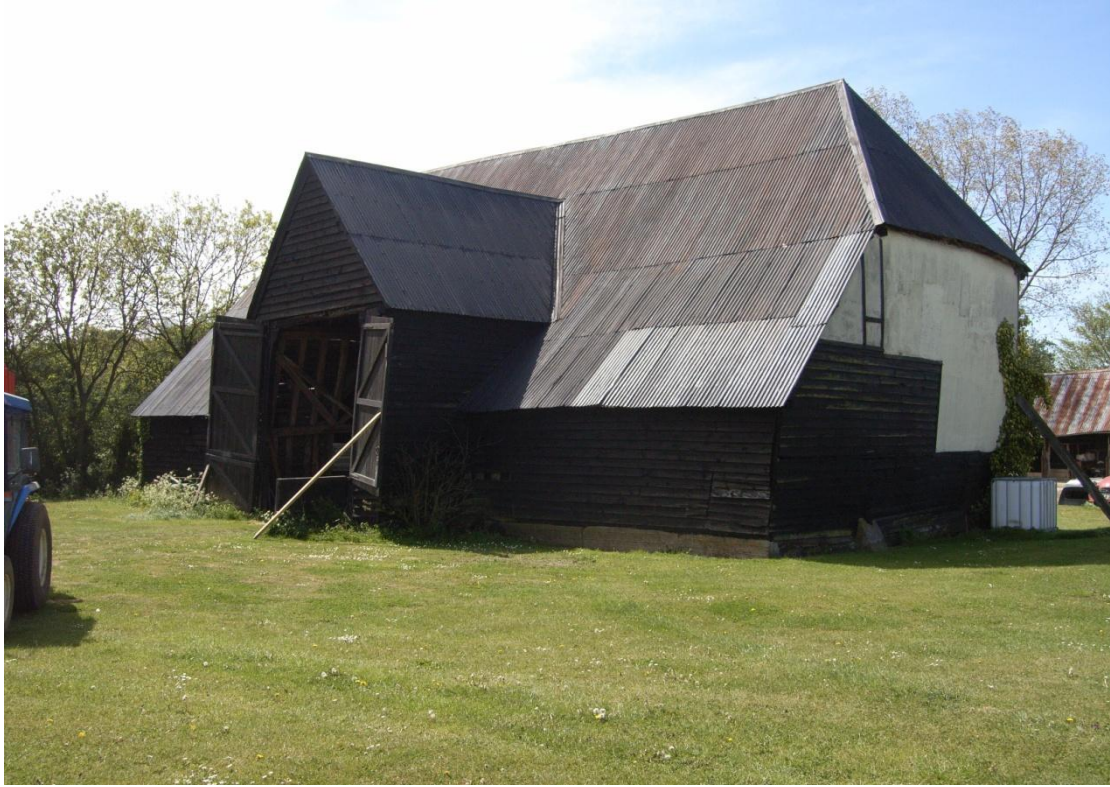
Illus. 3. Exterior of barn (1) from north-east showing secondary aisle and gabled porch with original hipped northern gable (lacking its gablet) to right.

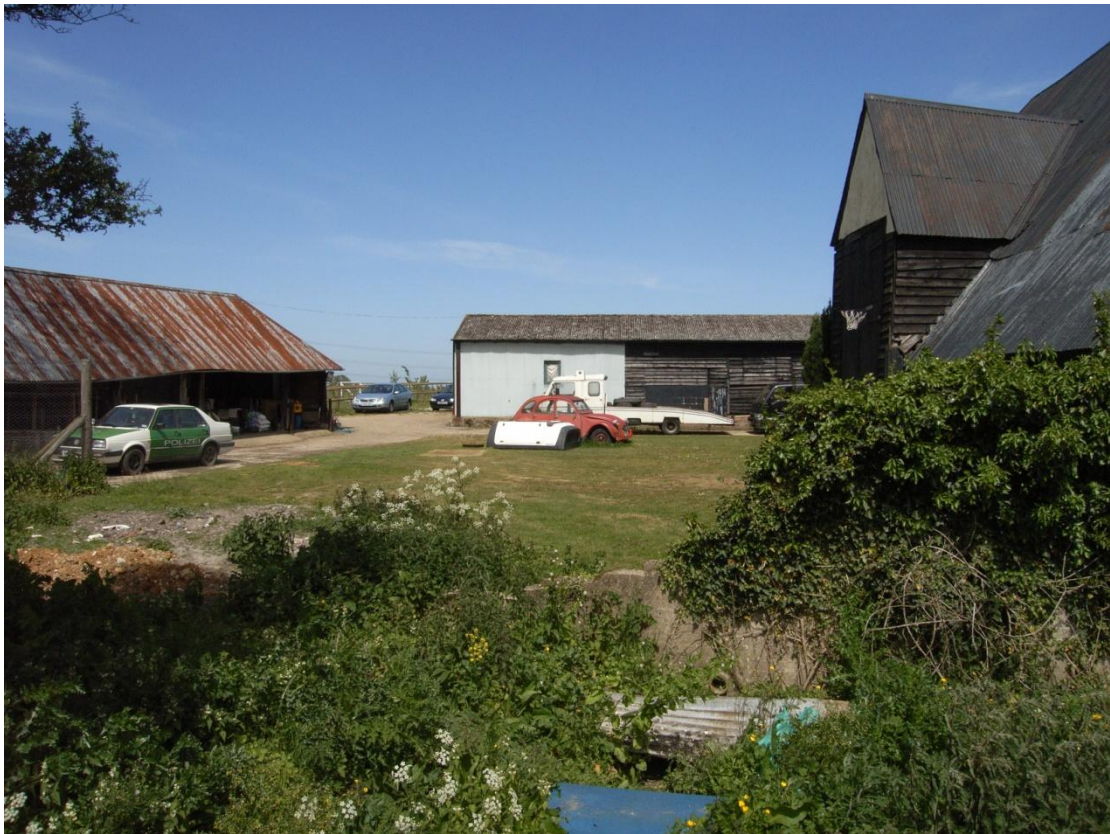
Illus. 4. Farm yard from south showing the late-16th century barn (1) to right, the early-17th century stable (2) in centre rear and 19th century shelter-shed (3) to left.

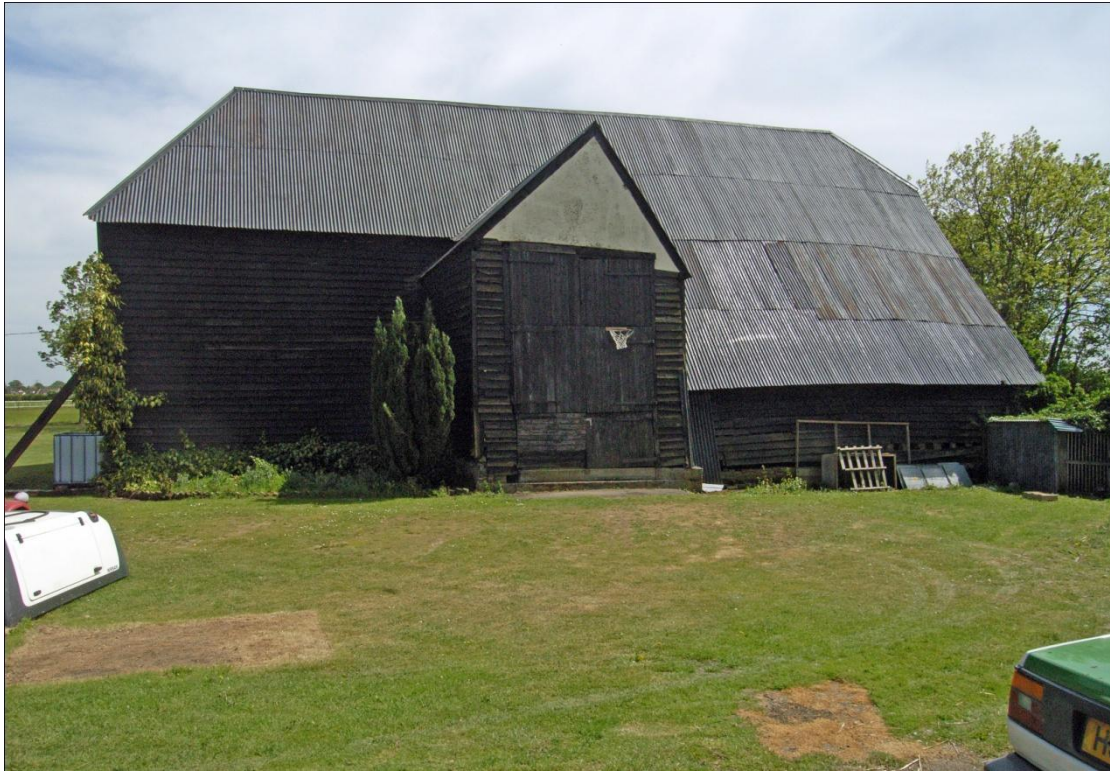
Illus. 5. Western external elevation of barn (1) from the yard showing the original porch and wall height to the left with the later aisle to the right.

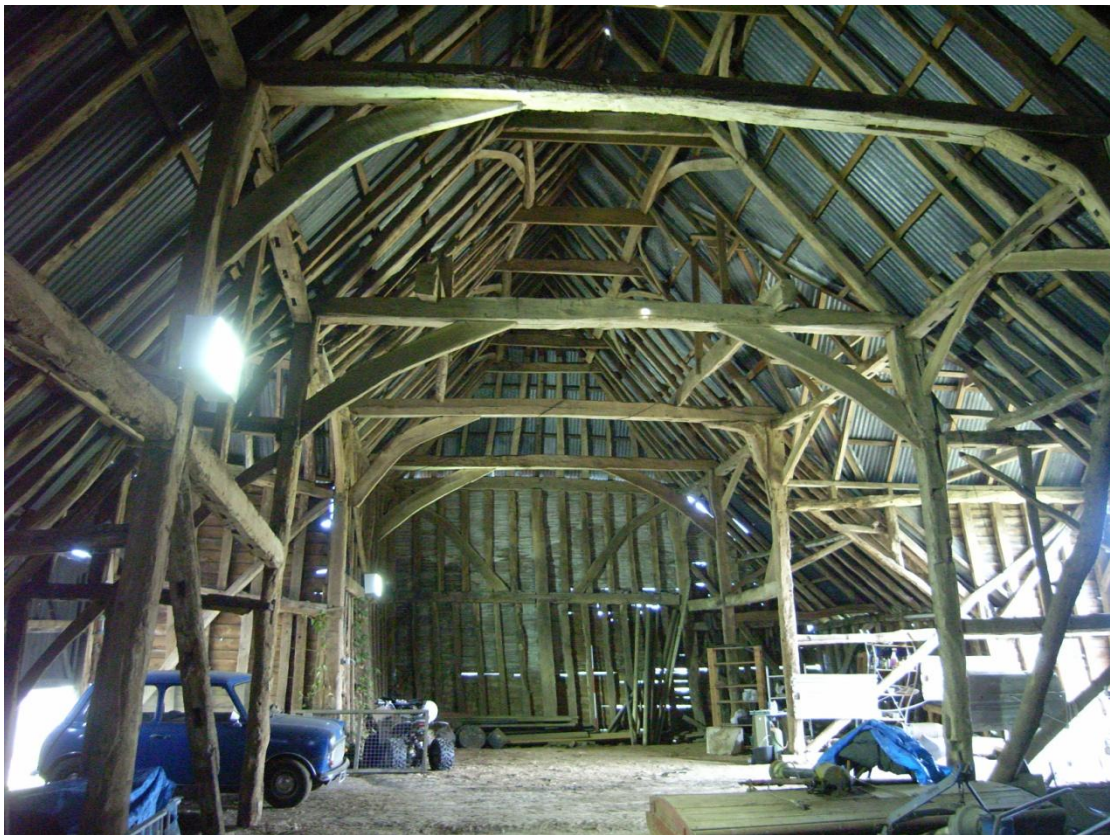
Illus. 6. Barn (1). General view of interior from south showing the original storey-posts, arch-braced tie-beams and clasped-purlin roof with the later aisles to right and left (removing the original wall studs).

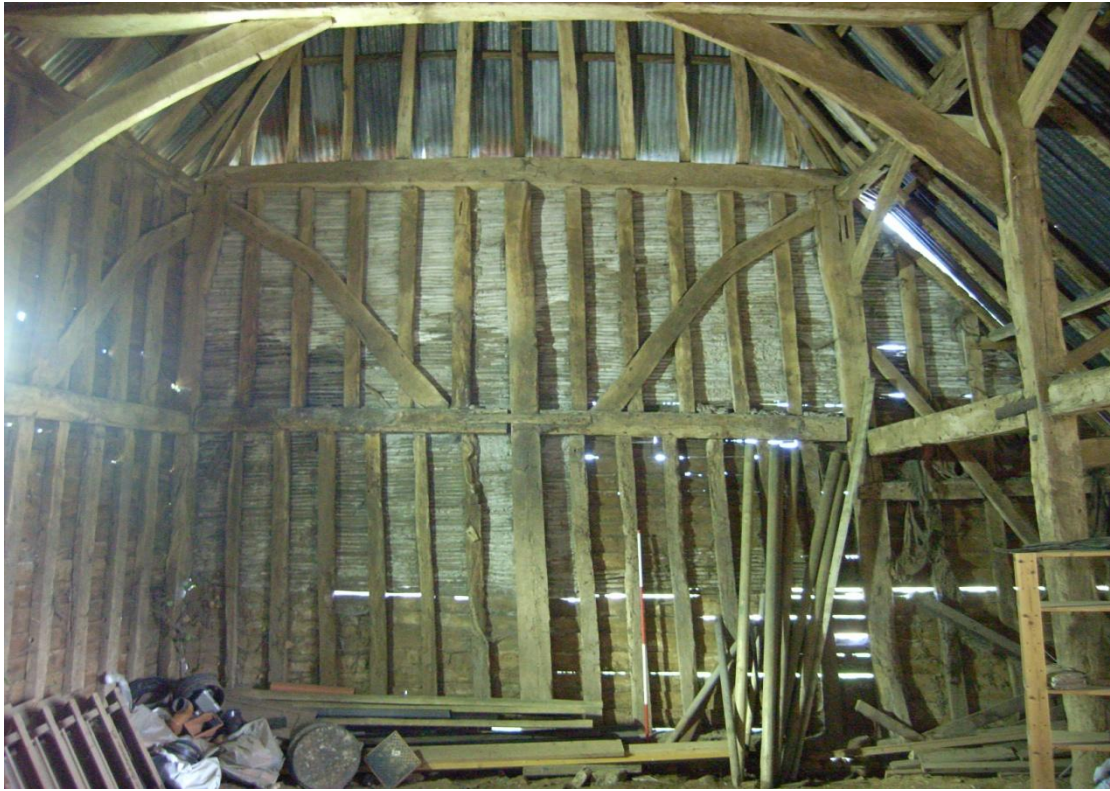
Illus. 7. Barn (1). Interior of northern gable showing original close-studding and internal bracing. This, and the two northern bays of the western elevation visible to the left, represents the only intact 16th century studwork in the barn. Mortises for the missing studs of the eastern elevation (removed when the aisle was added in the 17th century) can be seen in the roof-plate and mid-rail to the right.

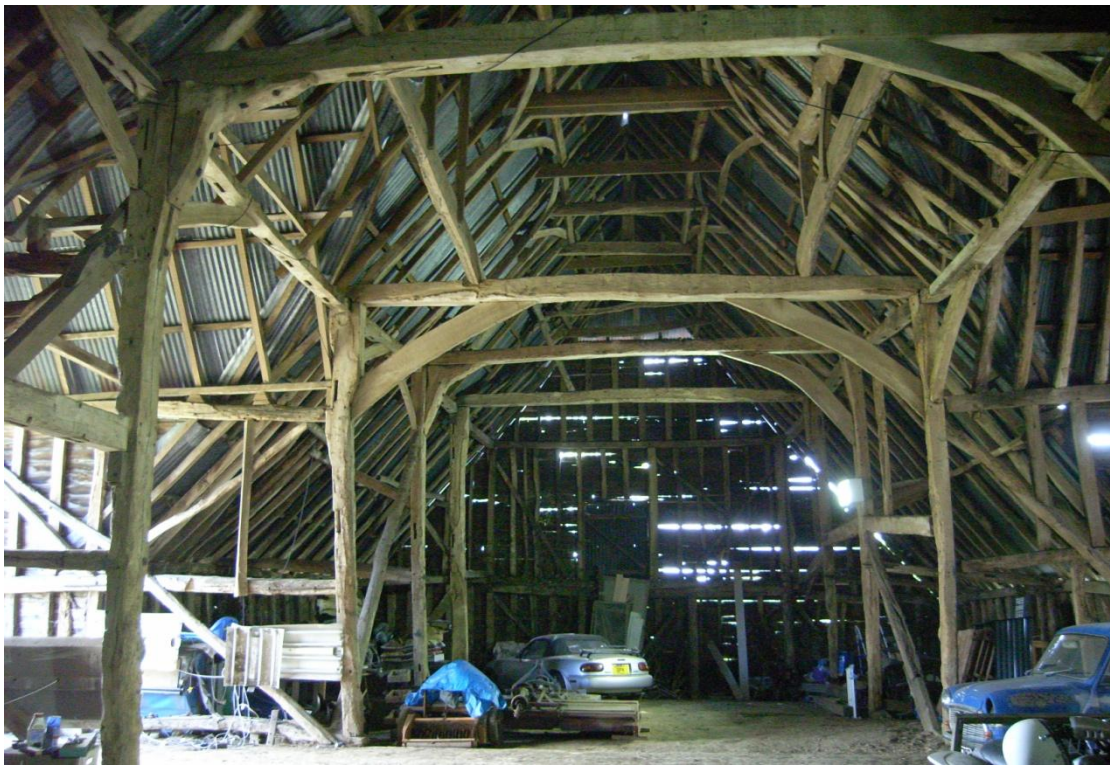
Illus. 8. Barn (1). General view of interior from north showing the original porch to right and the secondary porch & aisle to left.

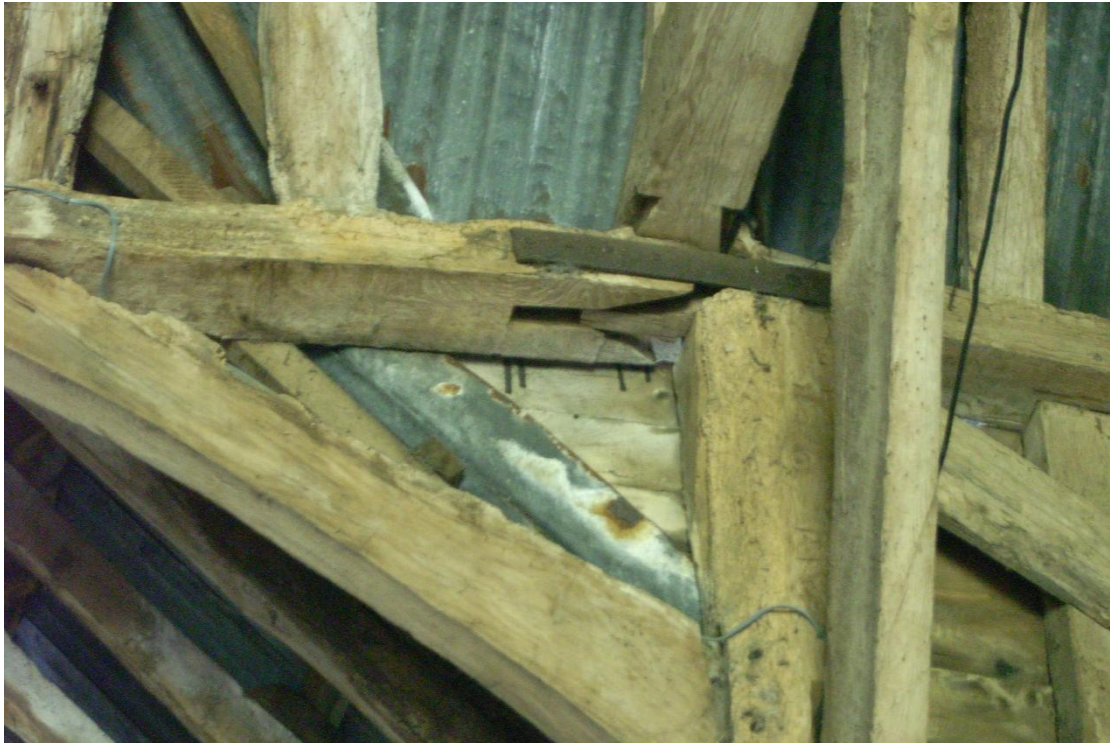
Illus. 9. Barn (1). Detail of an original edge-halved and bridled scarf joint with splayed abutments in the roof-plate adjacent to the western porch. The arch-brace to the roof-plate of the entrance bay (left) is also an original feature.

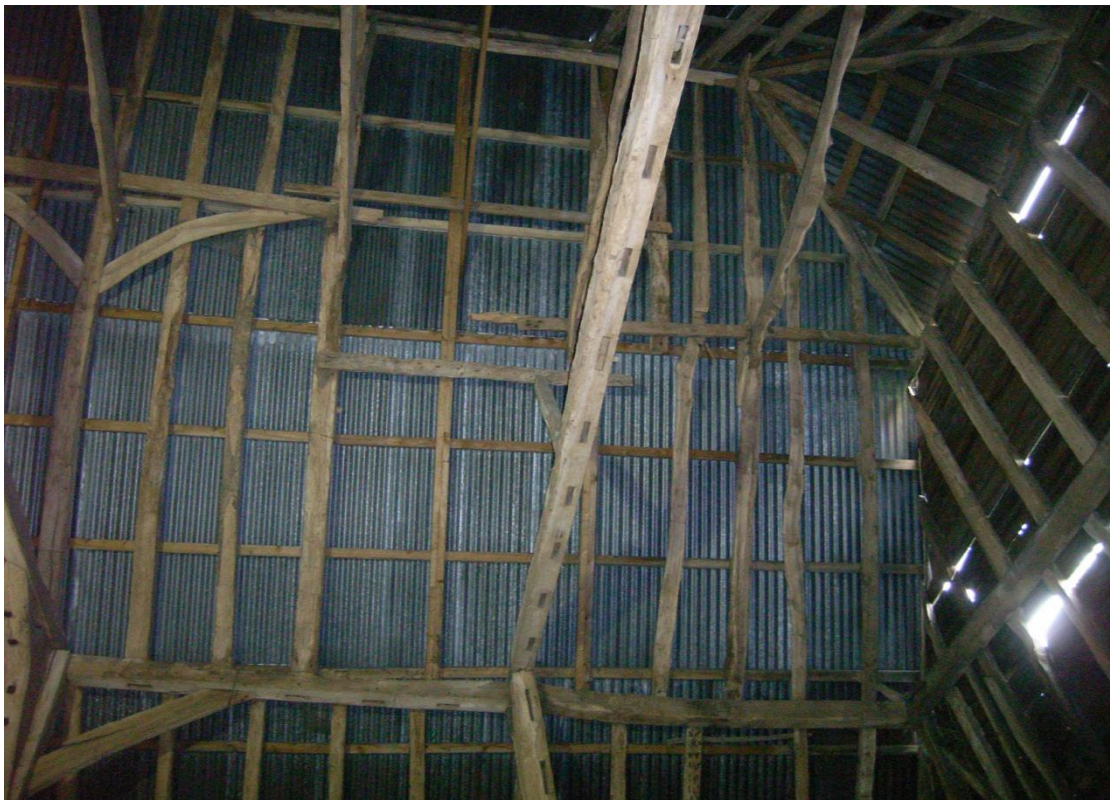
Illus. 10. Barn (1). The southern end of the clasped-purlin roof structure showing the original wind-braces and the tie-beam of the original hipped southern gable with mortises for the framing that was removed when an end-aisle was added in the 17th century. This end-aisle was later raised to form the additional bay visible to the right.

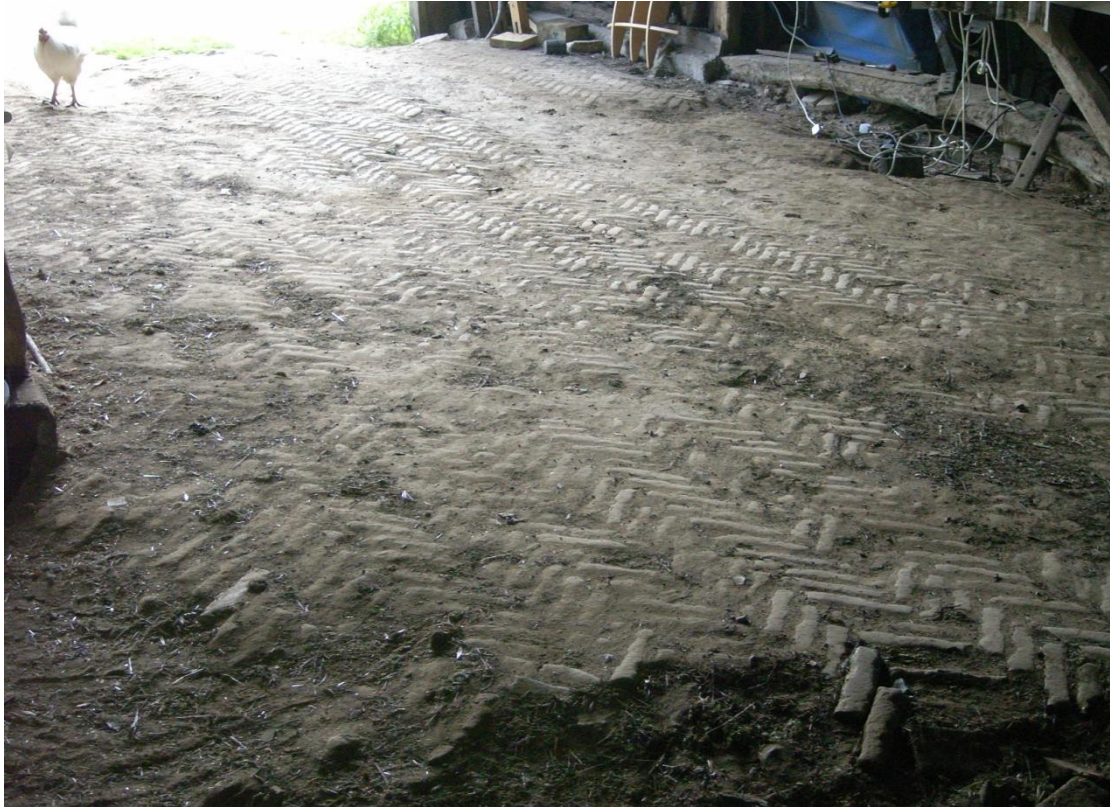
Illus. 11. Barn (1). Detail from east of the good 19th century threshing floor which extends into both porches. The bricks are laid in a herringbone pattern.

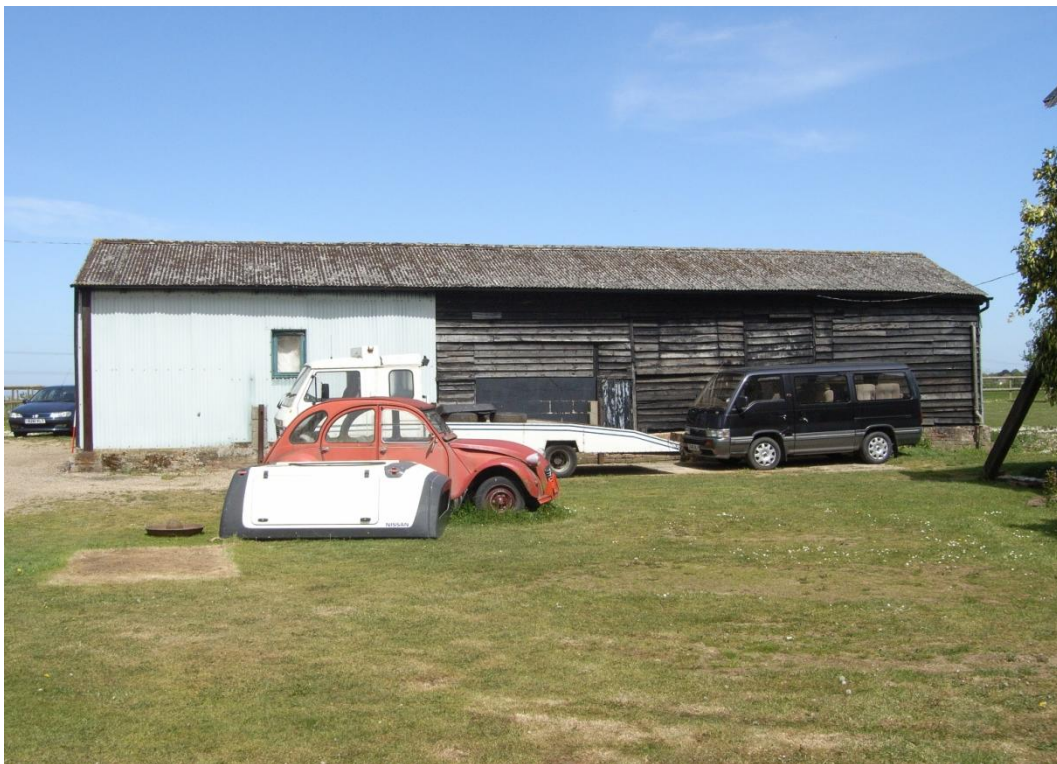
Illus. 12. Southern exterior of the rare but well-disguised early-17th century stable (2) seen from the yard and showing the late-18th or 19th century extension behind modern corrugated cladding to the left.

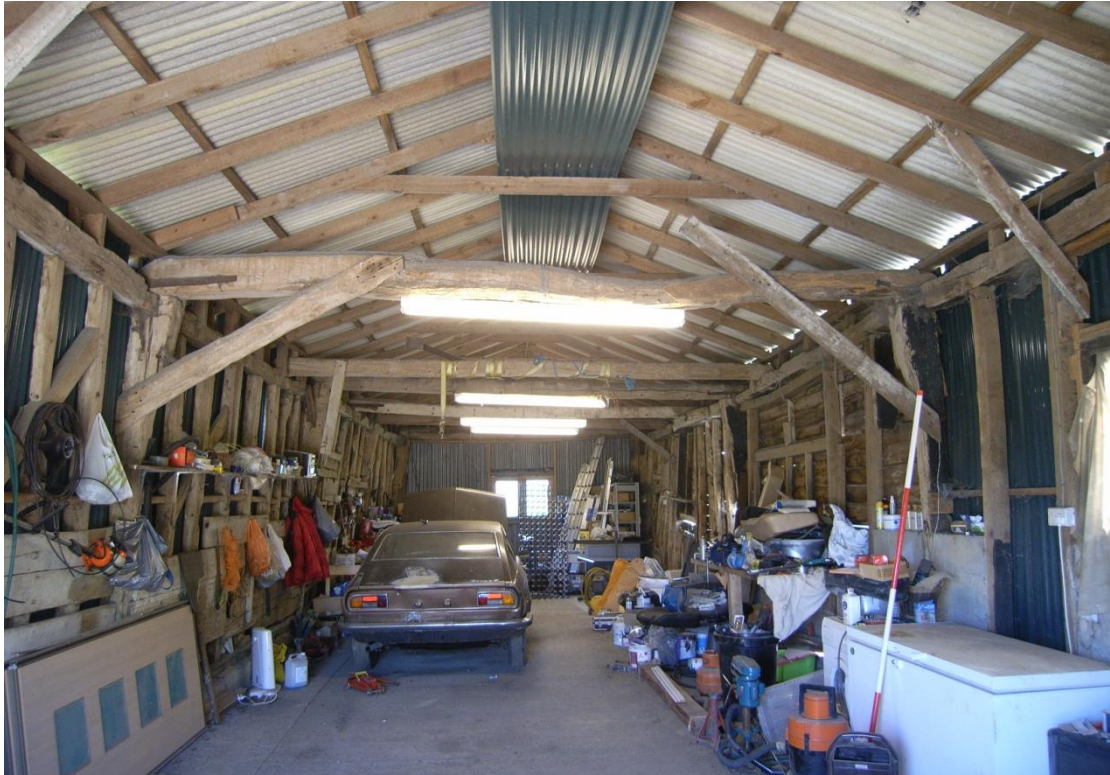
Illus. 13. Stable (2). General view of the interior from modern entrance in western gable showing 20th century softwood roof structure with well-preserved 17th century framing to right and left.

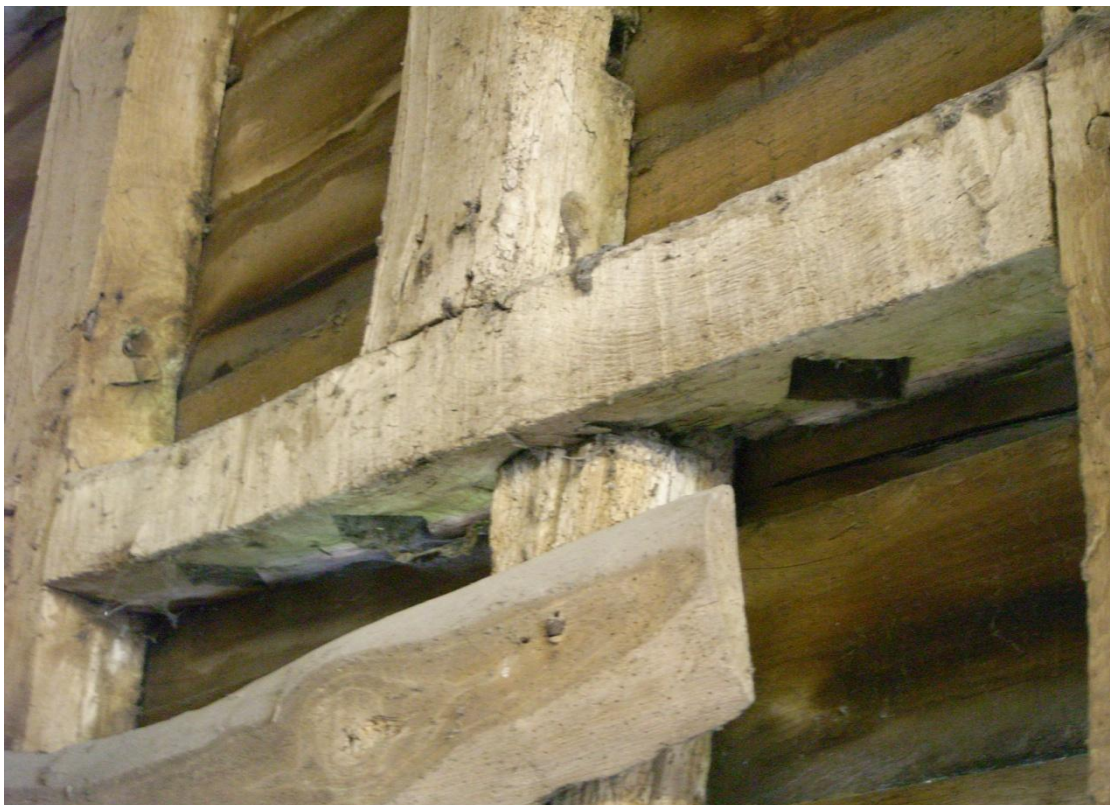
Illus. 14. Stable (2). Detail of diamond-mullion mortises in soffit of window sill in southern interior of eastern bay.

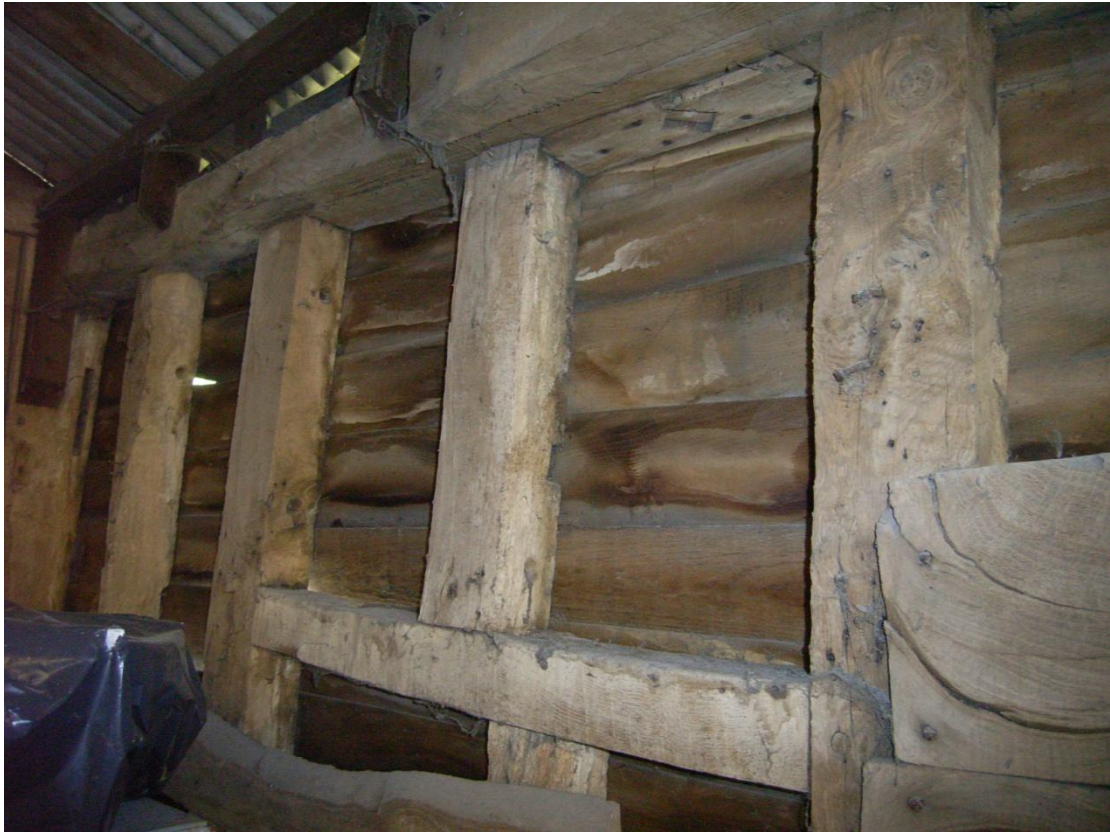
Illus. 15. Stable (2). Detail of secondary diamond-mullion lintel nailed beneath roof-plate in southern interior of eastern bay (immediately above the window lintel shown in illus. 14). This window would have served the missing hay loft

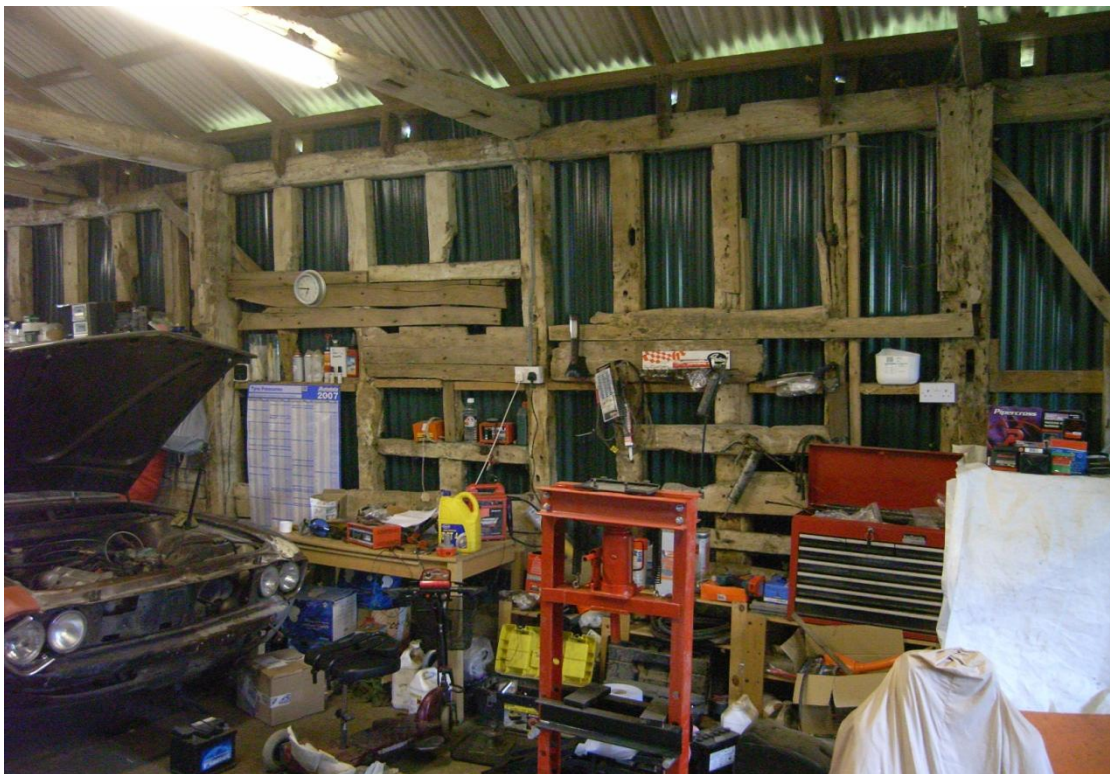
Illus. 16. Stable (2). Northern interior of penultimate eastern bay showing position of original stable entrance to right and original window to left.

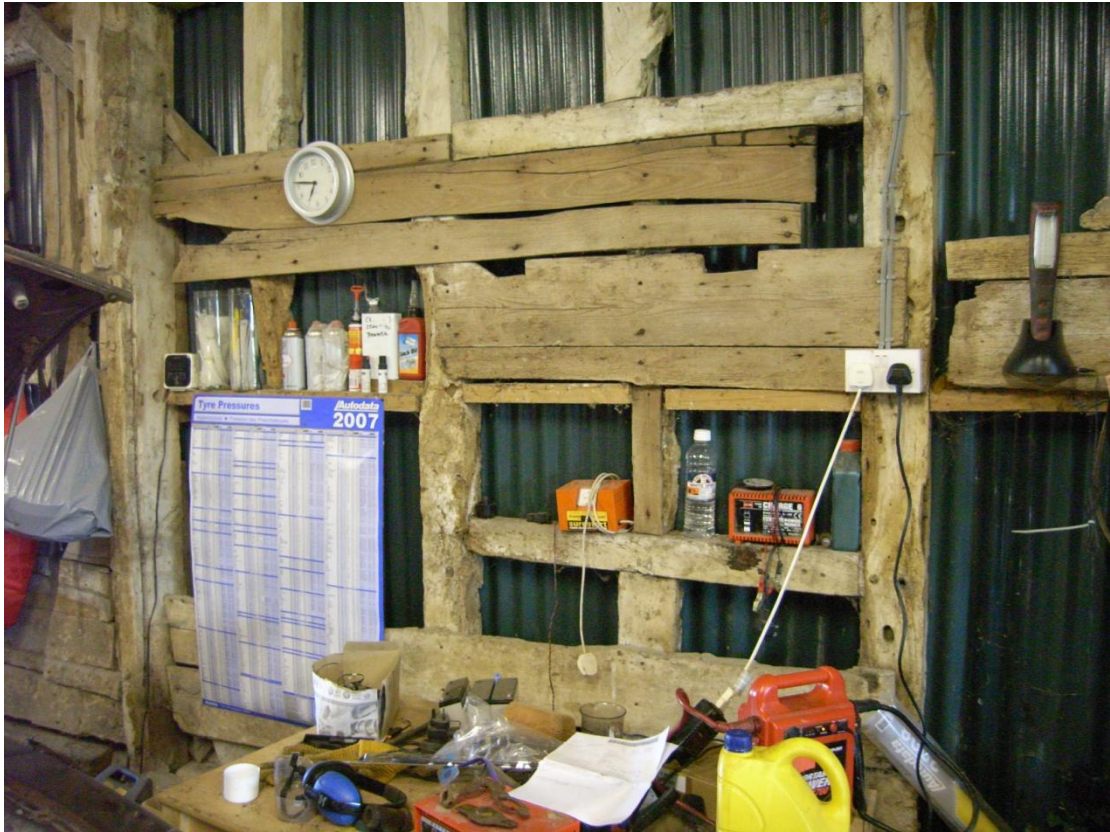
Illus. 17. Stable (1). Detail of the original window lintel and sill in the northern interior of the penultimate eastern bay, partly hidden by 18th or 19th century boarding.

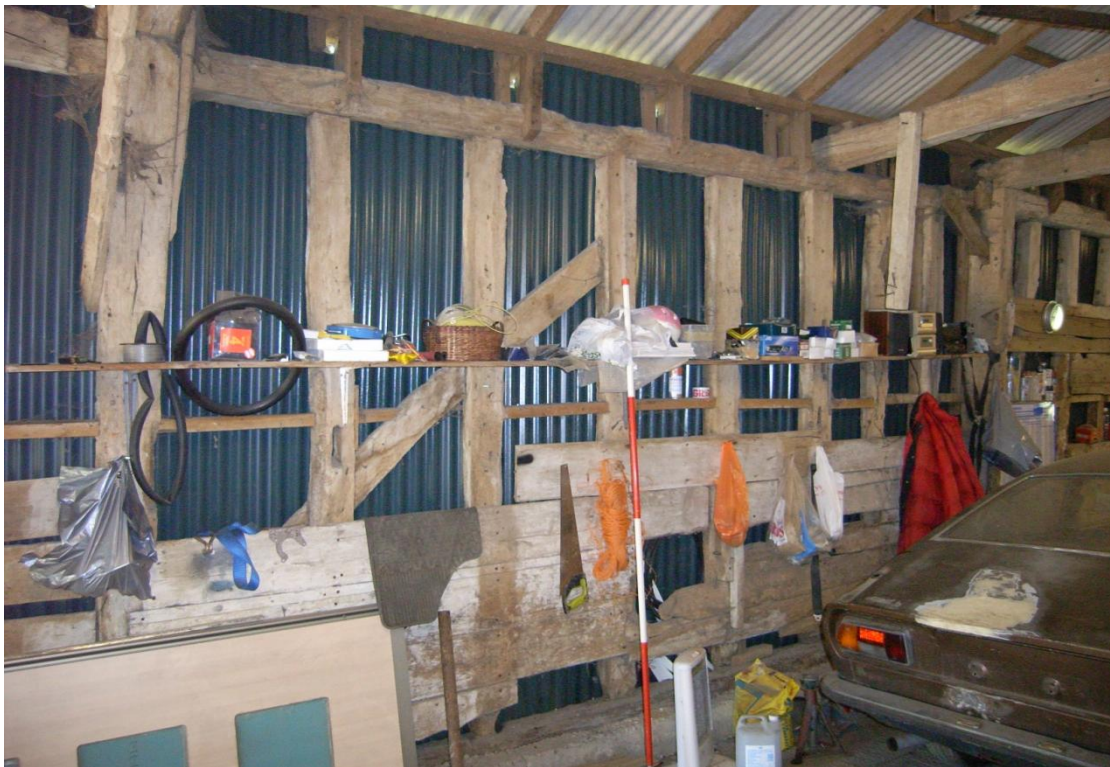
Illus. 18. Stable (2). Northern interior of central bay showing intact studs & eternally trenched brace of the mid-17th century extension, with the original stable's western gable to the right.
